Revisiting Solar Array String Failures on the International Space Station

Steven Korn
NASA Glenn Research Center
Space Power Workshop 2025

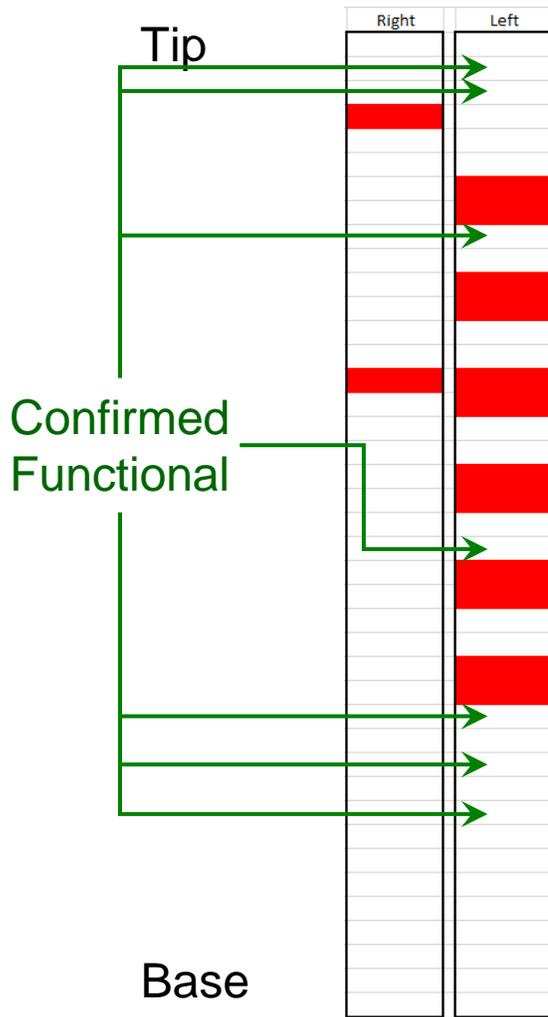
2022 String Failures, Damage

Arcing damage visible on inboard ribbon cable

Thought to be caused by MMOD

Twelve strings now unable to contribute power
