# NASA Exploration Toilet Hardware Technical Challenges and Accomplishments

**The Universal Waste Management System (UWMS), ISS operational nomenclature “Toilet” was initially installed on the International Space Station (ISS) in 2020 with final installation completed in 2021. Technical progress continues to be made with each on-orbit operation and will ultimately culminate with nominal US crew use of the hardware on ISS.**

**During 2024, another attempt was made to perform the Artemis II Demonstration on ISS with a re-flight of the Dosing Assembly using original components. This paper discusses the issues encountered when the Dosing Assembly failed to dispense pretreat as well as a subsequent failure to start of the UWMS and the on-orbit troubleshooting resulting in the removal and return of the controller. A summary of ground troubleshooting of the controller (which is the Orion common controller used in the Orion vehicle for numerous systems) as well as planned repairs is discussed. An updated design of the commode seat and fecal bag for Artemis-2 UWMS was demonstrated on ISS and a summary of the hardware, results and selection of seat for use on Artemis-2 is included in the p

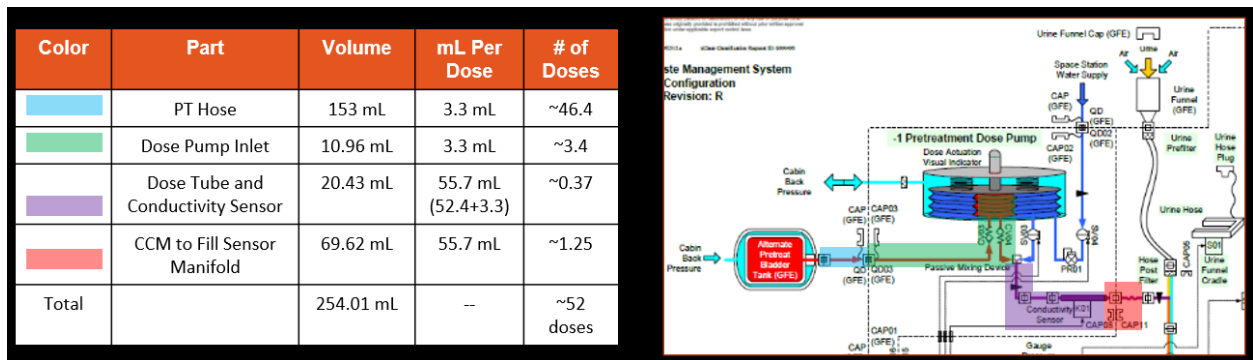
Figure 6. Volume and number of doses needed to purge UWMS of pretreat lite.

doses of 3.3ml each would be needed to fully purge the system and begin acceptable dosing with the mixture of pretreat concentrate and water, as shown in Figure 6.

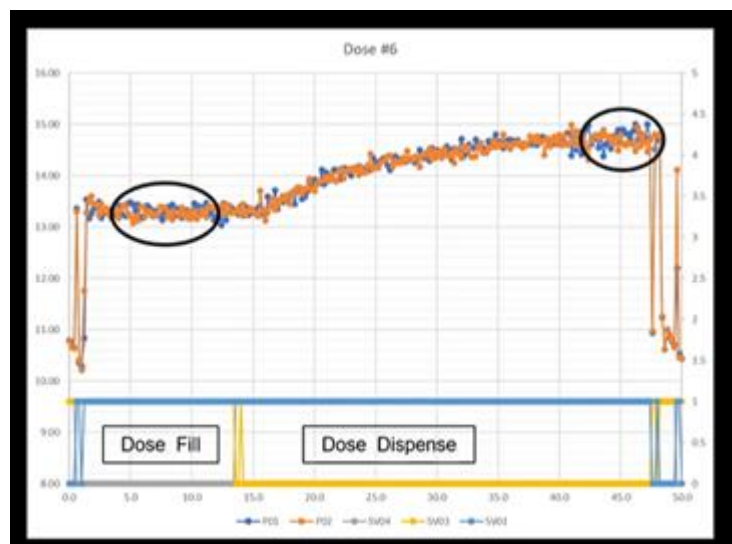
Figure 7. Ideal profile shown from GMT 294, dose 6.

compared to known values based on volume and density of the fluid (noted as the separator delta-pressure). Ideal profile is shown in Figure 7 which shows pressures recorded during dose fill and dose dispense.

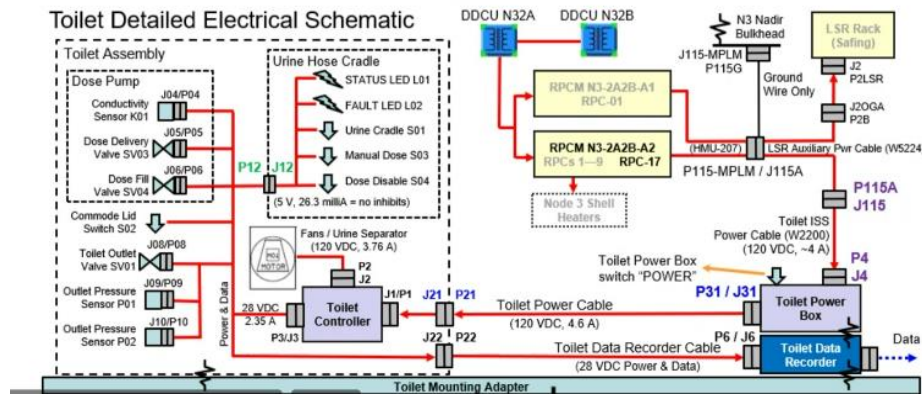
Further testing included testing to ensure power was being applied to the pressure sensor circuit. During the start-up sequence, power was not seen going to the pressure sensors. Testing with the sensor removed from the circuit had no impact on the conditions, prompting the conclusion that the sensors themselves were not causing the trip. (See

Figure 11. Toilet schematic from JSC's training materials.

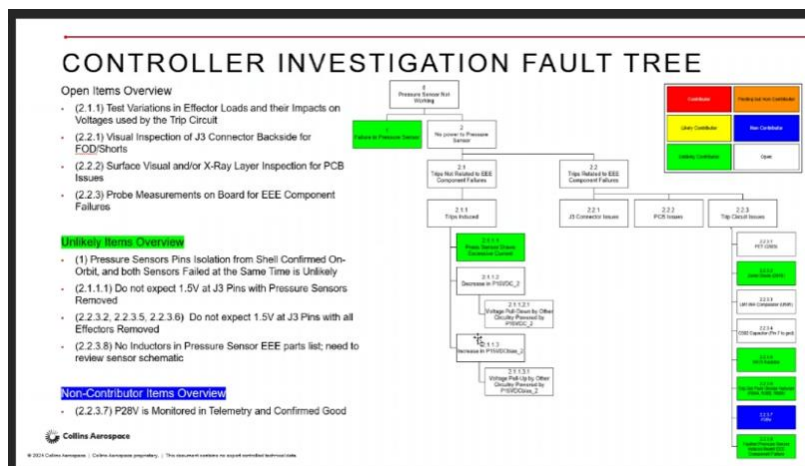
A theory that other effectors in the schematic might be causing an impact resulted in attempting startup testing with the effectors removed from the circuit. All but the motor effectors were removed with no impact. And finally, all including the motor were removed with no impact. Additional UWMS troubleshooting repeated readings made during previous troubleshooting. Resistance readings did show low resistance (~8.7, 9.3 k-ohms) which was 0.01k-ohms previously. Voltage readings were 1.47 Volts on the circuit with all effectors (pressure sensors, cradle, and conductivity sensor) removed and only the motor in the circuit. Measurement of resistance was then repeated with all effectors including the motor removed and the readings were essentially the same. This indicates an issue in the controller in the pressure sensor excitation circuit. Testing on the ground is needed to determine root cause, see Fault

Figure 12. Fault Tree developed by Collins for the controller failure on ISS UWMS.

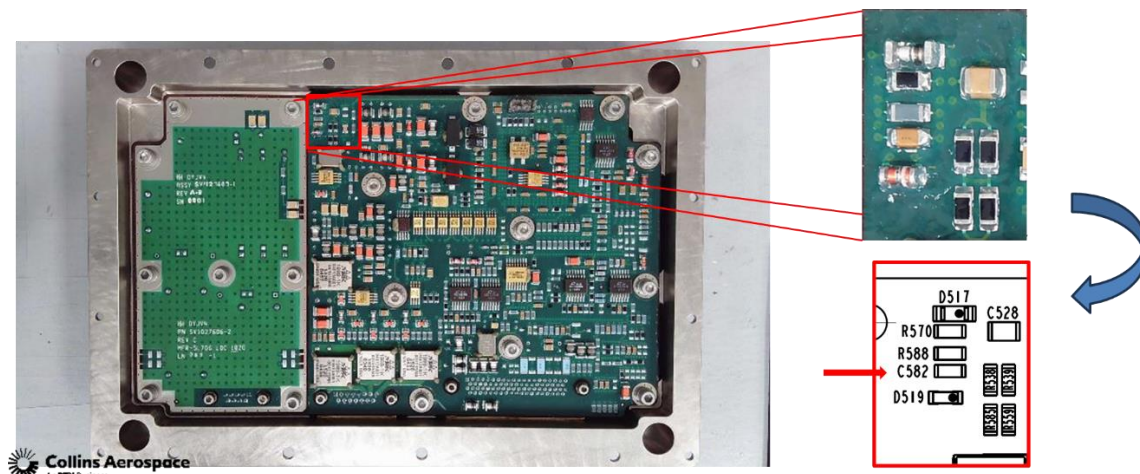
Testing on the circuit board showed a current backflow towards the comparator which should not be occurring. The comparator was suspected as being failed and causing a current leakage. Circuit analysis simulation models by the NASA Engineering and Safety Center (NESC) understand why the comparator could fail came up with 3 theories, 2 of which based on the test data were ruled out. #3 was to be checked after part removal. The flight controller was received at the Collins Windsor Locks facility in mid-November 2024. A Tiger Team convened at the facility to begin troubleshooting to determine the root cause of the failure. The cover was removed to reveal the secondary side. Photos were taken of the board and then a visual inspection was completed, with no findings (Figure 13).

**Figure 13. Photos taken of the UWMS Controller Board (at Collins Windsor Locks facility). No anomalies identified.**

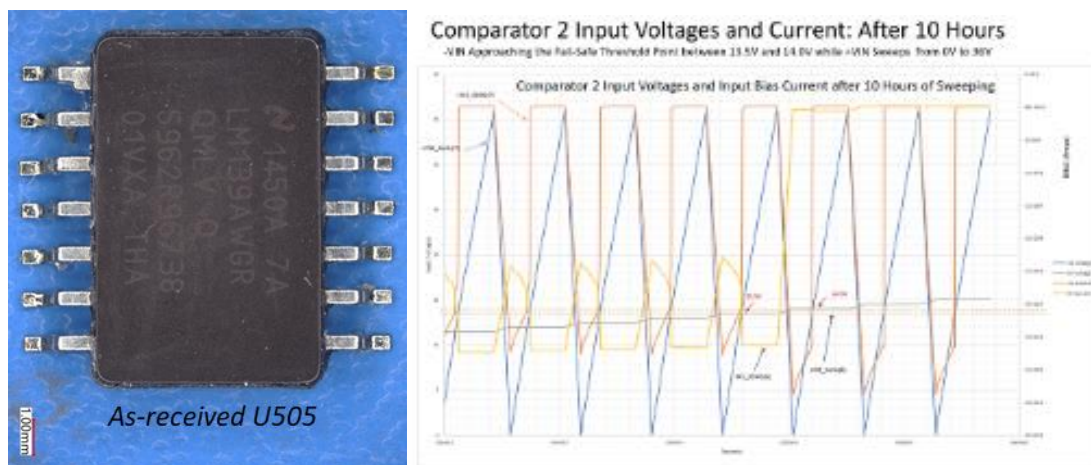
Optical and x-ray tests were completed and didn't show anything "too terribly anomalous." Electrical testing of the comparator at GSFC showed nominal performance compared to a pristine part and is not manifesting the problem seen on shutdown (Figure 14.) There was slight damage noted on one of the pins. Based on the testing it was determined the comparator LM139A, U505 was not the source of the excess current through the 1k $\Omega$  resistor R570.

**Figure 14. Comparator 2 input voltages and current after 10 hours.**

removed indicating the comparator was not the source of the leakage. Testing isolated the source to a capacitor in the circuit. Collins testing of the capacitor showed leakage current of 270 microamps.

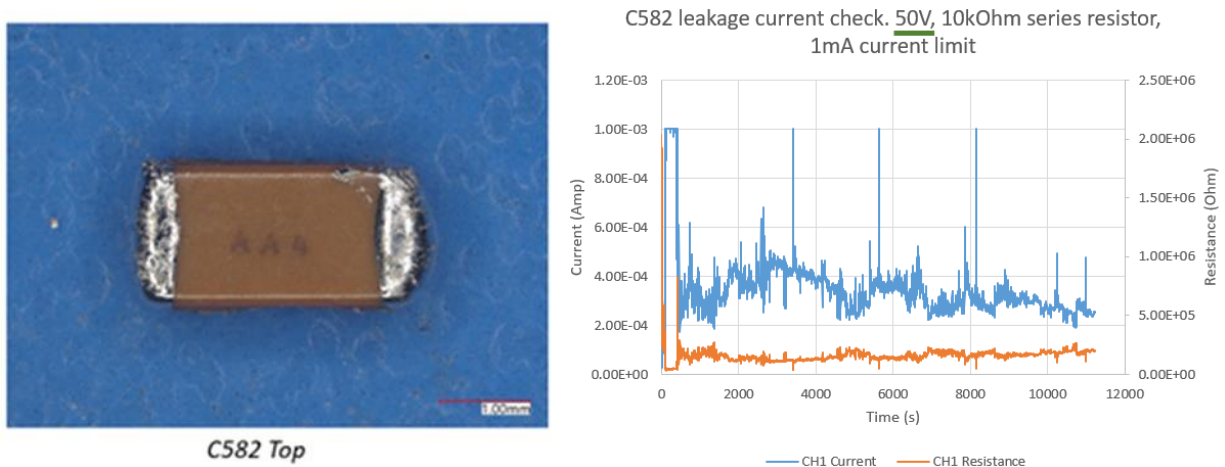
The subject matter expert at GSFC provided details on what could be causing leakage current to increase voltage to the comparator causing a trip. Dendritic growth could be providing a media for current to flow thru. This could be at a crack in the capacitor or in the board itself. The crack may be a defect or could have been a workmanship issue caused by rework on the board during testing in 2019. The C582 capacitor was sent to GSFC for failure analysis, and it was shown to have off-nominal leakage current, indicating a low/unstable insulation resistance, see Figure 15. Removing C582 from the circuit showed the leakage was no longer present.

**Figure 15. C582 leakage current check.**

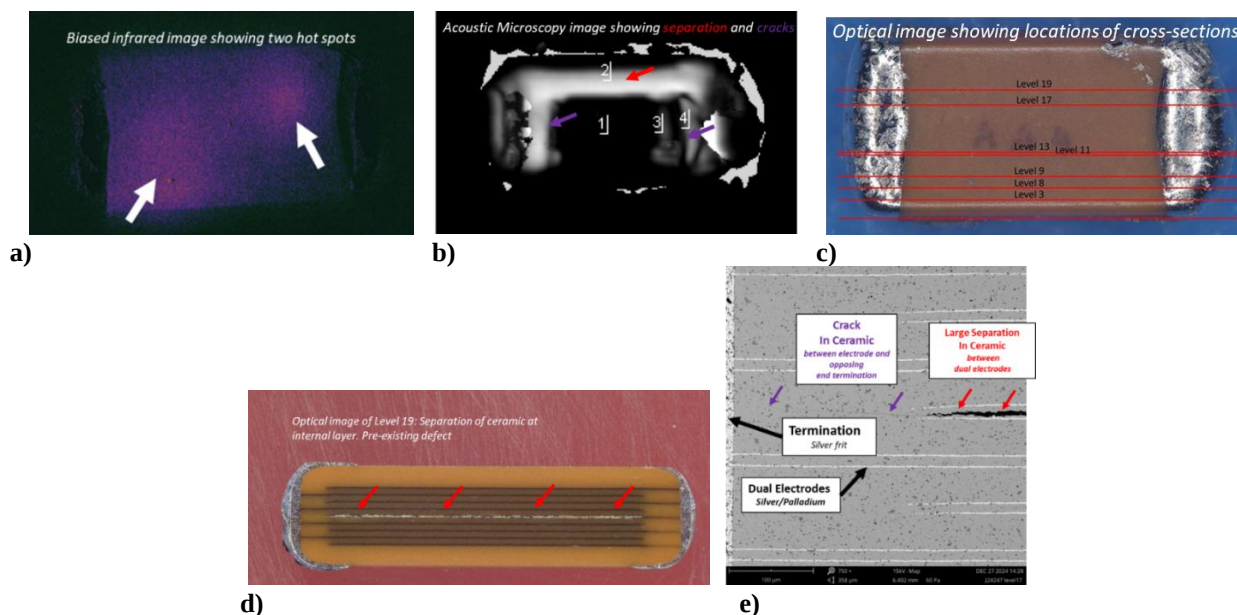
The GSFC team concluded via acoustic microscopy and sectioning of the capacitor that the internal delamination is most likely a pre-existing defect as-received from capacitor manufacturer. NOTE: Acoustic Microscopy is not a required screen for “CDR” capacitors. Per GSFC SME experience/feedback, even nominal stresses associated with part assembly, thermal and mechanical environments, and voltage application, may contribute to a delamination becoming an internal crack in the ceramic dielectric material spanning between opposing electrodes/terminations.

**Figure 16. Details of testing of C582 at GSFC, a) Hot Spots during infrared testing, b) acoustic microscopy showing separation and cracks, c) cross-sections, d) details of separations of ceramics at internal layer, e) scanning electron microscope image at level 17 of a crack.**

Biased operation over time most likely lead to electrochemical migration (ECM) of silver from the electrode and/or termination metals in the form of “dendrites” along the crack surfaces. Dendrites develop erratically leading to variable and generally decreasing insulation resistance failure modes. Figure 16 shows the results of the testing at GSFC.

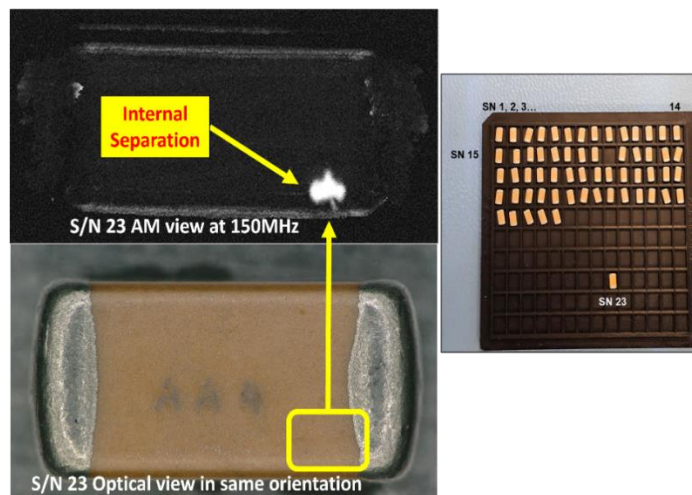
The lot date code of the failed capacitor was identified and 61 remaining parts from that lot were in inventory. Jet Propulsion Laboratory (JPL) performed acoustic microscopy on these parts and revealed an internal separation (void and/or delamination) defect in one of the parts, see Figure 17. Investigation showed that a total of 1914 parts were received by Collins from this lot. The parts were located on the ISS UWMS, Orion Artemis-2 board and other hardware on the Artemis-2 vehicle supporting life support hardware.

Investigation is in progress on the locations within these boards and potential impacts of a similar outcome as the capacitor on the ISS UWMS board. Corrective actions are currently to be determined based on conclusion of the evaluation of the probability and impact of the capacitor failures. Root cause of the “failure to start” event of the ISS UWMS was determined to be a single part failure (capacitor) in the controller and although the defect rate for the lot was higher than expected, a higher failure rate was not seen.

**Figure 17. Testing at JPL of remaining parts in the lot.**
