# History of 14x22 Fan Blade Maintenance

59<sup>th</sup> Meeting of the Subsonic Aerodynamic Testing Association

14- by 22-Foot Subsonic Wind Tunnel

NASA Langley Research Center

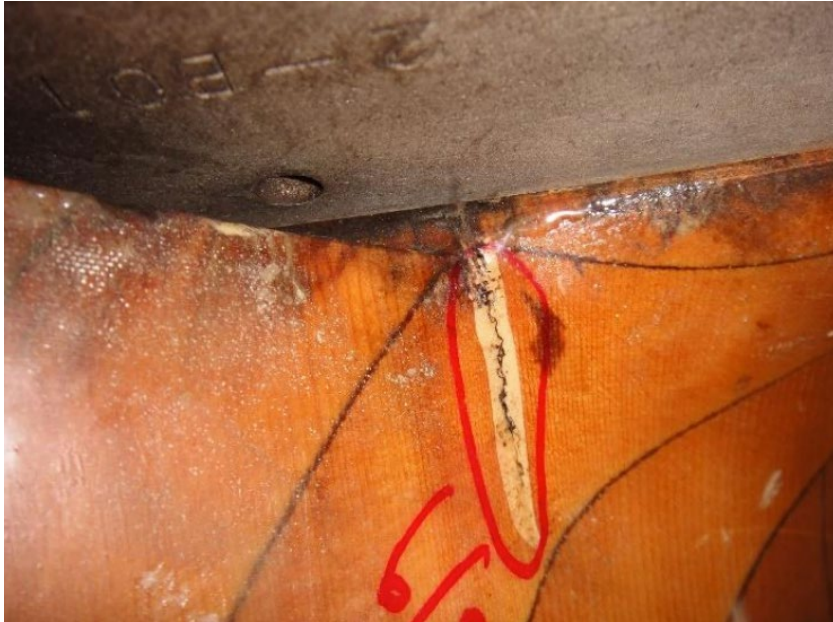
Crack found during 2018 inspection

GACO Coating  
Damage from Window

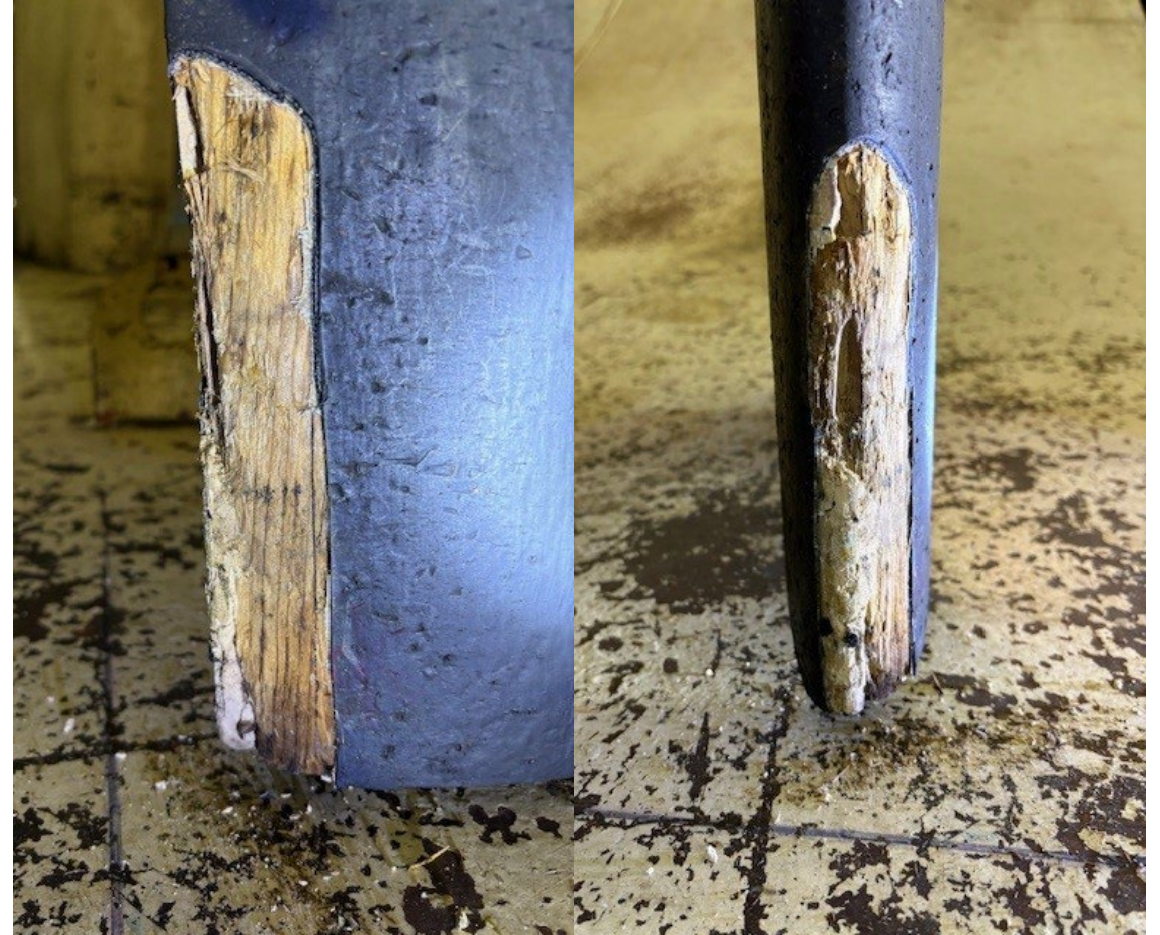
- During daily checks, it was noticed there was a soft spot underneath the Gaco coating on the leading edge of blade 1
- Model shop was called to inspect the area
- After removing the coating, more extensive damage was discovered
  - Evidence of moisture damage and dry rot
- Repair was done with the blades in place
- The model shop recommended a more thorough inspection of each blade during the next blade removal
- Longer term repair can be completed with better access to area

Leading Edge Damage 2024

1. Removed Celastic and GACO coating from leading edge
  - Approximately 8 inches from the blade tip
2. Removed compromised wood using a Dremel tool with a rough spur bit
3. Area was cleaned with acetone and a clean rag
4. Evercoat Lite-Weight body filler was used to fill voids from where wood was removed
5. Once fully cured, the filler was sanded smooth to reshape the leading edge
6. Three layers of 0.005” thick fiberglass (style 1522) was applied with West System 205 resin/206 hardener
7. One additional layer of fiberglass was applied on top
8. Two coats of GACO rubber were applied to the surface

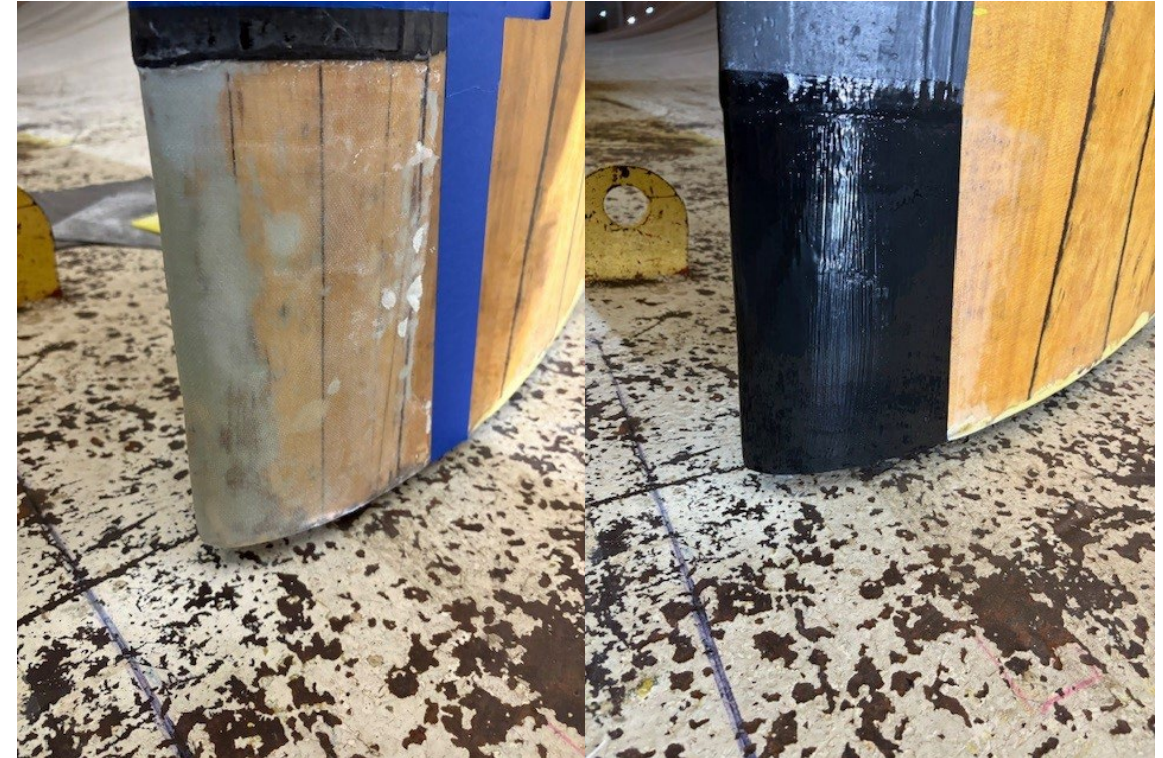
Fiberglass Repair

GACO Application
