# CT Scanning of Commercial Cells for Space Flight Applications

IAPG CWG Safety Panel Meeting

David Delafuente, NASA JSC

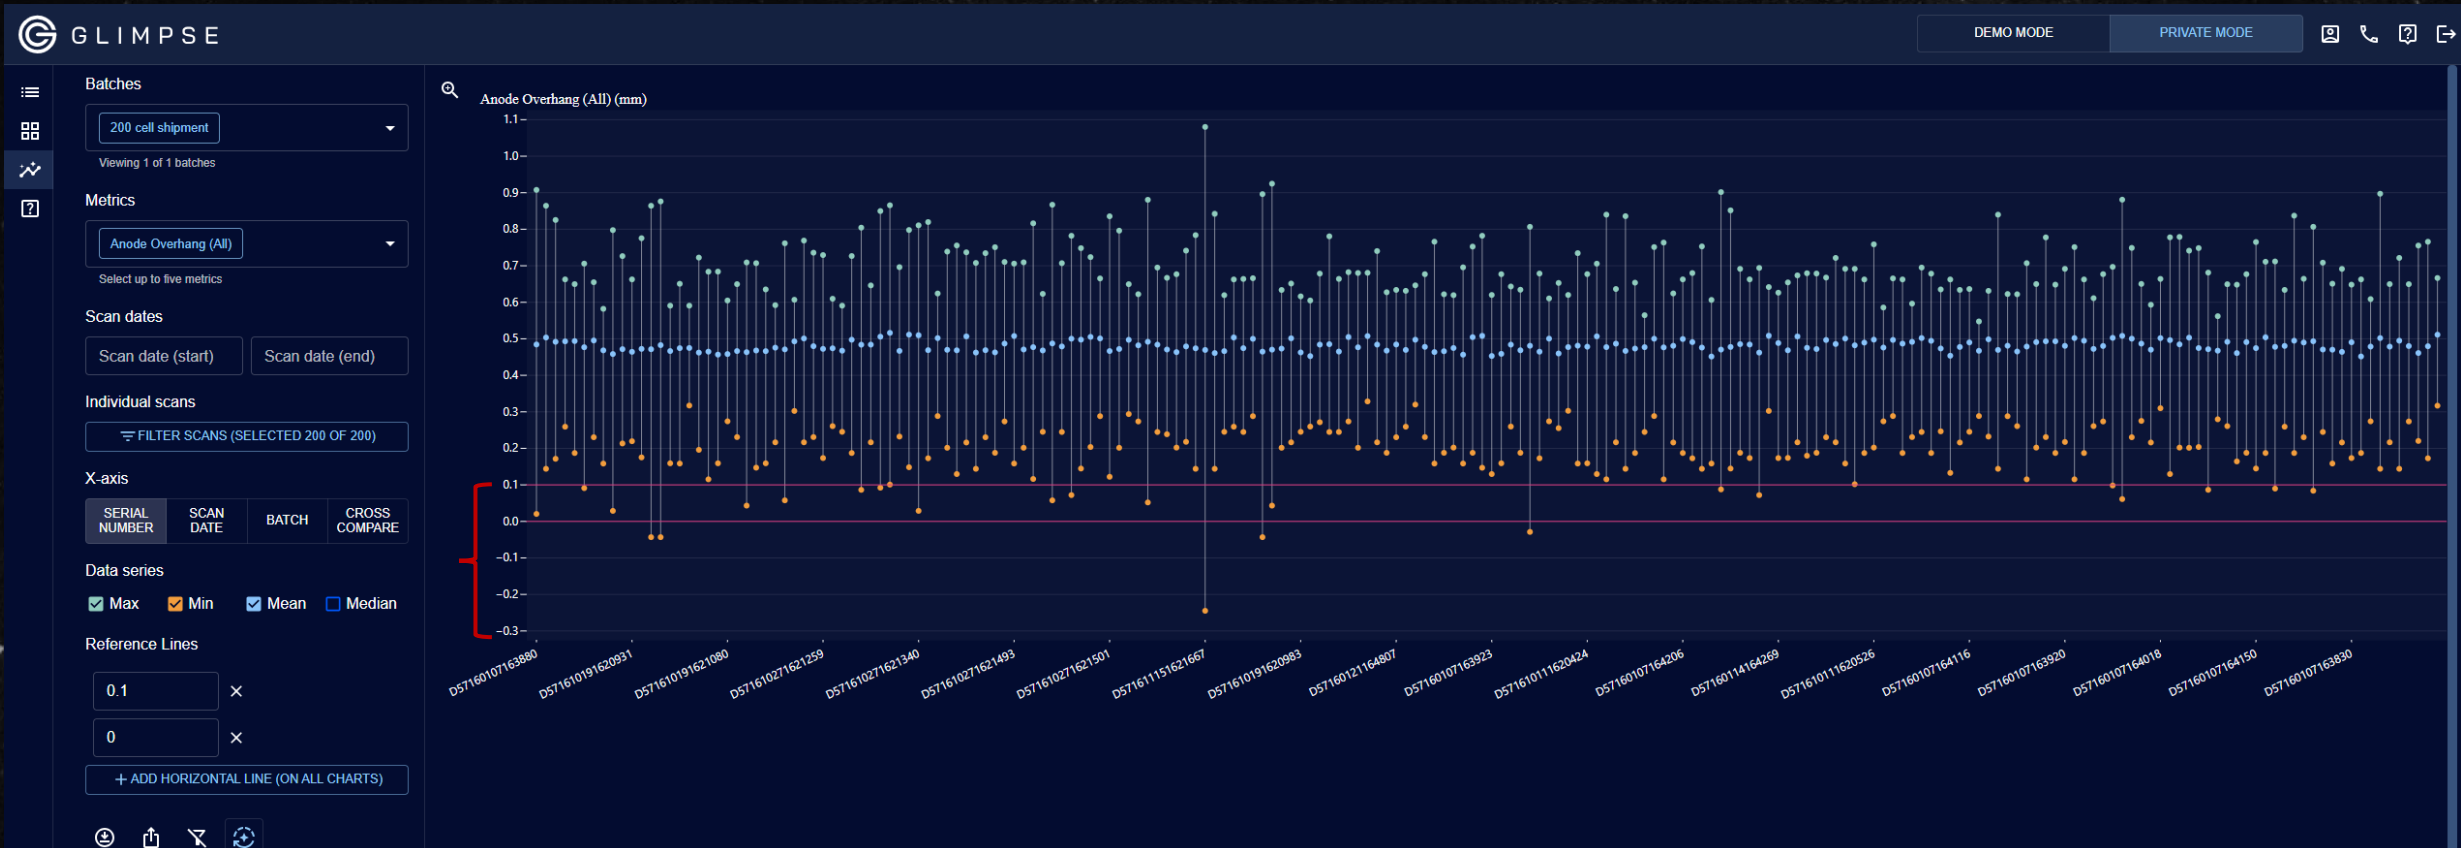
# Anode Overhang Results

- Industry standard IEEE 1725-2021 for minimum anode overhang to the cathode is 0.1mm
- 5 cells with negative anode overhang (below the 0.0 line)
- 19 cells with less than the industry standard for anode overhang (between purple lines)
- 12% of the cells do not meet the industry standard

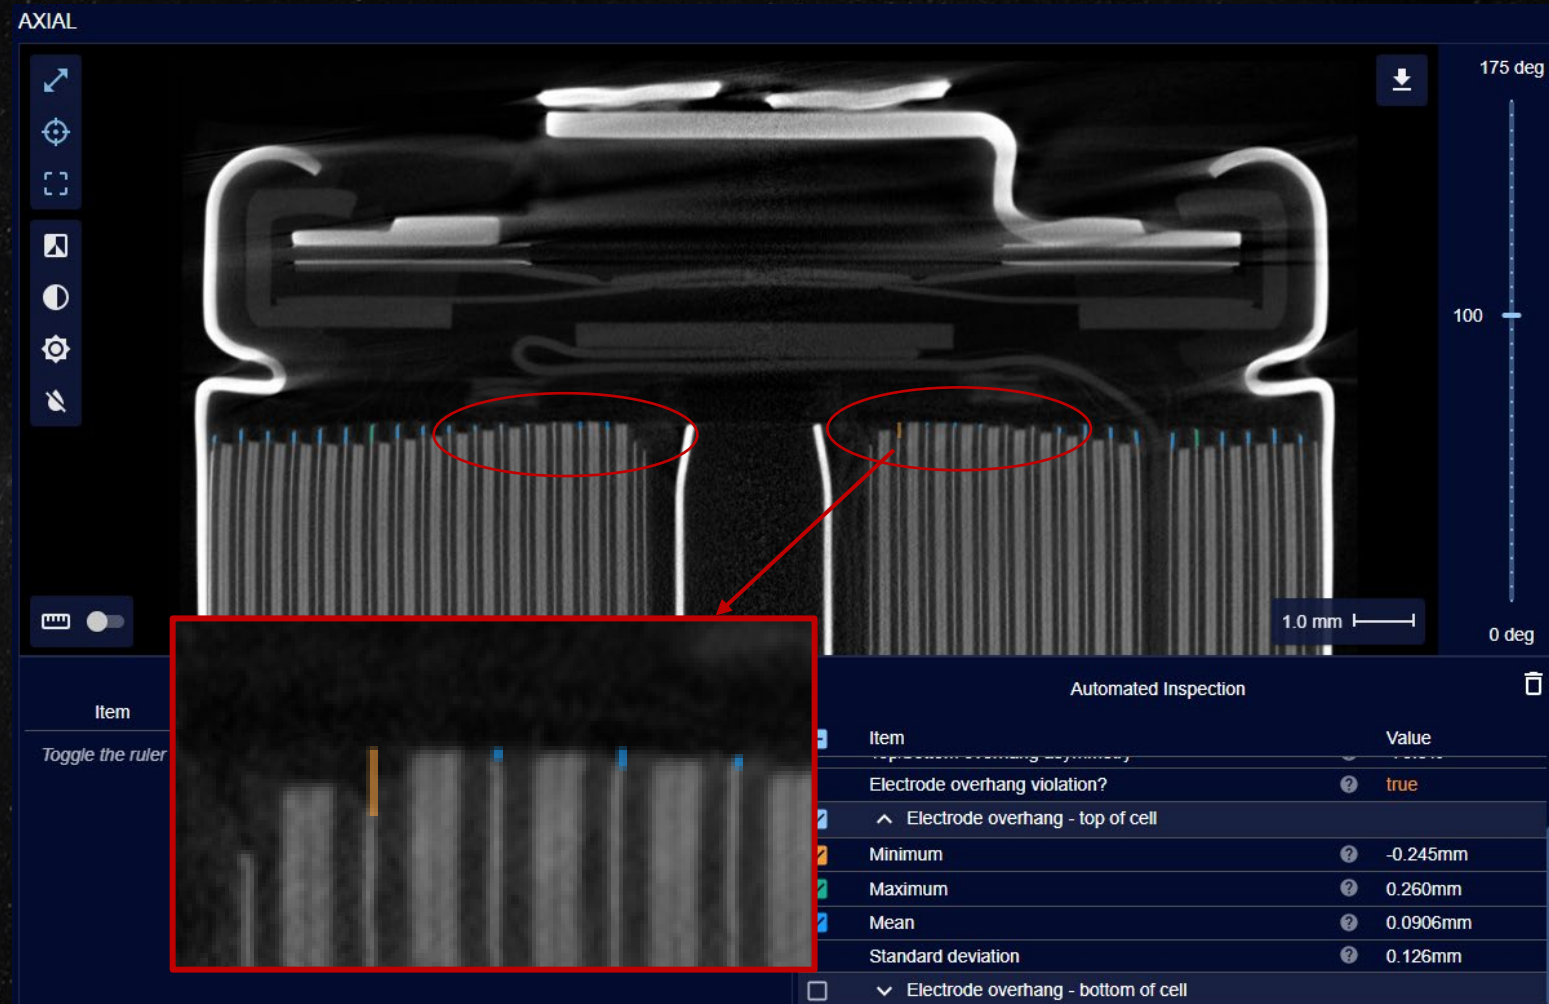
# Negative Anode Overhang, 1569

- Cell 1569 exhibited the greatest negative overhang at -0.245mm
- Industry standard for 18650 cells is a minimum 0.1mm positive overhang of the anode
- No corresponding cathode across from the anode causes lithium plating and dendritic growth which can lead to internal shorts
- The telescoping of the jellyroll occurs generally during assembly of the cell
- Cells are under internal pressure, and the jellyroll is taped tightly to prevent moving
- Vibe testing of 18650 cells following SAE J2380 is 100k mile driving equivalent without any damage or displacement of the jellyroll including the Panasonic NCR18650B cell\*

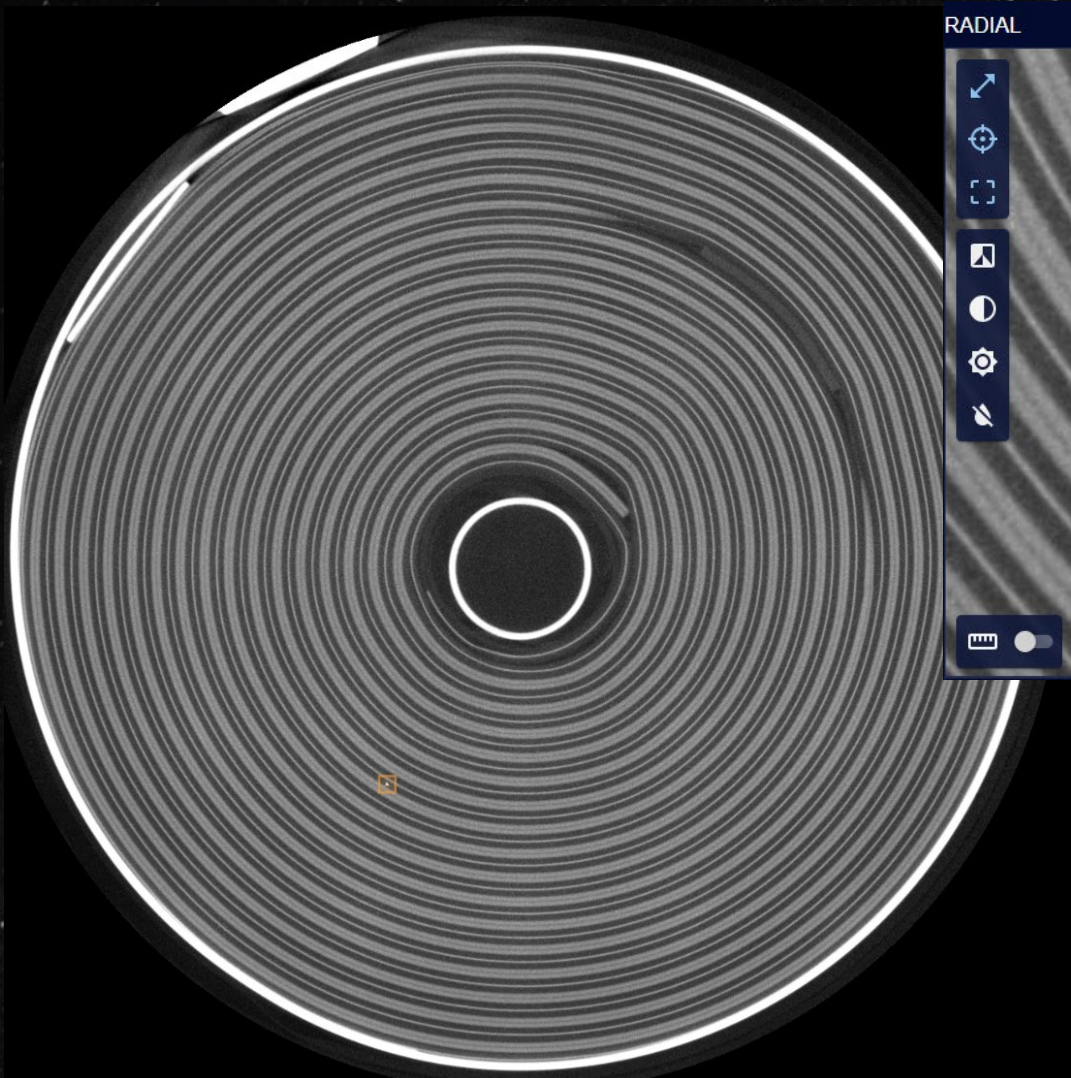
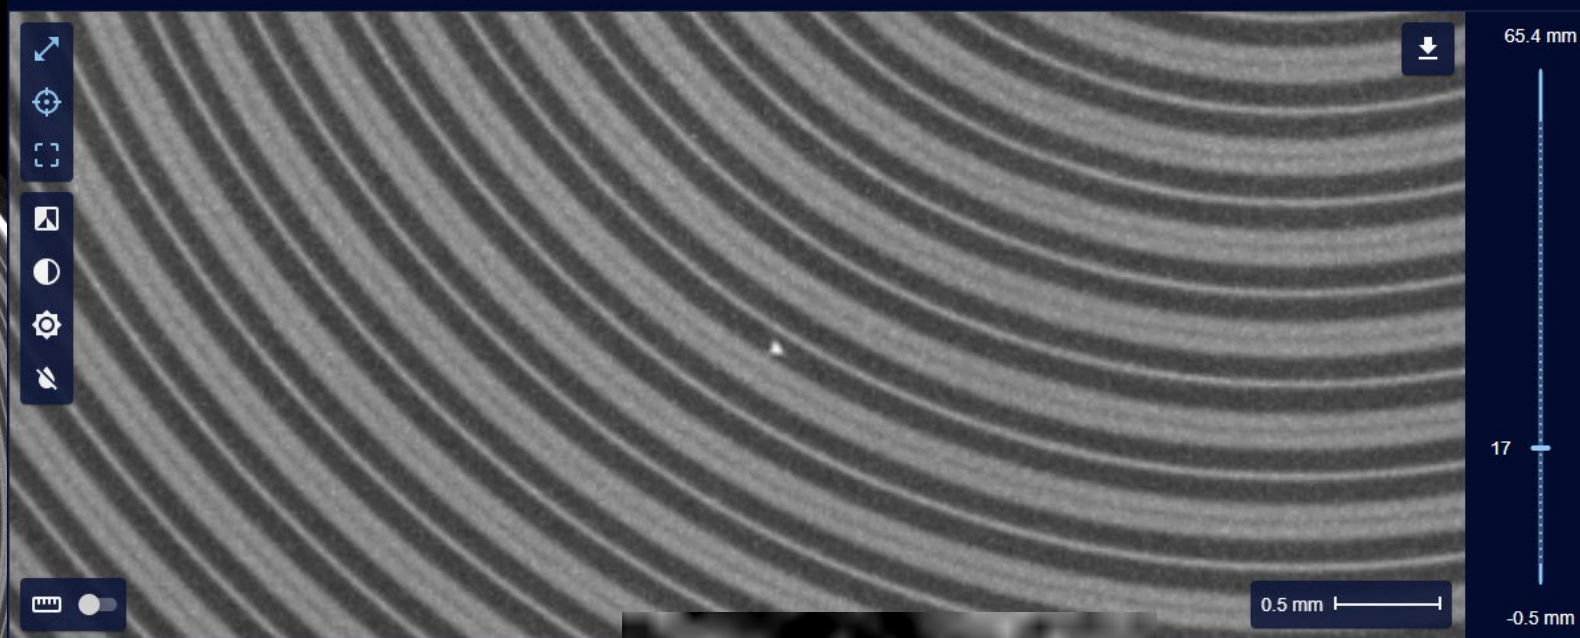
# Scan 1506

~50 $\mu$ m in size

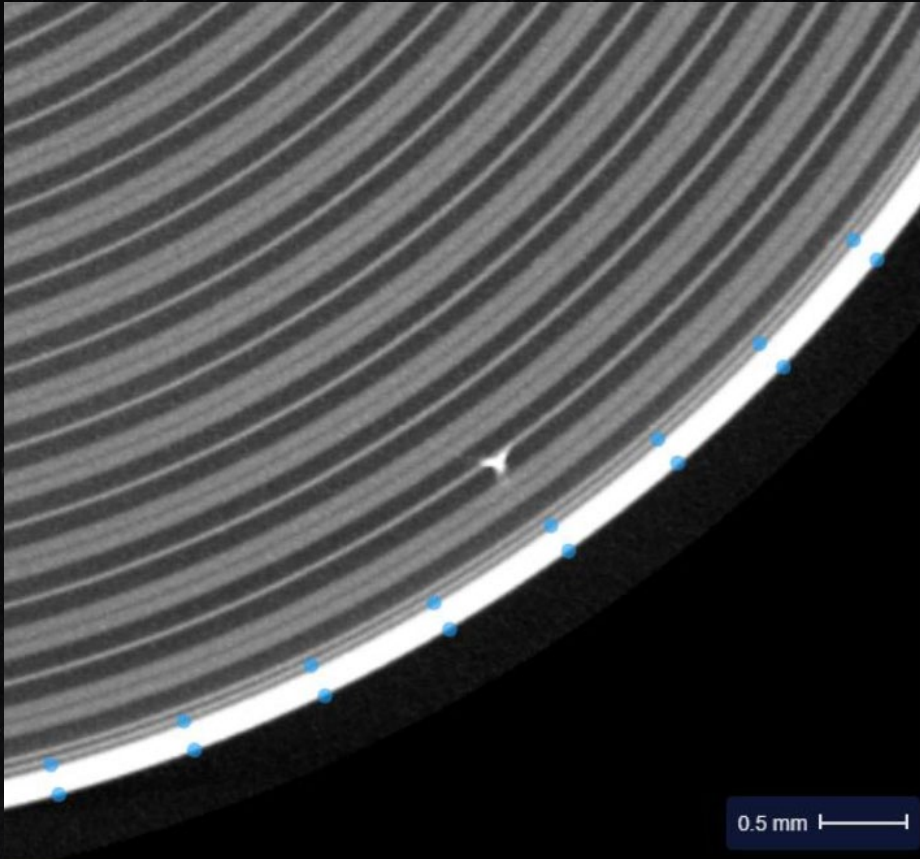
# Scan 1517

~180 $\mu$ m x 120 $\mu$ m x 60 $\mu$ m in size

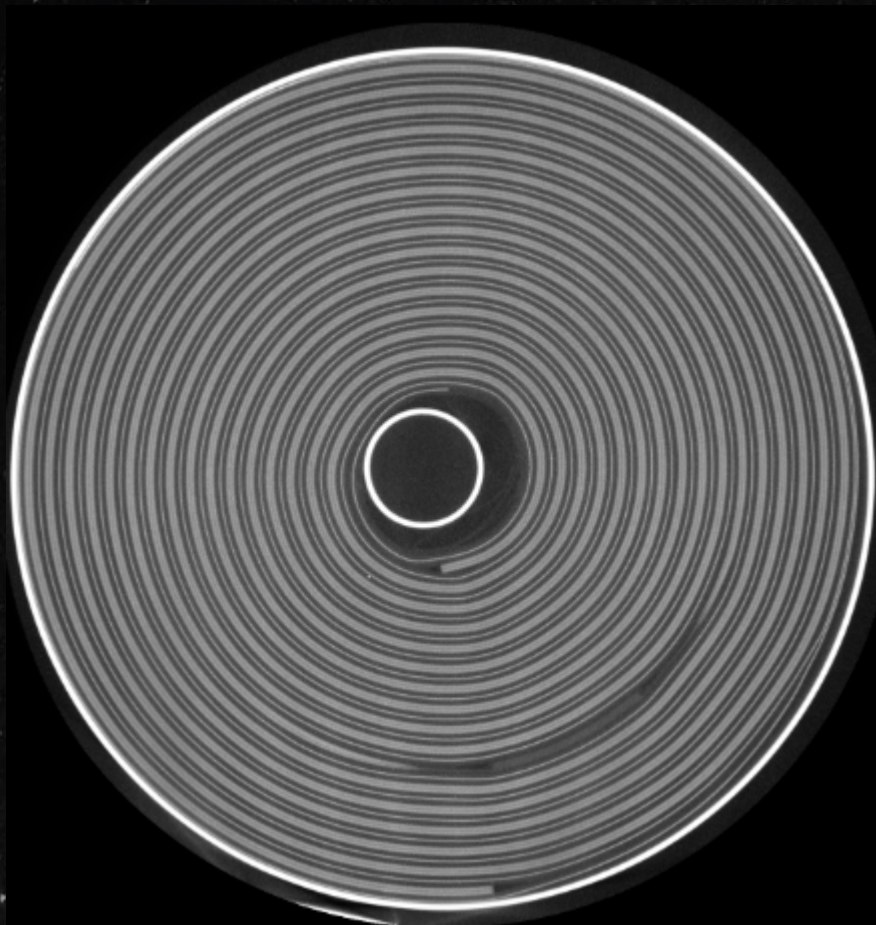
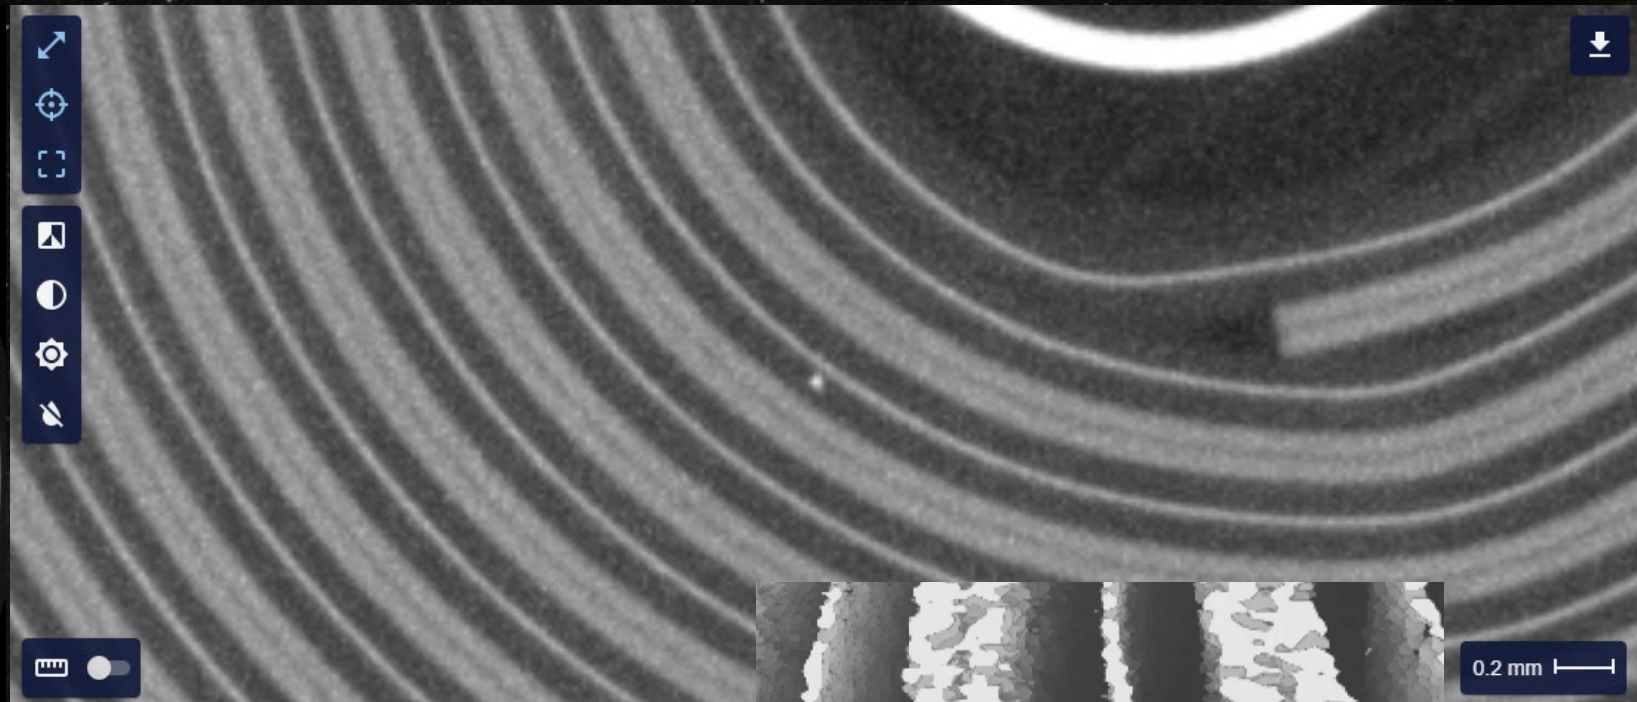
# Scan 1571

~60 $\mu$ m in size

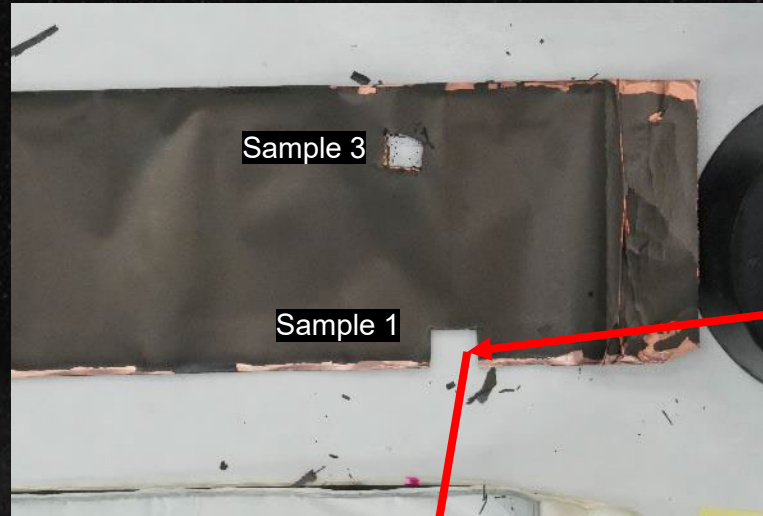
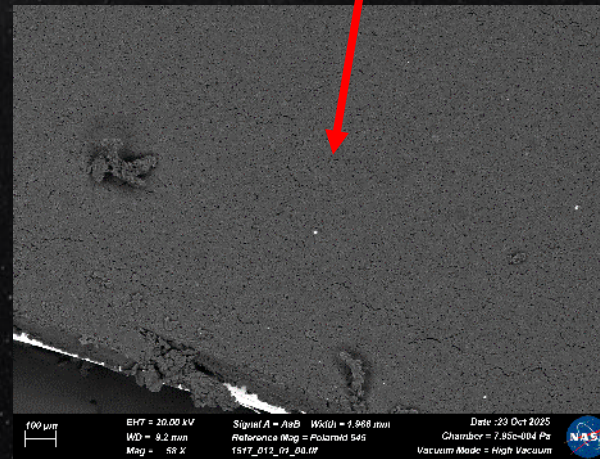
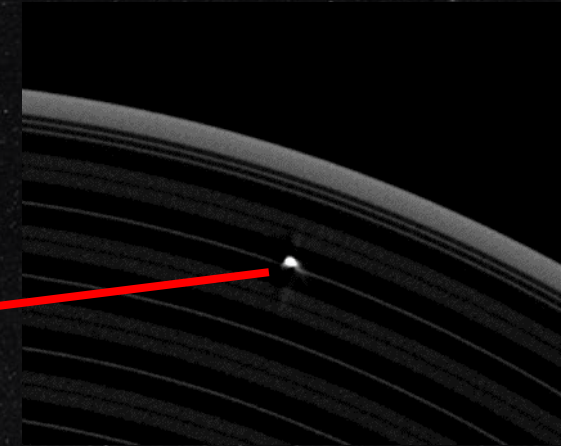
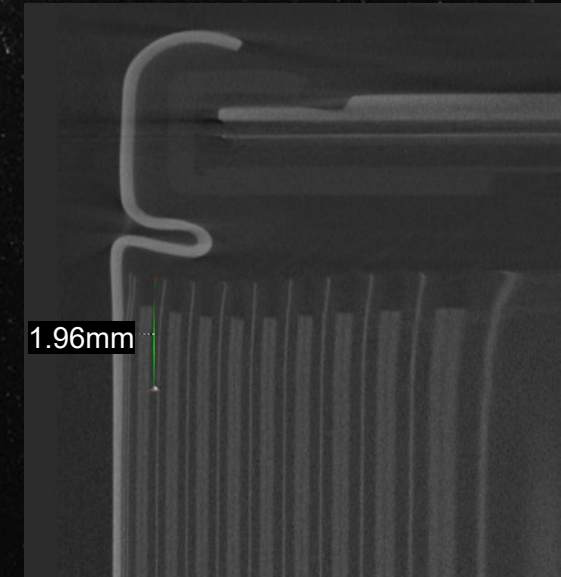
# Cell 1517, Sample 1

- CT Scan found metallic particle
- Sample 1 taken to search for this particle based off where it should be in cell
- Nothing was found matching CT scan
- More noticeable particle seen on Sample 3, on opposite side of cell

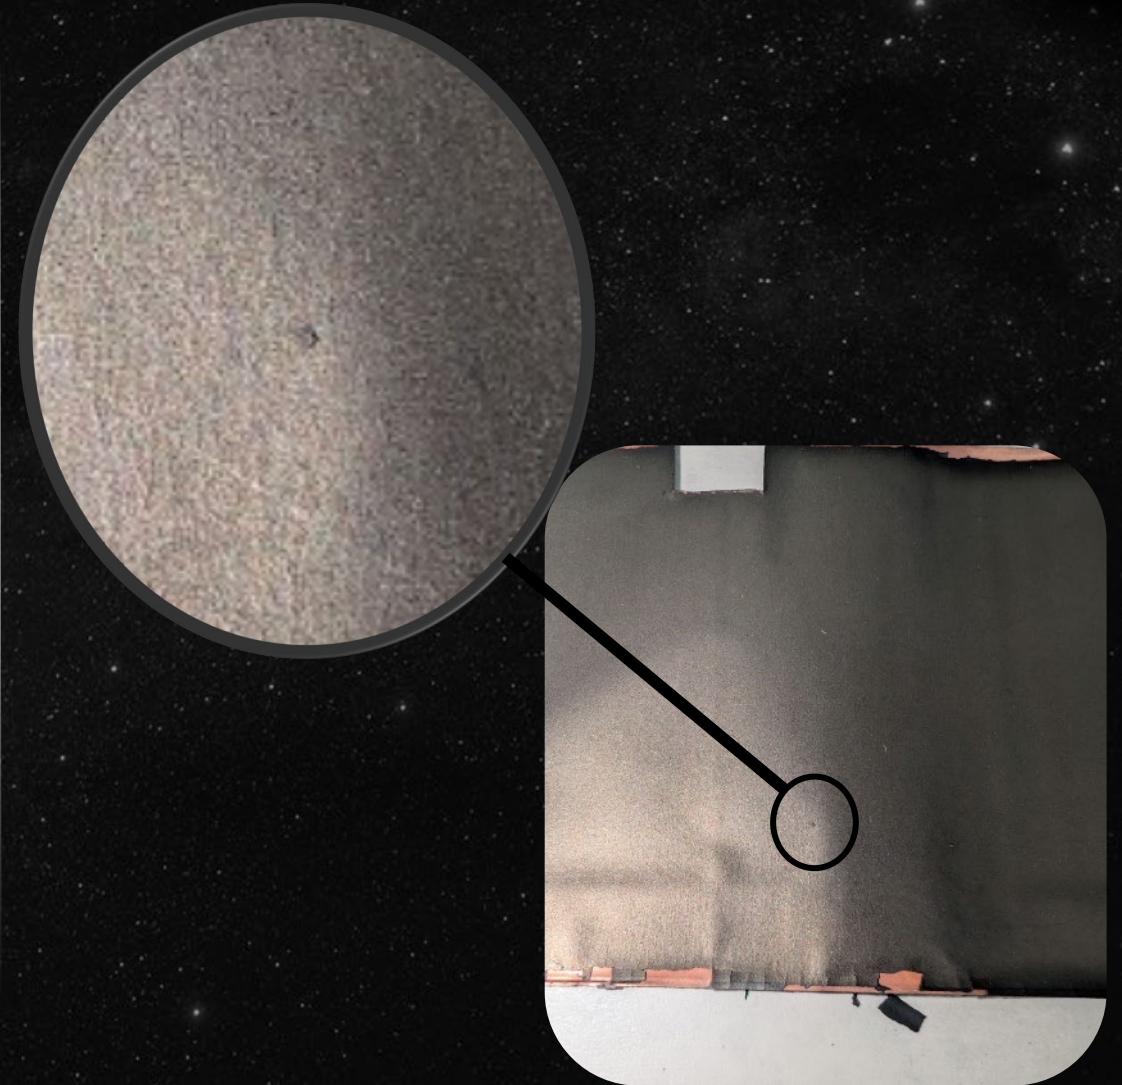
# Cell 1517, Sample 3

- Small bump seen on Anode Side C
- Not seen in CT scans
- Perhaps there was somehow a migration from one location to another? Seems unlikely
- Unlikely to be FOD from DPA process or something that fell on this while unrolling jellyroll. Saw this right as jellyroll was unrolled
- SEM & EDS seen in next slides

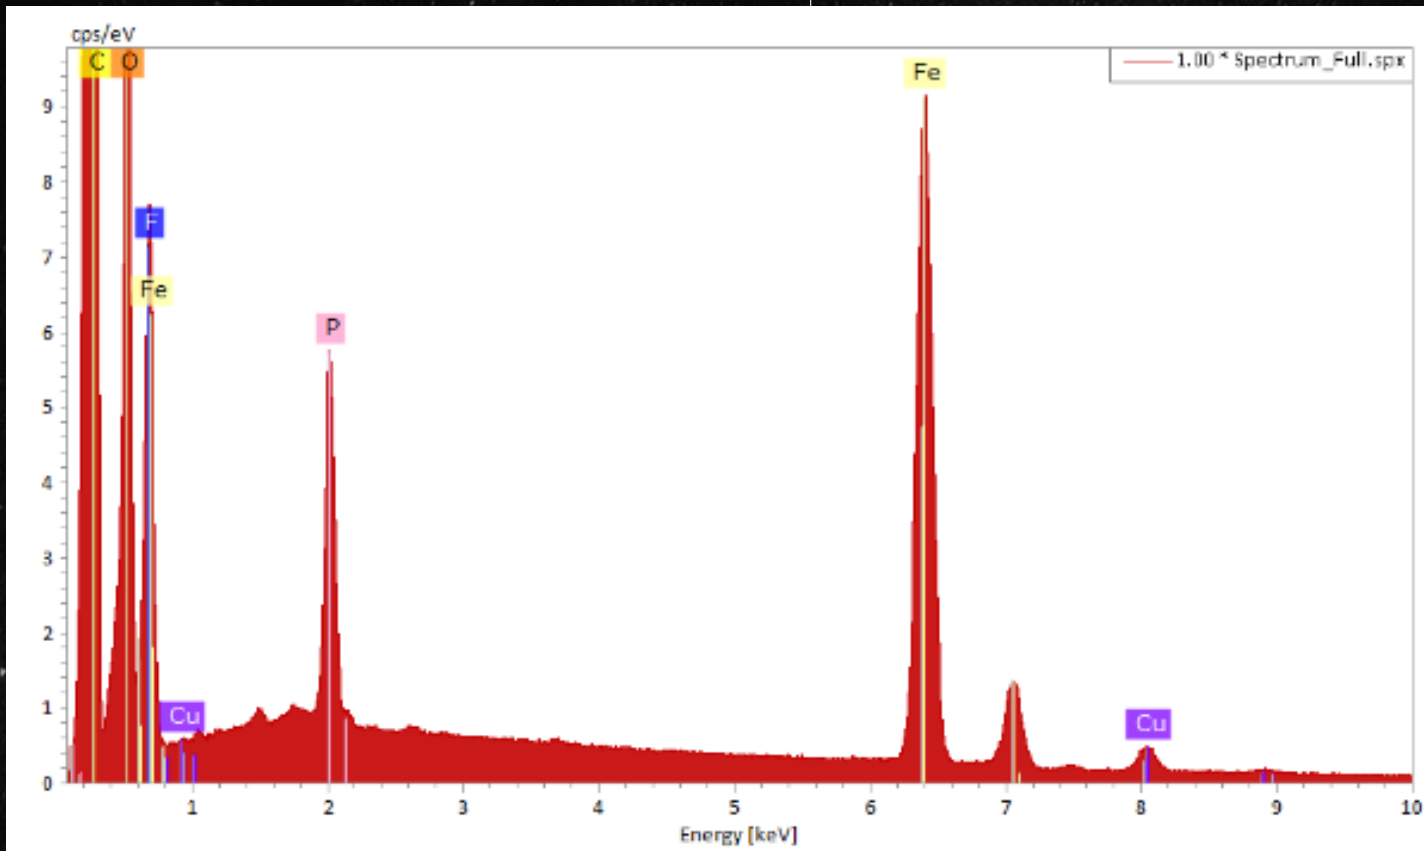
# Cell 1517, Sample 3

- EDS indicates this is composed of mainly iron, oxygen, fluorine, phosphorus

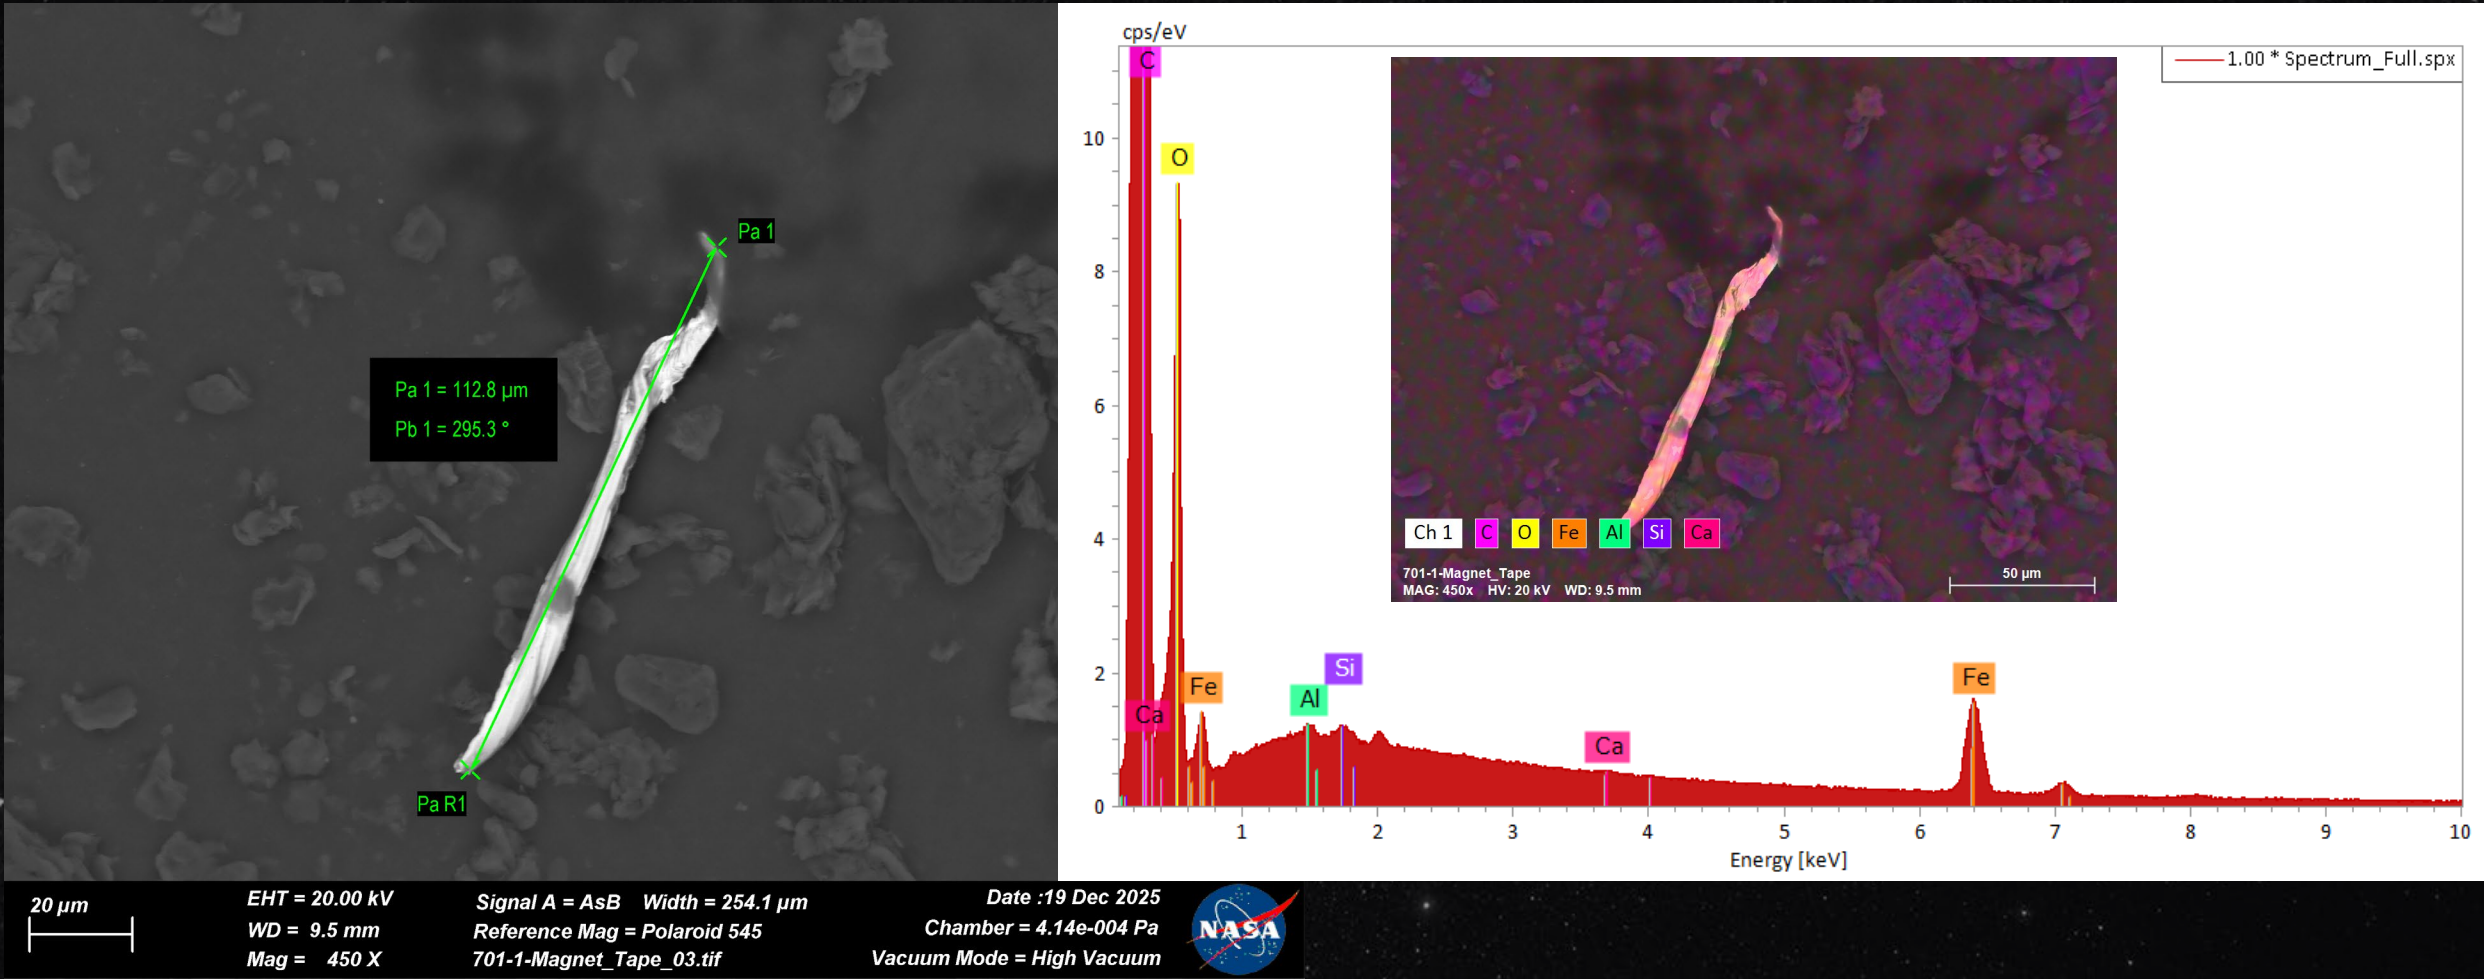
# Cell 1506, Map 01

- Long thin particle potentially from a manufacturing process

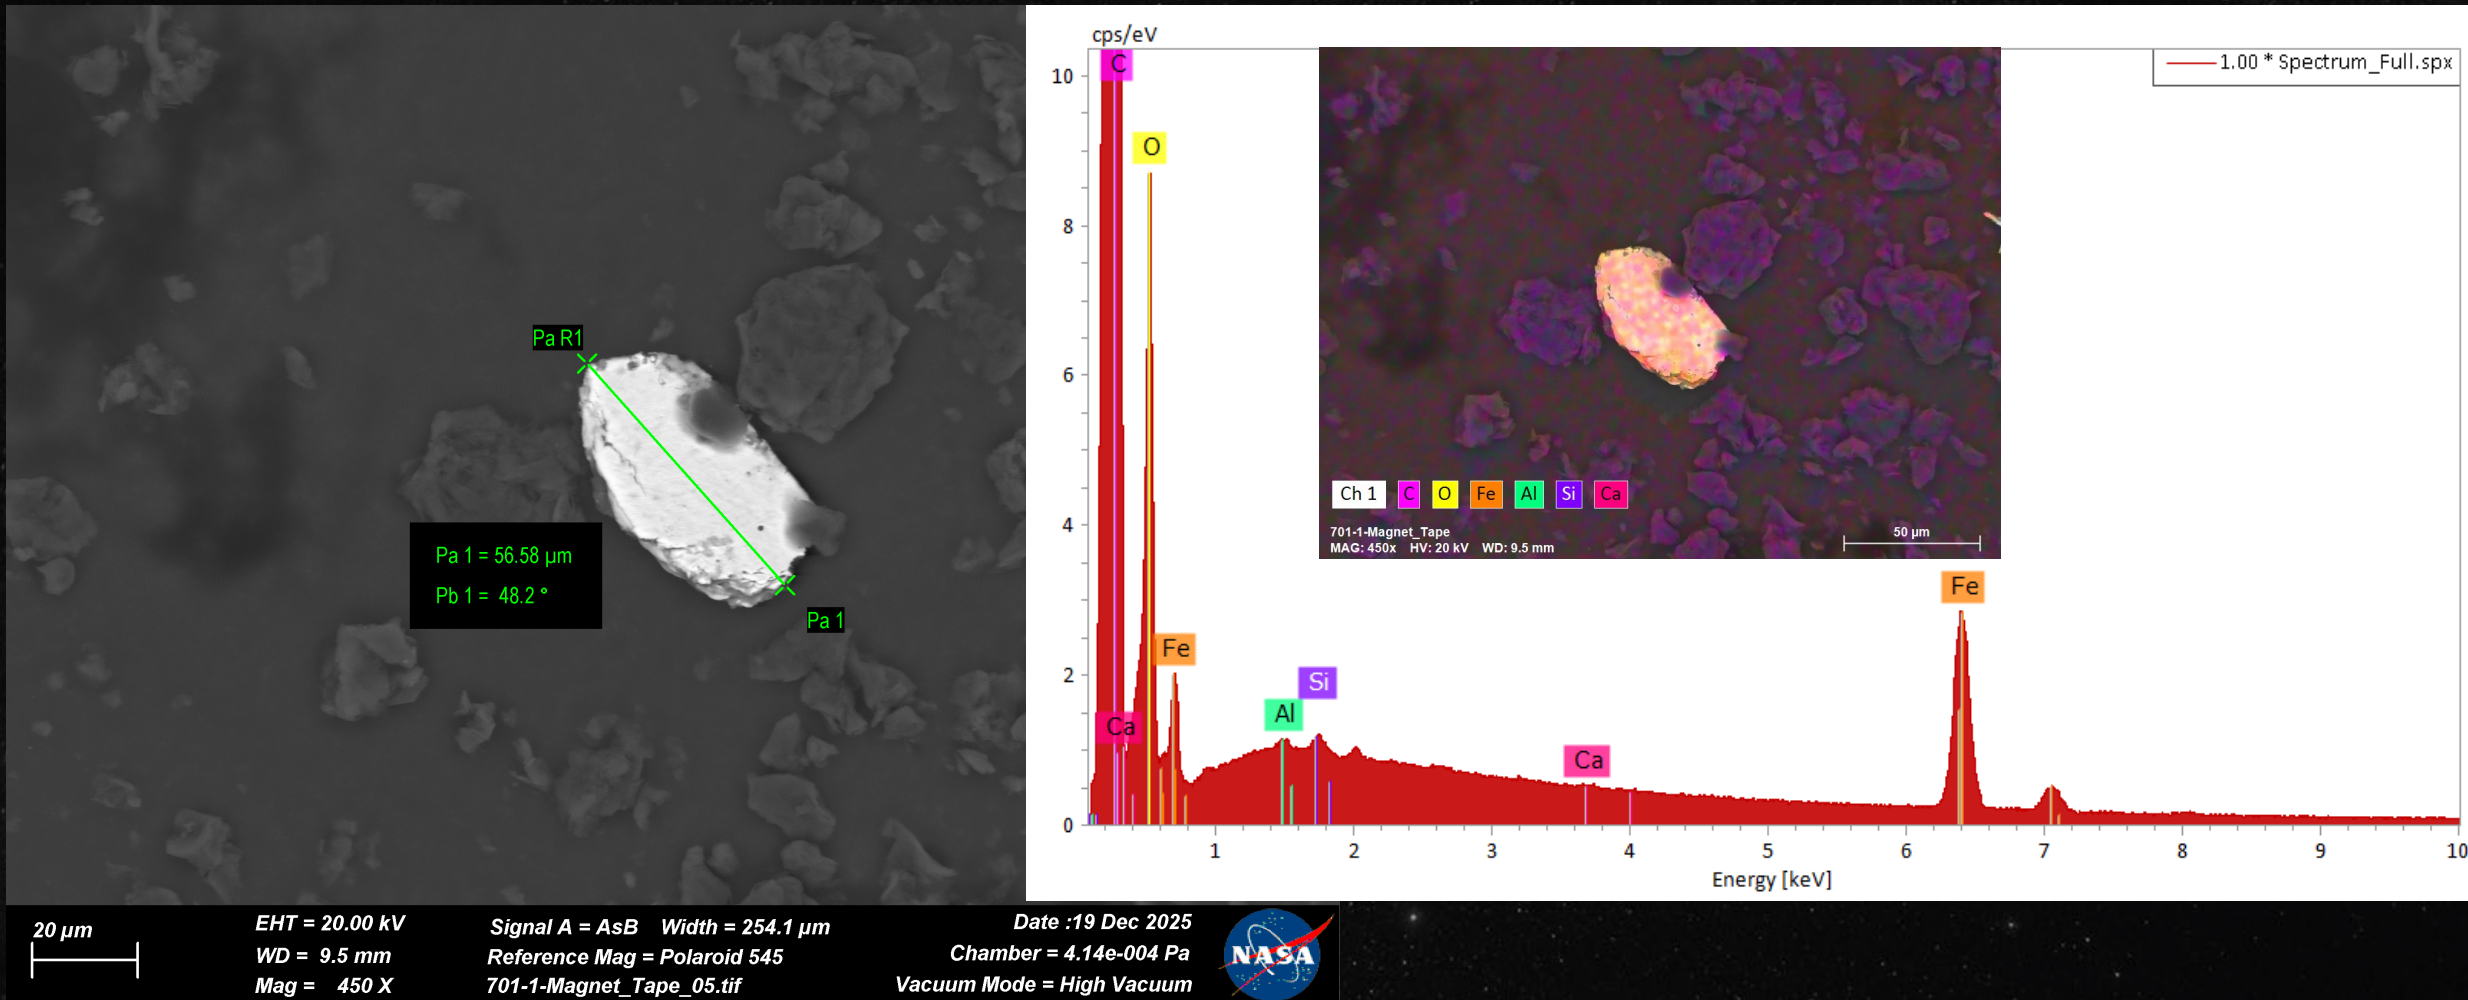
# 1506 Map 02

- With blooming effects from CT this could be the particle of interest

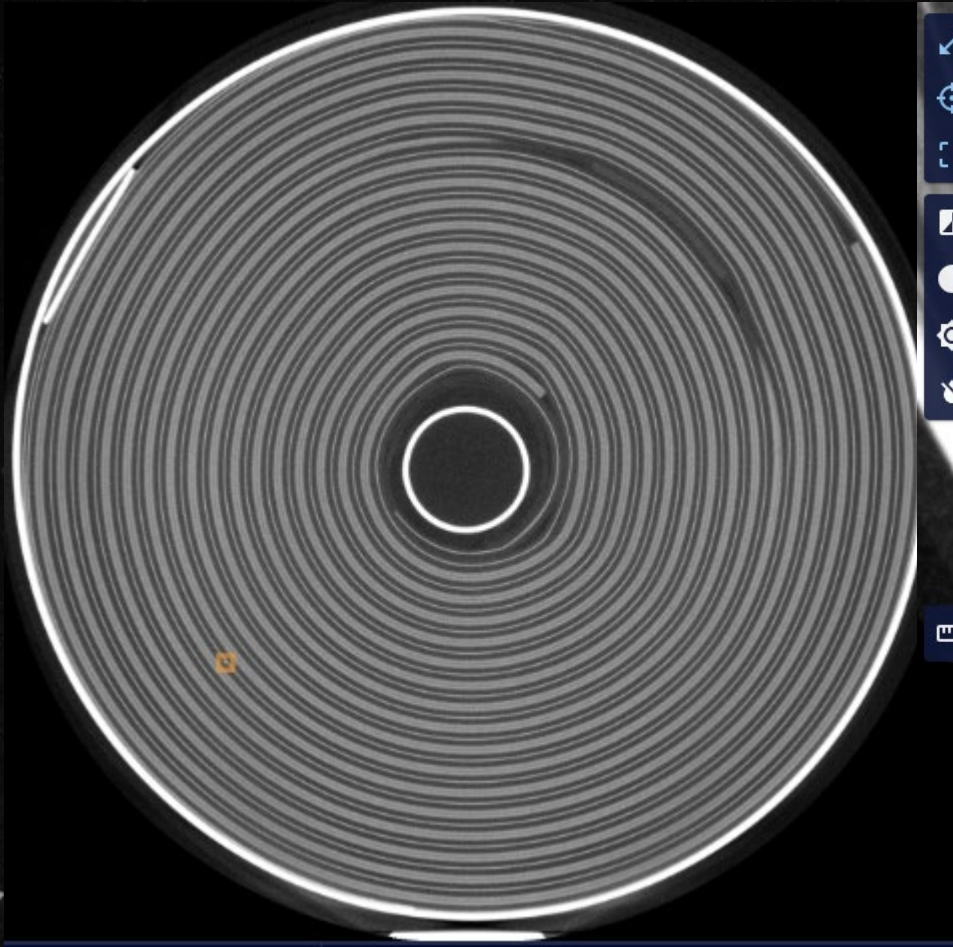
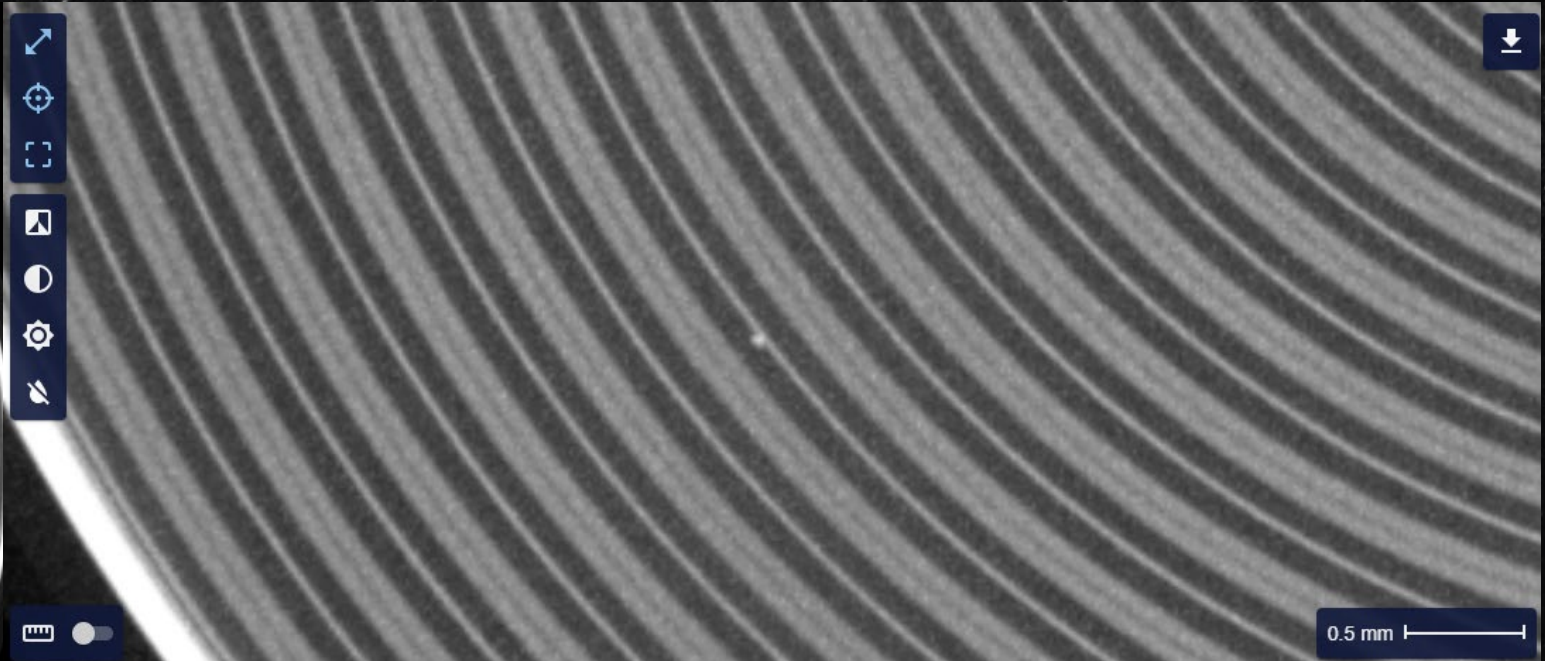
# Scan 1520

~50 $\mu$ m in size

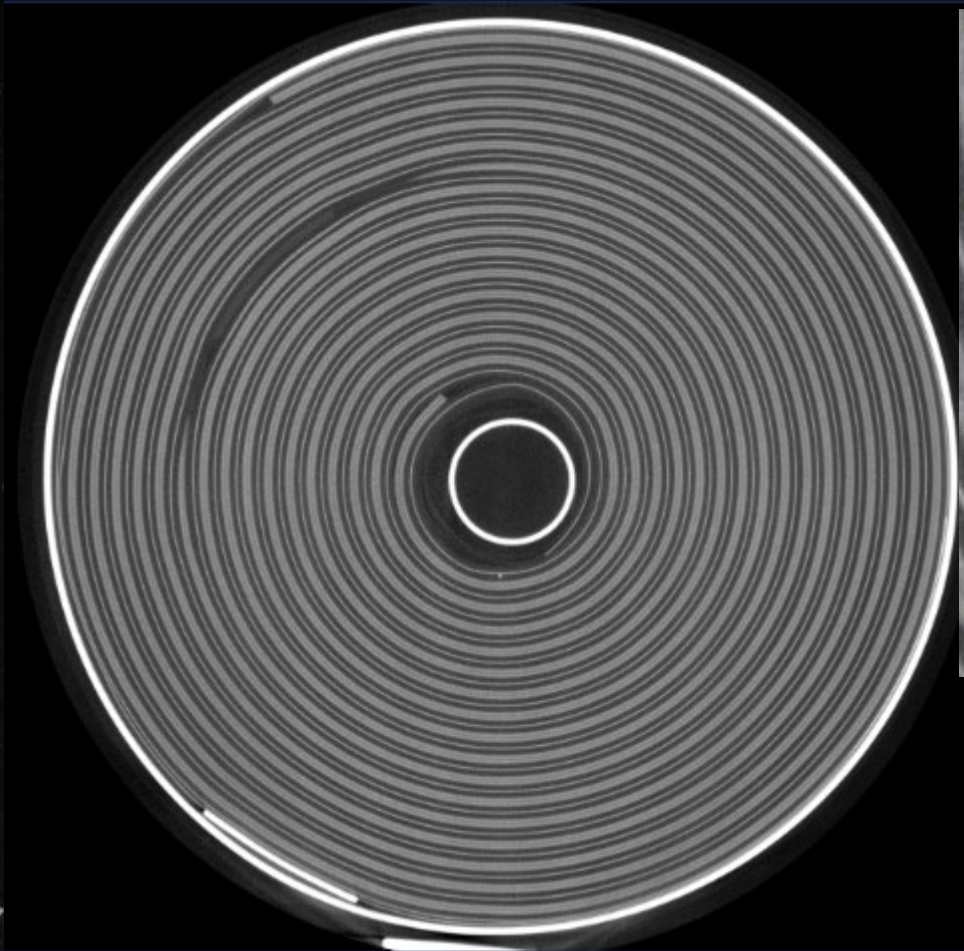
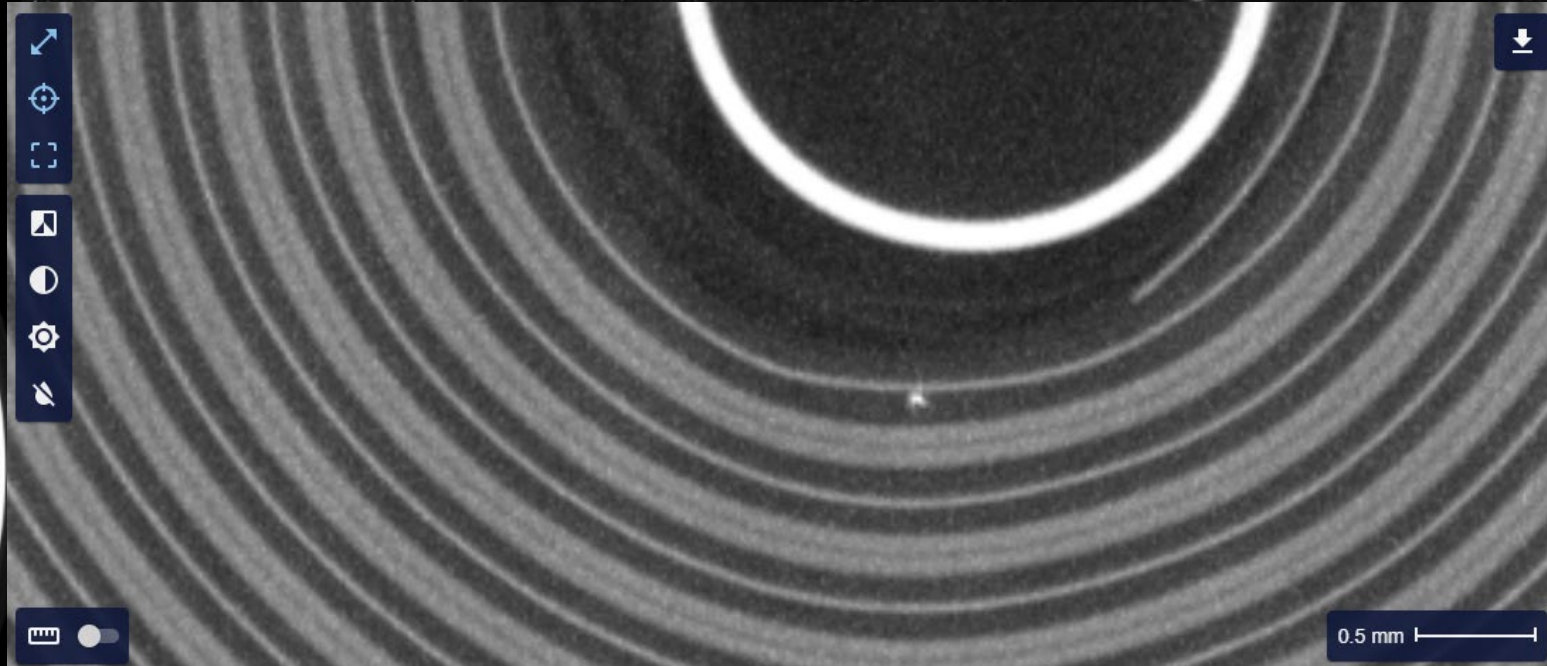
# Scan 1555

~70 $\mu$ m in size
