# CT Scanning of Commercial Cells for Space Flight Applications

IAPG CWG Safety Panel Meeting

David Delafuente, NASA JSC

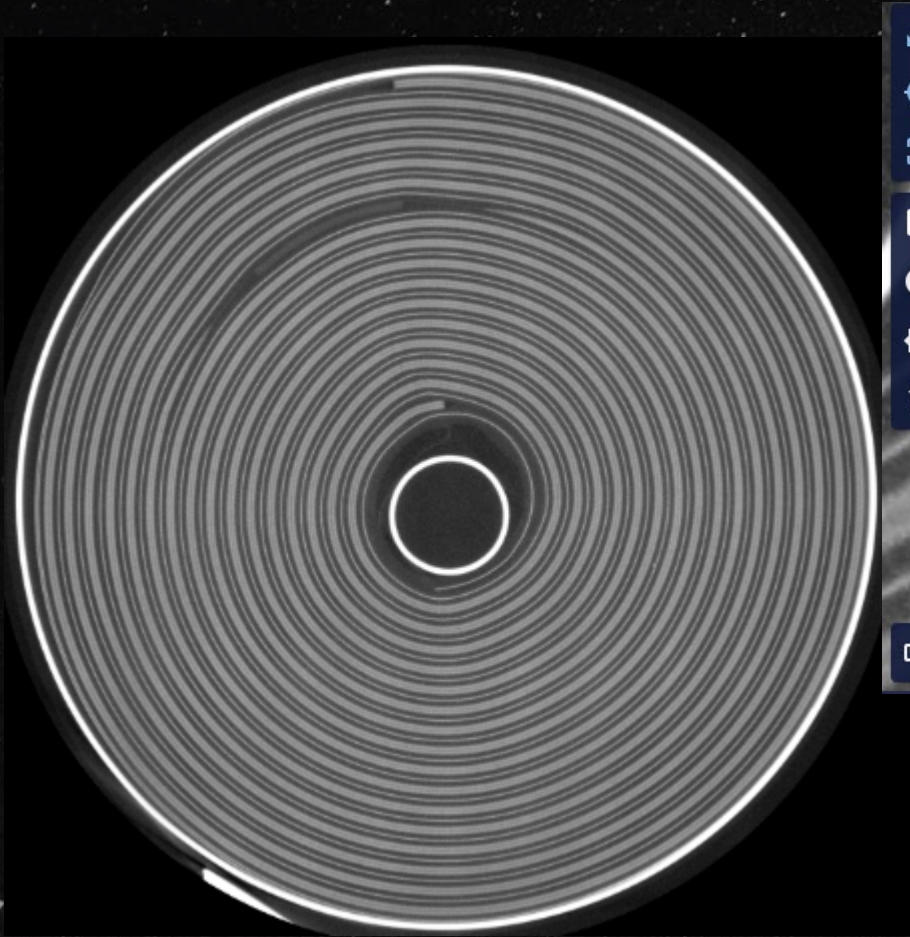
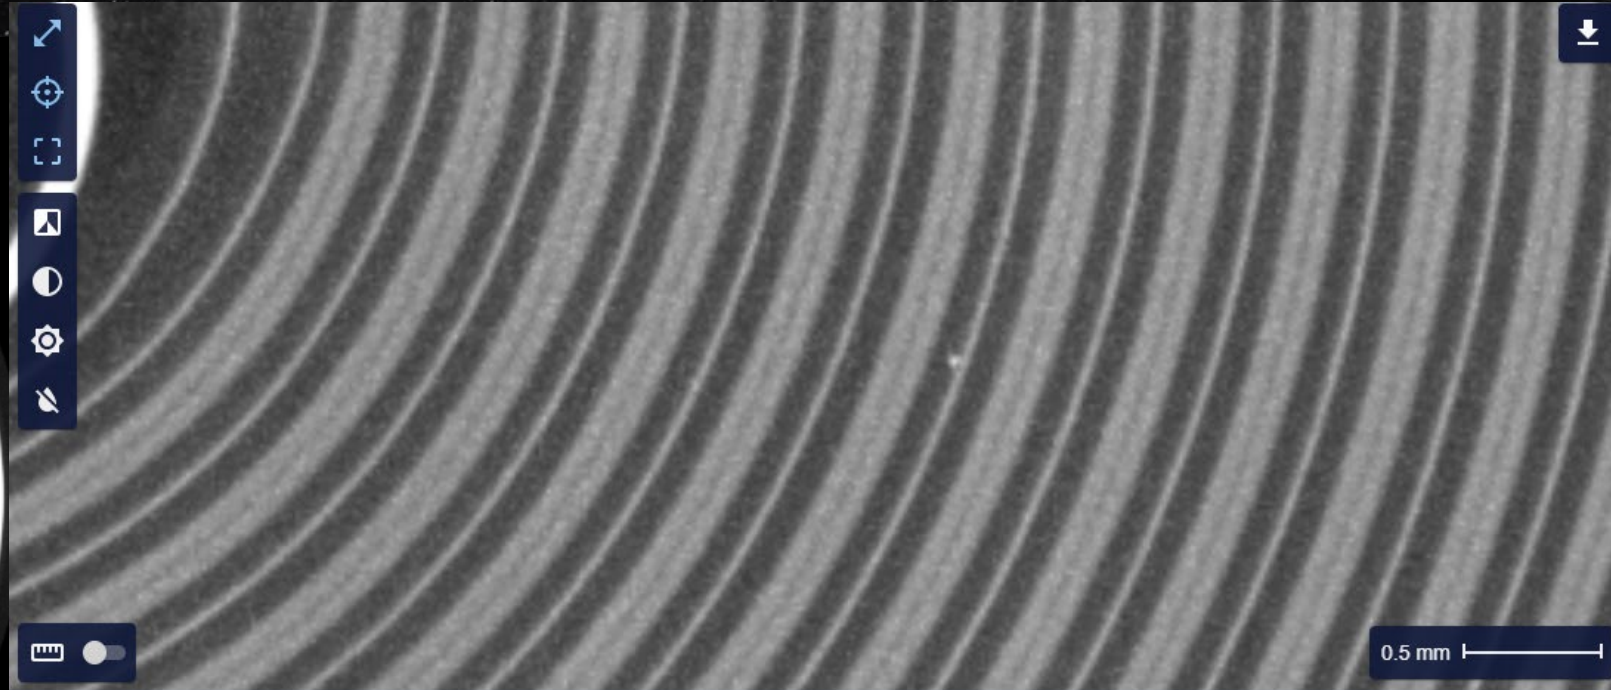
# Scan 1585

~60  $\mu\text{m}$  in size

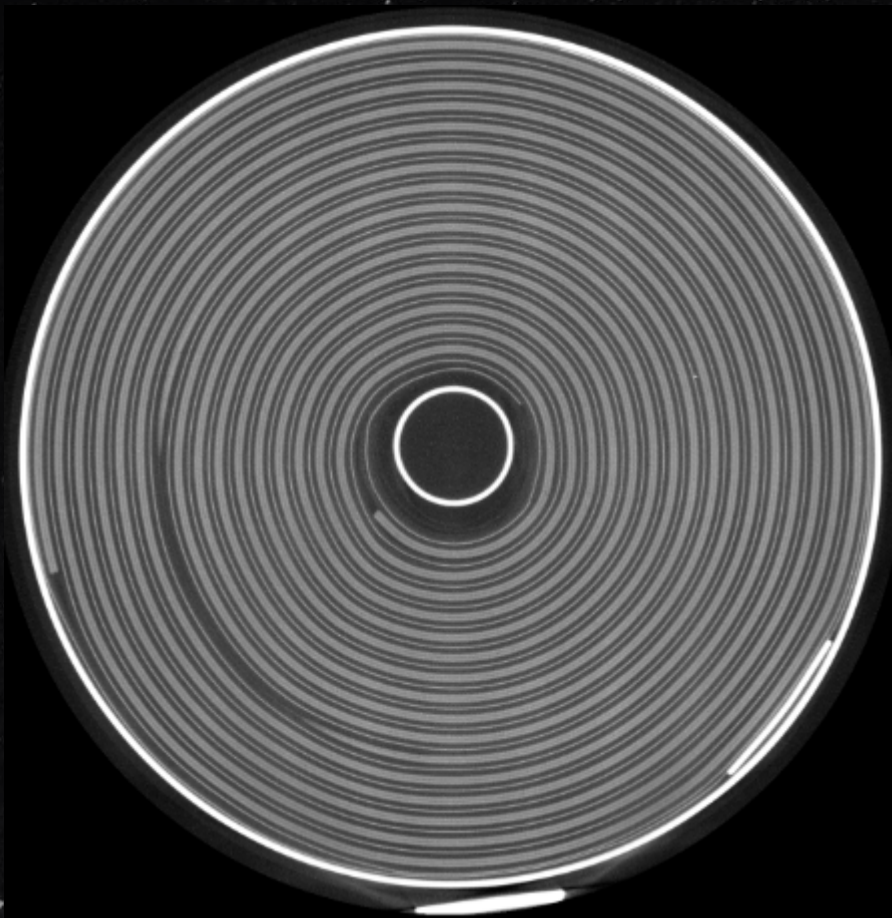
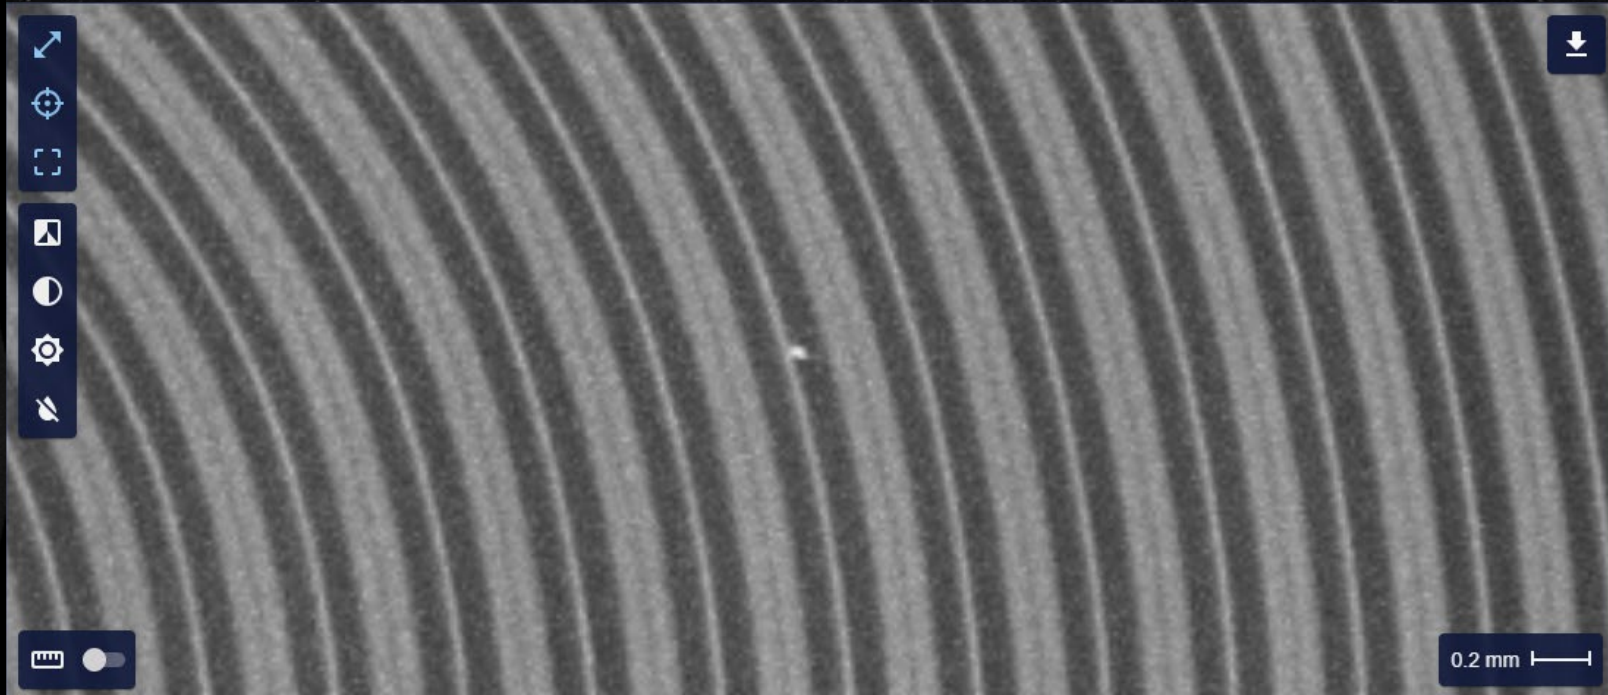
# Scan 1598

~50 $\mu$ m in size

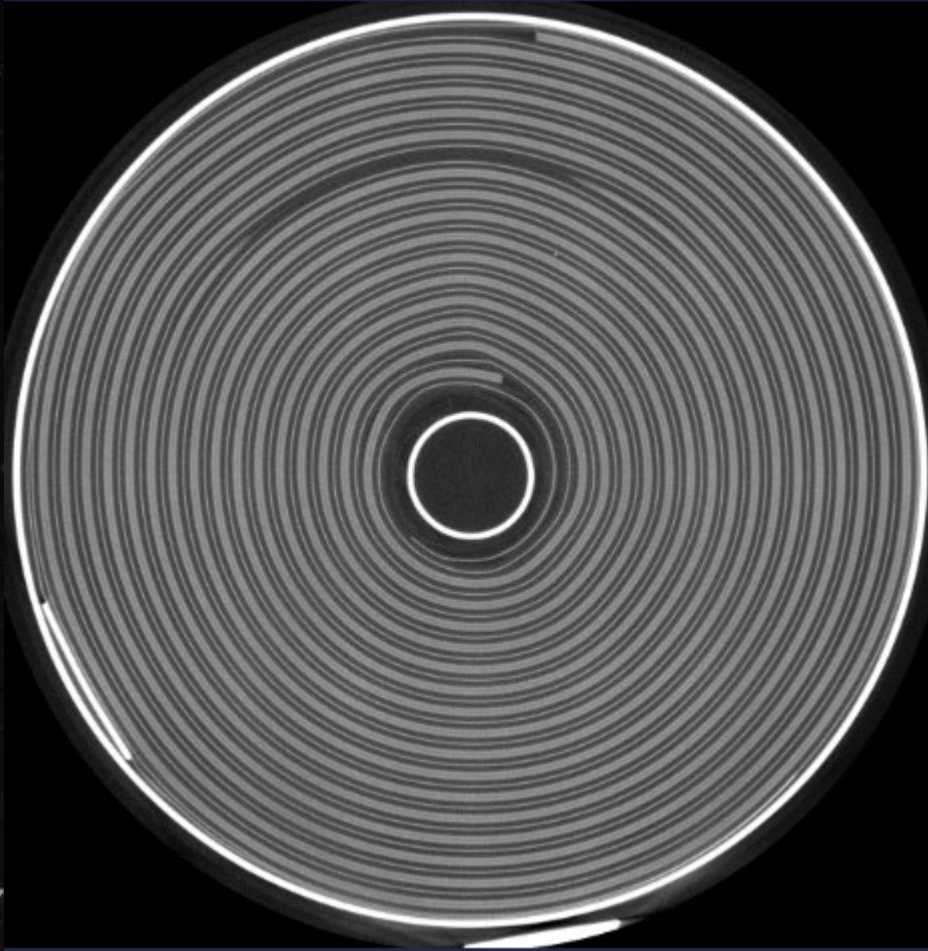
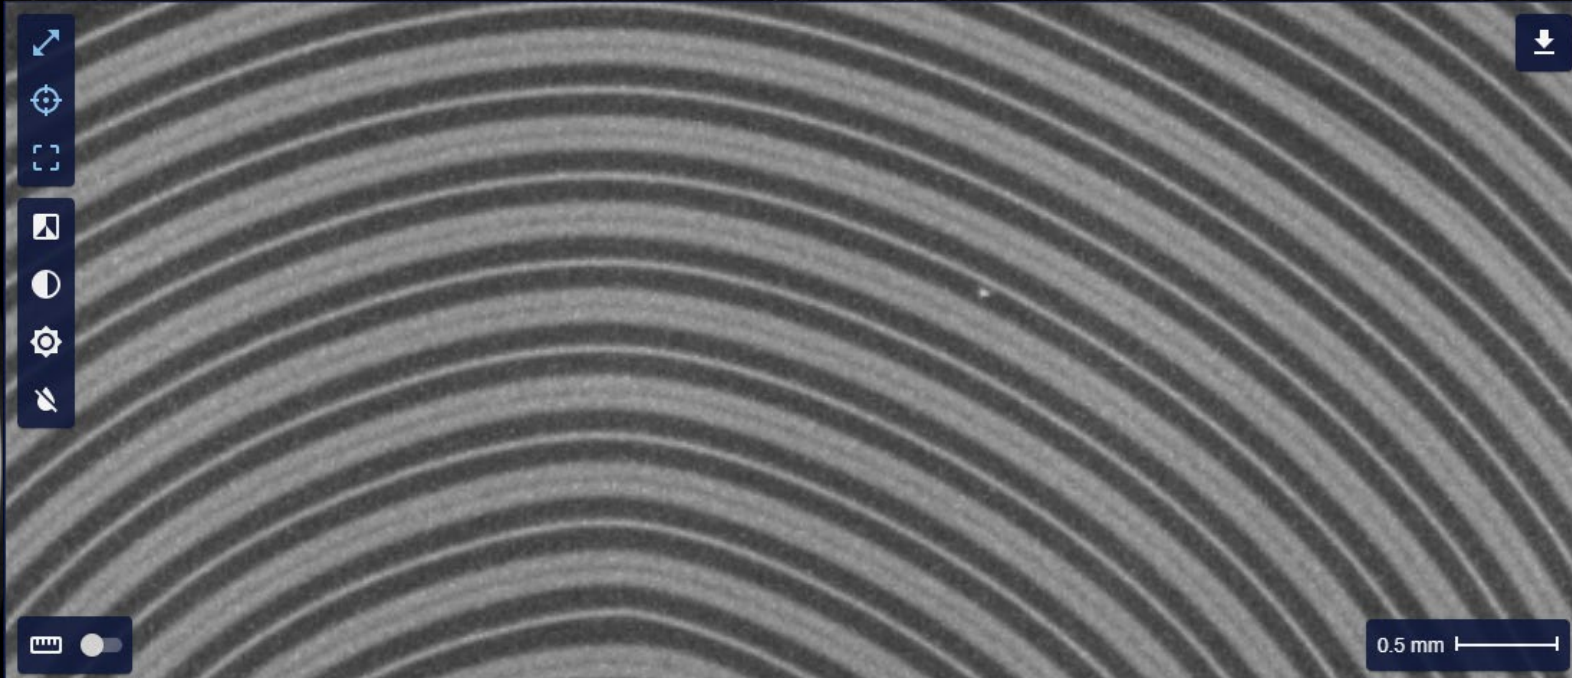
# Scan 1604

~40 $\mu$ m in size
