# ISS Radiator Face Sheet Anomaly Investigation and Return to Function

Aaron Rodriguez<sup>1</sup> and Richard Morton<sup>2</sup>  
*NASA, Houston, TX, 77058*

Maintaining sufficient heat rejection on the International Space Station (ISS) is critical to the function of the Low-Earth Orbit station. The External Active Thermal Control System (EATCS) rejects the excess heat generated by the US On-Orbit Segment (USOS) modules. The system uses single-phase liquid ammonia to collect the heat and reject it to six radiators (three on the Starboard side, three on the Port side). Each radiator is made up of eight panels. In September 2008, imagery of the Starboard radiators was conducted and showed one of the panels' face sheets had peeled up from the internal honeycomb core structure. Out of an abundance of caution, the radiator was isolated from the rest of the EATCS and the ammonia was vented to space. Since the radiator was vented, periodic imagery of all radiator panels was taken to monitor any changes in the face sheet and inspect for other radiator anomalies. In January 2025, after years of trending and inspections, the radiator was reintegrated into the system to increase heat rejec

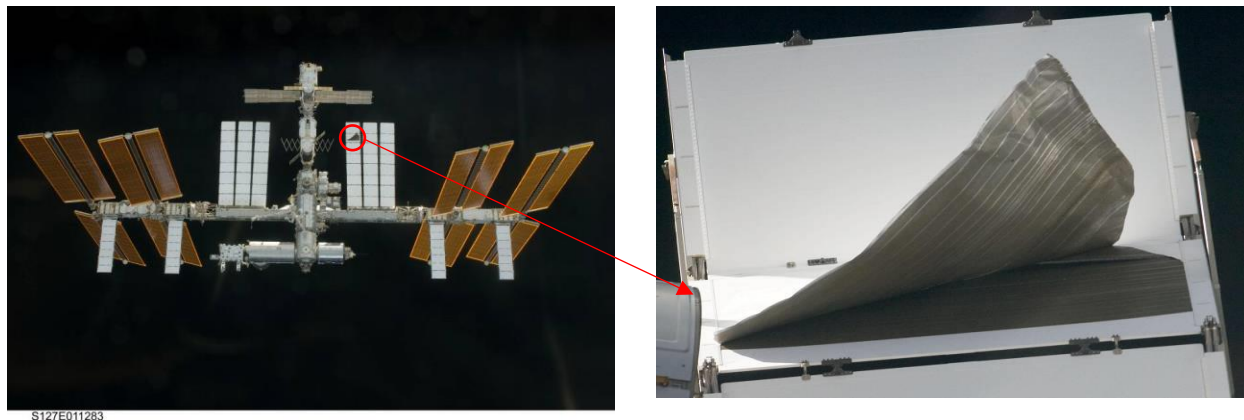
Figure 1. Image of ISS with detailed image of peeled face sheet.

Following the discovery of the face sheet separation, infrared (IR) and high-resolution images of the radiators were taken to assess damage and trend further peeling of the face sheet. A fault tree was developed, and using analysis and ground testing, most probable cause was determined to be a small undetectable flaw in the raw tube stock of the flow path. The flaw in the flow tube caused a leak inside of the radiator panel which caused pressure to build and rupture the panel. This leak was not detected at the system level. A flaw of this size could have only been discovered with x-ray inspection or helium leak tests of the raw tube stock which were not required as part of verification.

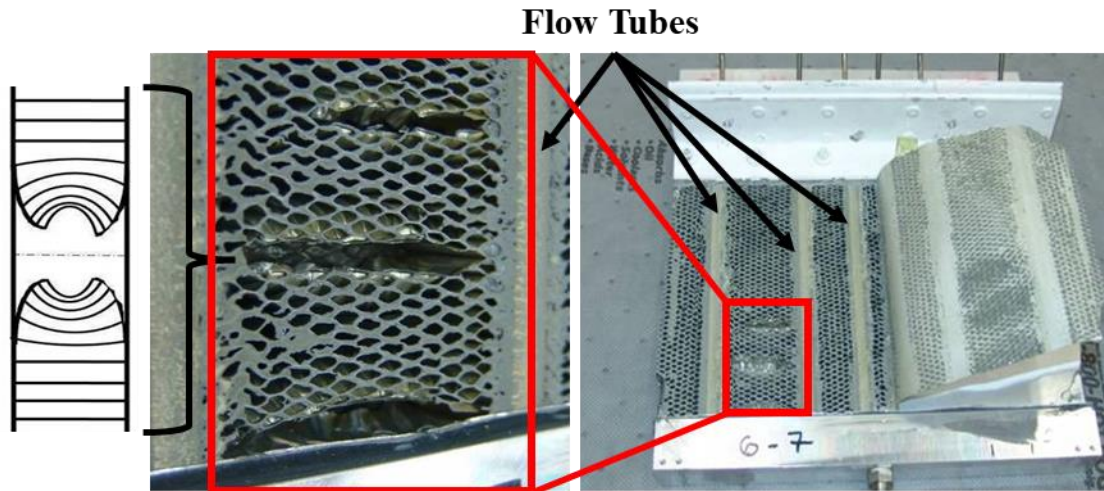
For the final test, a qualification radiator panel was sectioned and the volume between the face sheet and outside the flow tubes were pressurized. The goal of the test was to determine the failure mode and failure pressure of the panel if pressure were to build within the panel. This assumes a small leak in the flow tubes that passes through the extrusion into the honeycomb structure. This is possible as the aluminum extrusion consists of two parts that are epoxied together to hold the flow tube. The test showed that the bond between the honeycomb layers were the first to fail at around 20–40 Pounds per Square Inch (psi) (138–207 kPa). The core peeled inward away from the face sheet to start. Once the honeycomb failed, the face sheet began to delaminate as the bond between the face sheet and honeycomb structure failed at around 150 psi (1034 kPa). Figure 5 shows the damage to the honeycomb structure and where the damage occurred relative to the test sample.

**Figure 5. Honeycomb structure damage after pressurization. Face sheet peeled back to show damage, not caused by pressure.**

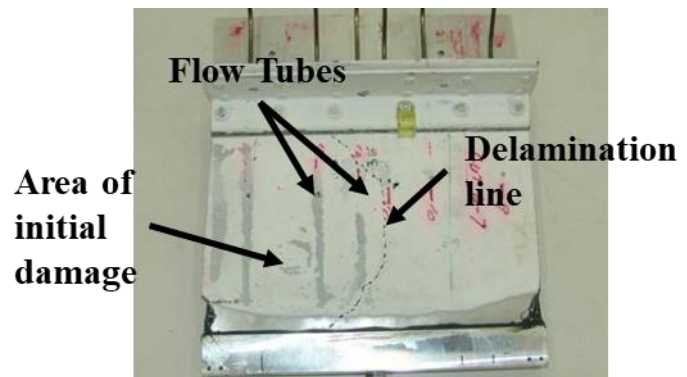
Once the honeycomb bond failed the face sheet began to delaminate, as showed by Figure 6. The tap test was used to identify where the delamination took place. The tap test showed the gas pocket jumped the flow tube extrusions and grew the delamination without further damaging the honeycomb structure. A failure of this nature could have caused pressure to build in the panel until the face sheet rips away from the rest of the panel structure. This test also showed that the panel design could hold internal pressure and that a leak would not simply vent to space. The combination of these tests provides a plausible scenario for how the damage to radiator could have occurred.

**Figure 6. Pressurized panel test article.**

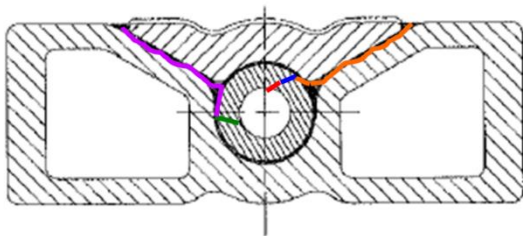
**Figure 7. Flow tube and extrusion cross section with possible leak paths.**

There are two possible scenarios for the leak to migrate to the panel core. The first relies on a pre-existing flaw that was too small to detect during the pressurized leak test prior to build up. The leak travels through the epoxy through degradation or freeze/thaw cycling creating micro-cracks. This path is shown in Figure 7 with the green and purple lines. The other scenario relies on a flaw in the flow tube that is not through the entire flow tube. This is similar to the flaw found on reinspected flow tube stock. This flaw could worsen due to

the freeze-thaw cycles and leak through the epoxy the same way as the previous scenario as shown by the red, blue, and orange lines in Figure 7.

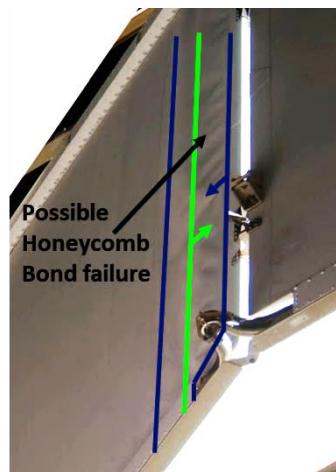
**Figure 9. Back of radiator panel.**

imagery in Figures 8 and 9. Figure 8 shows delamination across the top of the panel, not just where the face sheet peeled back. The zoomed in image overlays the ammonia (blue) and nitrogen (green) flow path lines over the area with the most face sheet distortion. Figure 9 shows the back of the panel, which also shows distortion localized to the area between the last nitrogen and ammonia flow path. This damage is consistent with the failure scenario and the ground testing.

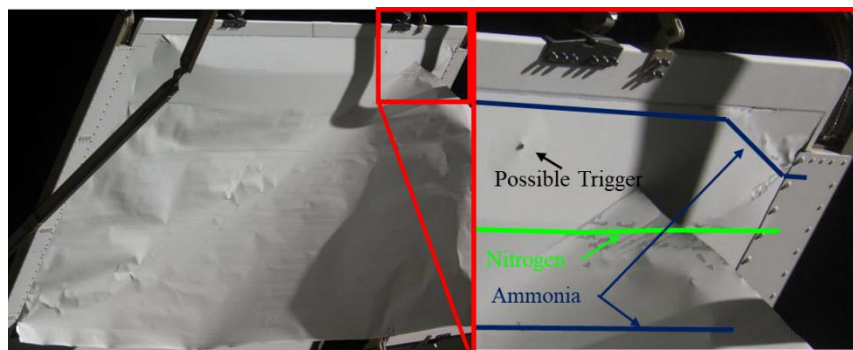
**Figure 8. Top of radiator panel with detailed image of delamination and possible MMOD trigger site.**

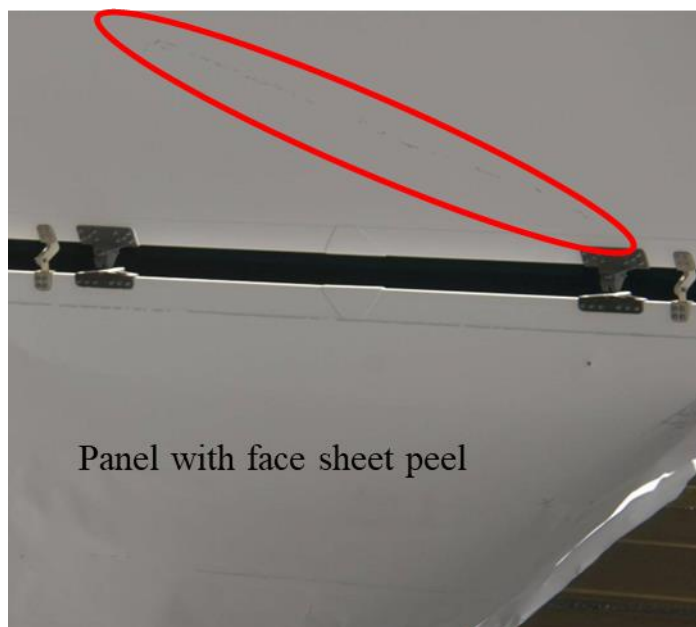
**Figure 10. Image of mark caused by peeled panel.**

above. On-orbit imagery confirms the analysis successfully reproduced the failure. Figure 10 shows possible evidence of a scuff mark on the panel above the peeled face sheet indicating the panel stuck the face sheet. Figure 11 compares the analysis to on-orbit imagery and shows a detailed view of the fastener holes in the face sheet.

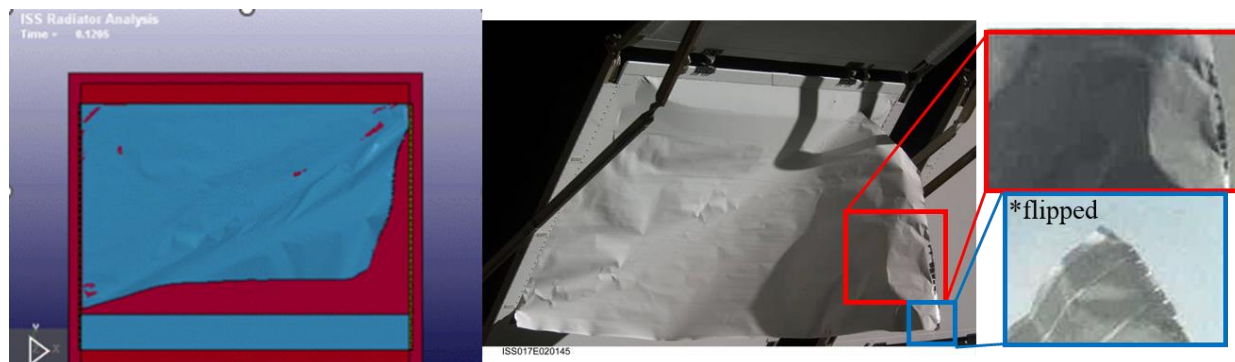
**Figure 11. NESC LS-DYNA analysis compared to on-orbit imagery.**
