# **A Review of Pump Package Assembly Anomalies and Demonstration to Gain Motor Controller Replacement Capability**

The International Space Station (ISS) generates heat within the US modules from systems used to operate the station, maintain crew health, and conduct science experiments in the orbiting laboratory. The Internal Thermal Control System (ITCS) collects this heat in water loops and transfers it to the external ammonia system for rejection to space. The ITCS uses six Pump Package Assemblies (PPA) as the motive force to circulate the water within the Lab, Node 2, and Node 3 (Node 1 is parasitic to the Lab and Node 3 ITCS loops). In the life of ISS, 3 PPAs have had to be replaced and 2 PPAs are currently showing signs of degradation. The first PPA to fail in 2003 was due to early coolant chemistry issues; the remaining pump failures and current pump degradations are determined to be related to the Pump/Fan Motor Controller (PFMC), with their individual signatures all being unique to this point. The PFMC of one of the failed PPAs was returned and testing confirmed its sub-components to be the root cause of the PPA failure. Due to the relative size and weight of the standalo

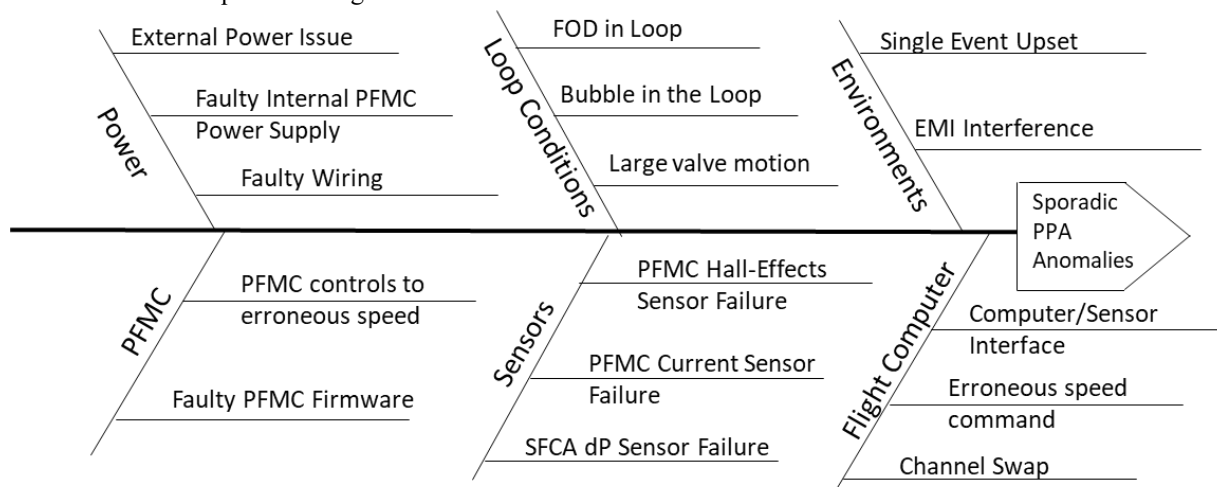
**Figure 4: PPA Anomaly Fault Tree**

Prior to 2015, the six ISS PPAs experienced no failures or anomalies in their pumping capability except for the PPA failure in 2003 that was due to coolant chemistry. Since 2015, four different PPAs have experienced sporadic anomalies. The signature of each anomaly is unique but does not impact the pump's performance in the loop when the PPA is operating nominally. To assess each anomaly, a fault tree was created (Figure 4). This fault tree was used to determine possible troubleshooting steps and to help generate a root/probable cause. None of the anomalies forced an immediate R&R, so long-term trending of the failure was possible. Given resource constraints of purchasing new PPAs and launching additional PPAs, the decision was made to run all the pumps to failure, or until the anomalies became too cumbersome to manage. With the criticality of the PPA, sometimes the next worst failure would also factor into when the decision to perform a R&R was made. The following sections will discuss the four anomalies and the results of the subsequent investigations.

Based on the telemetry, a few branches of the fault tree could be ruled out. Power to the PPA was nominal and no commands or channel swaps occurred in the ISS software. Single Event Upsets and Electromagnetic Interference (EMI) was ruled out by assessing known sources of radiation and EMI. The SFCA dP sensor and large valve motion was ruled out because telemetry showed the valves responded to the pump speed changes. Foreign Object Debris (FOD) and bubbles in the loop were also ruled out due to the low filter and gas trap dP. This indicates a clean filter and no gas in the gas trap. This left most of the possible causes internal to the PFMC. The only cause not internal to the PFMC was a Hall-Effect Sensor failure as this sensor is external to the PFMC.

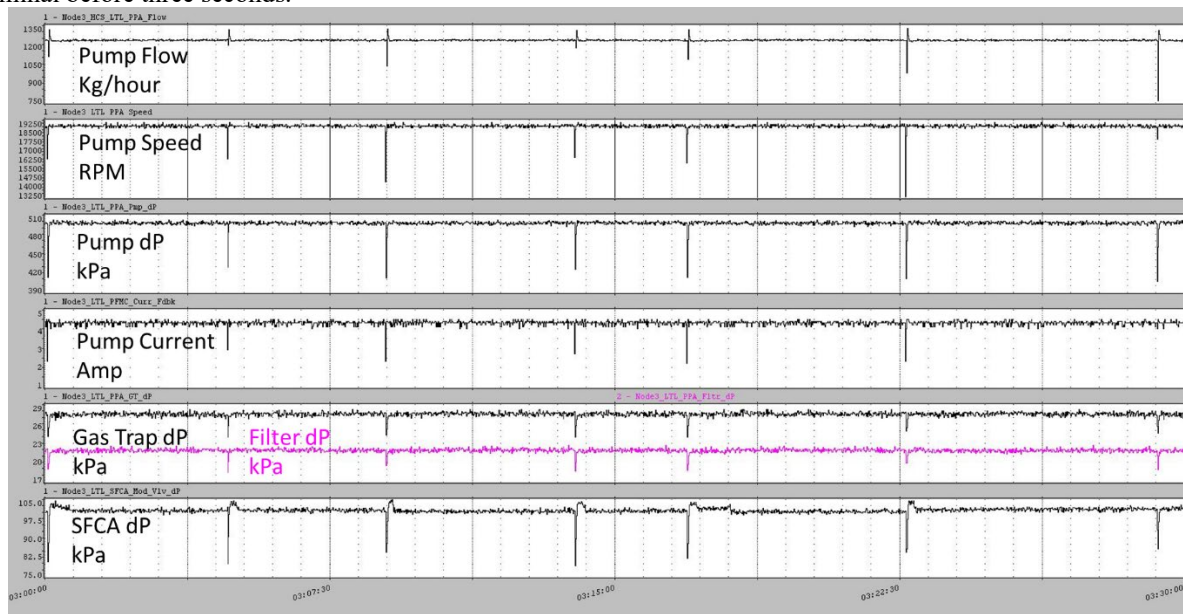
**Figure 5: Node 3 LTL PPA Anomalies (30 Minutes of Data)**

In May of 2017, Node 3 was transitioned to Single LTL for maintenance on an unrelated avionics box. In single loop mode, both the MTL and LTL are cooled by a single PPA, with Single LTL having the LTL PPA as the actively spinning pump. To achieve adequate cooling to both the LTL and MTL, the pump speed of the PPA is increased. Node 3 operated in this mode for five days and throughout the five days, the pump experienced almost 100 anomalies. These anomalies were characterized by rapid (<one second) drops in PPA speed. After each anomaly, the PPA returned to nominal operation. The magnitude and frequency of the transients were inconsistent. The anomaly was present in pump speed, current, flowrate and Gas Trap and Filter dP. The transient was also seen on the System Flow Control Assembly (SFCA) dP. Figure 5 shows this phenomenon. The SFCA is a valve that maintains the dP across the ITCS

users so that they receive a constant flow. This shows it was a real, hydraulic event and not a data issue in the PPA. The pump spun down and back up over the course of two seconds with the largest speed change being from 18.9K to 12.3K RPM. These anomalies never triggered a fault that caused any system response because the speed returned to nominal before three seconds.

These anomalies never occurred in Dual mode. In Dual mode, both PPAs are pumping their own loop (MTL and LTL). The Node 3 LTL PPA is also operating at a lower speed (10.8k RPM). After the anomalies were seen in May 2017, data from previous instances when Node 3 was in Single LTL were examined. It showed this anomaly occurred in 2015 (previous instance Node 3 was in Single LTL) at a rate of nine events over three days. Node 3 was in Single LTL six times between 2012 and 2015 and showed no anomalies. This anomaly was also not present when Node 3 was in Single MTL. Due to the architecture of Node 3, loss of the Node 3 LTL PPA did not result in any loss of function in Node 3. For Node 3, Dual mode is the nominal operating configuration, so the LTL PPA is rarely operated at the higher speed.

With the increase in frequency from 2015 to 2017, it appeared that the PPA was degrading. To monitor the degradation, Node 3 was transitioned to Single LTL every three to four months for a three-day period. Every three-day period showed an increase in frequency. Even at the increased frequency, nominal cooling was being provided to all the Node 3 ITCS users because the transients were so fast, cooling was never truly lost. Of primary concern with the increase in frequency is the increased odds that multiple events could stack together trigger a fault response. The PFMC will trigger a fault if the speed drops below 17.6k RPM for three consecutive seconds. In March of 2018, during the last three-day Single LTL period, two events happened 1 second apart which nearly triggered the fault. While this didn't constitute a failure, trust in the PPA's ability to maintain cooling was lost. Single LTL would be required if there was an issue with the MTL PPA, either with the PPA itself or the power and software that operates the PPA. If Node 3 were forced to operate in Single LTL, loss of the LTL PPA due to this anomaly would result in loss of cooling to Node 3. The decision was made in April 2018 to R&R the PPA to return full fault tolerance to Node 3. Due to return mass constraints, the failed PPA was not returned for TT&E. The new LTL PPA in Node 3 has continued to operate nominally, even in Single LTL mode, since being replaced.

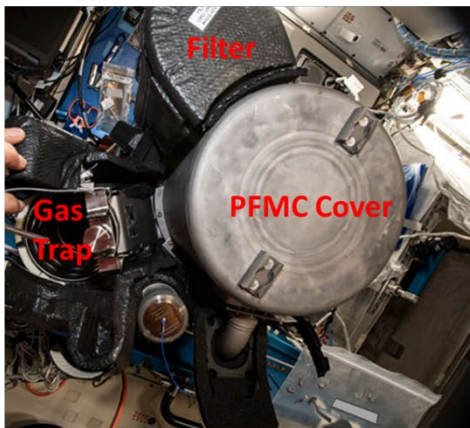
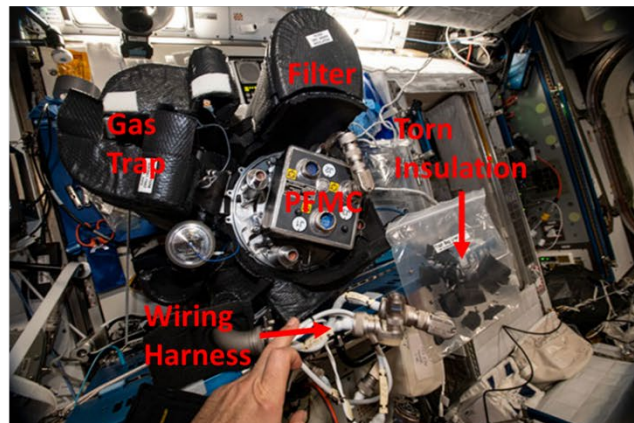
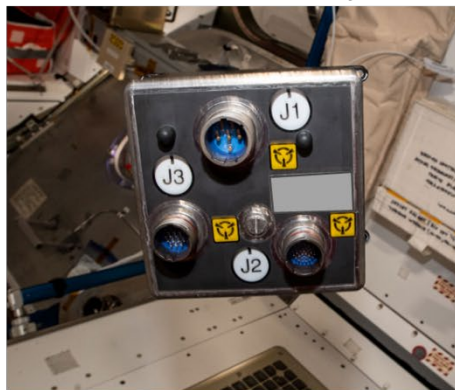
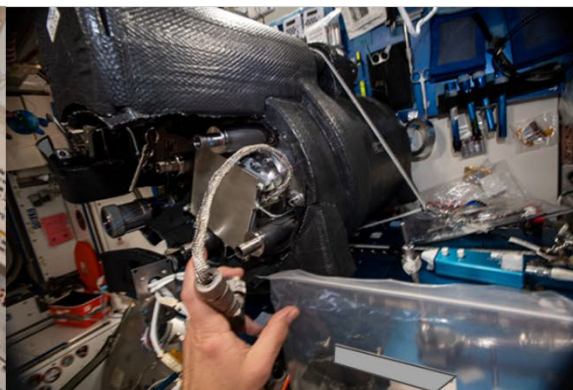
**Figure 6: On-Orbit PFMC Removal**

There was a strong desire to return the PPA for TT&E to determine the root cause of the failure. With the previous Node 3 LTL PPA failure, there was also a concern that the aging PPA fleet would start failing. Due to size constraints and down mass priorities, returning the entire PPA was not feasible. Given the failure had been narrowed down to either the PFMC or hall-effect sensor, the decision was made to return only the PFMC and dispose of the rest of the PPA. If the PFMC is tested and shown to be without defect, then the hall-effect sensor was the likely root cause. As the PFMC was not designed to be removed, new procedures were developed to remove the PFMC. Figure 6 outlines the process for removal. With the rest of the PPA being disposed of, crew did not have to carefully remove the insulation. This saved time and effort but left much of the insulation in pieces. If crew were to replace the PFMC, crew would have to reinstall the insulation so that condensation would still be prevented, which could be difficult if not removed carefully. Once the PFMC was removed, it was returned to the ground and sent to Honeywell for testing.

Honeywell began the TT&E by checking the resistance across the electrical connector pins and chassis which all showed nominal. A functional test was then performed on the PFMC without an anomaly. The data was compared to the pre-flight values which were in family. The functional test, which is a portion of the Acceptance Test Procedure (ATP), only operated the PFMC at maximum speed for 30 seconds. The test was re-run at the nominal speed of 9.4K for four hours. During the test, two events where speed sharply increased and returned to nominal speed over the course of one second occurred. This and subsequent tests showed the returned PFMC anomaly rate was about eight per 24 hours of runtime compared to the average three per day on-orbit when the PPA was removed.

An oscilloscope was used to measure current from the PFMC and captured dozens of current spikes where current doubled for 0.3-0.4 seconds. This is why on-orbit data never captured more than a data point of the anomaly. The PFMC was also tested at 20K RPM and showed a different signature where current spiked down for a shorter period (0.03-0.04 seconds). The frequency was also higher. The tests were repeated while capturing the output phase-voltage and input hall-effect sensor voltage with results showing the root cause was likely in the inverter or microprocessor Circuit Card Assembly (CCA). To determine which CCA was at fault, the PFMC cover had to be removed to test the internal components. These tests showed the microprocessor CCA was sending incorrect current commands. It was also determined this was due to faulty hall-effect speed signals. Signals coming into the microprocessor were being corrupted by the Schmitt Trigger. The Schmitt Trigger is a microcircuit meant to clean up the analog hall-effect sensor signal and send it to the microcontroller to calculate speed. The Schmitt Trigger would glitch and send an extra signal that the microprocessor would interpret as a high-speed value. This would cause the microprocessor to react incorrectly yielding anomalous behavior. With the root cause determined, the PFMC could have been repaired. Due to cost, and the ample ground spares, it was decided to shelve the PFMC and not proceed with the repair.

**1) Remove insulation around PFMC Cover 2) Remove PFMC Cover and disconnect wire harness**

**3) Remove PFMC**

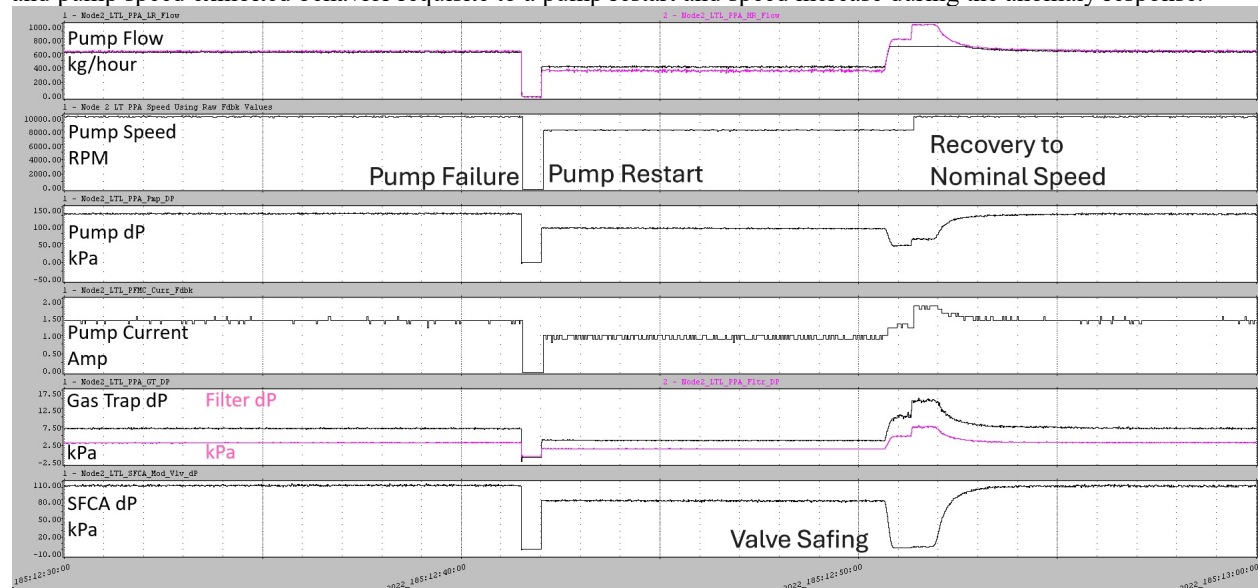
**Figure 7: Node 2 LTL PPA Anomaly (Initial Occurrence)**

In July of 2022, the Node 2 LTL PPA experienced an operational anomaly leading to a loop failure. The fault detection software proceeded into the retry algorithm, which recovered the PPA successfully. Unlike the anomaly on its sister unit on the Node 2 MTL, telemetry did not show any mechanical or hydraulic response prior to failure. The operational mode transitioned into a diagnostic state, stopping the pump, before the PFMC communicated through the recovery software to return to its operational state at a reduced pump speed. Composite data related to the PPA portrayed nominal health preceding and proceeding the recovery of the loop. Flight controllers returned the pump to nominal speed following the automatic recovery. Figure 7 shows the filter, gas trap, and pump dP, SFCA response, and pump speed exhibited behavior requisite to a pump restart and speed increase during the anomaly response.

After this initial failure, the failure did not recur until September of 2023. With each recurrence that followed, PFMC fault data, PPA diagnostics, and software connections were analyzed to determine an approximate cause. The signature of each recurrence established a running pattern, with the operational mode transitioning, leading to a PFMC fault and subsequent recovery conducted by the on-orbit software programming. No PFMC fault flag was triggered. ISS flight path data was also analyzed to determine whether radiation may be a contributing factor. A common orbital location for failure was not delineated.

To date, the anomaly's frequency has increased, but the requisite signature has not deviated from the original failure event. Ground operations have optimized recovery time to ensure the loop does not operate at reduced cooling for long periods of time. A decision to R&R the Node 2 LTL PPA has not been determined at this time given the known signature of the failure and ease of recovery relative to available resources, though the frequency is slowly increasing. Once the frequency becomes difficult for flight controllers to manage, the PPA R&R will be conducted to return Node 2 LTL to nominal operation.

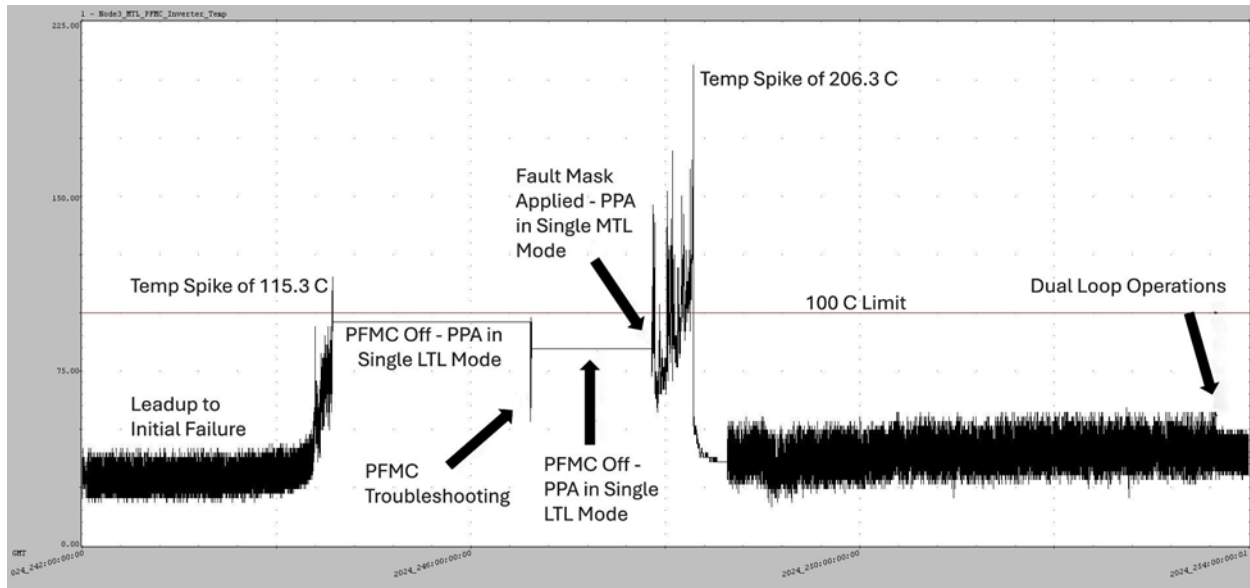
**Figure 8: Node 3 MTL PFMC Inverter Temperature Data**

In August of 2024, the Node 3 MTL PPA exhibited an increasing temperature within the PFMC despite no change in commanded loop setpoint or pump speed. In the hours preceding the loop failure event, the PPA, gas trap, and filter dP, pump speed feedback, current, and voltage did not exhibit anomalous behavior. Following the initial spike to just below the overtemperature fault limit, the temperature regressed before increasing back above the 100 Celsius (C) fault limit (Figure 8). Upon reaching the fault threshold, the MTL PPA attempted to recover via flight software before being deemed failed. Node 3 has single loop capability, so flight software combined the LTL and MTL and used the LTL PPA to recover the Node 3 ITCS. The overtemperature fault BIT within the hardware that tripped did not fall below the 100 C limit even after the PPA was restarted.

Due to the fault tolerance provided by single loop operations, the investigation into the Node 3 MTL PPA failure could proceed without having to R&R the PPA to recover the loop. The overtemperature fault reading uses a transducer temperature sensor to convert voltage into a temperature reading, with device error increasing after it surpasses its upper limit due to potential sensor damage. This sensor is a part of the Inverter CCA, with no availability for replacement on orbit. To gather additional data on whether the temperature sensor could be trusted, the PPA was restarted 48 hours after the failure which allowed the temperature to cool off (Figure 9). While the PFMC temperature data originally showed a decreased PFMC temperature, the sensor reported increasing temperatures once the PPA was turned back on. The test was aborted before the 100 C limit was reached and Node 3 was returned to Single LTL. The methodology for conducting the operational test was due to this signature not being a first occurrence.

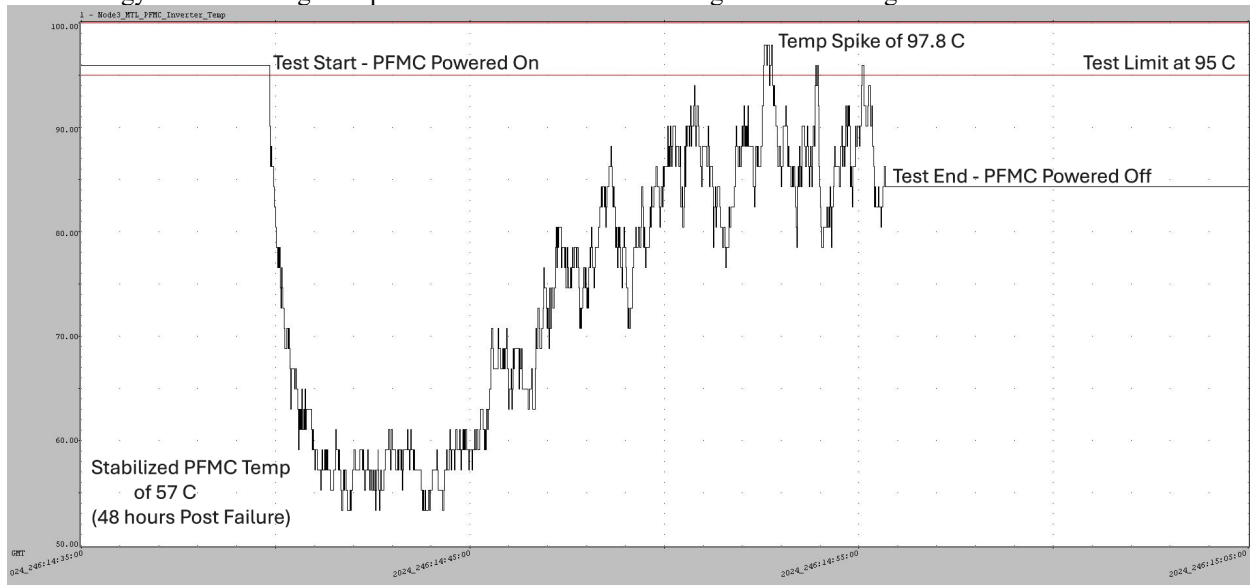
**Figure 9: PFMC Inverter Temperature During Troubleshooting**

This anomaly had been previously seen on the Carbon Dioxide Removal Assembly (CDRA) which also uses a PFMC. During the timeframe of the CDRA anomaly, the temperature sensor was determined to be erratic following data monitoring and discussions with the OEM, Honeywell. To not cause operational contingencies after determining the erratic nature of the transducer sensor, a fault mask was put in place over the BIT for the overtemperature fault. In addition to the overtemperature fault, there is a secondary sensor within the inverter CCA to ensure the hardware safes

To test the effectiveness of the fault mask, the Node 3 MTL PPA was operated in Single MT for a period of five days. After the restart of the PPA, the temperature data remained erroneous before achieving its highest reading and dropping back to within a few degrees of the original temperature reading from before the loop failure. After the operational test in Single MT was completed, the loop mode was shifted back to its nominal operational mode of Dual and the Node 3 MTL PPA is considered a degraded yet operational hardware. Since September of 2024, the data relayed from the transducer temperature sensor has varied from nominal data to a bias high, with intermittent temperature spikes up to 223.7 C. In comparison to the Node 3 CDRA PFMC signature, the Node 3 MTL PPA PFMC has exhibited more intermittent spike events while exhibiting a similar erratic behavior in temperature over time. The data from the transducer has trended towards a higher bias with time. Prior to failure, the Node 3 CDRA PFMC exhibited off-scale high temperatures until the point of a loss of communication. With only one available reference point, the Node 3 MTL PFMC temperature will continue to be monitored, while being prepared for an R&R should the hardware hard fail rather than continue to operate.
