# A Review of Pump Package Assembly Anomalies and Demonstration to Gain Motor Controller Replacement Capability

Authors: Aaron Rodriguez (NASA JSC), Colton Krutilek (S&K Technologies)

55th International Conference on Environmental Systems

ICES-2026-280

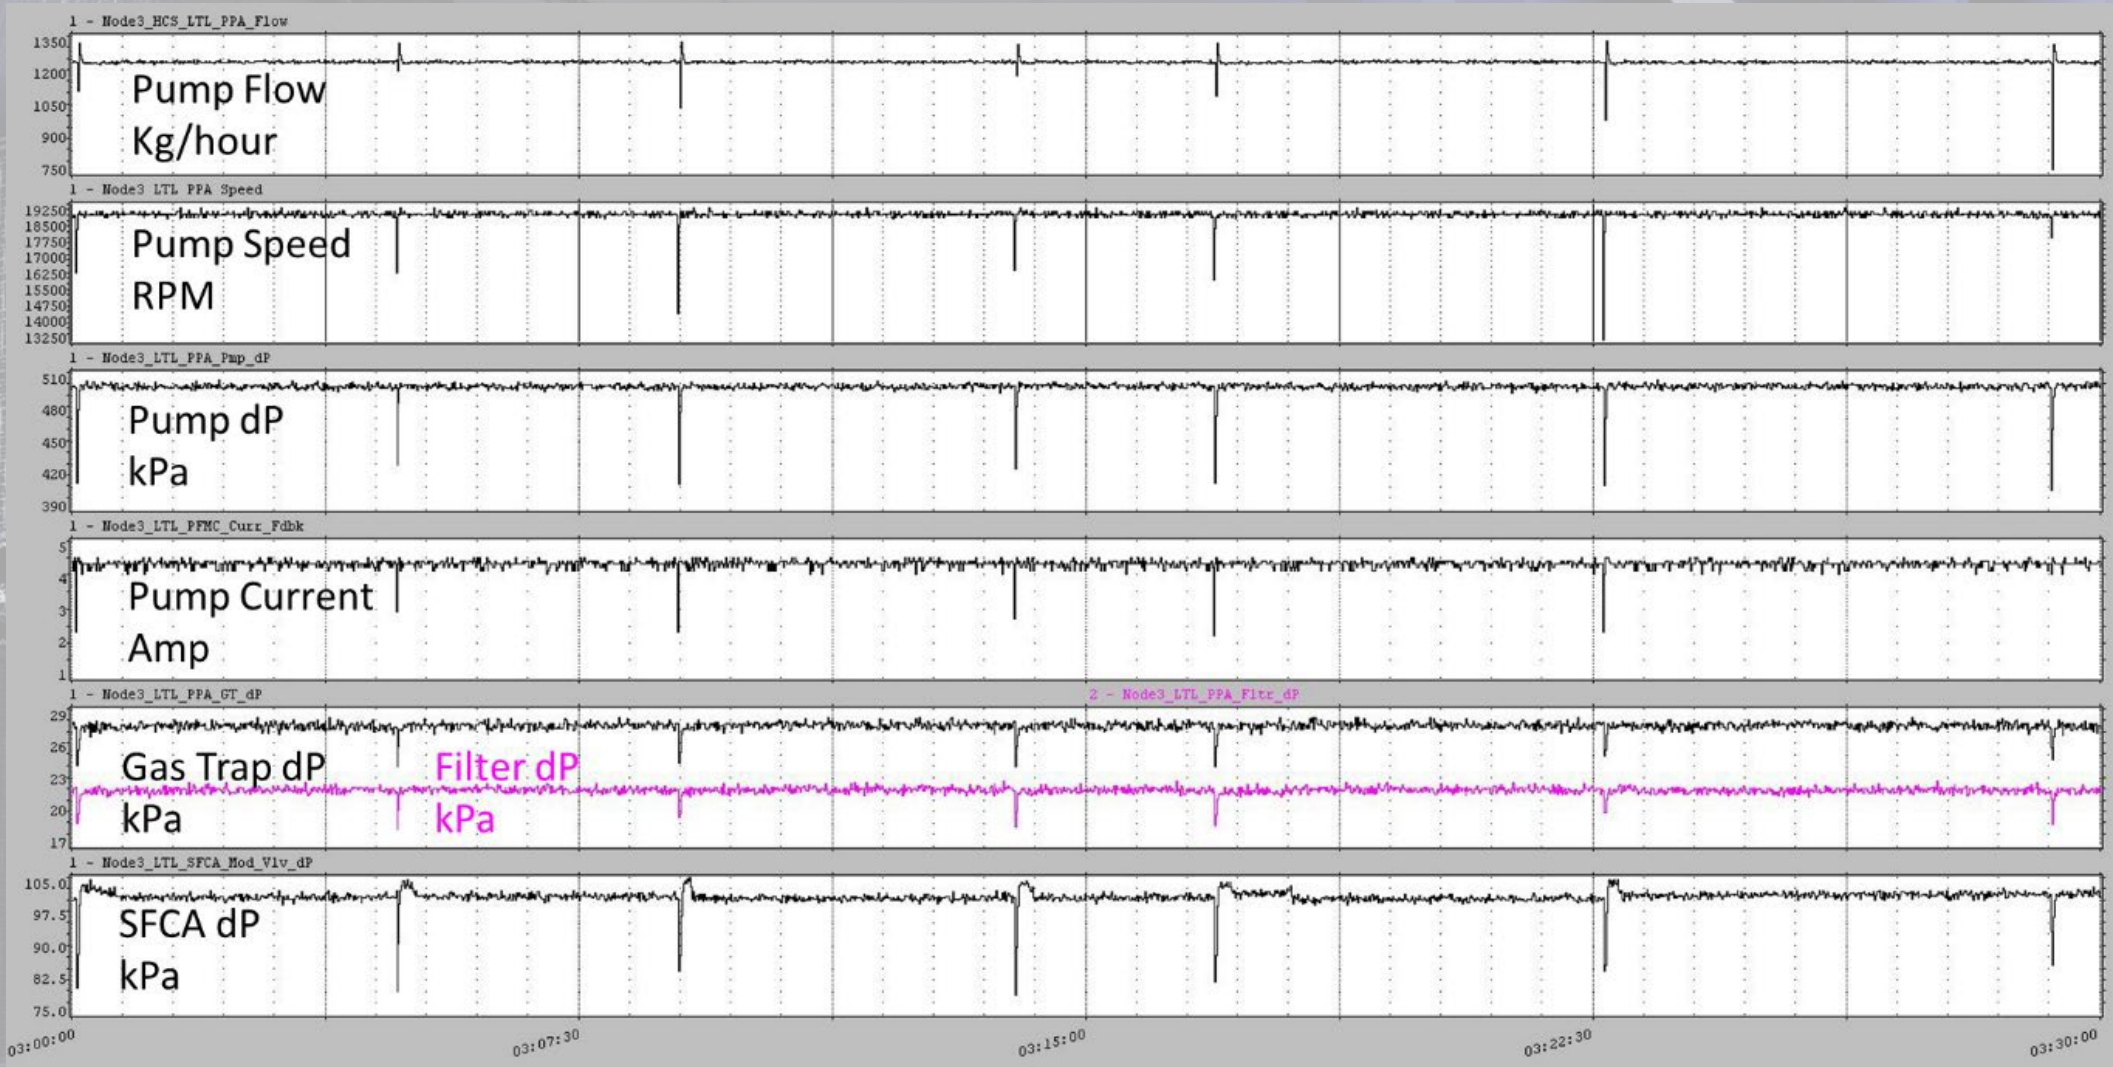
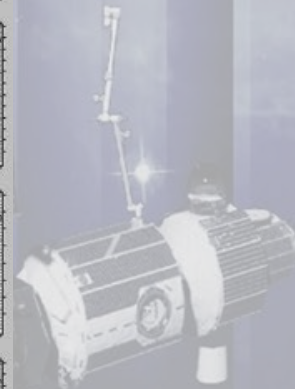
# 30 minutes of N3 LTL PPA data

- Rapid (<1 second) speed drops – 19K to 12K RPM
- Otherwise, nominal performance
- Anomaly was captured in pressure and flowrate telemetry it was a true hydraulic event
- Only seen at elevated pump speed which are used when MTL and LTL are combined
- Frequency of anomalies increased from 2015 to 2018 (up to multiple times per hour)
- PPA was replaced due to its criticality to EVA operations
- PPA was not returned to ground

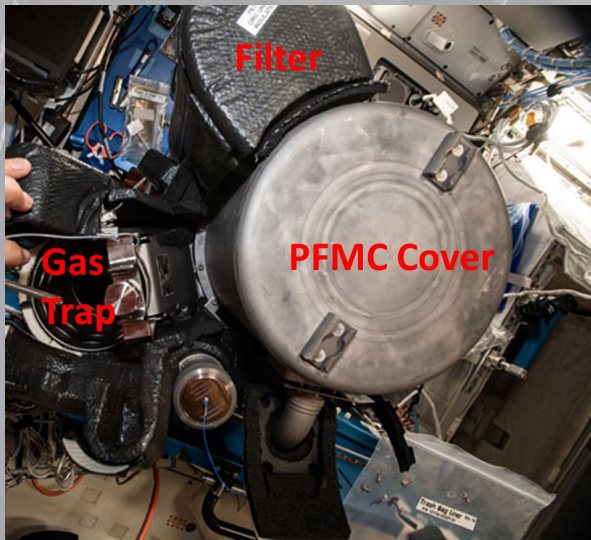
1) Remove insulation around PFMFC Cover

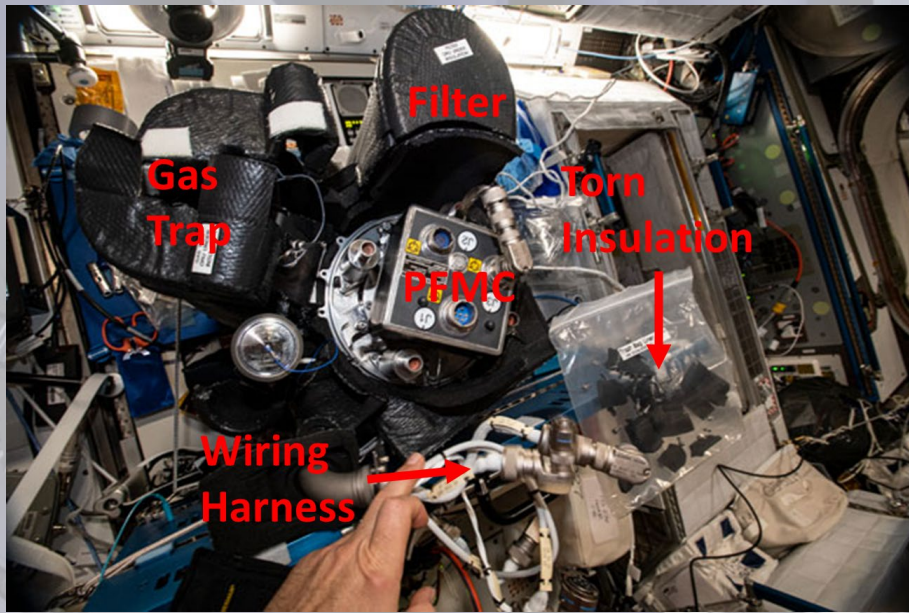
2) Remove PFMFC Cover and disconnect wire harness

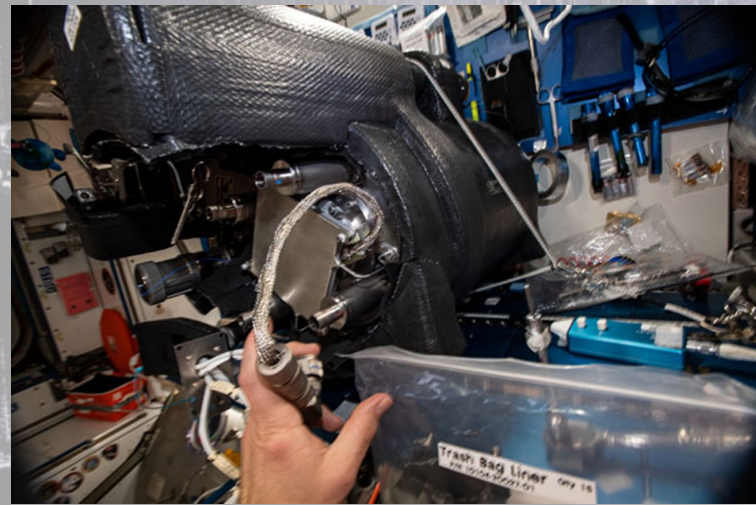
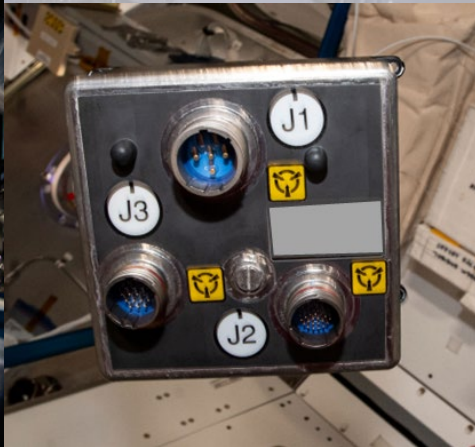
3) Remove PFMFC

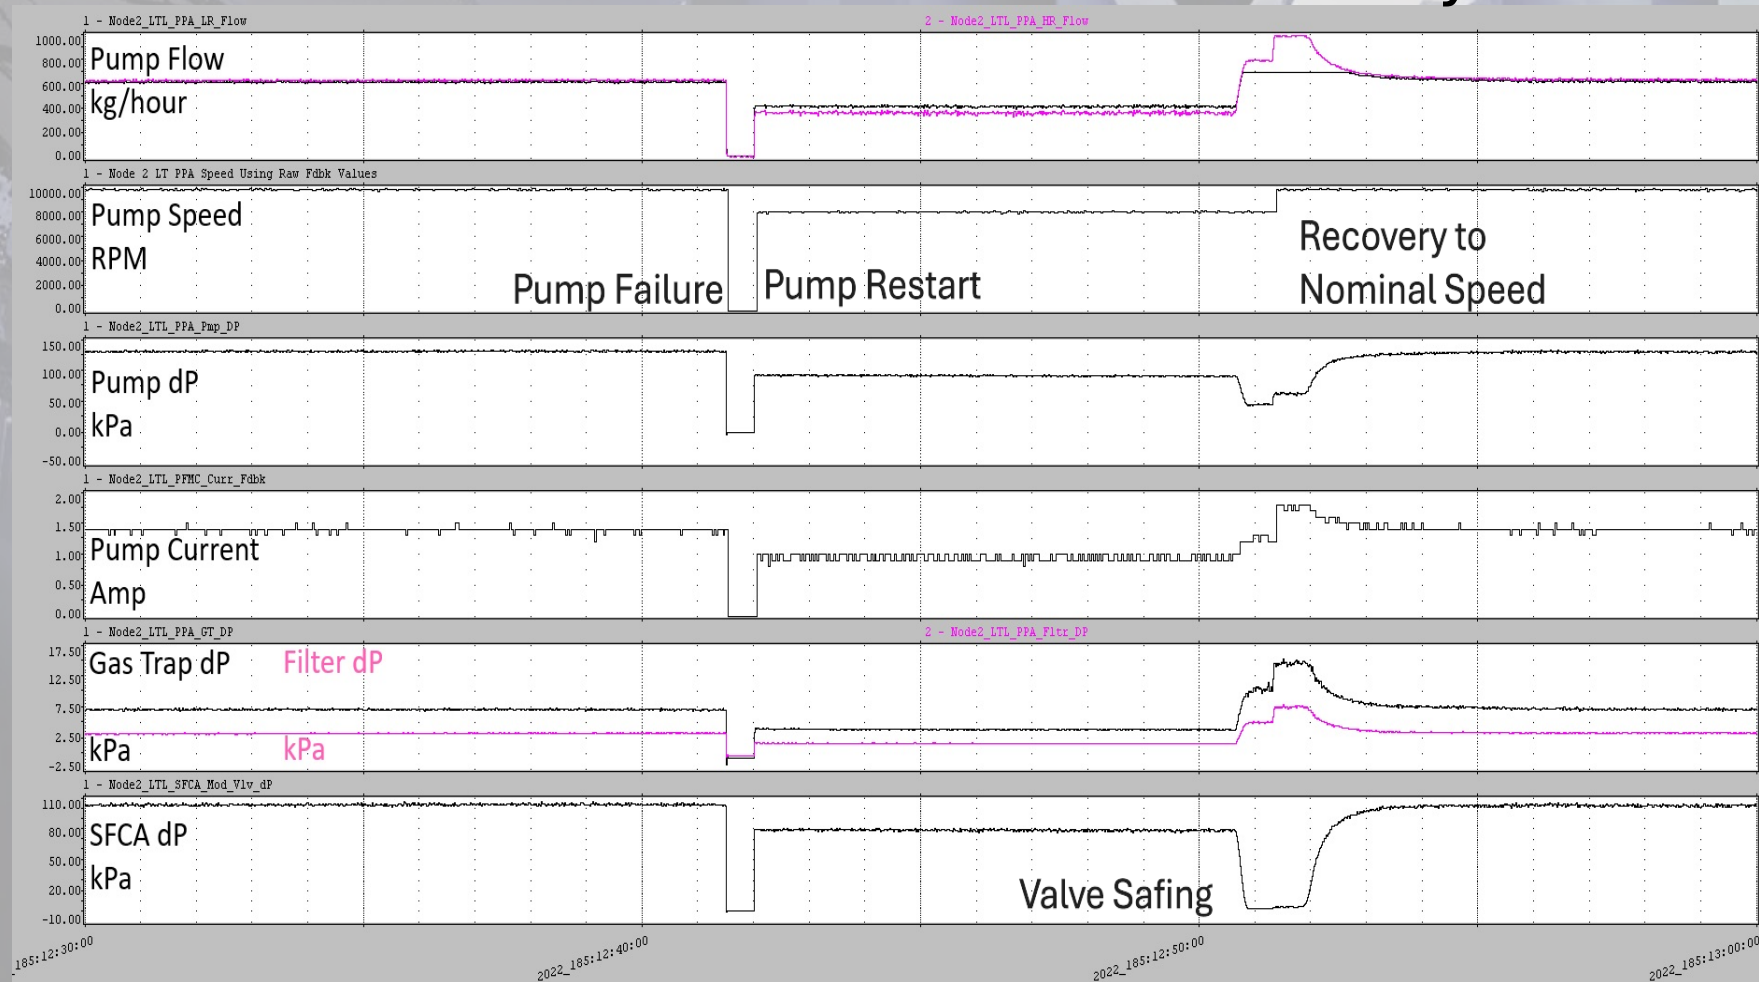
## Initial occurrence of Anomaly

- PPA would intermittently restart itself
- No flag or other indication of issue would be present
- Plan is to operate until it becomes too burdensome for Flight Controllers

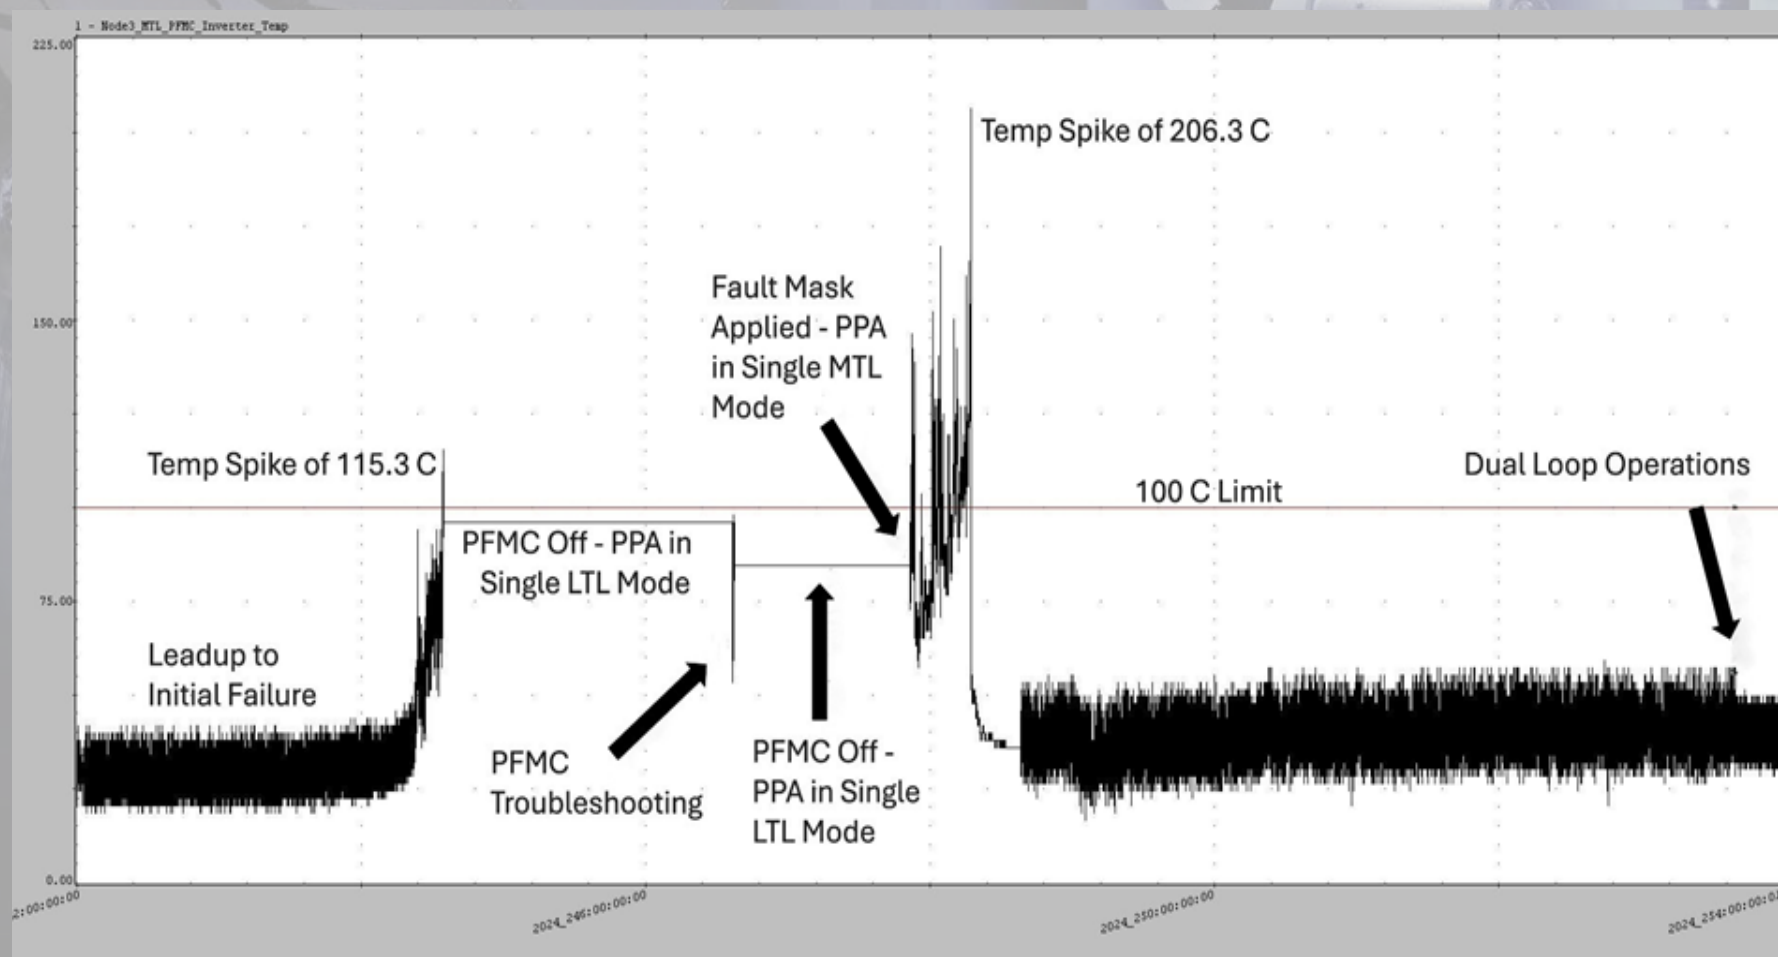
## PFMC Inverter Temperature – 12 days of data

- Inverter Temperature exceeded limit
- No other indication of fault, also seen in CDRA
- Masked the fault and continue to monitor for hard-failure

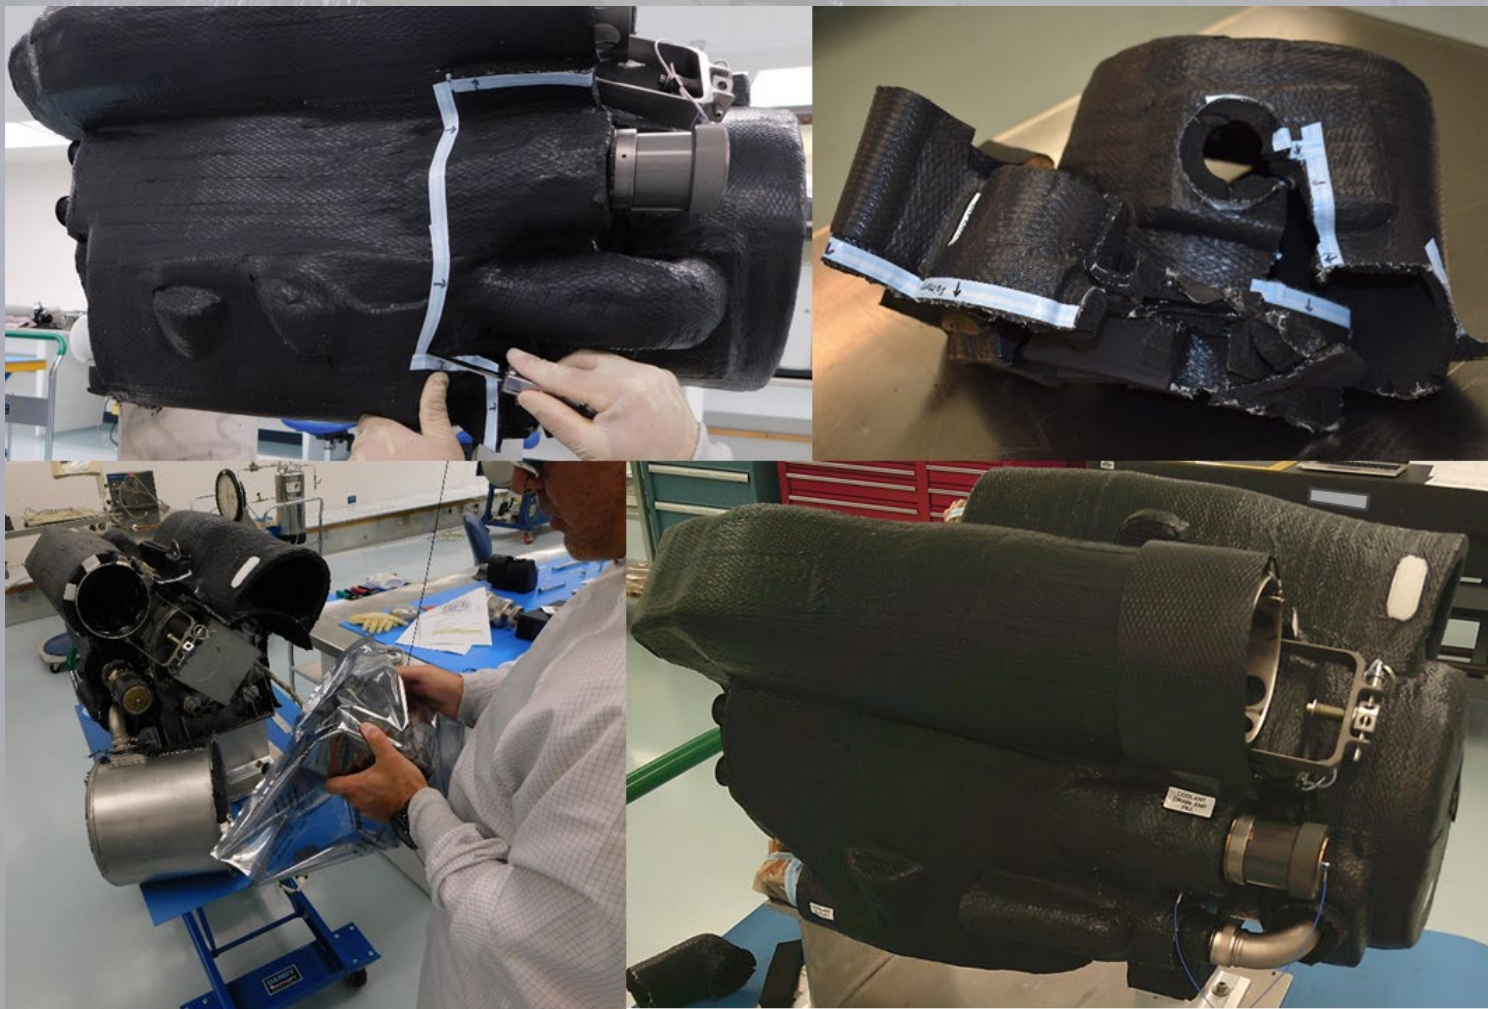
# PFMC R&R Demonstration

- Conducted a ground demonstration to show PFMC could be R&Rd using crew tools.
- Performed tests to show PFMC was not damaged and that insulation could be re-installed
