NASA TECHNICAL NOTE

NASA TN D-563

INVESTIGATION OF S-IV ALL SYSTEMS VEHICLE EXPLOSION

Compiled and edited by J. B. Gayle

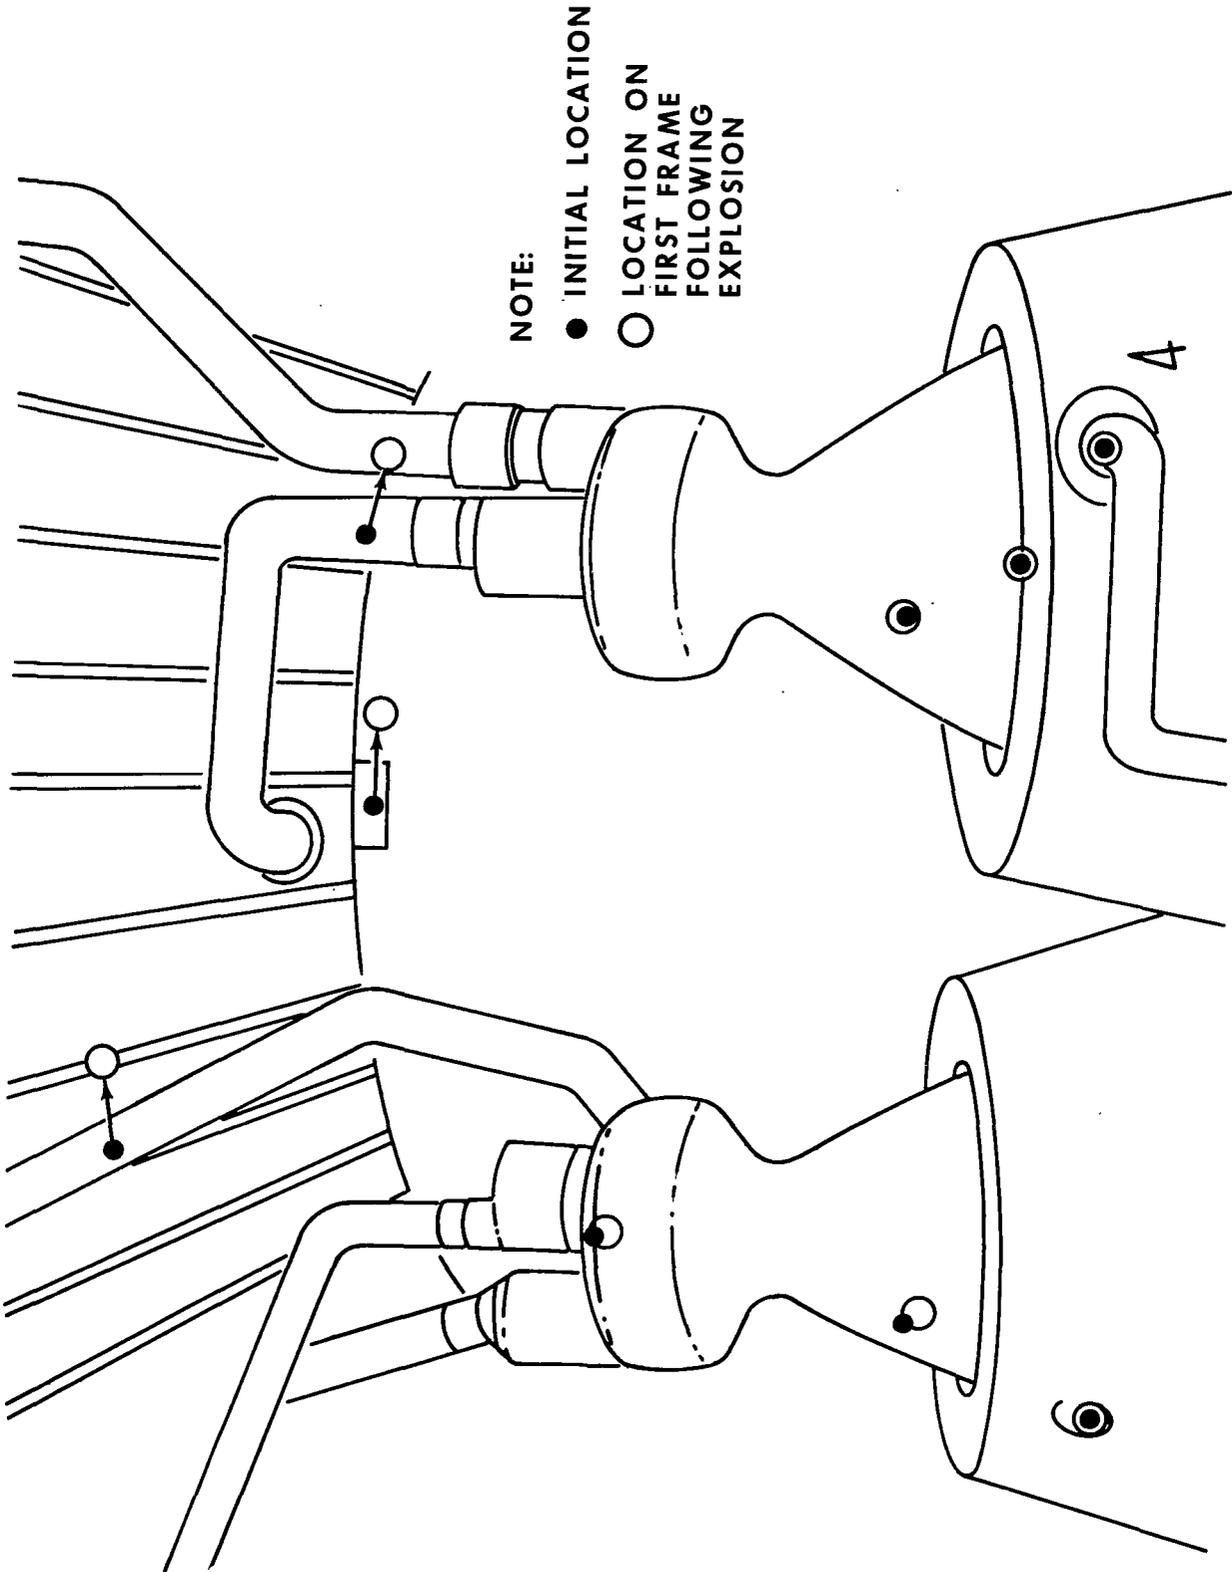
FIGURE 1. MOVEMENT OF VEHICLE AFTER EXPLOSION

Inspection of photographs prepared by enlarging individual frames from one of the engine area cameras indicated that the initial motion of the vehicle caused by the explosion had a definite westerly vector. This was determined by locating readily definable parts of the vehicle with reference to the test stand structure from photographs taken immediately before and after the start of the explosion. The results are shown in FIG 1. The movement from left to right shown in this figure represents movement in a north-west direction. Since this analysis indicates that the initial movement of the upper part of the vehicle was toward rather than away from the apparent center of the explosion, it appears that the principal explosion may have been preceded by a smaller one located near the periphery of the vehicle.

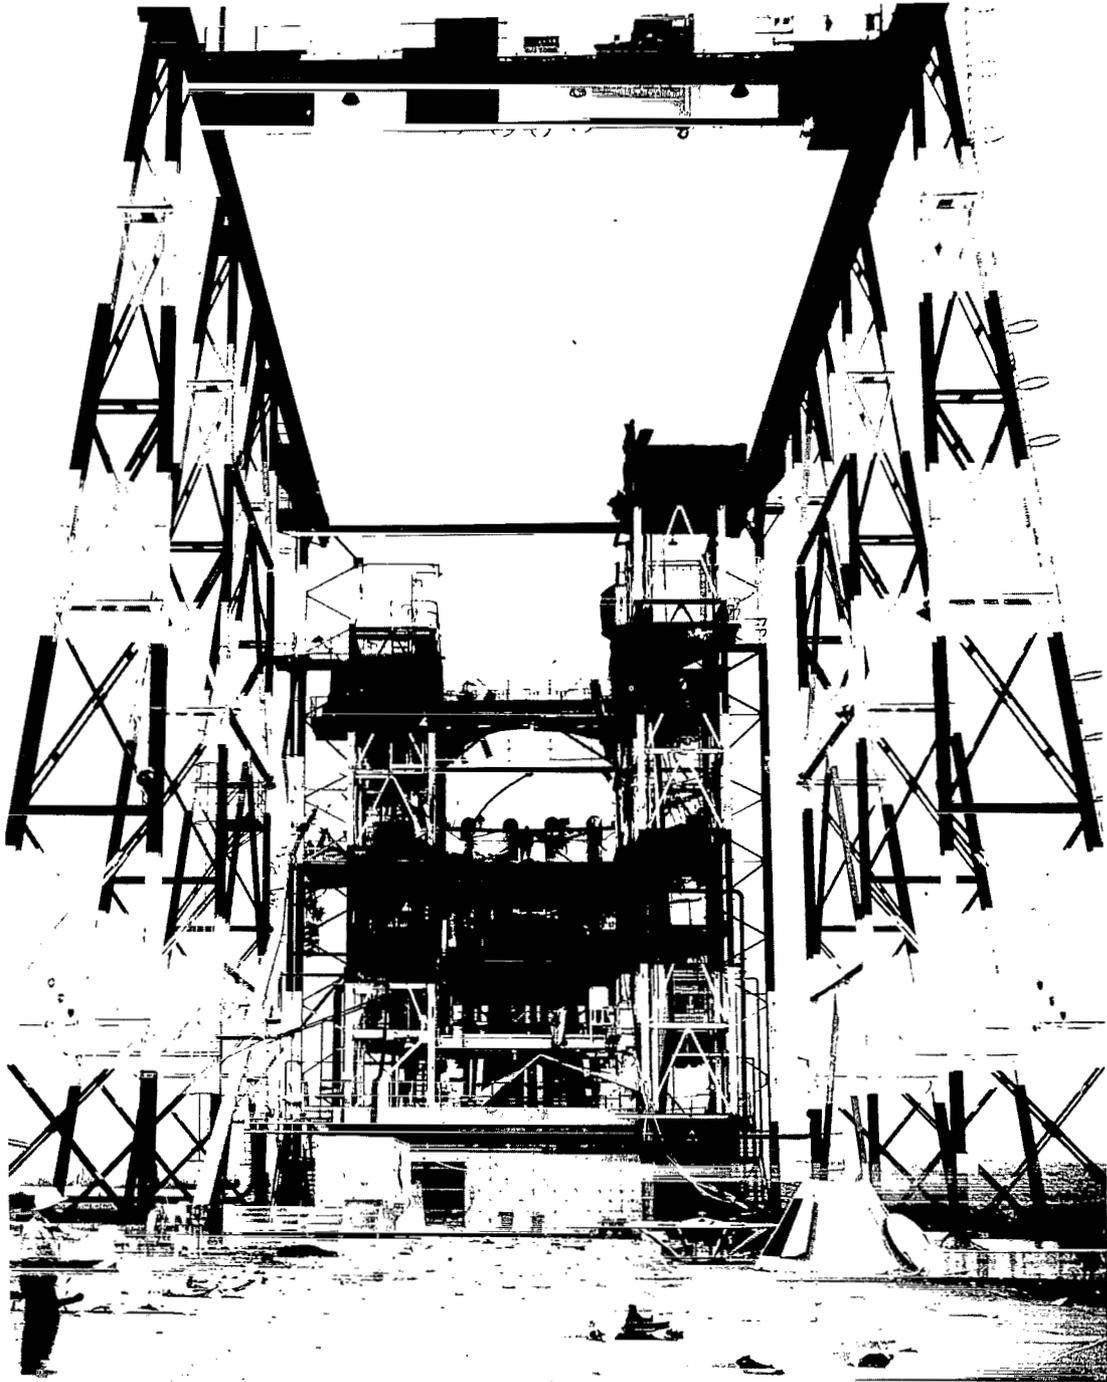
FIGURE 2. VIEW OF TEST STAND AFTER EXPLOSION

Figure 2 shows the test stand and vicinity after the explosion. Inspection of this figure indicates that the overhead crane and supporting structures were virtually undamaged and that the effects of the explosion were largely confined to the test stand proper.

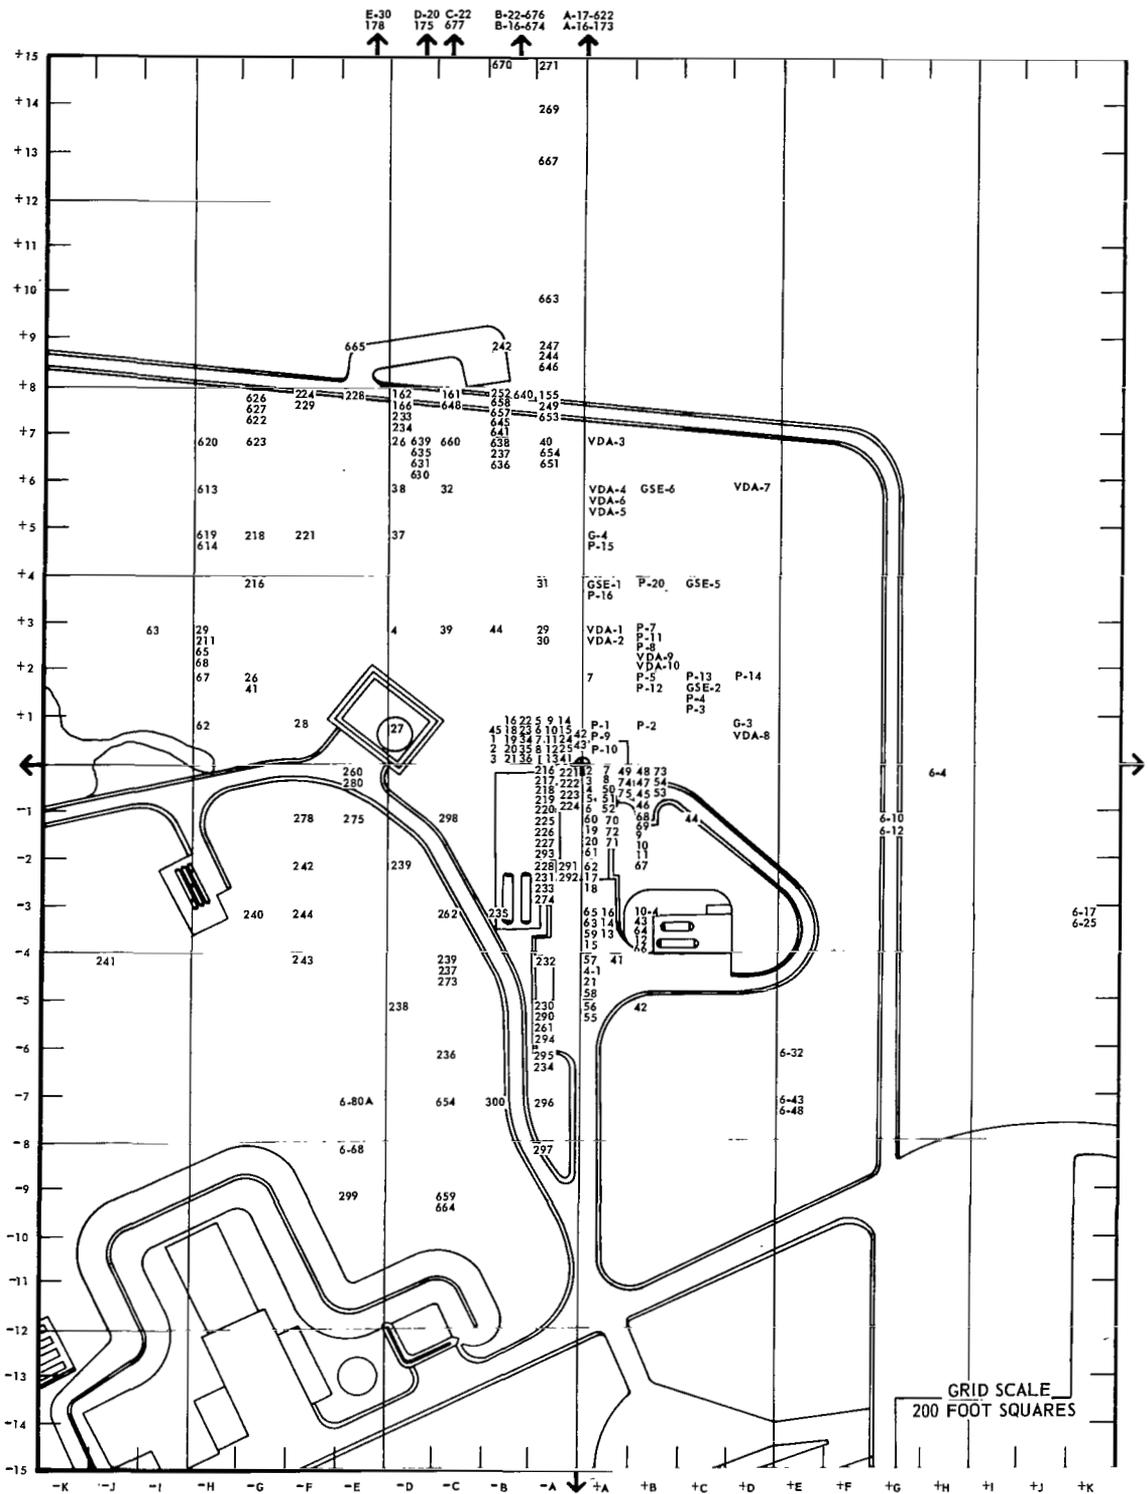
FIGURE 3. FRAGMENT DISPERSION PATTERN

Figure 3 is a map showing the location of debris which was dispersed as shrapnel. Table II gives the identification of the fragments shown on FIG 3. Table III is a tabulation of the approximate sizes, weights, and locations (in distance from the center of the explosion) of fragments selected for possible detailed investigation.

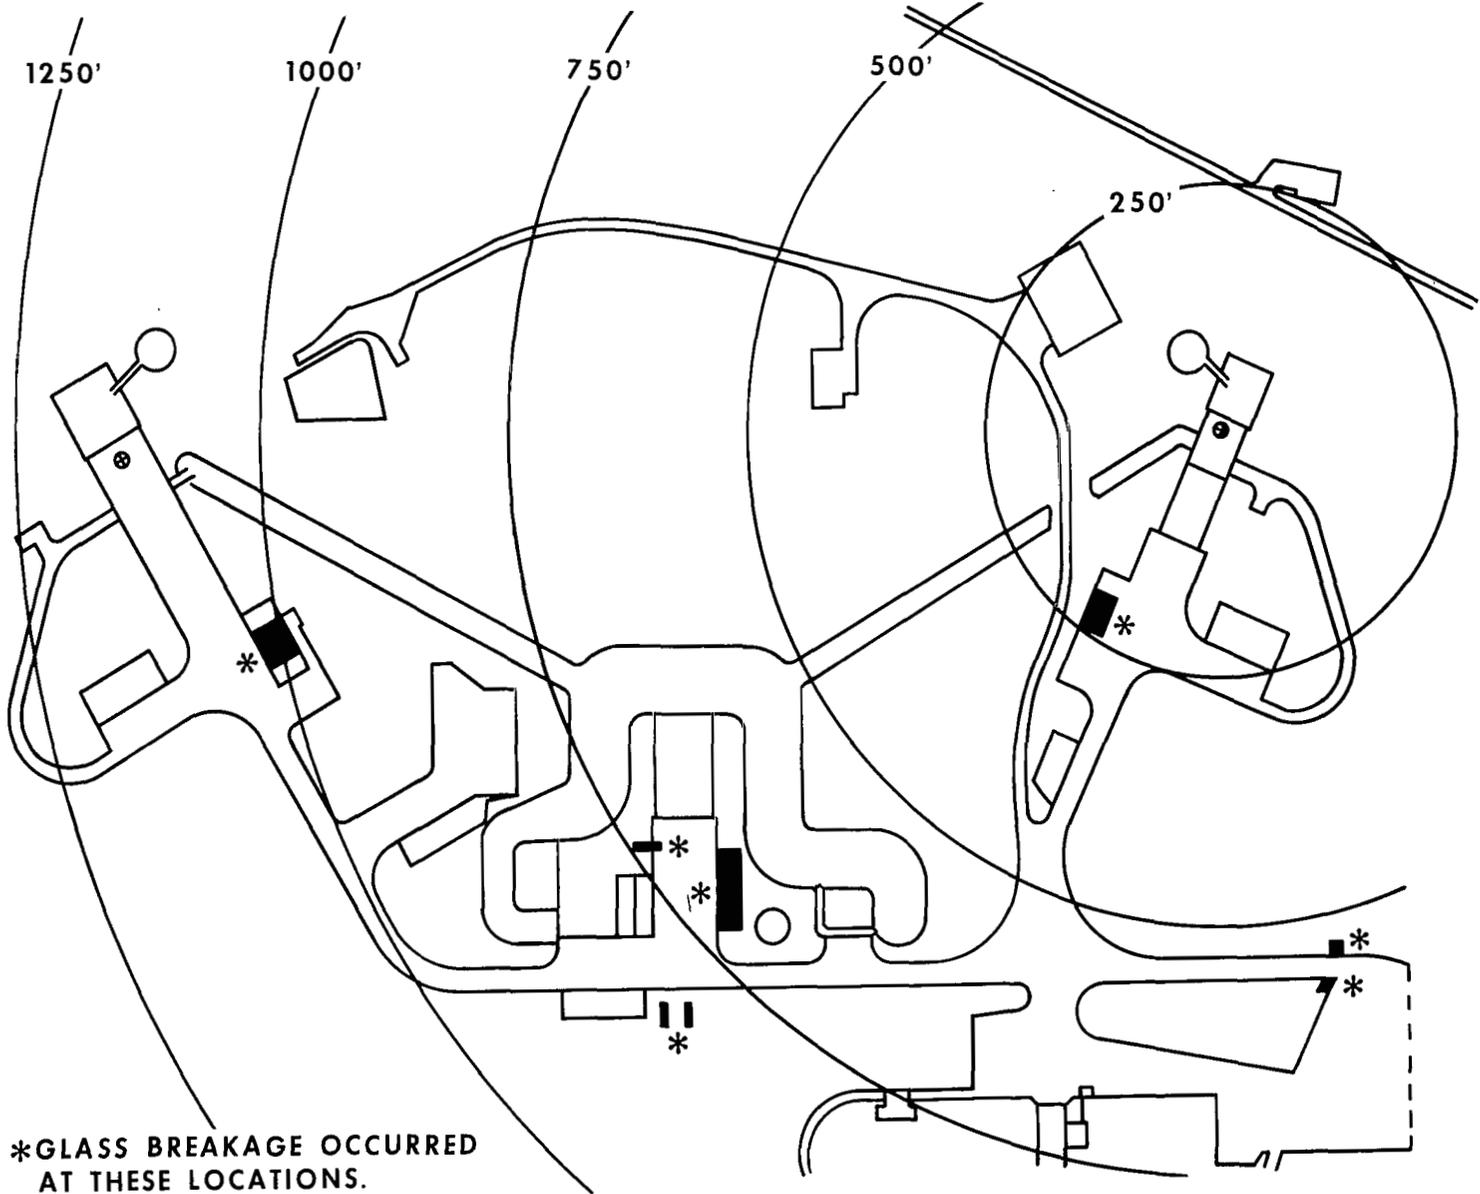
FIGURE 4. GLASS BREAKAGE PATTERN

Glass breakage occurred at distances up to approximately 1,100 feet from the center of the explosion, as shown in FIG 4. Most significant to this study were windows broken in guard shacks, house trailers, and Butler buildings.

*GLASS BREAKAGE OCCURRED AT THESE LOCATIONS.

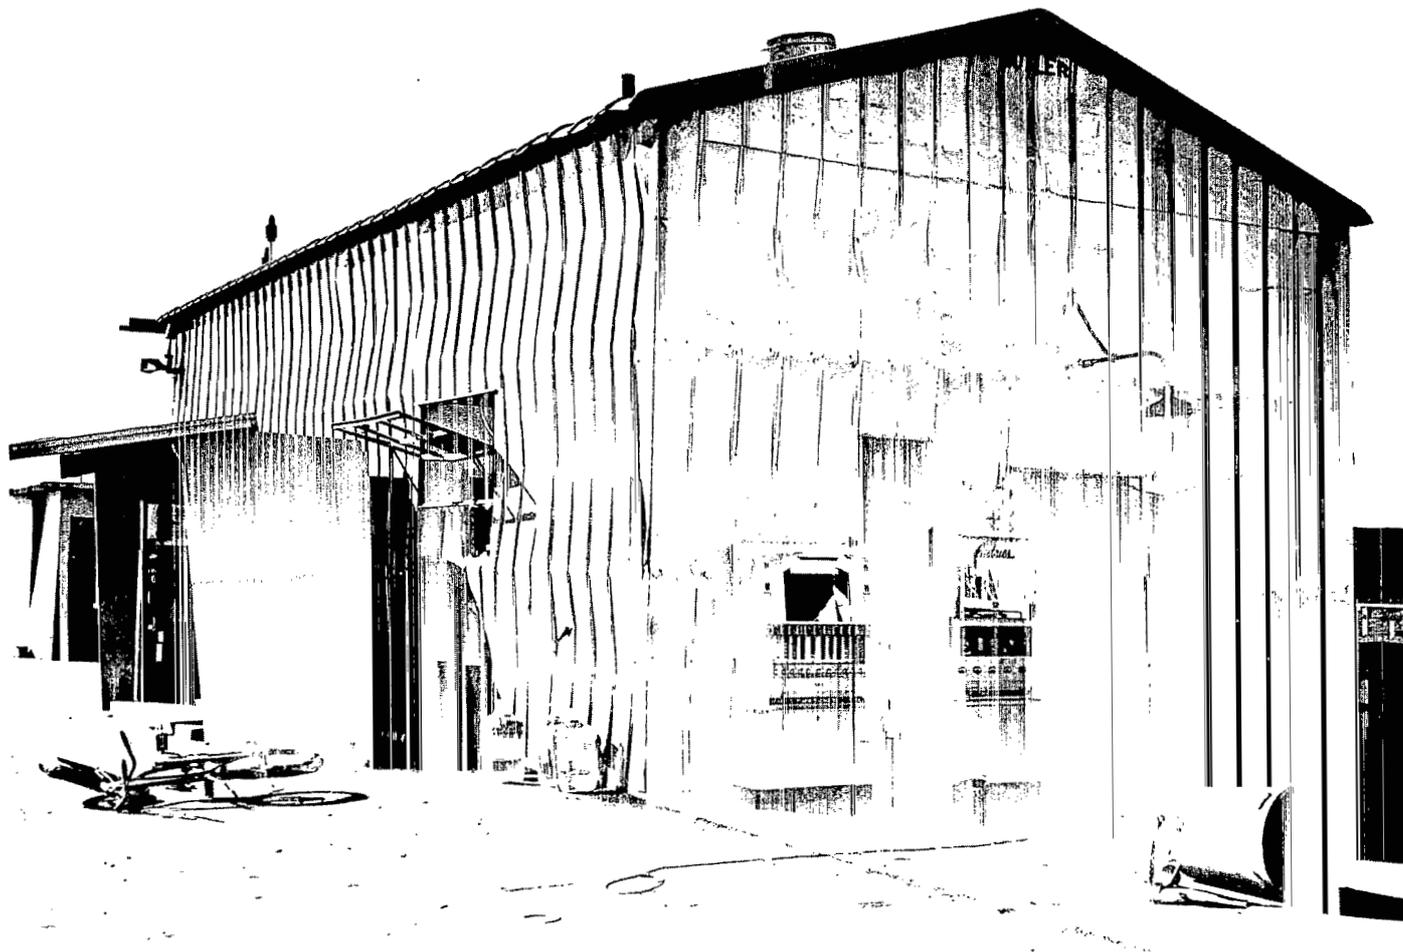
FIGURE 5. DAMAGE TO BUTLER BUILDING, TS-1

The Butler Building designated TS-1 suffered what we considered relatively light damage (FIG 5). One end of this building was positioned facing the blast, with the nearest surface at a distance of 210 feet from a point on the ground directly below the assumed center of the explosion. Damage to the test stand is described by individual levels.

Damage sustained by the Butler building was considered to be relatively light. The most extensive damage occurred on the end facing the blast, which would have been within the Mach stem. A general description of the damage would include a wrinkling to a slight crushing of the corrugated steel panels of from four to six inches in both the side walls and roof. Several windows were broken on the sides receiving the more direct blast, but only one was broken on either of the other two sides. Several structural members in the roof were slightly buckled or deflected a maximum of two inches while several others were loosened at the joints.

It has been assumed that a reflected overpressure of nearly five psi would be necessary at the near end of the building to produce damage of this extent from a relatively short (something less than 50 milliseconds) duration blast wave. The side-on overpressure at the near end of the building would then be approximately 2.5 psi and would require a high explosive weight of approximately 760 pounds.

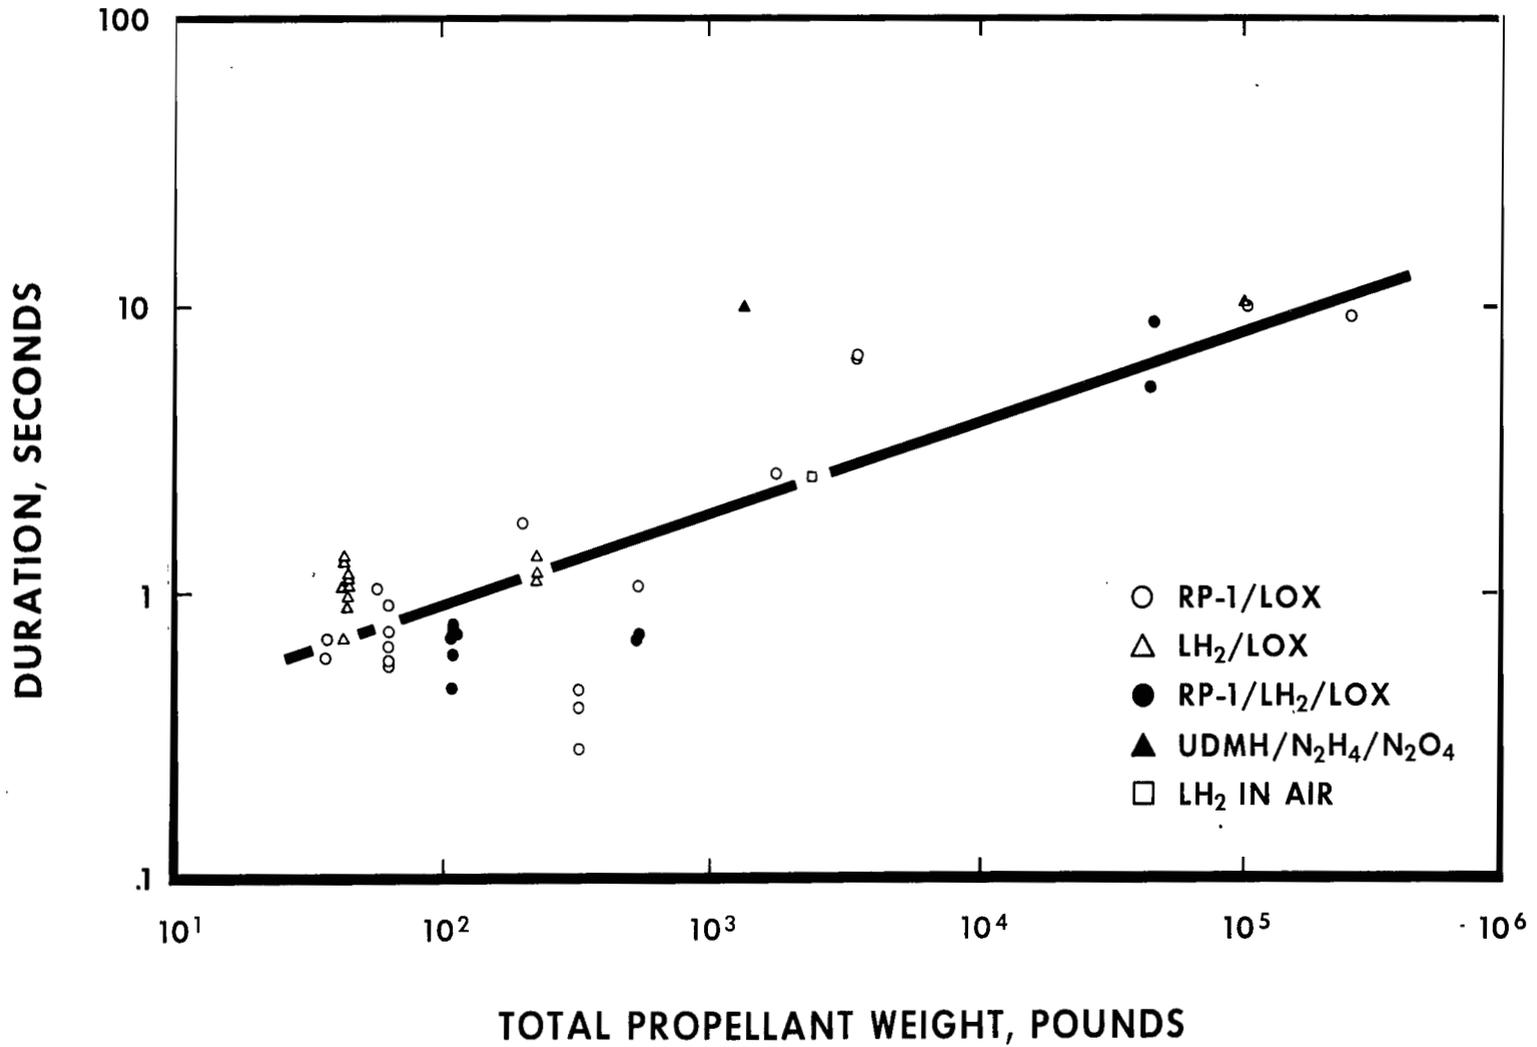
FIGURE 16. FIREBALL DURATION FOR VARIOUS WEIGHTS AND TYPES OF PROPELLANTS

Figure 16 shows the duration of the fireball together with similar values for small scale experimental studies and full scale vehicle failures. These data scatter widely and, therefore, are compatible with equations having a wide range of slopes. For consistency with the results obtained from the other explosive parameters, a slope of 0.33 is used; this appears to adequately describe the data. No doubt, much of the observed scatter is due to the difficulty in judging when the fireball has subsided.
