NASA TM X-1195

ANALYSIS OF AN EMERGENCY
DECELERATION AND DESCENT OF THE
XB-70-1 AIRPLANE DUE TO ENGINE DAMAGE
RESULTING FROM STRUCTURAL FAILURE

by *Chester H. Wolowicz*
Flight Research Center
Edwards, Calif.

NATIONAL AERONAUTICS AND SPACE ADMINISTRATION • WASHINGTON, D. C. • MARCH 1966

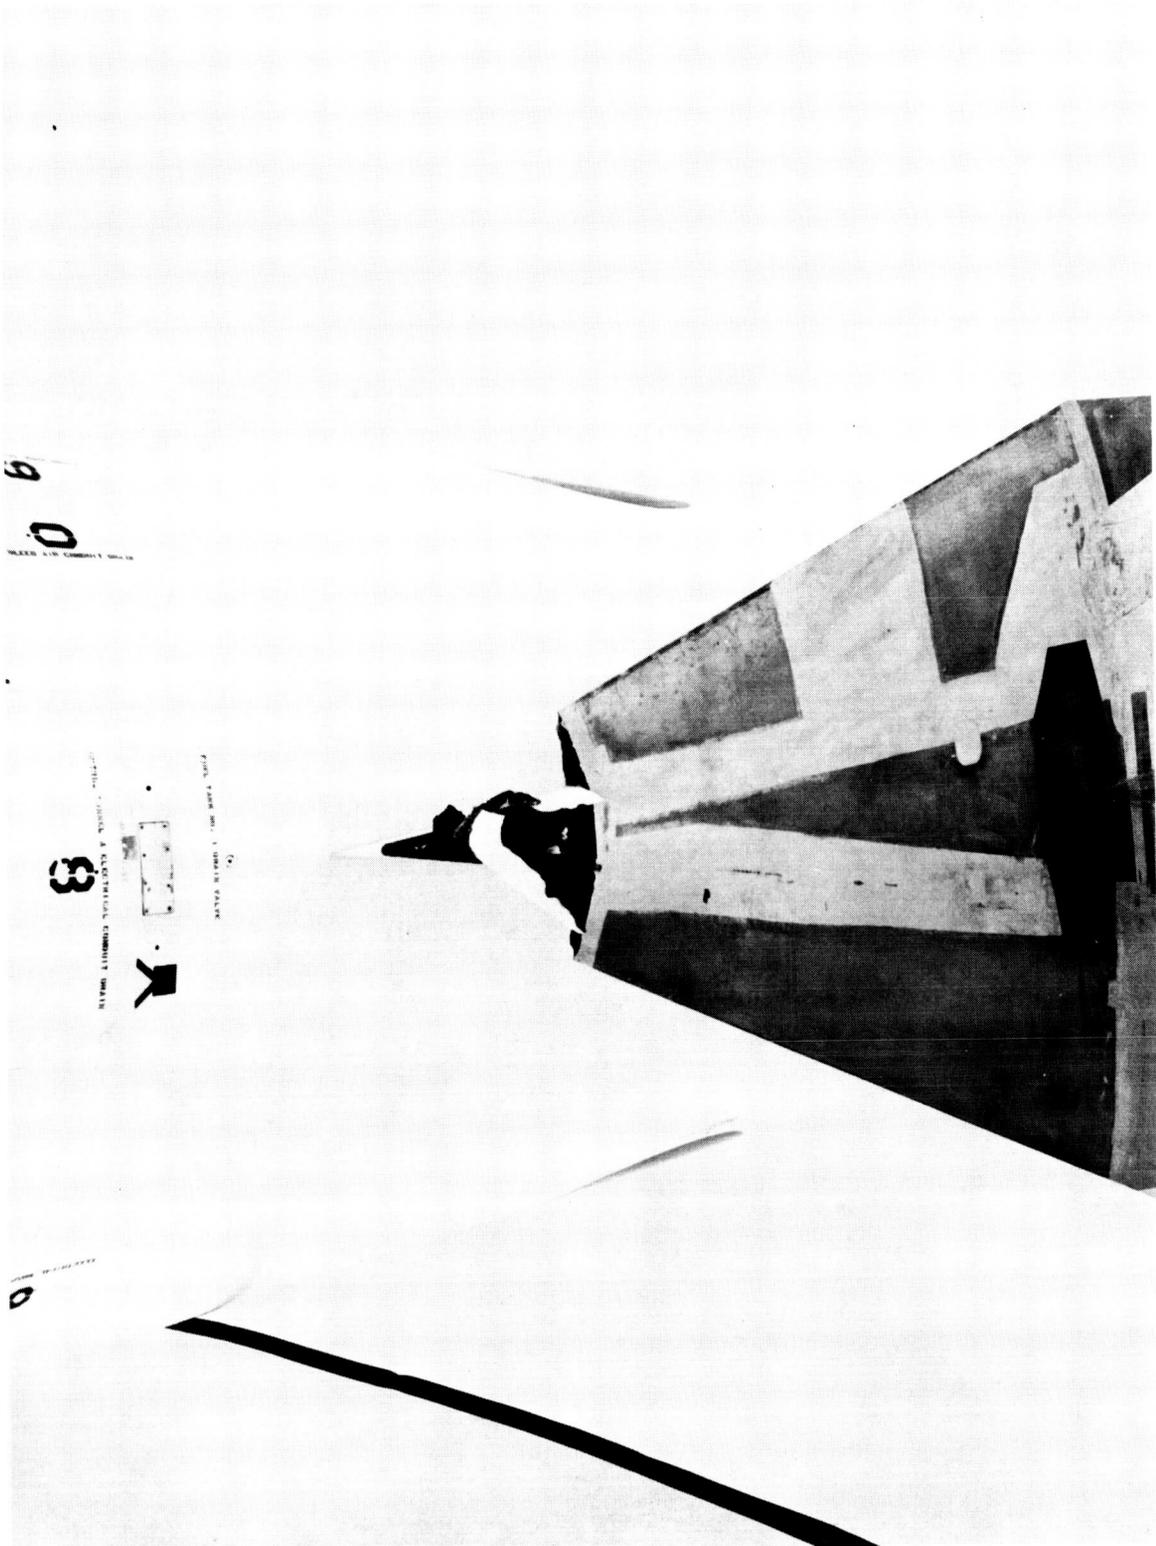
As deduced from postflight inspections of the aircraft, analysis of flight data, study of flight-monitoring notes, and information supplied by the manufacturer (ref. 1), the initial duct unstart of the emergency portion of the flight was caused by a stall of the No. 5 engine (in the right duct) resulting from ingestion of pieces of the wing apex into the right duct. Figure 3 is a postflight photograph of the damaged apex section of the wing.

Figure 3. - Postflight photograph of disintegrated apex of wing. XB-70-1; flight 12.

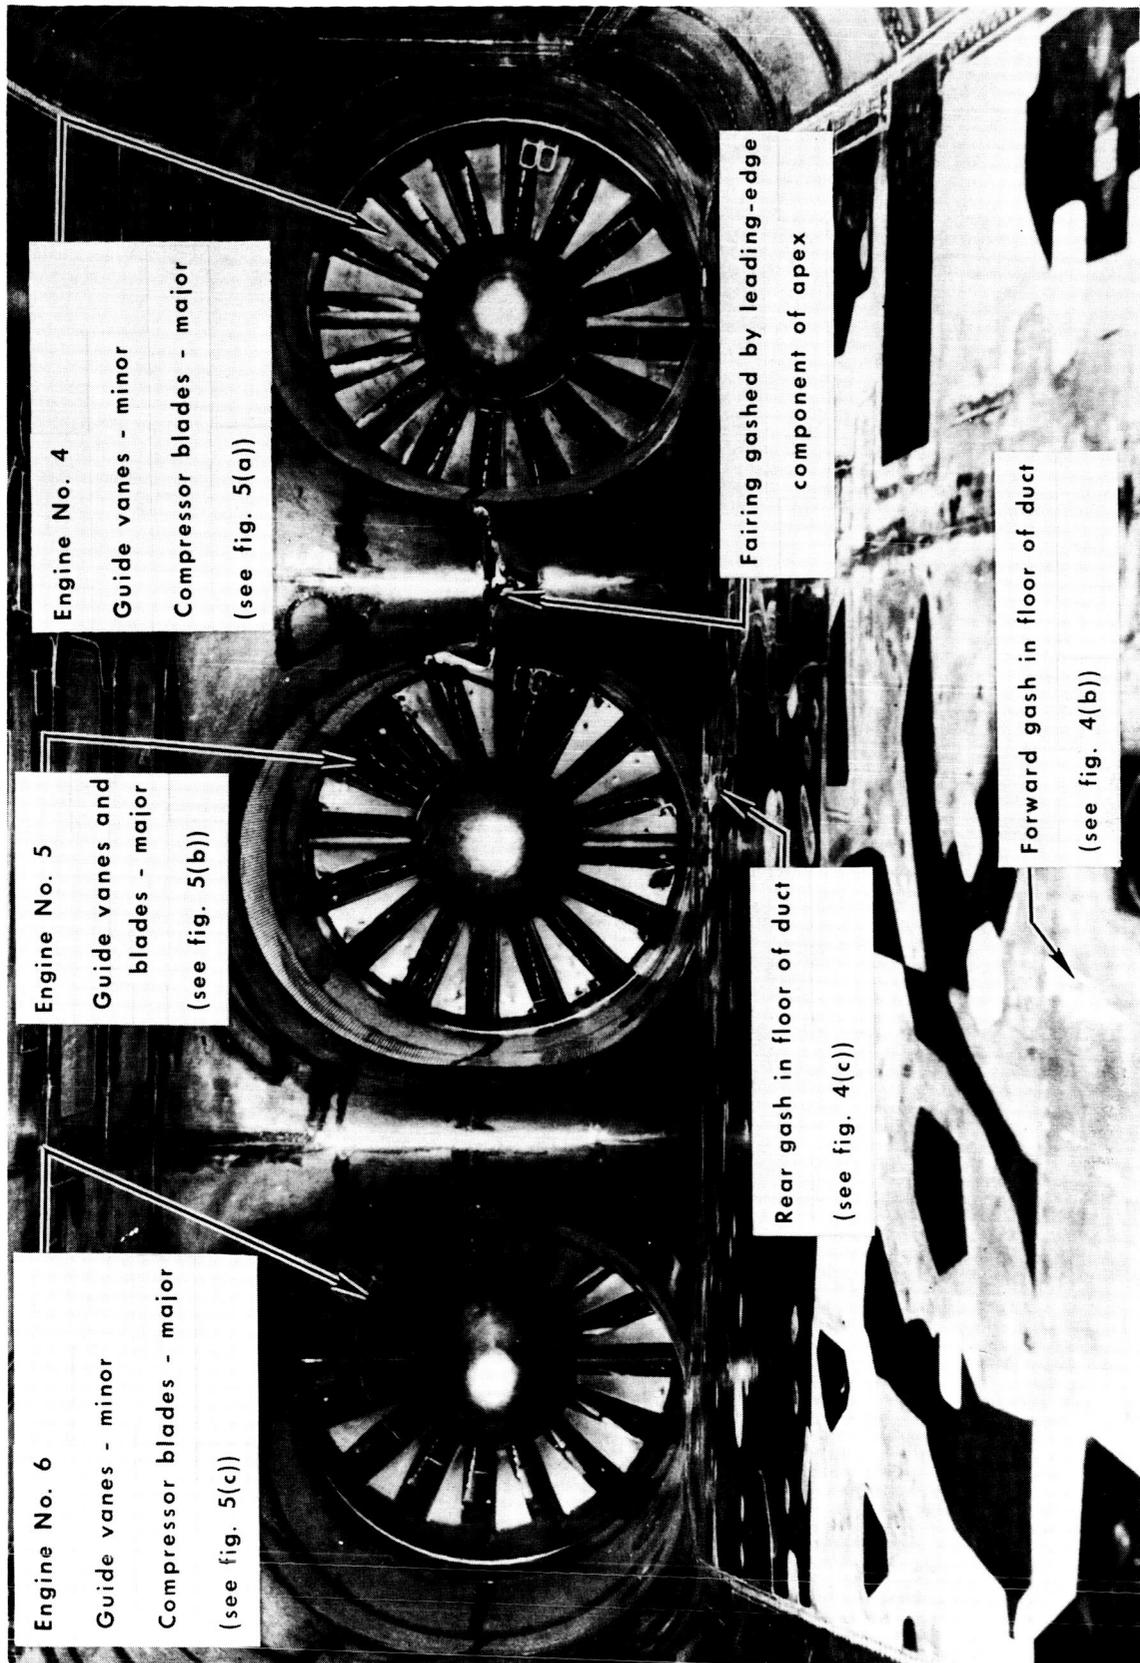
Figure 4. - Right-hand-duct damage.

The damage done to the right duct and its engines is shown in figures 4(a) to (c) and 5(a) to (c). Fortunately, time histories of propulsion and aerodynamic parameters were obtained for the entire duration of the ensuing emergency. Time histories of the pertinent propulsion parameters for both ducts are shown in figure 6. The more pertinent portions of the aerodynamic time histories obtained from the manufacturer's tabulated data are shown in figures 7(a) and 7(b).

(a) Overall view encompassing areas damaged by disintegrated wing apex.

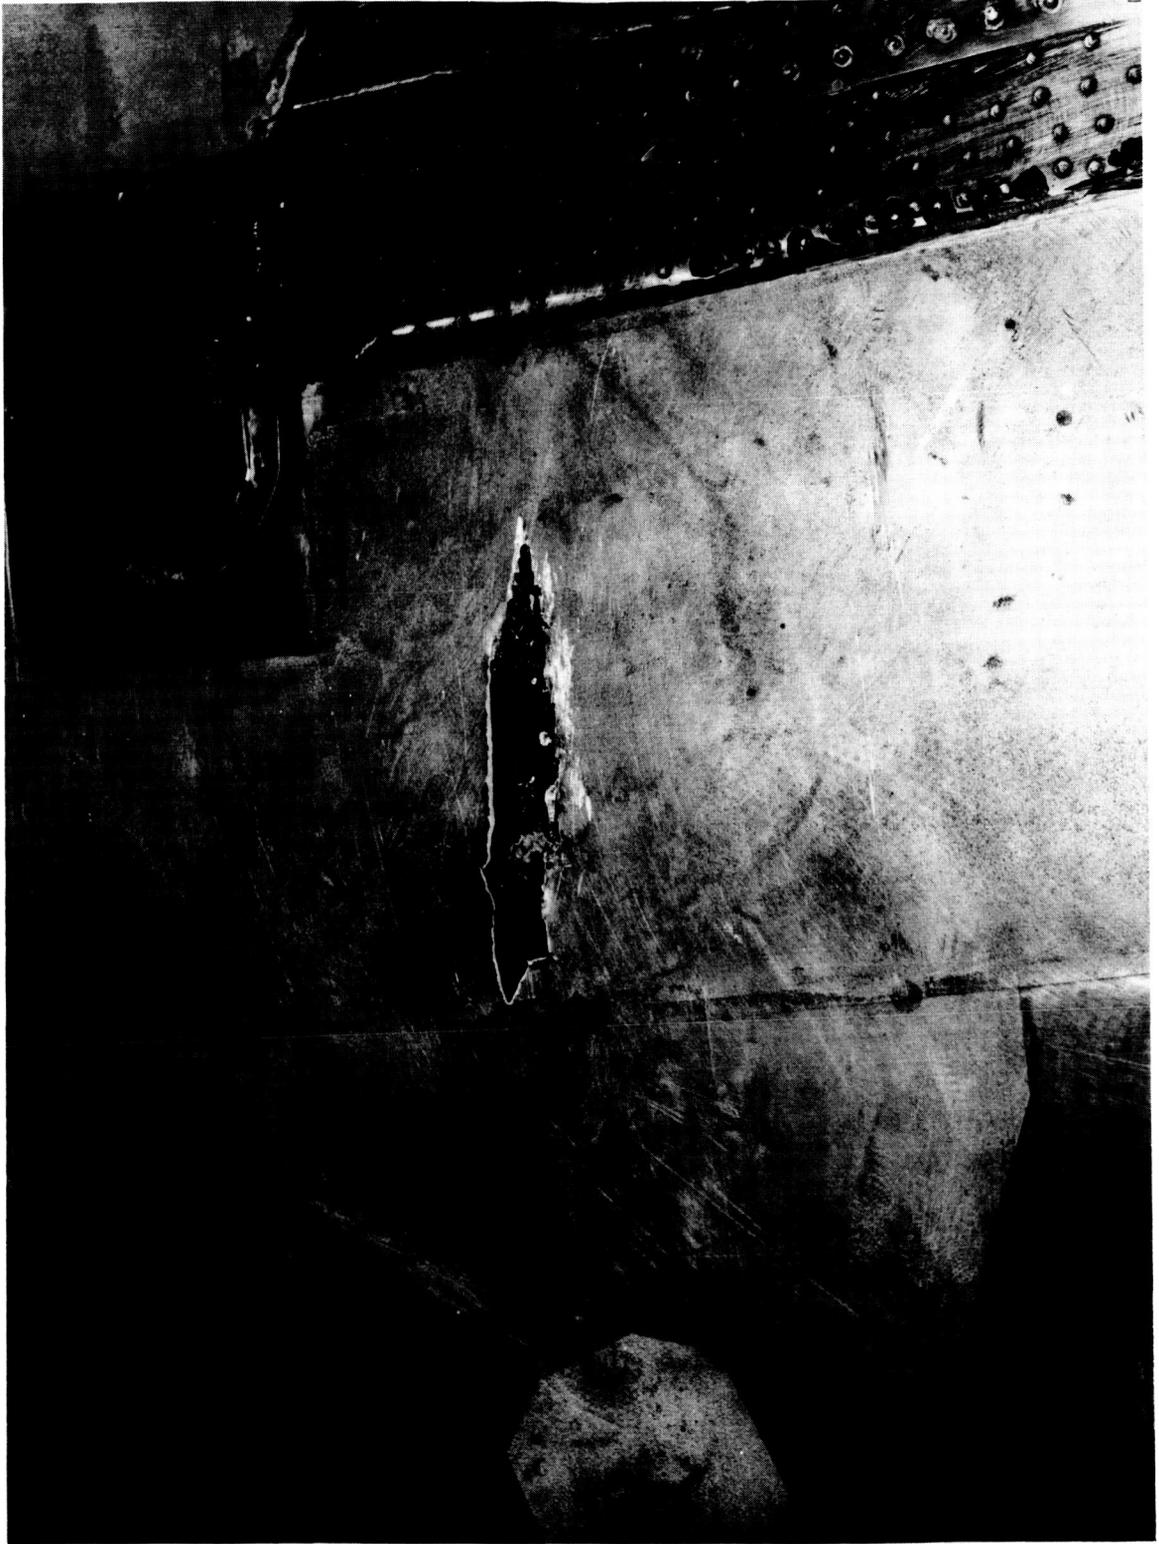
Figure 4. - Continued.

(b) Detailed view of forward gash in floor.

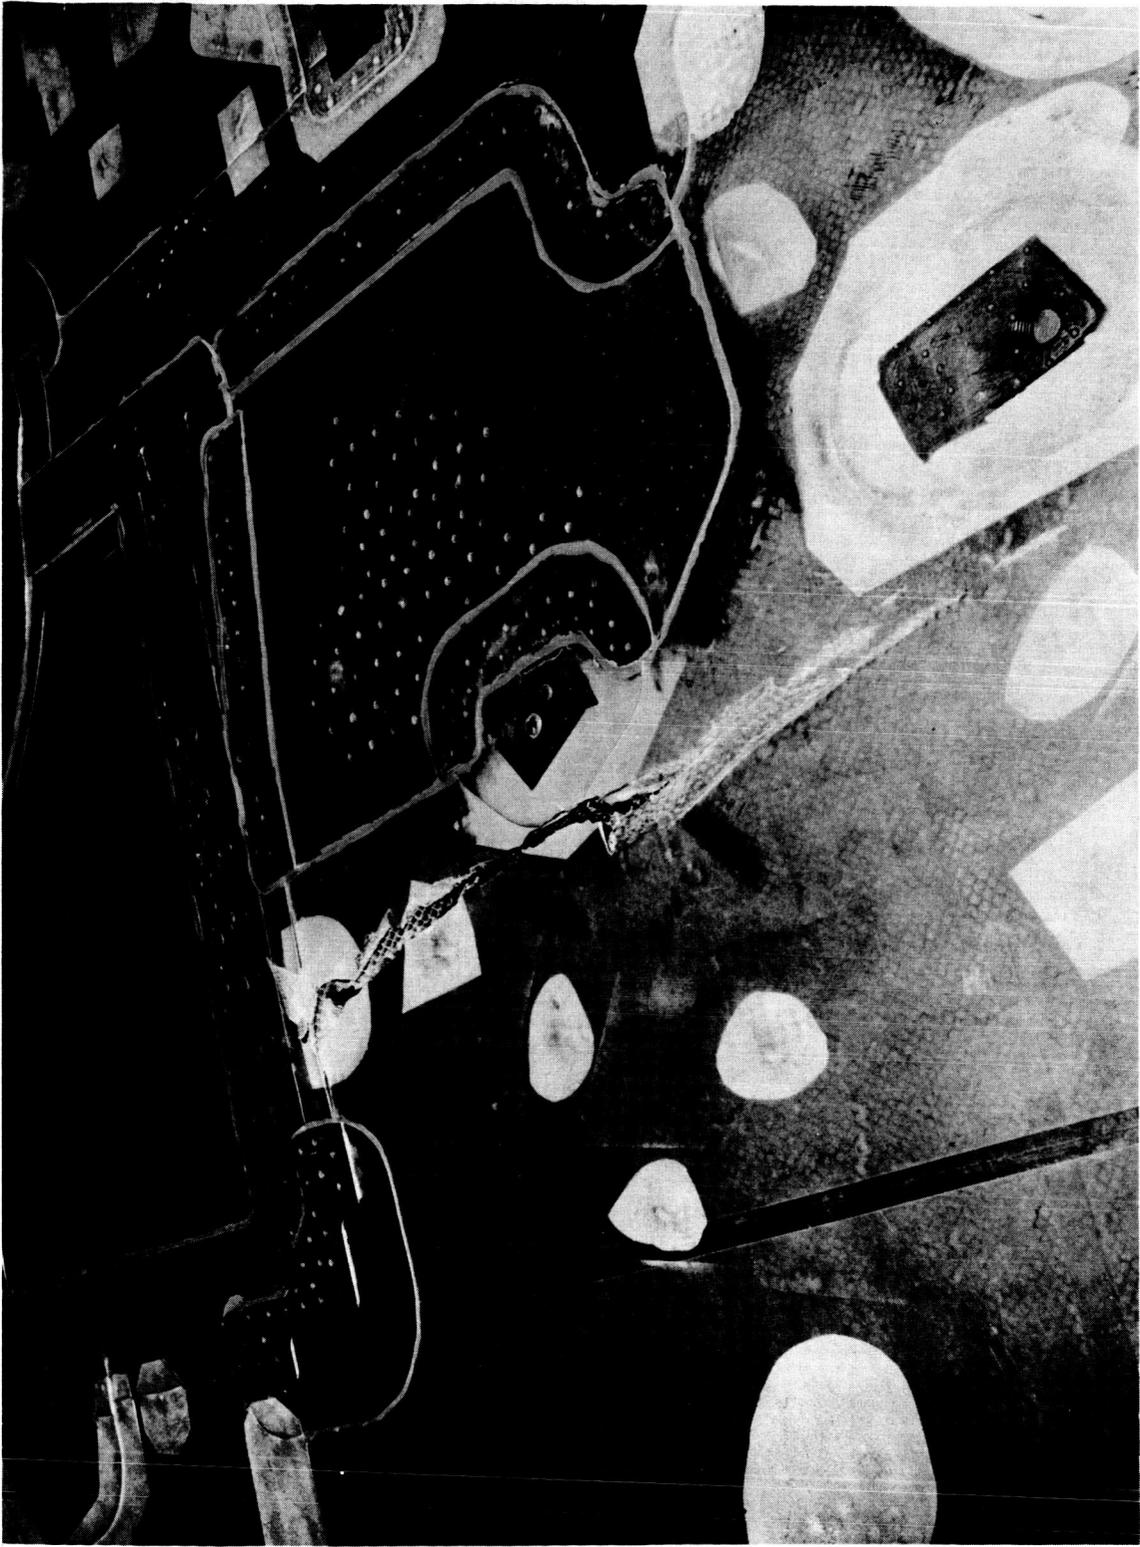
Figure 4. - Concluded.

(c) Detailed view of rear gash in floor.

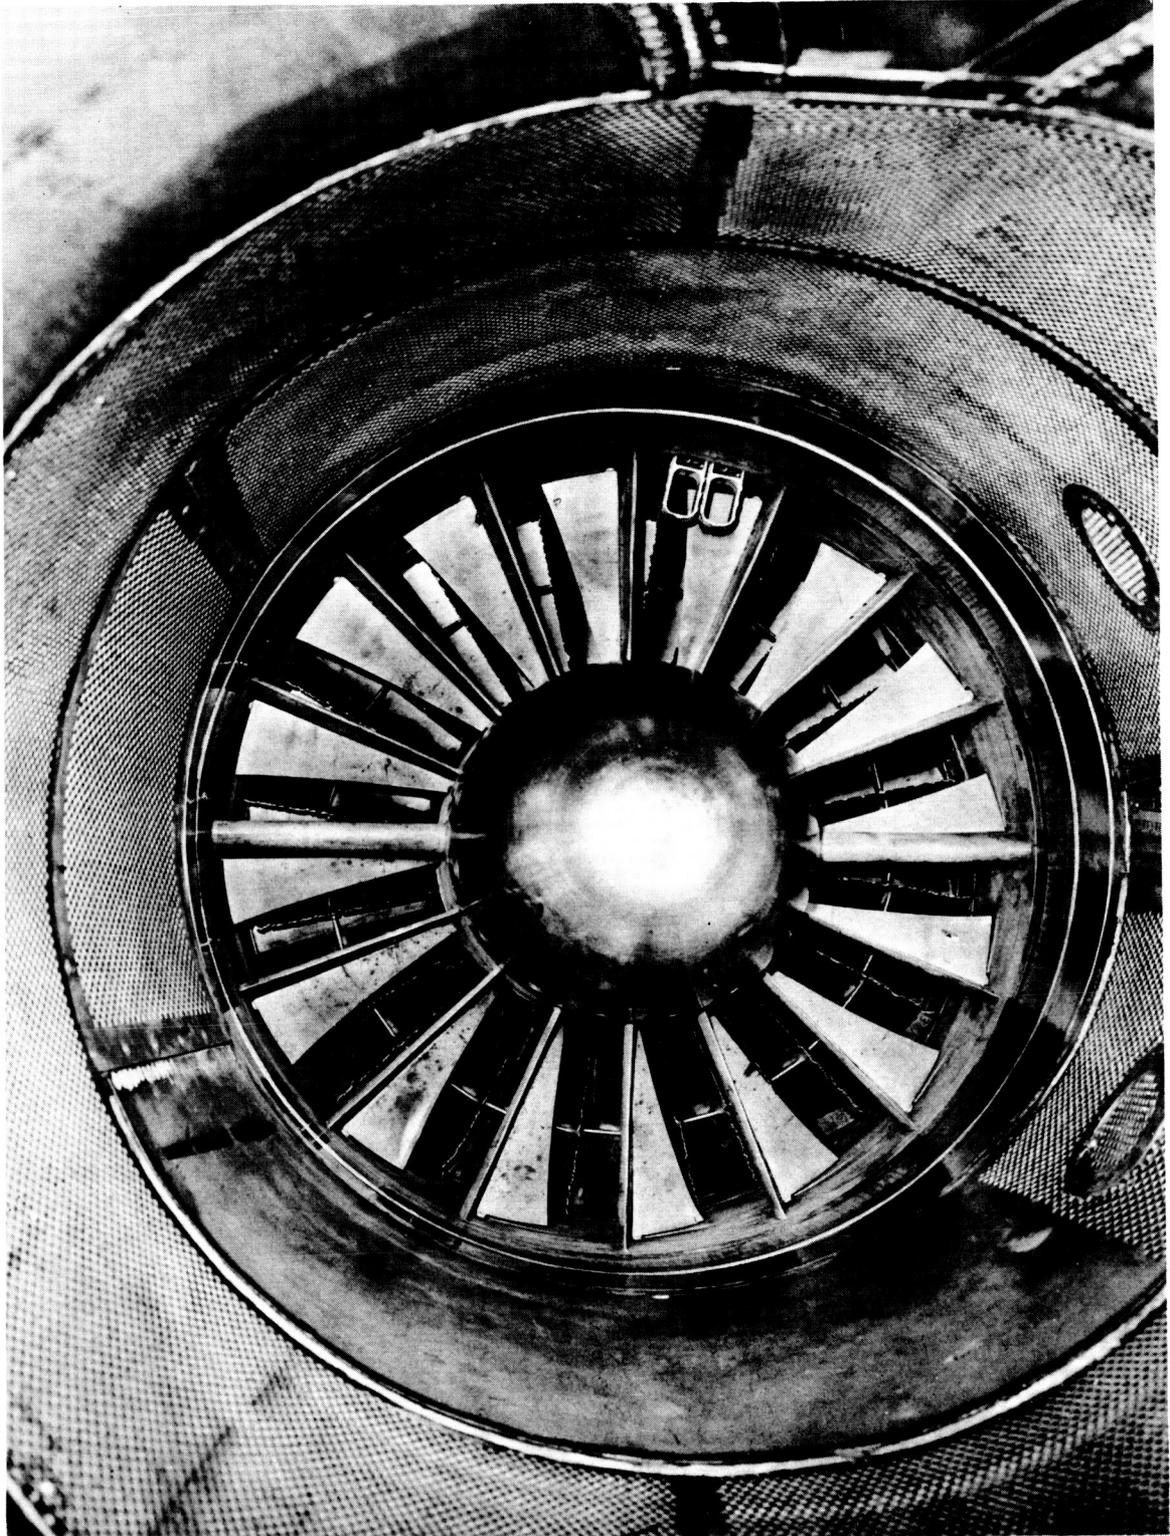
Figure 5. - Detailed views of engine damage.

appears to have contributed to the steady-state stall of engine No. 4, which occurred at time 1:11:08. At time 1:11:09, the FACS was turned back on. The closing of the right bypass doors to $4\frac{3}{4}^\circ$ and the steady stall of engine No. 4 forced the inlet into a full buzz situation at about the same time the FACS was turned on, and the mild resonant transverse vibration which was present during FACS-off increased to a peak magnitude of $\pm 0.7g$ (fig. 7(b)). Figure 7(b) shows an irregular beat-frequency pattern in the transverse accelerations. The cause of the irregular beat frequency of approximately 3 seconds is not known. Whether or not this vibration would have built up to the maximum of $\pm 0.7g$ in beat-frequency fashion at the pilot station had FACS been left off is unknown.

During the vibration at time 1:11:24, $M = 1.87$, engines No. 4 and No. 5 were shut down because of the continued stall condition of No. 4 and overtemperature of the exhaust gas on No. 5. At the same time, the throttles for engines 1, 2, and 3 in the left duct were retarded to idle. At time 1:11:27, the crew noticed that the right buzz light was on, and the copilot opened the right bypass doors to 7° . This appears to have caused the amplitude of the transverse vibrations to decrease to approximately $\pm 0.2g$. At time 1:11:45, $M = 1.8$, the bypass doors were closed down from 7° to $4\frac{1}{2}^\circ$ without causing any significant increase in the amplitude of the vibration, probably due to the decreasing Mach number. At 1:11:52, $M = 1.75$, the bypass doors were opened to $16\frac{1}{2}^\circ$, causing the buzz and resonant oscillation to cease.

(a) No. 4 engine.

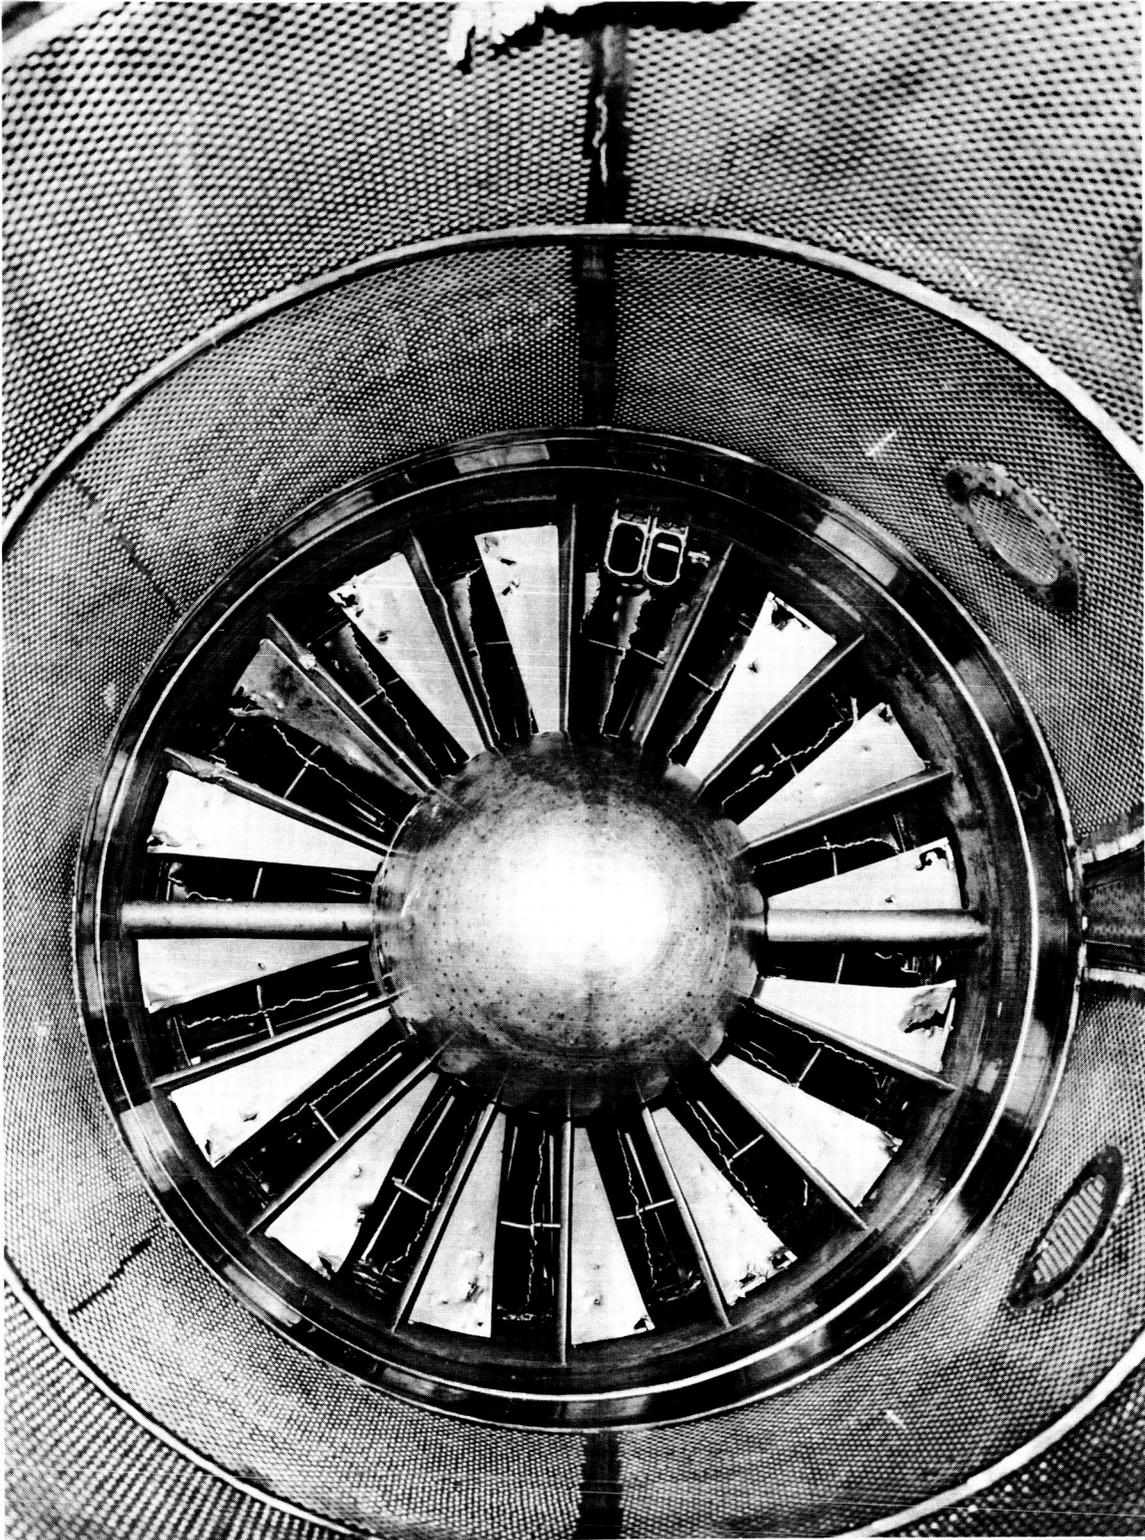
Figure 5. - Continued.

1:06:21	High vibrations on No. 5 engine followed almost simultaneously by right-duct unstart.	Accompanied by a loud bang, right-duct unstart light "on," a 0.06g change in longitudinal acceleration, and aircraft shaking at approximately $2\frac{1}{2}$ cps (natural frequency of the fuselage).
	The copilot opened the right-duct bypass doors to 13° and in a time span of 13 seconds to 19° .	At the time the unstart light went on, the shock-position indicator moved to high red and showed a need to open the right-duct bypass doors. Approximately 4 seconds after the unstart, the light went off as a result of opening the bypass to 13° and of opening the throat; inlet start condition regained.
	The unstart caused the pilot to apply corrective control to counter the pitch and yaw due to the unstart.	The elevon input was pilot-induced, as evidenced by the correlated canard surface movement; an FACS input in pitch affects elevon only.

(b) No. 5 engine.

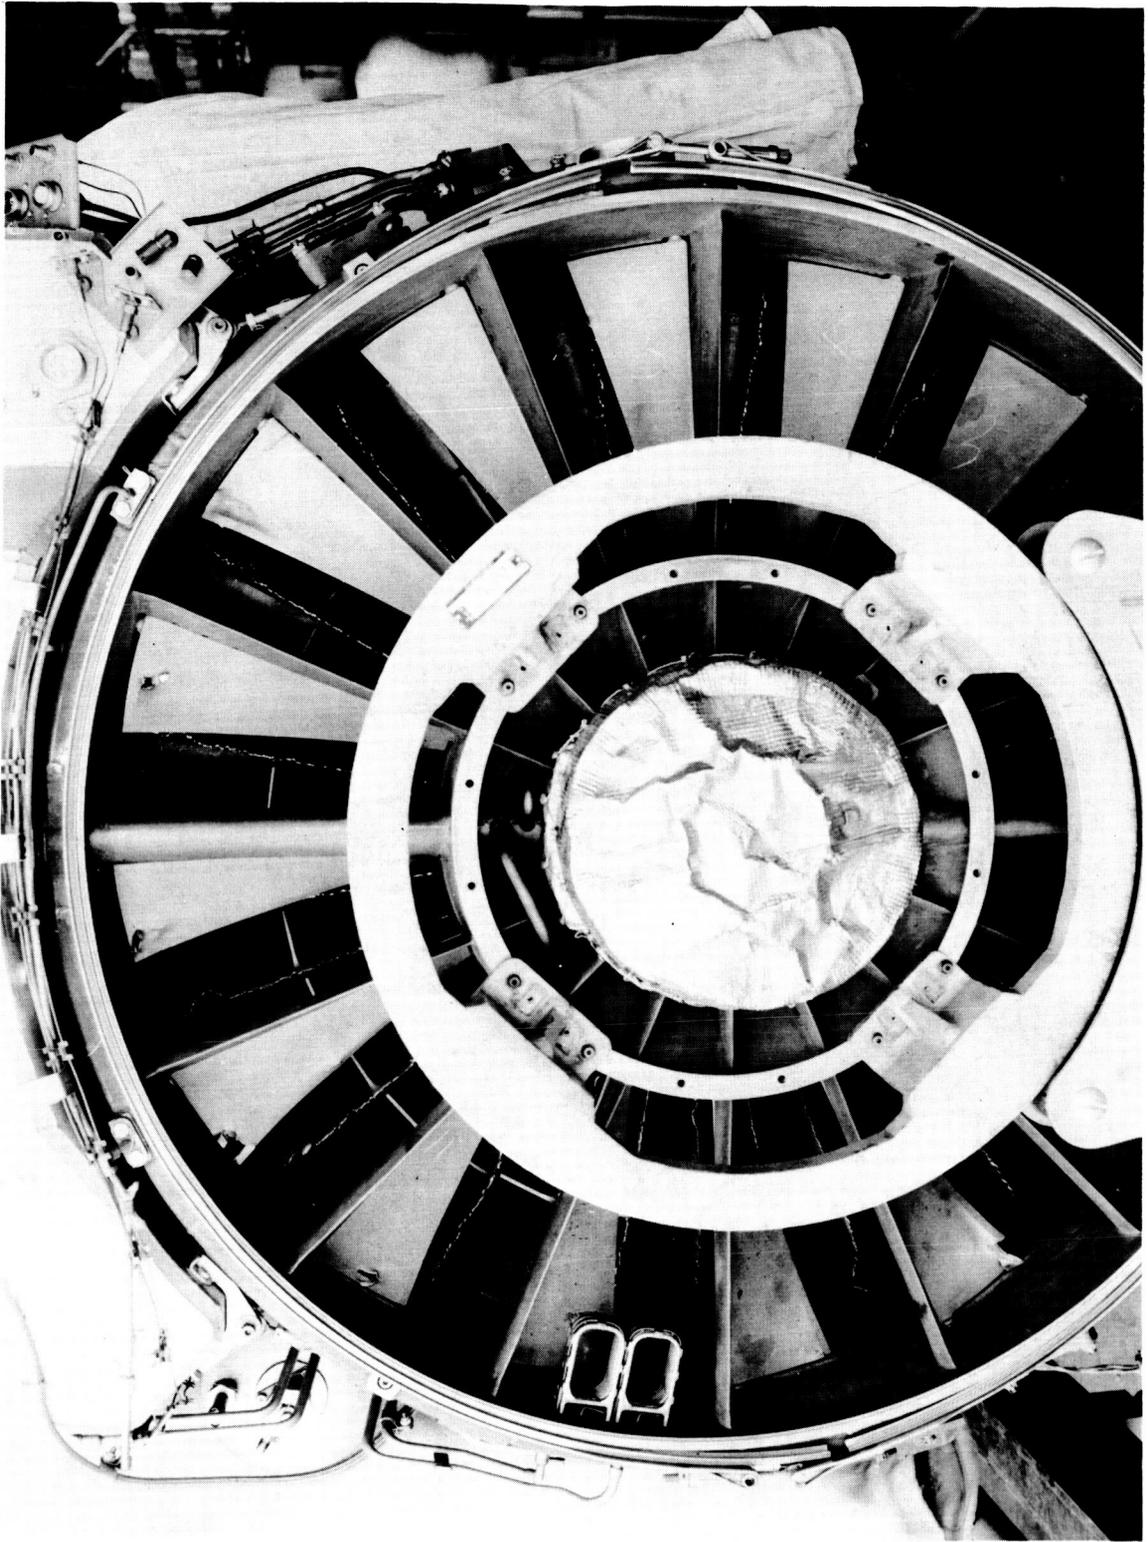
Figure 5. - Concluded.

1:09:03	Right duct unstarted. (Records showed that No. 6 engine had stalled.)	M = 2.2. Noise sounded like compressor stall. Exhaust-gas temperature of engine No. 6 went to 1100° to 1200° F. M = 2.2. An abrupt opening of the right-duct bypass doors from 21° to 28° failed to restart the duct.

(c) No. 6 engine removed from the aircraft installation. Center fairing dome and other fairings removed.
