K-PA-0002
March 10, 1965

SA-9/APOLLO

FIRING TEST REPORT

Saturn I, 1B Test & Systems
Engineering Office
John F. Kennedy Space Center, NASA

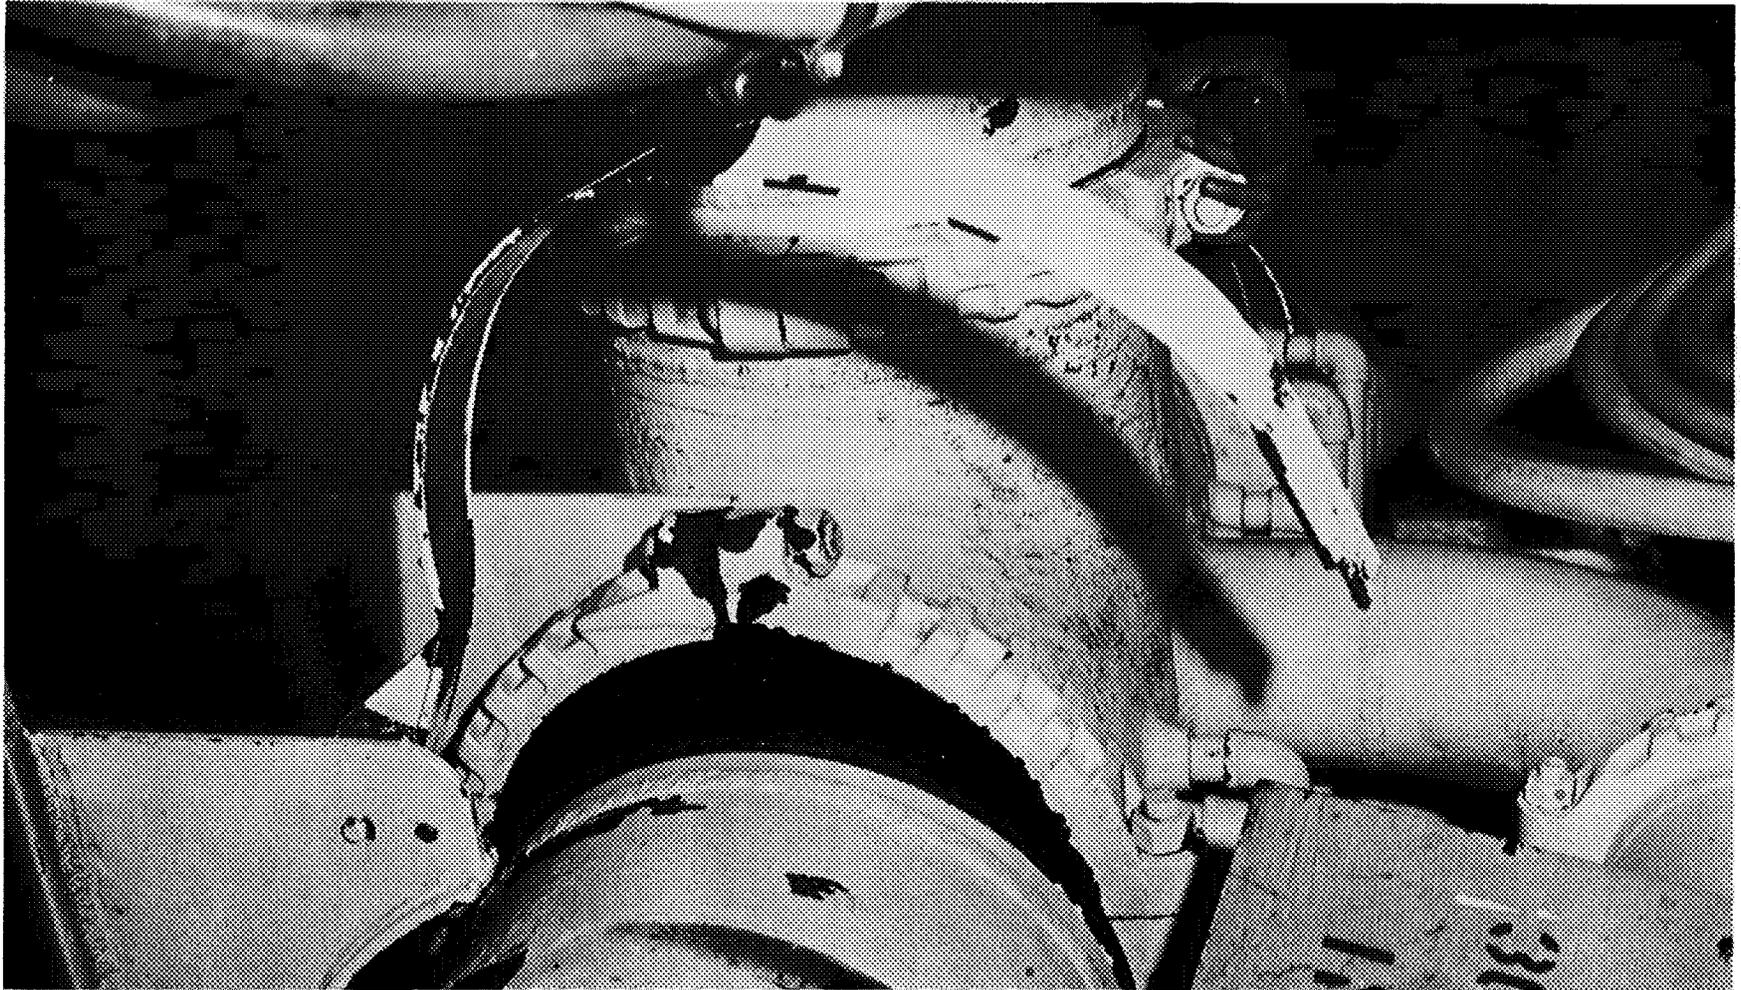
Figure 1. North Torus Ring, showing line rupture.

A torus ring water supply pipe separated at several joints after vehicle liftoff. Known water damage to equipment is not considered to be serious at this time.

and reinforcement protected the systems to the extent that no major assembly was damaged beyond repair. During the operation of the launch water system after vehicle liftoff, the northeastern torus ring, figures 1 and 2, separated at several joints flooding the interior of the launcher, the launcher AGCS bridge, and AGCS levels to a lesser degree. Extent of damage to electrical cables in these areas is unknown at this time. Details of the preceding items are listed in the following paragraphs.

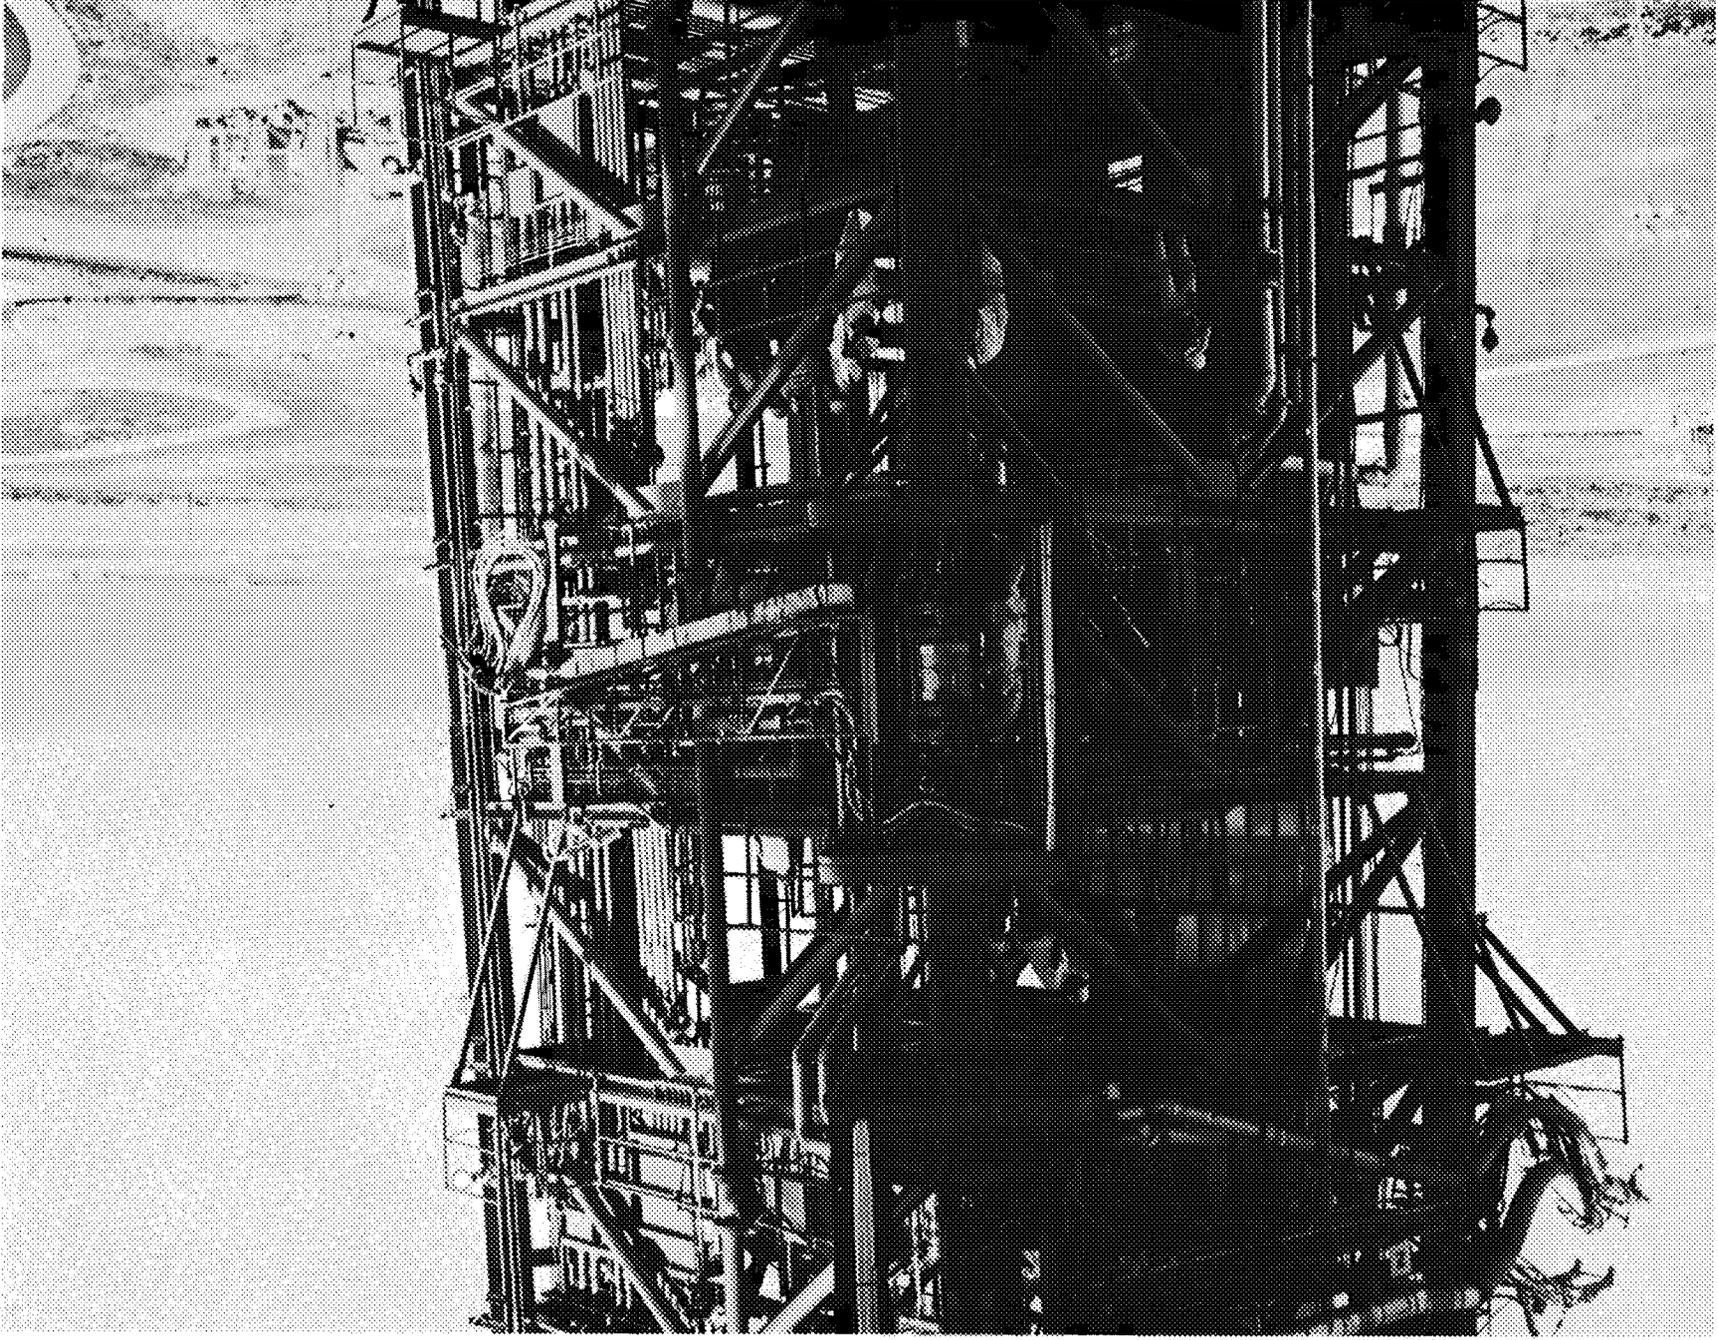
Figure 15. Umbilical Switch Arm No. 2.

c. A visual inspection of the umbilical swing arm system, figures 14 through 17, revealed damage to the system as follows: USA #1 air-conditioning duct and USA #4 housing retract lanyard were frayed; the pointer on USA #1 accumulator pressure gauge (75M50174-13) was removed from its shaft.

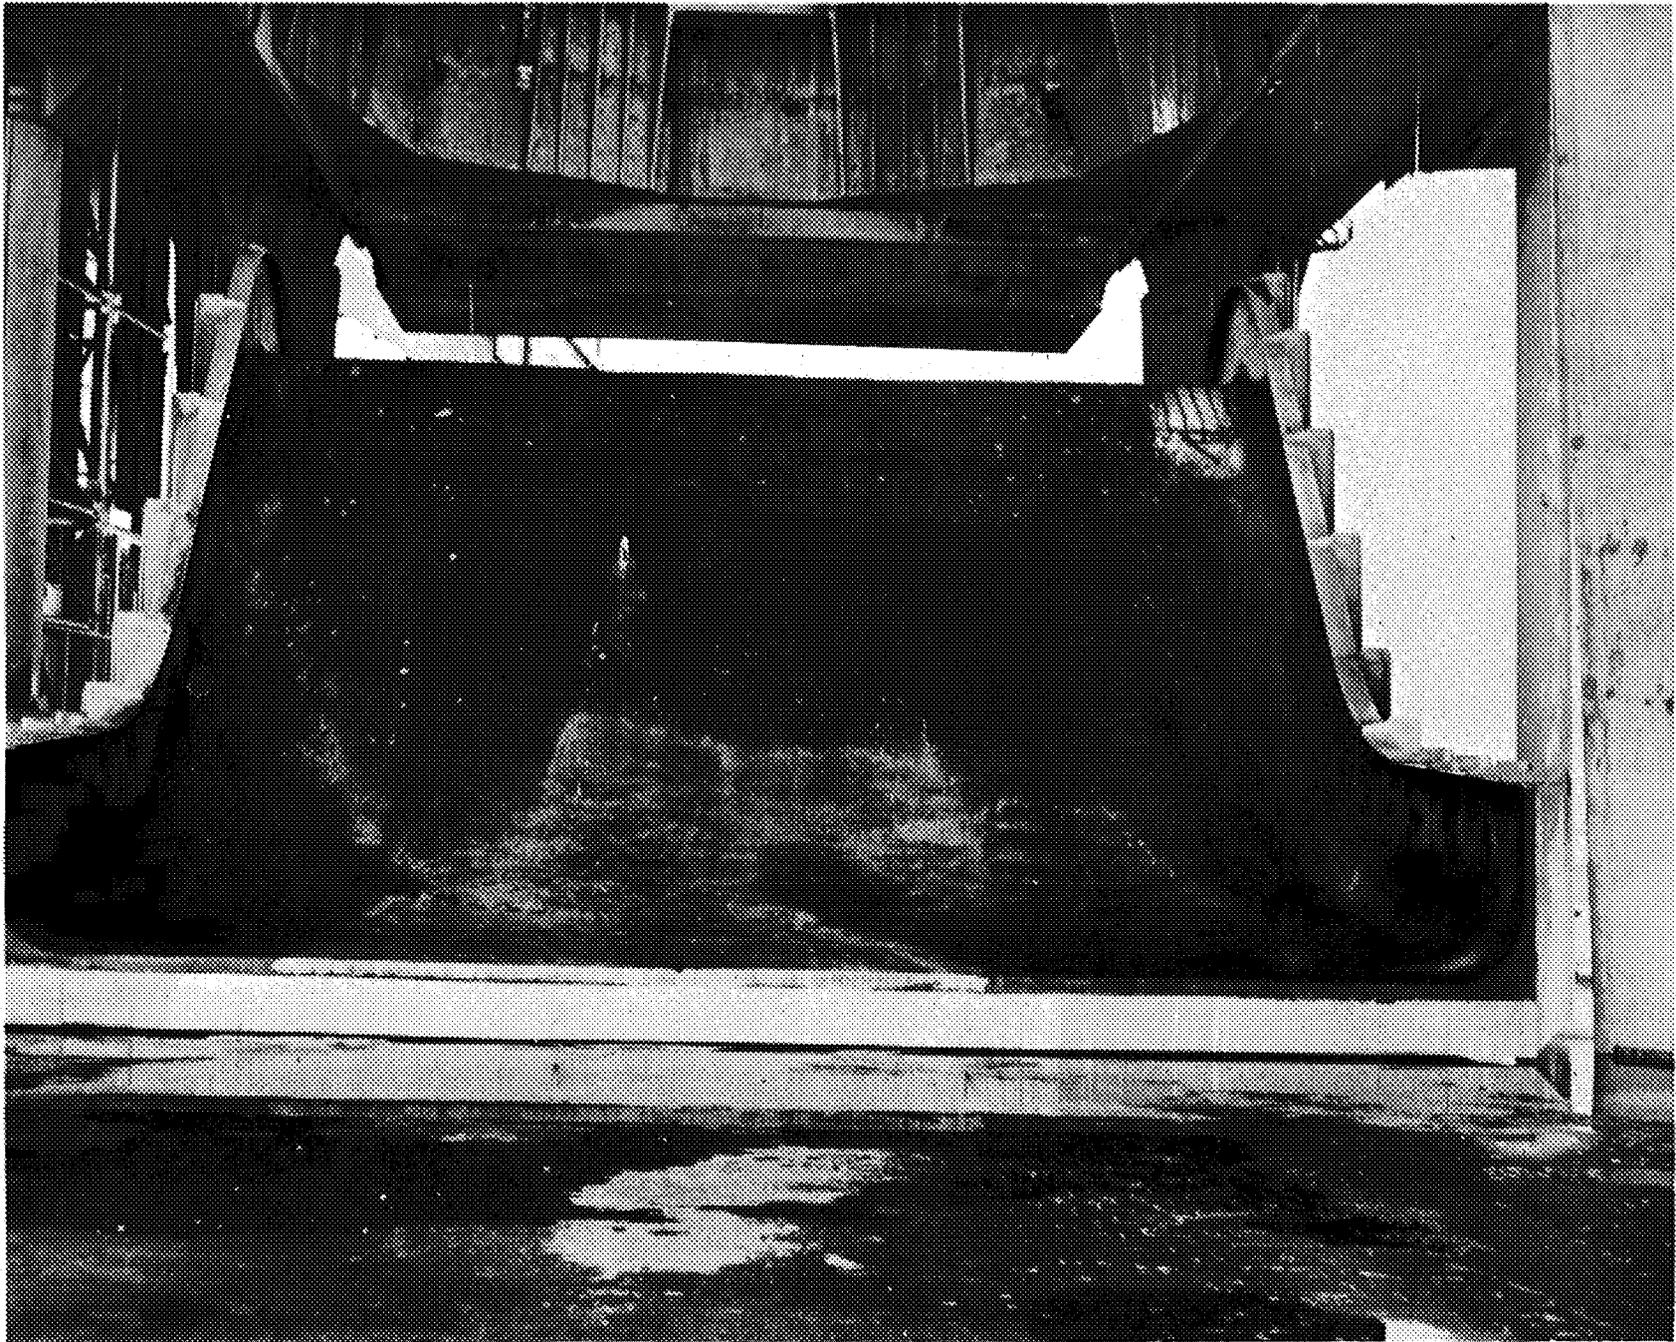
Figure 18. Flame Deflector

Damage to the flame deflector, figure 18, was greater than that sustained after the previous launch, but not serious enough to require any repair. Some washout of the Fondu-Fyre coating, figure 19, as well as cracks in the vertical plane of the coating occurred. The visible cracks are all very shallow; the integrity of the basic bonding remains good. (After three launch operations the Fondu-Fyre coating and structural integrity of this flame deflector are still in satisfactory condition for future use.)

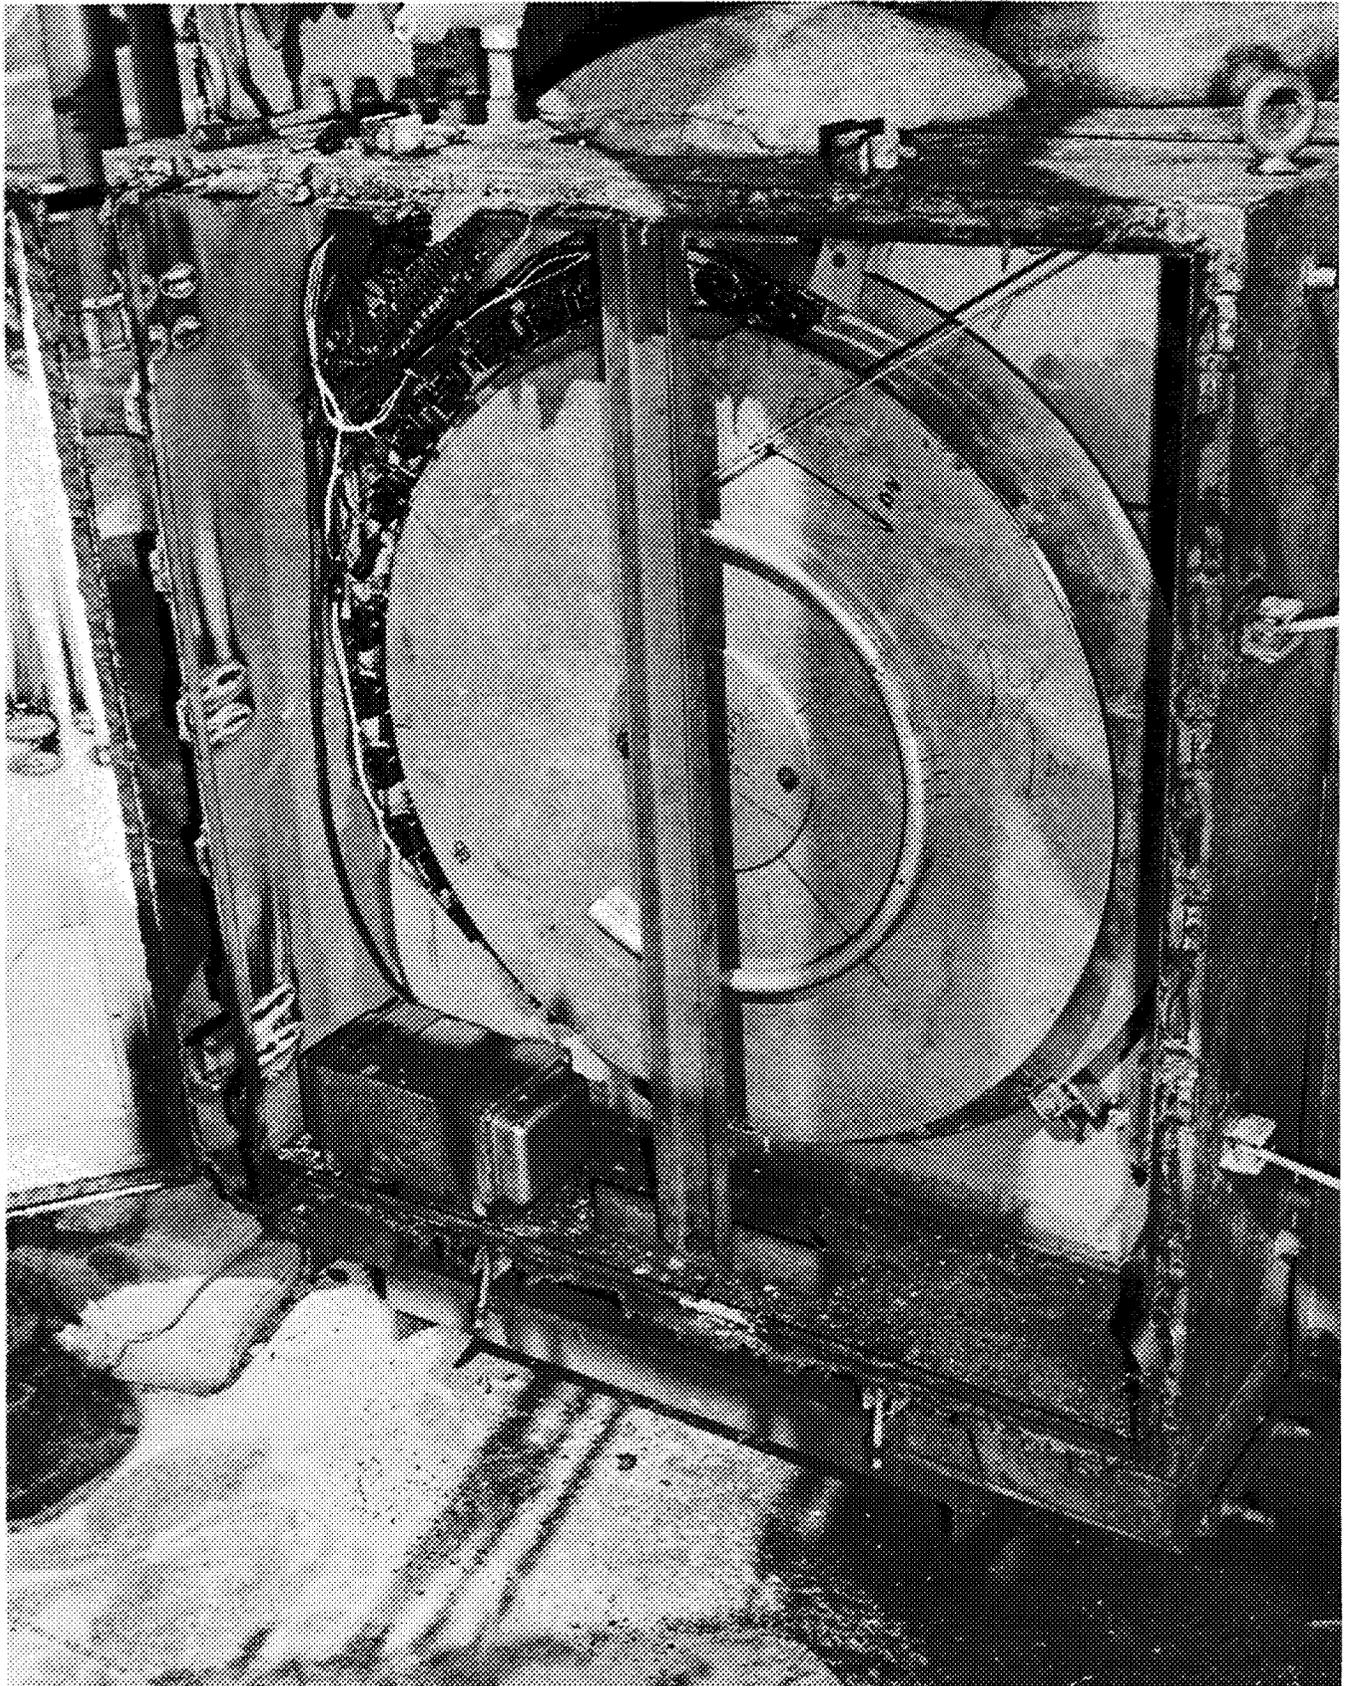
Figure 20. Umbilical Tower Elevator Floor Selector Wheel.

The floor-leveling selector wheel, figure 20, of the umbilical-tower elevator located on the fourth, or 48-foot, level of the umbilical tower is enclosed in a heavy metal cabinet that was sandbagged to the top. The wheel was skewed so that the majority of the floor level microswitches were either not making contact or had been bent out of alignment. The damage was not as severe as experienced in previous launch operations. The wheel was repaired and the elevator back in operation the next day.

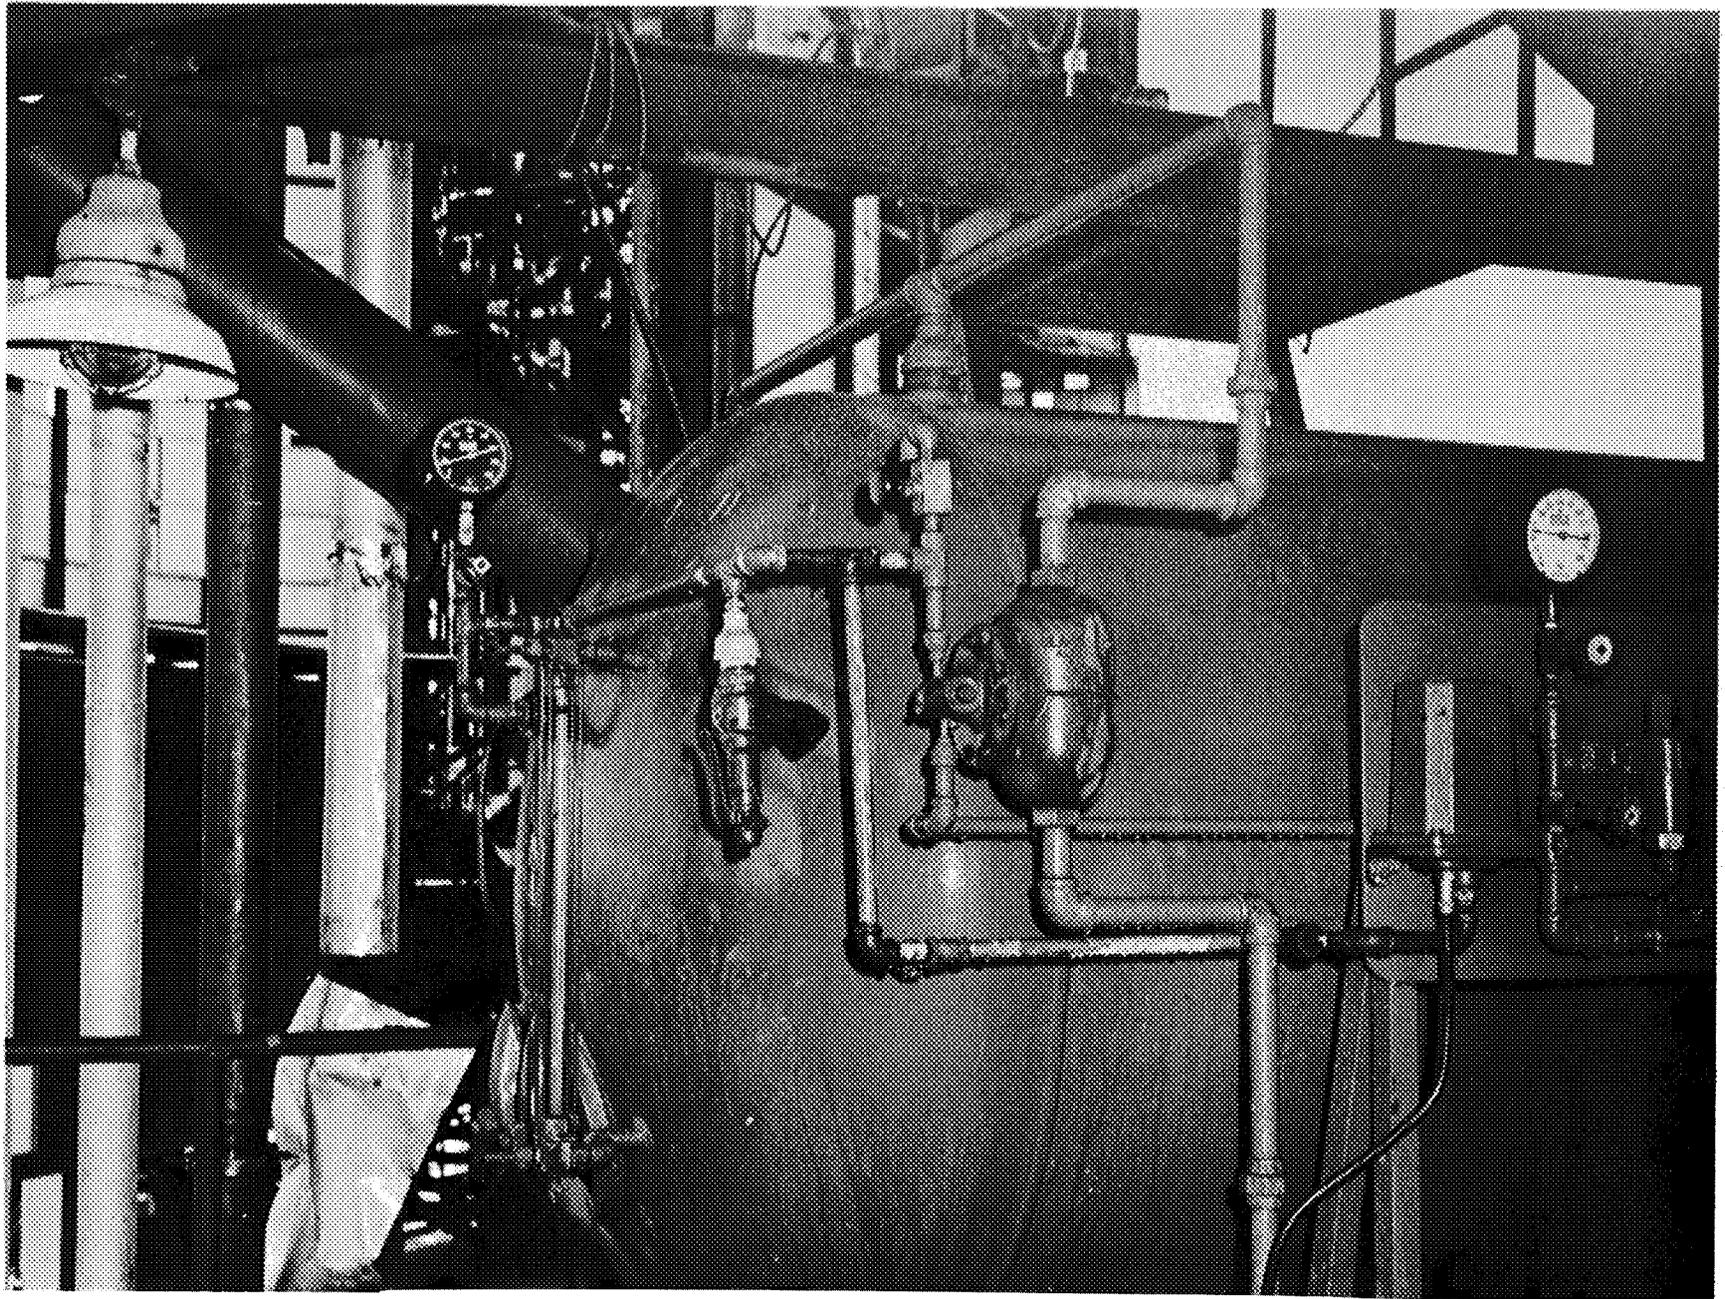
Figure 21. Umbilical Tower Hydro-pneumatic System Storage Tank.

The hydro-pneumatic-system storage tank on the fourth, or 48-foot, level of the umbilical tower sustained damage as shown in figure 21. The oblong object just to the right center of the picture is the GN₂ gas float type regulator. Gas supply pipes to this unit were broken, allowing leakage of water and GN₂ gas pressure as indicated by the glassless-faced gauge to the left. Glass sight gauges just beneath and to the right of the gauge were not damaged. The gauge on the far right was not affected. This is the first launch operation in which this unit has sustained damage.

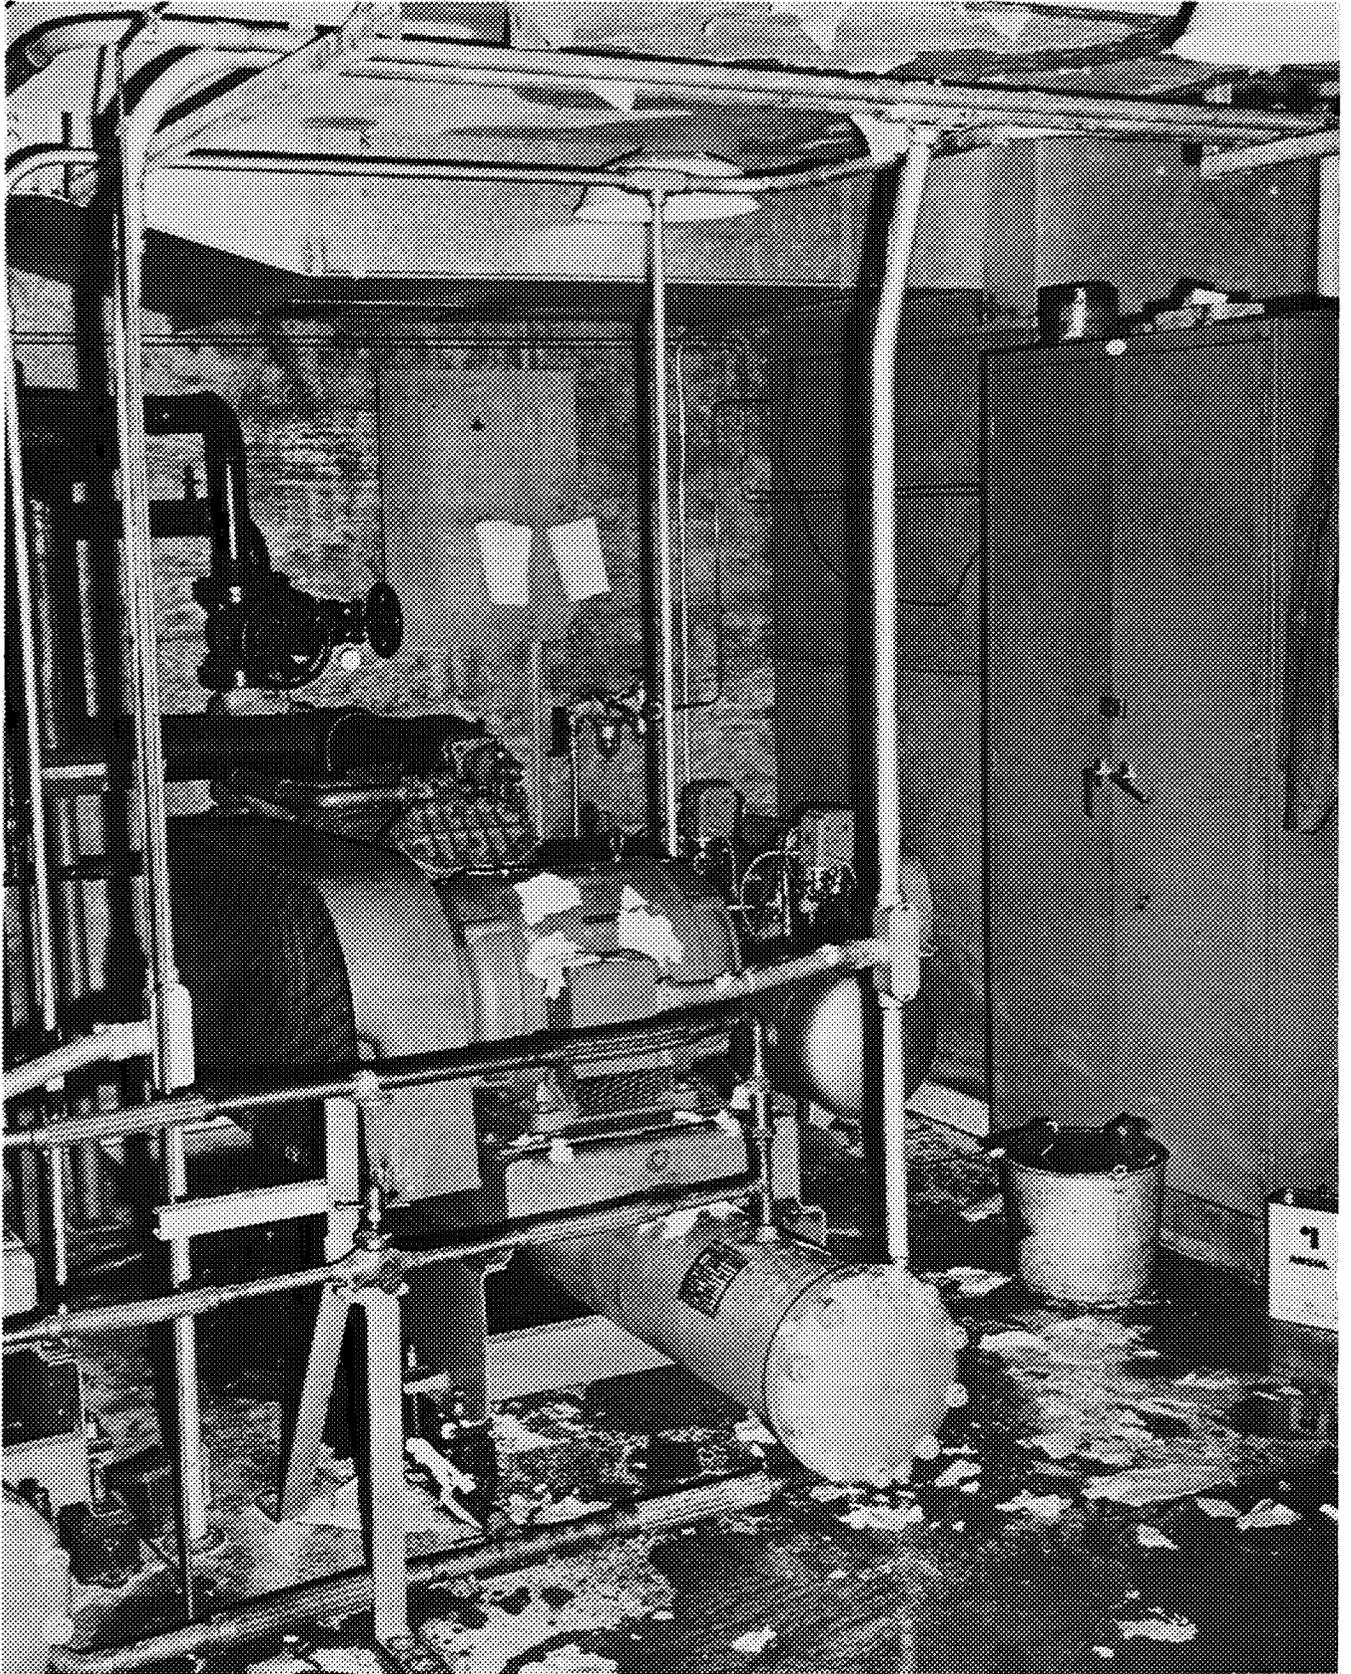
Figure 23. Air-Conditioning Equipment Room in AGCS Building.

As a result of the failure of the torus ring water supply pipe, flooding and damage to the AGCS Building occurred. Figure 23 shows the air-conditioning equipment room on the first floor. Tile and plaster on the ceiling was water soaked from above and fell, as evidenced by the picture. The floor was covered by more than one inch of water. Electronic equipment, being mounted above the highest water level, was not damaged. The networks office area on the second floor of the AGCS Building was deluged by the water. Desks, books, papers and drawings were soaked. Water on this level leaked through the false floor and spread out in the cable routing area under the floor and leaked through to the first floor.

The third floor of the AGCS Building was the first to feel the effects of the flooding. When the torus ring water supply pipe broke (at 175 psi

pressure) the launcher bridge was flooded and pressurized from the water. This water was forced through conduits extending from the launcher bridge through the AGCS wall to the third floor. Lockers located about 6 feet in front of the conduits broke the full force of the water streams and prevented any serious damage or shorting out of electrical circuits. There was no electrical equipment damaged as far as is known at this time. Power conduit for the holddown-arm cameras and purge lines located on the pedestal were destroyed. These items are considered expendable and are replaced prior to each launch.

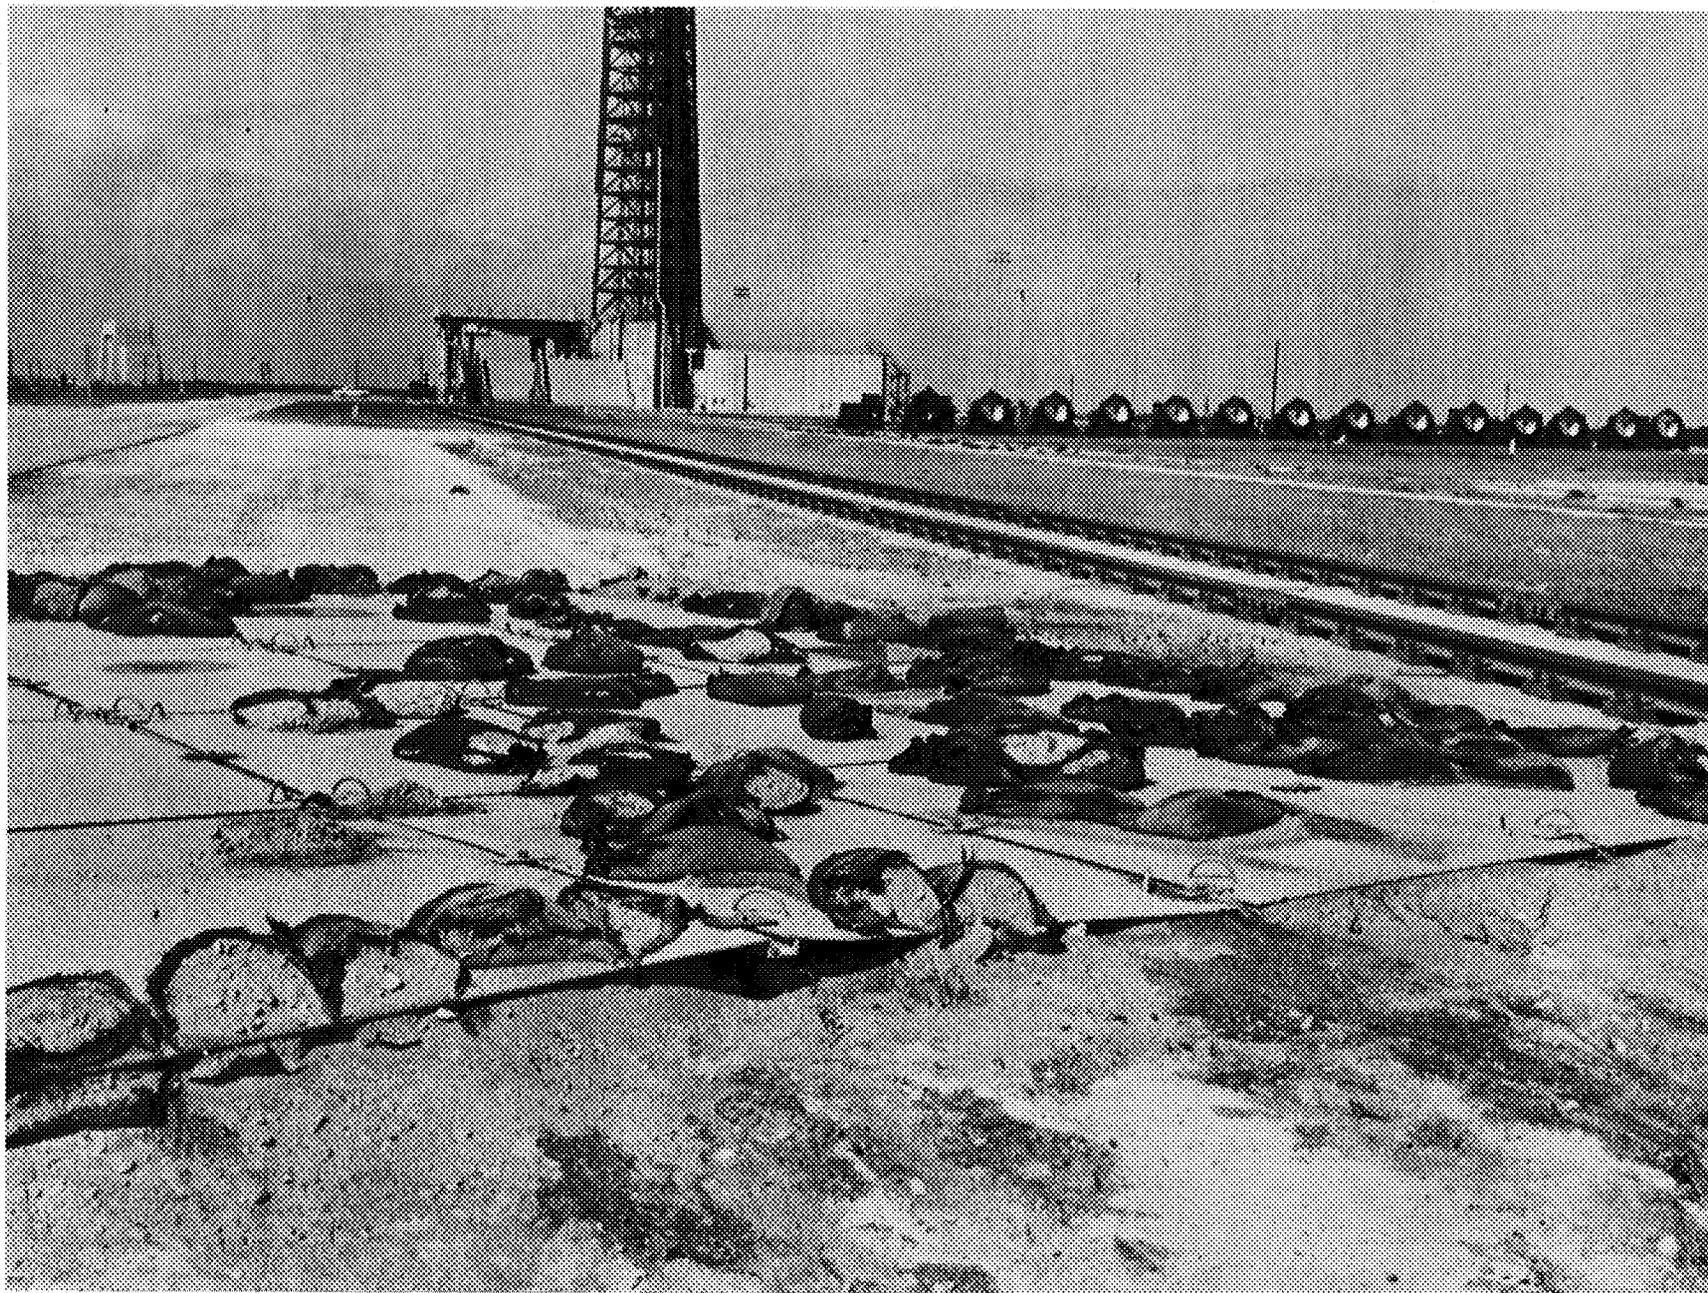
Figure 24. High-Pressure Gas Line Expansion Pit.

Figure 24 shows the covers over the high-pressure gas line expansion pit. The framework was raised (lower center), the access cover holddown bolts were stripped, and the cover was blown away (upper center). This location is roughly 300 feet from the launch pedestal.
