8. PROBLEM AREAS ASSOCIATED WITH THE CONSTRUCTION AND OPERATION OF THE LANDING RESEARCH RUNWAY AT NASA WALLOPS STATION

By Curtis R. Allen and James W. Quillen

NASA Wallops Station

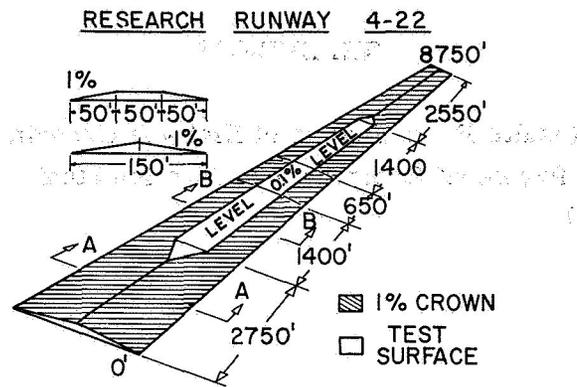
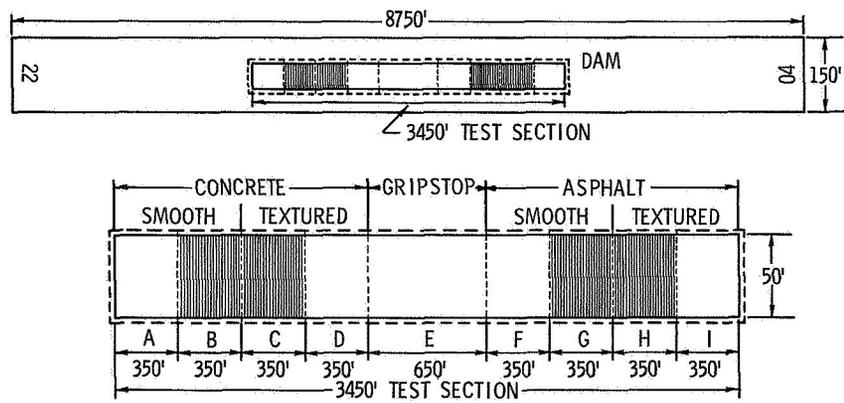
Figure 1.- Landing research runway 4-22 at NASA Wallops Station.

Runway 4-22 is the landing research runway at Wallops Station. The runway is 8750 feet long and 150 feet wide; the test section, which is almost centrally situated, is 3450 feet long and extends 25 feet on either side of the runway center line. Figure 1 shows the test section relative to the overall length and width of the runway.

This test area was designed to be as flat and level as possible by using standard construction methods to aid in maintaining the constant depth of water or slush necessary for obtaining reliable data during the tests. The rest of the runway proper is crowned to the standard 1-percent slope to permit water runoff (fig. 1).

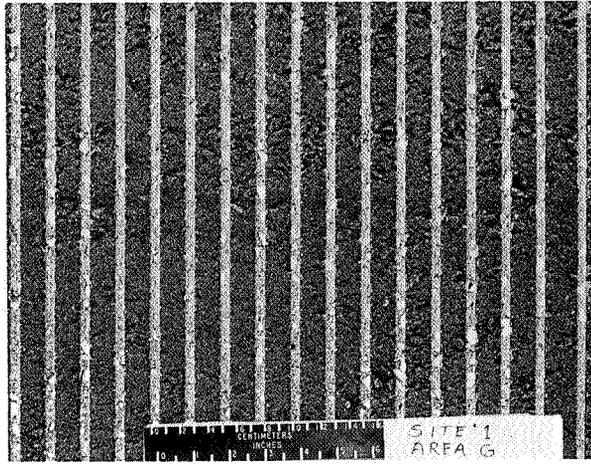
Figure 8.- Surface G.

Surface G – Grooved, small aggregate asphalt (3/8 inch or less) (fig. 8)

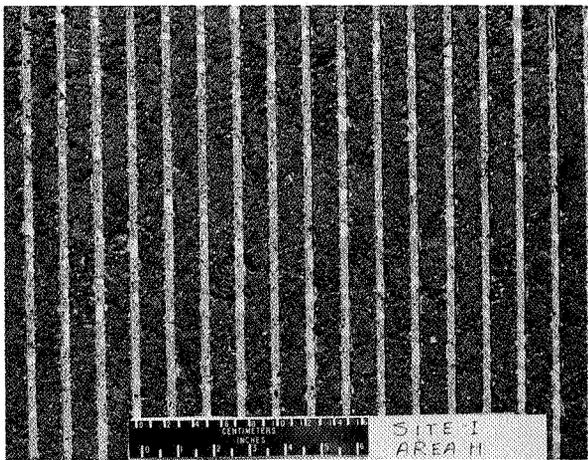
Figure 9.- Surface H.

Surface H – Grooved, large aggregate asphalt (3/4 inch or less) (fig. 9)

Another problem associated with grooving occurred on the large aggregate asphalt section H where the 1/2- and 3/4-inch aggregate stones had a marked tendency to break loose from the grooved surfaces. Because of this problem, numerous runway inspections and sweepings were necessary to keep the runway clean. These stones, if left on the runway, would present a most serious hazard to jet aircraft because of possible ingestion into the engines. Therefore, the continual care required to keep this particular type of surface clean is believed to be too extensive to justify grooving on asphalt with aggregate greater than 3/8 inch in diameter.

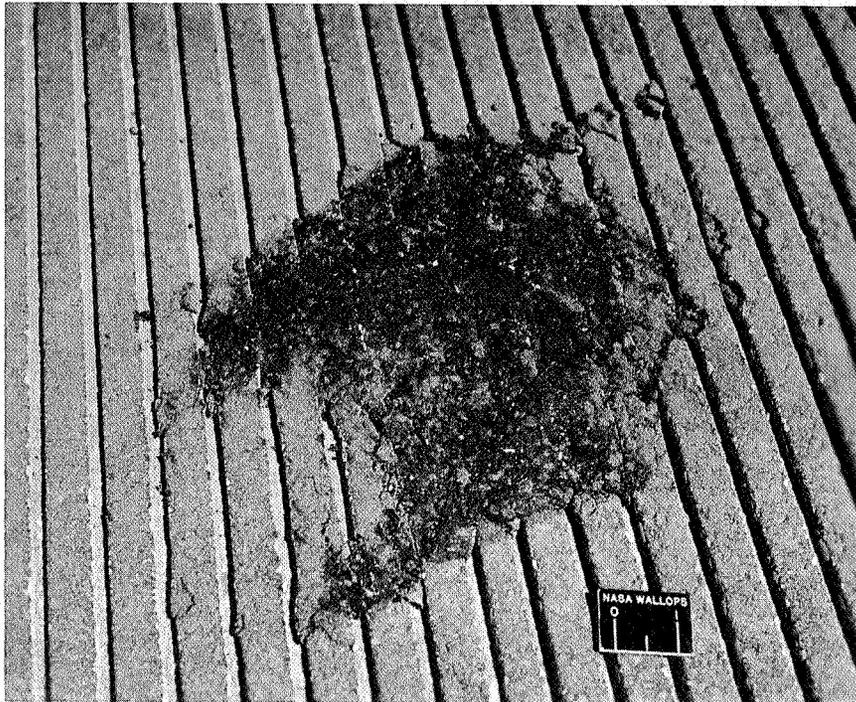
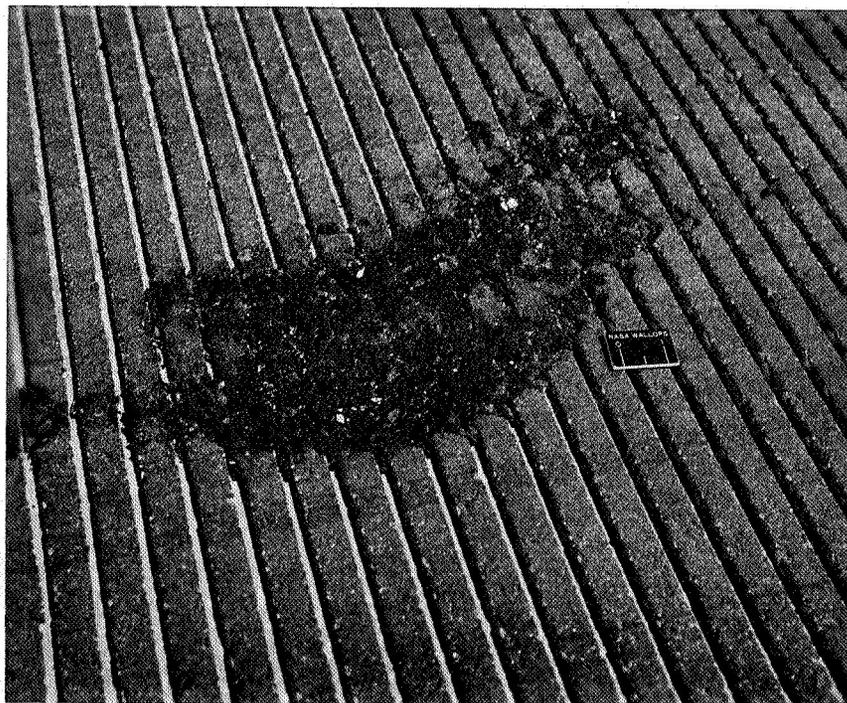
An unsatisfactory occurrence took place on grooved asphalt sections G and H. During routine inspection following each braking run, it was discovered that the asphalt

grooves were being completely obliterated during hardover 180° turns by the 990 aircraft. Figure 11 shows the damage produced by a 180° hardover turn made by the 990 aircraft on the grooved asphalt surface. Some damage occurred also on the ungrooved sections.

Figure 11.- Damage produced by 180° hardover turn by 990 aircraft on grooved asphalt surface.

No damage to concrete sections has been experienced thus far in the tests. However, surface damage has resulted from turns on asphalt sections and this alone points to the obvious need for having all aircraft roll free of grooved asphalt surfaces prior to making hard turns on the runway. Furthermore, on the basis of results obtained thus far, aggregate larger than 3/8 inch is not recommended as a wearing course.

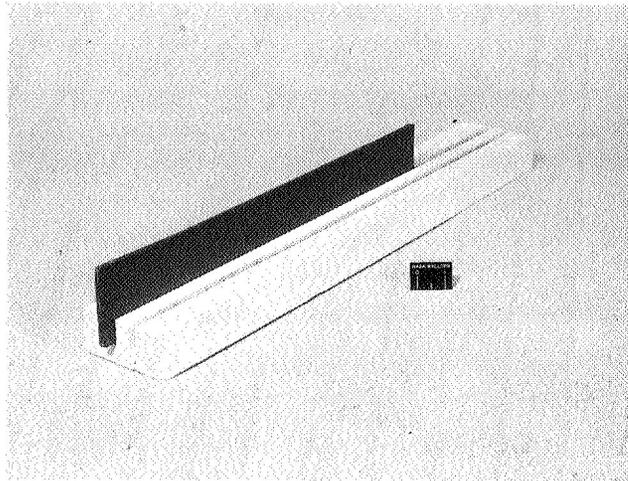
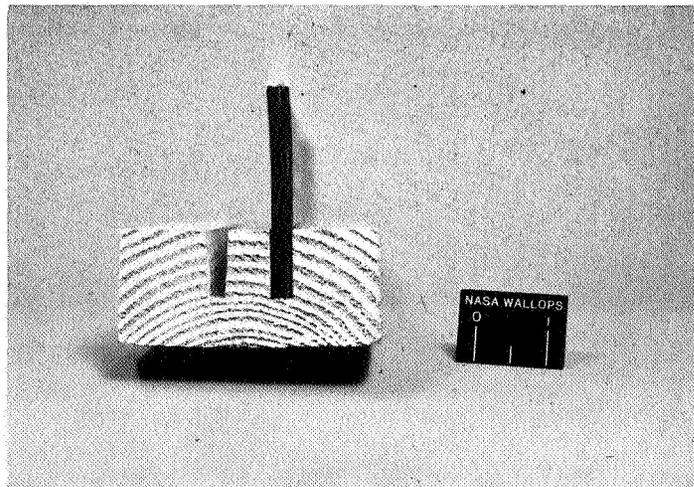
Figure 12.- Model of belting-groove system.

After numerous methods and plans were discussed, tested, and discarded, the idea of inserting rubber belting into a groove cut into the runway surface was conceived. The procedure used in construction of the prototype of the test model (fig. 12) was as follows: a groove 1 inch deep and 5/16 inch wide was cut in a standard piece of 2- by 4-inch wood framing, and a two-ply canvas-reinforced rubber belting $2\frac{1}{2}$ inches wide and 17/64 inch

thick was inserted in the groove. This produced a somewhat snug fit while still allowing the rubber belting to fit fairly easily into the groove. The information gained from this model was then applied to the research runway. A groove 1 inch deep and 10 feet long was cut into one of the concrete sections of the landing research runway. A 10-foot length of rubber belting was inserted into this groove, over which numerous high-speed runs were made with a heavy truck. Some runs were made with locked brakes to determine whether the belting would hold in the grooves, withstand tearing or stretching, and retain its resiliency. It was noted that the passage of the truck wheels over this piece of rubber belting in no way damaged or dislodged the material, nor did it cause the wheels to bounce or swerve. Thus, this system seemed to meet all the test requirements with the exception of providing a constant water level; this requirement still had to be investigated. Therefore, a groove 1 inch deep and 5/16 inch wide was cut around the full perimeter of the 3450-foot-long test area and across each 350-foot section. When these grooves were finished, four men installed the 7400 feet of rubber belting in less than 8 hours. Tests showed that this system did perform the desired function. Hundreds of subsequent tests have proved the durability of both the grooves and the rubber belting. The rubber belting was easy to install and it was a simple matter to lift out selected sections of belting on a previously flooded section for drainage while an adjacent section was being flooded. The consensus of the Project Engineers and all participants of the tests conducted thus far is that the conception, the development, and the final installation of this rubber dam system was perhaps the most important single factor which contributed to the immediate and rapid success in carrying out the actual test operations.
