**S-IVB/V AUXILIARY PROPULSION
SYSTEM 90-DAY RECYCLE
CAPABILITY TEST REPORT,
MODULE I**

**DAC-56728
FEBRUARY 1969**

**PREPARED BY:
MCDONNELL DOUGLAS ASTRONAUTICS COMPANY
WESTERN DIVISION
SATURN S-IVB TEST PLANNING
AND EVALUATION COMMITTEE**

**PREPARED FOR:
NATIONAL AERONAUTICS AND
SPACE ADMINISTRATION
UNDER NASA CONTRACT NAS7-101
MODEL DSV-4B**

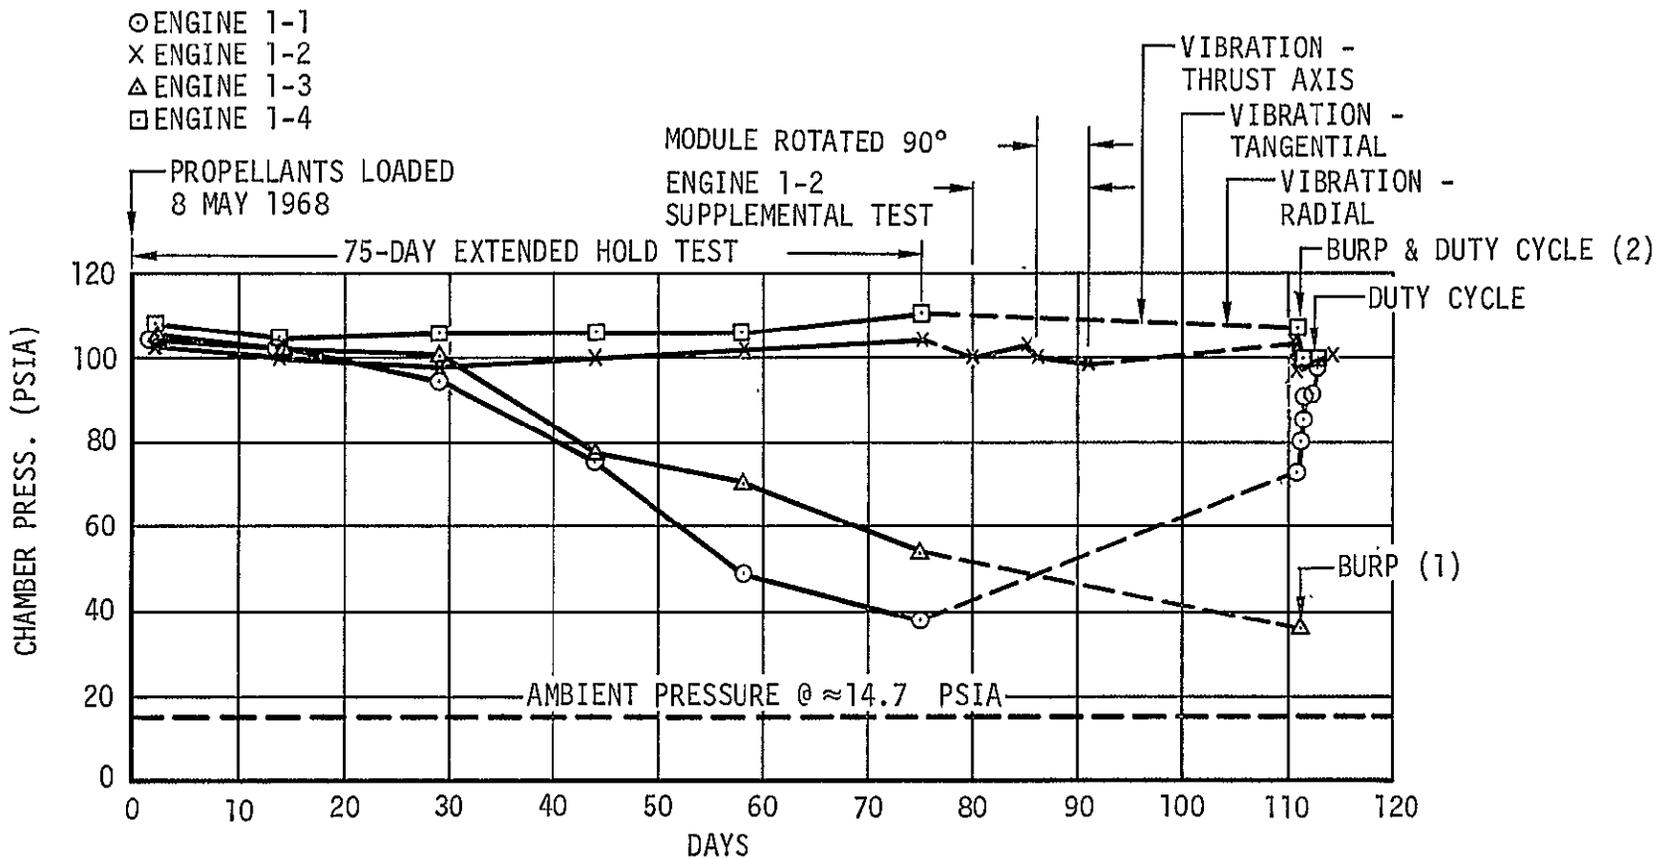
During the extended hold test, APS engines 1 and 3 exhibited a significant degradation of chamber pressure while being burp-fired. The ullage engine (No. 4) performed satisfactorily. Investigation indicated a high probability of a restriction of oxidizer flow in the injector tube inlets, injector tubes, and injectors. Supplementary testing results indicated the anomaly to be directly related to firing the engines for short times at sea-level, with an extended hold between firings.

Figure 2-1. APS Engine Chamber Pressure History

Results of recent tests conducted by MDAC and MSFC showed detrimental effects of sea level burp-firings on APS engine performance. Consequently, MSFC has concurred with the MDAC recommendation to delete prelaunch burp-firings.

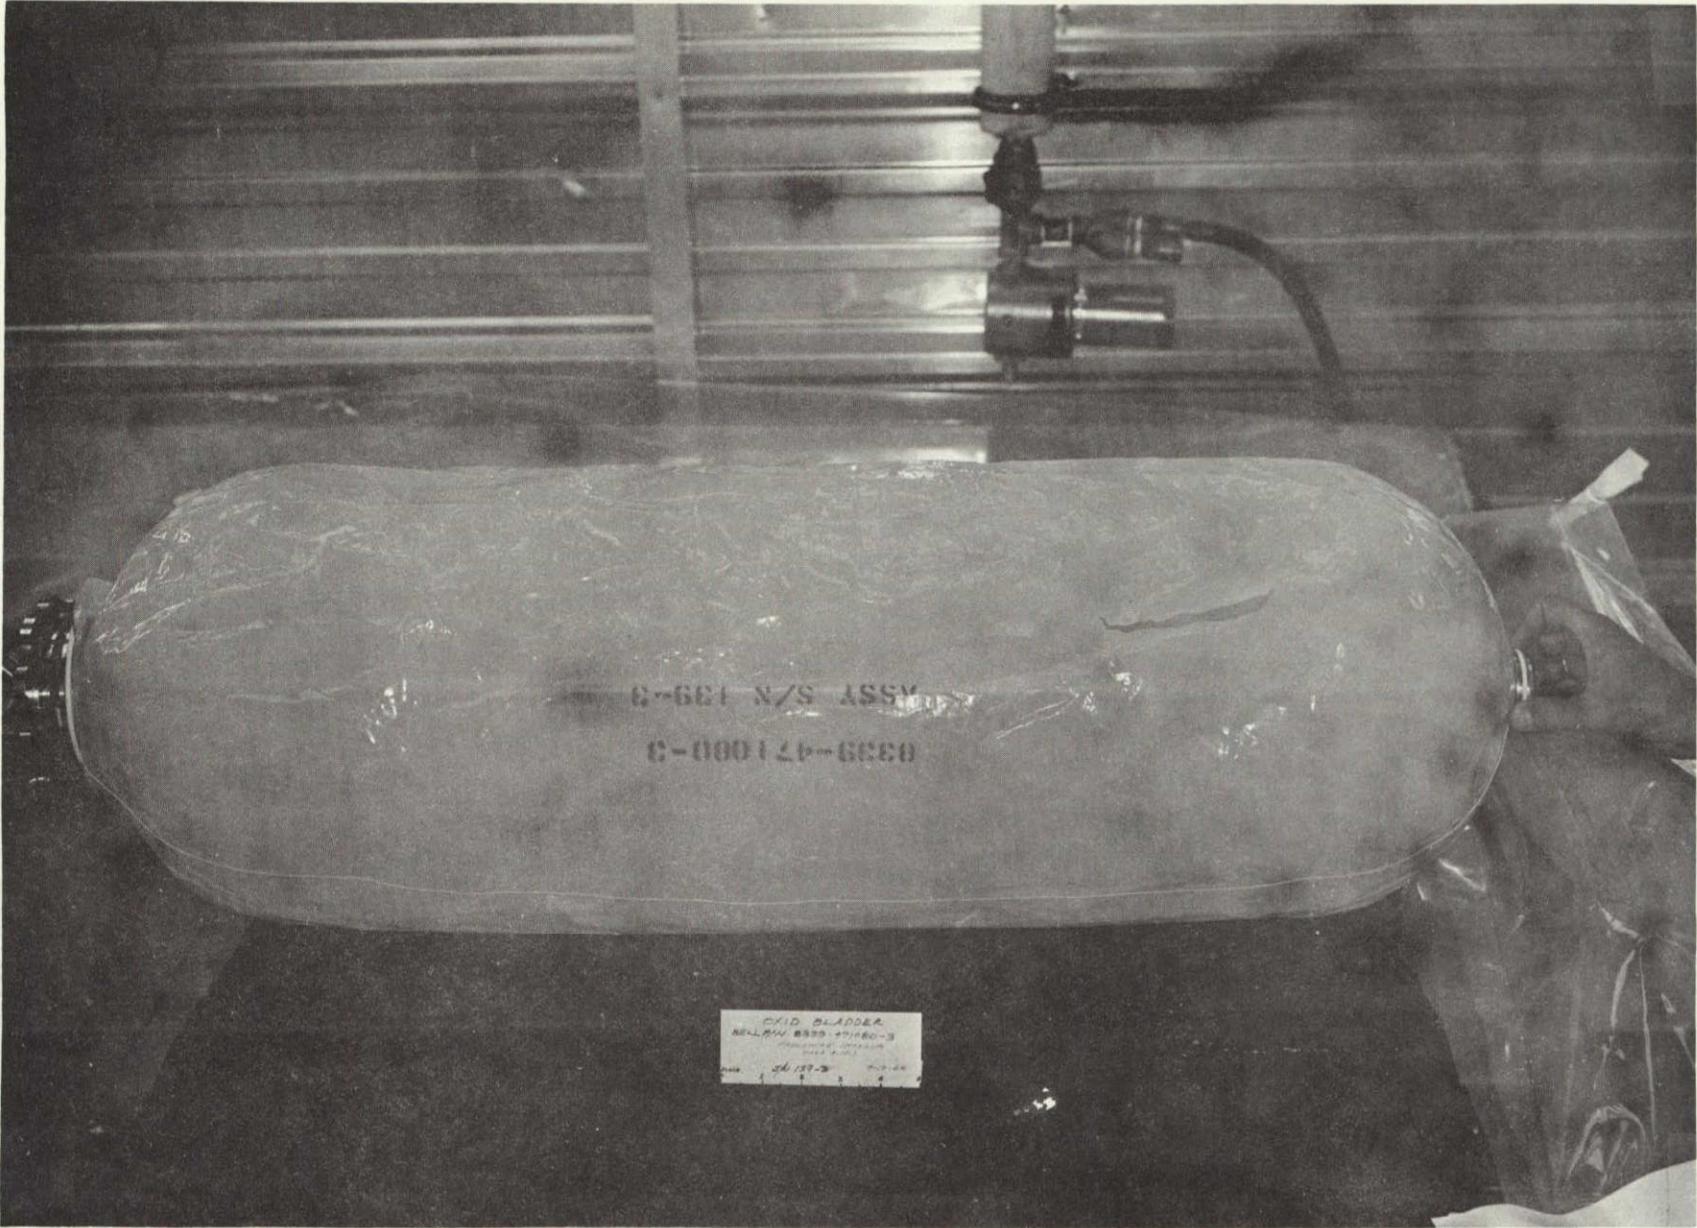
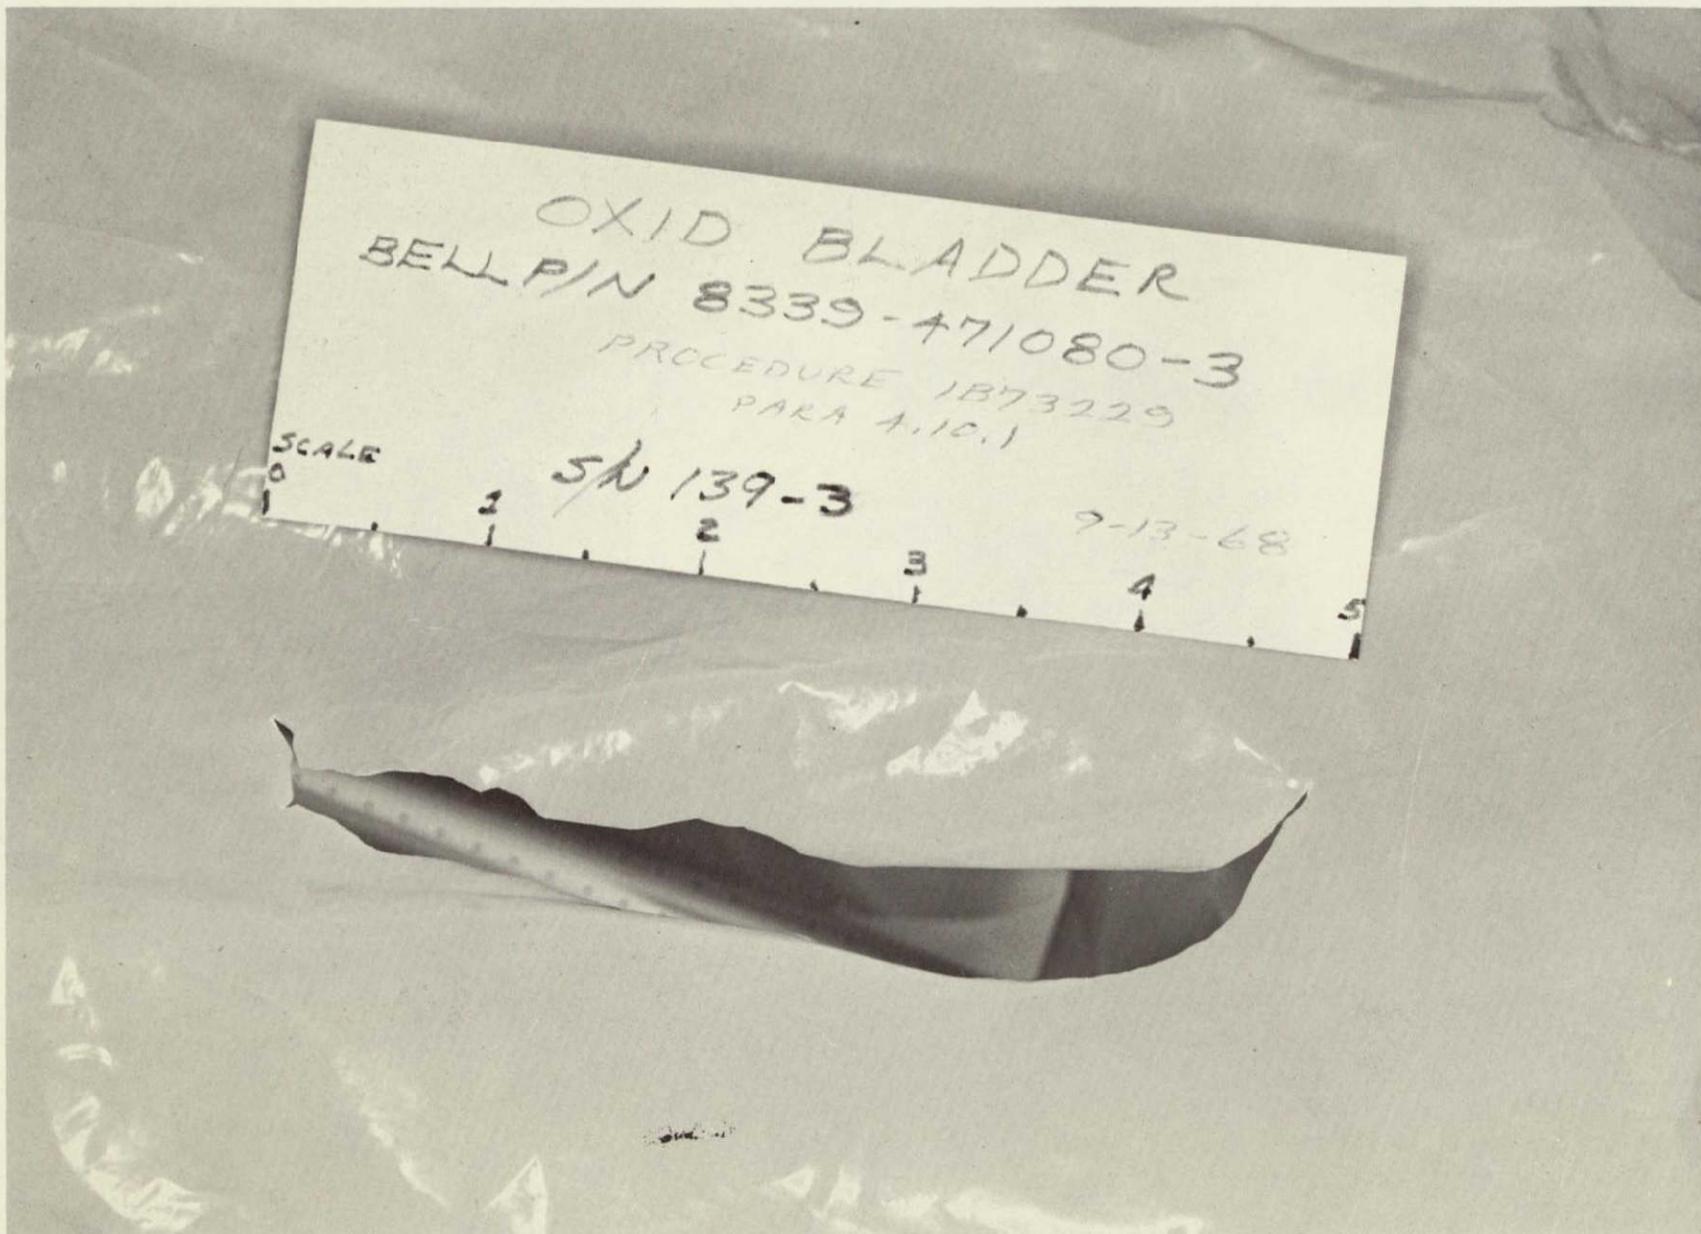
- a. A tear approximately 5 in. long was found in the forward end of the oxidizer bladder.
- b. A tear approximately 5 in. long was found in the forward end of the fuel bladder.
- c. The oxidizer tank diffuser tube had a break completely around the aft end.

Figure 9-1. Oxidizer Bladder (Sheet 1 of 2)

Figure 9-1. Oxidizer Bladder (Sheet 2 of 2)

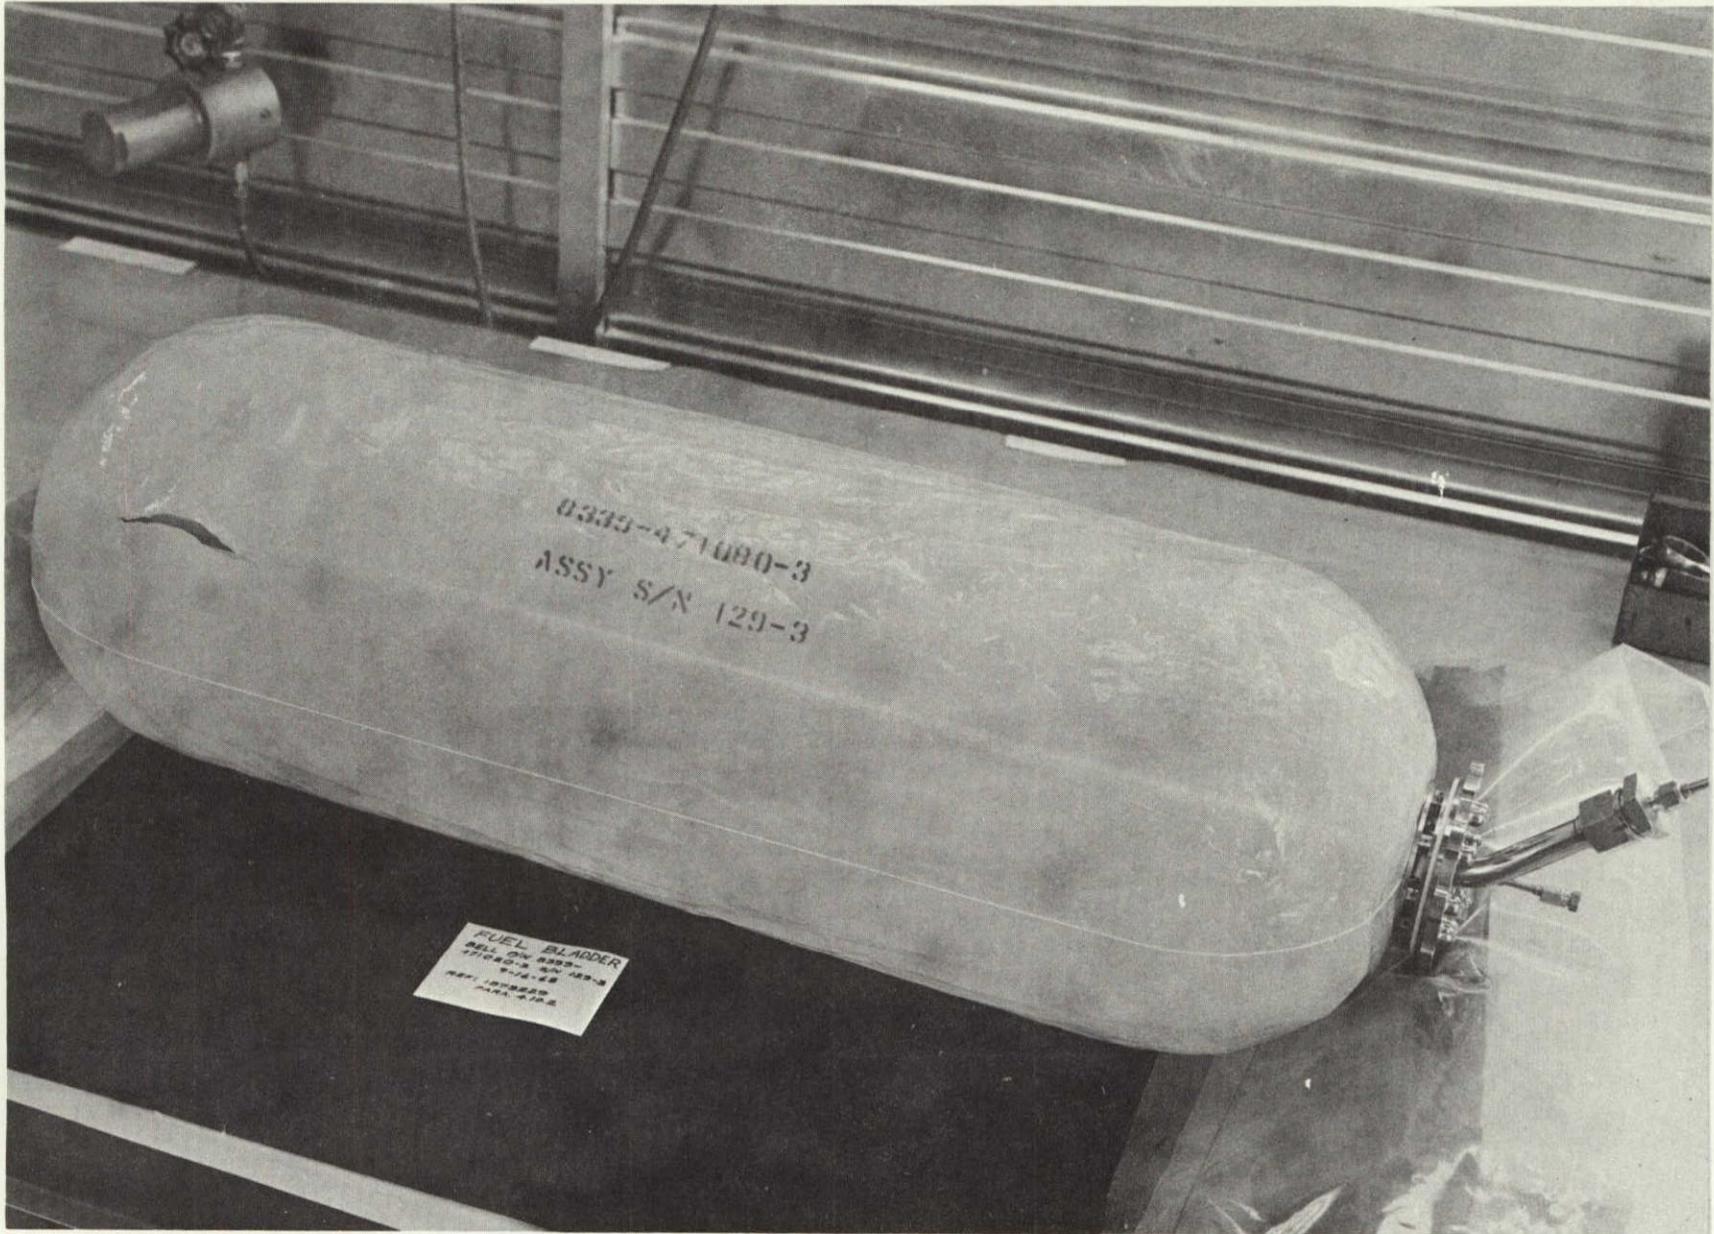
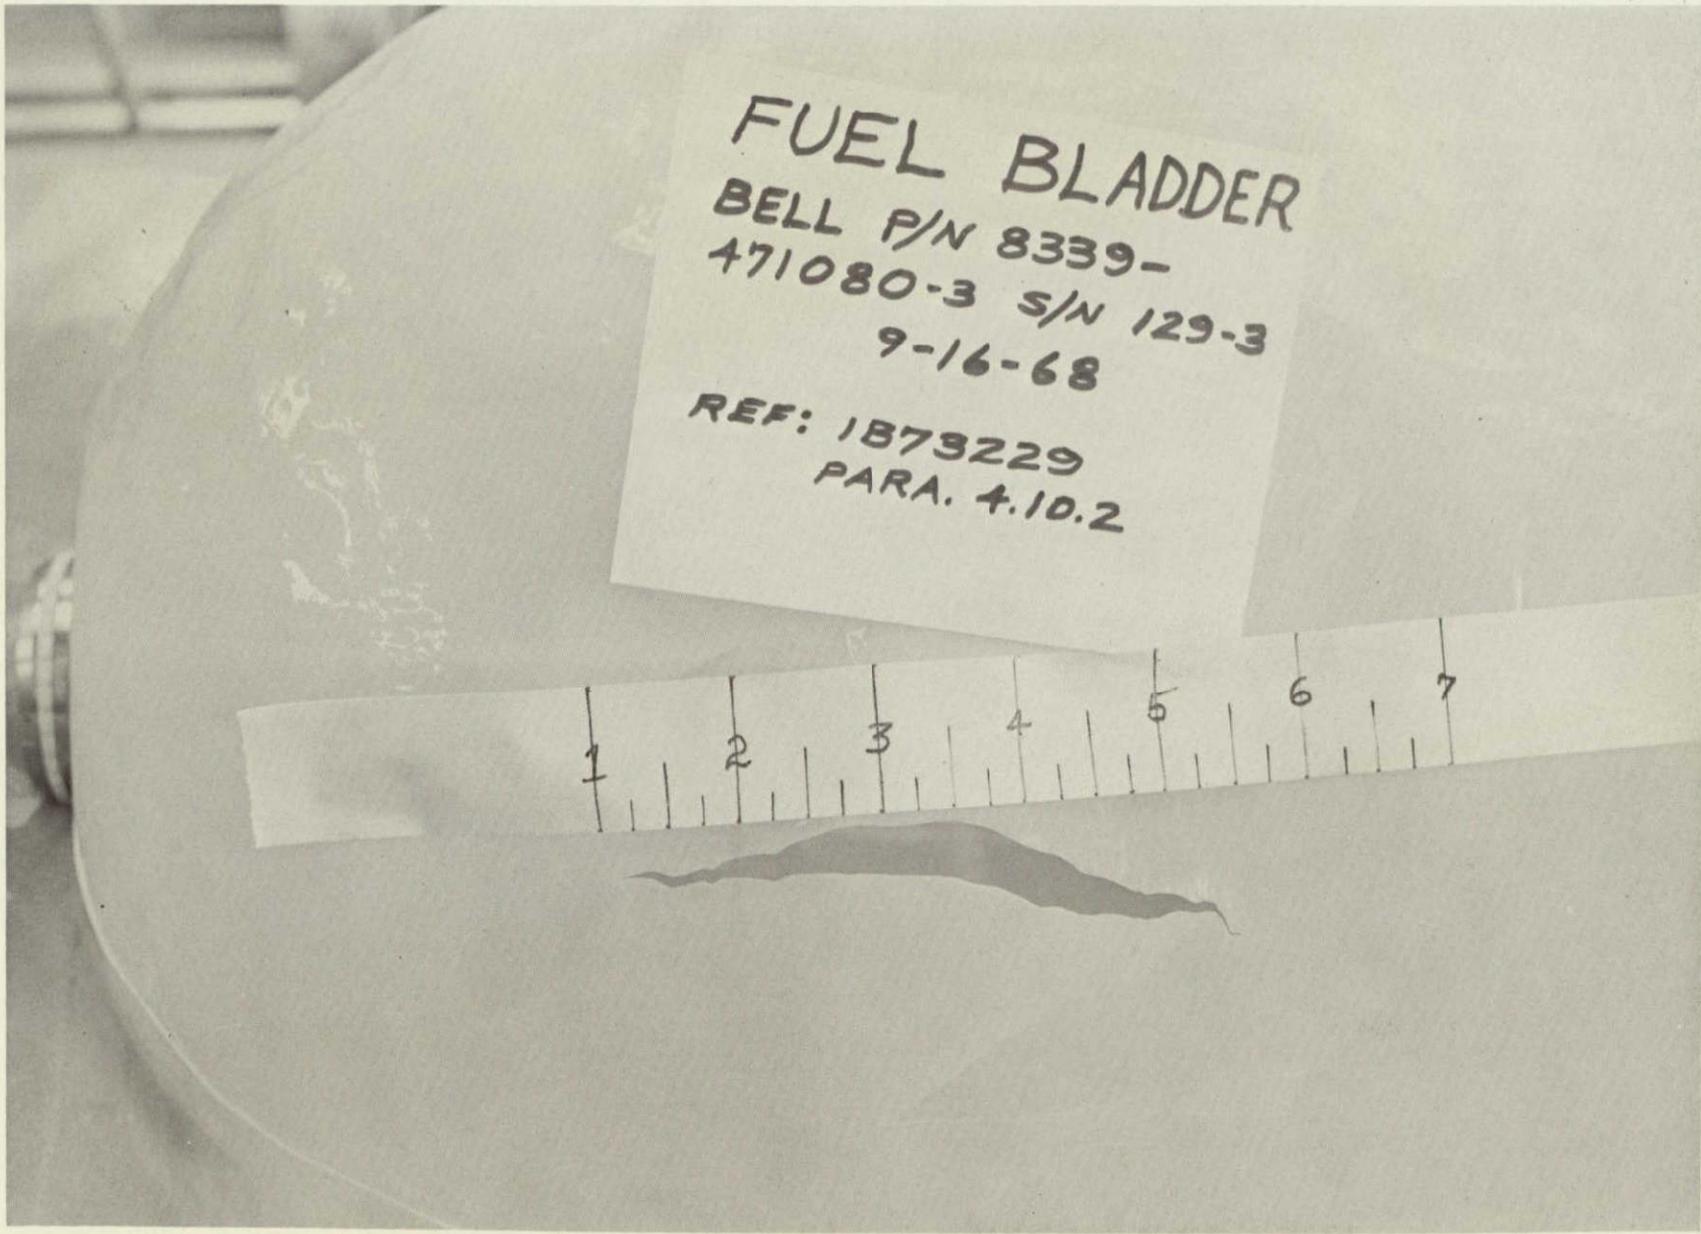
Figure 9-2. Fuel Bladder (Sheet 1 of 2)

Figure 9-2. Fuel Bladder (Sheet 2 of 2)

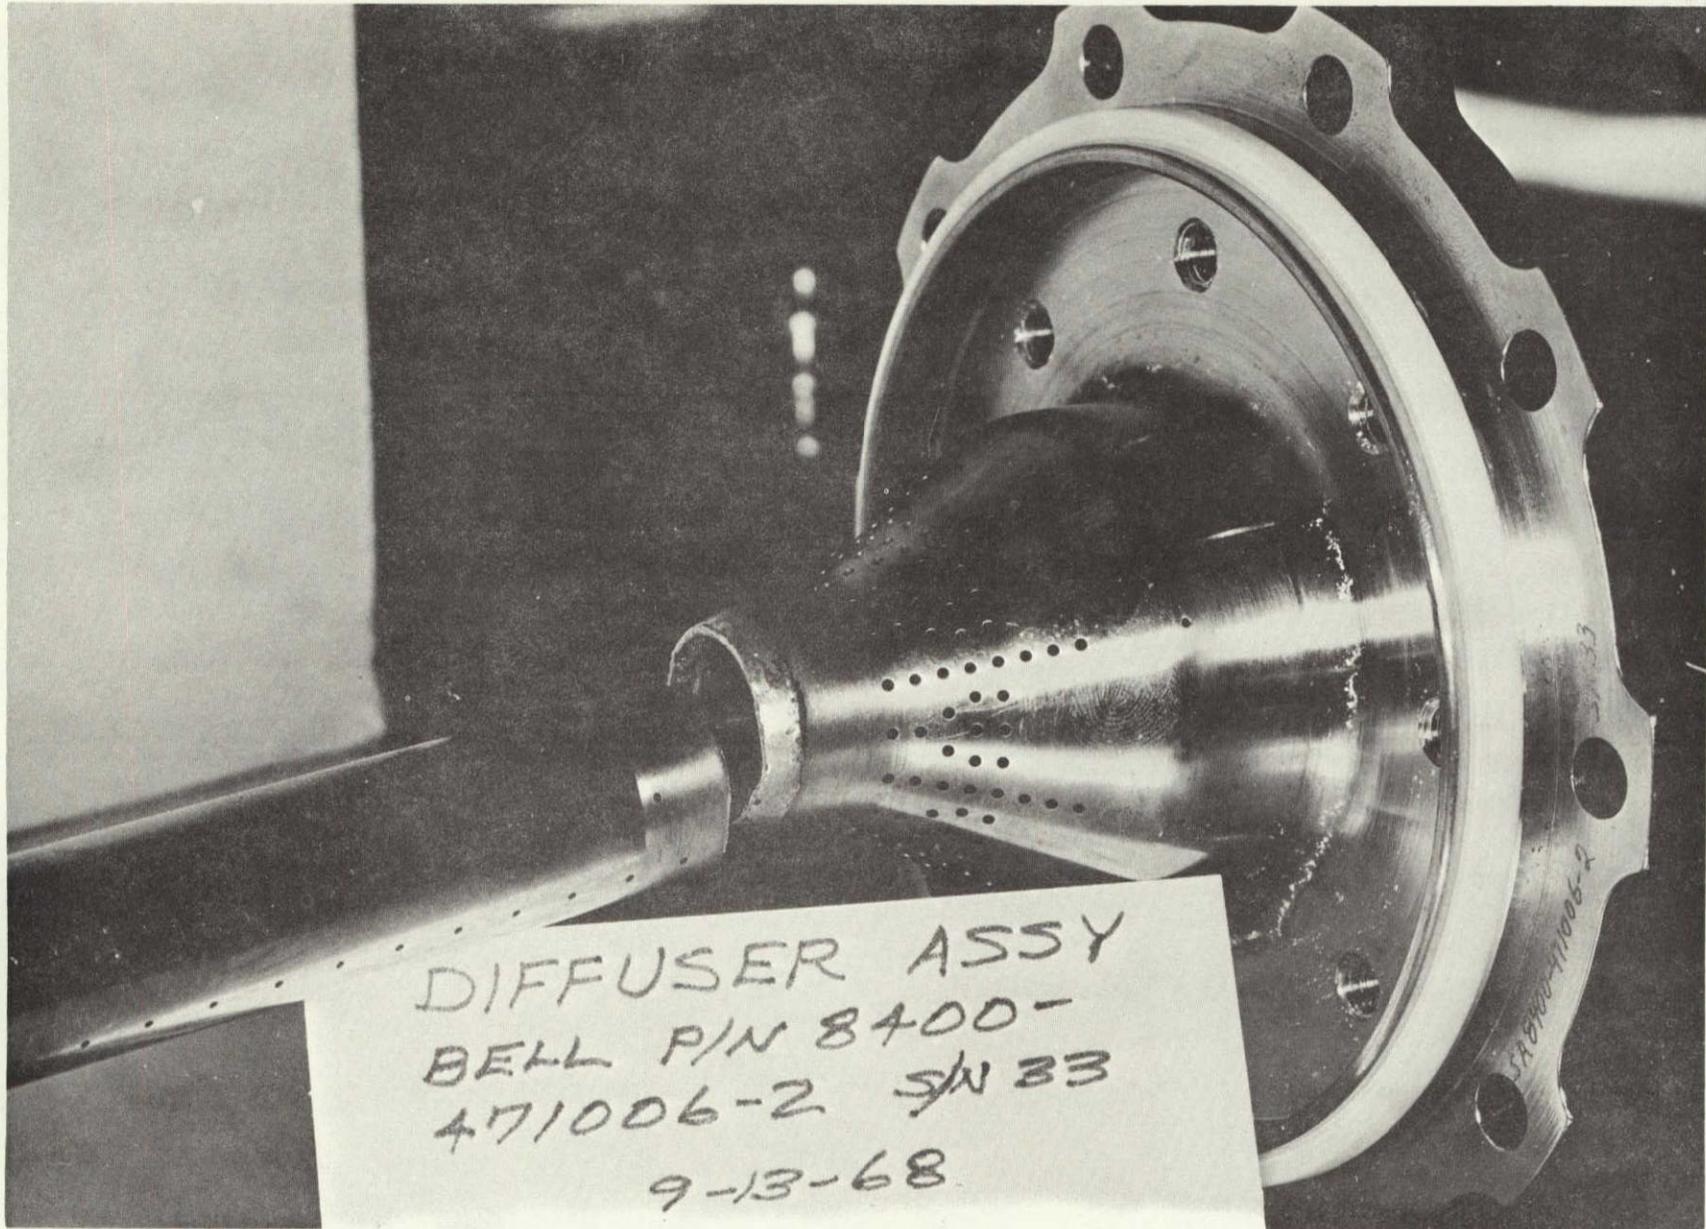
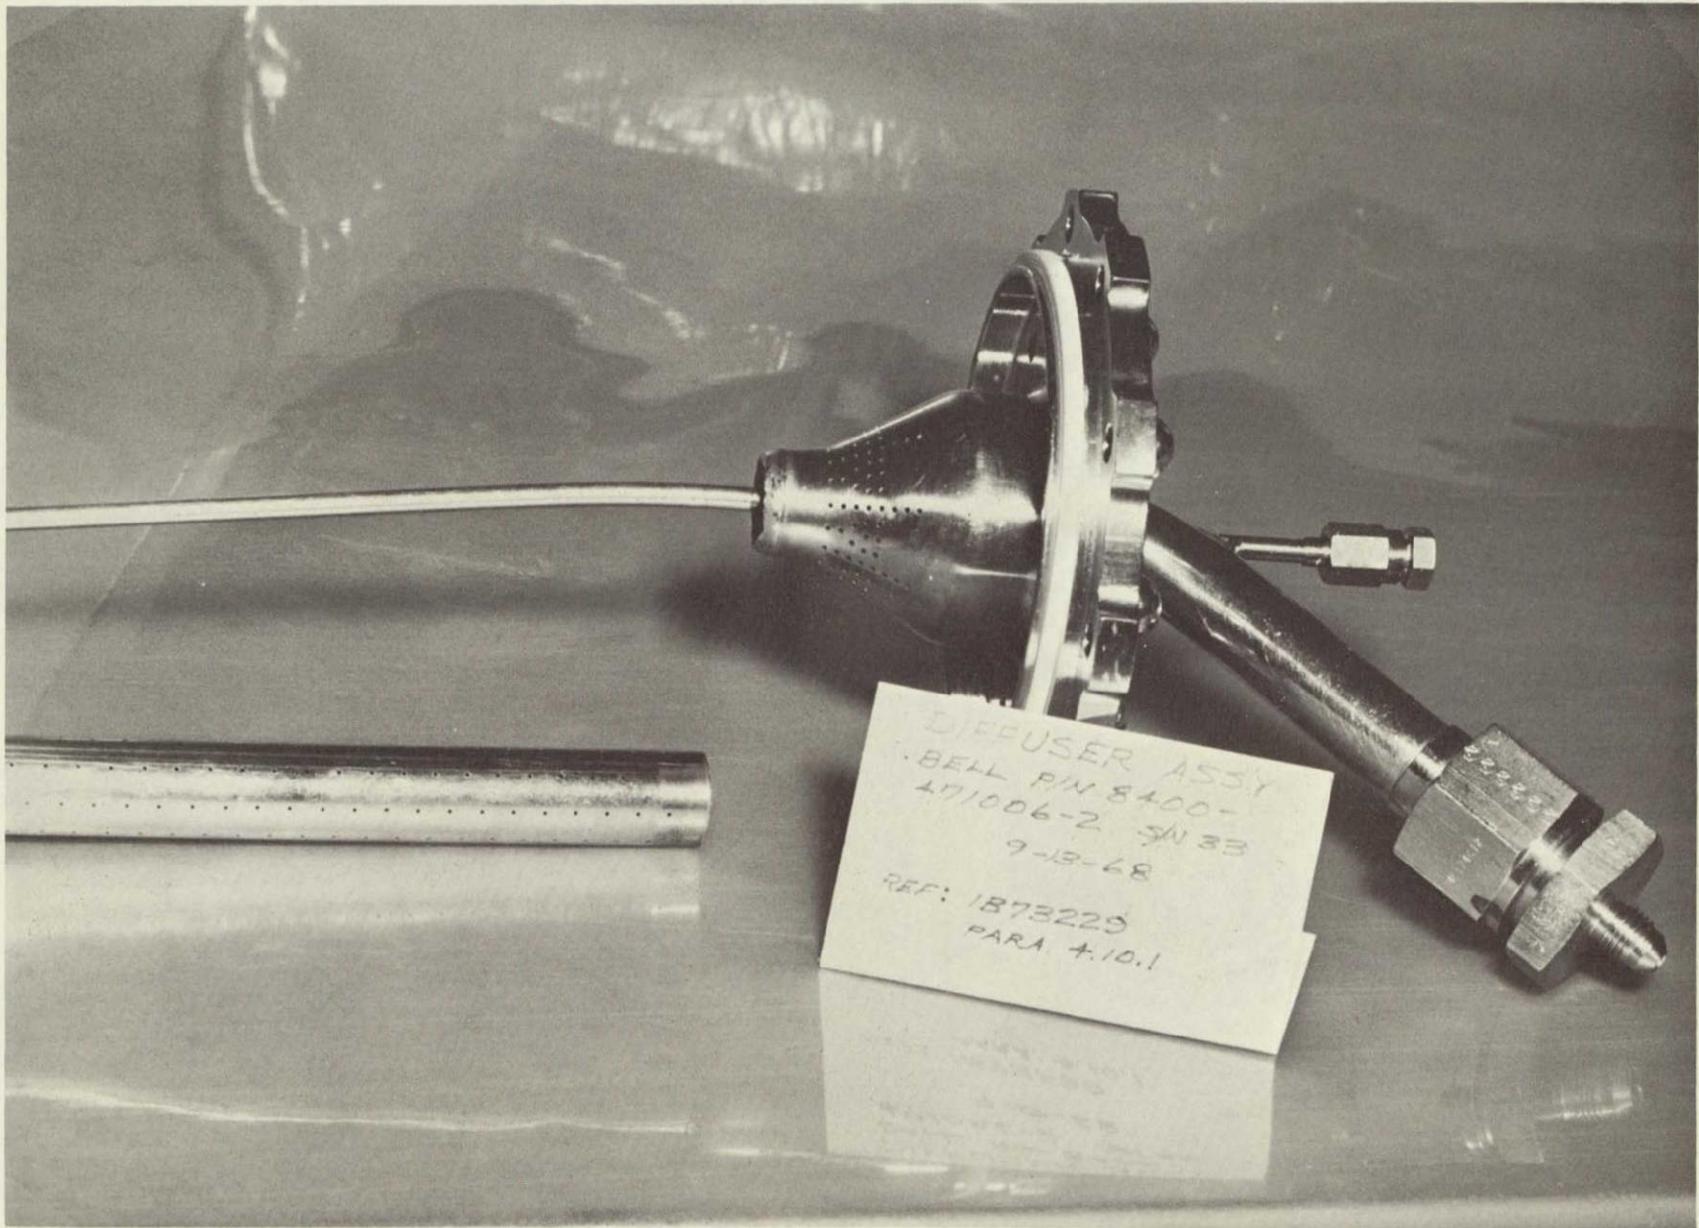
Figure 9-3. Oxidizer Tank Diffuser Tube (Sheet 1 of 2)

Figure 9-3. Oxidizer Tank Diffuser Tube (Sheet 2 of 2)

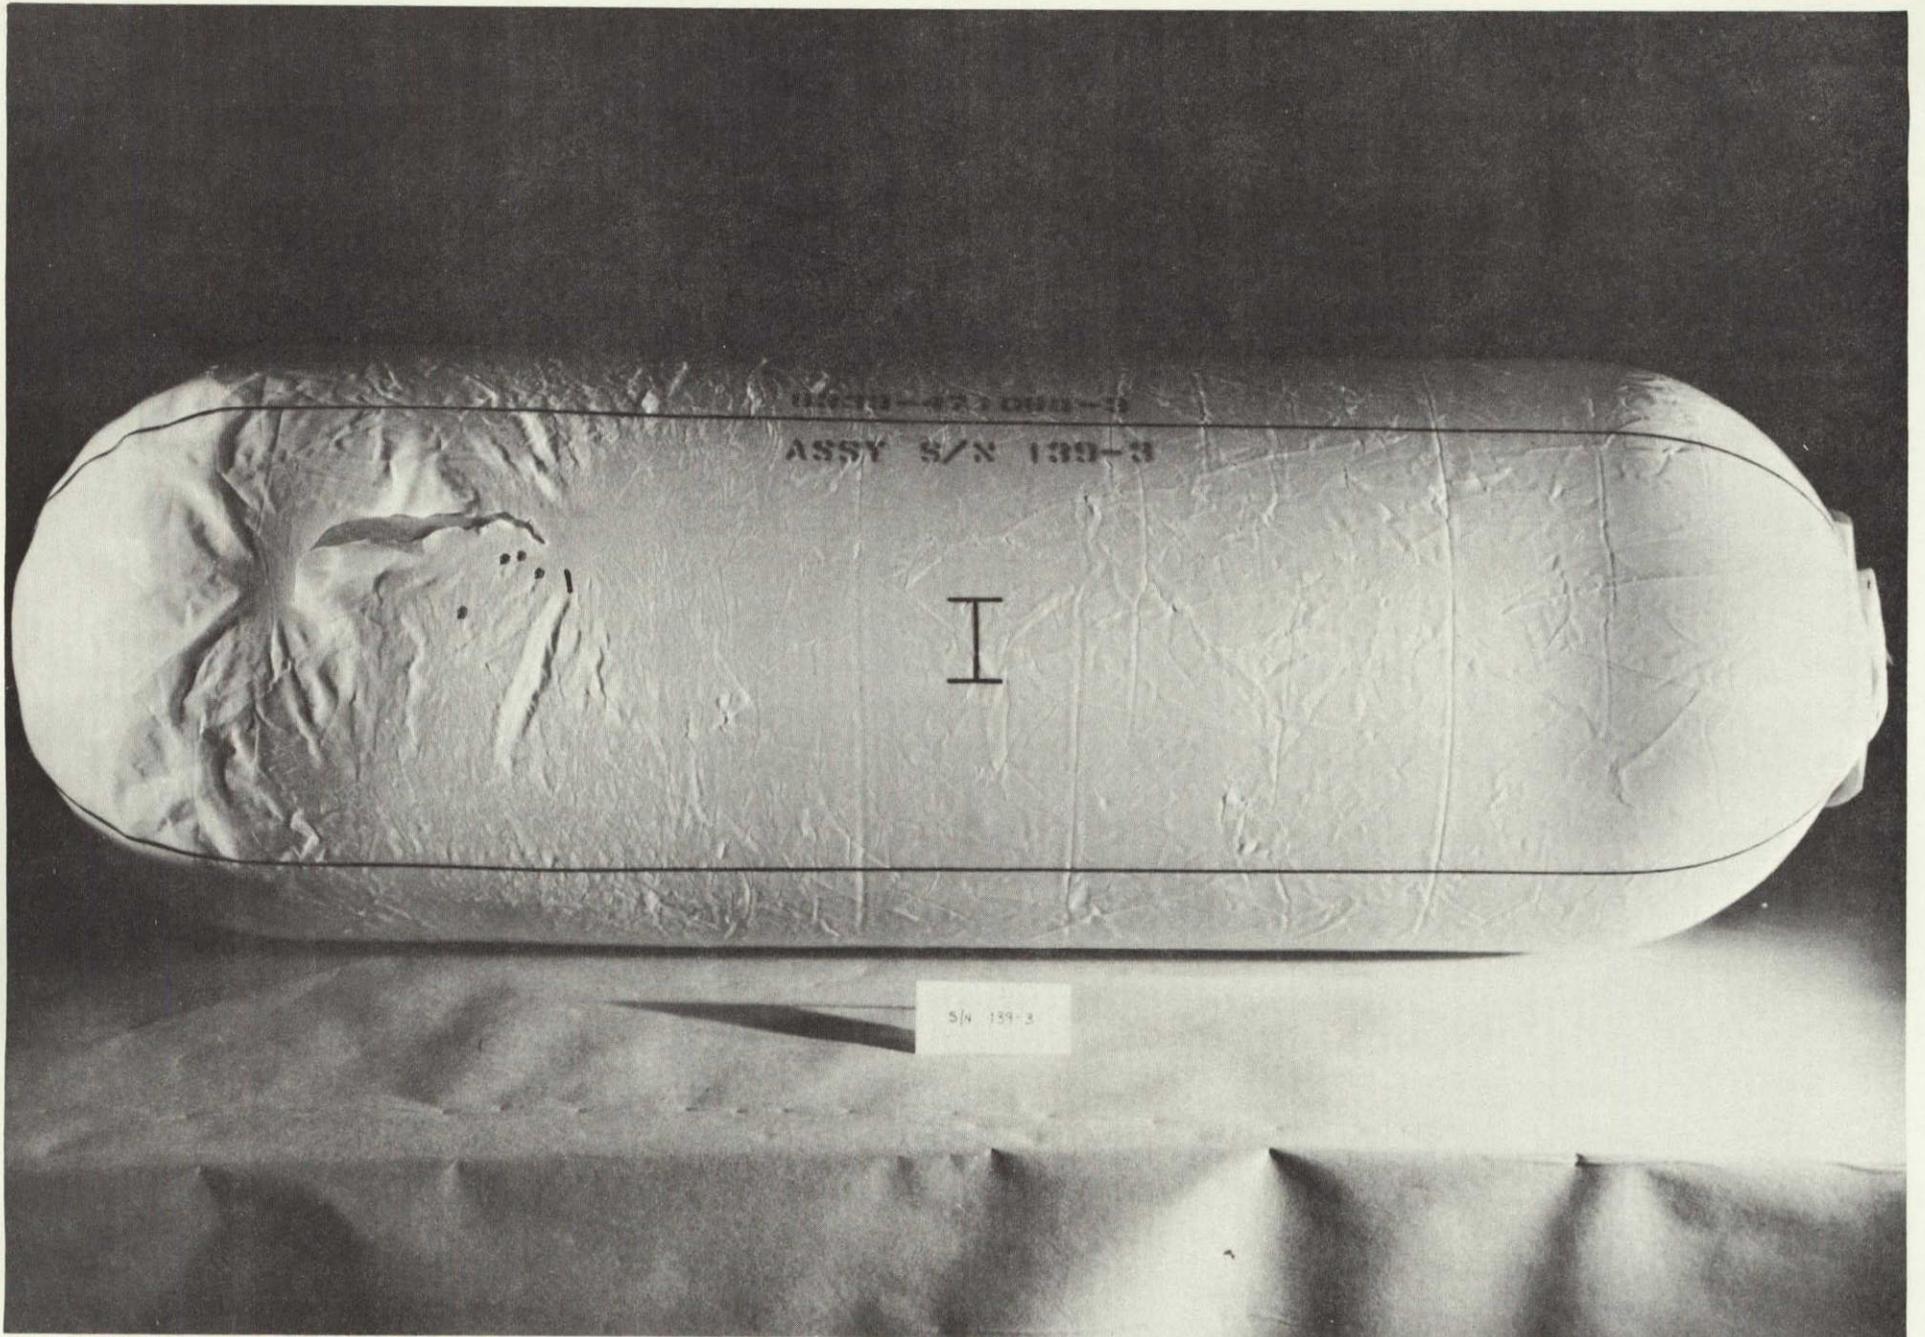
storage period, as reported in Reference B, was determined. Bell feels that the validity of such a test, with the tank loaded with oxidizer, is questionable. However, assuming that the leakage rate is valid, it would not be indicative of bladder failure since leakage through a failure even of "pinhole" size would be many times that value. Such a rate could be caused by bladder damage incurred by repetitious local movement of the bladder, possibly during M/DC repositioning procedures.

The reported presence of liquid N_2O_4 on the gas side of the bladder can be explained by alternate heating and cooling of the tank shell due to ambient temperature changes at the test site. Since the ullage volume outside the oxidizer bladder becomes saturated with propellant vapor within a short period of time after propellant loading, any subsequent temperature fluctuations of the shell will cause condensation during temperature decay periods, followed by non-saturation (with additional permeation through the bladder) during subsequent temperature increases.

FIGURE 1 - OVERALL VIEW OF FAILURE QUADRANT - OXIDIZER BLADDER

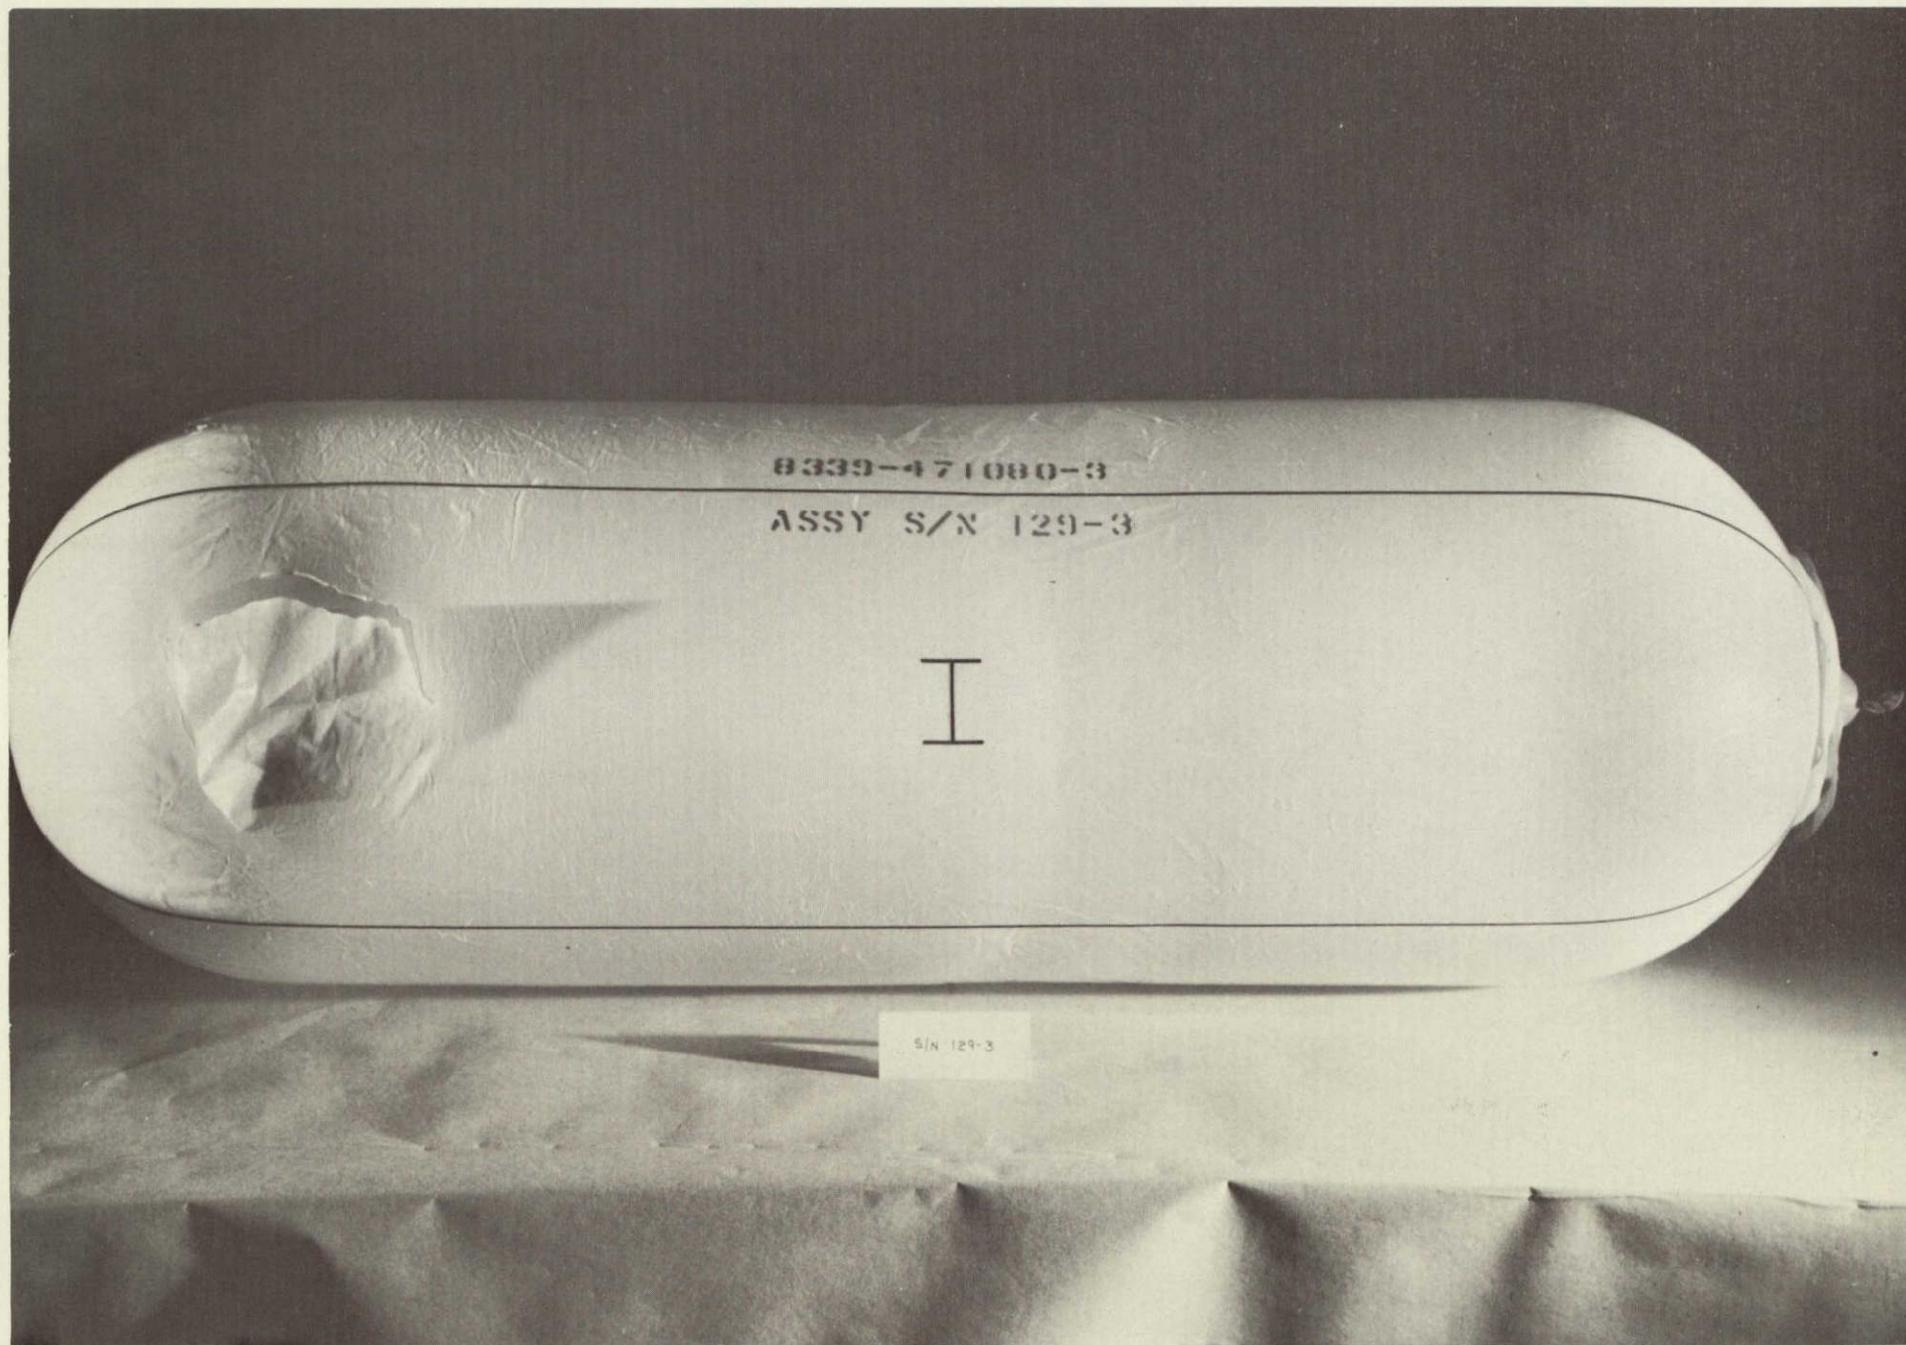
FIGURE 2 - OVERALL VIEW OF FAILURE QUADRANT - FUEL BLADDER

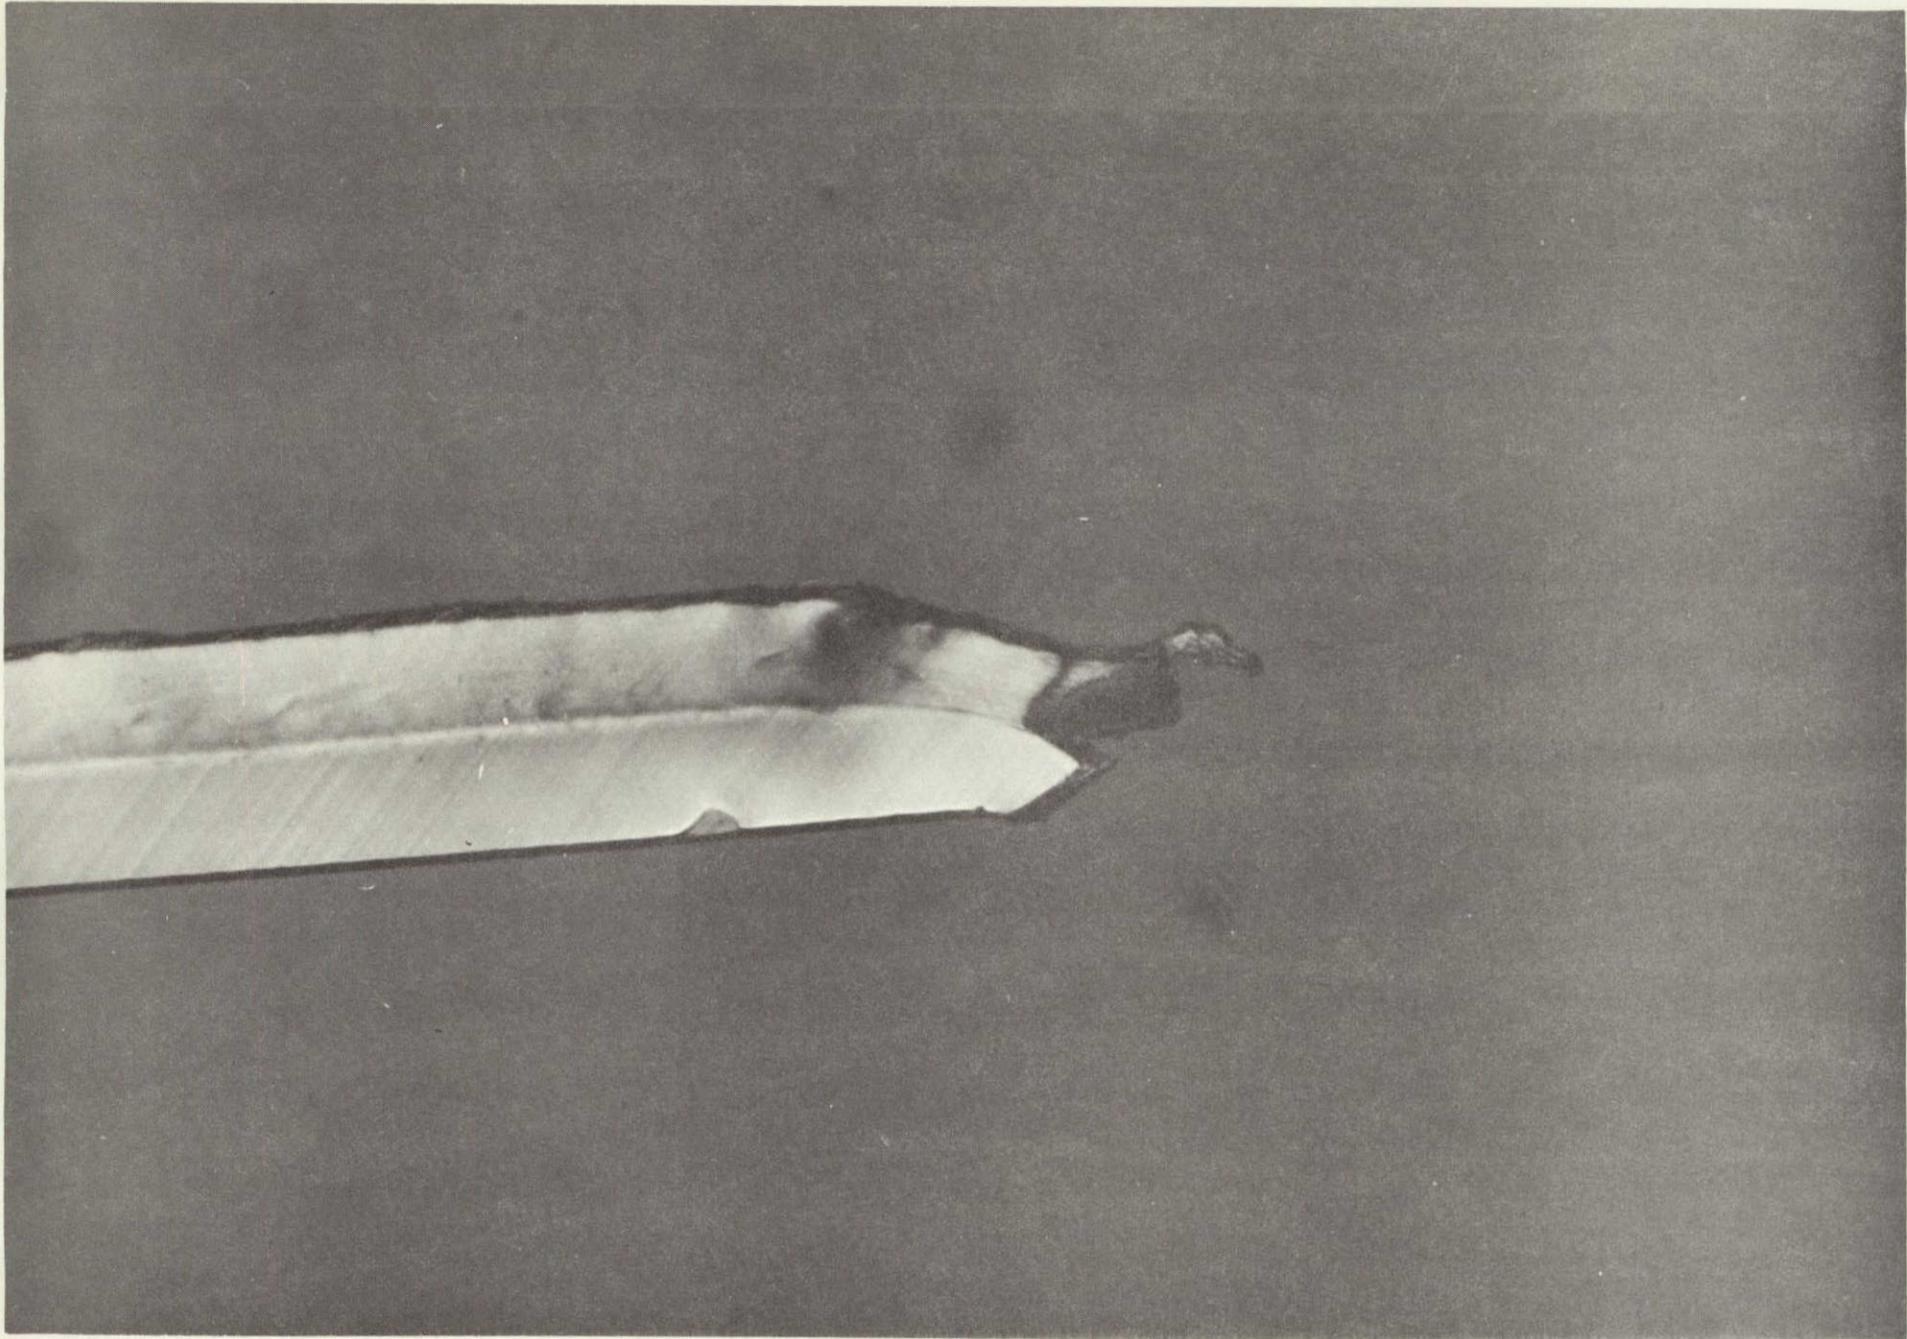
FIGURE 9 - TEFLON LAMINATE (6 MIL) - FATIGUE FAILURE
