**NASA TECHNICAL
MEMORANDUM**

NASA TM X-52972

**SHOCK, VIBRATION, AND ACCELERATION-LOAD TESTS
OF A SNAP-8 MOTOR-DRIVEN LUBRICANT-COOLANT PUMP**

by A. J. Stromquist
Lewis Research Center
Cleveland, Ohio

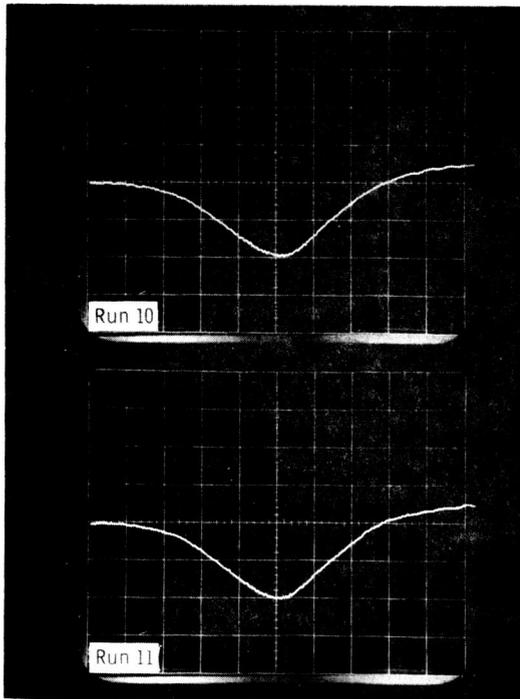
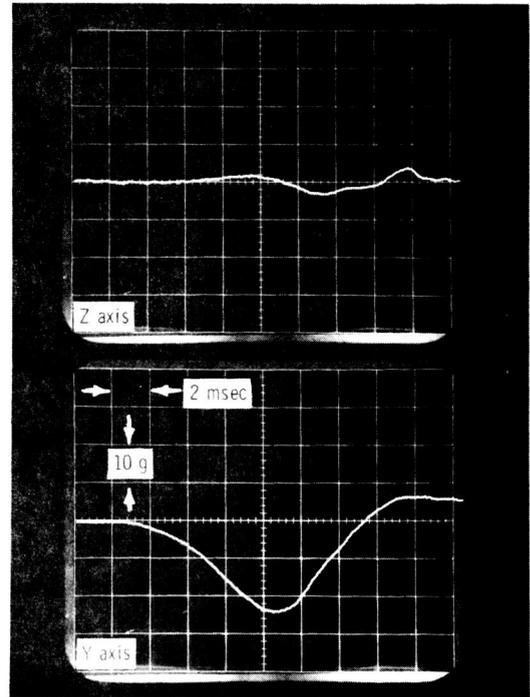
Figure 7. - Typical shock test data from control and response accelerometers.

Table I summarizes the shock testing, showing the programmed machine inputs in each axis and the responses of the accelerometers mounted on the pump, also for all three axes. In general, the response accelerometers showed little amplification with the maximum being 25 percent in the +X axis. Also, the two mutually perpendicular axes showed no more than 2 to 3 G's with a 20-G input. A sample of the data, which was taken photographically from an oscilloscope, is shown in figure 7. The nonreturn of the trace to the abscissa merely means that vibrations resulting from the shock had not fully damped when the picture was taken.

(a) Control accelerometer; Y axis.

(b) Response accelerometer; run 10.

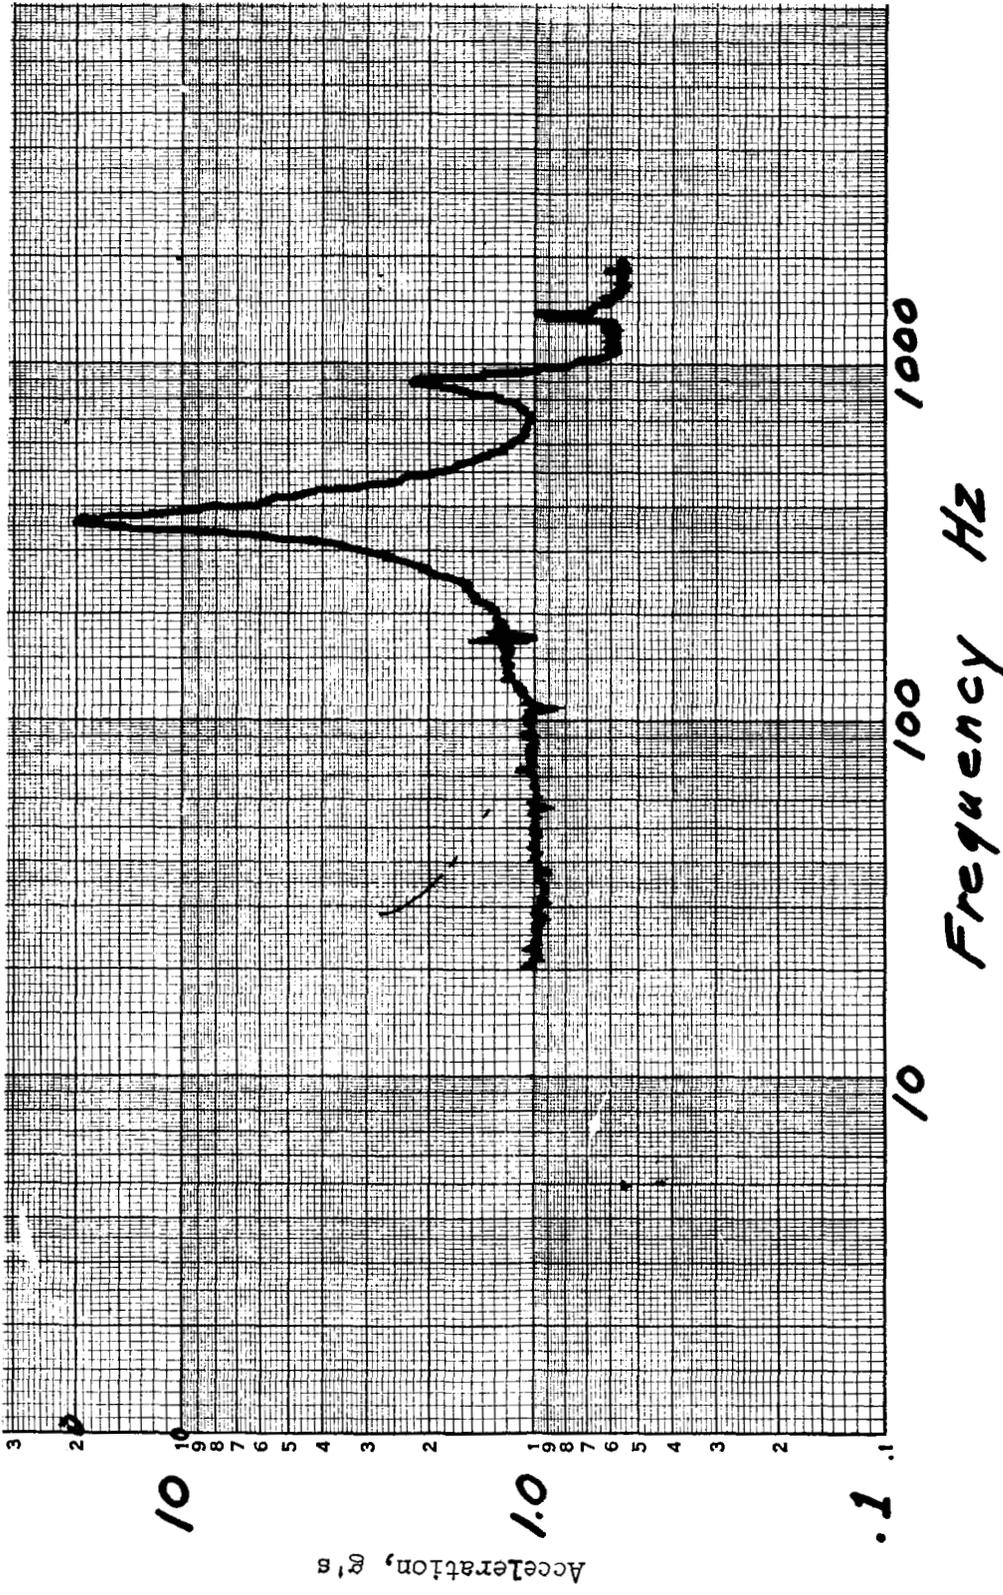
Figure 8. - Response of accelerometer 8 during X axis, 1G sweep at a rate of 1 octave/minute.

In the X axis, the 1-G sinusoidal tests showed most of the resonances at 350 to 360 Hz, with the highest amplification factor of 20 at the top of the motor housing (run 21). For the specified X-axis sweep, the resonances occurred from 250 to 300 Hz, the highest response being 110 G's at the discharge tube. In the Y-axis 1-G sweep (run 24), the resonances occurred at 360 Hz and 2000 Hz with amplification factors of 10 at the motor housing and 13 at the discharge tube, respectively. For the specification load-frequency sweep (run 25), maximums of 100 G's were noted at the pump volute and discharge tube at frequencies of 1600 and 1800, respectively.

A typical plot of "G" level versus frequency for an accelerometer on the motor housing is shown in figure 8.
