THERMAL CYCLING EFFECTS ON SOLAR CELL INTERCONNECTION TABS ON AN OAO-B SAMPLE MODULE

X-761-71-315

Clara M. Vermillion

July 1971

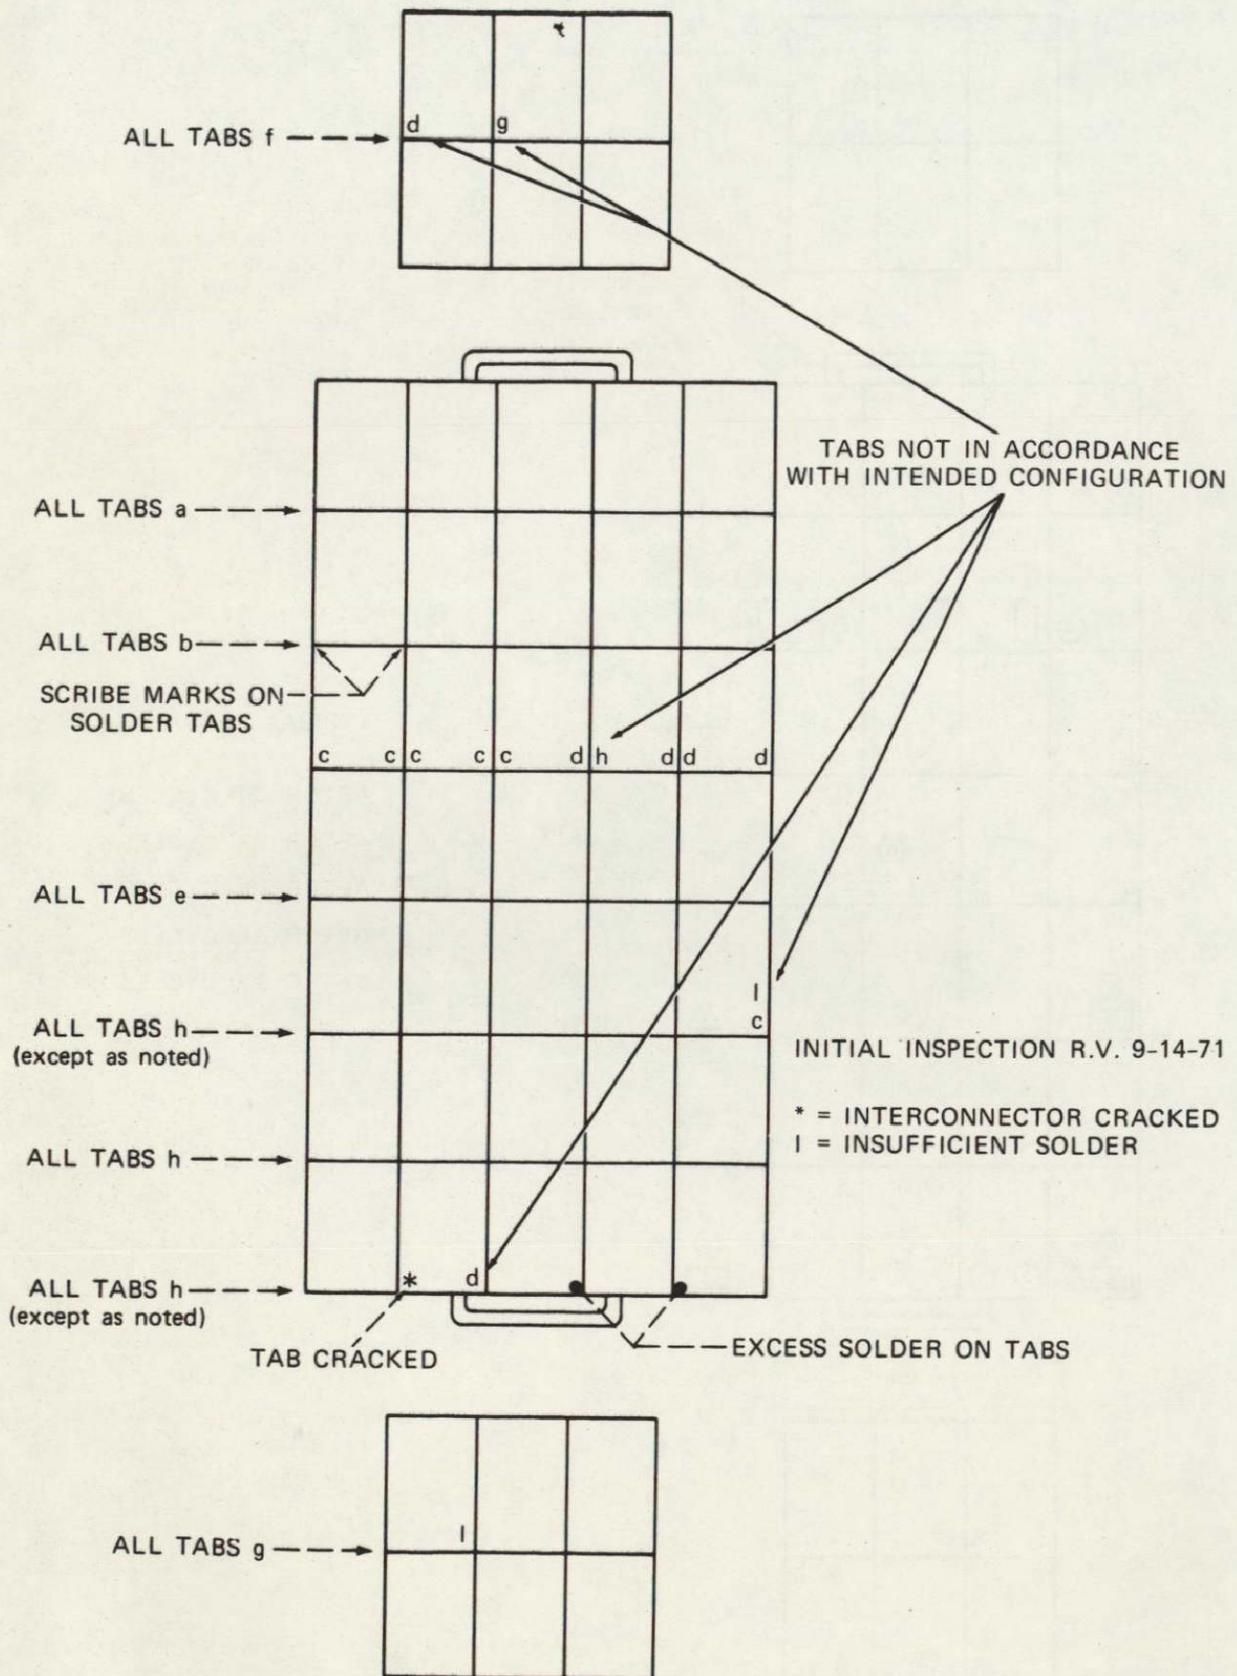
Figure 7. Initial Inspection Results

The initial microscopic inspection results are shown in Figure 7. In general the results confirmed the Spectrolab information sheet. However, the following deviations, which could affect the test results, were noted:

1. Two of the type-f tabs in addition to being spliced were bent. One had a type-d bend and one a type-g.
2. One of the tabs which was supposed to have a type-d (reverse) bend was actually a type-h tab (not bent).
3. Two of the tabs which were supposed to be type-h (normal) were found to be bent. One had a forward, type-c bend, and one had a reverse, type-d bend.
4. In addition it was noted that two tabs had scribe marks on them, two had insufficient solder, and two had excess solder.
5. Finally, one of the type-h (normal) tabs was found to be cracked.

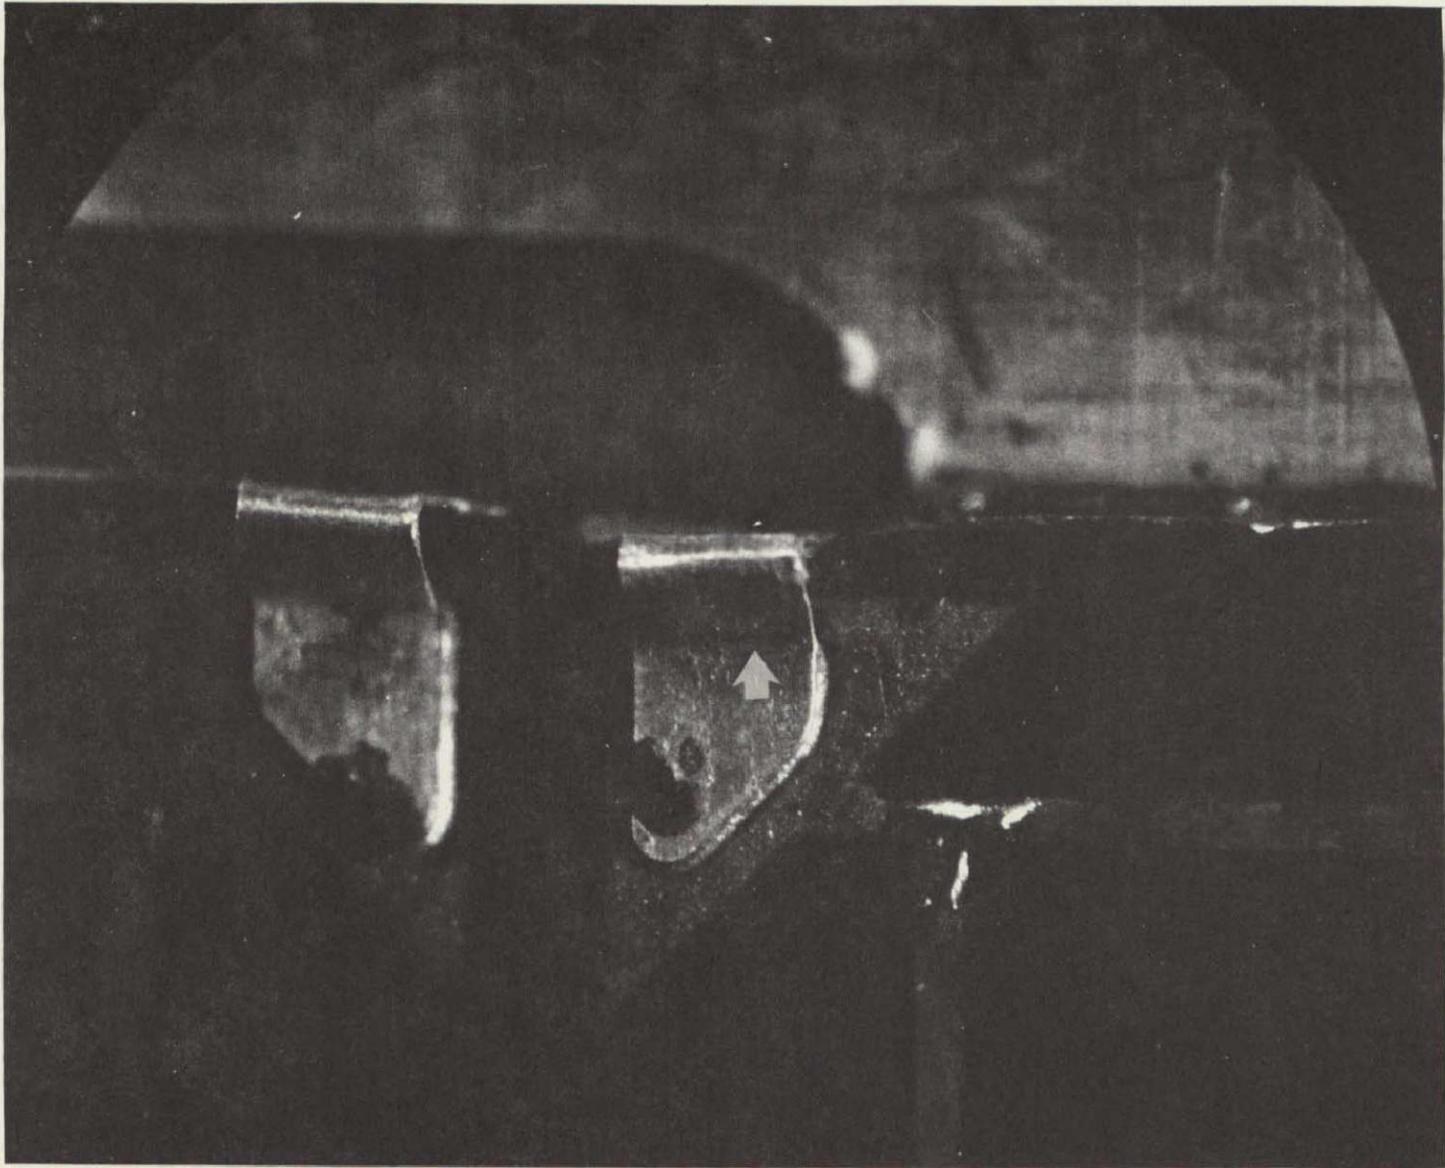
Figure 8 shows a type-d tab. (This is the tab that was supposed to be type-h but was actually type-d.) A crack is forming in the tab at the bend at the soldered portion of the tab.

Figure 8. Crack in Type-d Tab After 50 Cycles

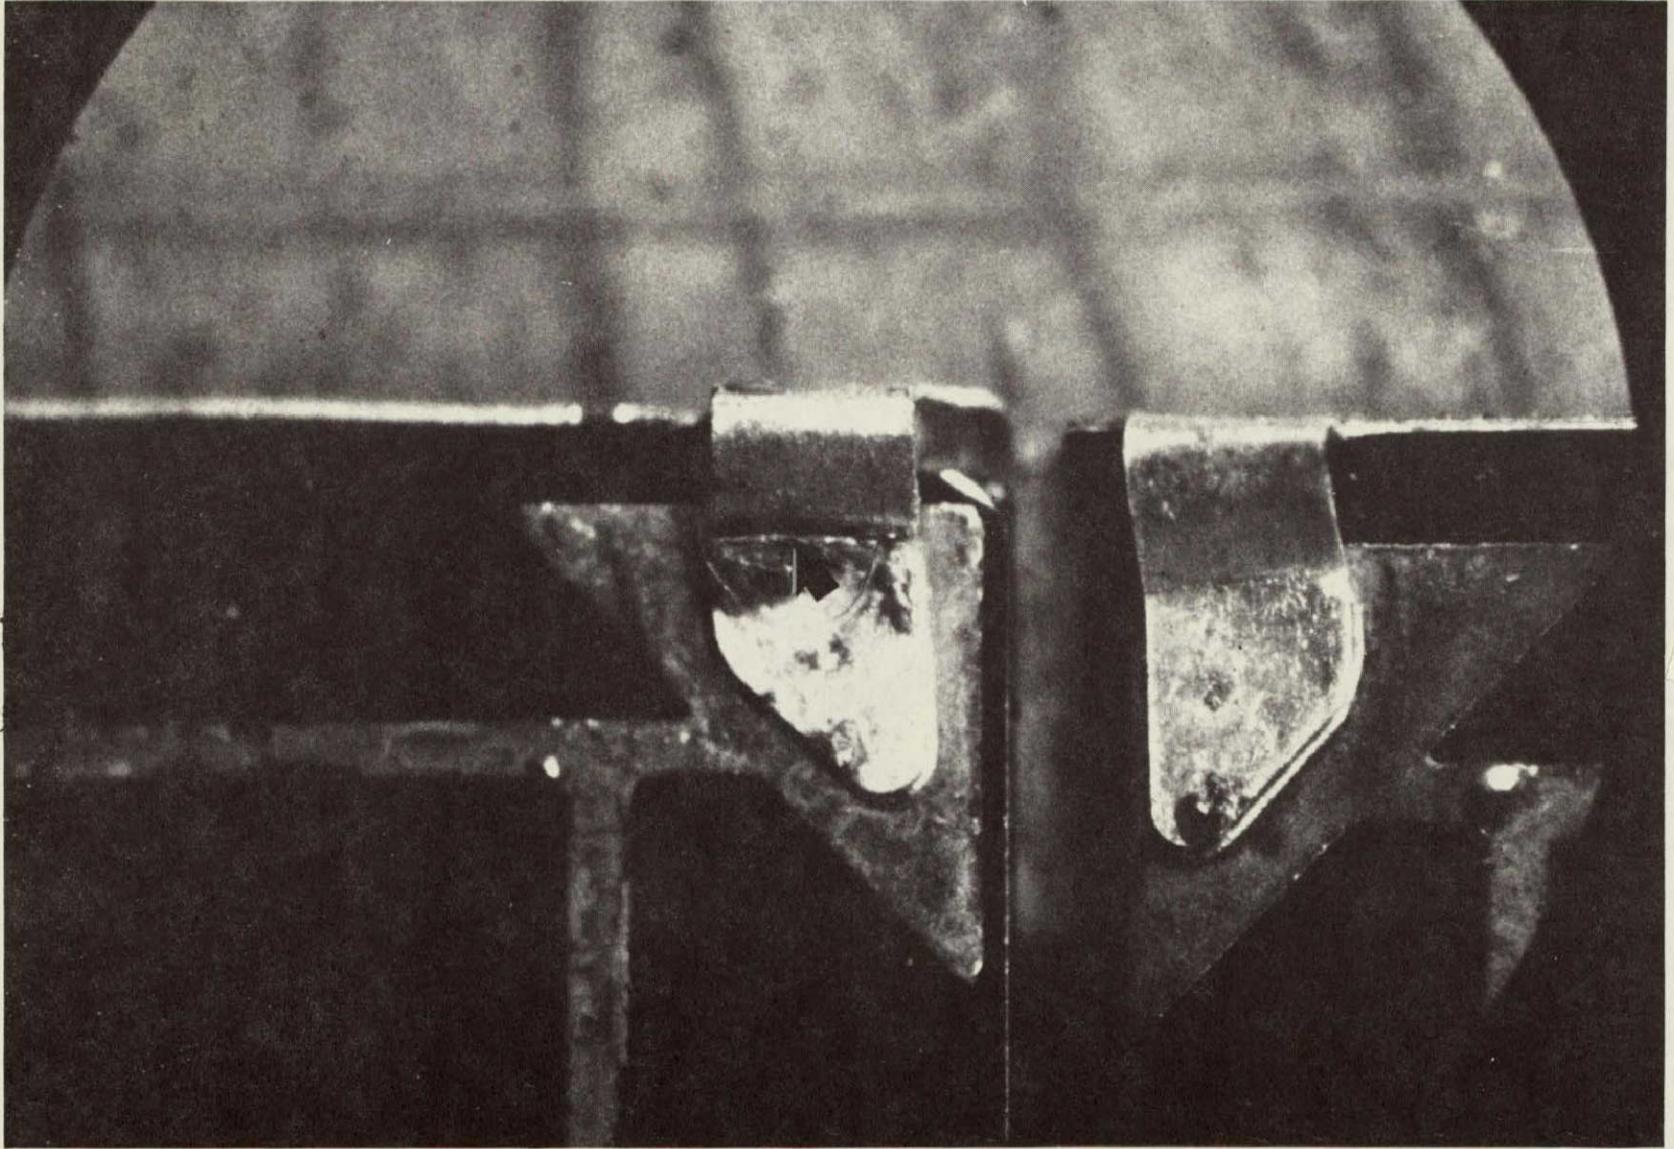
Figure 9 shows a broken type-h tab. This tab was beginning to crack when received, as noted in Figure 7. This tab is on the same cell as the cracked tab in Figure 8.

Figure 9. Broken Type-h (Normal) Tab After 50 Cycles

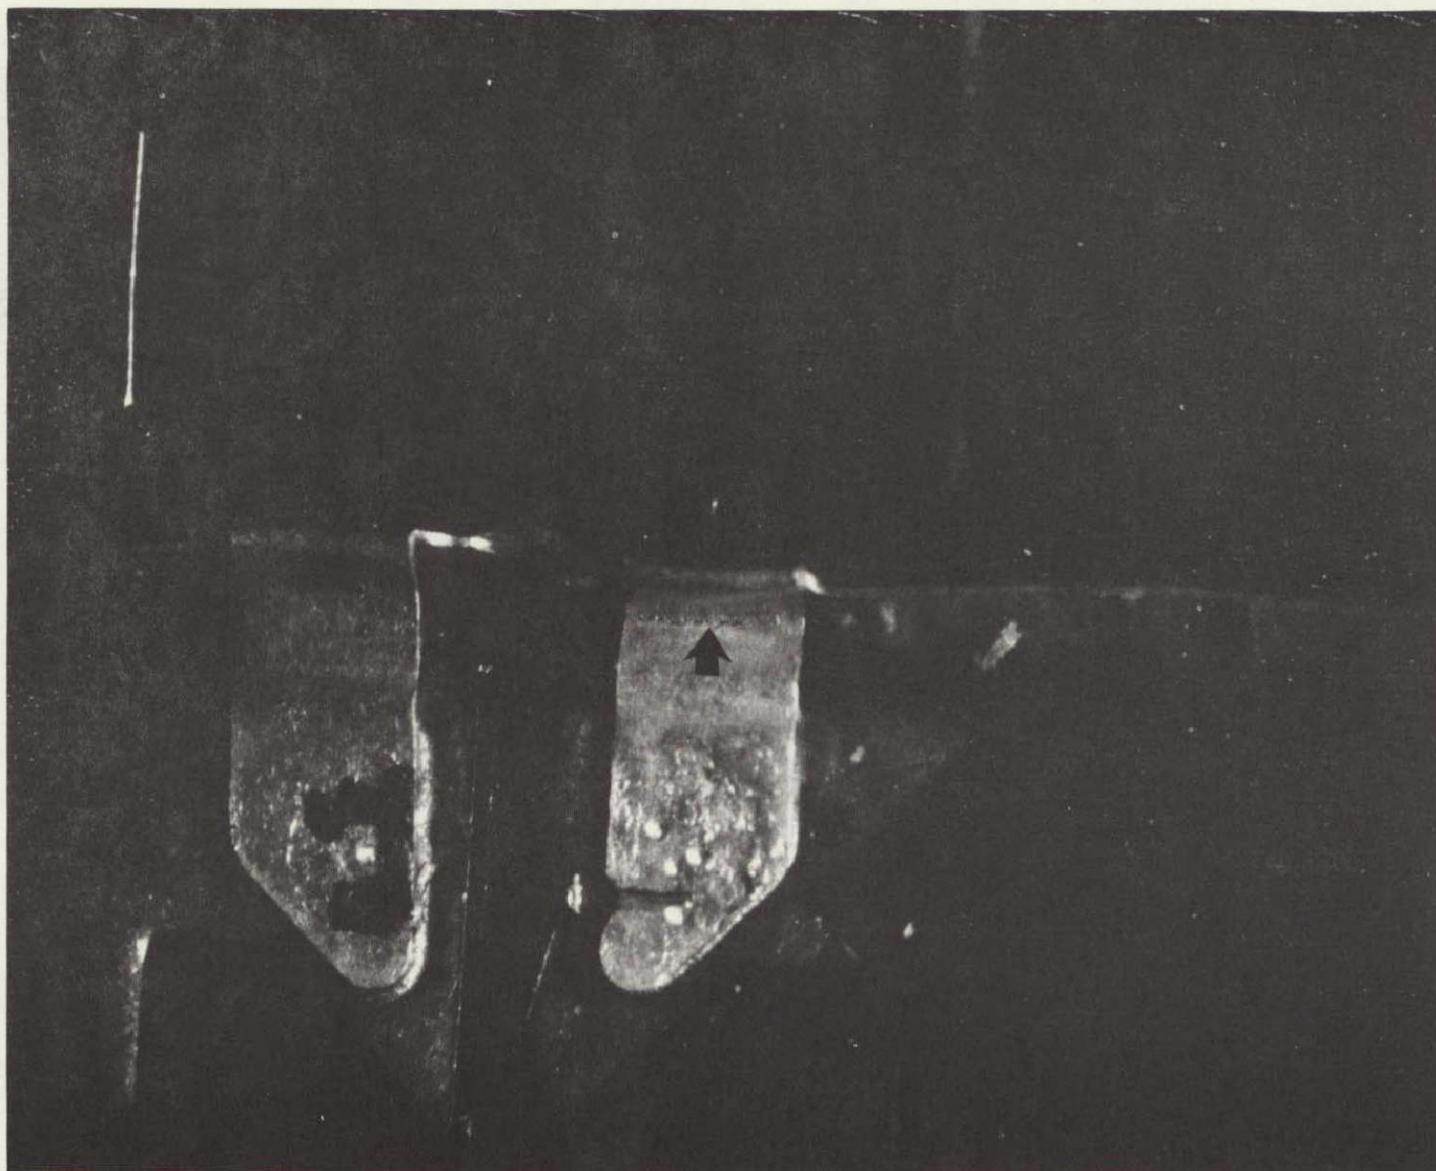
Figure 10 shows a crack forming on a type-b tab. (This photo also includes the adjacent tab which showed a defect after 200 cycles as seen in Figure 23.)

Figure 10. Crack Forming on Type-b Tab After 50 Cycles

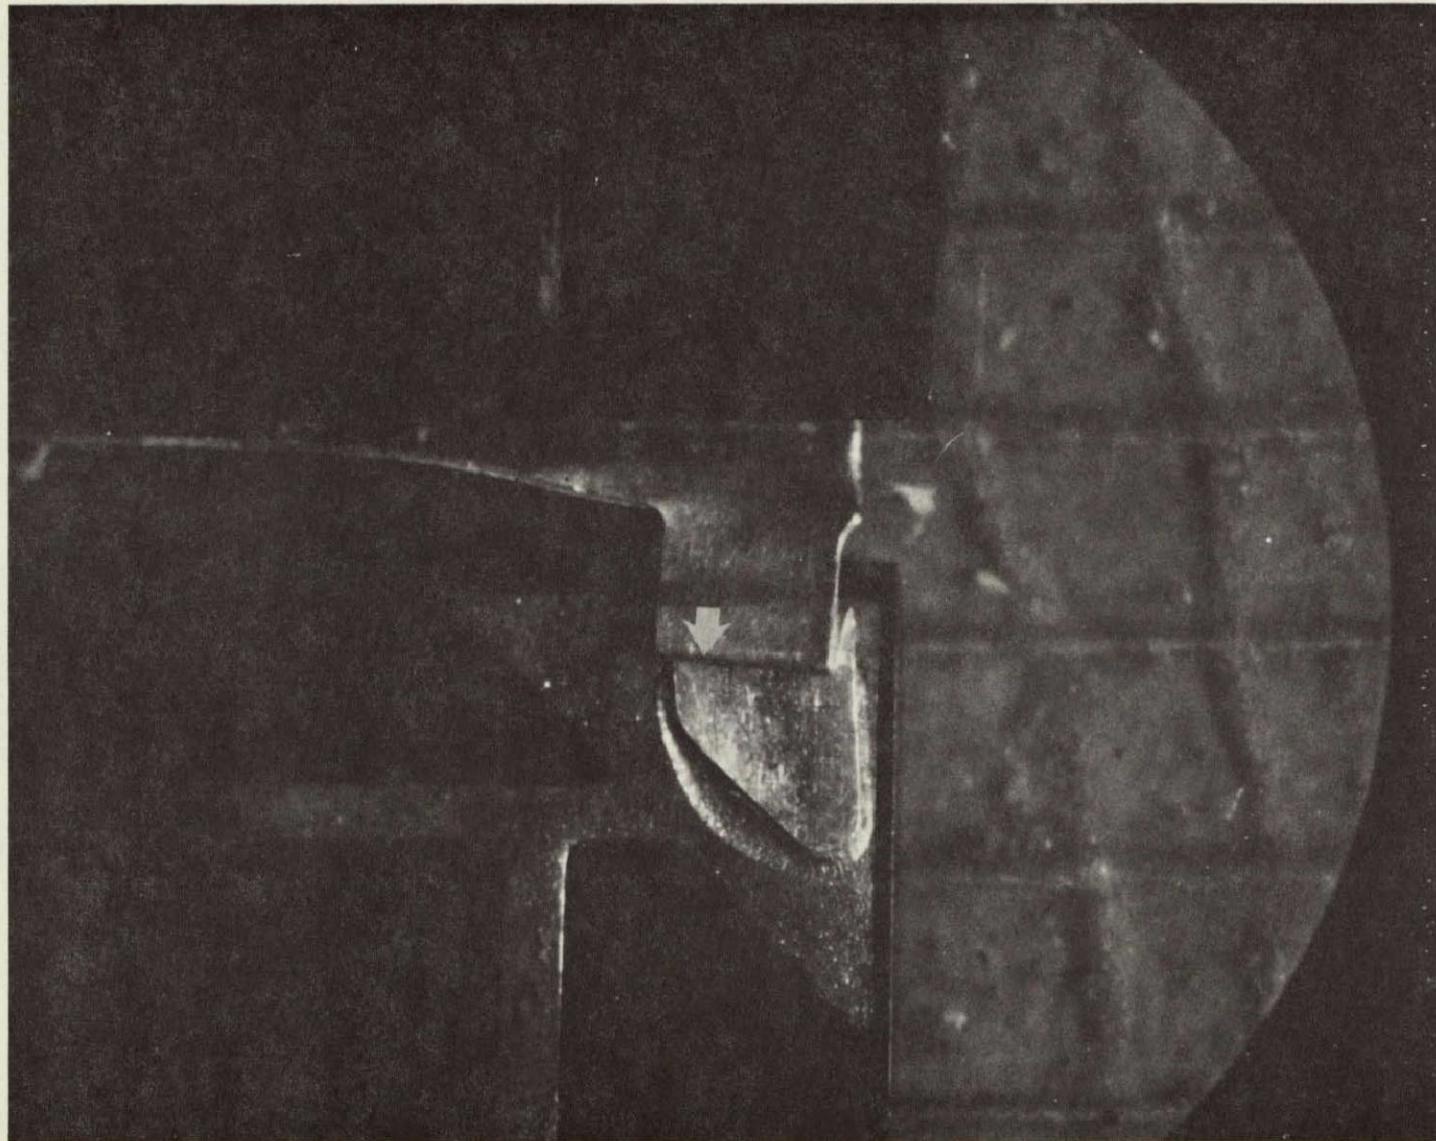
Figure 11 shows a type-a tab. A crack has occurred at the top of the tab where it has been bent.

Figure 11. Crack in Type-a Tab After 50 Cycles

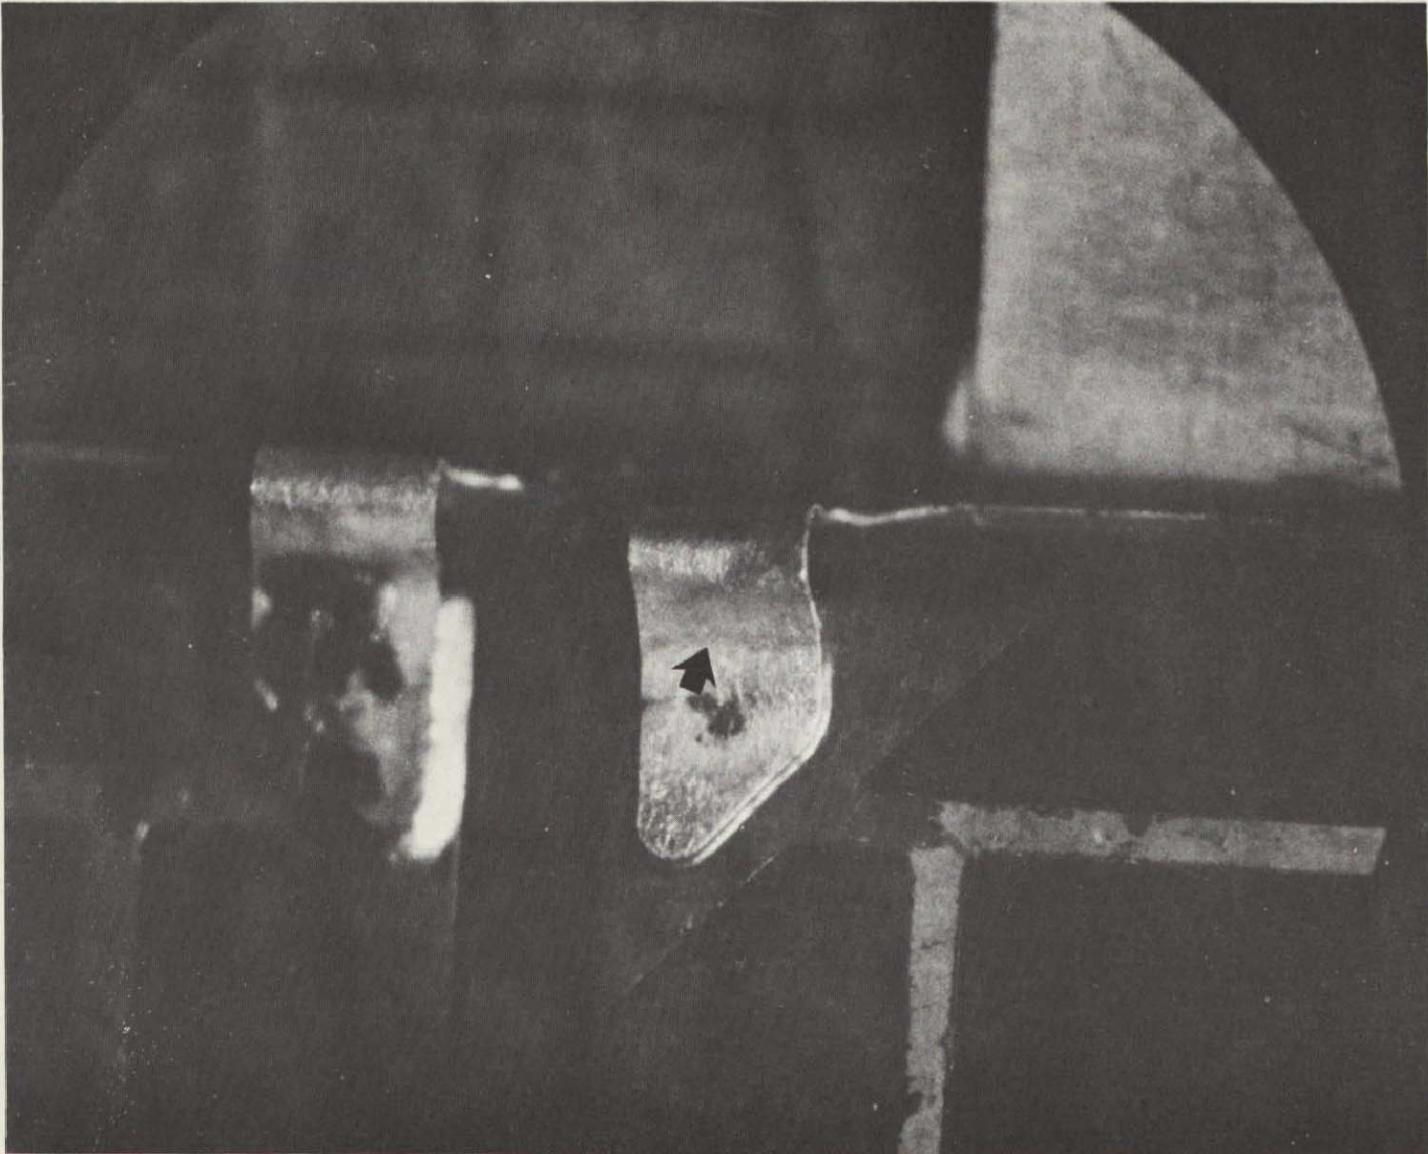
Figure 12 shows another type-h tab with a crack forming at the bend adjacent to the solder connection.

Figure 12. Crack in Type-h Tab After 50 Cycles

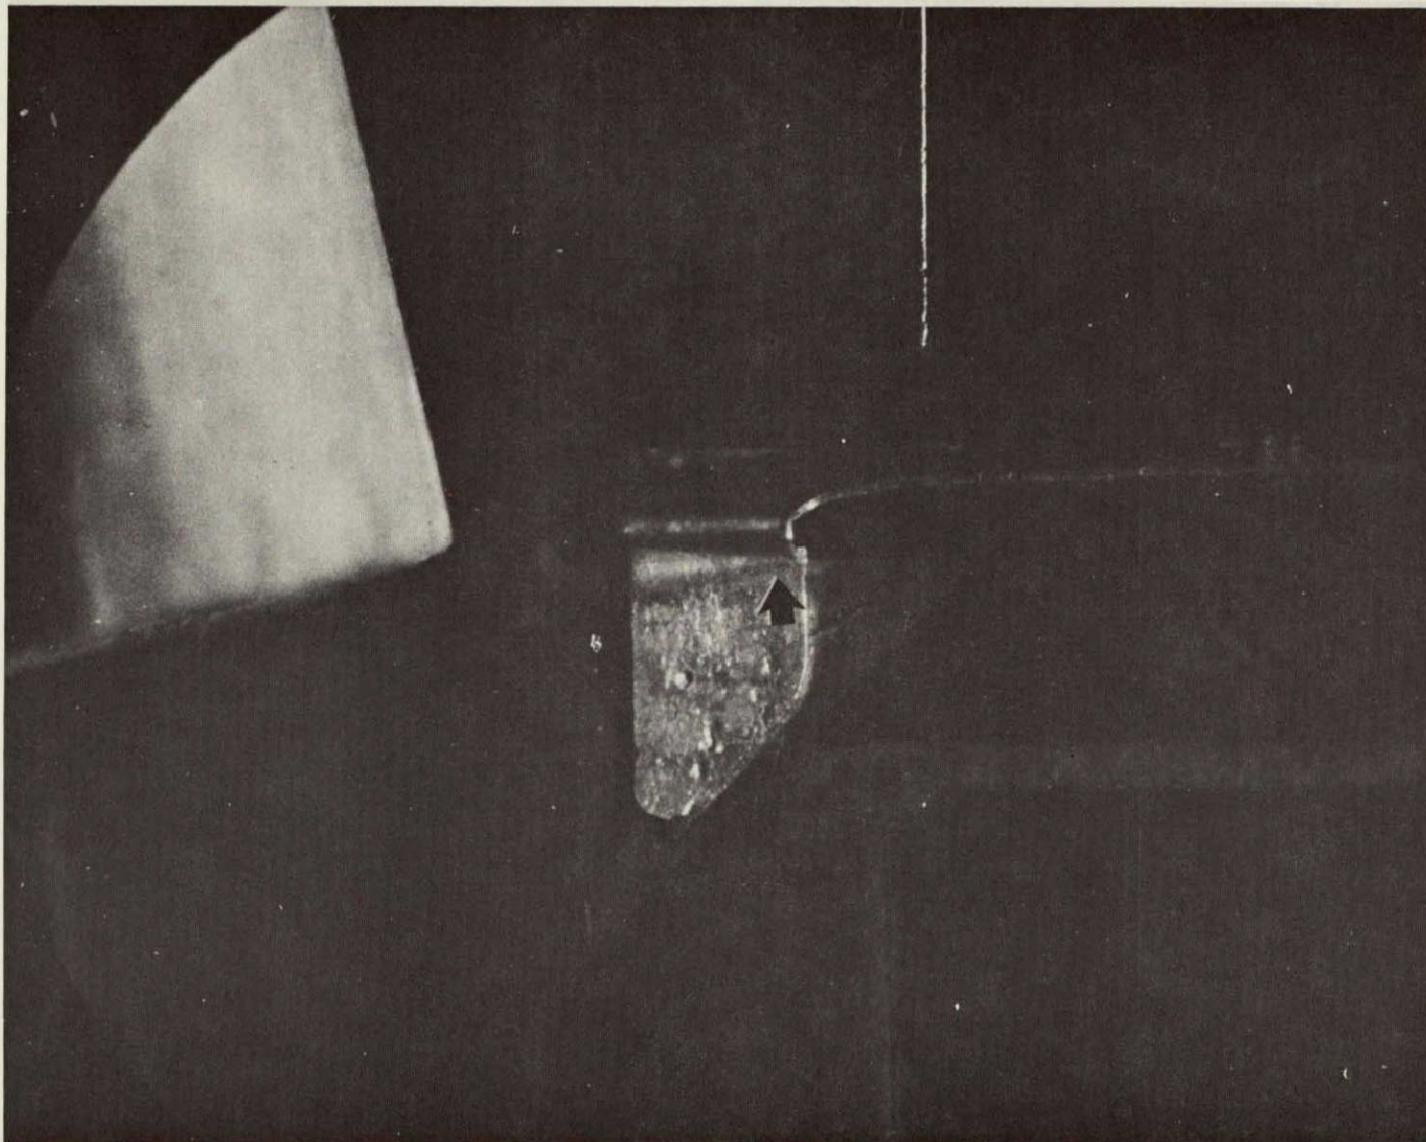
Figure 13 shows a crack in a type-c tab. (This tab was one of those in the row of type-h tabs which was found to be a type-c tab in the initial inspection.)

Figure 13. Crack in Type-c Tab After 100 Cycles

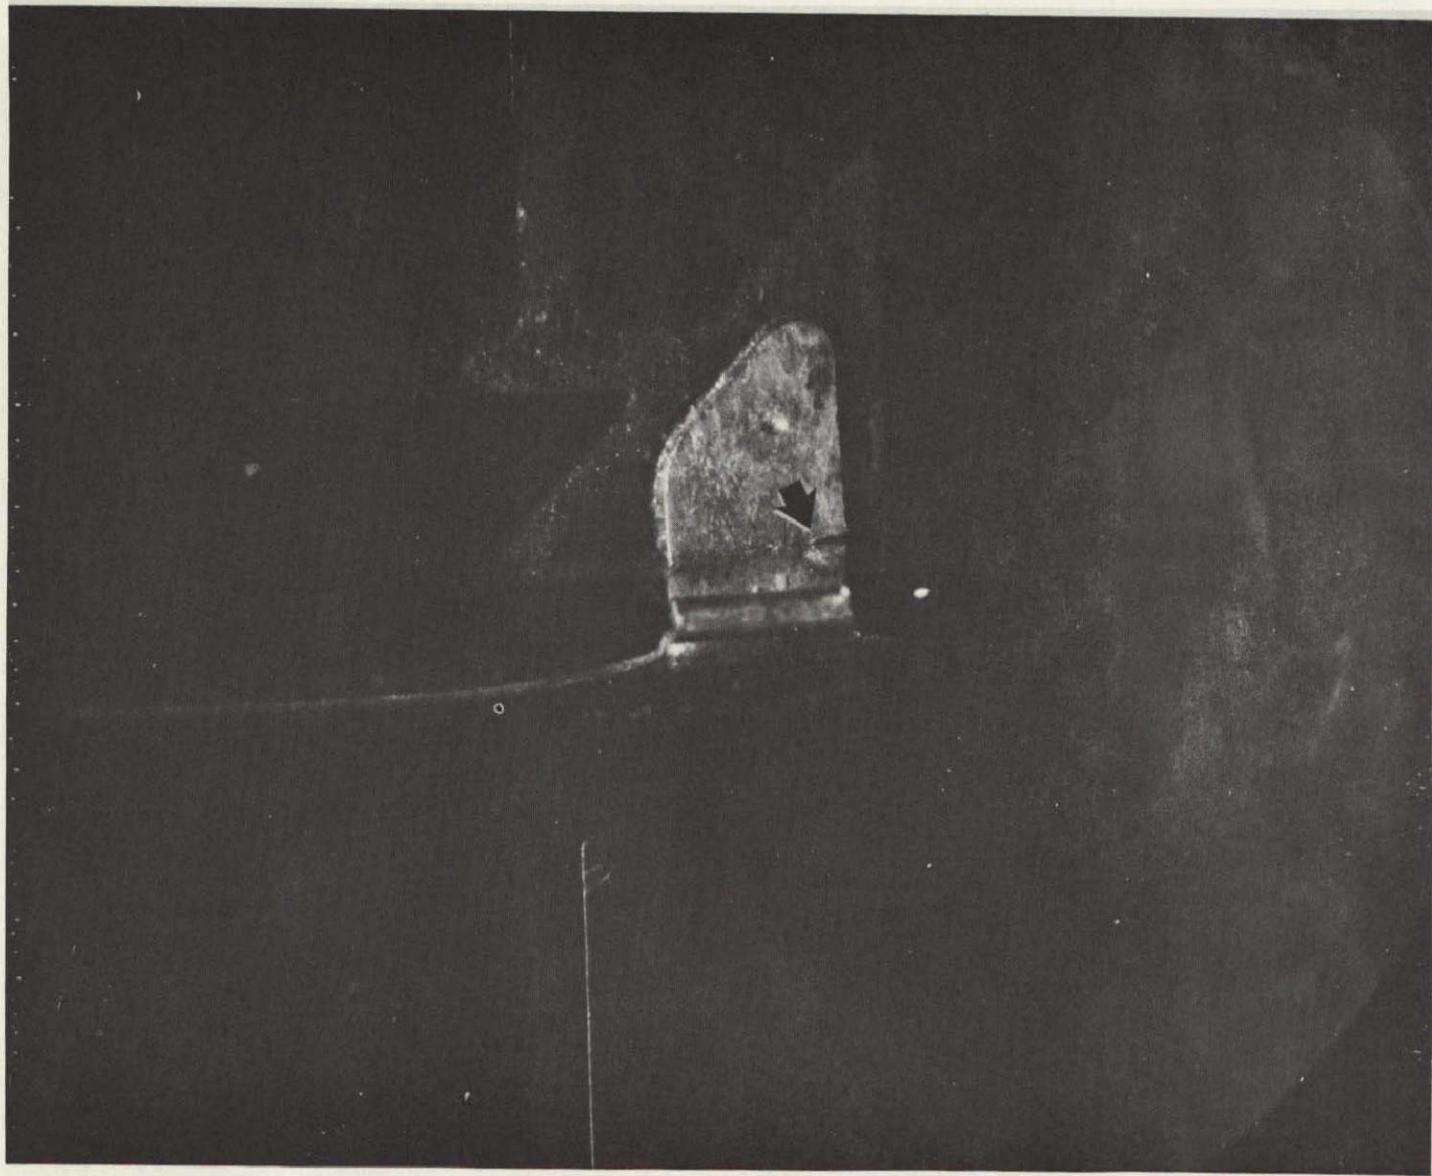
Figure 14 shows a type-d tab with a crack in the tab along the solder contact.

Figure 14. Crack in Type-d Tab After 100 Cycles

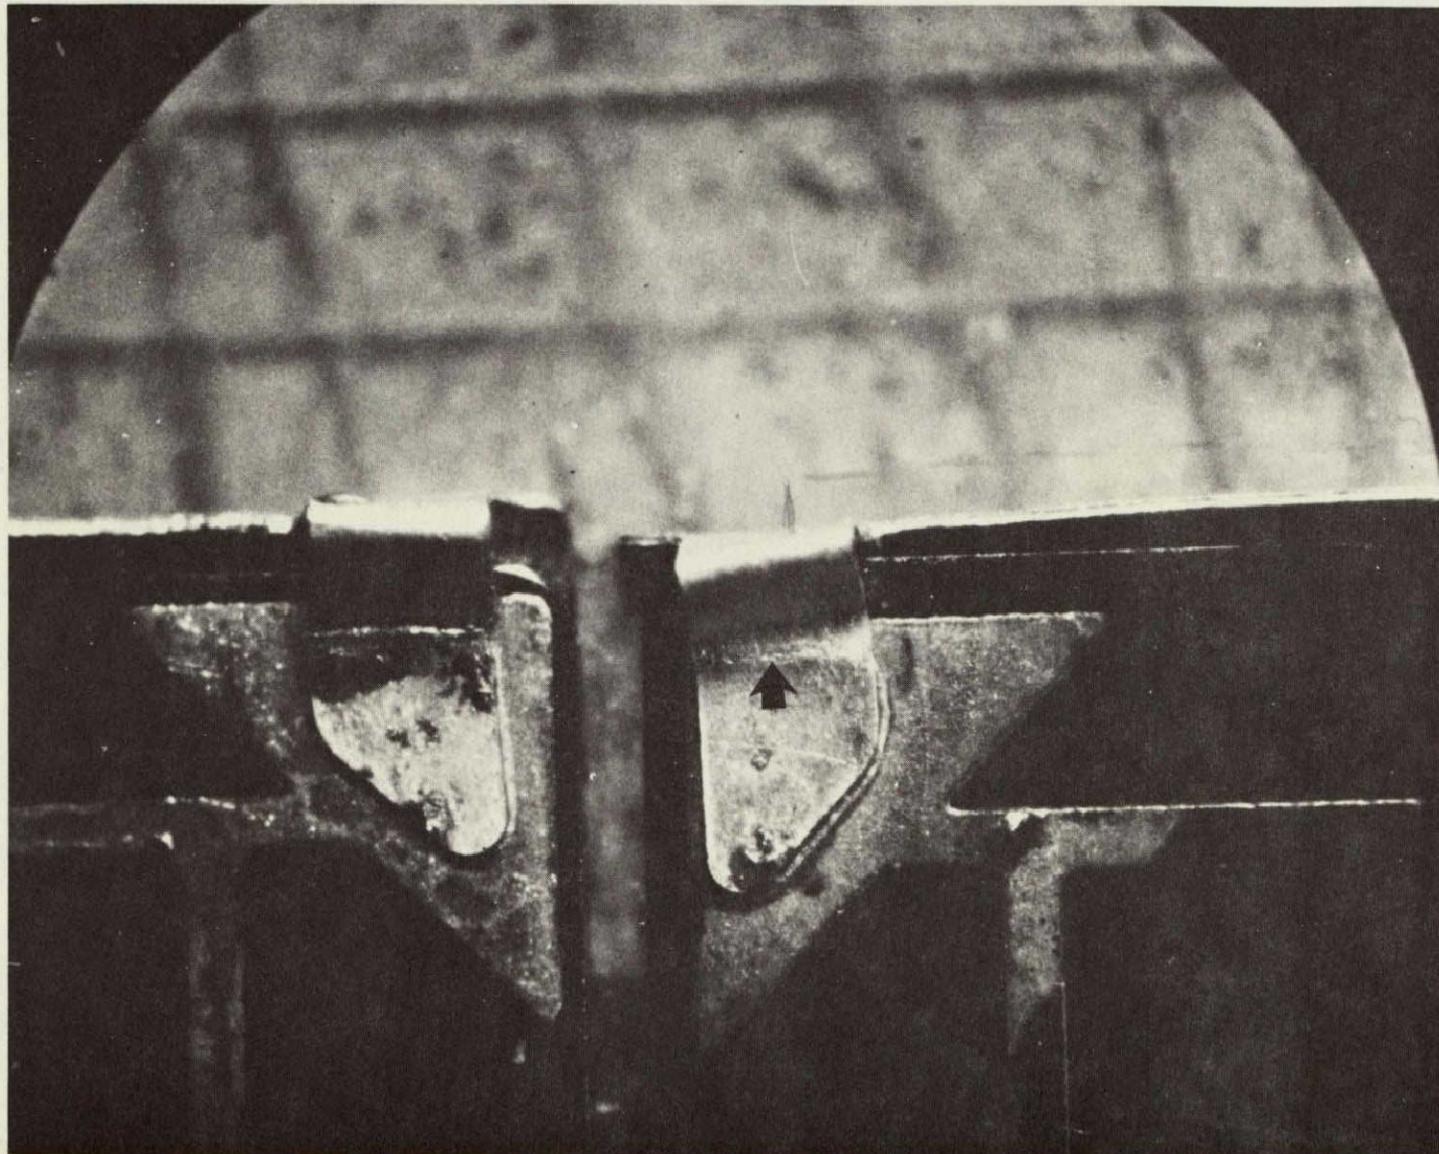
Figure 15 is a type-h tab (on the right) with a crack. (The tab on the left failed after 50 cycles. See Figure 9.)

Figure 15. Crack in Type-h Tab After 100 Cycles

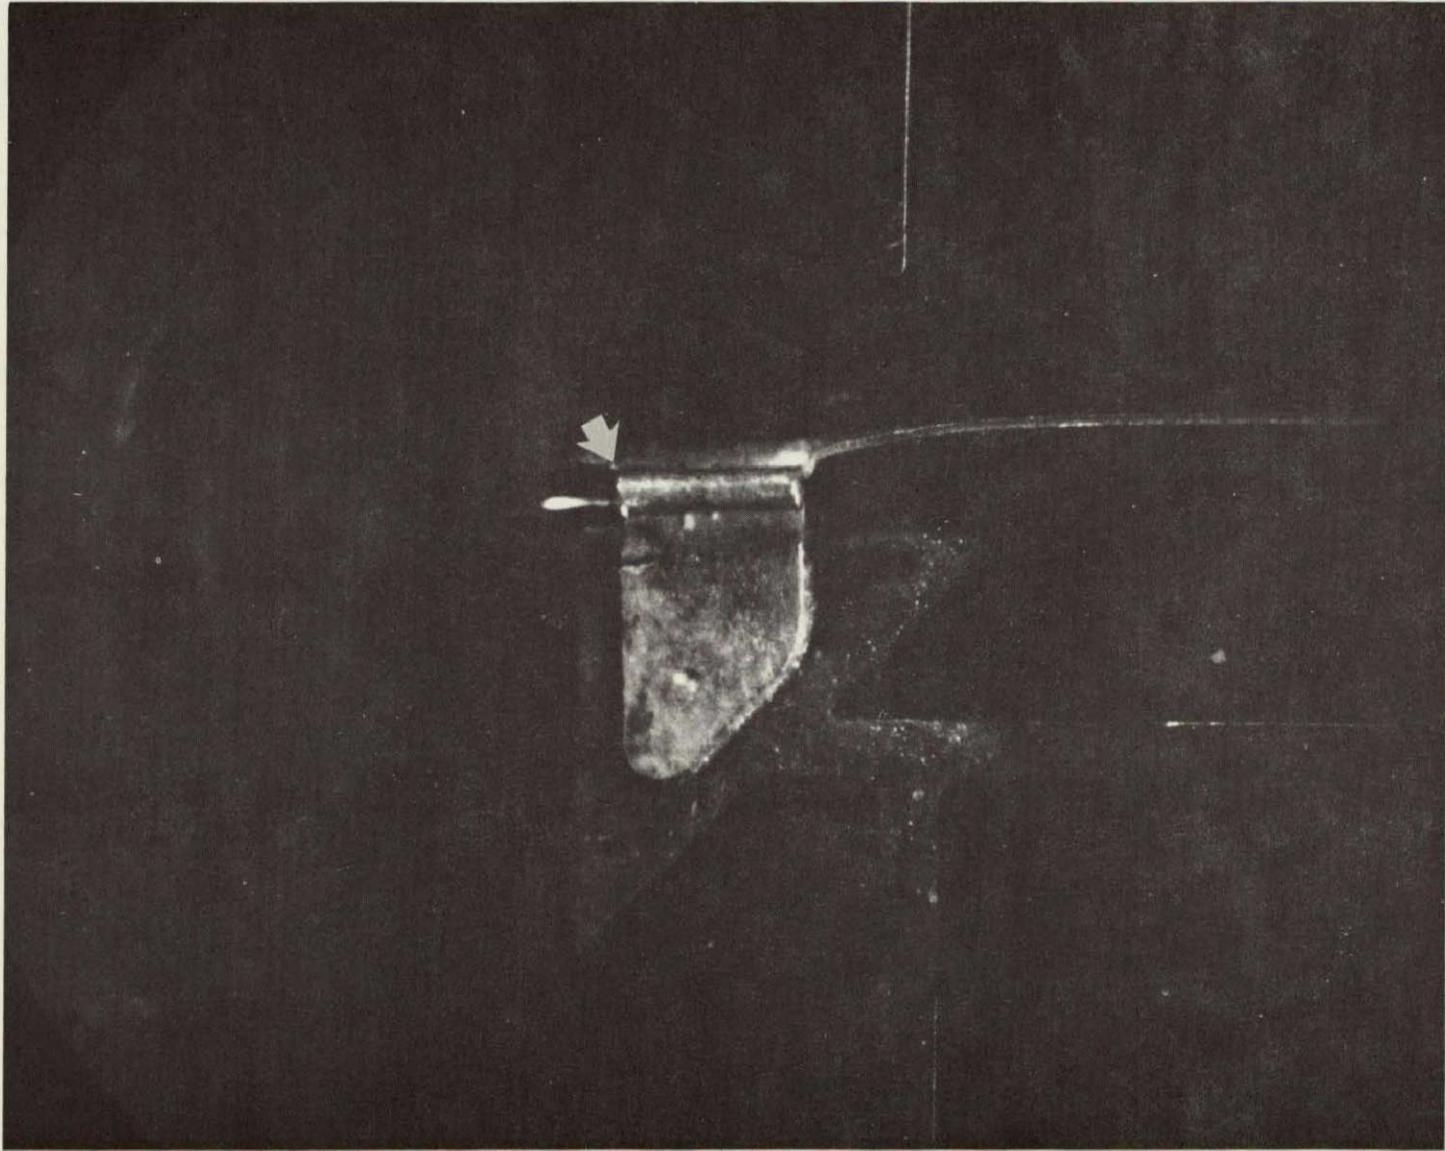
Figure 16 shows a second crack in a type-d interconnector tab. The first crack occurred after 100 cycles as shown in Figure 14. The second crack formed on the back of the interconnector away from the solder tab.

Figure 16. Second Crack in Type-d Tab After 150 Cycles

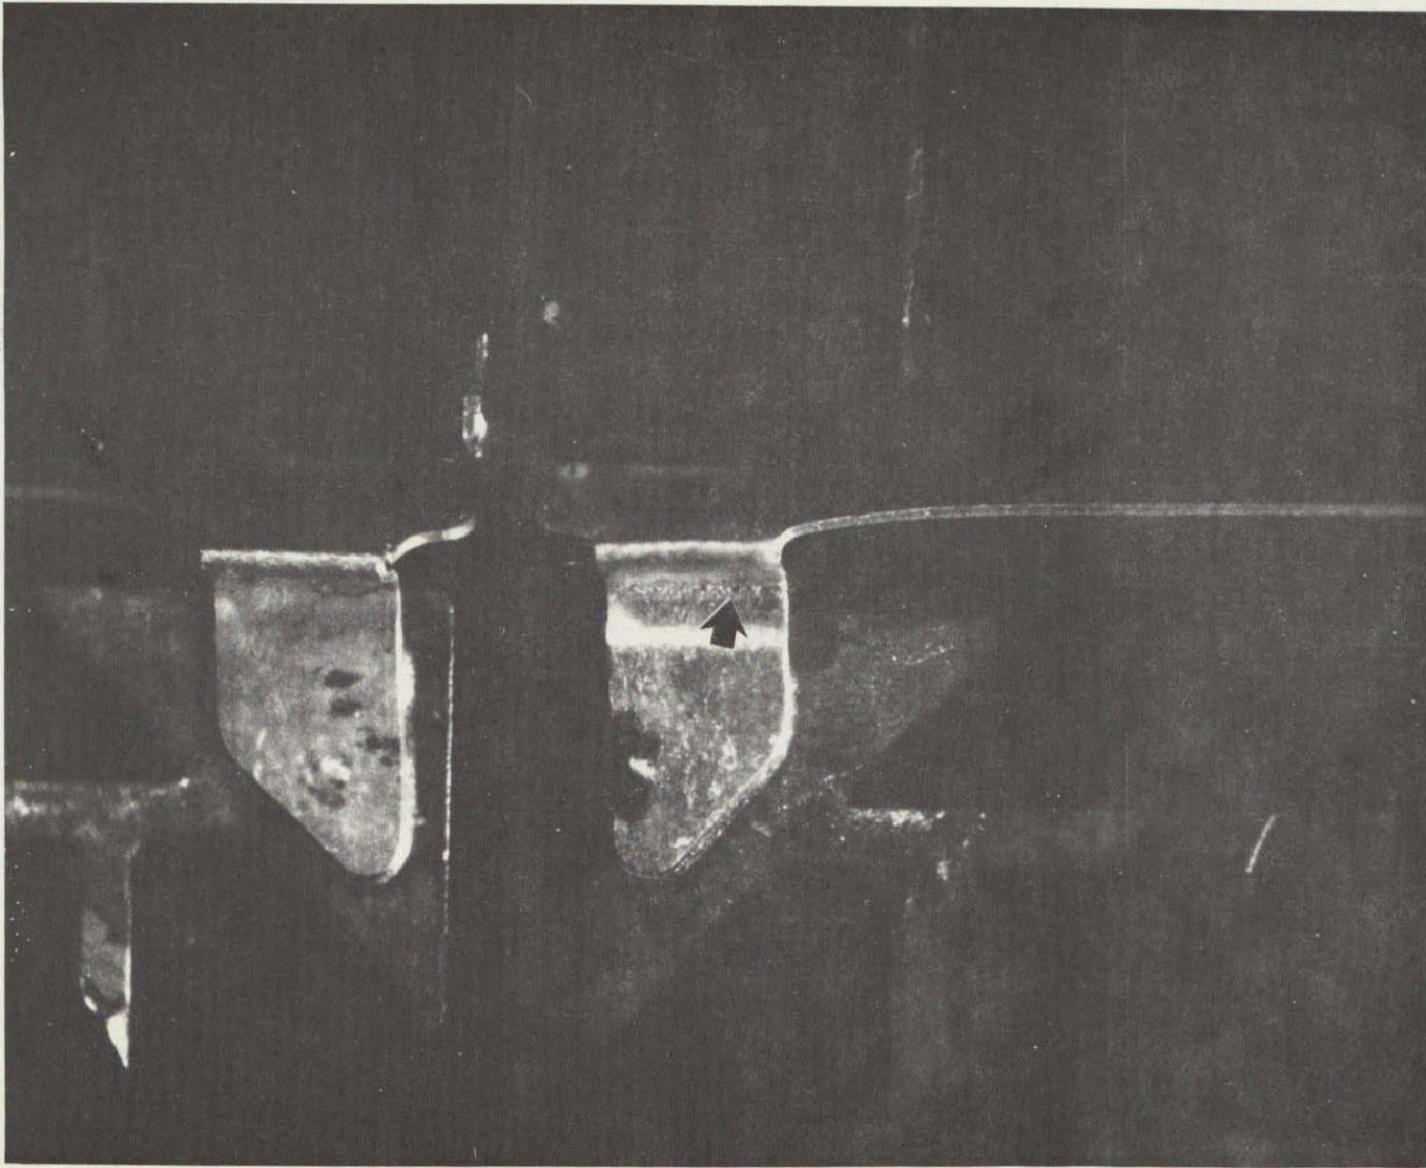
Figure 17 shows a type-e tab with a crack beginning at the bottom of the 90° bend. It is interesting that this crack did not occur at the crimped top where the crack would be expected.

Figure 17. Crack Beginning in Type-e Tab After 150 Cycles

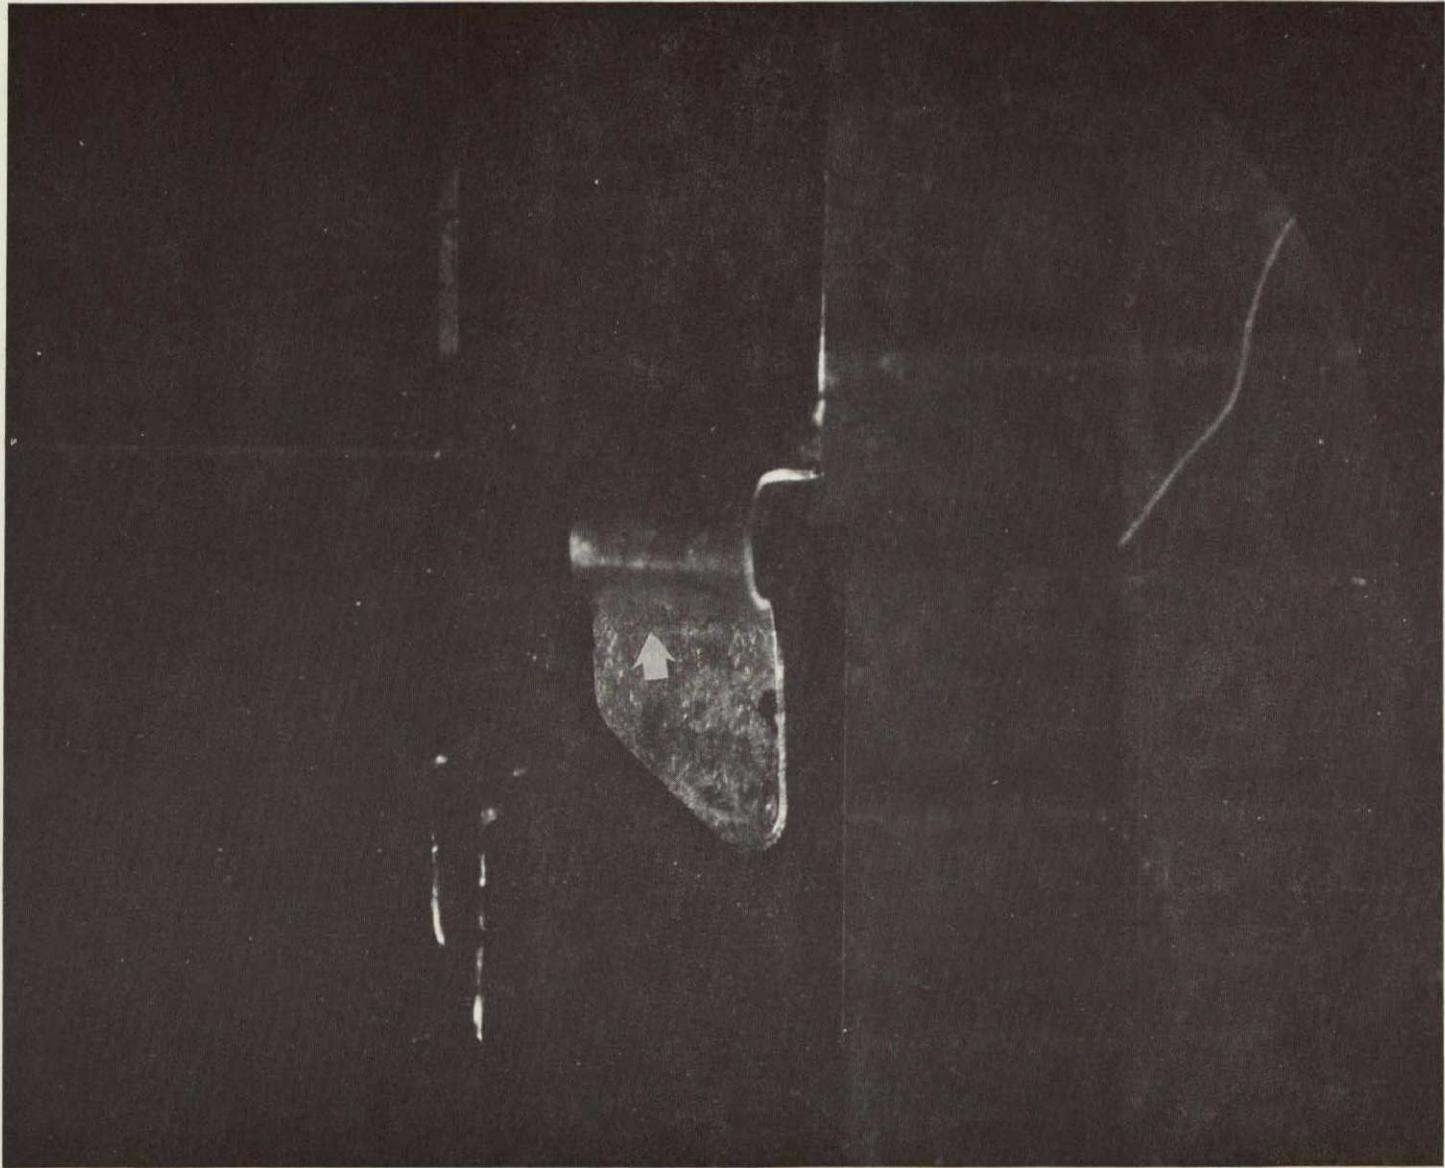
Figure 19 also shows a crack forming in a type-h tab. This tab is directly below the tab in Figure 18. (See the final inspection sheet Figure 36.)

Figure 19. Crack Forming in Type-h Tab After 150 Cycles

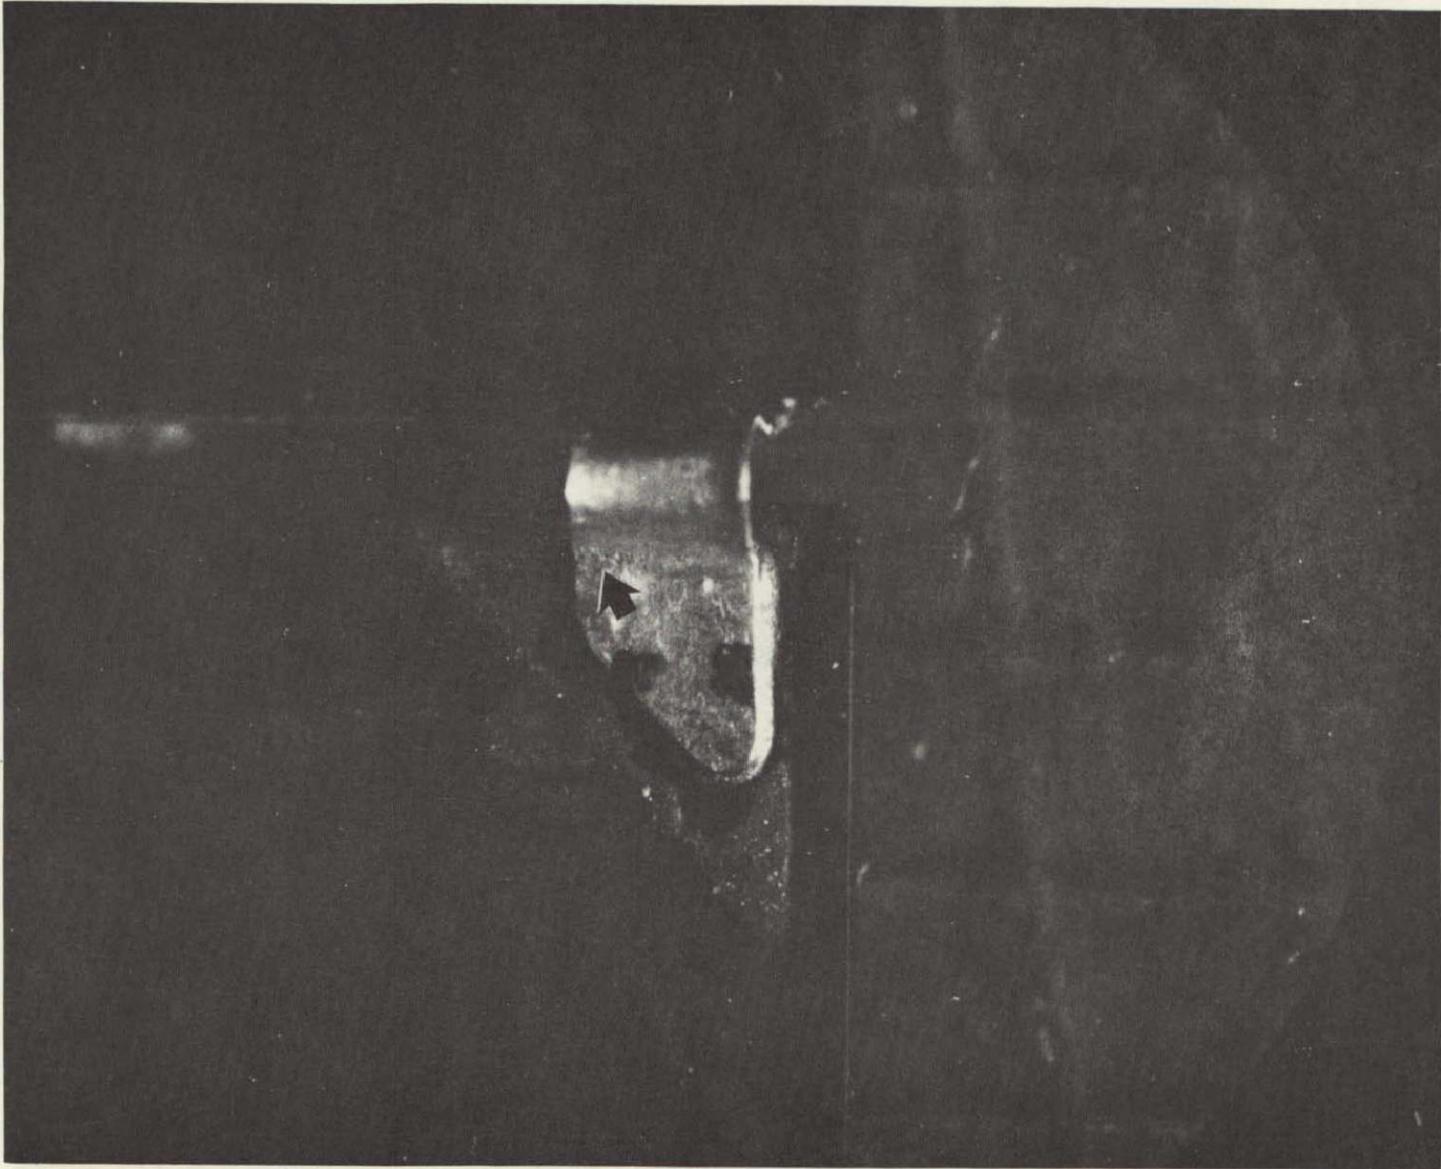
Figure 18 is a type-h tab. A crack is beginning at the 90° bend adjacent to the solder joint.

Figure 18. Crack Beginning in Type-h Tab After 150 Cycles
