THERMAL CYCLING EFFECTS ON SOLAR CELL INTERCONNECTION TABS ON AN OAO-B SAMPLE MODULE

X-761-71-315

Clara M. Vermillion

July 1971

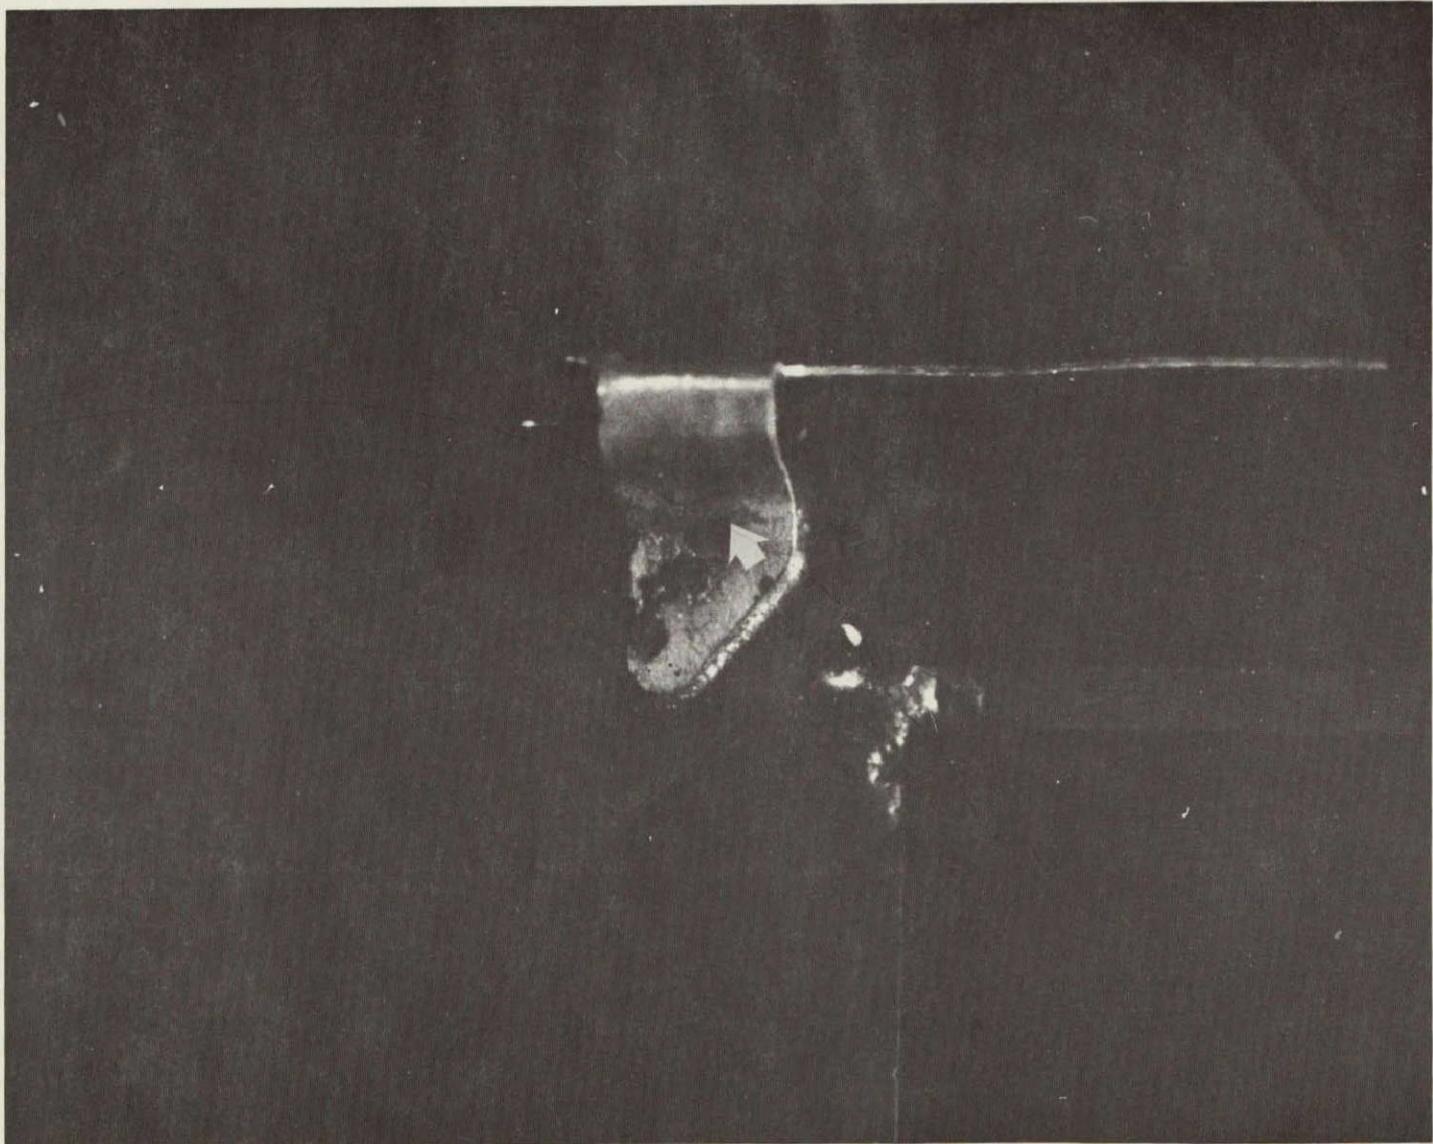
Figure 21 is another type-h tab with a crack forming. This tab is at the opposite end of the same submodule with the defect shown in Figure 20.

Figure 21. Crack Forming in Type-h Tab After 150 Cycles

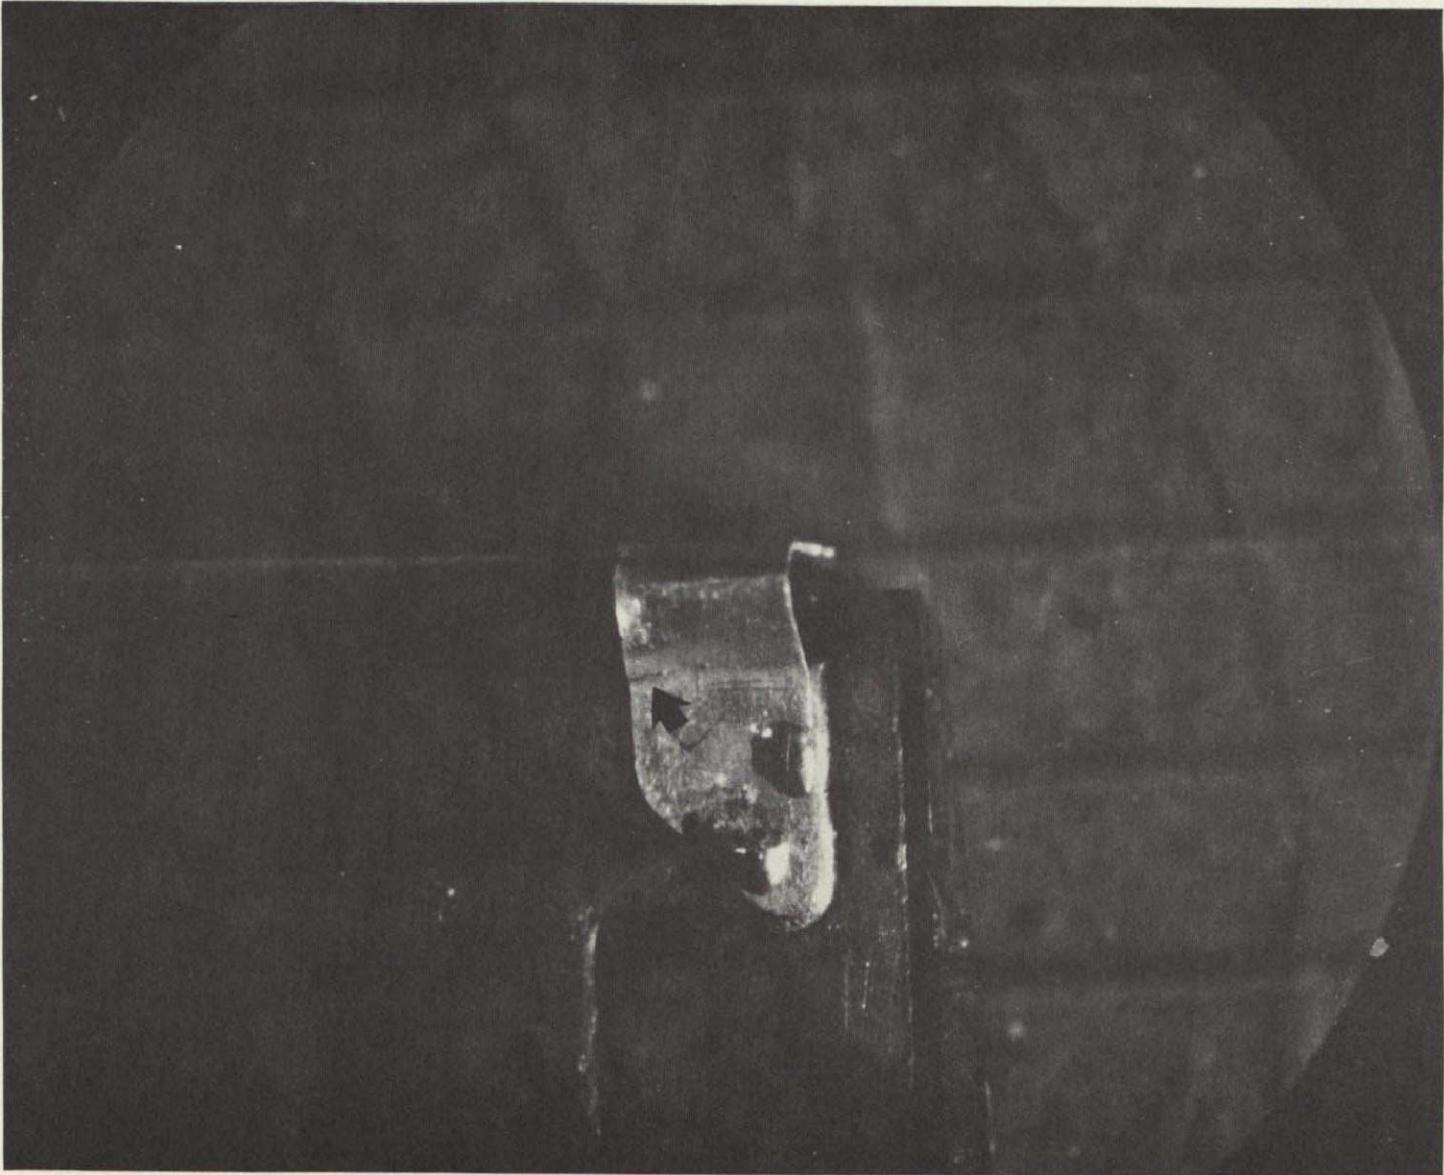
Figure 20 is again a cracked type-h tab. This tab is directly below the tabs in Figures 18 and 19.

Figure 20. Cracked Type-h Tab After 150 Cycles

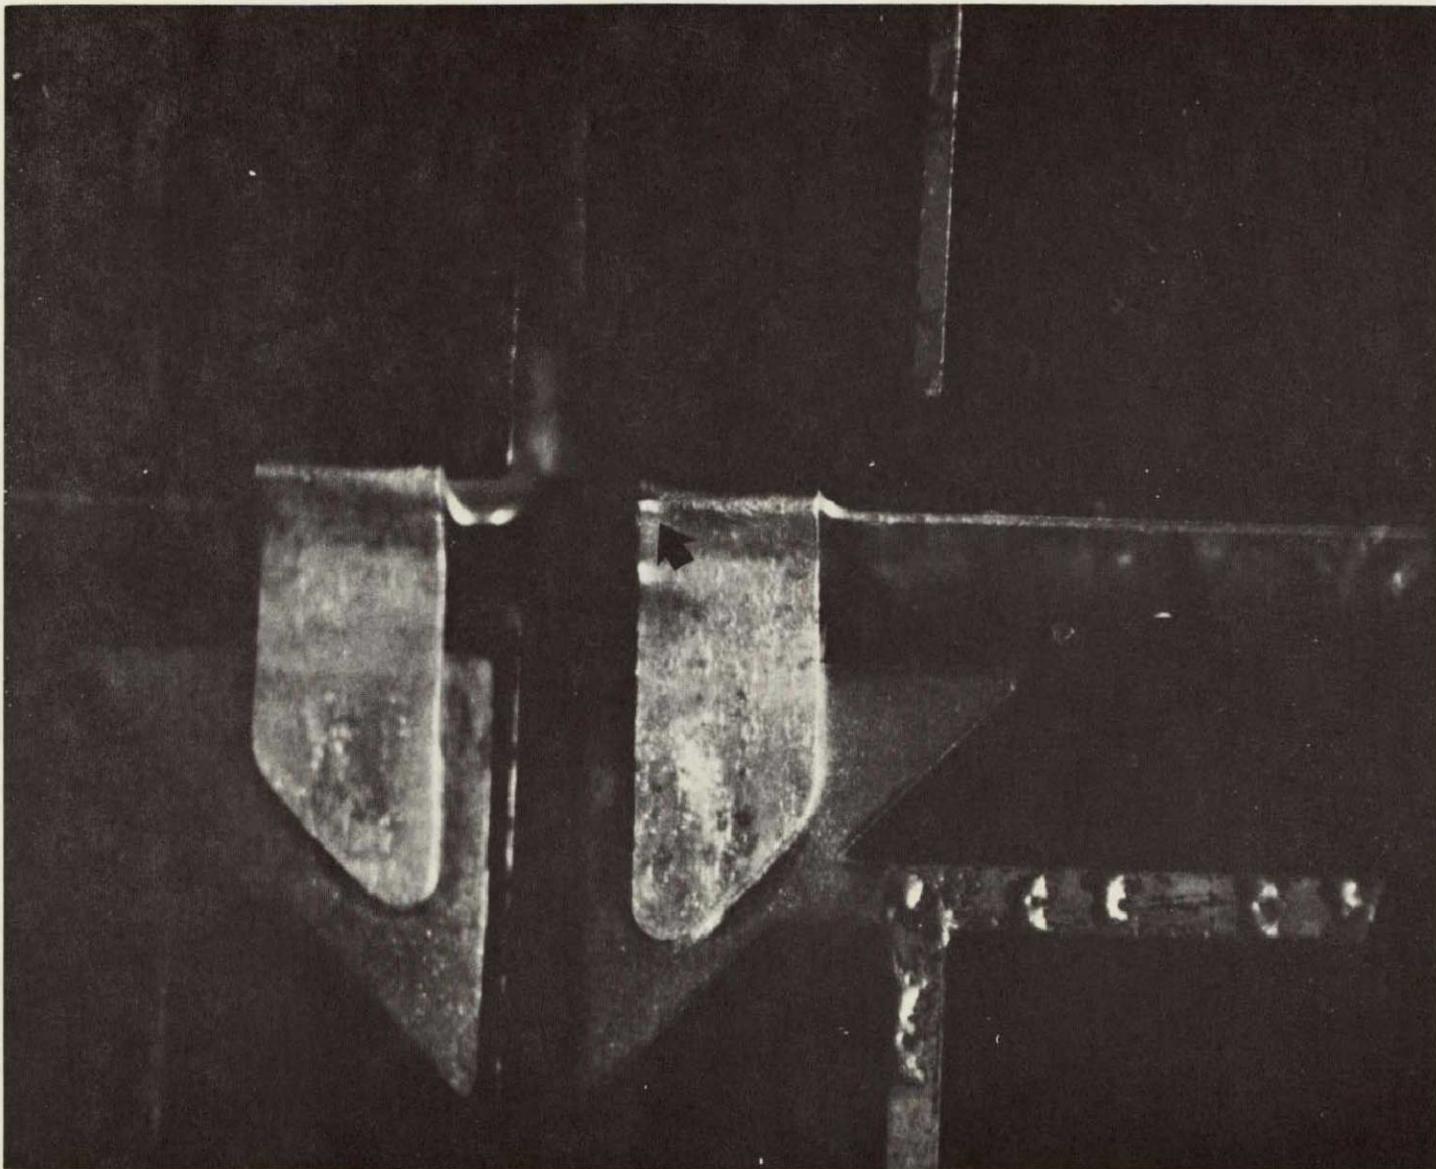
Figure 22 is a type-b tab. The crack is beginning to separate at the crimped area at the top of the tab.

Figure 22. Crack in Type-b Tab After 150 Cycles

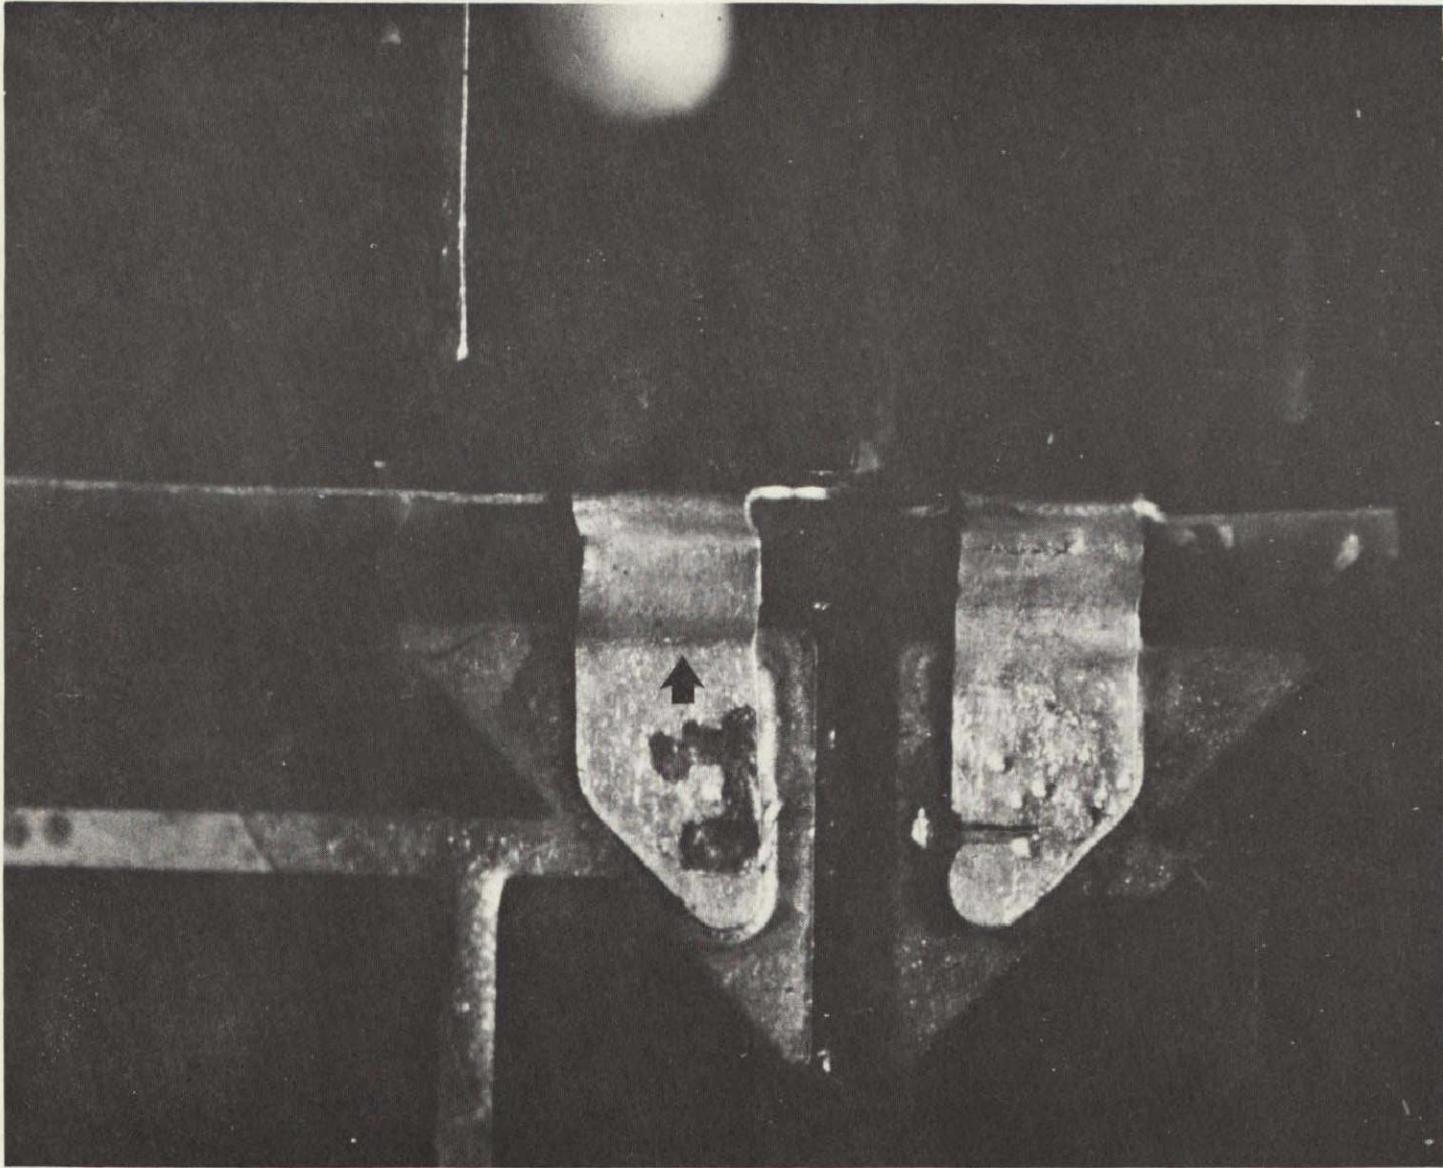
Figure 23 is a type-b tab with a crack forming. Also shown in this photo is a crack in the adjacent tab which occurred after the 50 cycles test (Figure 10).

Figure 23. Crack Forming in Type-b Tab After 200 Cycles

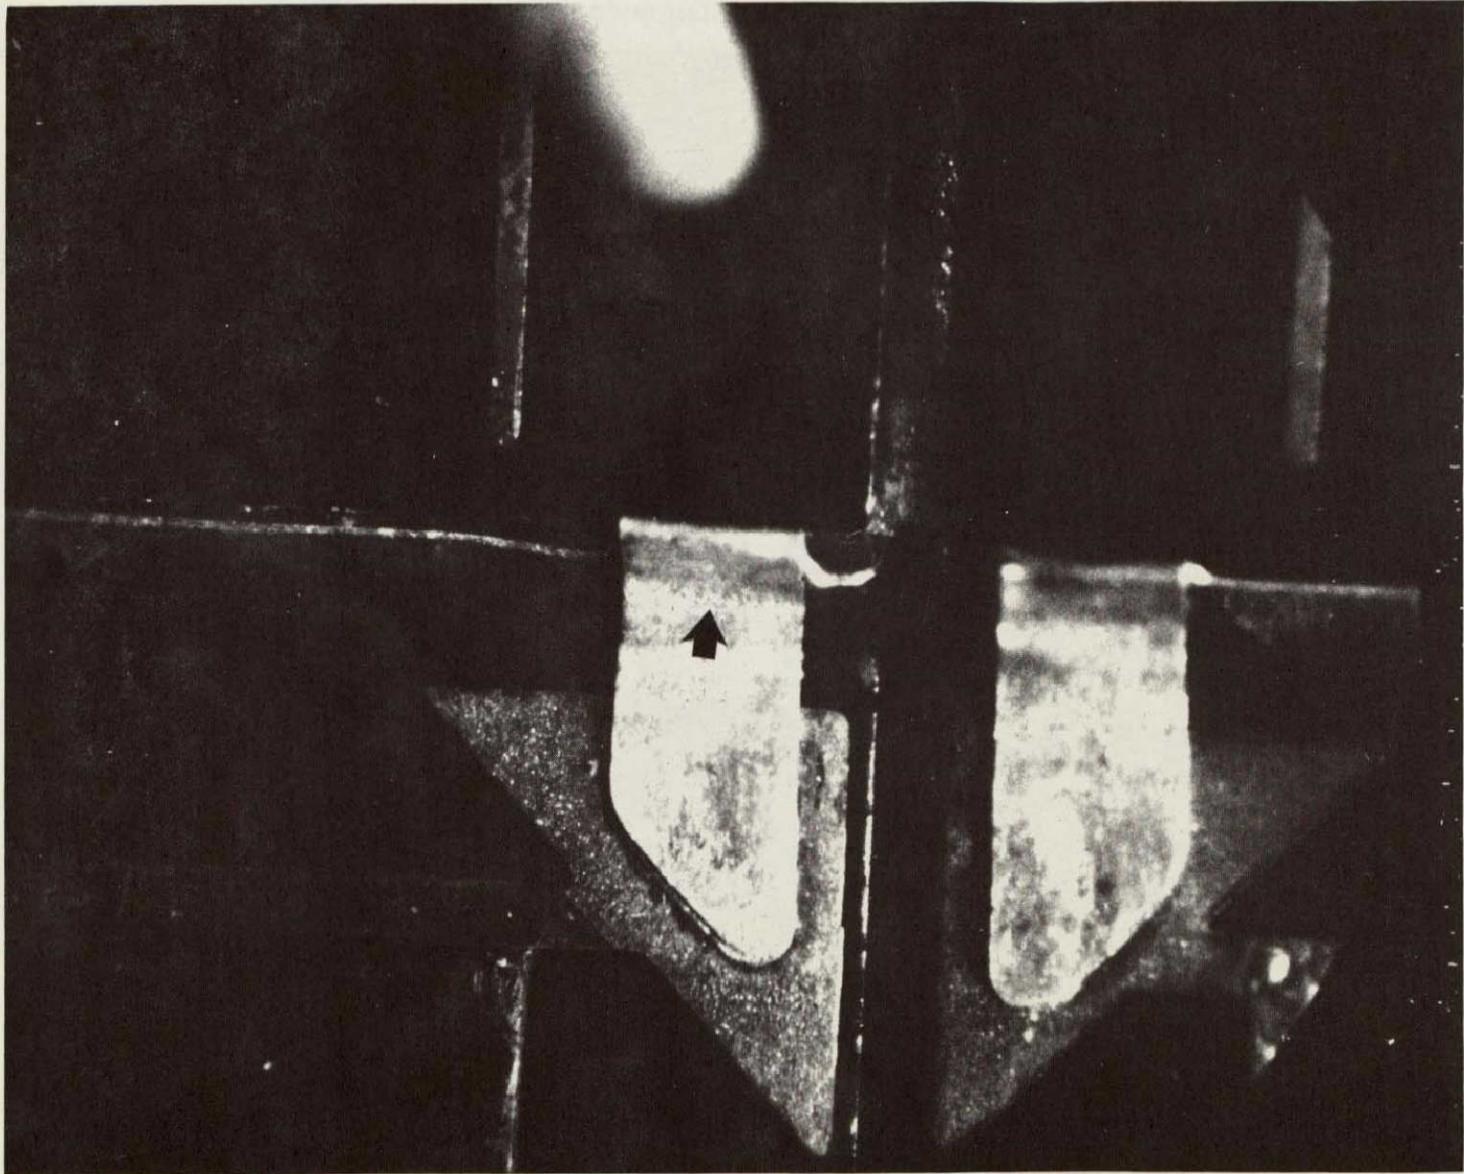
Figure 25 is also a type-b tab with a crack forming.

Figure 25. Crack Forming in Type-b Tab After 200 Cycles

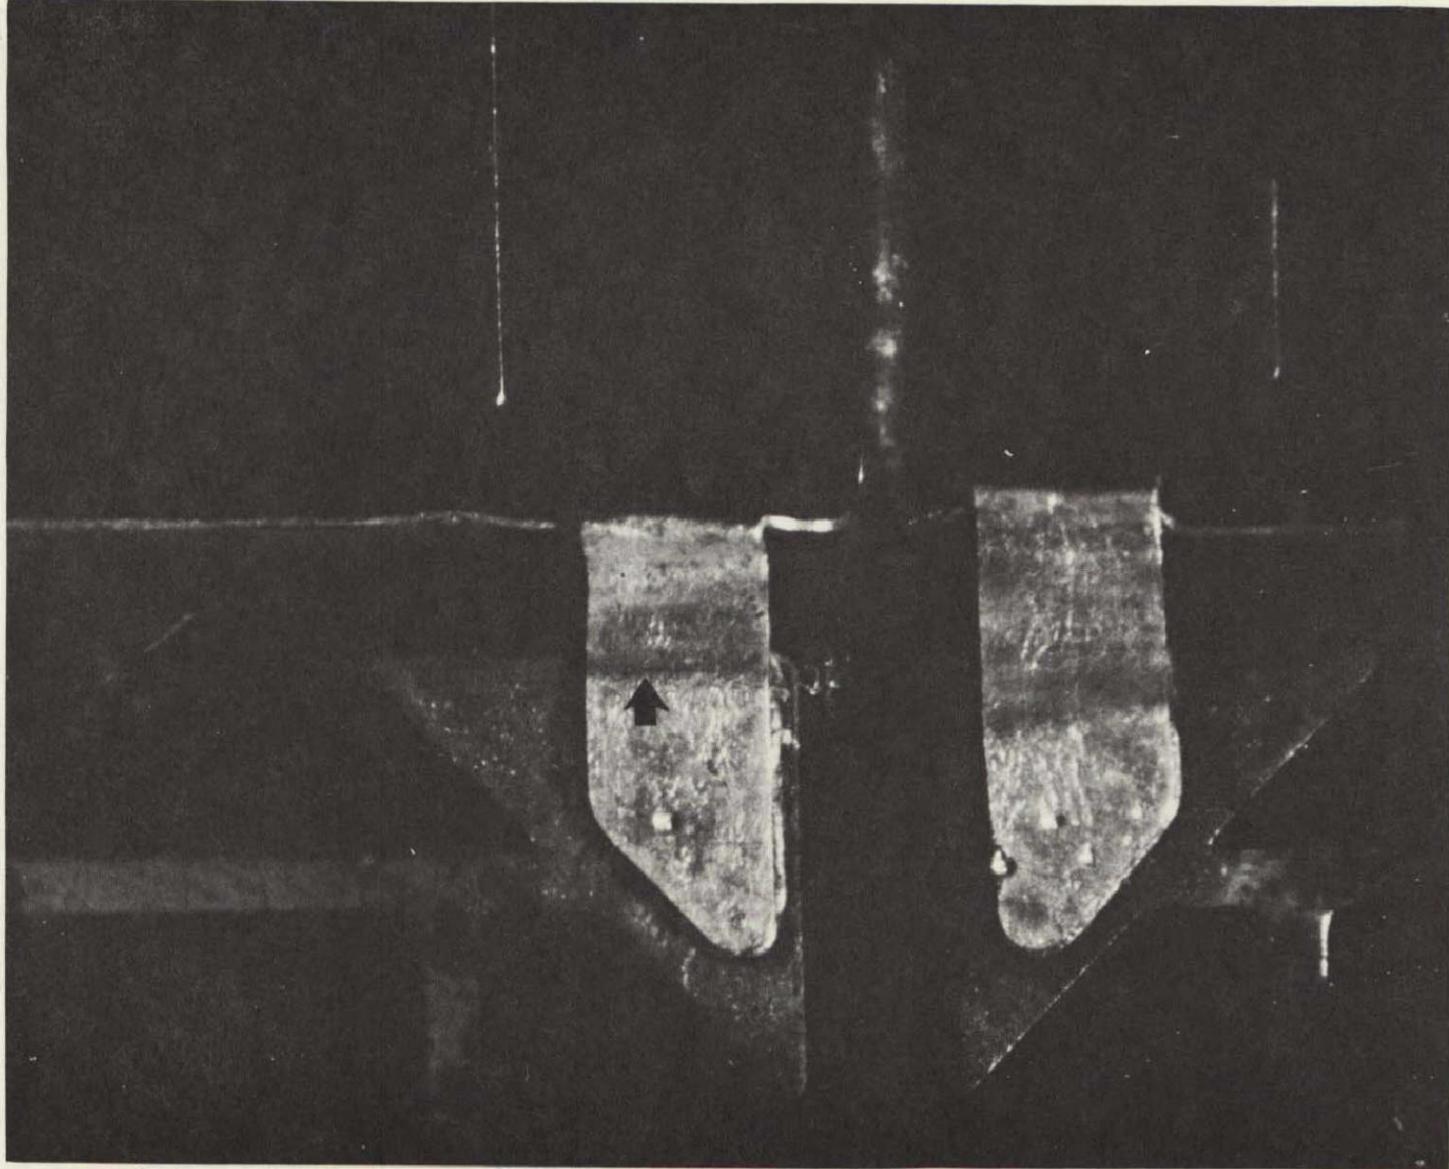
Figure 24 is another type-b tab with a small crack beginning.

Figure 24. Crack Beginning in Type-b Tab After 200 Cycles

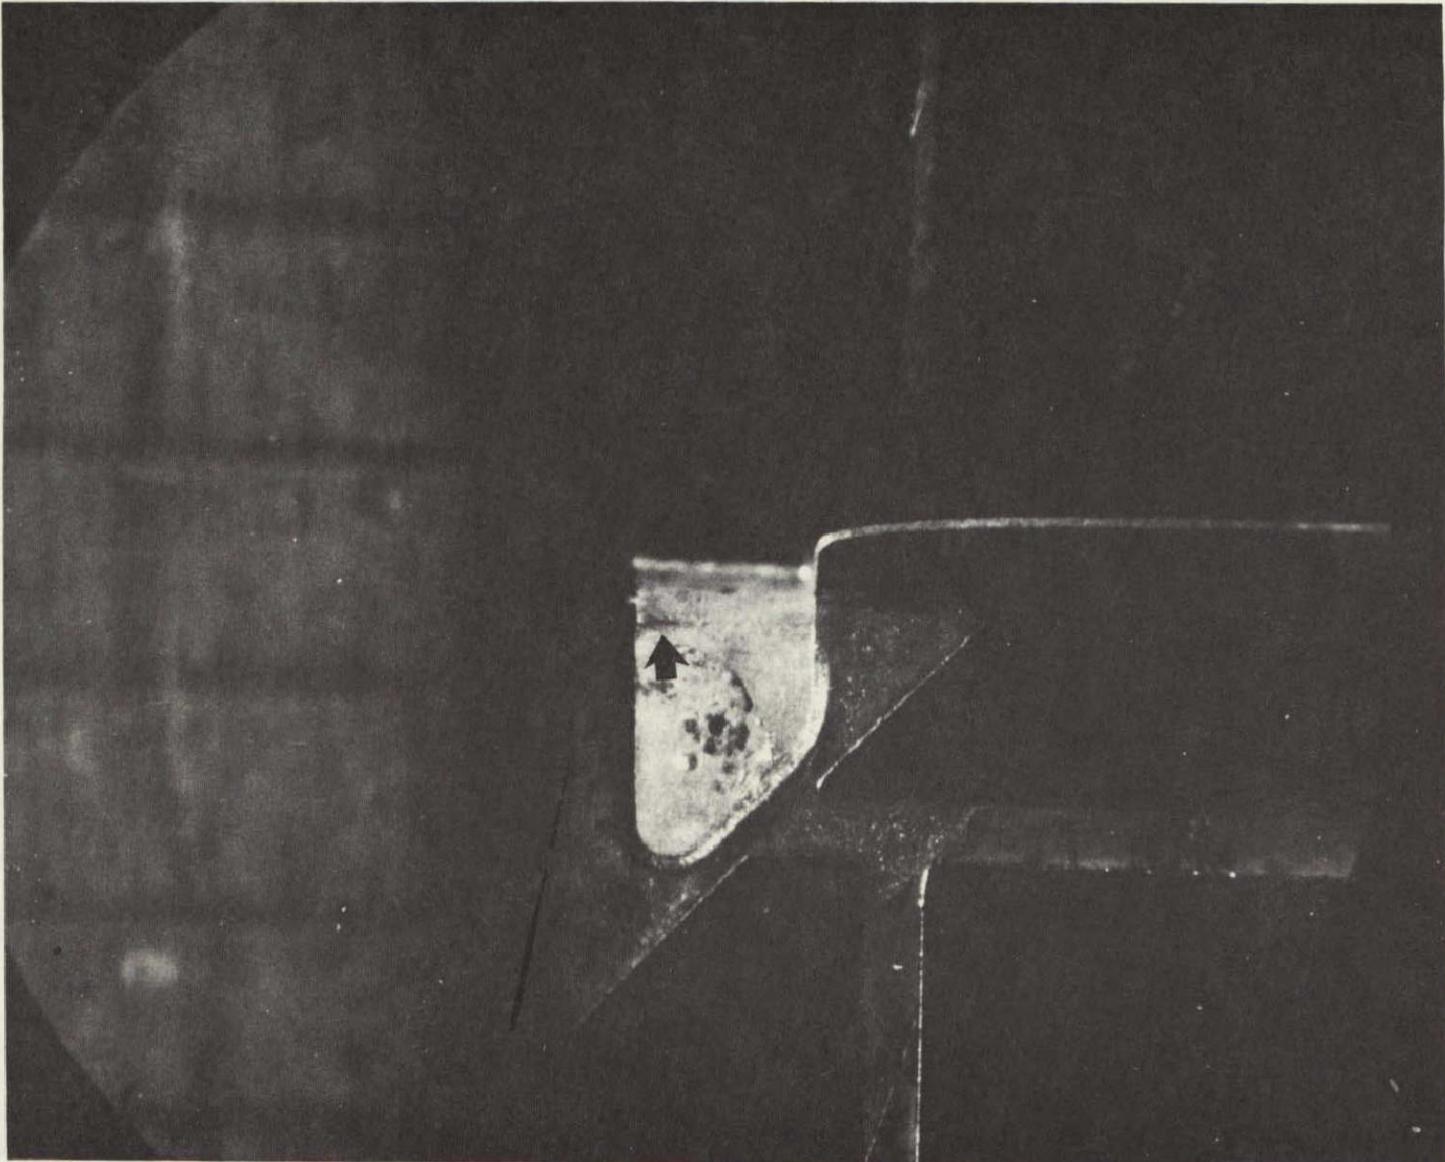
Figure 26 shows a crack defect in a type-e tab. Again the crack is at the soldered part of the tab (similar to the one shown in Figure 17) and not at the crimped area as expected.

Figure 26. Crack in Type-e Tab After 200 Cycles

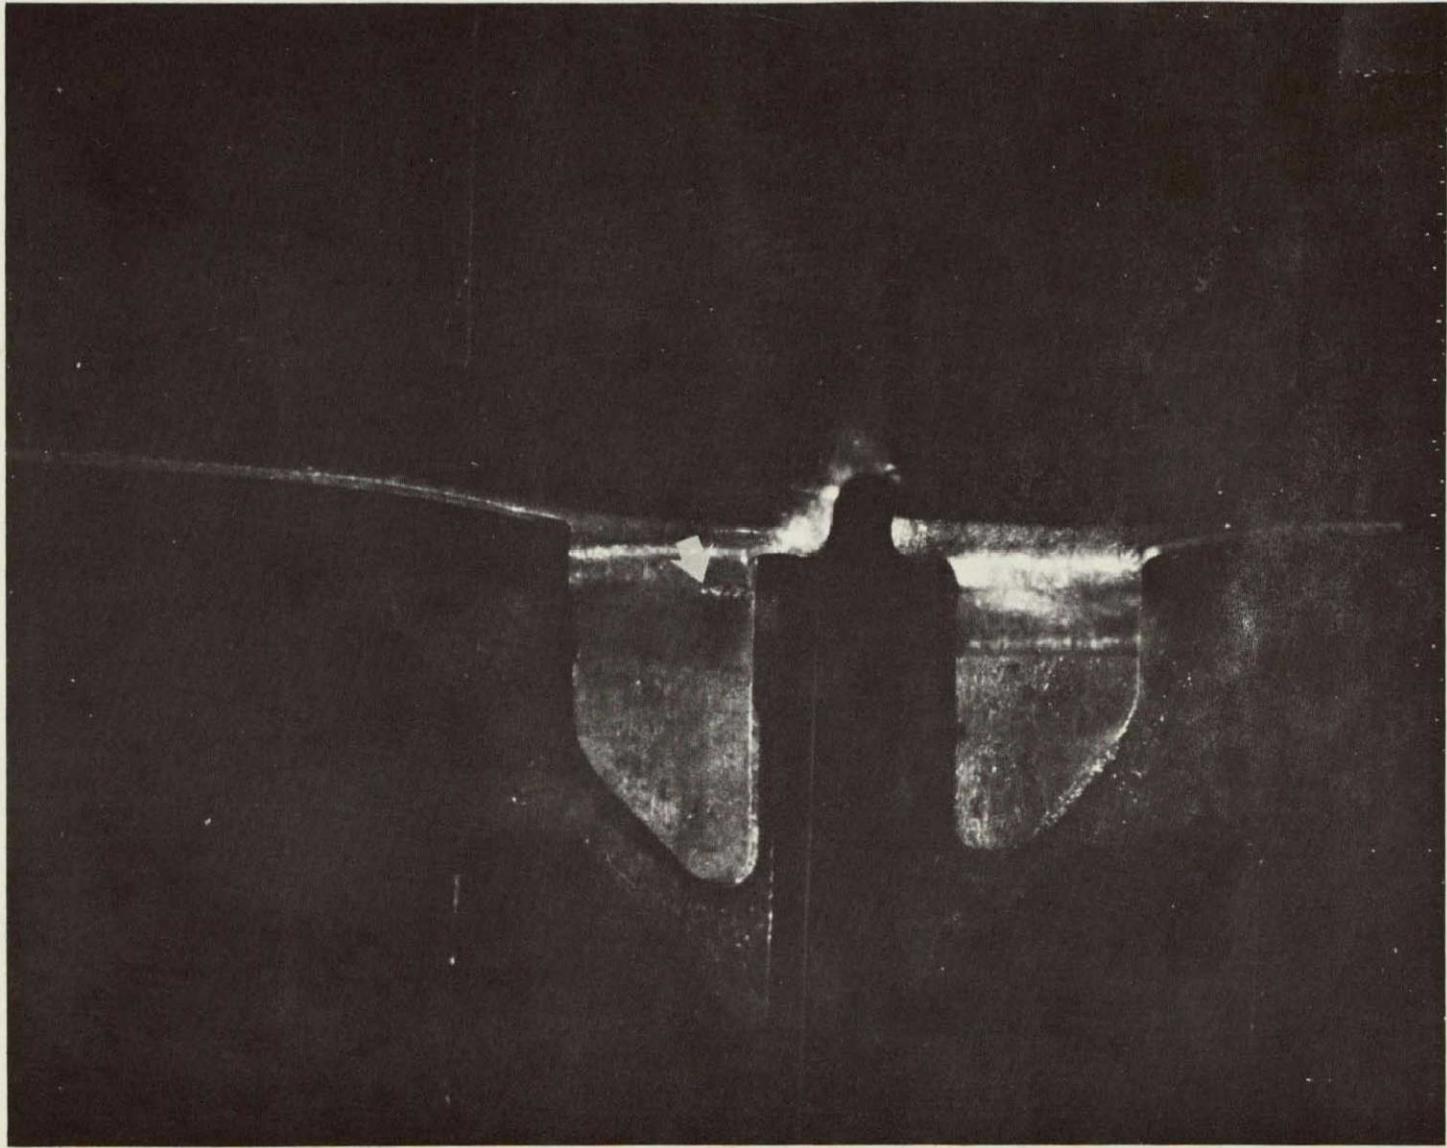
Figure 28 shows a new cracked type-a tab.

Figure 28. Crack in Type-a Tab After 300 Cycles

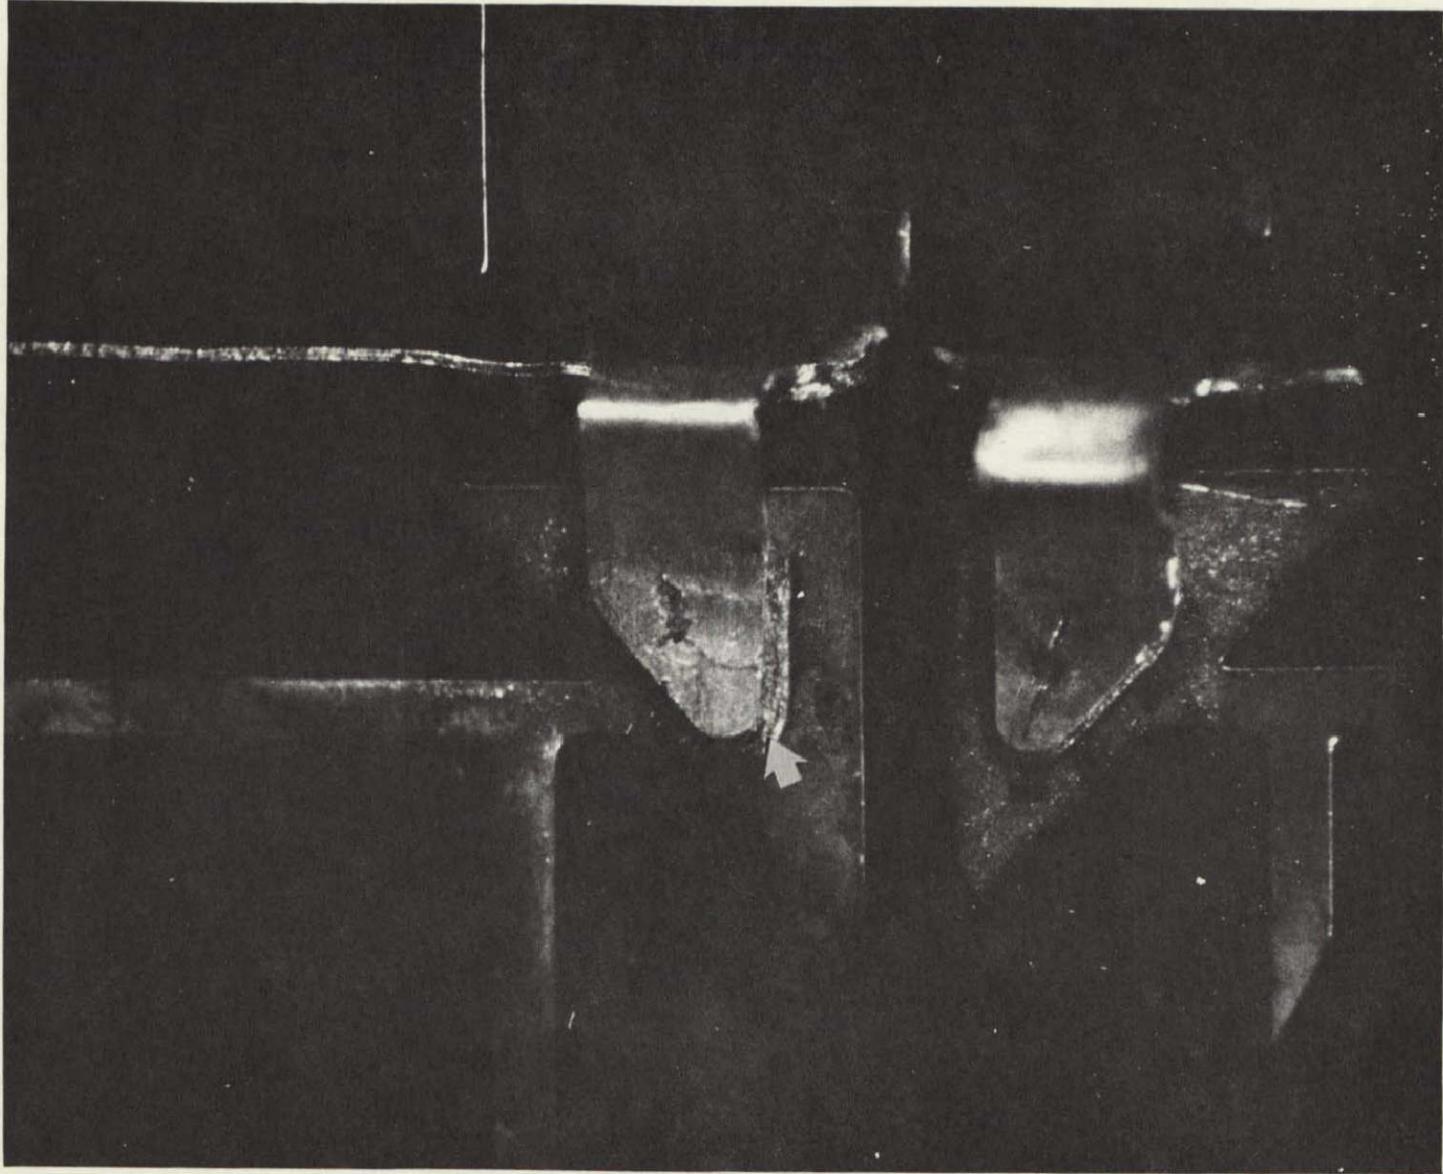
Figure 27 is a type-f tab. The solder contact failed in this case as in the case of the type-f tab at 100 cycles.

Figure 27. Solder Contact Failure in Type-f Tab After 300 Cycles

The other failures were in two of the f-type tabs where the solder contact failed. The tab lifted from the solder contact of the solar cell. Failure occurred within the solder leaving solder on both the tab and the cell. The splice on the back of this tab may cause an increased stress on the solder connection during thermal cycling because of the reduced length of the overall stress relief loop.

- b. With adequate care, bent tabs can and should be avoided.
 - c. For tab repair, a new submodule should be used or the cell at the defect should be lifted and a new interconnector added. Tabs should not be spliced.

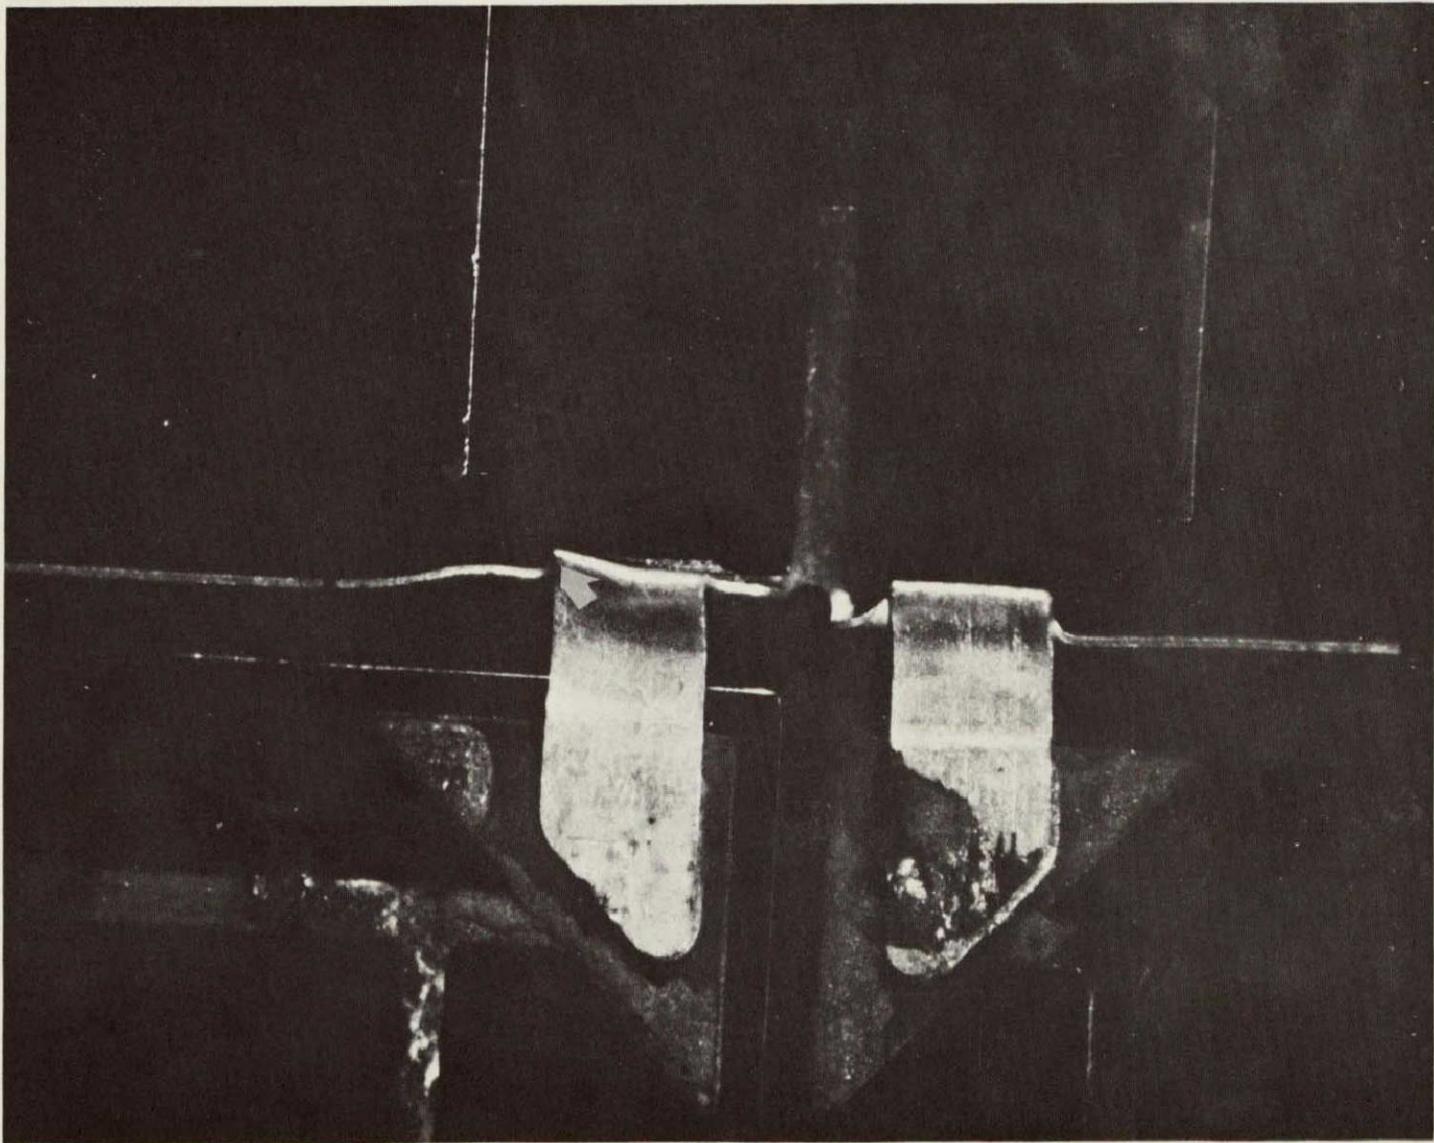
Figure 30 shows a new defect in a type-b tab. The tab is cracked.

Figure 30. Cracked Type-b Tab After 300 Cycles

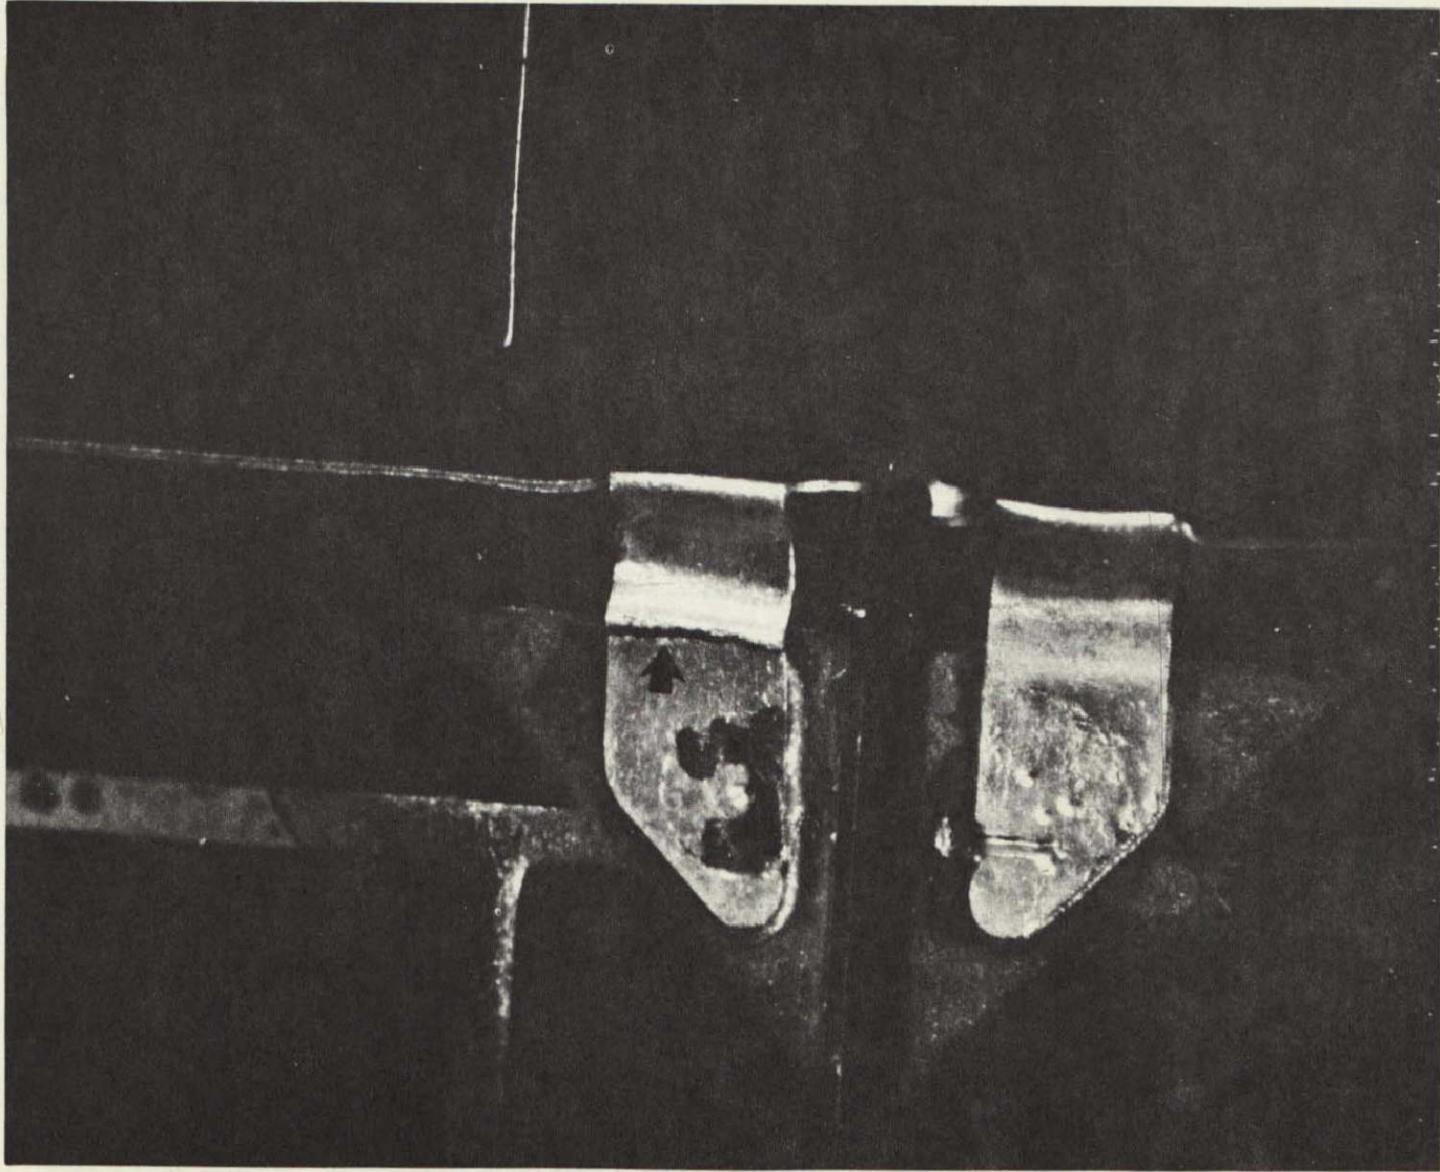
Figure 29 shows a type-b tab. This tab has now become completely open. It showed as a defective crack after 200 cycles (Figure 23).

Figure 29. Open Type-b Tab After 300 Cycles

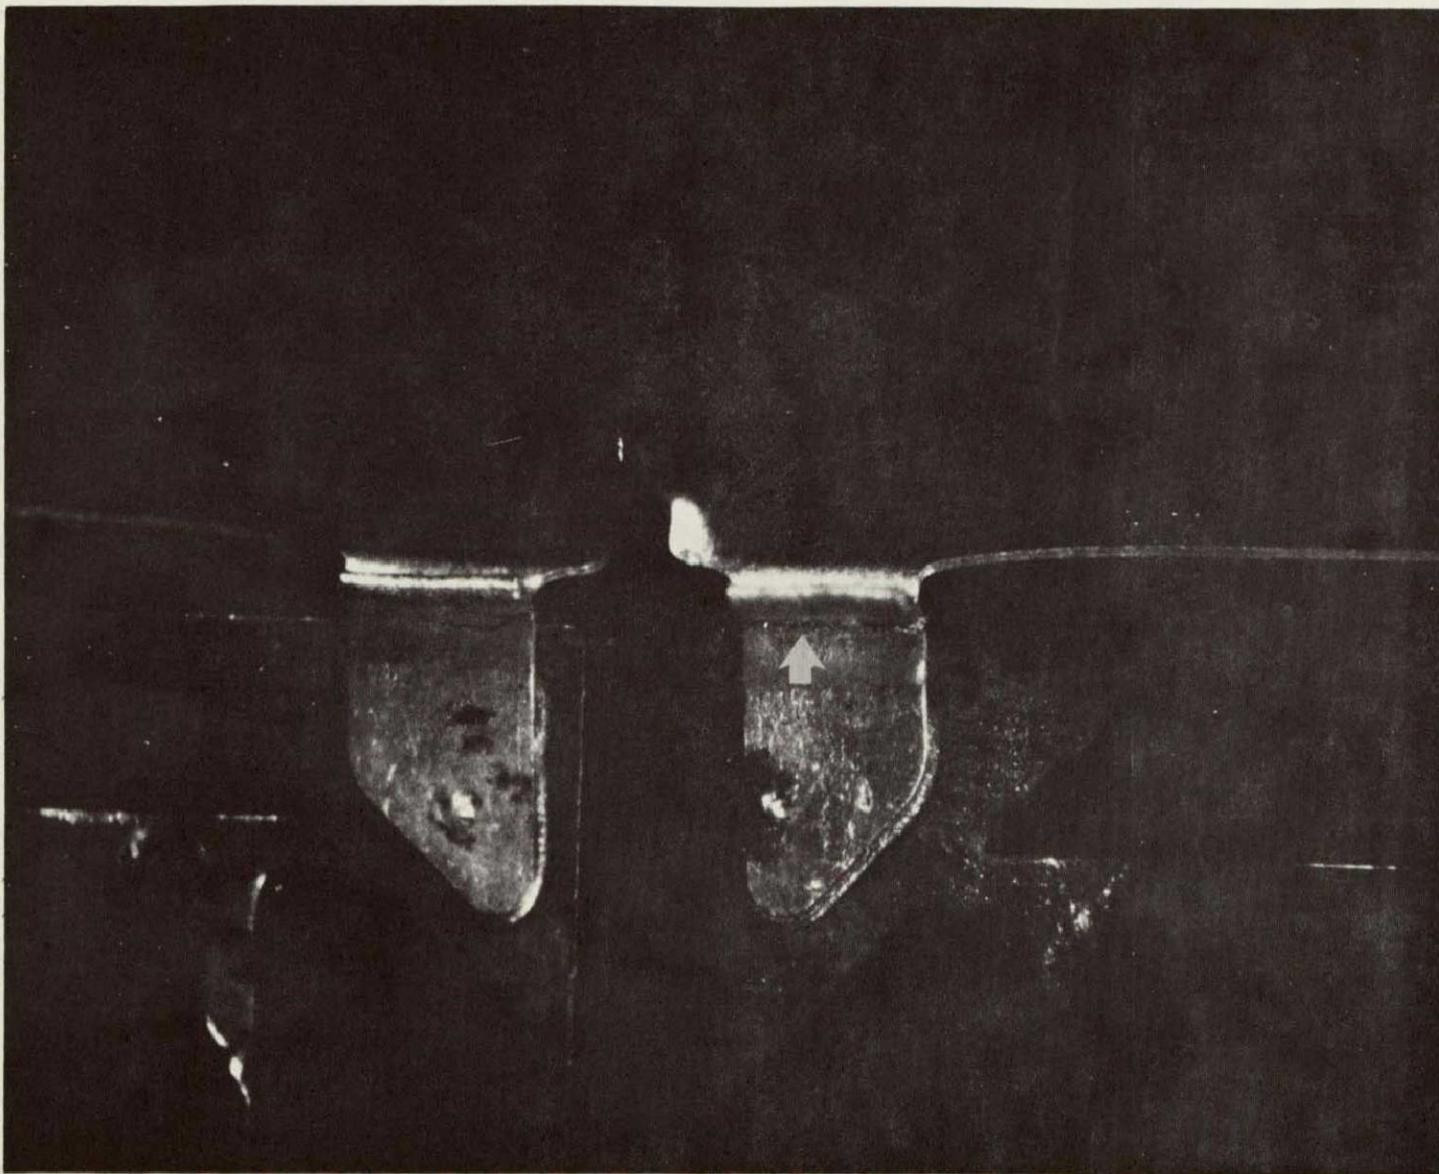
Figure 32 is a type-e tab that opened. It was noted as being cracked after 150 cycles.

Figure 32. Open Type-e Tab After 300 Cycles

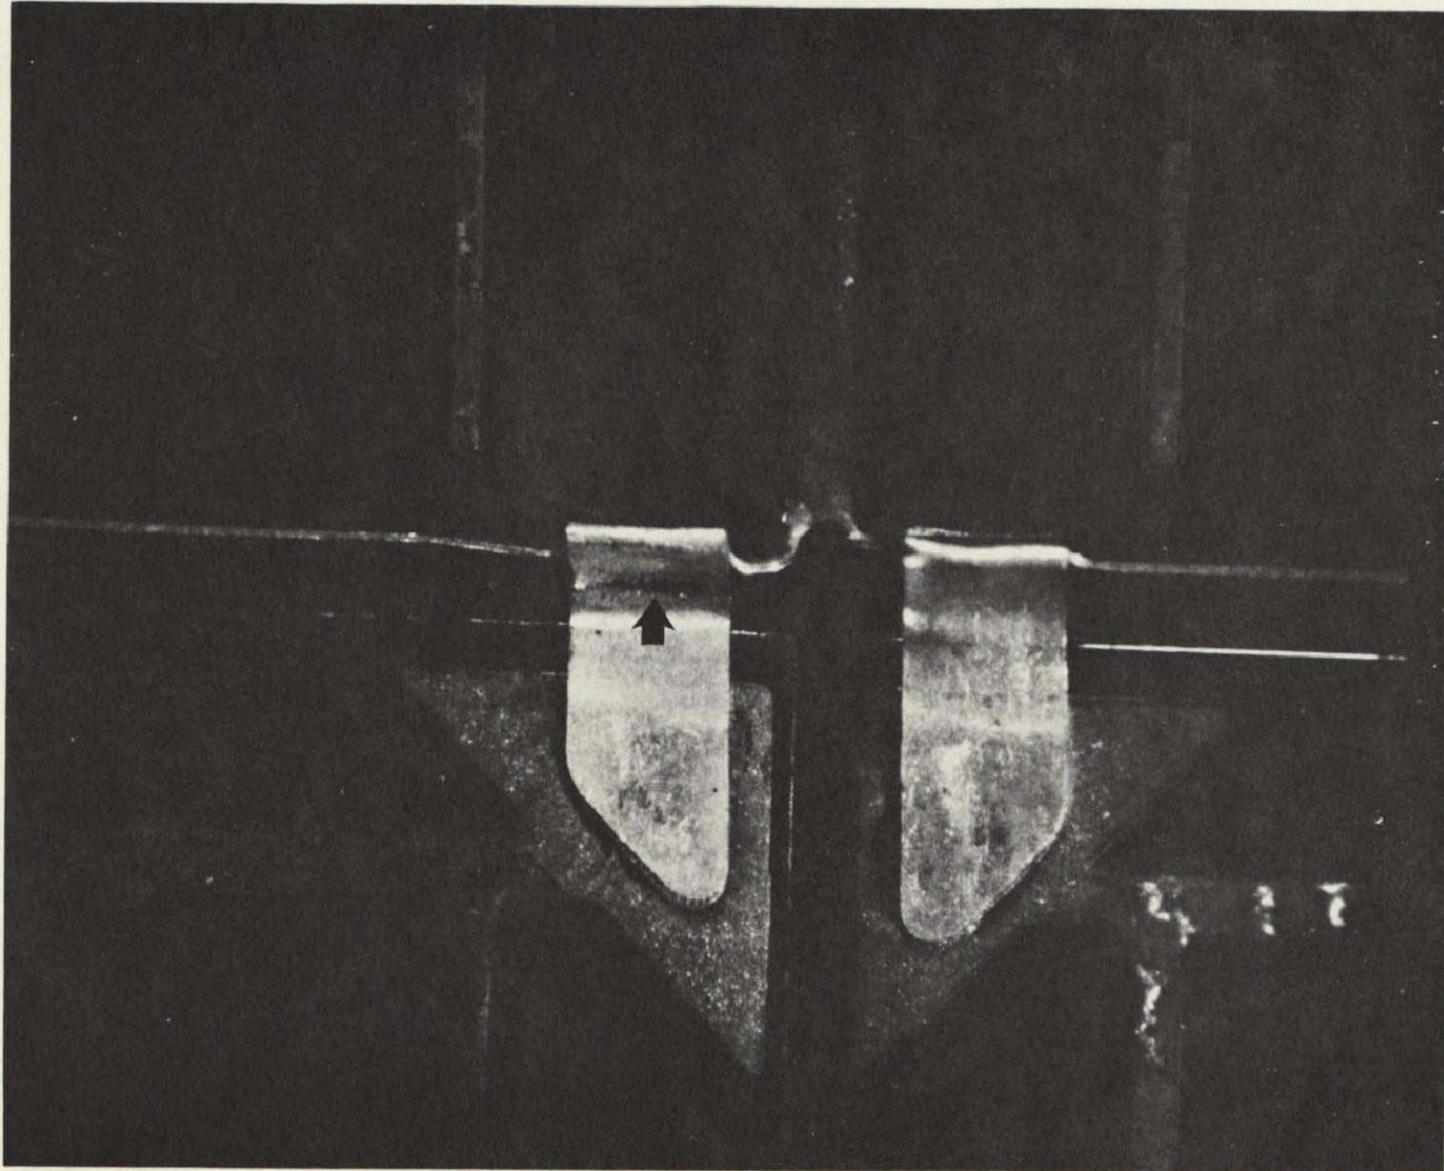
Figure 31 is another type-b tab that became completely open. The interconnector was found to be cracked after the 200 cycle test (Figure 25).

Figure 31. Open Type-b Tab After 300 Cycles
