THERMAL CYCLING EFFECTS ON SOLAR CELL INTERCONNECTION TABS ON AN OAO-B SAMPLE MODULE

X-761-71-315

Clara M. Vermillion

July 1971

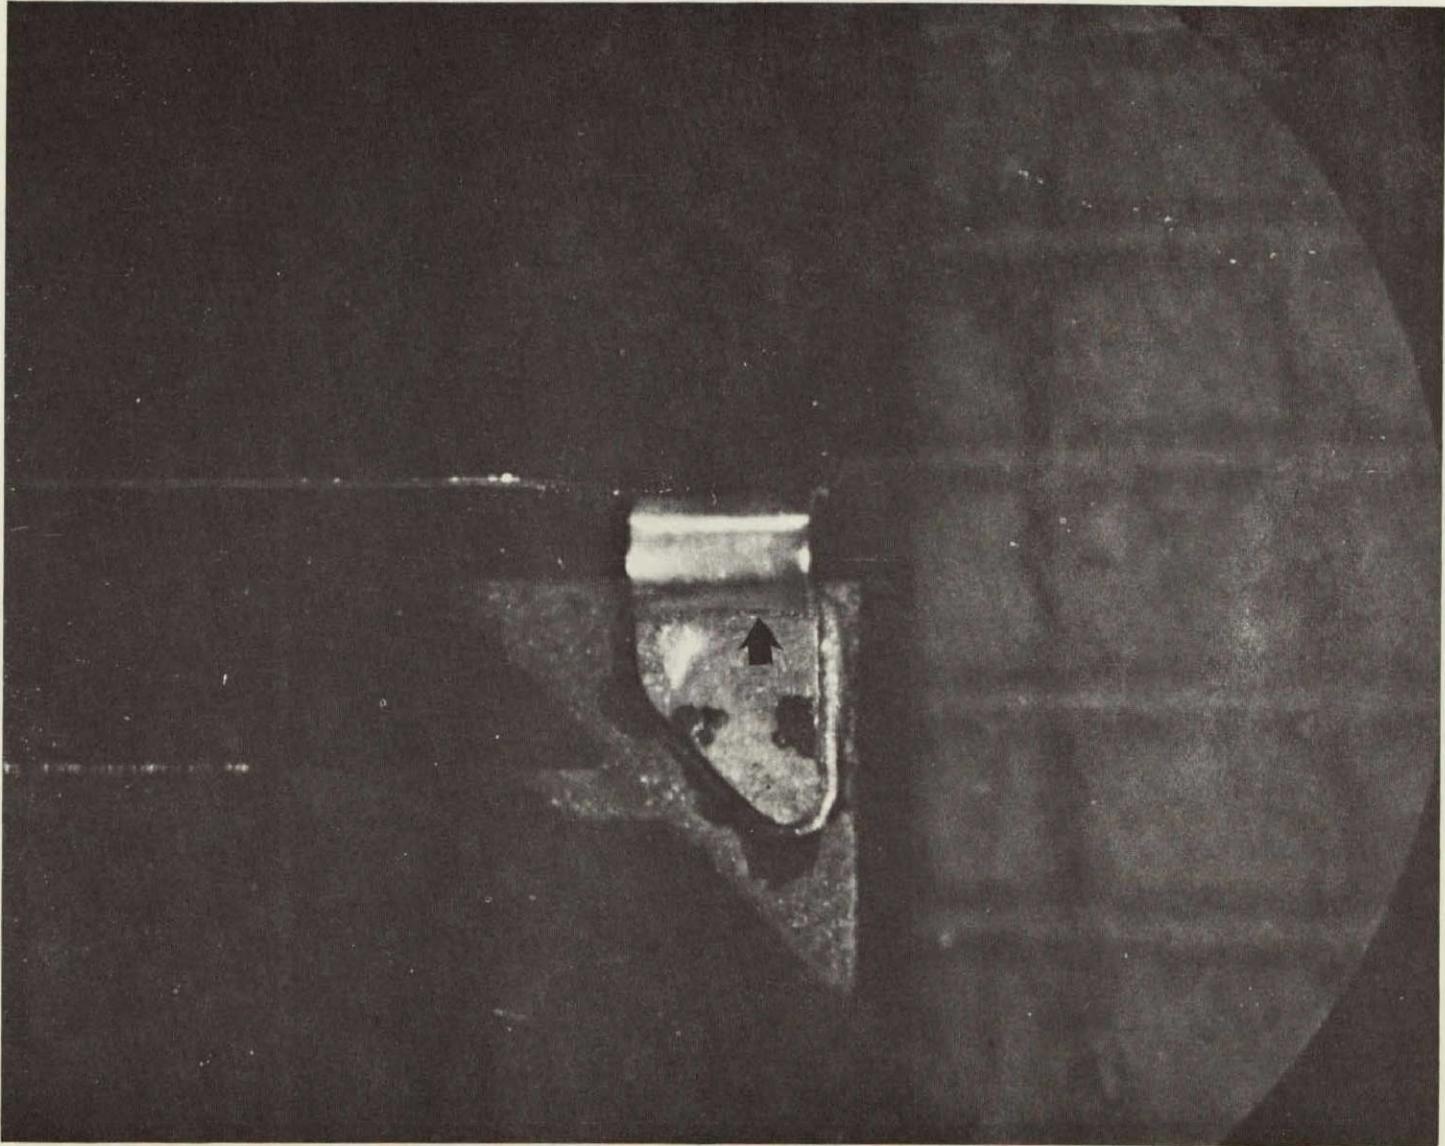
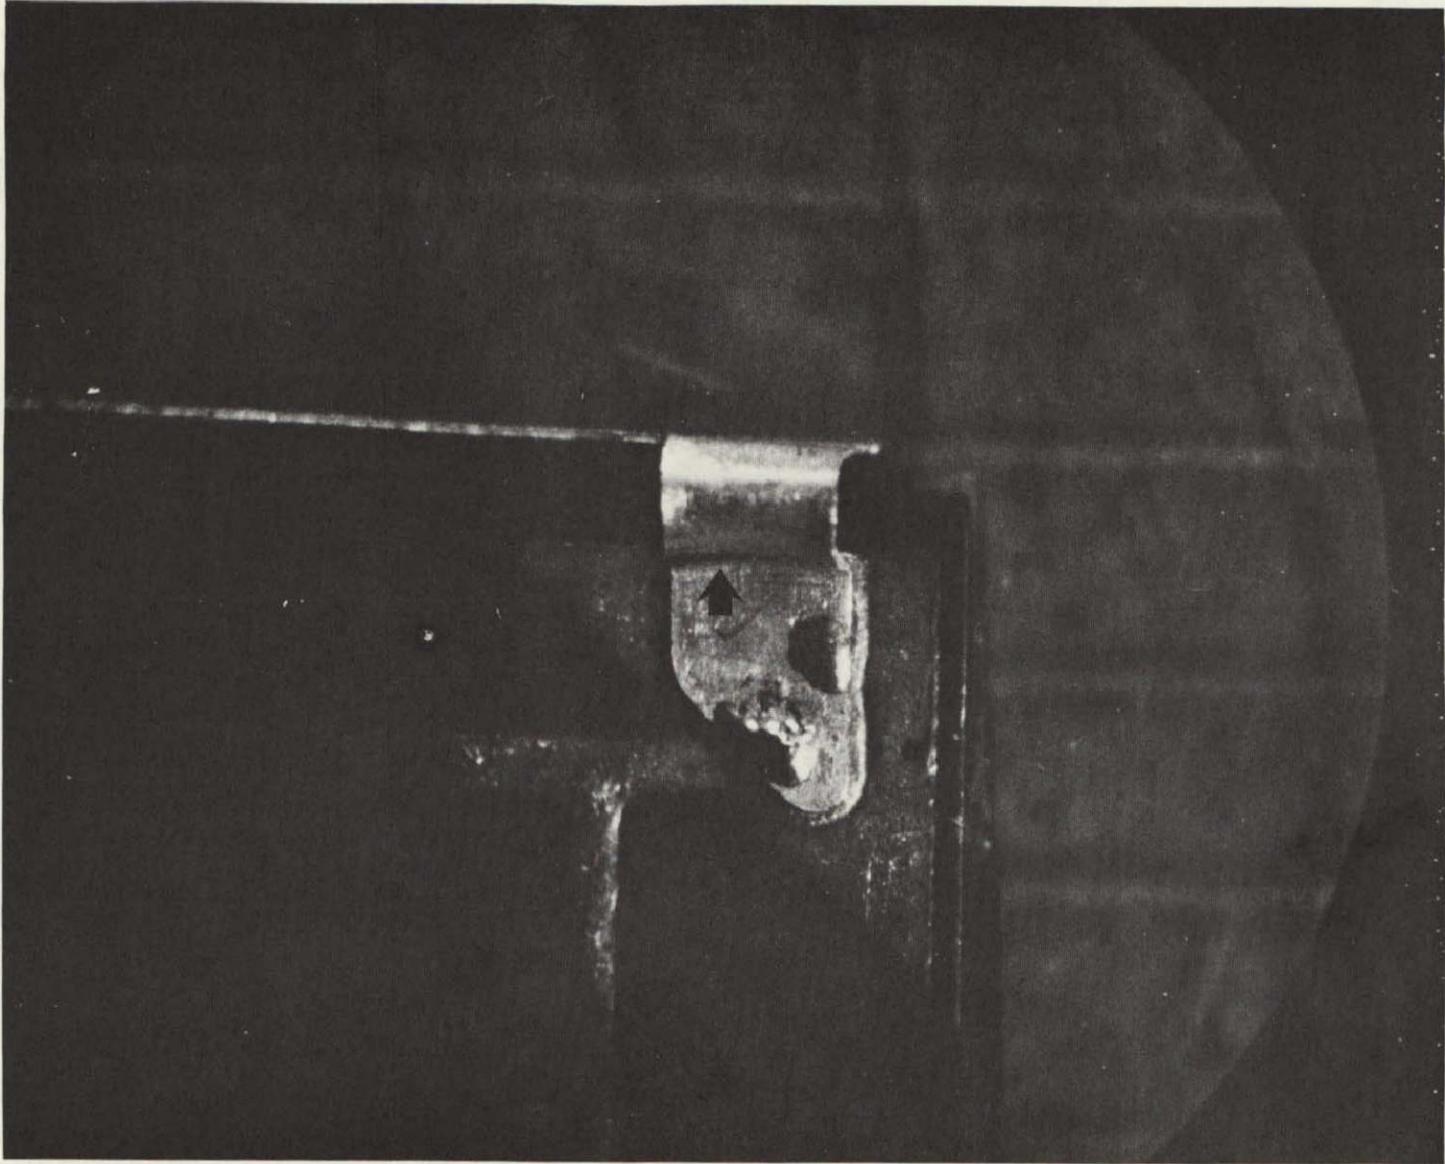
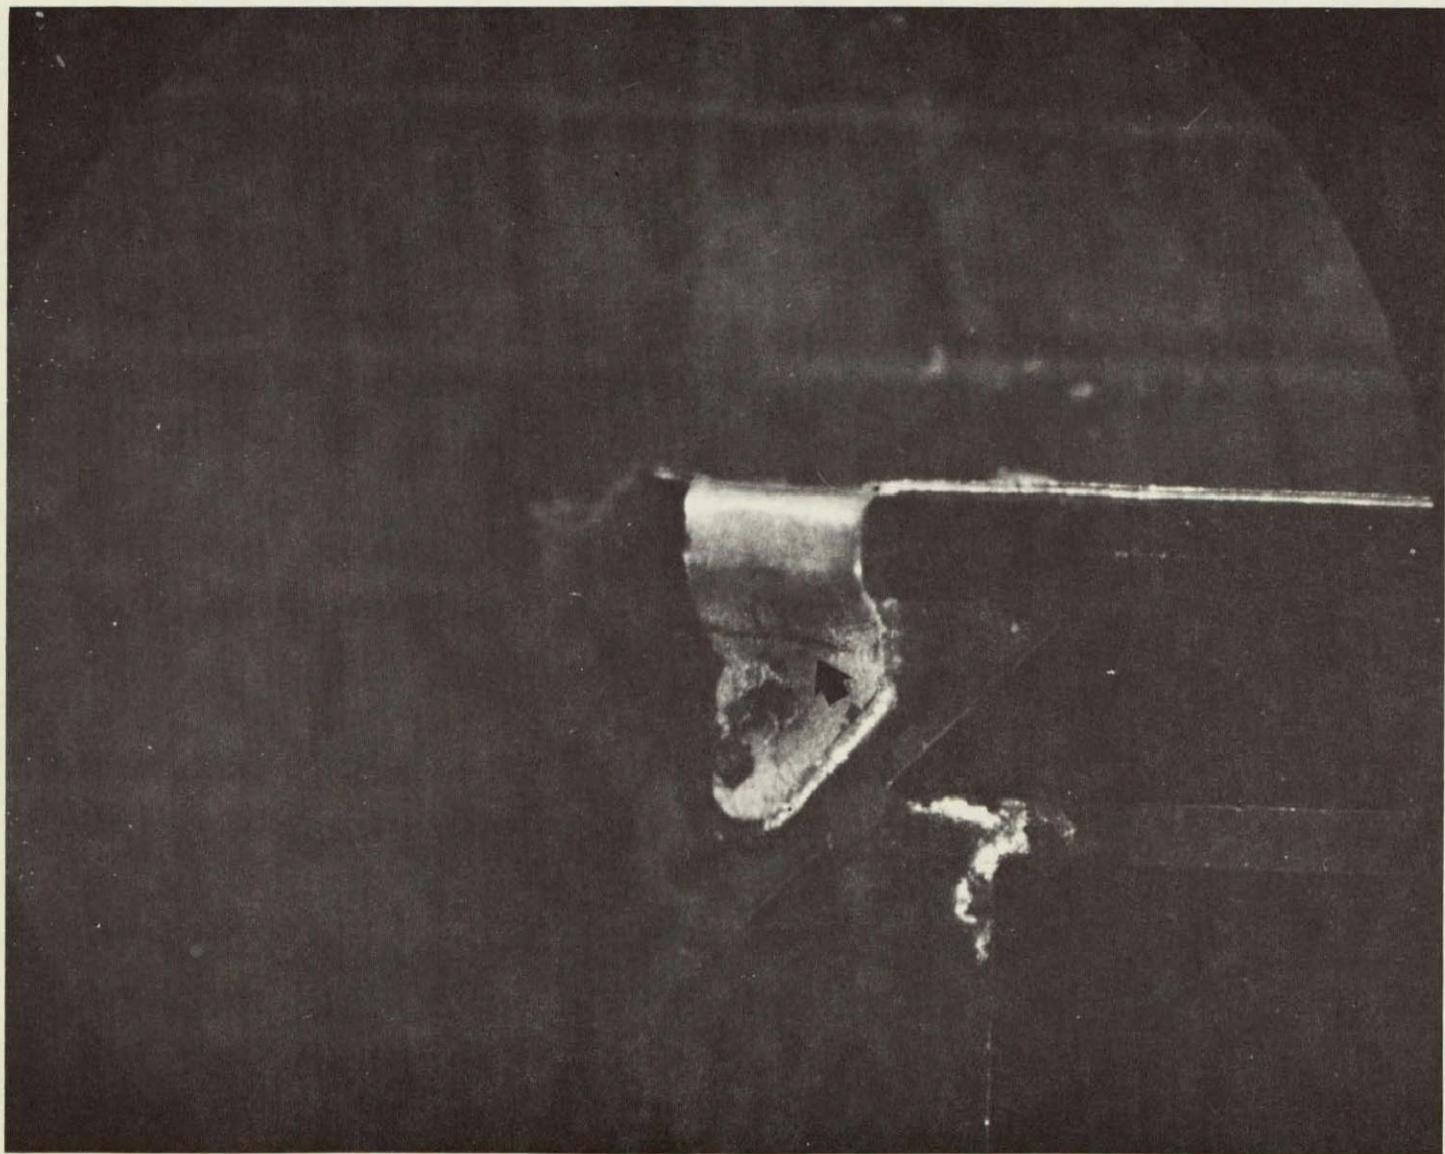
Figures 33, 34 and 35 are all type-h tabs each of these tabs were found to be cracked after 150 cycles. Now all three have become open.

Figure 33. Open Type-h Tab After 300 Cycles

Figure 34. Open Type-h Tab After 300 Cycles

Figure 35. Open Type-h Tab After 300 Cycles

Of particular concern is the high number of defects observed in the type-h normal tabs where 7 of 29 cracked and 4 of these were catastrophic failures within 300 cycles. It is noted that all of these defects occurred at the bend at the solder joint and that they were all observed on tabs on the periphery of the module. In addition it is noted that the two tabs with "excess solder" did not show defects. This condition indicates a tab design problem or a fabrication and assembly problem. The tabs were too weak at the bend at the solder joint to withstand

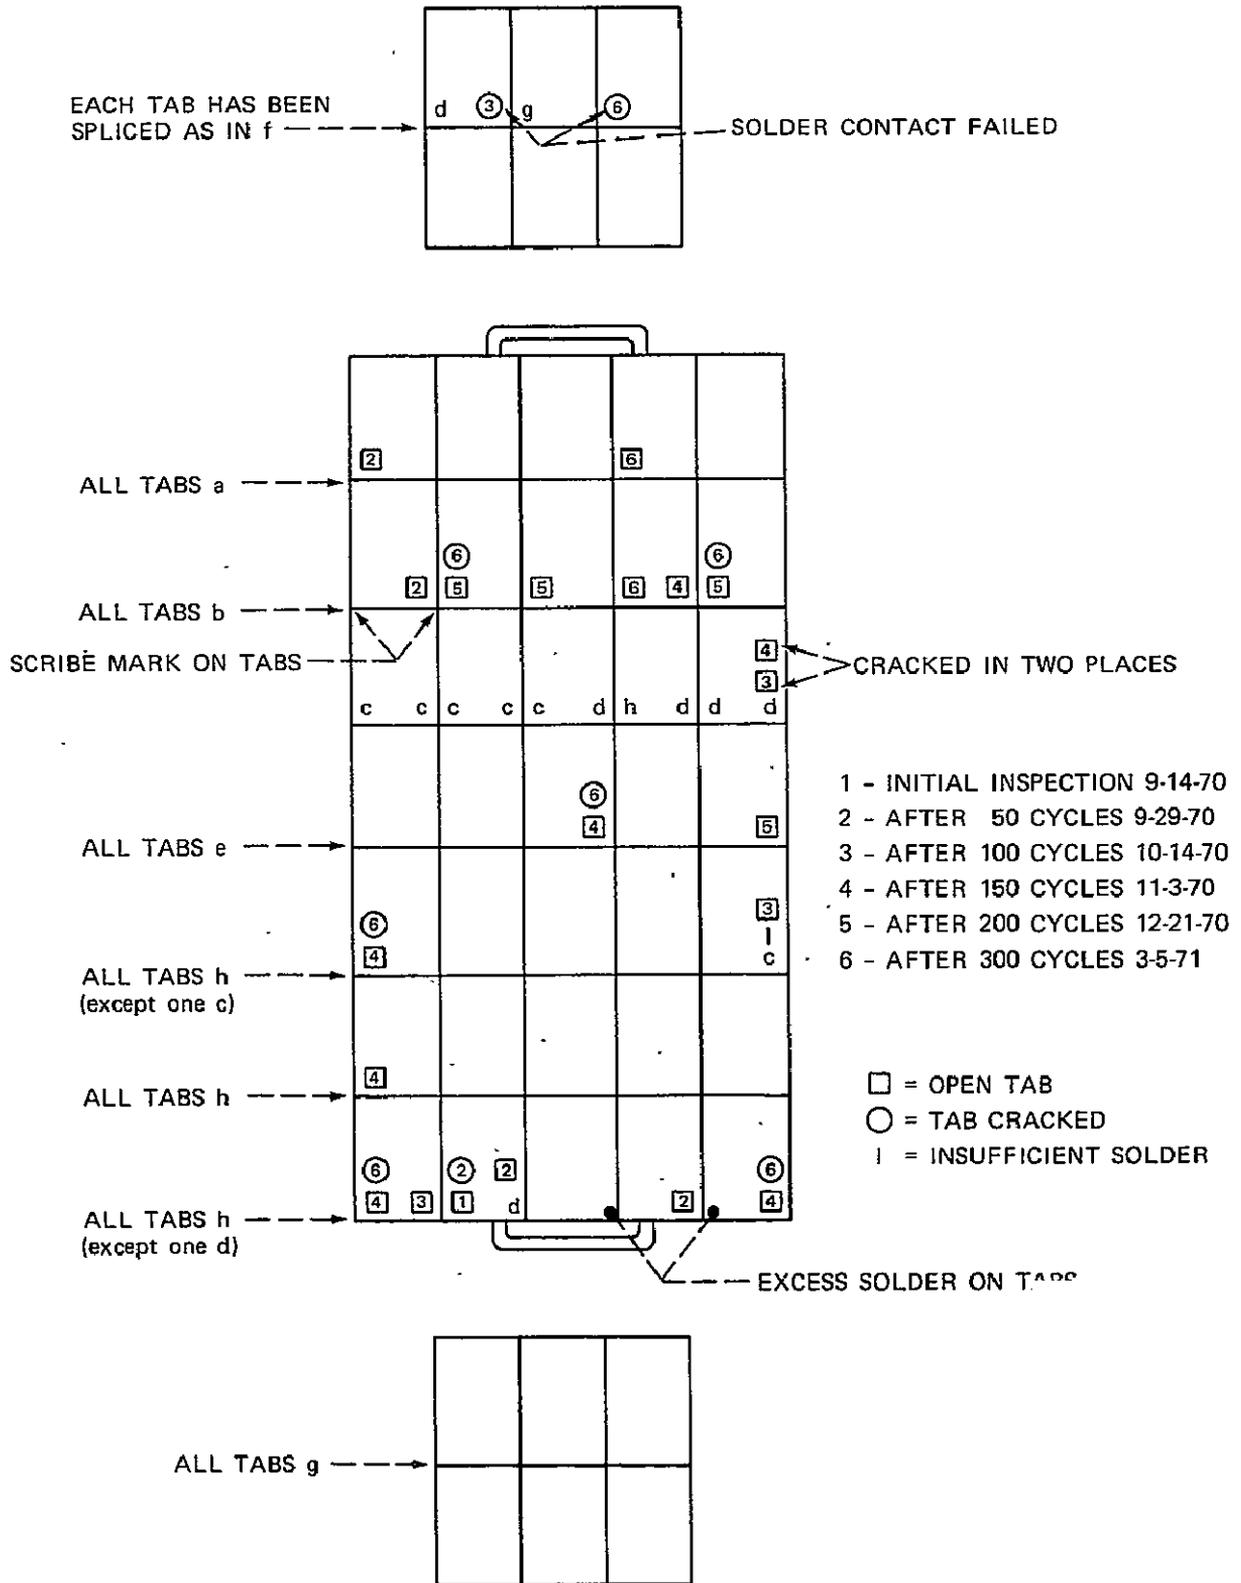
Figure 36. Final Inspection Results

The progression defects noted at each interval of testing is given in Table I and in Figure 36. The location of the various defects is summarized in Table II. Two types of failures were observed. In the one case the tab cracked and later failed completely; in the other the solder joint to the cell failed. Twenty cracked tabs and two failed solder joints were observed.
