MSC-05101

APOLLO 14 MISSION  
ANOMALY REPORT NO. 1

FAILURE TO ACHIEVE DOCKING PROBE  
CAPTURE LATCH ENGAGEMENT

MANNED SPACECRAFT CENTER  
HOUSTON, TEXAS  
OCTOBER 1971

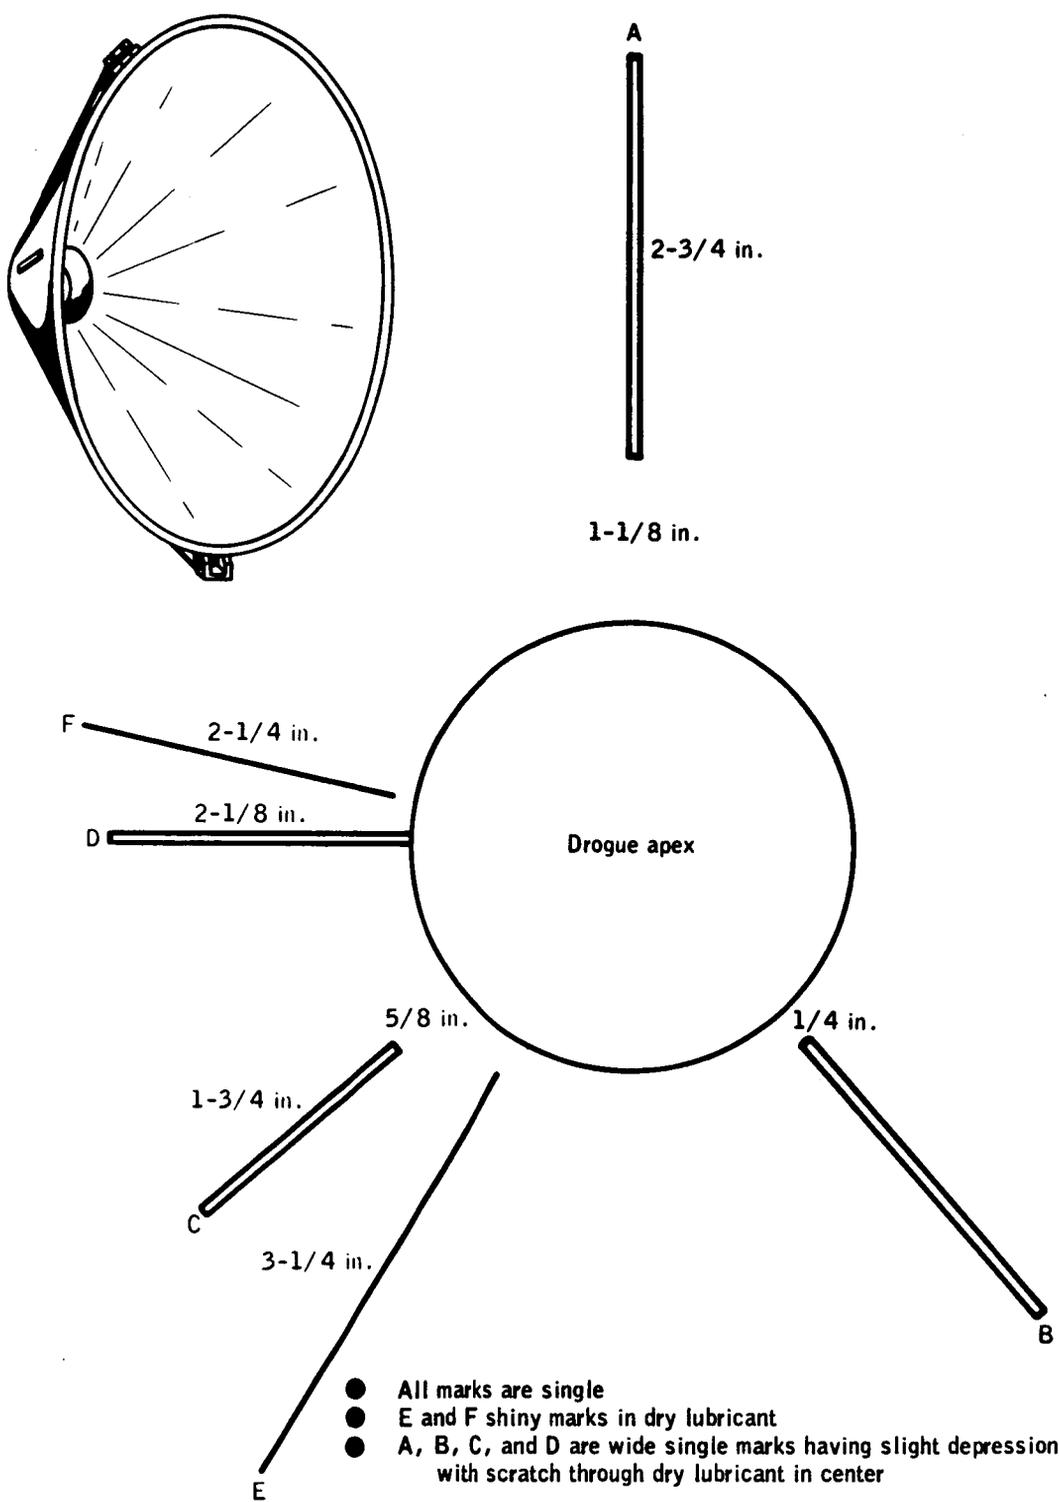
Figure 2.- Drogue assembly and location of radial marks.

2. The marks on the drogue noticed by the crew (fig. 2) indicate that capture latch hooks were cocked as they should have been during the docking attempts. This confirms the talkback indications at the time of the docking maneuver. Also, after the flight, a drogue that had been used in dynamic testing with multiple marks, scratches, dents, and tears in the face sheet skin was examined by the Command Module Pilot. The marks chosen by him to be most like those on the Apollo 14 drogue were caused by the capture latch hooks while operating normally (cocked position).

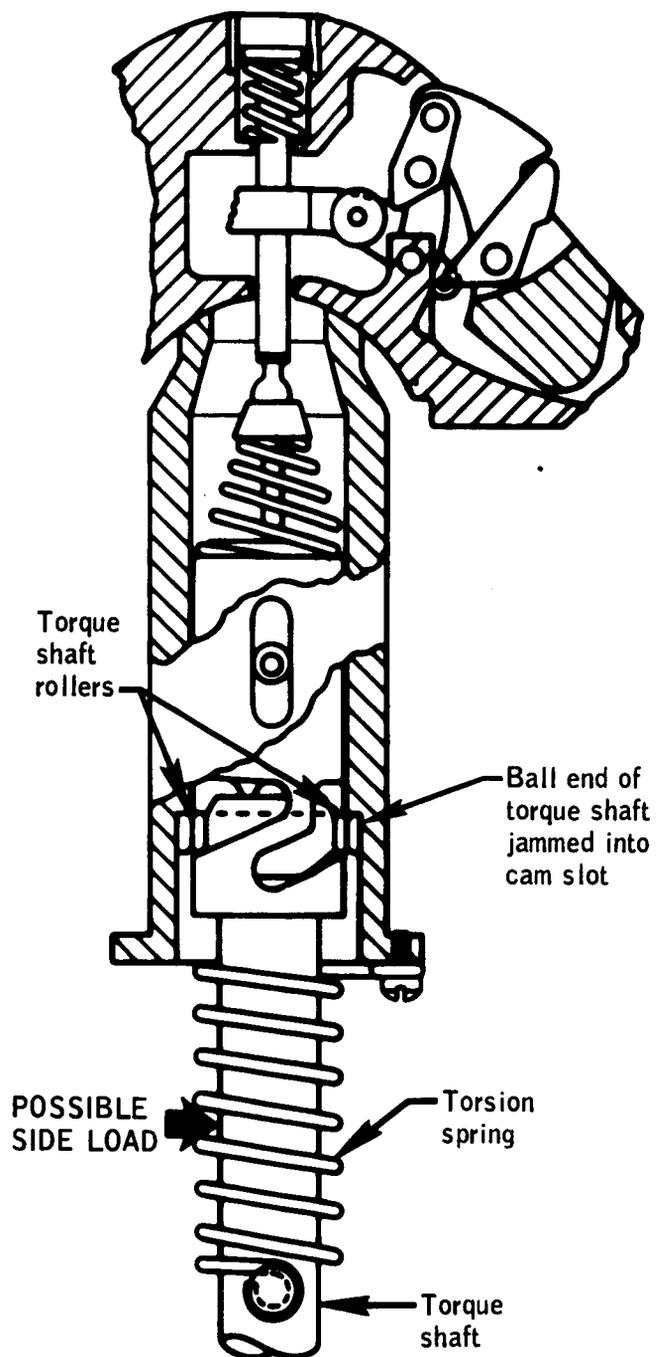
Figure 12.- Side load reaction on torque shaft operation.

The first possibility is that of a side load being introduced into the torque shaft (fig. 12) by the torsion spring or by other means; this may cause the ball end of the torque shaft to bind against the cam. This failure occurred on another probe during acceptance tests and it was possible to demonstrate this same failure on the Apollo 14 probe by applying a side load, but the failure did not occur consistently.

1. The probe translation-cam assembly (fig. 15) was modified to eliminate possible binding of the cam and spider.
  - a. The diameter of the ball machined on the forward end of the torque shaft was reduced.
  - b. The roller pin surface was machined to allow a rocking motion between the roller pin and hole in torque shaft.
  - c. A spherical surface was provided on the roller ends and roller pin ends for improved clearance.
  - d. An alignment bushing was added to insure proper torque shaft alignment.
2. A requirement was added to test the probe in the horizontal as well as vertical position during the capture latch timing test of the acceptance testing.
3. Capture latch timing tests were added just prior to the countdown demonstration test for the latest possible verification of latch operation in the spacecraft checkout flow.

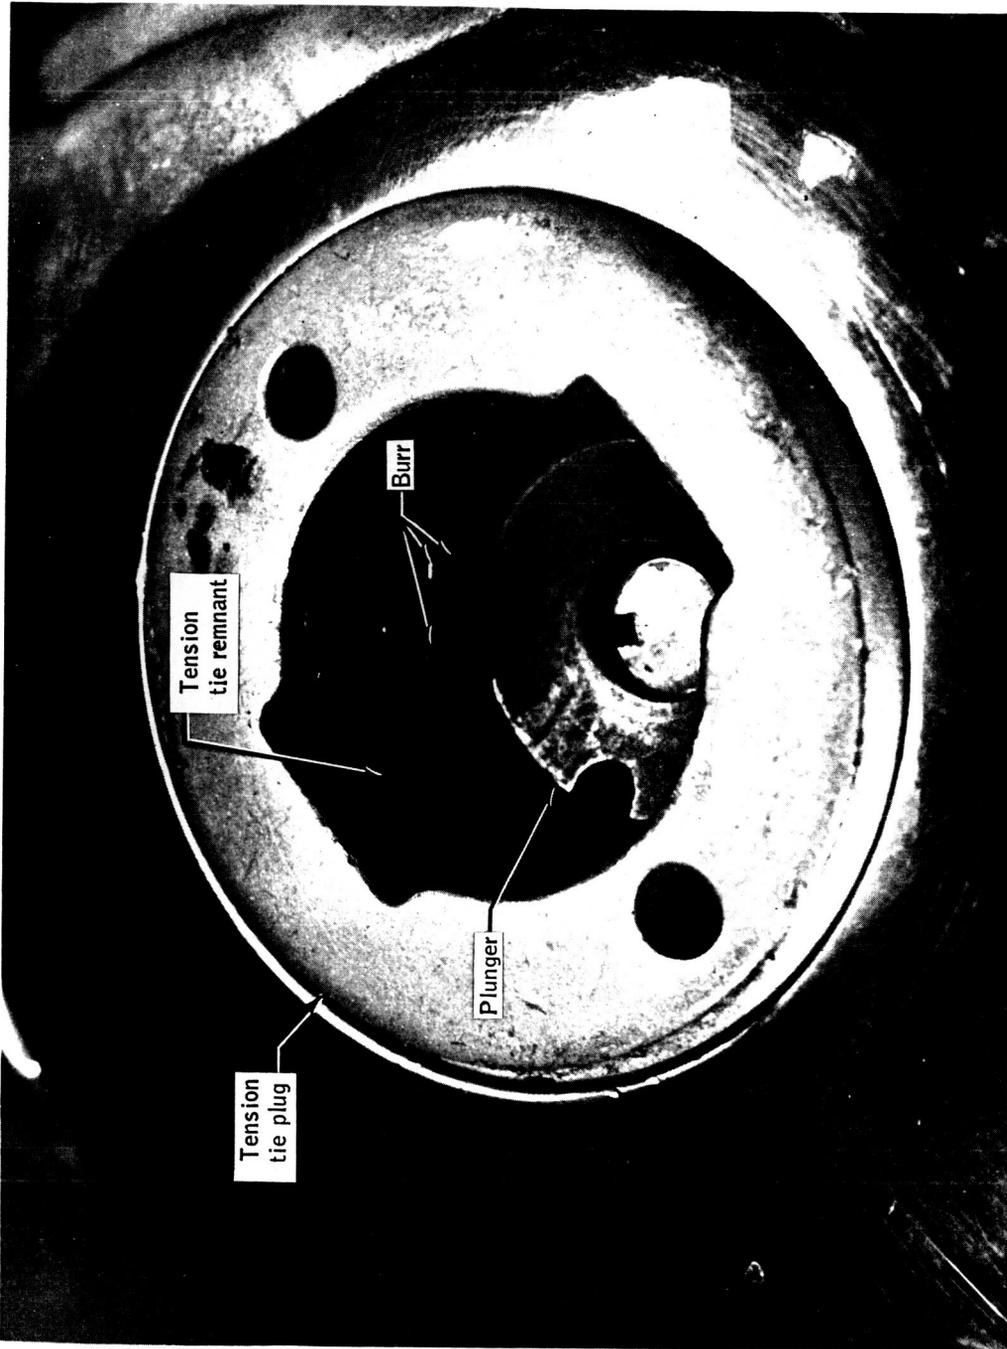
Figure 13.- Scratches and burrs adjacent to capture latch plunger.

The second possibility is that some small foreign material may have been lodged in the probe in a manner that prevented operation of the mechanism. Burrs from an unknown source were discovered in the bore of the tension-tie plug (fig. 13). A foreign particle might have been lodged between the plunger and the plug and may have caused the problem.

1. A removable cover was provided for the probe head. The cover will be installed at the completion of acceptance testing and remain in place until the tension-tie assembly is installed at the launch complex. It will be removed only when the probe is being tested.
2. Cleanliness requirements for all ground support equipment mating with the probe have been implemented.
3. Use of cleaners or primers when potting the tension tie nut during installation has been prohibited.
4. Shear pin remnants in the tension tie have been safety wired, and the potting holding the shear pins in place has been removed (fig. 14).
