# GENERAL INSTRUMENT CORPORATION

FINAL REPORT

NIMBUS 4/IRLS BALLOON INTERROGATION

PACKAGE (BIP)

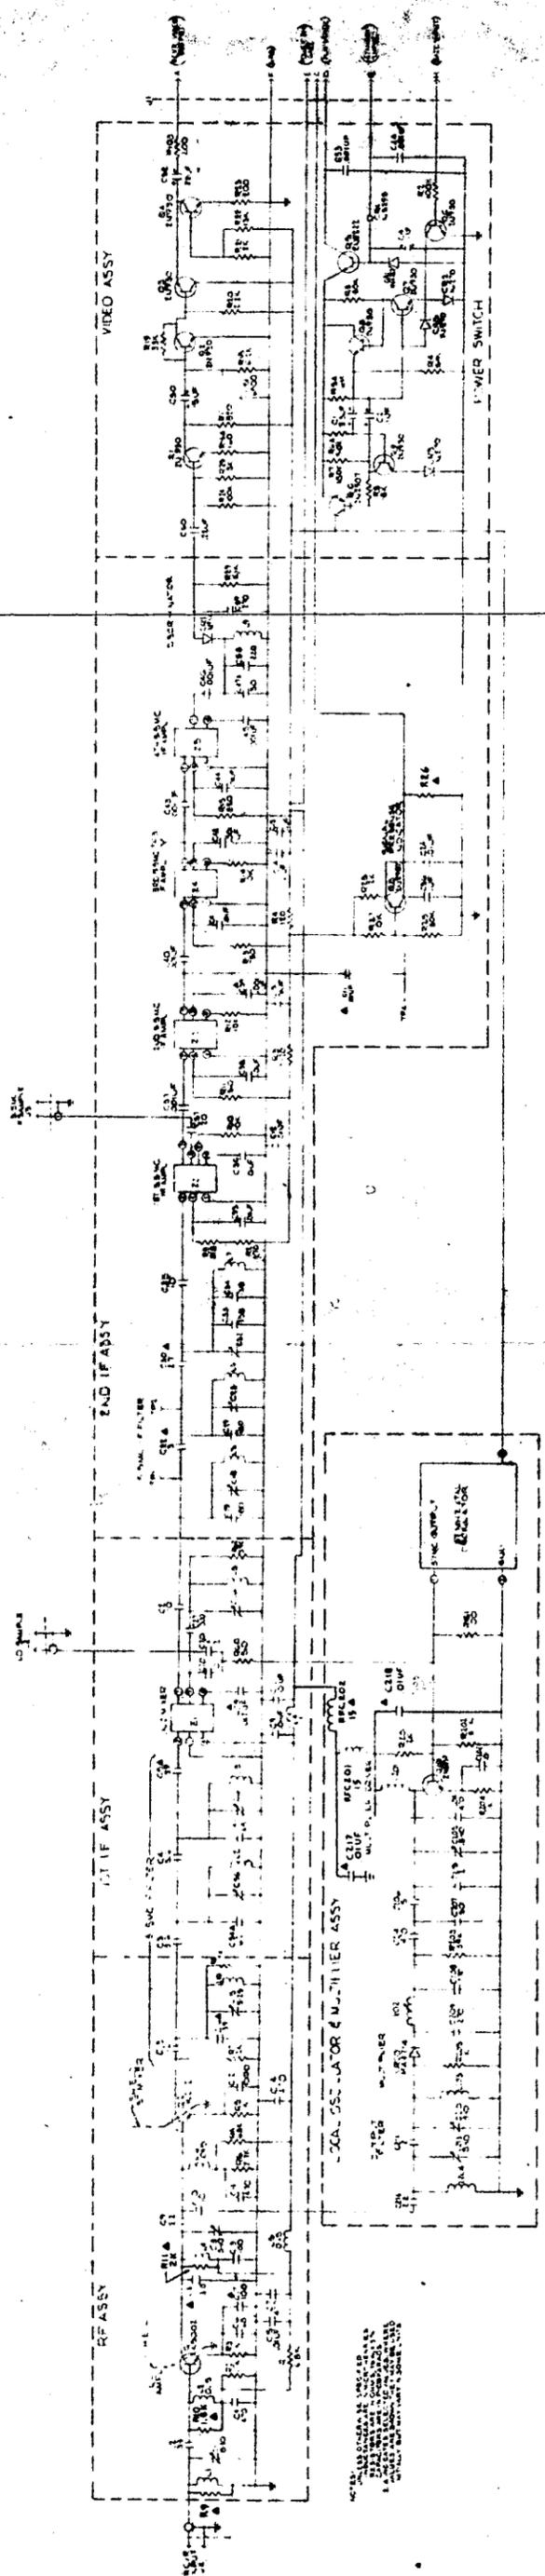
FIG. 3-3 - RECEIVER SCHEMATIC

Tests at ESD revealed that the receiver could only be made to oscillate if long leads were connected between the DC power supply and the receiver. It was found during the ESD tests that the receiver was unstable only near the high voltage extreme of the input DC voltage range at room temperature. However, at  $-20^{\circ}\text{C}$  the receiver was unstable over most of the input DC voltage range. This problem was corrected by placing a 0.001  $\mu\text{f}$  capaci-

tor (C53) from the collector of Q5 to ground in the receiver power input circuit (Figure 3-3). This transistor is connected as an emitter follower and the capacitor reduces the high frequency gain, thus making the circuit more stable. Since long power leads were used in the tests at Radiation it was felt that this was the cause of the difficulties encountered in the first test at Radiation. That no problem was encountered in the second test could have been due to the addition of the patch cable to externally control the transmitter. After addition of this capacitor no combination of temperature, input DC voltage, and length of power leads could induce a receiver oscillation.

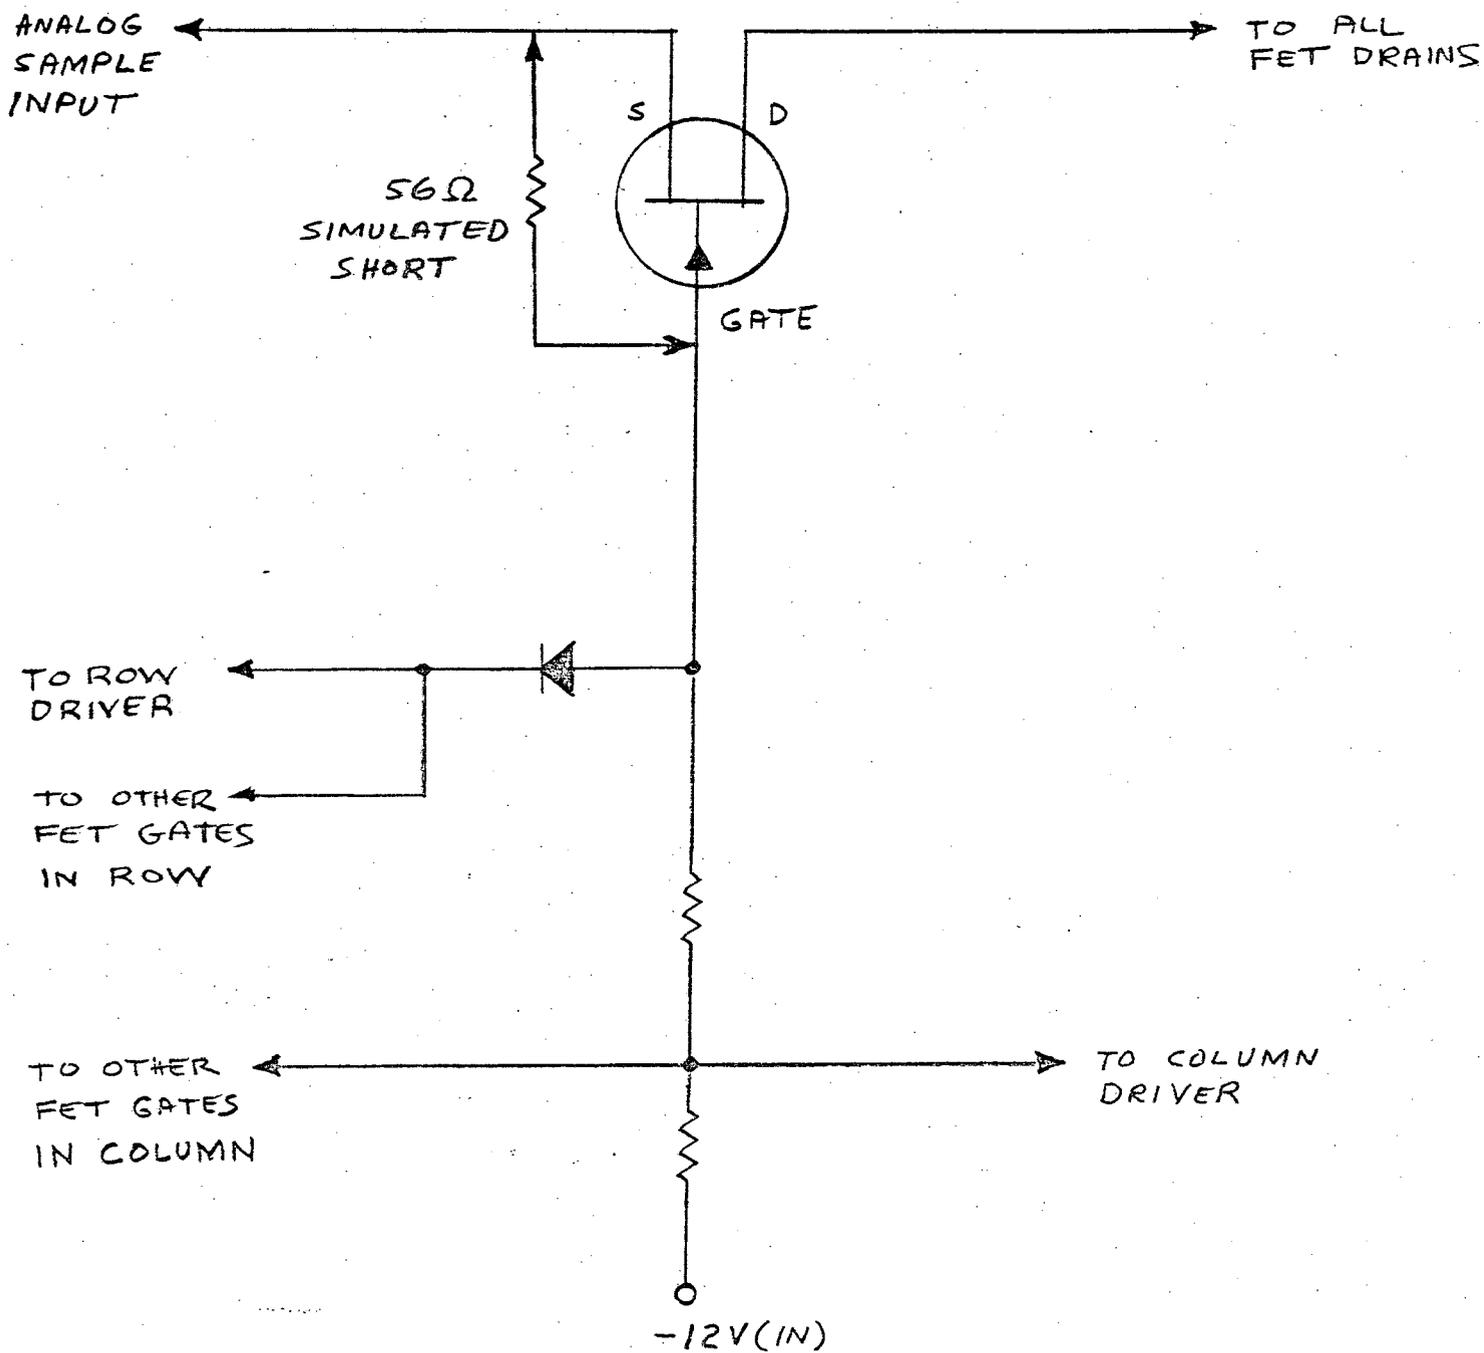
FIG. 10-1 - TYPICAL MULTIPLEXER FET

1. A 56 ohm resistor was connected between the gate and source of the input FET.(Figure 10-1 shows this connection).
2. Only single FET failures were simulated.
3. Channels 2, 5 and 6 were connected in the normal operational mode.
4. Channels 1, 3 and 4 had resistors of 43K ohm, 100K ohm, and 10K ohm, respectively, connected between the FET source and analog psc. These resistors were used to simulate the flight impedances that are normally present on these channels.
5. Channel 7 FET source was connected to +6.4 volts.
6. All tests were performed at room temperature.
7. Channel data was observed on the bench check-out equipment display unit.

1. A channel with the short simulation (56 ohm resistor) always has the correct data.
2. A short in channels 1, 2, and 3 will cause channels 5, 6, and 7 data to read zero or very low.
3. A short in channel 4 will cause channels 6 and 7 to read a count of 76 and channel 5 to read zero. Also, channels 1, 2, and 3 track channel 4. This was a mode of operation that occurred many times in the balloon launch no. 1 data. Channel 4 dominates since its source impedance is much lower than any of the other channels.

Using the equivalent circuit of each channel and the superposition theorem, close correlation was obtained between calculations and the experimental results described above for a one channel FET failure. Multiple channel FET failures, however, made calculations more difficult since the source impedance connected to each FET varies considerably during normal operation. A computer program, where the source impedances could be varied in increments would have been necessary to complete the calculations in a reasonable time period. Additional calculations, however, were not necessary since the failure mode had been isolated to channel FET shorts.

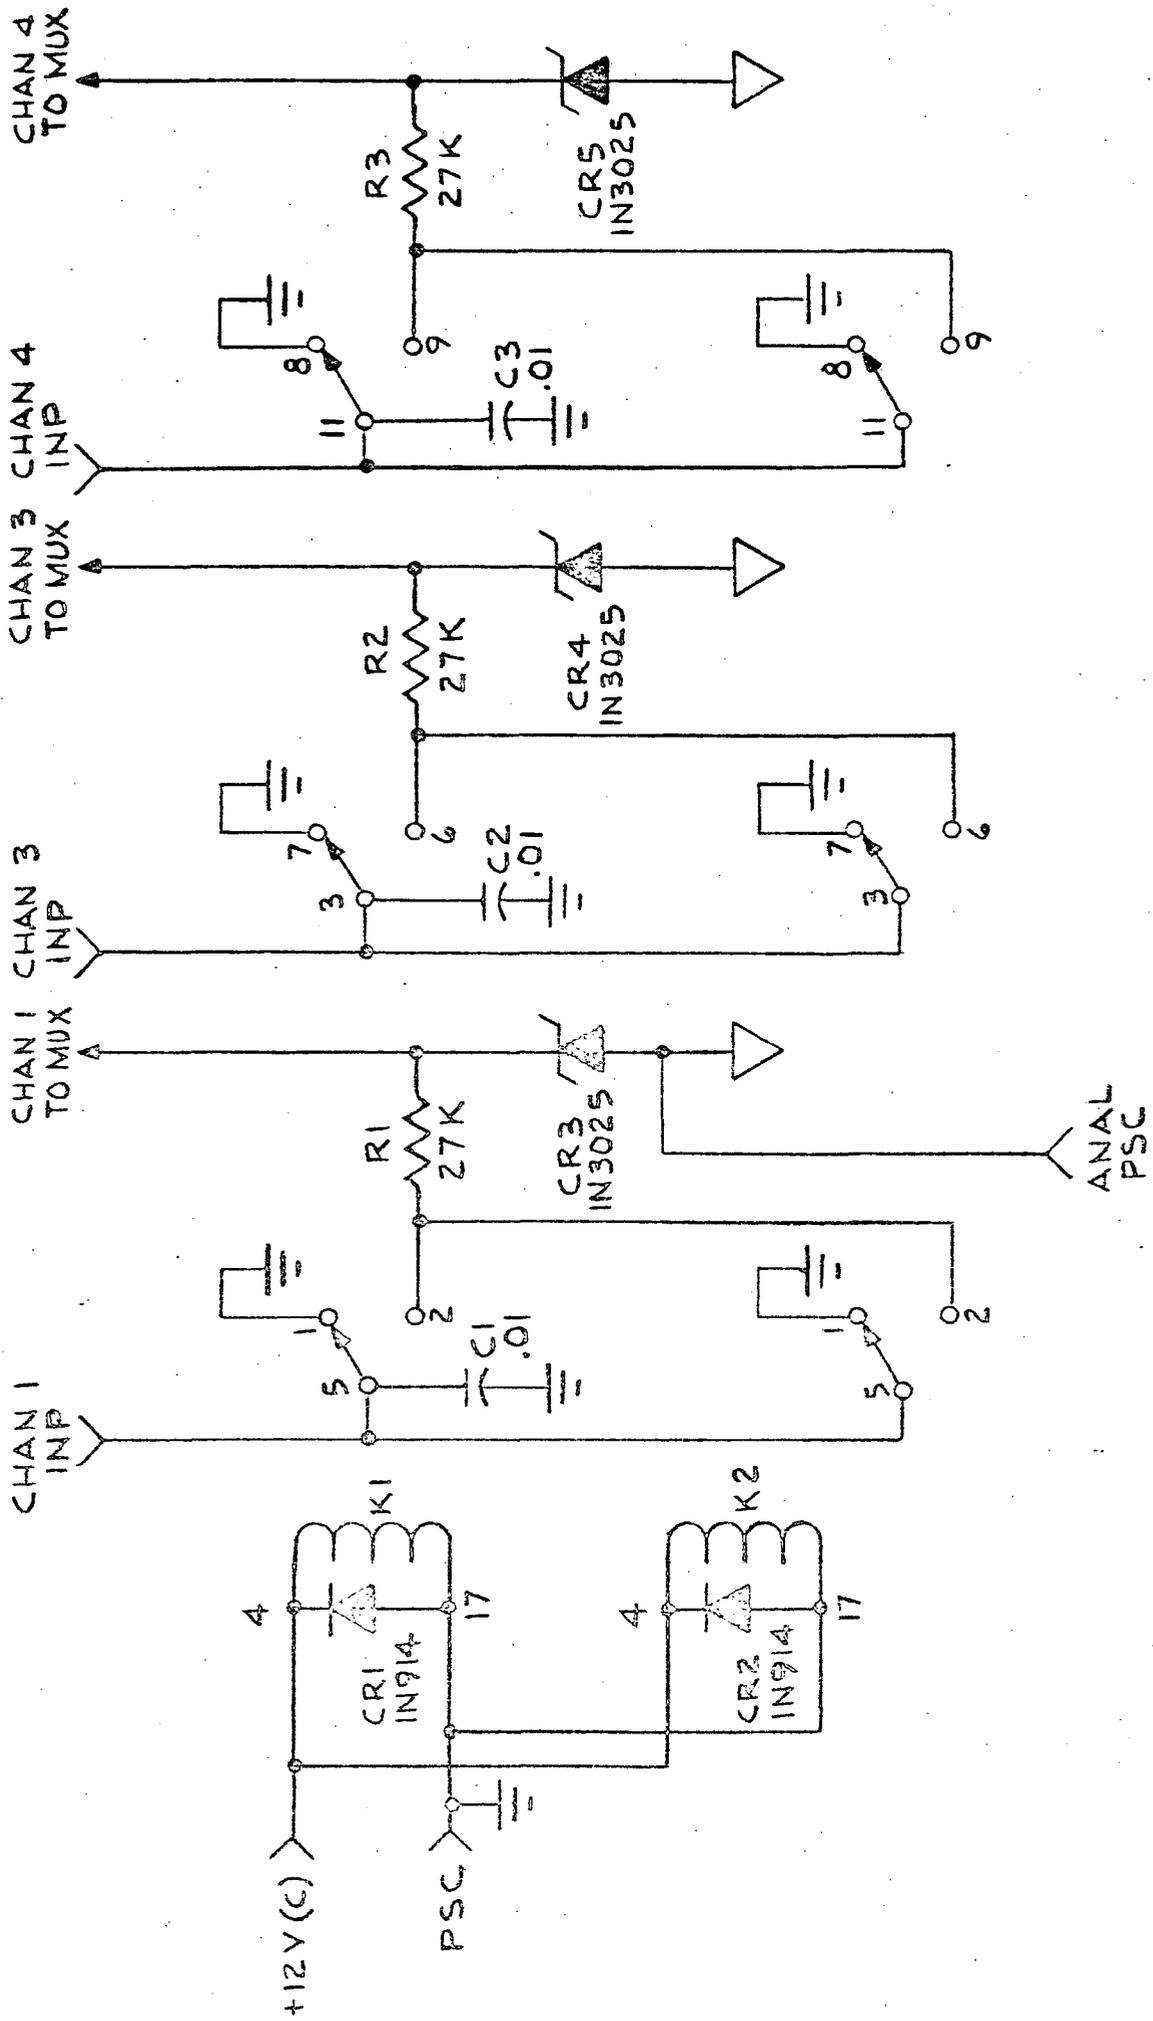
FIGURE 10-2 EXTERNAL TELEMETRY SENSOR RELAY BOARD SCHEMATIC

The remaining four BIP systems that were launched in October and November 1970 employed two relays in parallel that would operate only when +12 volt "C" power was energized. Figure 10-2 shows the schematic of the electrical circuit and connections. Telemetry channels 1, 3 and 4 were connected to the external sensors, through the relay contacts, only during the satellite interrogations, thus minimizing the probability of BIP damage. The resistor and zener diode were placed in the circuit to prevent damage if a high voltage spike occurred at the time when the relay was energized.

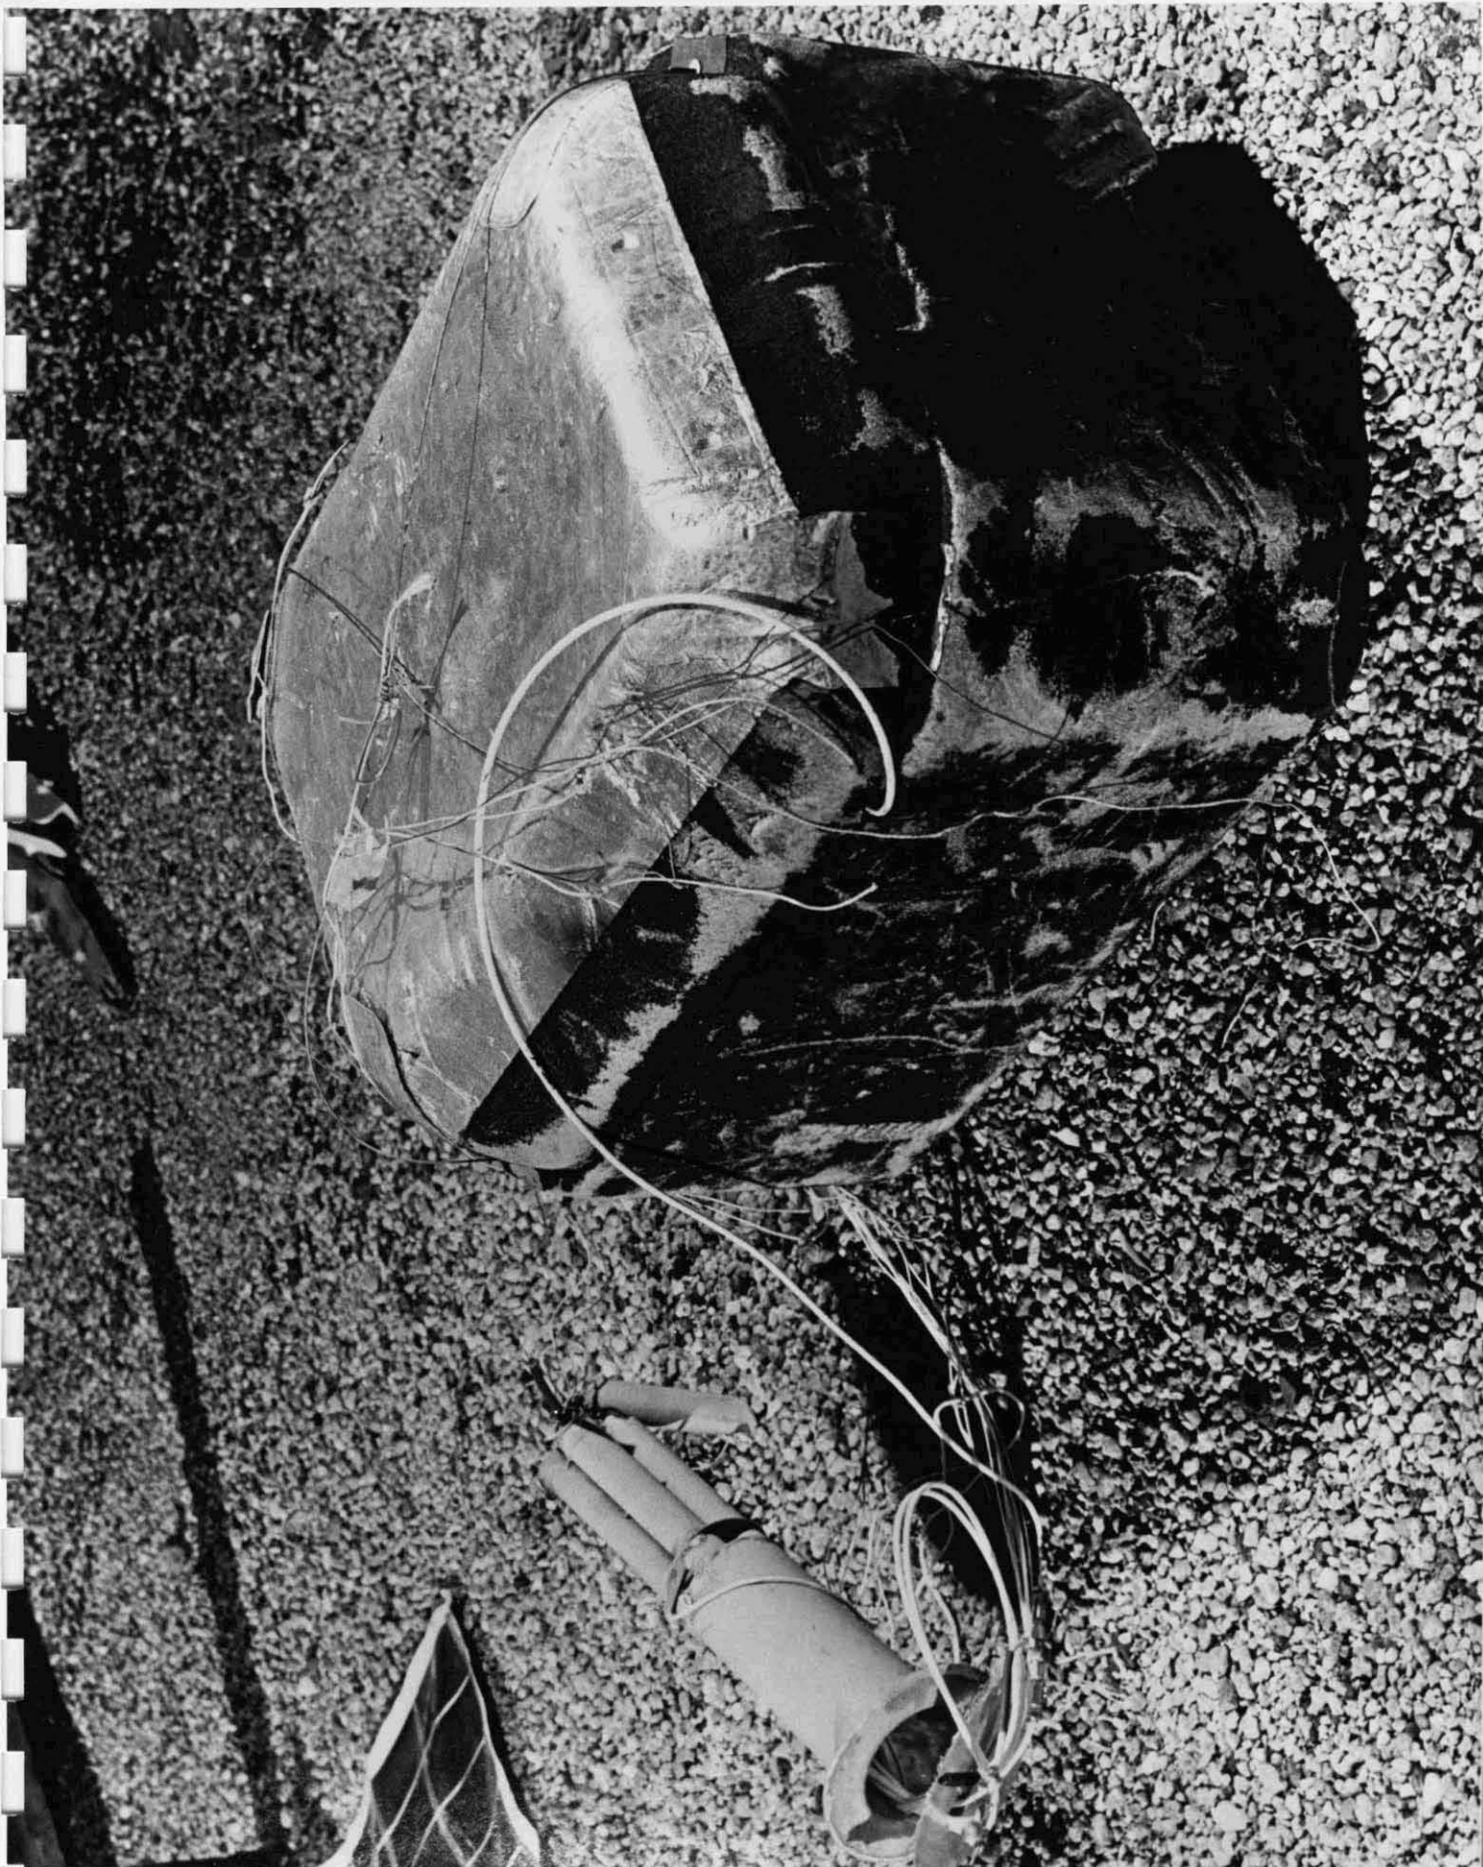
Fig. 10-3

The balloon system of P15 failed over Africa and was recovered at Lumbumbashi, Congo, Africa. Figures 10-3 and 10-4 are photographs, taken after the African recovery, of the electronics unit and the solar panel, respectively, of P15. The BIP was returned to General Instrument in February of 1970. First, the system was checked for possible damage, then connected to the BCE (Bench Check-out Equipment) where the telemetry sensor data loss mode was verified. The channel FET's were then checked with an ohmmeter and channel 1 and 3 were found to have gate-to-source and gate-to-drain shorts. These two FET's were replaced and normal operation was verified on the BCE display.

Subsequent visual analysis of the damaged FET's, under a microscope, showed black spots at the shorted junctions. Discussions with Motorola, Inc., indicated that this failure was due to a high voltage, low current transient. Since the header had not arced over, Motorola felt that the voltage was less than 600 or 700 volts. A high voltage, high current transient would have, obviously, destroyed the chip.
