NASA TN D-6519

CORROSION STUDY OF BARE AND COATED STAINLESS STEEL

by J. D. Morrison

John F. Kennedy Space Center

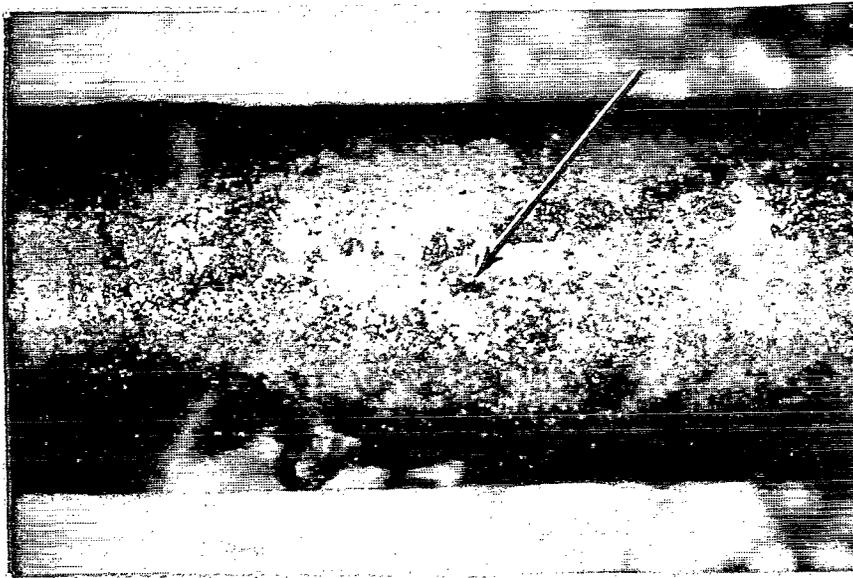
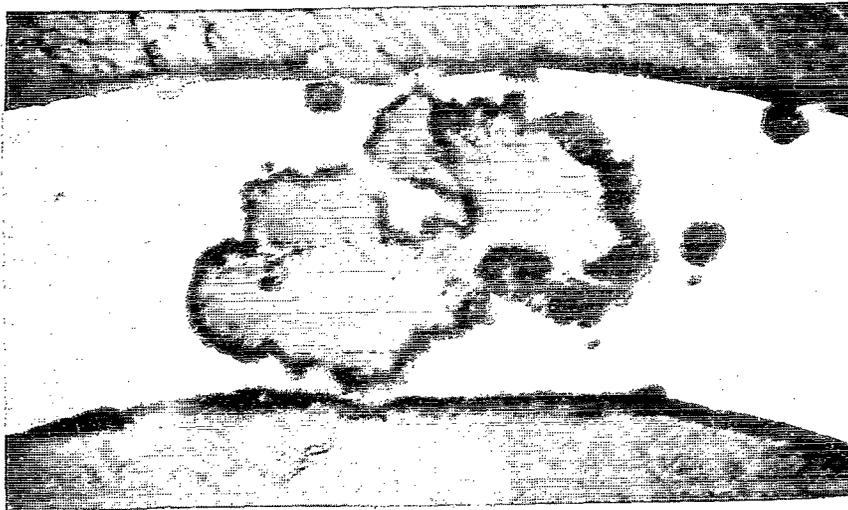
Figure 1. Perforation of Stainless Steel Tubing Used in High-Pressure Oxygen System on Astronauts' Transfer Van

Figure 1 shows an enlarged view of the surface of a 0.955-cm (0.375-inch)-diameter tube with the perforation indicated by an arrow (View A). A cross-section through the tubing wall in the perforation area is also shown (View B) enlarged to 50X. This failure occurred in a high-pressure oxygen line on the Astronauts' Transfer Van.

Perforation on tube surface indicated

Cross-section through perforation in tubing wall

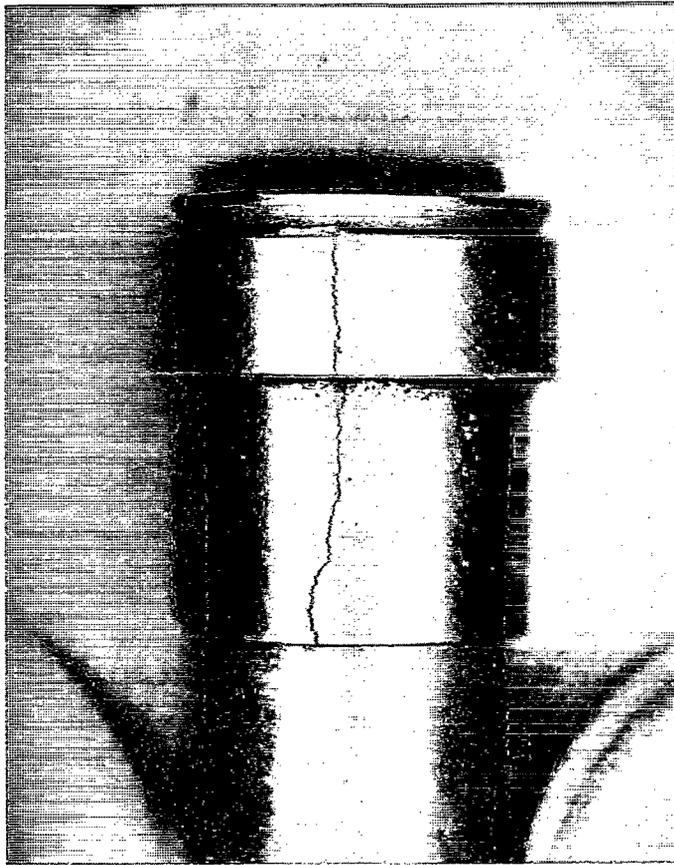
Figure 3. Cracked B-Nut Sleeve from Control Console Line,
Mobile Launcher Service Arm 8, Complex 39

Figure 3 illustrates a typical example of stress-corrosion failure. The sample shown is a stainless steel B-nut sleeve containing a longitudinal crack extending the full length of the sleeve. This sample has been removed from a console line used on a mobile launcher service arm.

Sleeve full-length stress corrosion crack

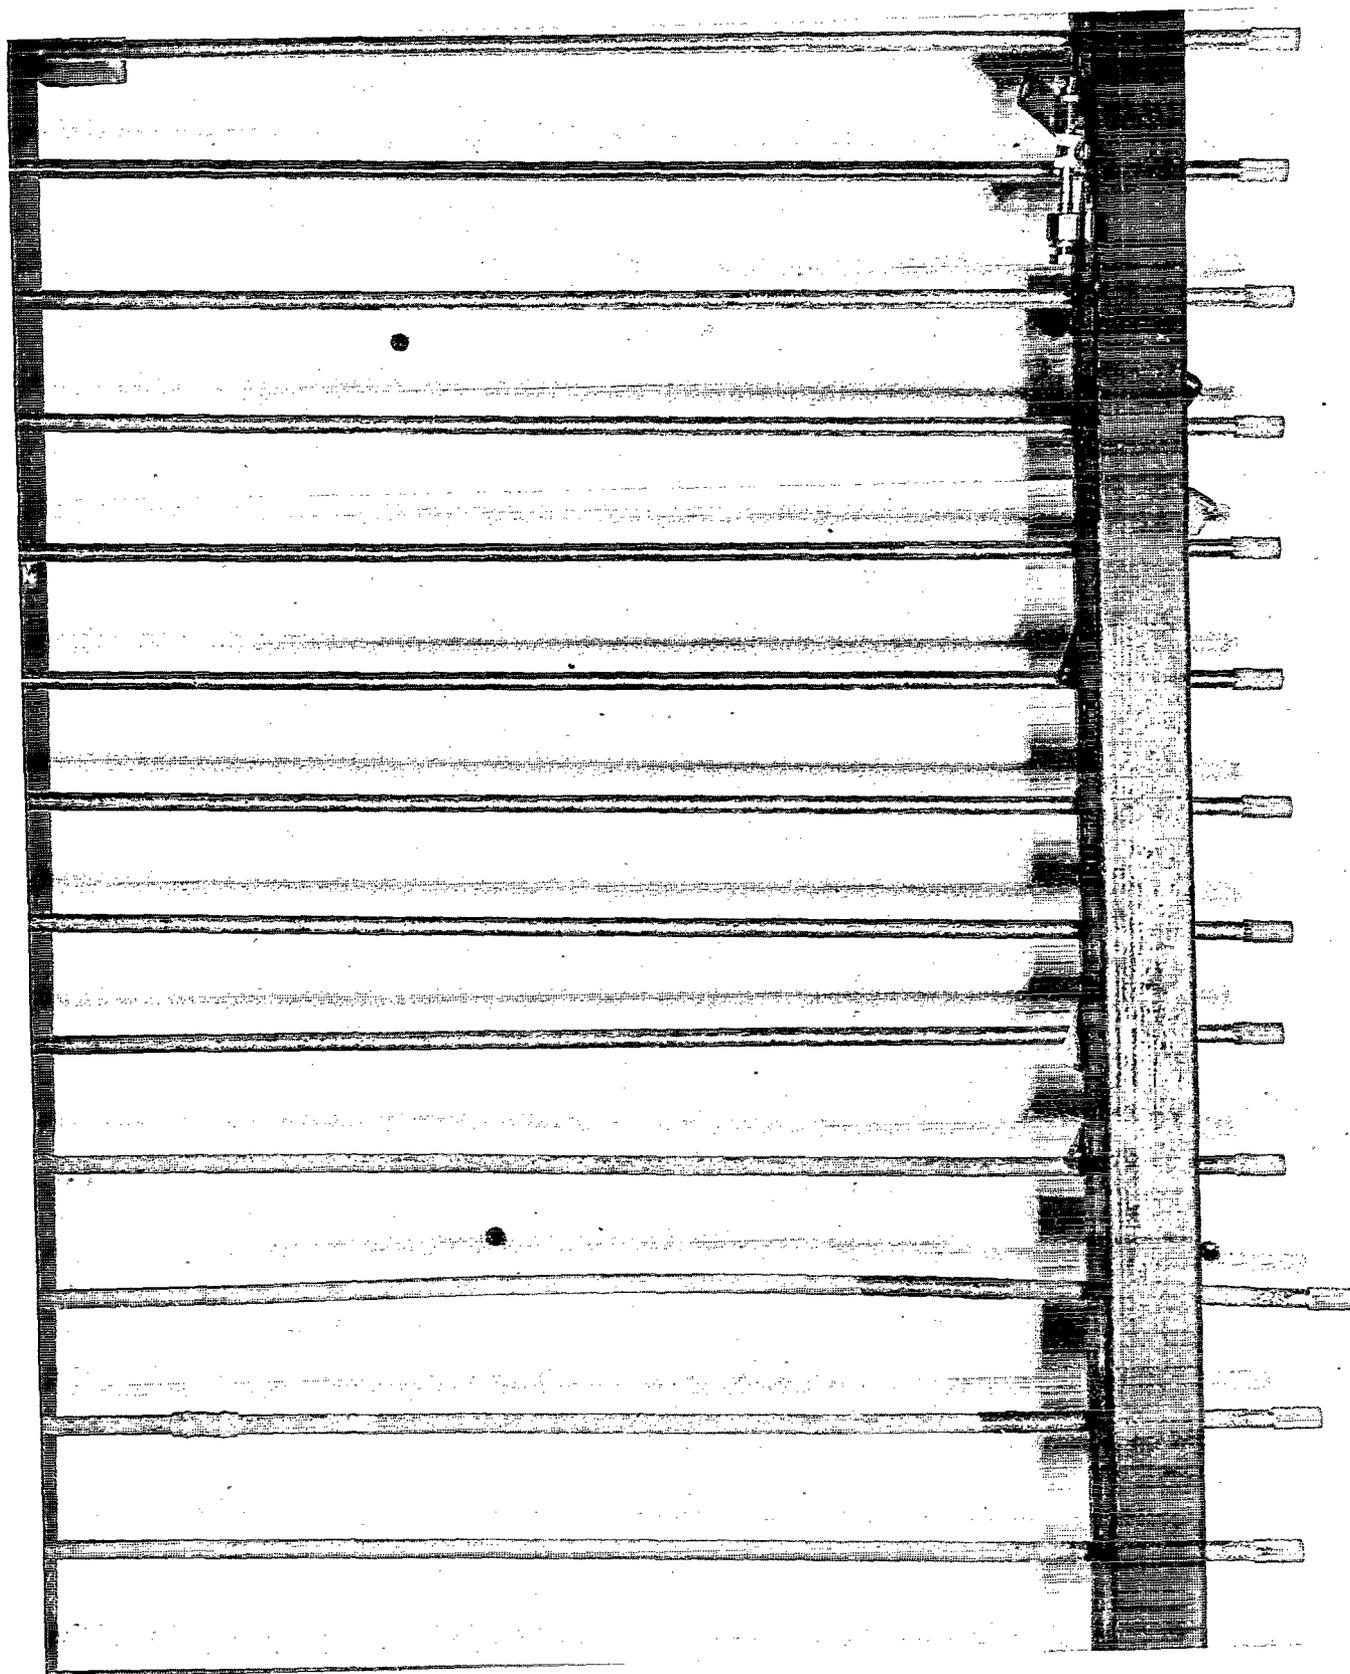
Figure 5. Tubing Samples in Sheltered Section of Rack Number 3 After 3 Months' Exposure
(The four organic-zinc-coated samples are shown at the bottom) (Sheet 1 of 2)

The general appearance of several of the coated and bare test specimens in Racks Number 3 and 4 is shown in Figures 5 through 10. Figure 5, Sheet 1 shows the underside of a group of bare and coated tubing samples in the sheltered section of Rack Number 3 after approximately 3 months' exposure. The four coated samples in Figure 5, Sheet 1 are the tubes removed from Complex 34 and brush-coated with organic-zinc paint. Two of the tubes also have short sections wrapped with self-sealing polyethylene tape. It can be noted that three of the coated tubes have bare spots near the end caps. These bare spots did not show active corrosion during the total exposure period of approximately 30 months, evidently because of sacrificial protection afforded by the zinc coating. The dark spots on the bare tubes are accumulations of corrosion products around active pits.

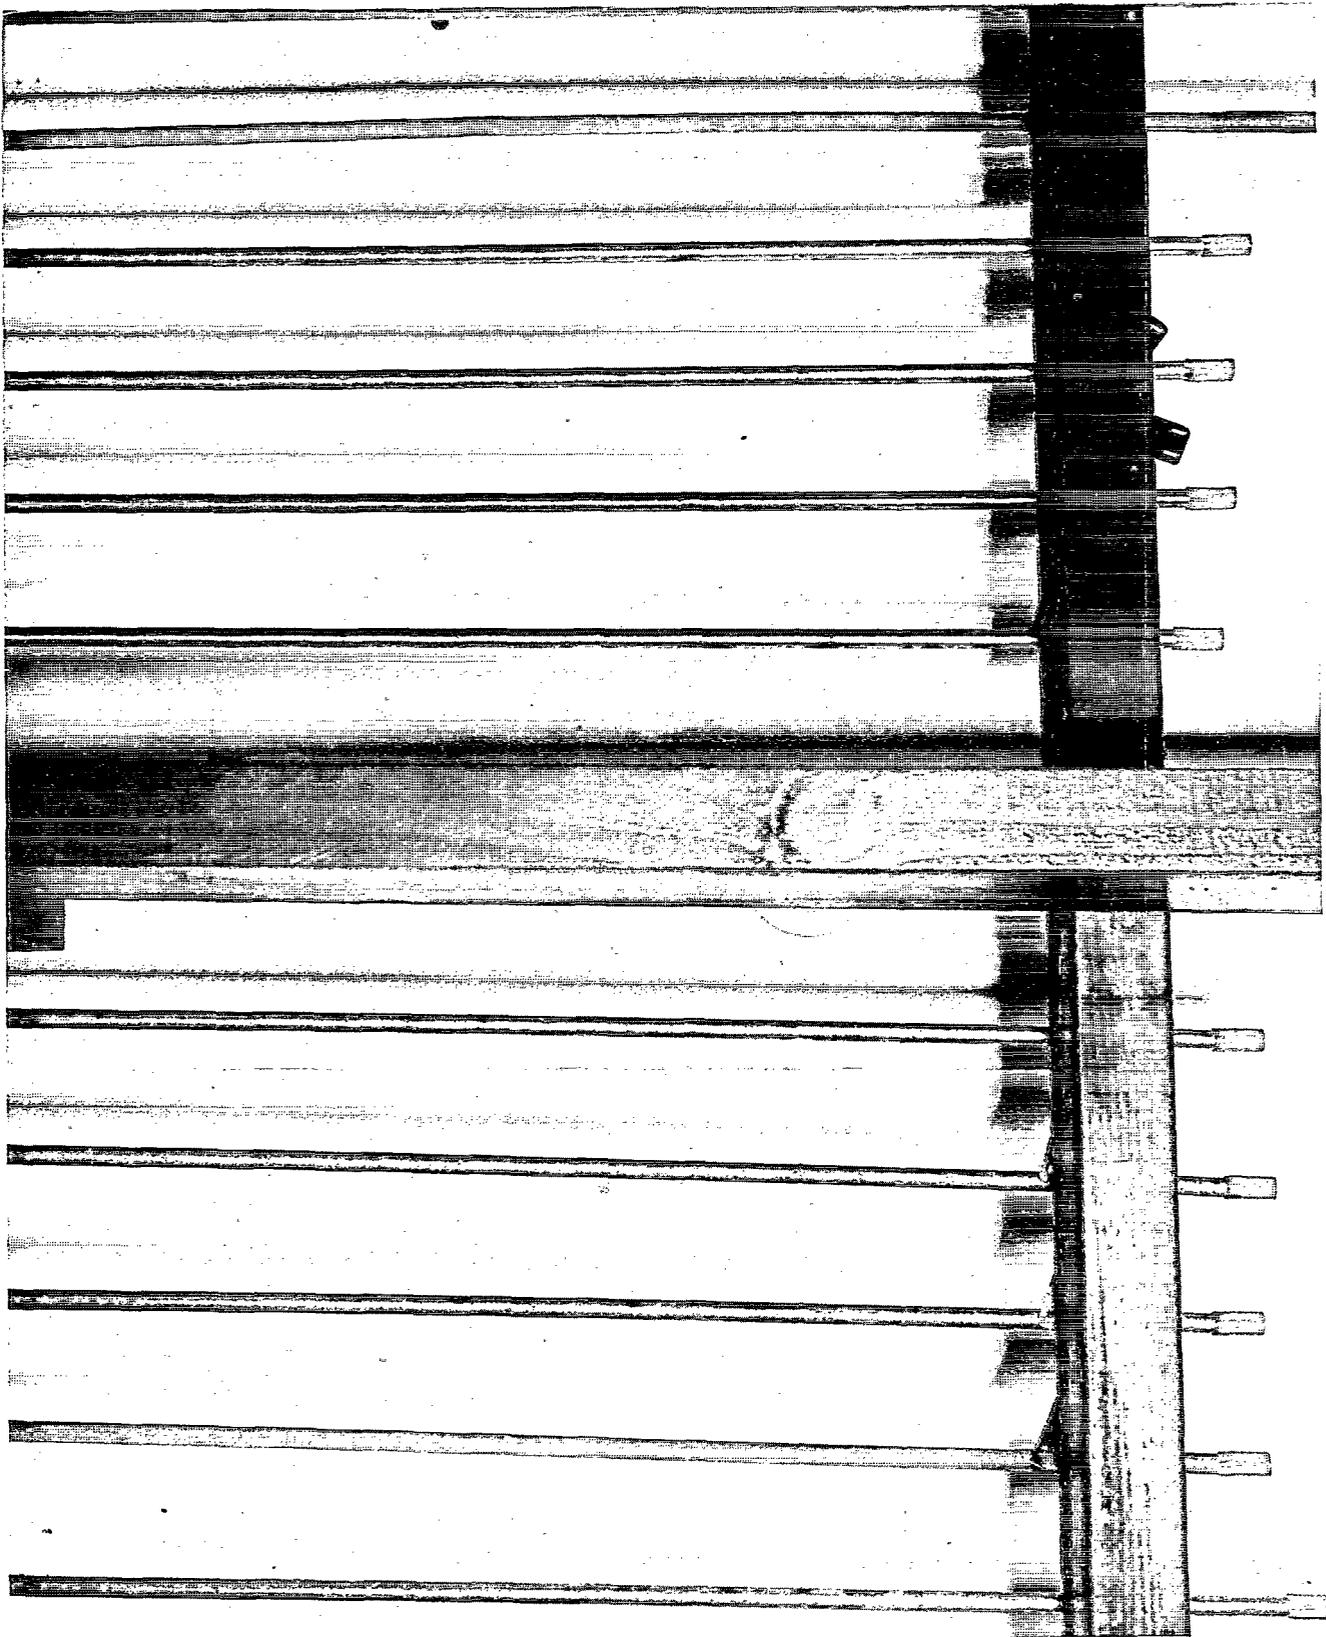
Figure 5. Tubing Samples in Sheltered Section of Rack Number 3 After 3 Months' Exposure
(The inorganic-zinc-coated sample is shown at bottom) (Sheet 2 of 2)

Similar conditions are shown on the bare samples illustrated in Figure 5, Sheet 2. The single coated sample at the bottom of the photograph has the inorganic-zinc paint applied over a sandblasted surface. This coating remained intact after 30 months' exposure.

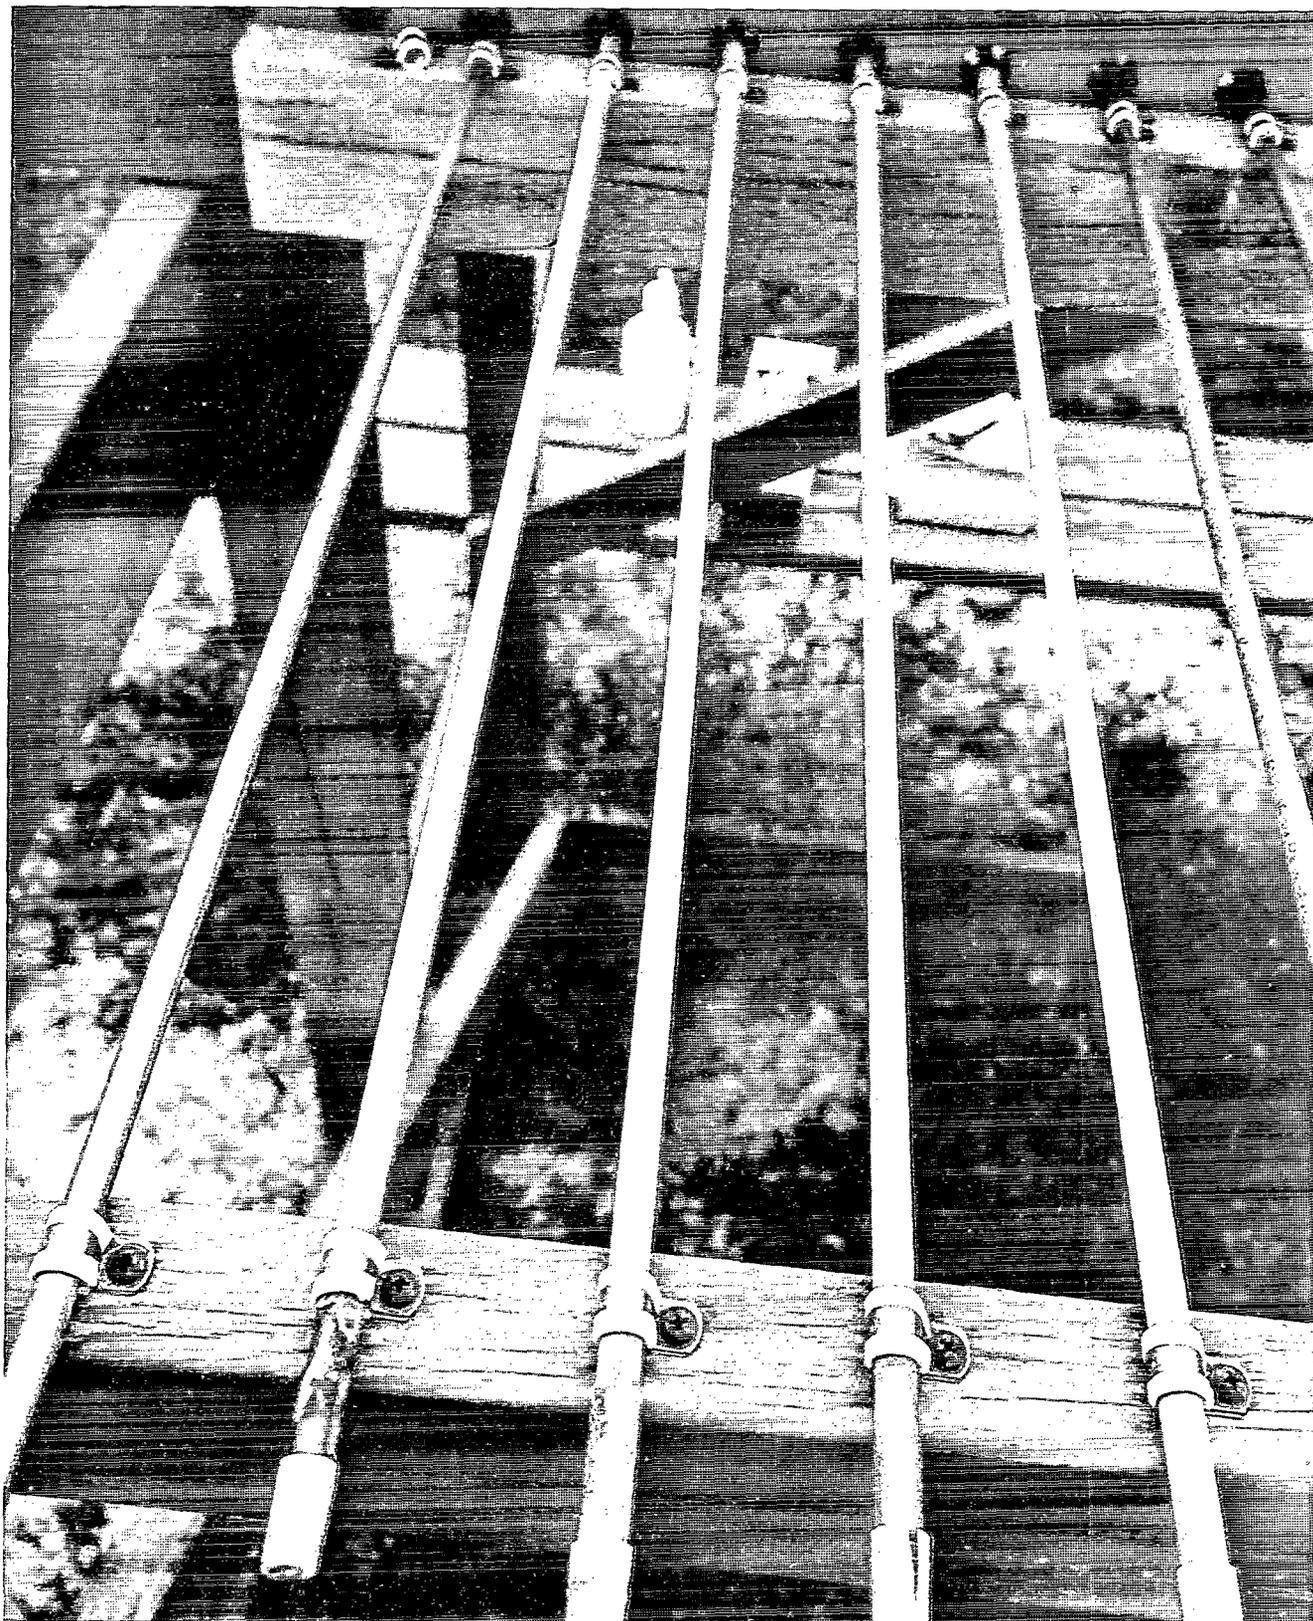
Figure 6. Bare and Organic-Zinc-Coated Samples in Exposed Section of Rack Number 3
(After approximately 30 months' exposure)

Figures 6 and 7 show other bare and organic-zinc-coated tubes in the exposed and sheltered sections, respectively, of Rack Number 3 after approximately 30 months' exposure. The coating was applied to "new" tubing samples that had been cleaned with the phosphoric acid wash. These samples, including intentional bare areas (or tape-wrapped areas) near the end caps, remained essentially free of corrosion during this exposure period.

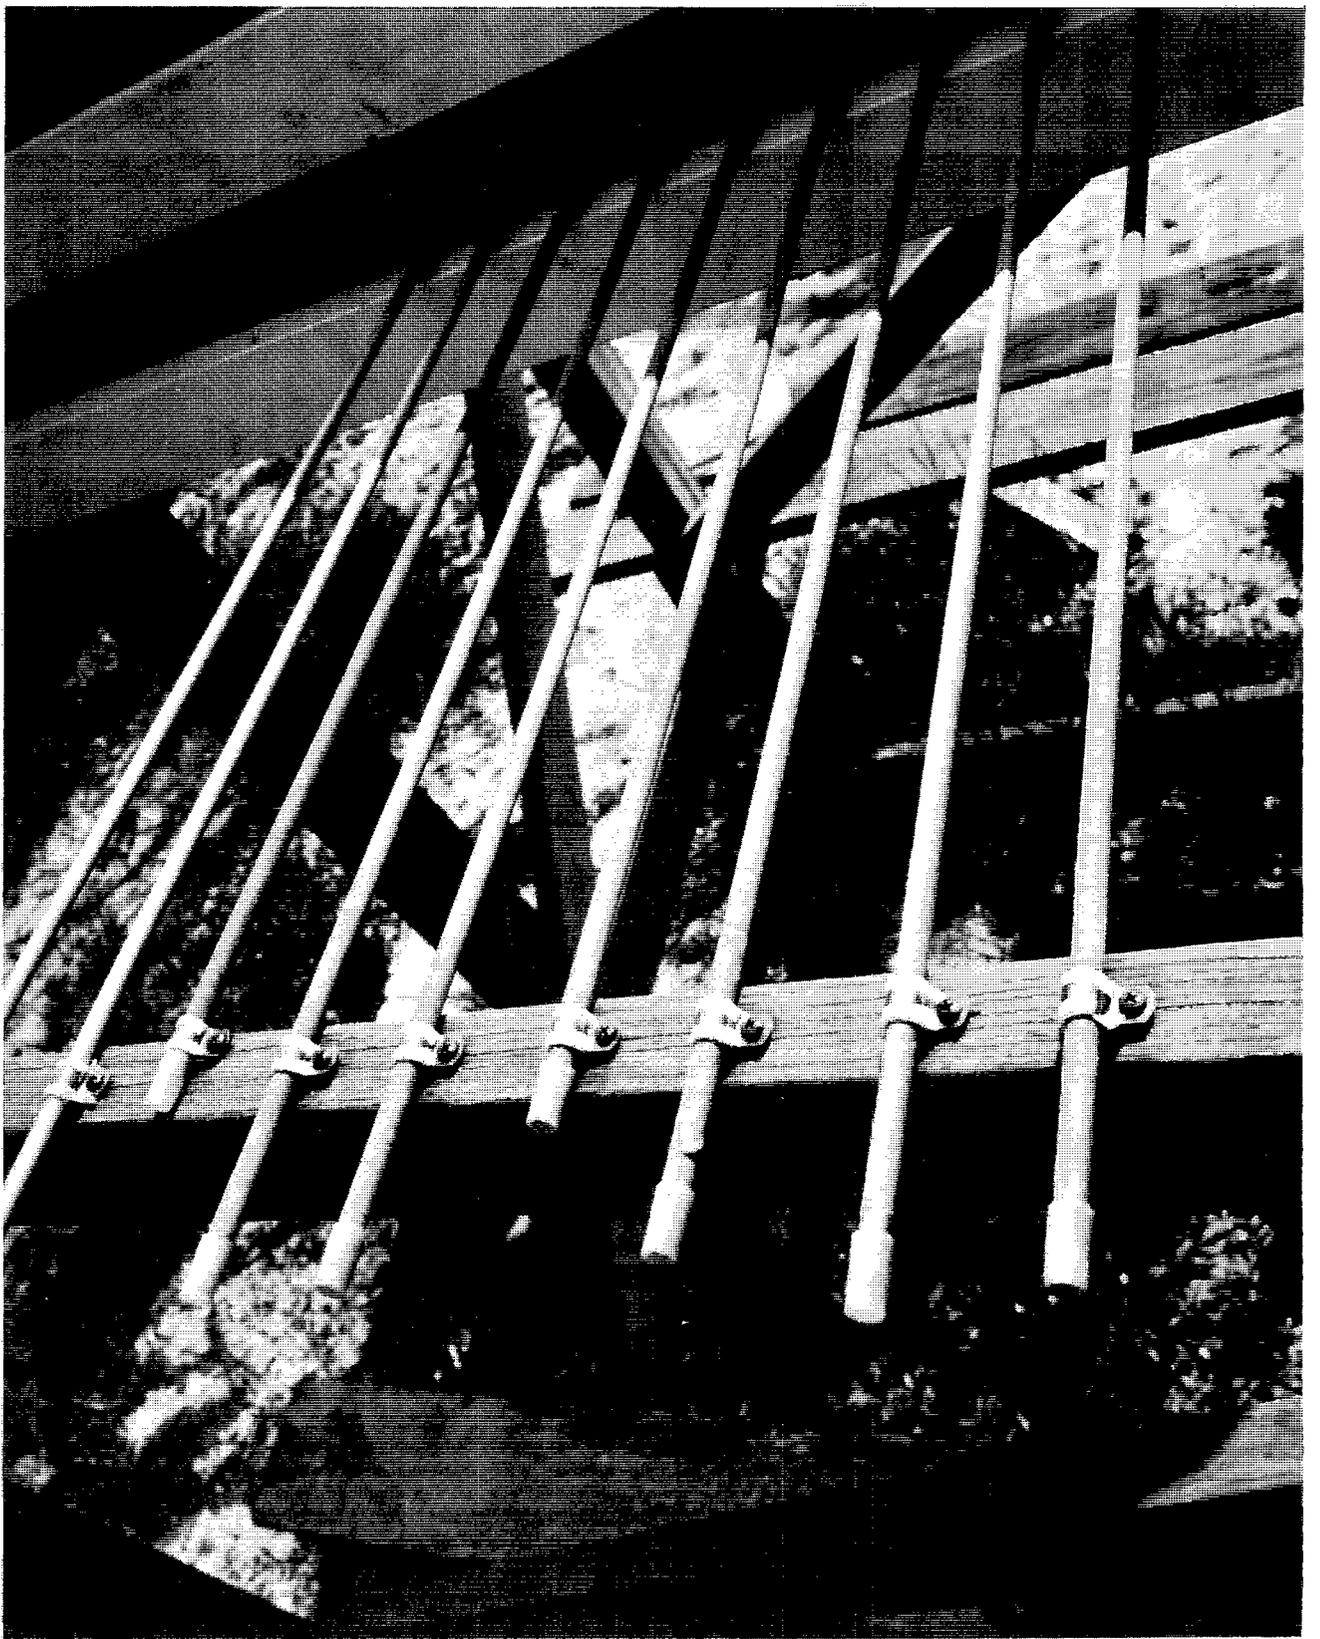
Figure 8. Coated Samples in Exposed Section of Rack Number 4 After 10 Months' Exposure
(Two aluminum-filled coatings and one aluminum-zinc-filled coating on left;
remaining six samples are organic-zinc-paint-coated)

These coatings have remained entirely intact and protective to the stainless steel substrate during the 10 months of exposure. Slight flaking of the organic-zinc paint has occurred on the sheltered side of two of the samples, at the X-shaped scribe marks in the coatings. However, the organic-zinc coating has continued to protect the substrate in these areas.

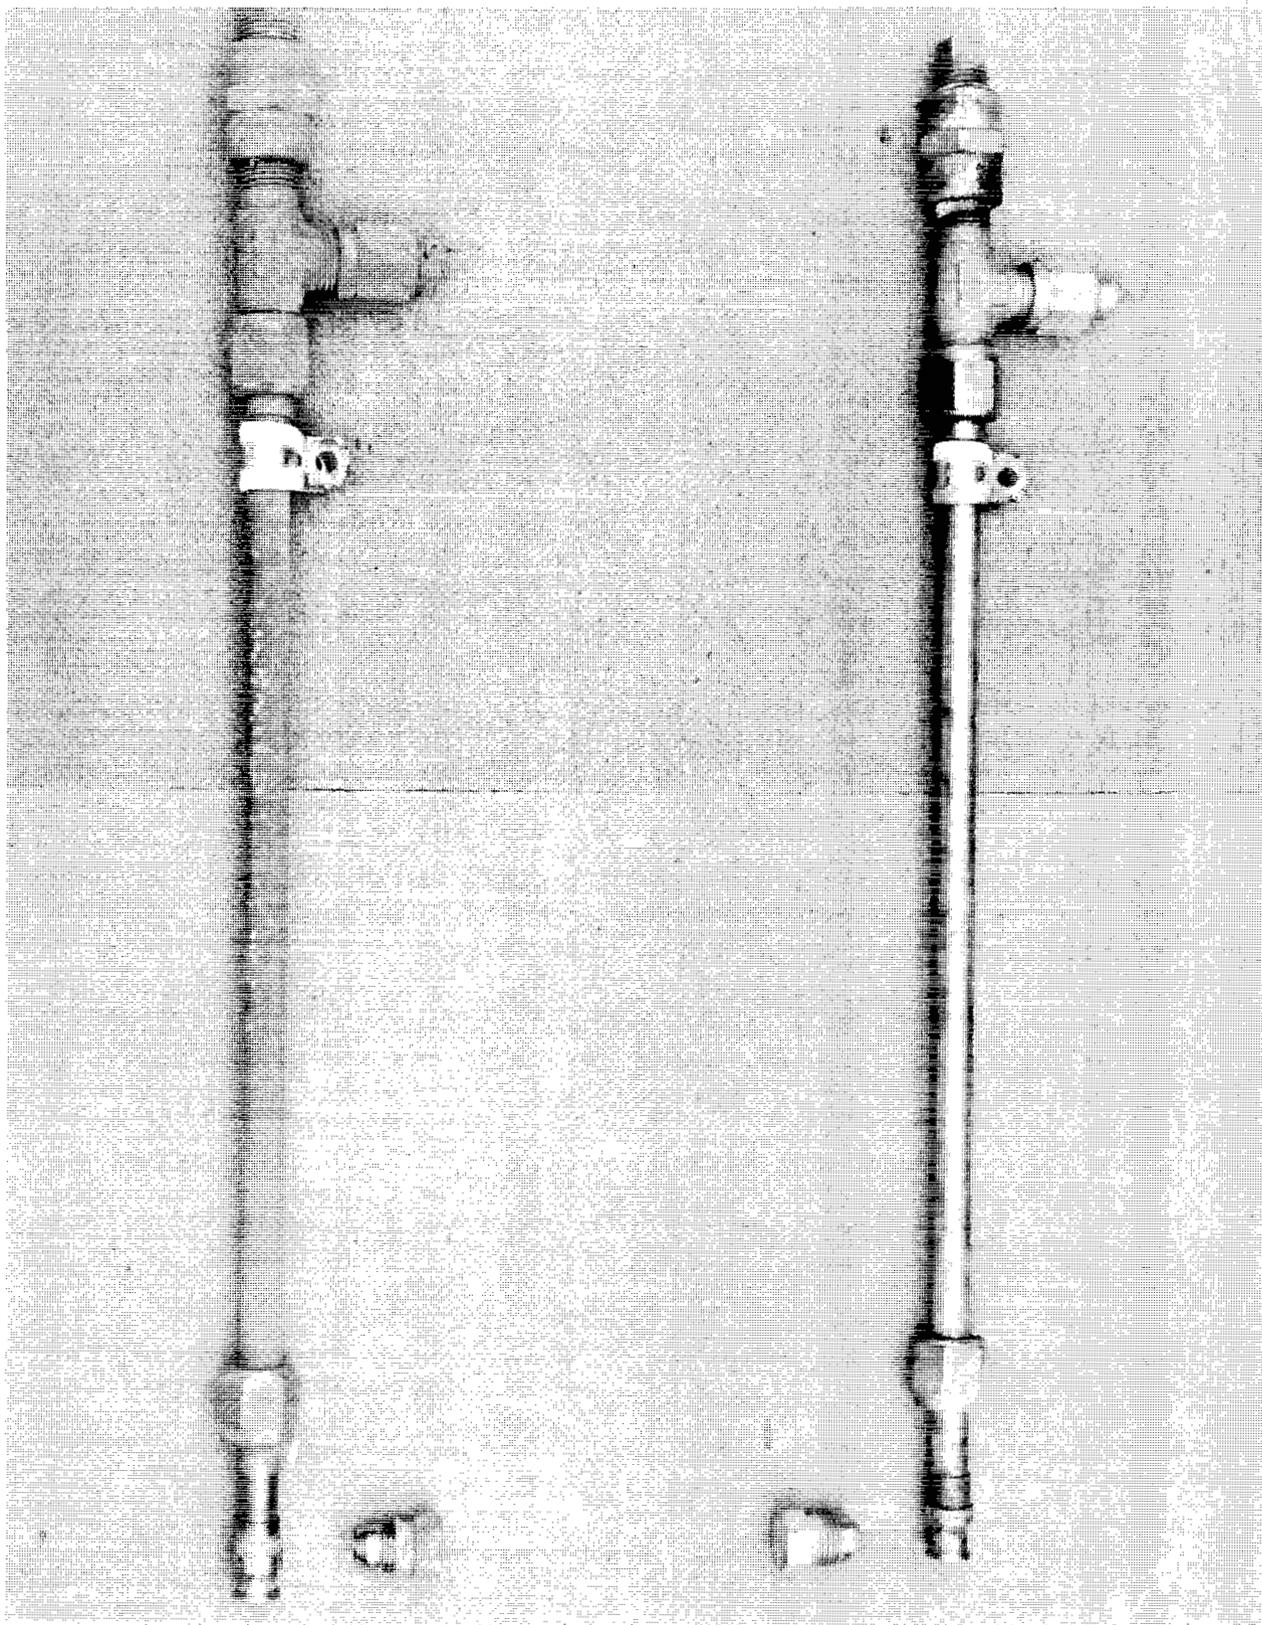
Figure 10. Coated and Bare Tubing Assemblies After 12 and 14 Months' Exposure, Respectively, in the Sheltered Section of Rack Number 4 (Inorganic, zinc-rich paint applied over sandblasted surface)

Figure 10 shows two tubing assemblies removed from the sheltered section of Rack Number 4. The sample on the left side has been sandblasted and coated with inorganic-zinc paint, and was exposed at the corrosion test site for 12 months. The bare sample was exposed for 14 months. The B-nuts and end plugs were removed, exposing the flared ends of both samples. The zinc-coated sample showed no evidence of corrosion. The bare sample had undergone considerable crevice corrosion in the B-nut area, and there were large corrosion deposits under both the B-nut and sleeve. Several longitudinal cracks were noted in the sleeve. The extent

of the stress-corrosion cracking is this B-nut sleeve is described in more detail in subsequent paragraphs herein. It is evident that the zinc coating affords protection against crevice corrosion and stress-corrosion cracking in the area of tubing attachments.

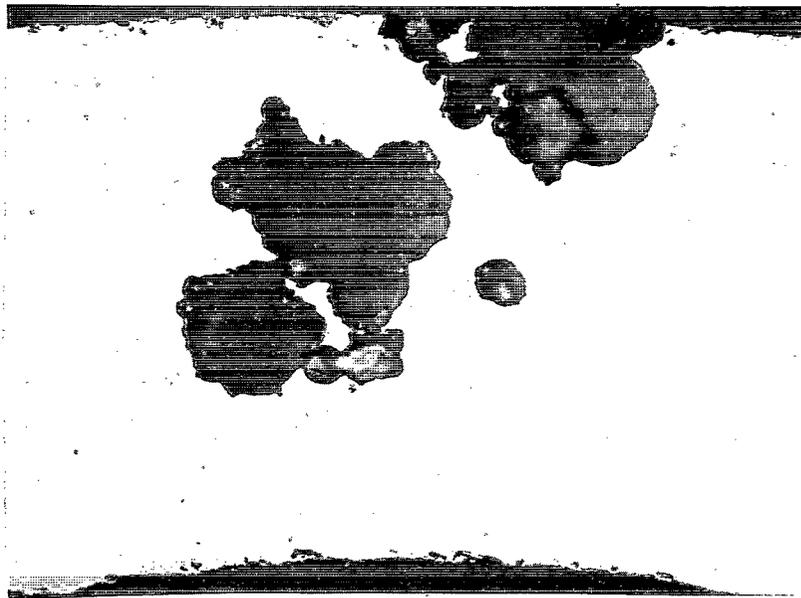
Figure 11. Surface Characteristics and Pit Depth of Type 316L Exposure Sample

Actually, the deepest pits found to date in any of the samples have been in Type 316L and in the Type 316 (MSFC 10M01734), as is shown in Figures 11 and 18. This is not to suggest that Type 316 has a higher pitting rate than the other grades; in another Type 316 sample (Figure 15), no deep pits were found. The evidence cited here does suggest that no single austenitic stainless steel of the grades tested in this program is significantly better than the others for the fluid-systems applications in an environment of the KSC type.
