FATIGUE EXPERIENCE FROM TESTS CARRIED OUT WITH FORGED
BEAM AND FRAME STRUCTURES IN THE DEVELOPMENT
OF THE SAAB AIRCRAFT VIGGEN

By S. E. Larsson
Saab-Scania Aktiebolag
Linköping, Sweden

SUMMARY

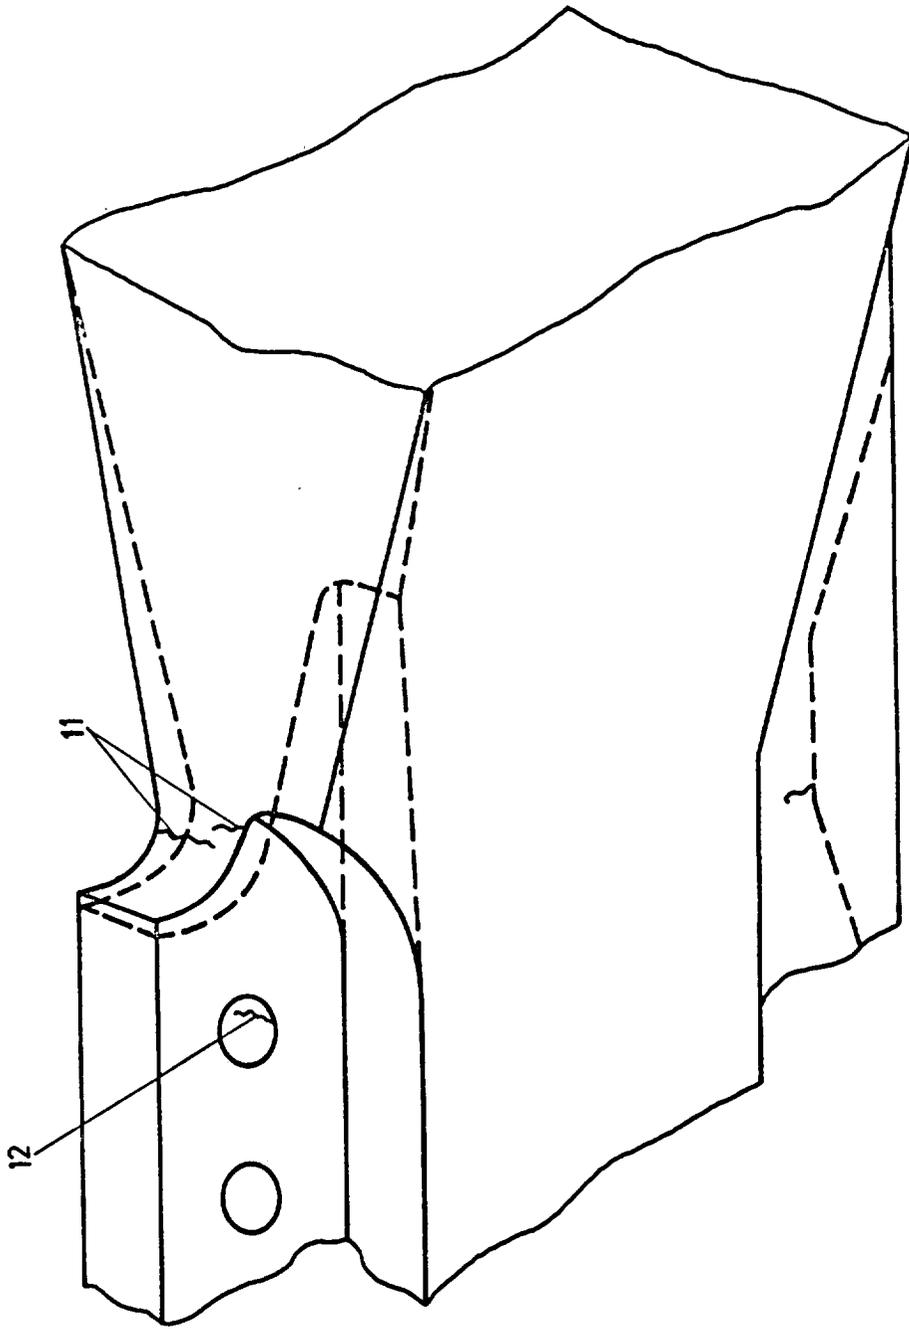
It can be seen in table I(b) that cracks appeared in specimen A₁ after only 3400 h. These cracks, no. 11, are shown in figure 9. One crack started where a radius $r = 3$ mm interacted with the principal notch radius $r = 10$ mm. Another crack started from the opposite side in a rough edge of the notch. Many very small cracks were also found in the anodized surface of the flange notch area.

The specimen in this original shape was not quite representative of the aircraft structure, and it became less representative because the specimen was modified to remove the cracked material. However, the test was continued in order to study the area with bolt holes in the boom flange – that area which originally had been thought to be the most critical. For this case the cracked material was milled off, and the shape was modified to that marked with the dashed lines. Besides cracks in areas not considered significant, no new damage was found until crack 12 appeared in bolt hole 1 at about 21 000 h. The test was finished at 24 100 equivalent flight hours without a limiting failure.

Figure 9.- Test specimen A₁ with cracks found. Solid lines indicate original specimen in which cracks 11 occurred. The cracked material was milled off and the shape of the specimen modified as shown by dashed lines before occurrence of crack 12.

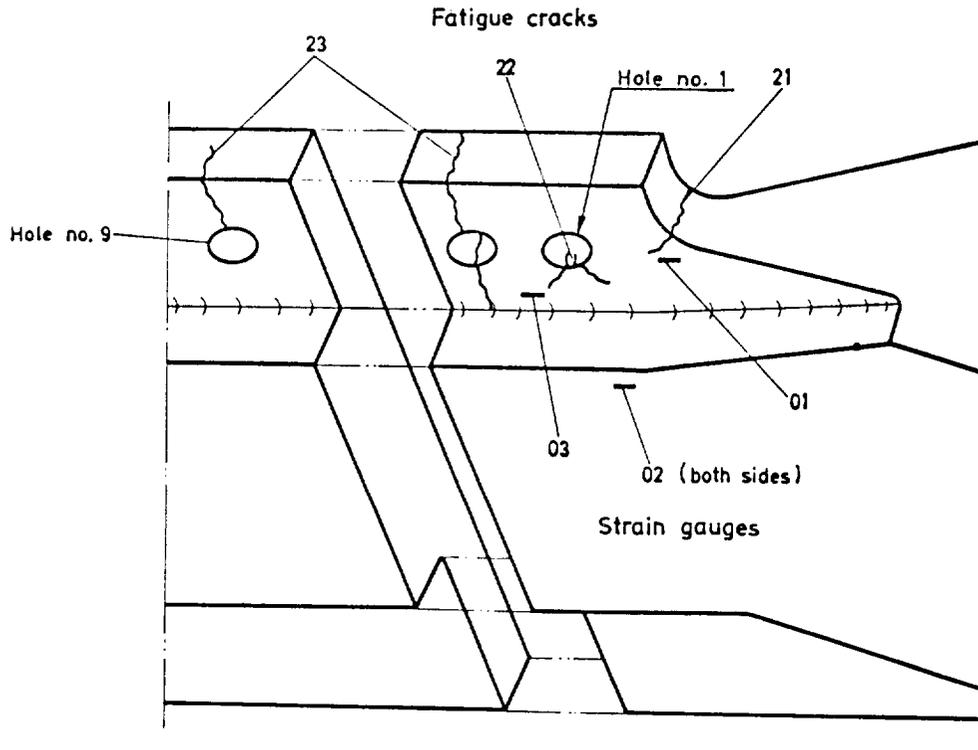
Figure 10 shows specimen A₂ in a late stage with the cracks fully developed. Crack 21 was found after 8400 h, when it had a length of $l = 1$ mm. Its slow propagation was studied and it was under control until the test was ended as a result of bolt failure in hole 1 at 15 200 h. The crack propagation history can be followed in figure 20 (which includes sketches defining l and δ). Figure 11 shows details of the cracked specimen A₂.

Figure 10.- Test specimen A₂ with cracks found.

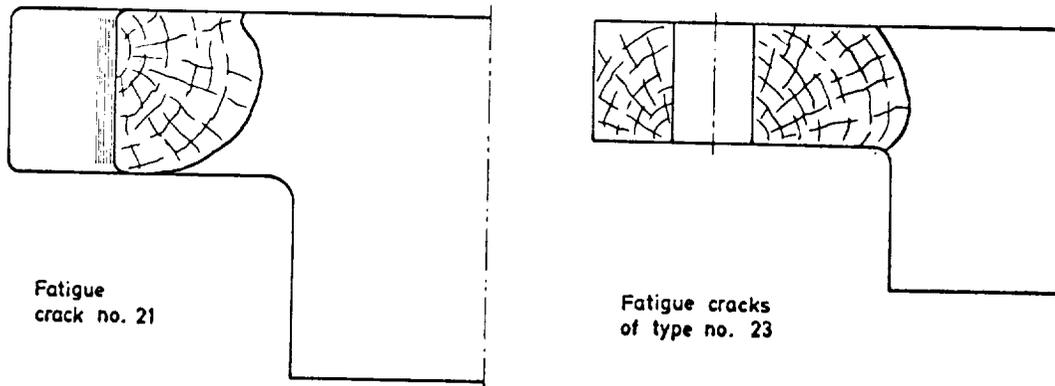
Figure 11.- Details of the cracked specimen A₂.

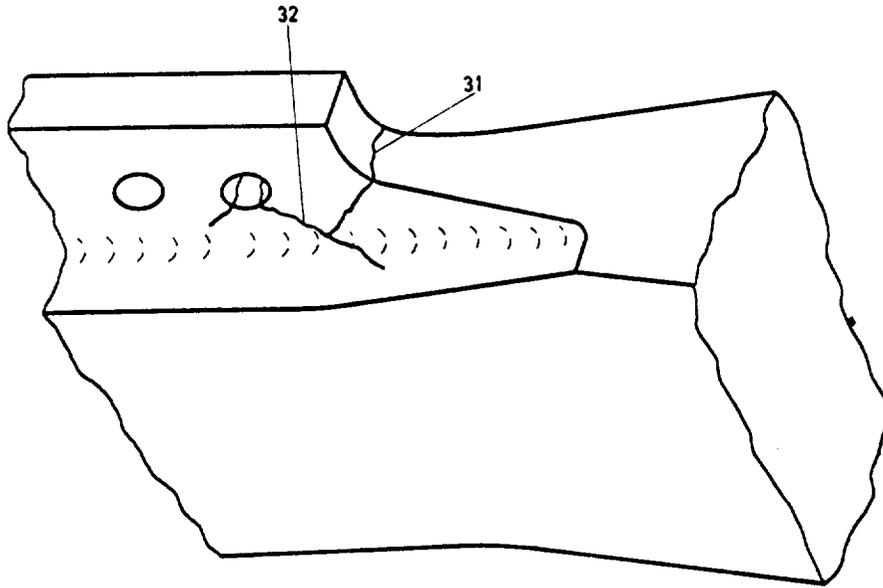
Figure 12 shows fully developed cracks in specimen A₃. The nature of crack 31 was about the same as that of crack 21 in figure 10. Crack 31 was found at 7700 h, when it had a length of $l \approx 5$ mm. It propagated somewhat more rapidly than crack 21.

The most interesting crack in specimen A₃ was the crack designated 32. This crack was seen for the first time at 10 500 h (not seen at crack search 600 h earlier). When discovered it had a visible length of about 10 mm (about 12 mm was hidden under the panel). From this stage it propagated rapidly (a rate of about 0.02 mm/h) and then more slowly. The same tendency toward crack development from bolt hole 1 can be seen in figure 10. The new results, however, are the rapid propagation of crack 32 and the complicated interaction with crack 31.

Figure 12.- Test specimen A₃ with cracks found.

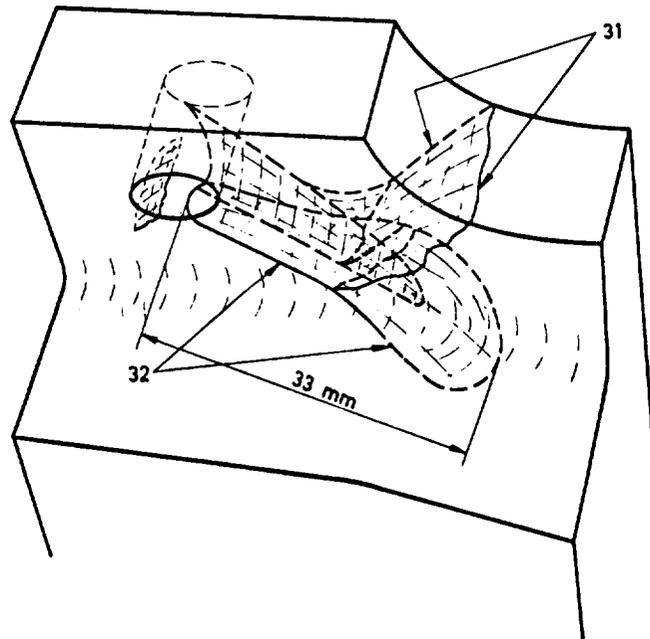
Figure 13 shows the features of the locally developed fatigue fracture surfaces of the cracked area in specimen A₃. The slightly concave boom-side surface of crack 32 is thought to be the result of "Stage I" crack growth according to reference 2. The 45° direction is pronounced, and no unusual material properties or defects have been found. The surfaces were rubbed and could not give adequate information. At the stage of figure 13, crack 32 shows a tendency to change over to a 90° fatigue fracture. Figure 13 also shows that crack 32 must have been present when crack 31 passed through its area. The less interesting surfaces are not numbered.

Figure 13.- Details of the cracked specimen A₃.

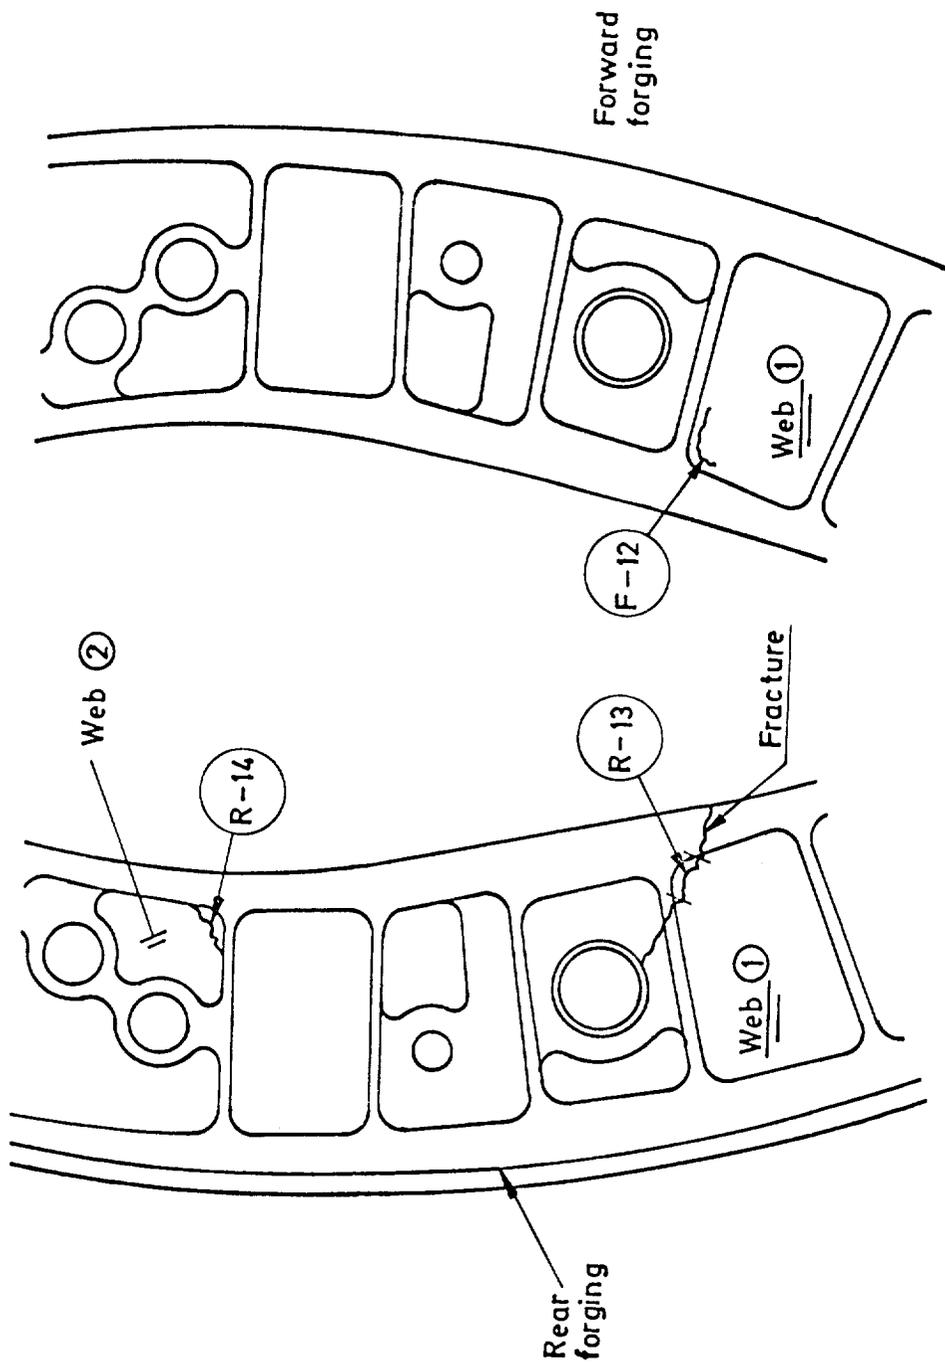
Ultimate failure of specimen B₁ occurred at 5300 h by fracture from an unexpected fatigue crack in web (1) of the rear forging, shown in figure 14. No crack search with fluorescent penetrant had been done in this area before failure. Afterward, however, four other cracks of about the same kind were indicated in three forgings of specimens B₁ and B₂. The B₂ test was also ended. An inspection made clear that the surface finish of the web areas of the milled frame forgings was worse than specified.

Figure 14.- Test specimen B1 with fatigue cracks and the location of failure indicated.

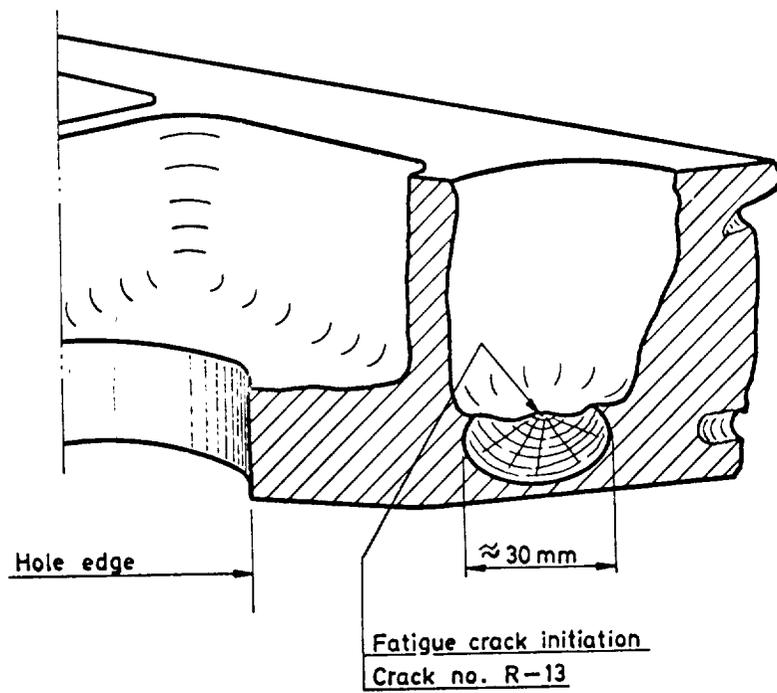
Figure 14 shows test specimen B₁ with fatigue cracks and the location of failure indicated. Figure 15 shows the fractured area of specimen B₁ with a sketch of the fatigue fracture surface, which represented ≈ 390 mm², or ≈ 10 percent of the whole area of the section. Figure 16 shows the surface shape of the fatigue crack that caused failure in B₁. It is representative of a number of web areas in both B₁ and B₂. The root radius ρ of the milling step marks was about 0.5 mm.

Figure 15.- Fractured area of specimen B₁.

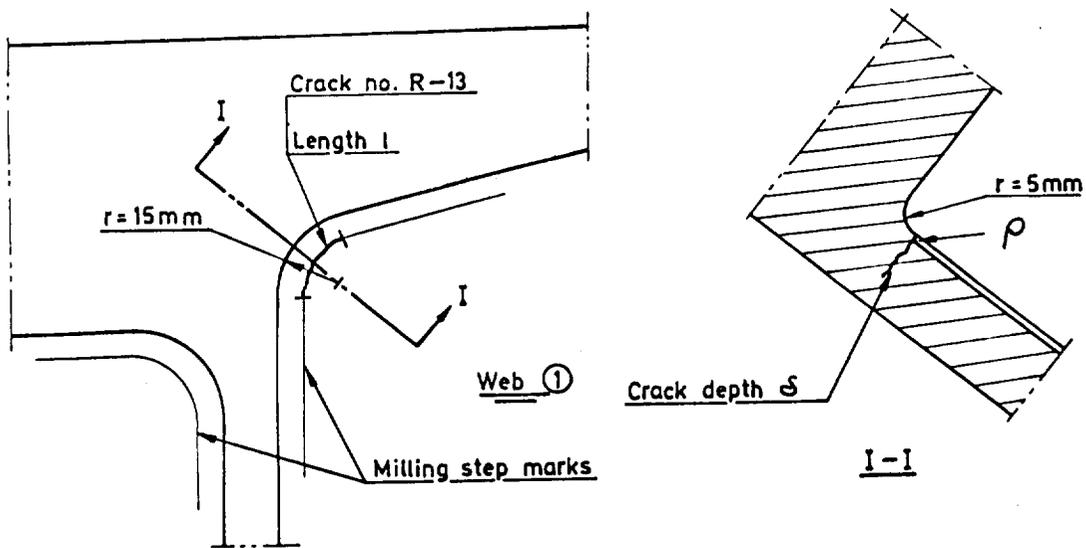
The main surface problem with the frame specimens B₁ and B₂ was the milling step marks shown in figure 16. In highly stressed areas, these milling marks and other surface imperfections on parts of the aircraft were eliminated by surface-improving procedures followed by adequate corrosion protection.

Figure 16.- The surface shape in a cracked area of specimen B₁.

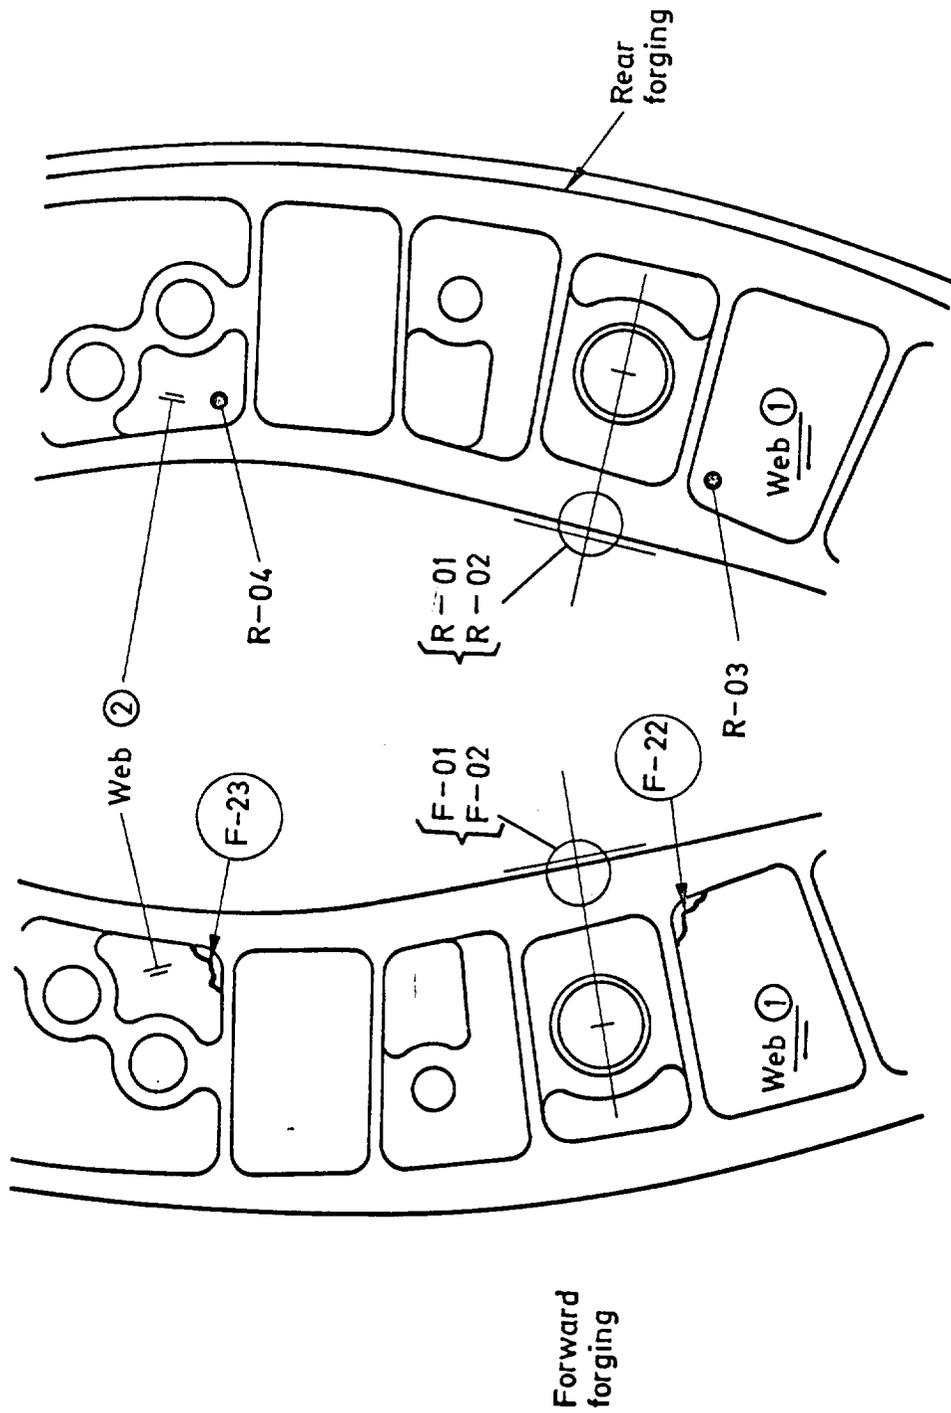
Figure 17 shows specimen B₂ with the location of cracks and strain gages indicated. Figure 18 shows the area with cracks in the inner sheet of the frame assembly. This area is not very representative of the aircraft because of the large unreinforced openings.

Figure 17.- Test specimen B₂ with cracks and location of strain gages indicated.

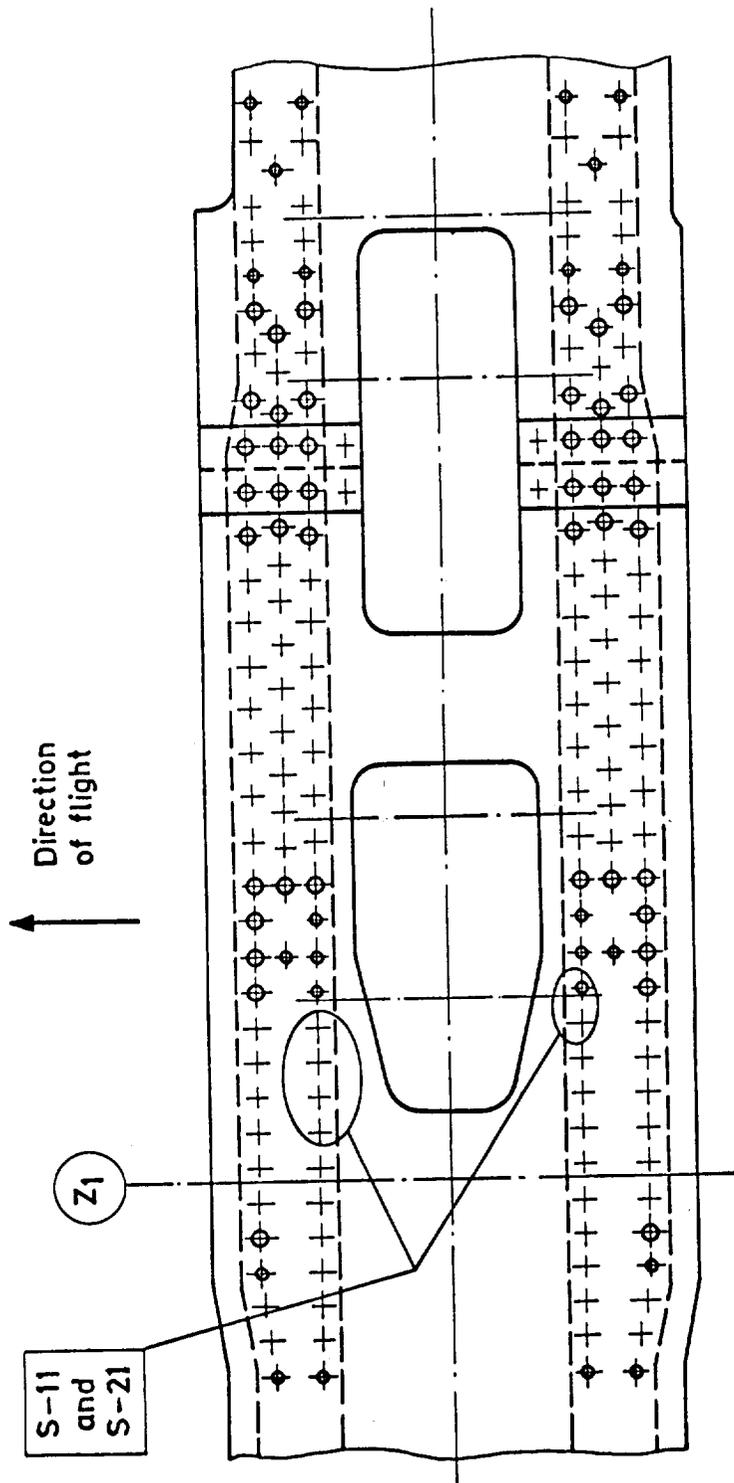
From table II(b) it can be seen that cracks appeared at screw holes in the inner sheet of the frame assembly after 4300 equivalent flying hours. Their propagation was observed, and in some cases they were stopped by the use of a blind rivet with $d = 4.8$ mm or plug with $d = 5$ mm (sheet thickness $t = 3$ mm).

Figure 18.- Area with cracks in the inner sheet of the frame assembly. This figure represents both specimens B₁ and B₂.

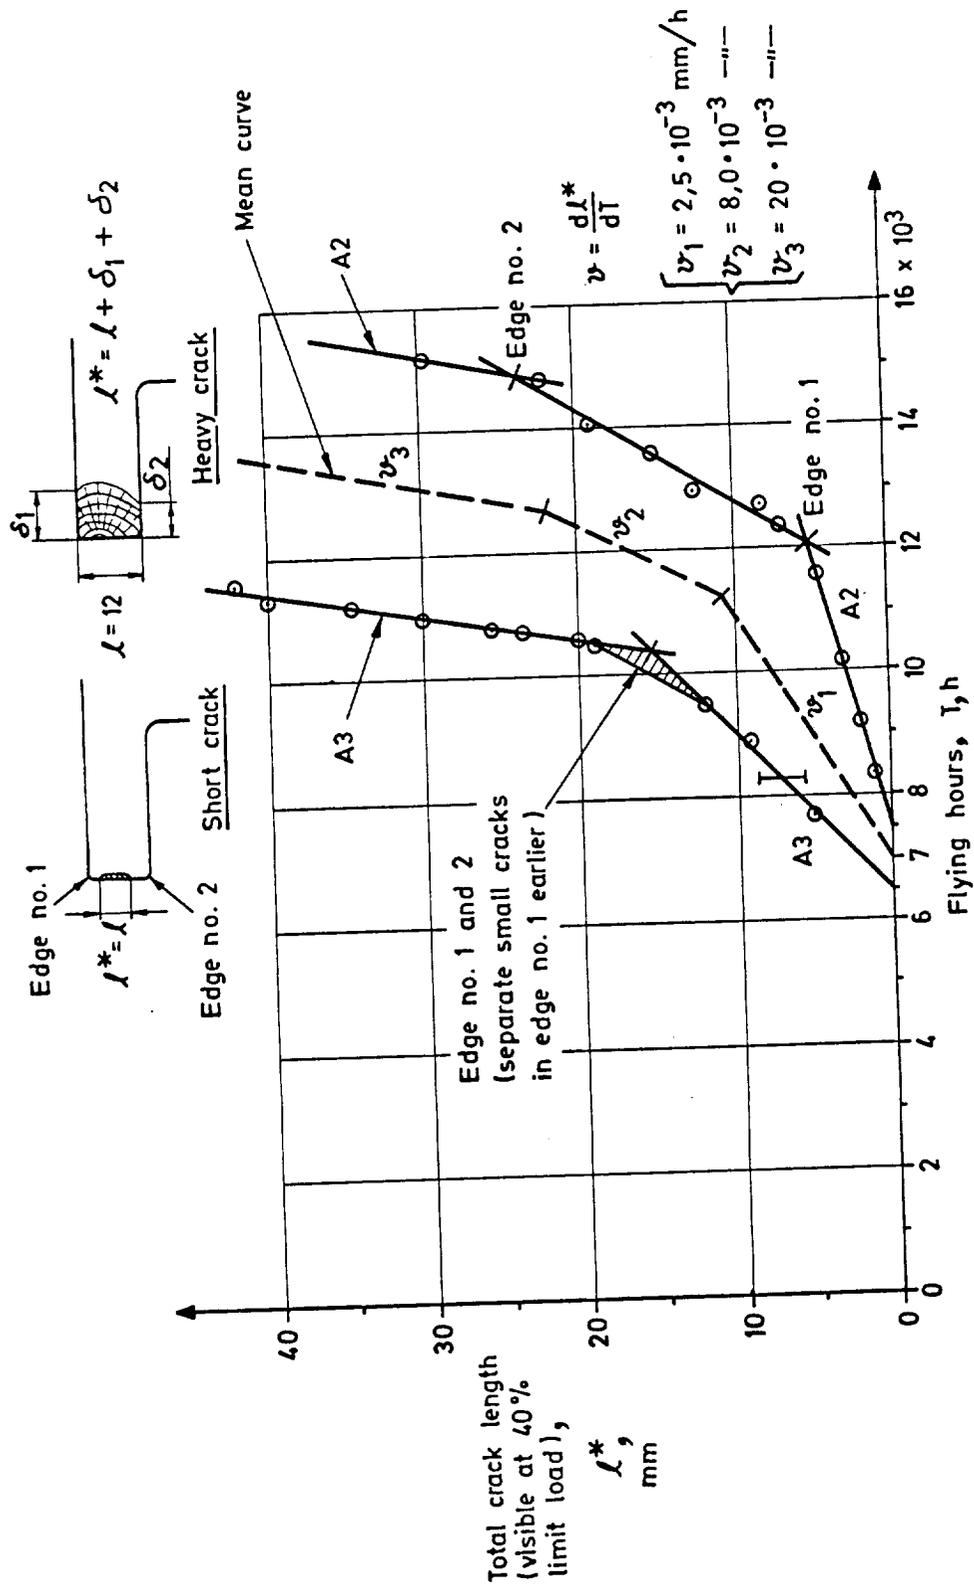
Propagation of the cracks in the AZ 74 boom flanges of specimens A₂ and A₃ (cracks 21 and 31) is shown in figure 20. Values of l^* (total visible crack length) were plotted against the number of equivalent flying hours T . The dashed lines make up a mean curve, visually estimated. This curve indicates that crack propagation, on the average, might be slow between $T = 7000$ h and $T = 11\ 000$ h. The mean crack propagation rate is $v_1 = 0.0025$ mm/h in this time interval. (Environmental conditions, not considered in the tests, must also be accounted for when estimating the probable damage tolerance of the aircraft structure.)

Figure 20.- Crack propagation at flange notch in specimens A2 and A3.
