MSC-07489

APOLLO 16 MISSION

ANOMALY REPORT NO. 11

MALFUNCTION OF TELEVISION CAMERA MONITOR
ON COMMAND MODULE

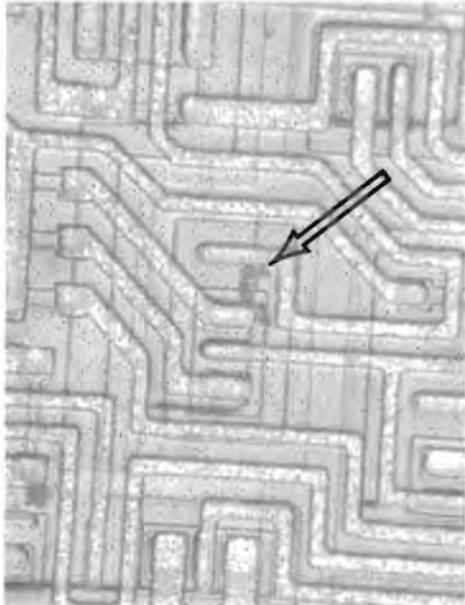
The problem was isolated to the precision voltage regulator which is a linear integrated circuit. The circuit assembly was removed and opened for inspection. It had the following defects:

1. There was general contamination and scoring on the chip face (fig. 1a).
2. Multiple attempts had been made in welding leads to the bonding posts and bonding pads on the chip (fig. 1b).
3. The lead on bonding post number 1 was loose (fig. 1c). As a result, the current sensing loop of the voltage regulator was open and the output ripple increased sufficiently to desynchronize the horizontal hold circuit.

(a) Contamination and scoring on chip face.

The precision voltage regulator with the television monitor low voltage power supply on Apollo 16 will be replaced and the regulator on Apollo 17 has been replaced. The replaced components will be opened, inspected, and tested.

2. The low-voltage power supply precision voltage regulator (linear integrated circuits) will be replaced on the seven remaining unmodified flight units.

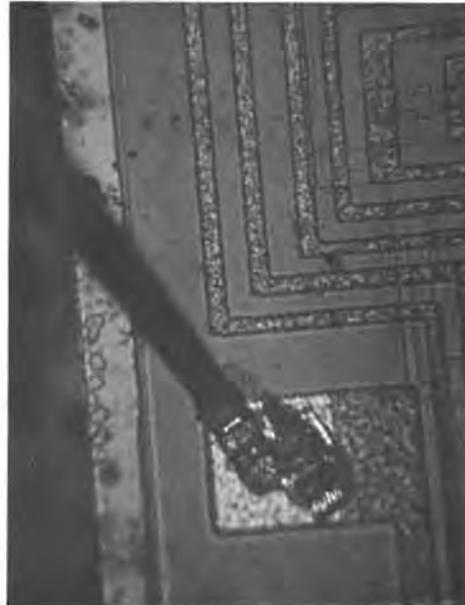
(b) Evidence of multiple attempts to weld lead to bonding pad.

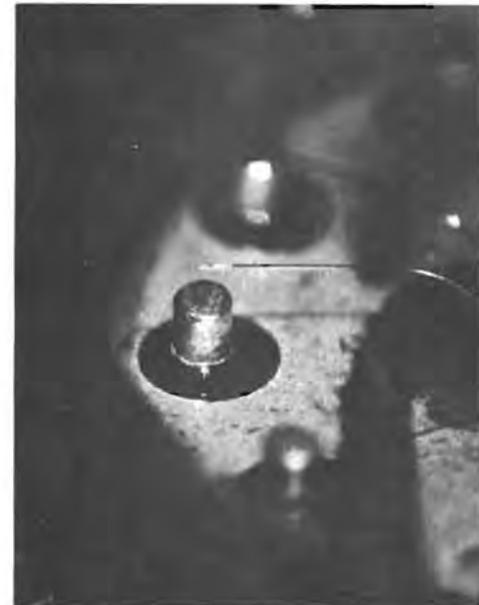
The loss of horizontal synchronization was most likely caused by either an intermittent condition in the precision voltage regulator circuit assembly in the low voltage power supply, or the shift of the stable range of the horizontal potentiometer setting when warming up after turn-on.

(c) Loose lead on bonding post.
