ABSTRACT

BYPASS CONTROL VALVE  
SEAL AND BEARING LIFE CYCLE TEST REPORT

Project 122

April 1972

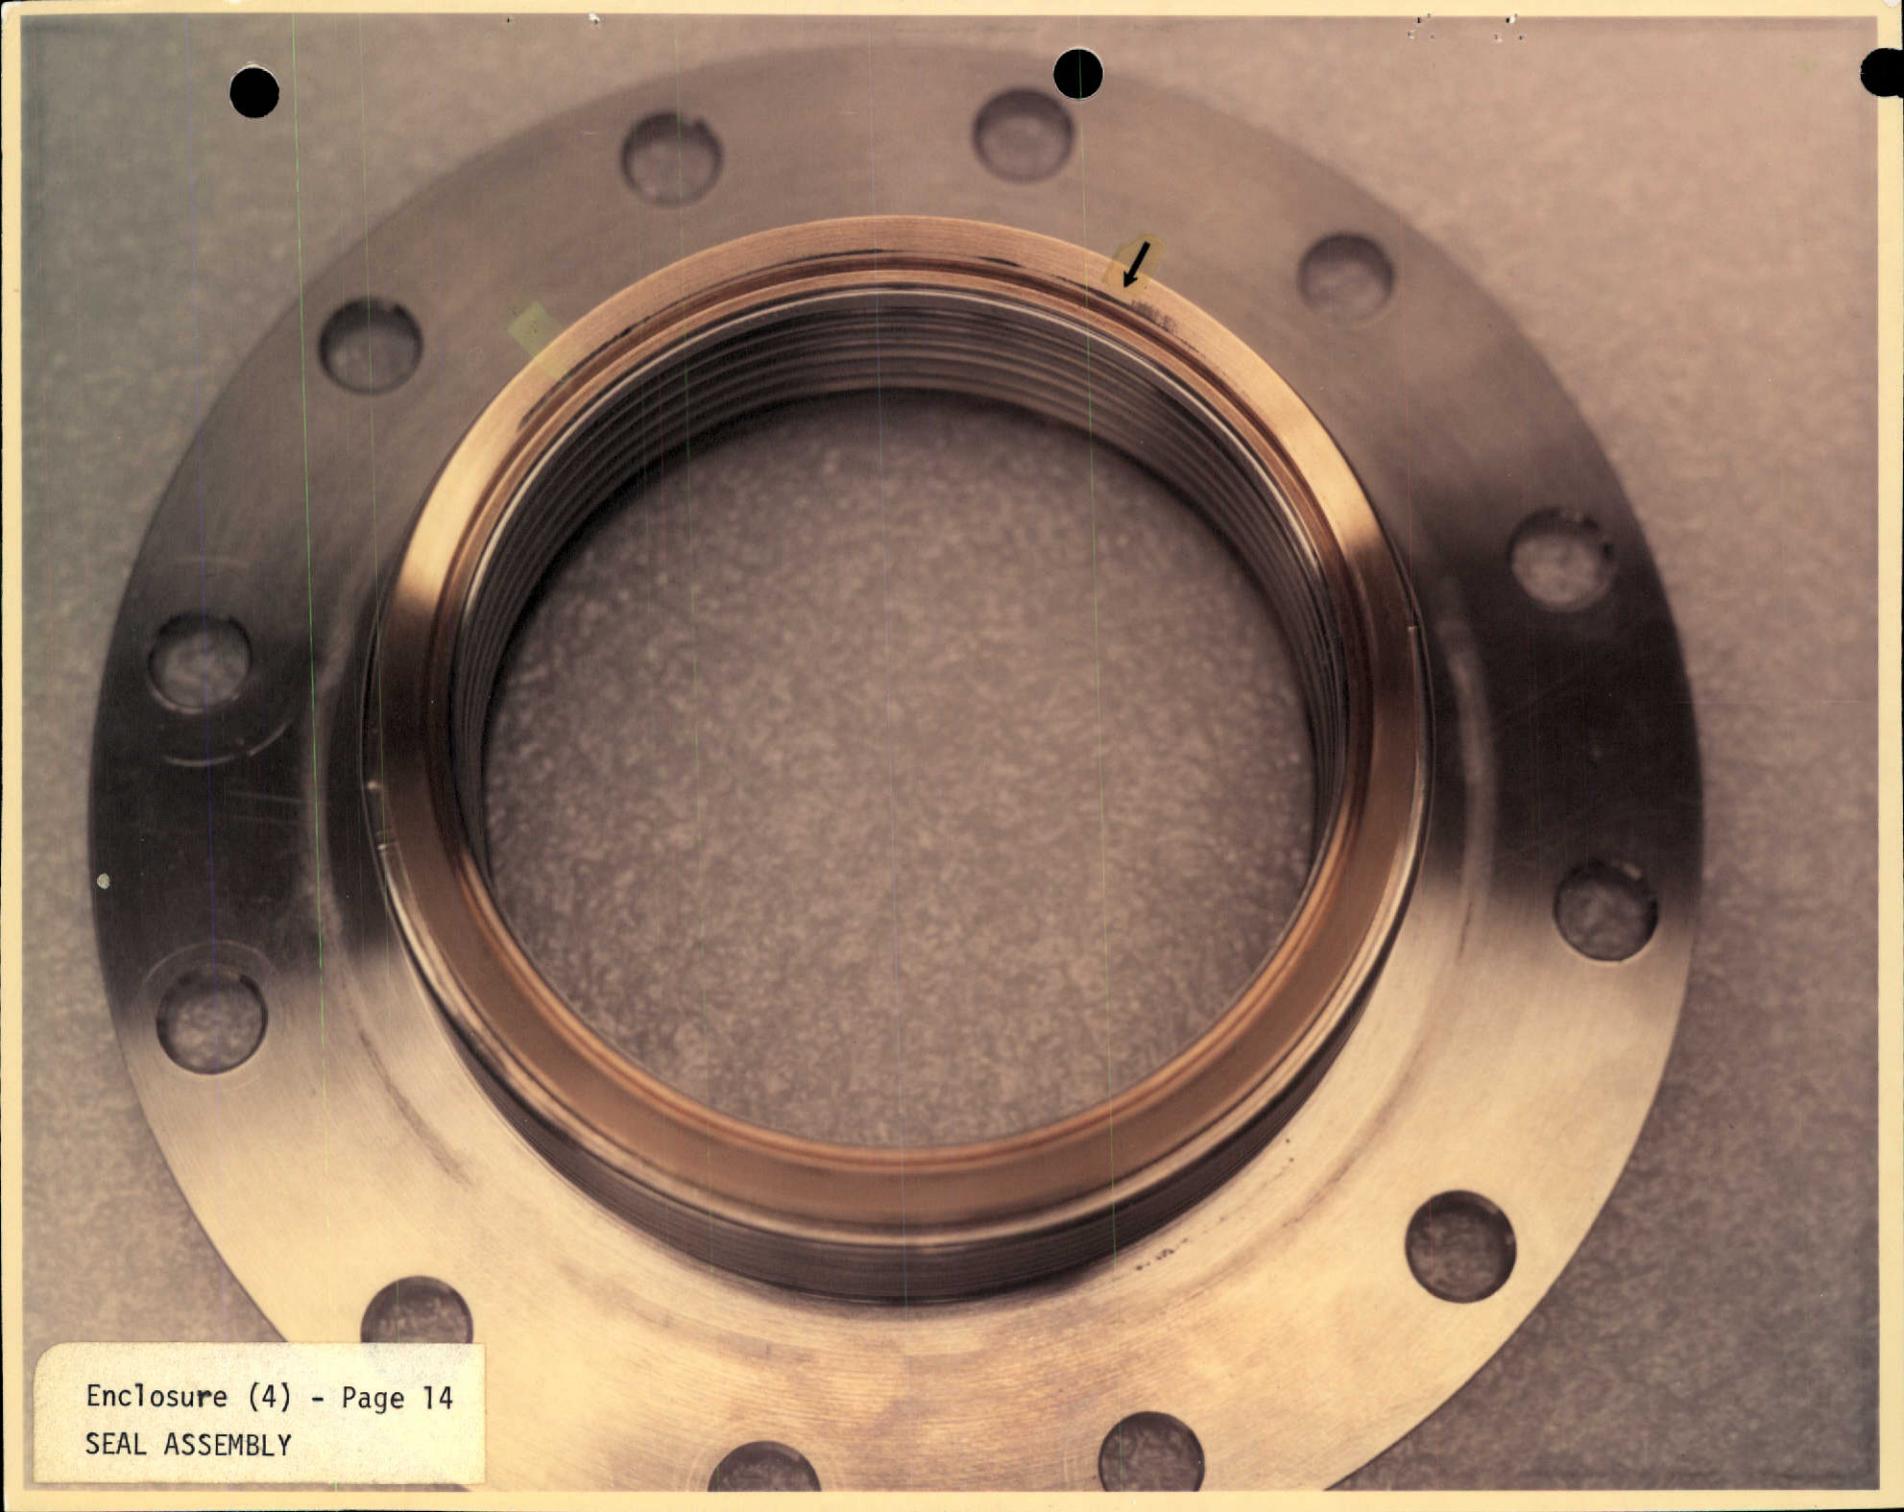
Enclosure (4) - Page 14  
SEAL ASSEMBLY

Following the initial leak and torque tests the BCV tester was disassembled and the shutoff seal was removed and examined. A photograph of the seal, Enclosure (4), shows the burnished areas on the sealing surface where contact between the seal and gate occurred.

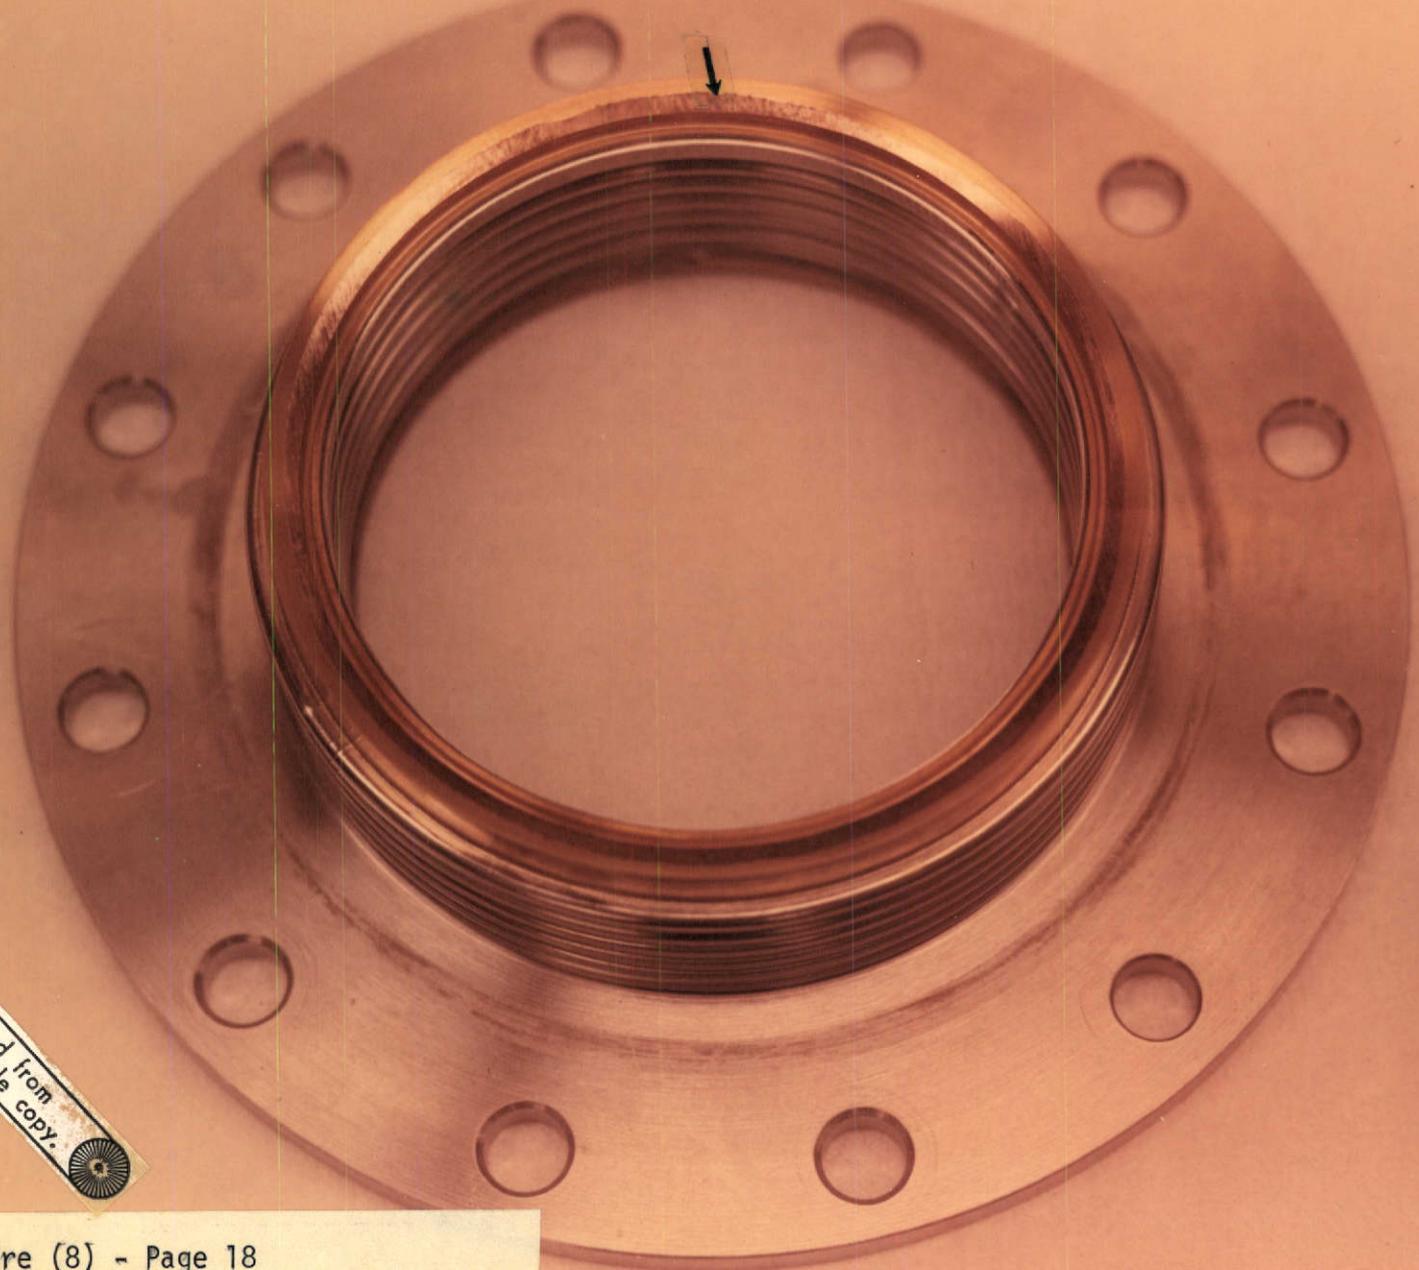
Enclosure (8) - Page 18  
SEAL ASSEMBLY - POST LIFE CYCLE TEST

Following the life cycle tests the valve was completely disassembled. Photographs were taken of the major component parts subjected to wear. A visual examination of the seal, Enclosure (8), and the visor, Enclosure (9), disclosed a scored wear pattern at the seal to visor interfaces. Based on measurements of the phosphor bronze seal the wear depth was approximately .002 inch. The electroplated A-286 visor surface was scored but not worn through. Examination of the visor bearing races revealed that the balls had worn through the gold plating in the race grooves on the loaded side of the bearings as shown in the photographs on Enclosures (10) and (11). The balls were slightly scored at the points of maximum load as shown in the photograph in Enclosure (12).

Disassembly of the valve revealed no part failure or galling. Scoring occurred at the seal to visor sealing interface and at points of maximum load where the bearing balls had worn thru the gold plated race surfaces. The wear on all other valve parts was insignificant.

1. Improve the visor fabrication process to obtain a more uniform spherical surface or develop a lapping procedure to assure conformance of the visor seal interface to the visor.
2. Conduct ambient air or GN<sub>2</sub> flow tests to ascertain the correlation between the predicted vs. actual hydrodynamic torque and loss coefficient.
3. Conduct a cryogenic life cycle test at pressures, temperatures flowrates and control positions expected during engine operation. The results of the test should then be correlated with the ambient life cycle tests to determine the extent of further development and redesign if required.

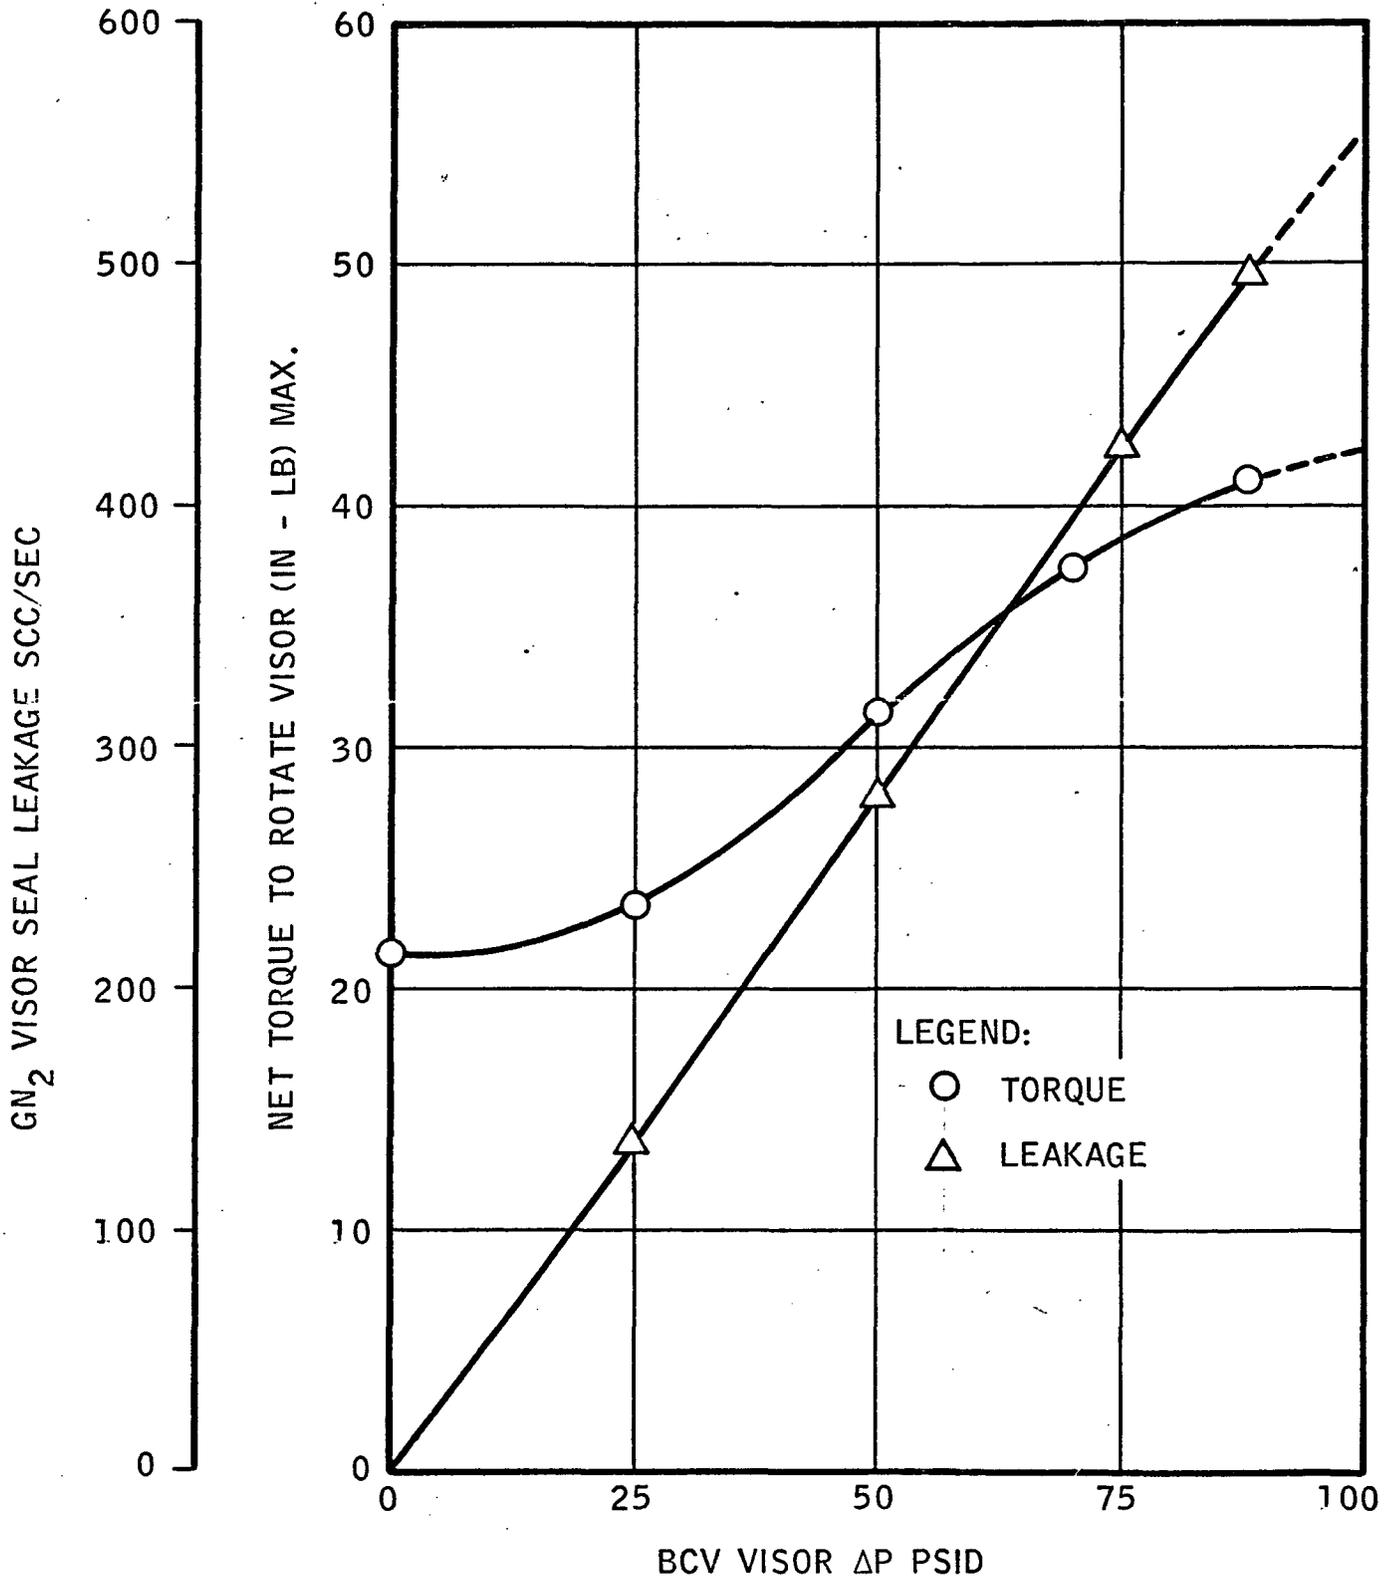
BCV VISOR  $\Delta P$  VS TORQUE AND LEAKAGE  
(INITIAL TESTS)

The initial leak tests were conducted using  $\text{GN}_2$  as the test fluid. The BCV was set up for test as shown on Figure 1 except that the gear motor was not installed for the initial leak and torque tests. The valve was pressurized upstream of the visor and the leakage rate was measured using Brooks Model 1110 rotameters with a calibrated accuracy of  $\pm 1\%$  of full scale from 100% to 10% of scale reading. The torque to rotate the visor was measured using a Snap-On Model TE-12FU 0-50 in.-lb torque wrench. The torque and leakage values recorded during the test were then plotted against differential pressure across the visor and the results are shown on Figure 2. It should be noted here that all torque values presented in this report are net values which are the result of subtracting the actuator simulator torque from the gross torque required to rotate the visor. A maximum  $\text{GN}_2$  leakage rate of 496 scc/sec, which corresponds to the maximum range of the largest rotameter, was recorded at a differential pressure of 88 psid. This leakage rate converts and extrapolates to approximately  $3.5 \times 10^4$  scim  $\text{GH}_2$  at 400 psid which is well below the  $3.4 \times 10^6$  scim limit requirement in Specification No. EC-90122B. Because of the high degree of non linearity, extrapolation of the torque data to 400 psid was not credible.

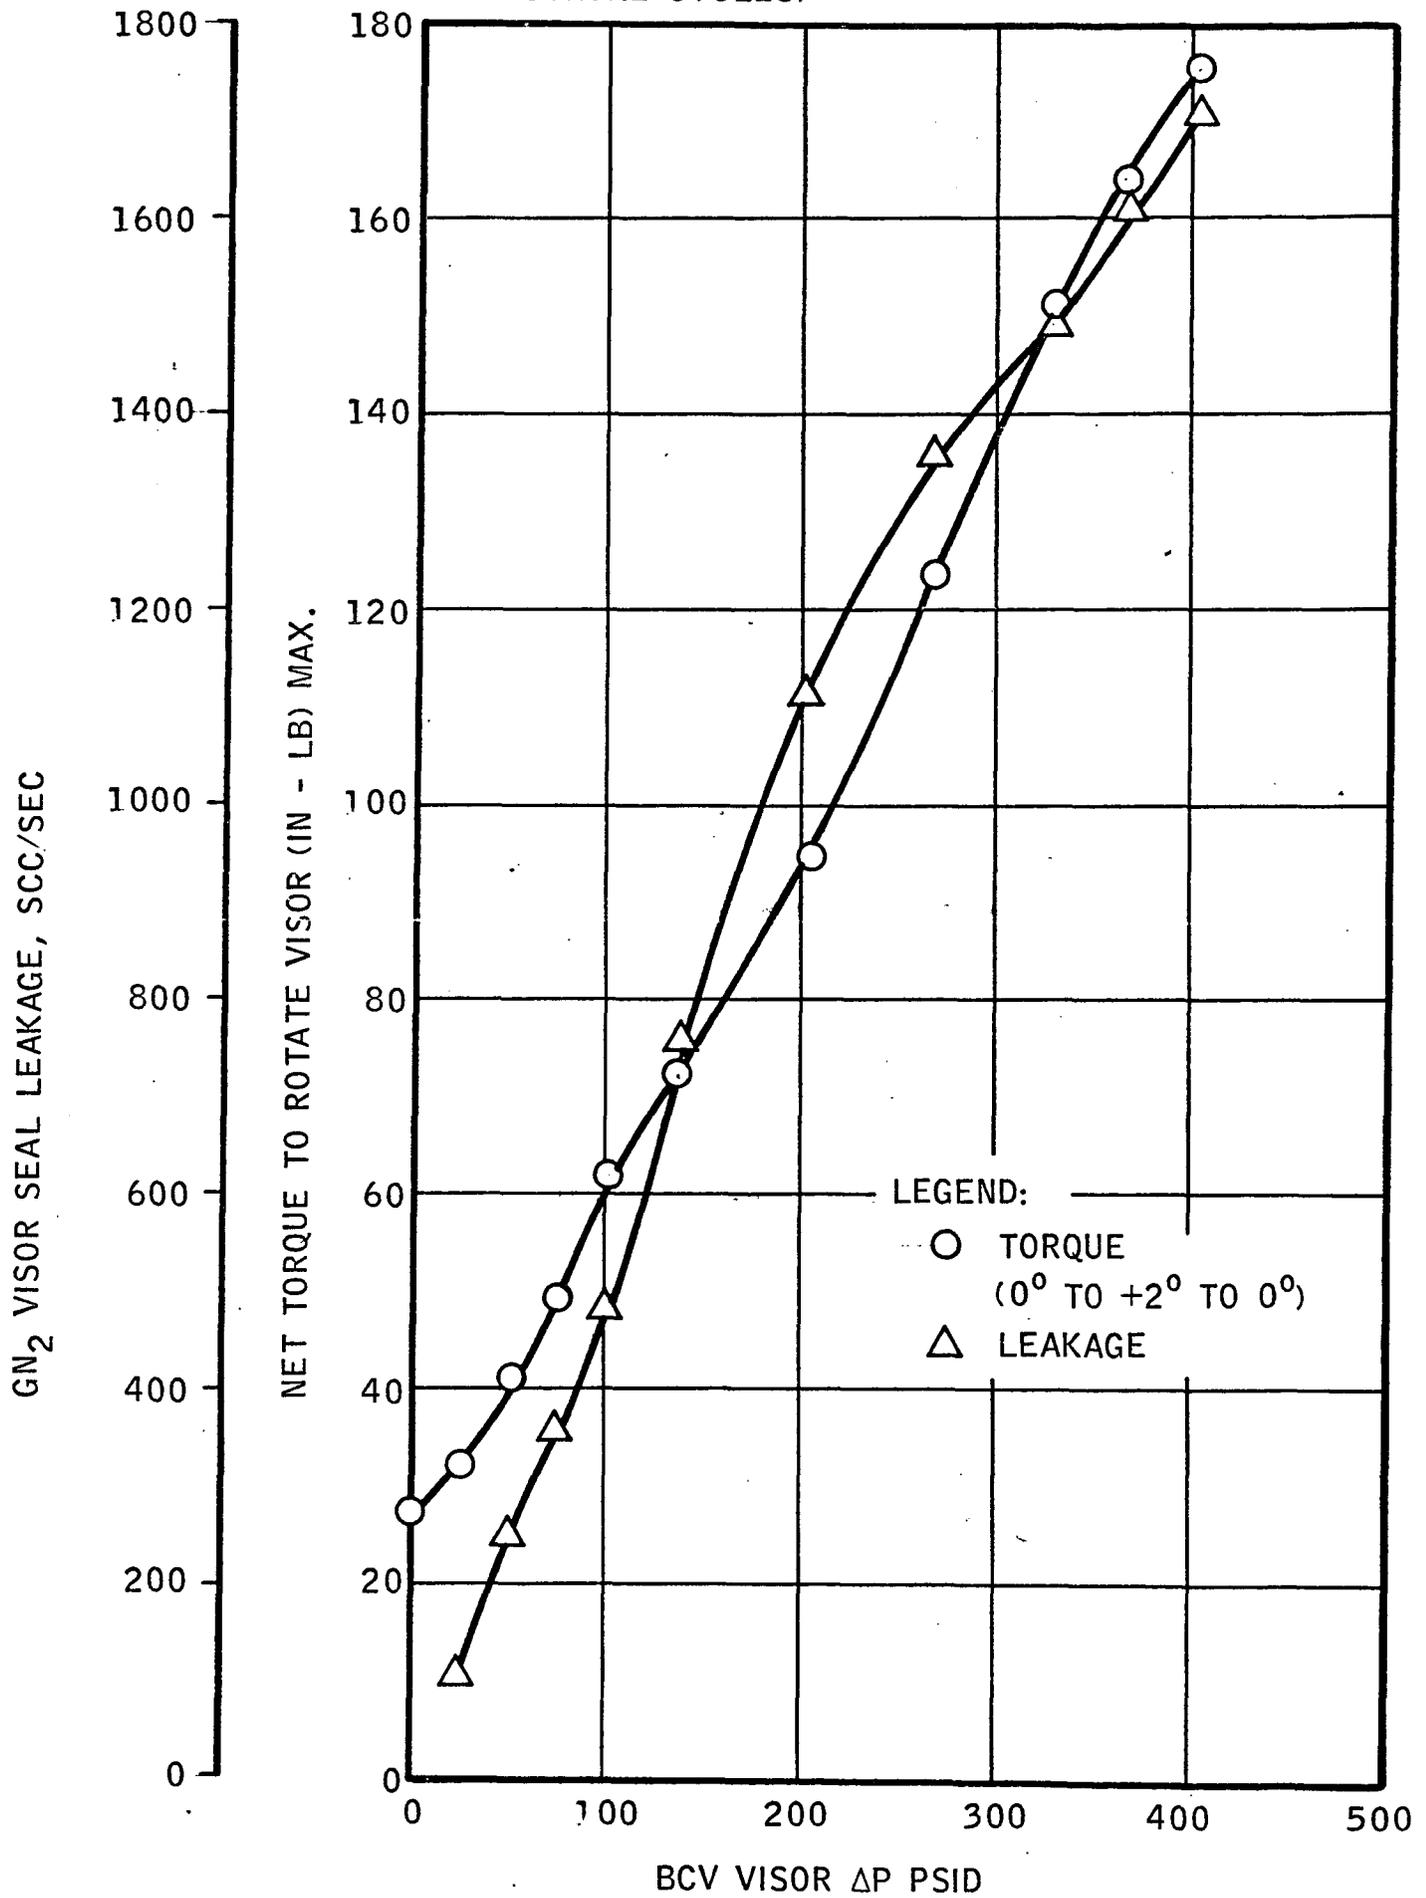
BCV VISOR  $\Delta P$  VS TORQUE AND LEAKAGE (AFTER 200 FULL STROKE CYCLES)

The valve was reassembled using the same shutoff seal and subjected to 200 full stroke cycles ( $0^\circ$  to  $123^\circ$  to  $0^\circ$  visor rotation per cycle) to determine if the seal would wear in to match the contour of the visor. No significant change in leakage rate occurred although the trend was toward decreasing leakage. The results of a torque and leakage test following the 200 full stroke cycles is shown in Figure 3.

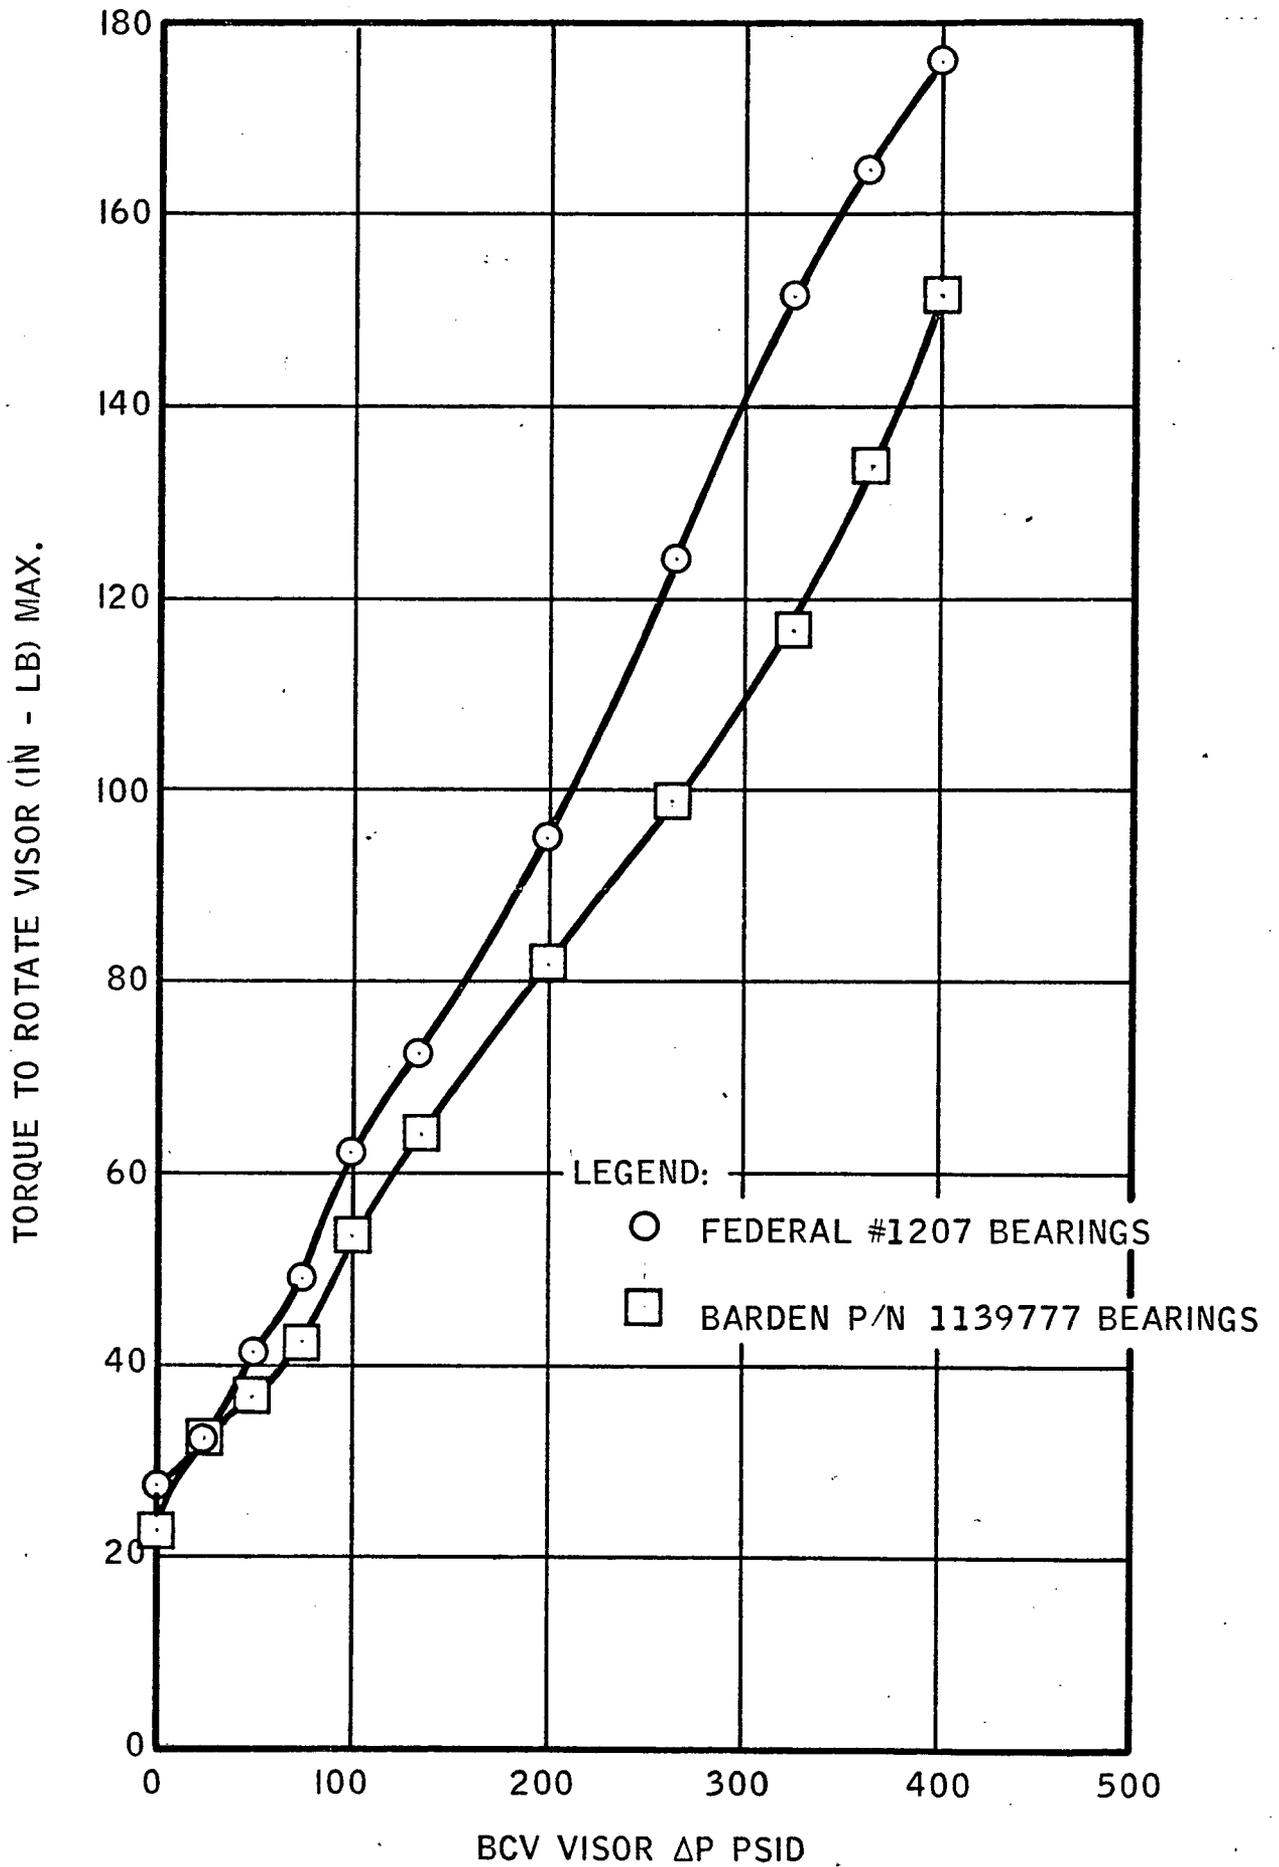
BCV VISOR  $\Delta P$  VS TORQUE  
(FOLLOWING INSTALLATION OF BARDEN BEARINGS)

Prior to the life cycle tests the Barden gold plated bearings P/N 1139777 had been received and installed. A torque test was then conducted and the results plotted as shown in Figure 12. The torque to rotate the visor with the Barden bearings installed was approximately 11% lower at 375 psid than the torque measured with the Federal bearings installed. It was estimated that the tighter tolerances of the Barden bearings as opposed to the commercial Federal bearings provided better load distribution within the bearings and thus lower torque to rotate under load.

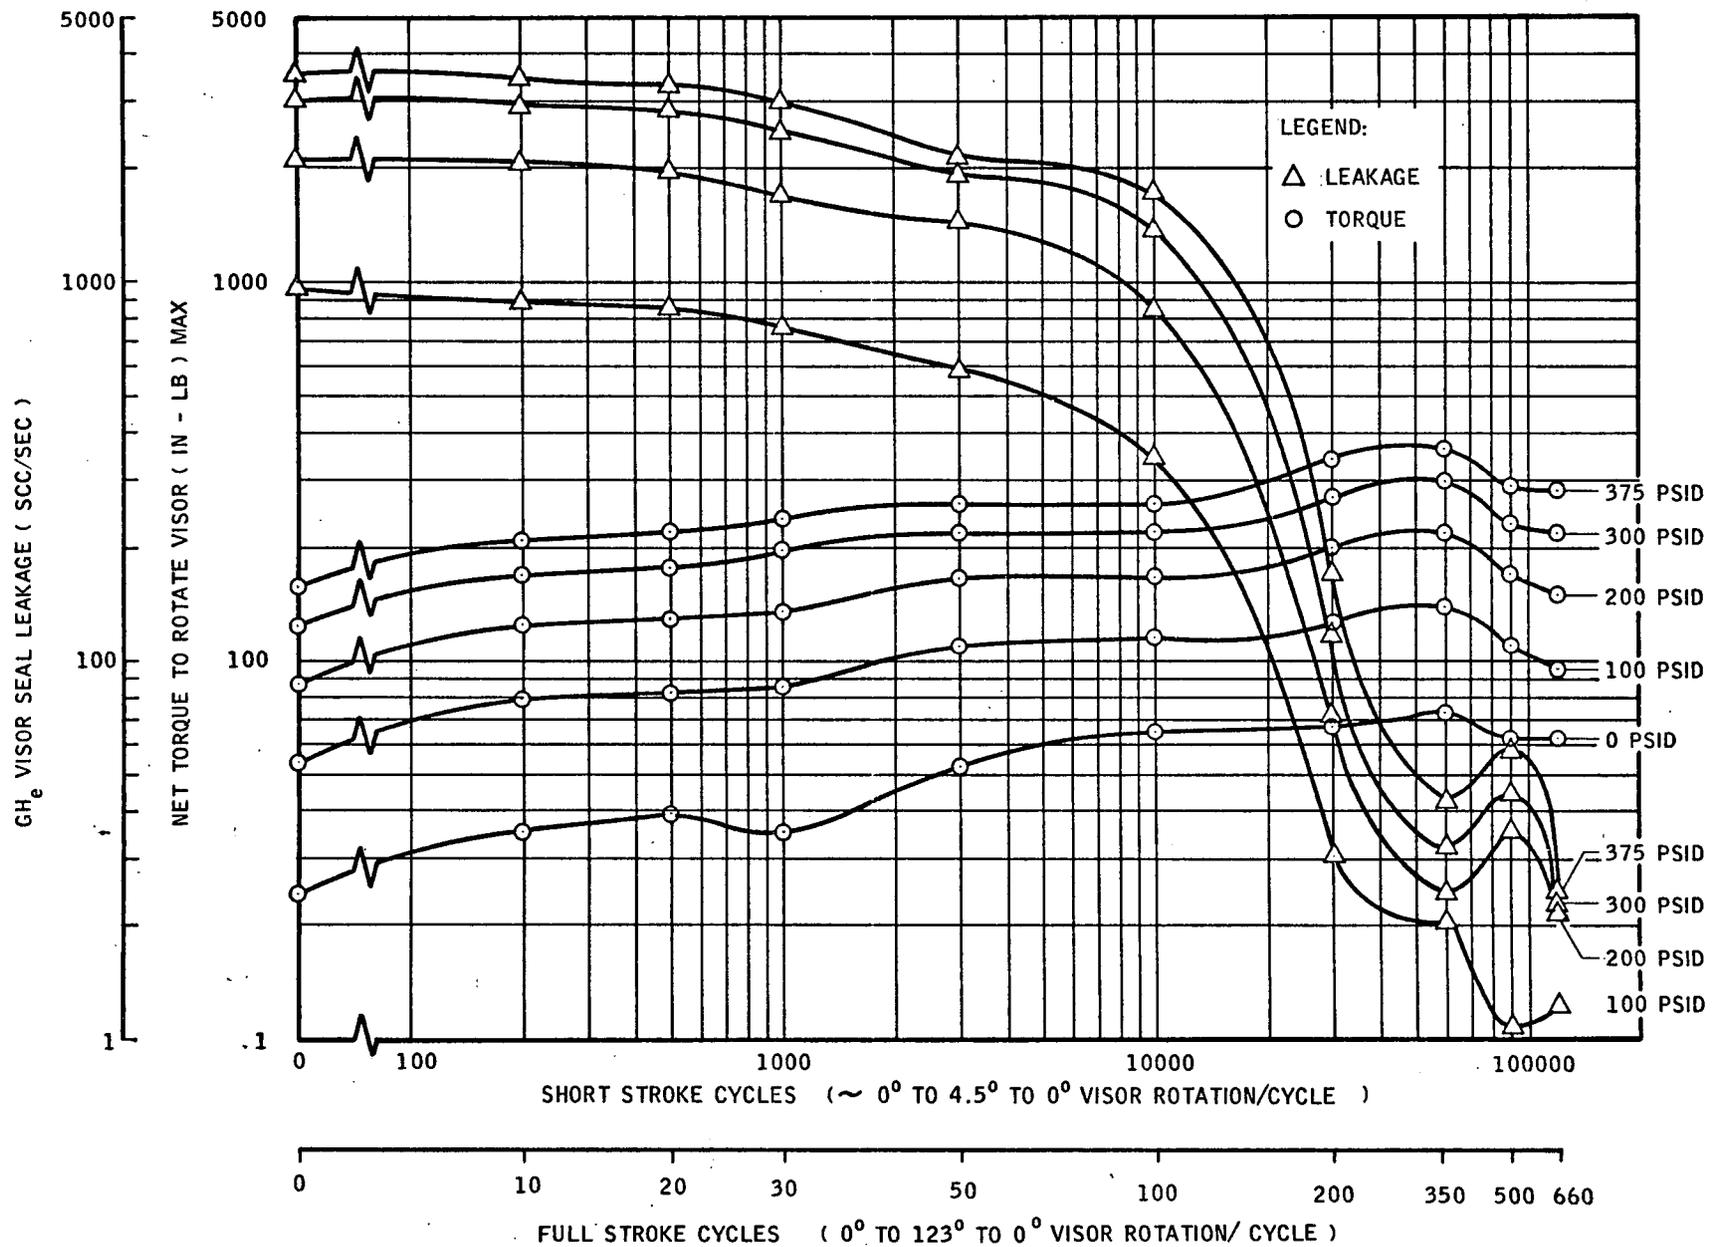
BCV VISOR BEARING AND SEAL LIFE CYCLE TEST

The test data reflects a gradual decrease in the maximum fully closed leakage rate to less than 60 scc/sec at 375 psid after approximately 45 thousand cycles. This reduction is attributed to a gradual wearing in of the phosphor bronze visor seal to conform to the electrolyzed A-286 visor. There was also a gradual increase in torque required to rotate the visor which is attributed to an increase in friction coefficient between the seal and visor plus an increase in torque required to rotate the bearings. This will be explained in more detail later in the discussion.

During the cycle tests an anomaly occurred at 49603 cycles which was not included in the data presented in Figure 13. At this point the gear motor stalled and power was immediately shut off. The crank lock bolt was disengaged and a torque wrench was installed on the visor shaft extension. Approximately 500 in.-lbs was required to initiate movement of the visor at 375 psid. However, after movement occurred the torque level decreased to 320 in.-lb which was approximately what the torque average should have been after 49000 cycles based on the test data to that point. The only other major change noted in the data was a considerable decrease in the leakage rate at the 4.5° position during cycling. It was postulated that as seal wear occurred the seal contact width increased allowing less leakage flow thru the slot at the 4.5° position. This in turn probably caused an increase in seal surface temperature resulting in slight galling between the seal and visor with a corresponding increase in torque.

For the rest of the life cycle test the visor position was adjusted to open to approximately 4.8° to allow more leakage flow. The torque required to rotate the visor did not exceed 370 in.-lb throughout the remainder of the cycle tests which tends to verify the postulation stated above.

The maximum torque of 370 in.-lb recorded during the tests exceeds the predicted 350 in.-lb maximum valve load that the BCV actuator transmission
