APOLLO 16 MISSION

ANOMALY REPORT NO. 4

UNEVEN DRIVE RATES OF THE SCANNING TELESCOPE

MANNED SPACECRAFT CENTER HOUSTON, TEXAS NOVEMBER 1972

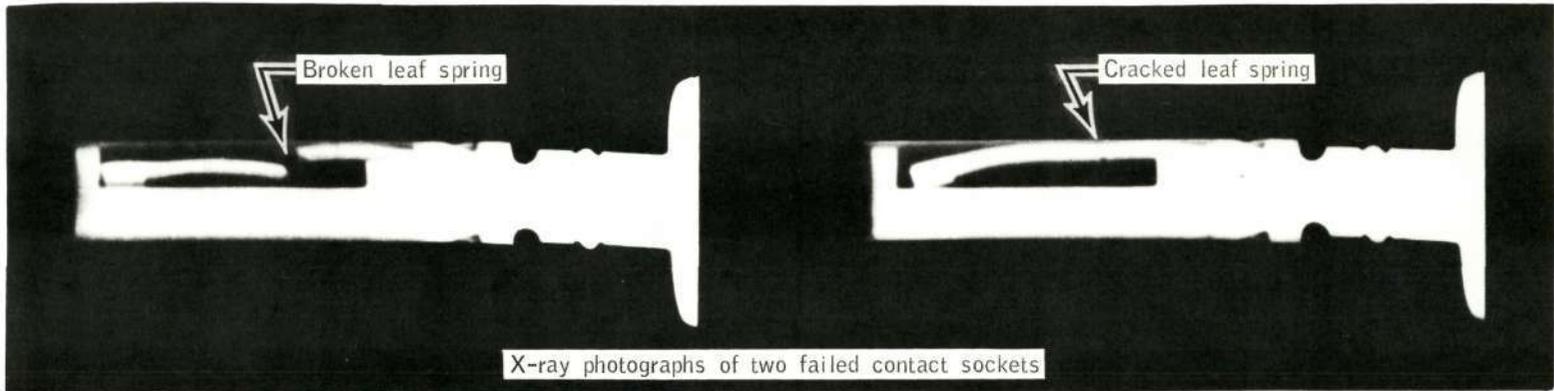
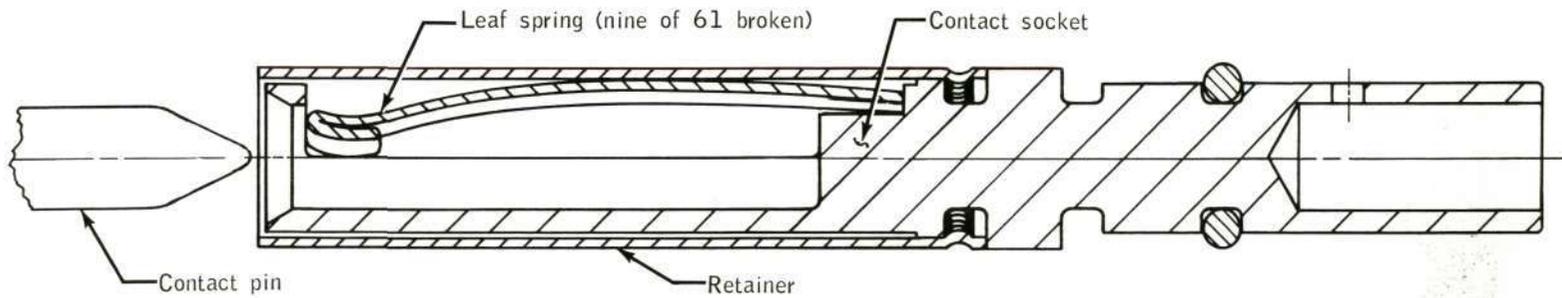
Figure 3.- Contact and leaf spring arrangement of optical unit connector.

Since the connector of the harness in the unpressurized compartment is not potted, the harness and connectors were dried and the closed-loop testing was repeated. The erratic condition was again observed and was traced to an intermittent contact in the connector. The contact provides the 28-volt, 800-hertz return voltage for the drive-motor reference winding. Vibration induced by slewing the telescope was sufficient to cause the intermittent to act as a high resistance conductor, thus slowing the motor, and causing the erratic slewing. A broken socket spring was found in the female half of the connector. Further examination showed broken springs in 9 of 61 sockets of the telescope connector and in 6 of 91 sockets of the sextant connector. Also, 25 cracked springs were found. Figure 3 shows the spring arrangement in the female socket and X-ray photographs of failed springs similar to the one which caused the uneven drive rate problem. The breaks and cracks were caused by stress corrosion, shown in figure 4.

This connector was manufactured prior to December, 1965, at which time the connector assembly procedure required the use of a pair of tweezers to hold the gold-coated copper-beryllium-base metal spring in position on the collar of the female socket while the monel sleeve was slipped over the socket and spring. The spring can be easily damaged by either scratching or gouging the gold plating using this technique, or by cracking the spring when too much force is applied with the tweezers. Automatic assembly procedures, instituted in December 1965, prevent this type of spring damage. Once the gold plating is scratched, the copper-beryllium base material is exposed to the environment and corrosion can occur. The two connectors in the optical unit assembly pressure bulkhead are not potted. Consequently, the sockets and springs of the Apollo 16 connectors have been exposed to the external atmosphere since 1965. This may have been detrimental to the springs. All other spacecraft connectors of this type are potted.

Harnesses which have been sealed in plastic bags since manufacture have been installed on Apollo 17. These harnesses were inspected for broken springs prior to installation. New harnesses will be manufactured for installation in the command modules to be flown in the Skylab program.

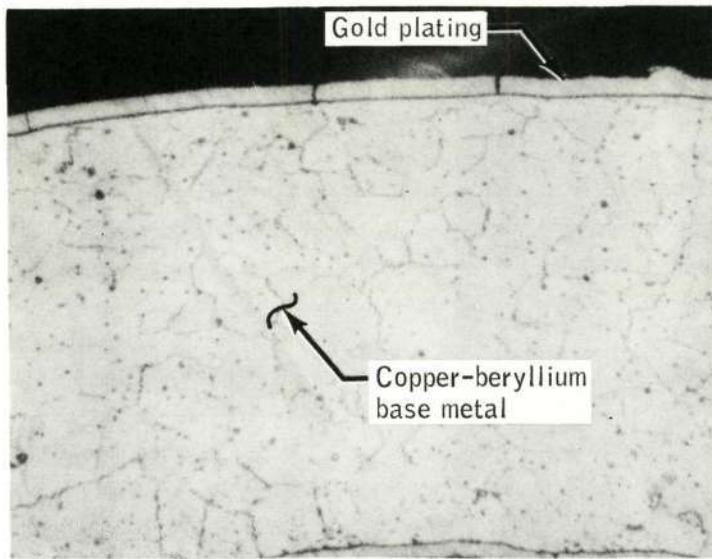
(a) Cracks in gold coating.

The uneven drive rates observed through the scanning telescope were caused by a broken socket spring in the telescope harness connector. Because of manufacturing procedures used prior to December 1965, the gold plating of the spring may have been damaged, and corrosive action could have occurred and ultimately caused spring breakage.

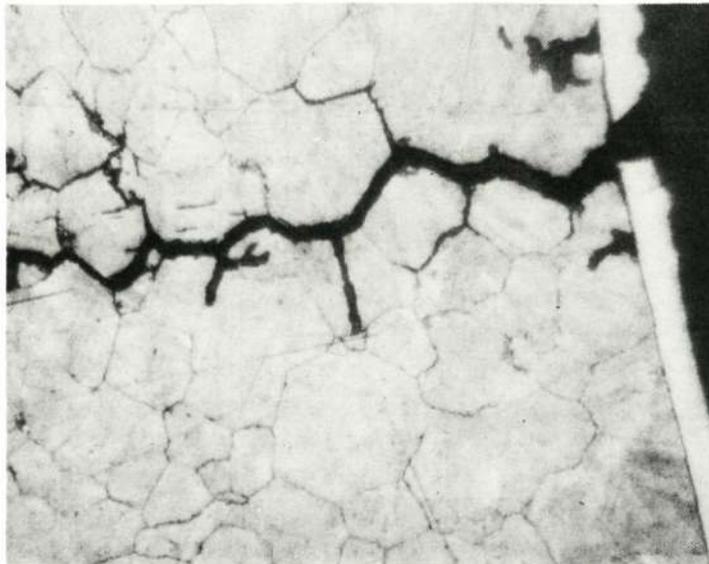
(b) Intergranular corrosion into spring after crack in gold plating.
