# FIELD REPAIR OF COATED COLUMBIUM THERMAL PROTECTION SYSTEMS (TPS)

## FINAL REPORT

MDC E0681

15 SEPTEMBER 1972

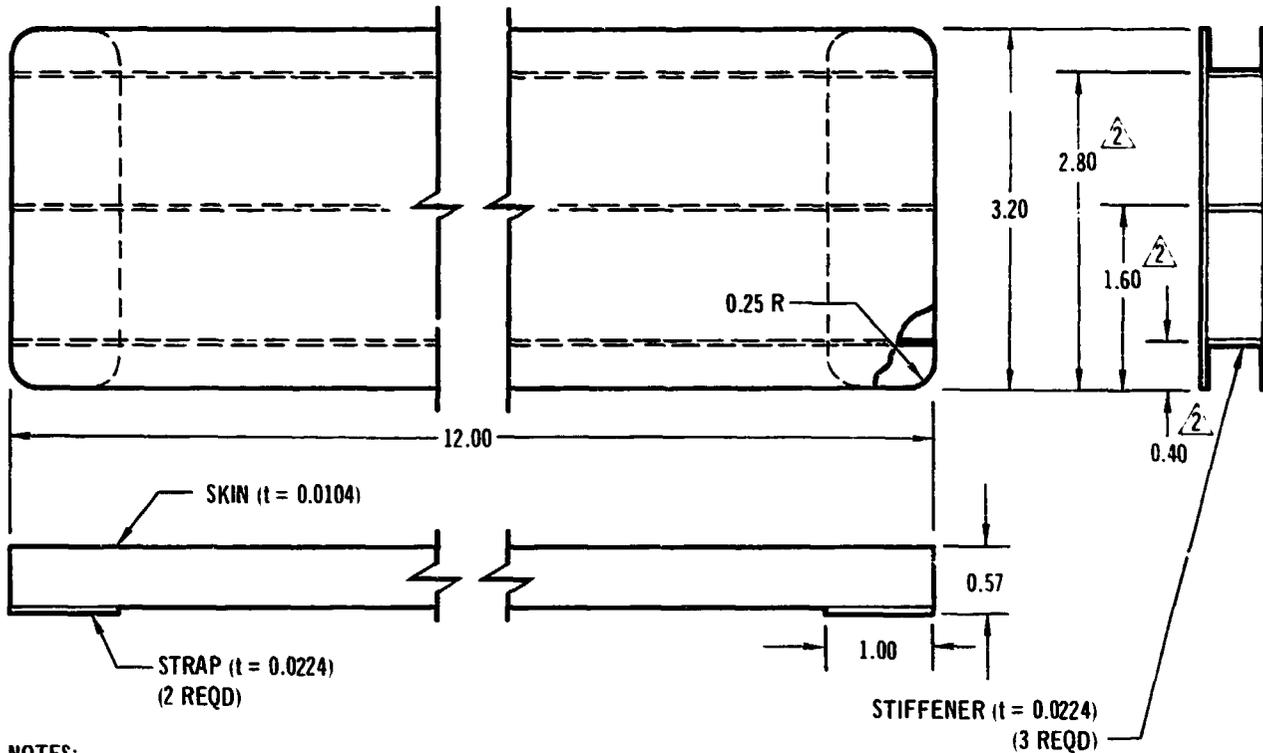
The fusion welding of the skin to the ribs caused a noticeable amount of distortion. Typical examples of this distortion are shown in figure 3-3. The longitudinal bowing of the panels produced a nominal deflection of 0.07 inch in the center of the span and a series of ripples, or buckling of the skin, between the ribs. The maximum depth of the buckles, 0.08 inch occurred in the center of the panel and the buckling of the skin was not noticeable on the unsupported edges.

The undesirable skin distortion was caused by shrinkage of the electron beam fusion weld which joined the ribs to the skin. The rib thickness was 0.022 inch and the skin was 0.012 inch thick. Because the 0.012-inch skin was not of sufficient strength and stiffness, it buckled between the ribs. The problem of producing distortion-free rib stiffened panels was attacked using two simultaneous approaches. The first approach was to prevent distortion during welding by altering the welding

A welding parameter study was conducted in which the total heat input was minimized. The only constraint on weld nugget size was that the total thickness of the rib had to be joined to the skin so that no crack or faying surface occurred. Several voltage and amperage combinations were tried for three welding speeds ranging up to 200 inches per minute. A measurable but insufficient reduction of skin distortion for the 0.012-inch skin to 0.022-inch rib combination was achieved. Welding parameters were then established for a rib stiffened configuration of 0.020-inch skin and 0.022-inch ribs. Test panels of this gauge combination were successfully welded and the skin distortion was completely eliminated. The increased skin thickness produced a 30-percent weight increase for the panel (an increase of 1.35 lb/ft<sup>2</sup> for 0.012-inch skin to 1.77 lb/ft<sup>2</sup> for the 0.020-inch skin). Since design studies conducted in the beginning of the program had established that only 0.008-inch load bearing skins, after coating, were required to carry the necessary loads, it was decided that the less weight-efficient design employing the 0.020-inch skin would be used only as a last resort.

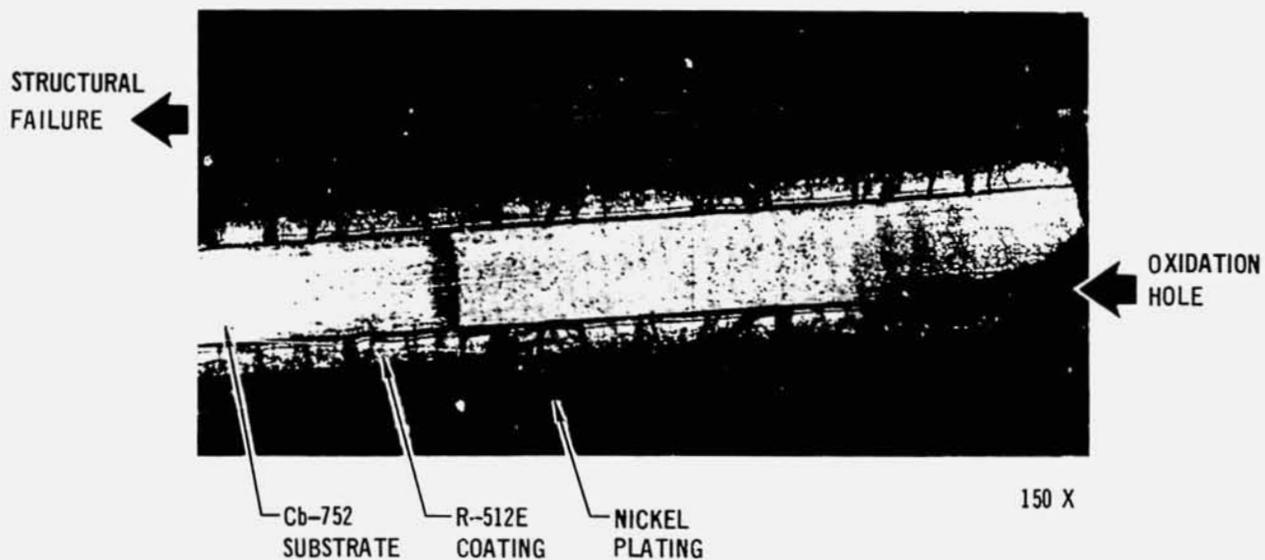
PANEL SHOWN IN FIGURE 6-6 IN DEFECT AREA -  
NOTE FAILURE IN OUTSIDE CONTAMINATION AREA

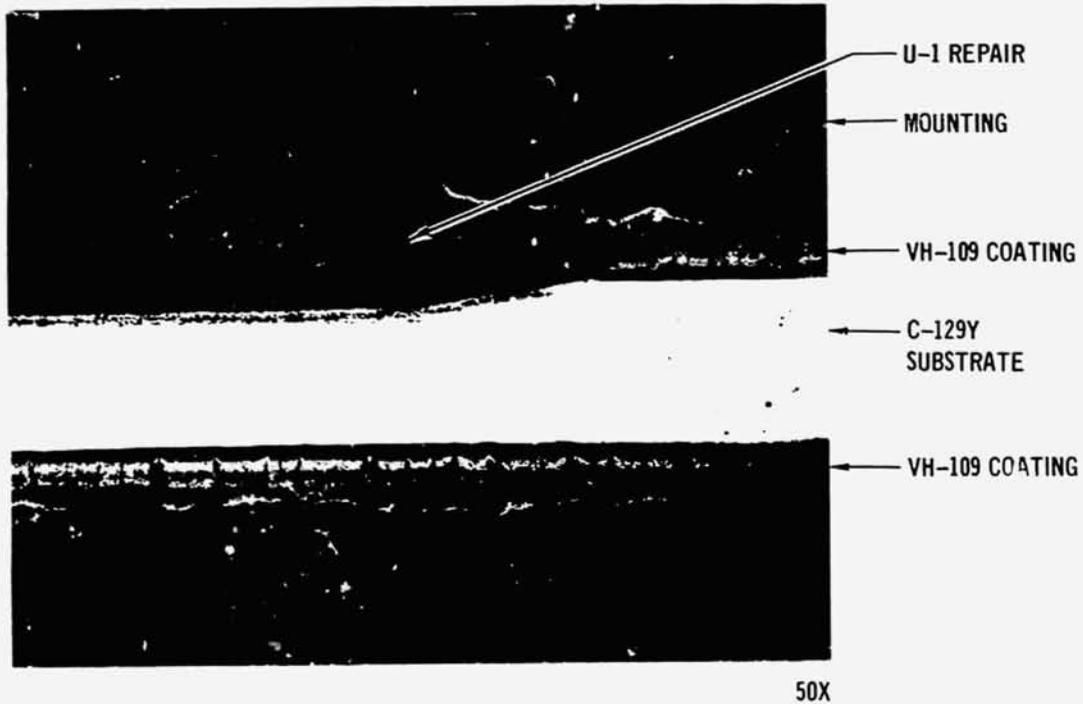
CROSS SECTION OF U-1 REPAIR OF VH-109 COATING AFTER  
100 SIMULATED REENTRY CYCLES

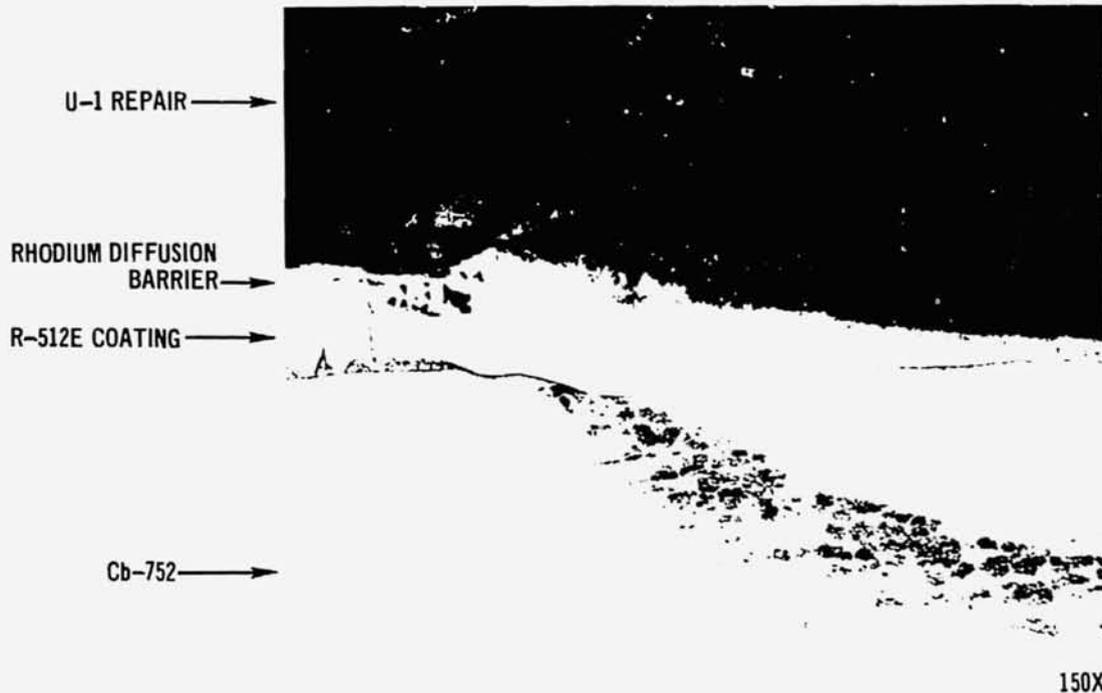
U-1 CERAMIC REPAIR COMPOSITION WITH RHODIUM DIFFUSION BARRIER  
AFTER 30 MINUTES AT 2400°F AND ONE ATMOSPHERE PRESSURE

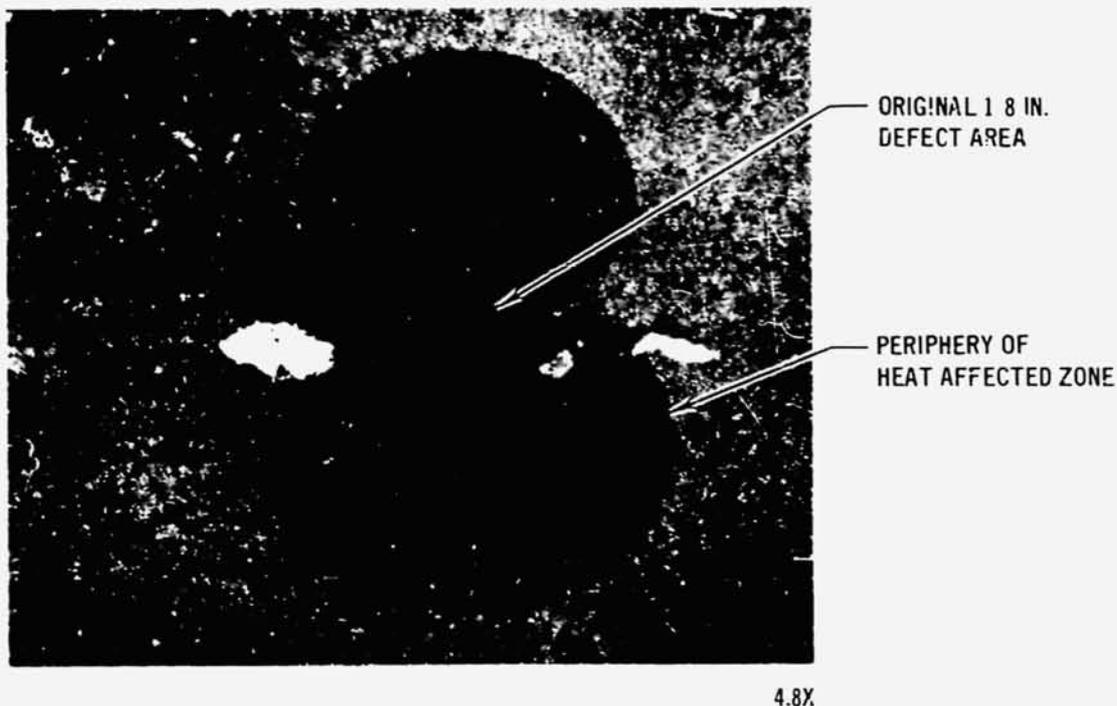
Enlarged View of Lamp Repair Site f  
Showing Oxidation Failure

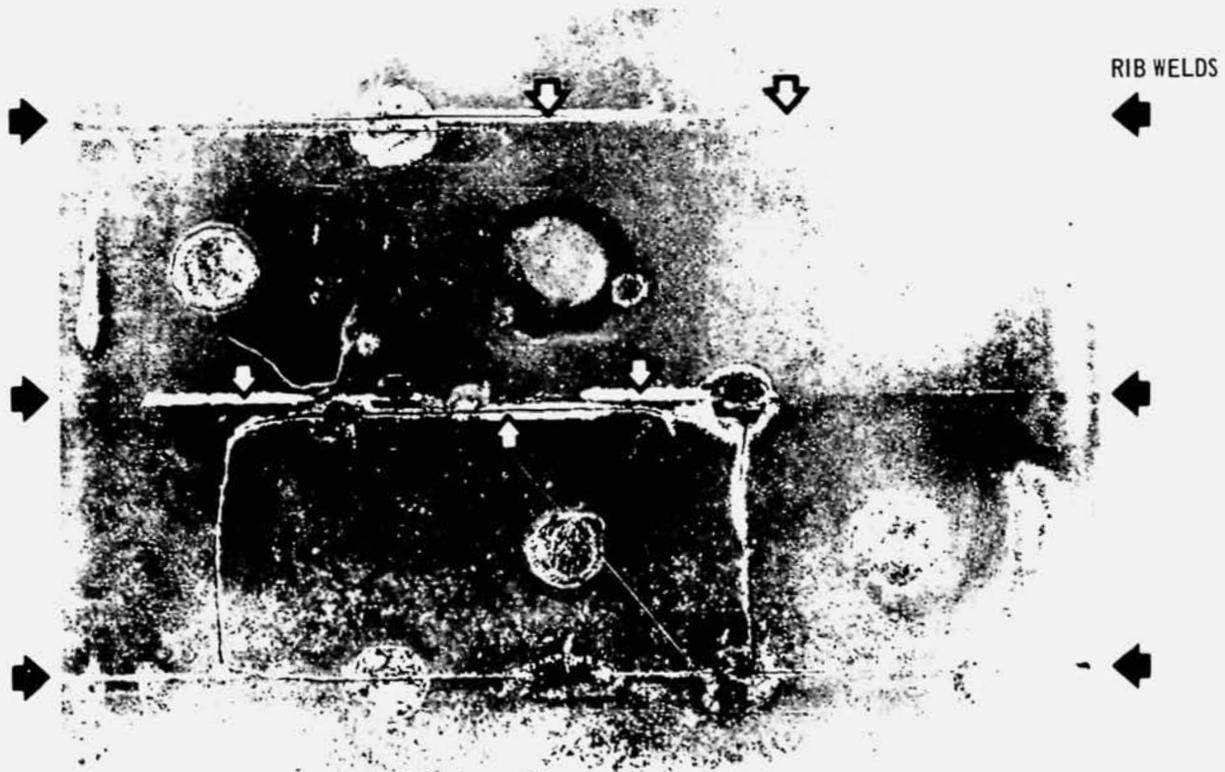
Figure 12-11

(White Arrows Show Spalled Areas)

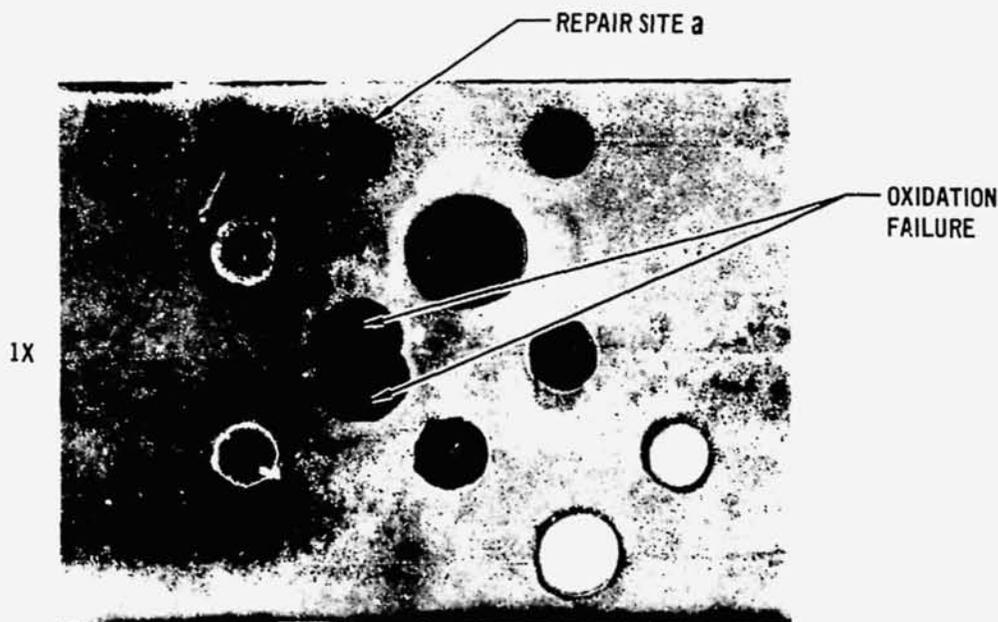
PANEL SYL-72 AFTER 22 REENTRY PROFILE CYCLES SHOWING OXIDATION  
FAILURES ADJACENT TO LAMP REPAIR SITE f

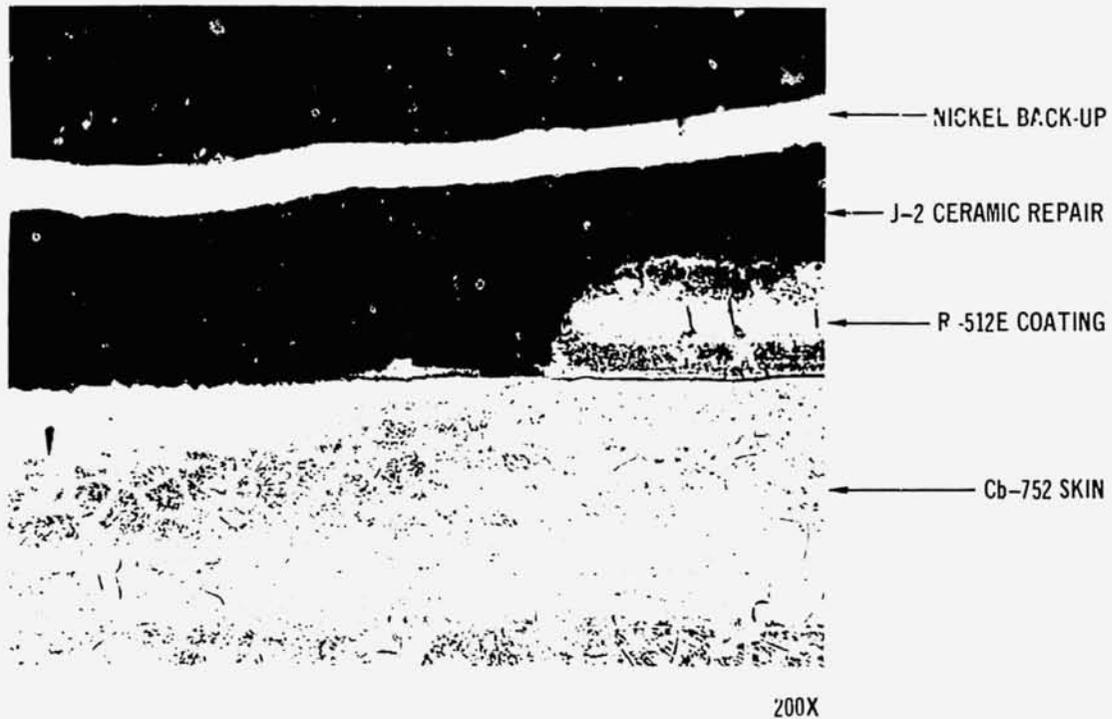
J-2 CERAMIC REPAIR FROM PANEL SYL-72 AFTER 110 REENTRY  
PROFILE CYCLES

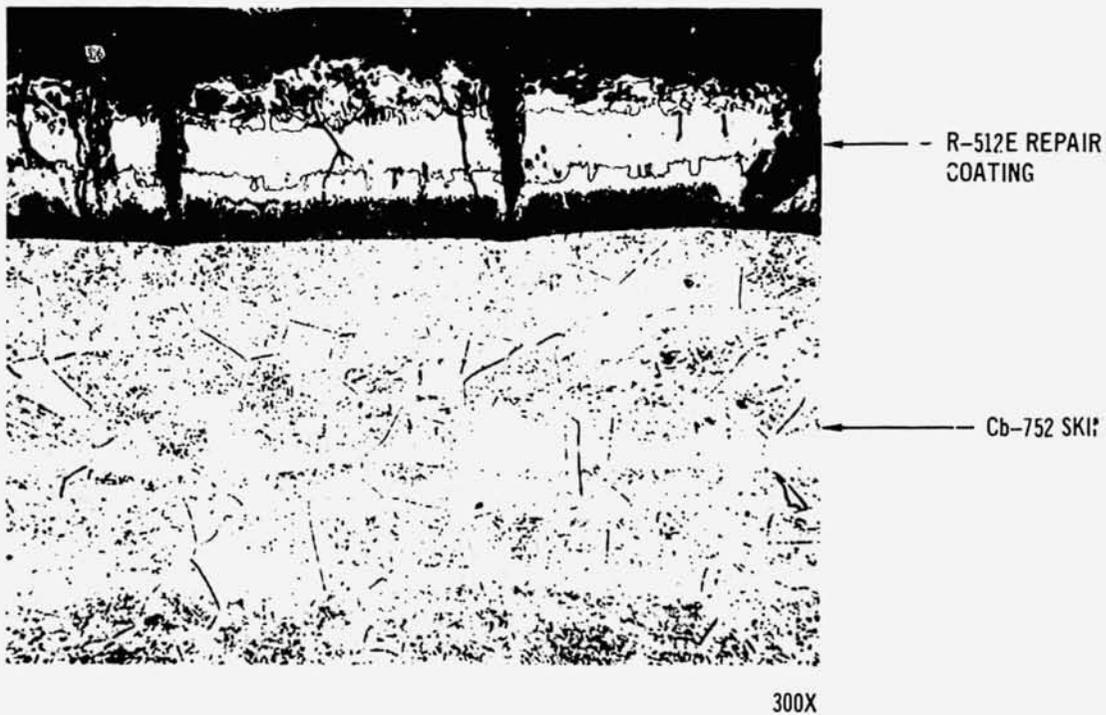
R-512E REPAIR COATING APPLIED WITH SYLVANIA SPOT HEATER ON  
PANEL SYL-72 AFTER 110 REENTRY PROFILE CYCLES

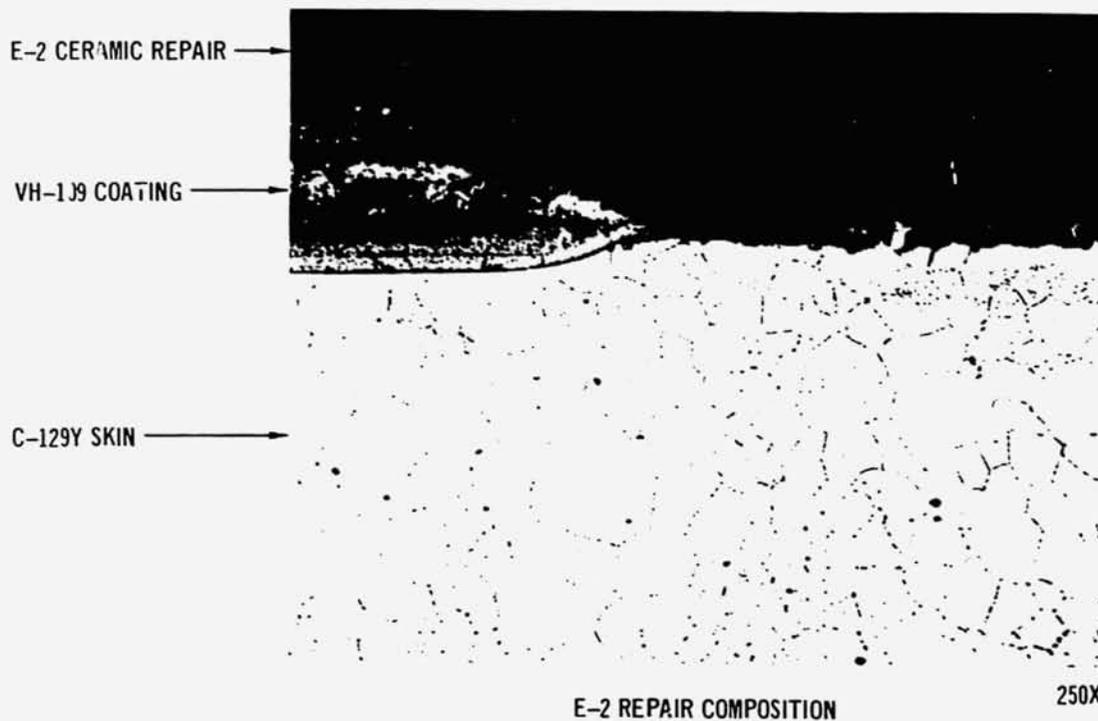
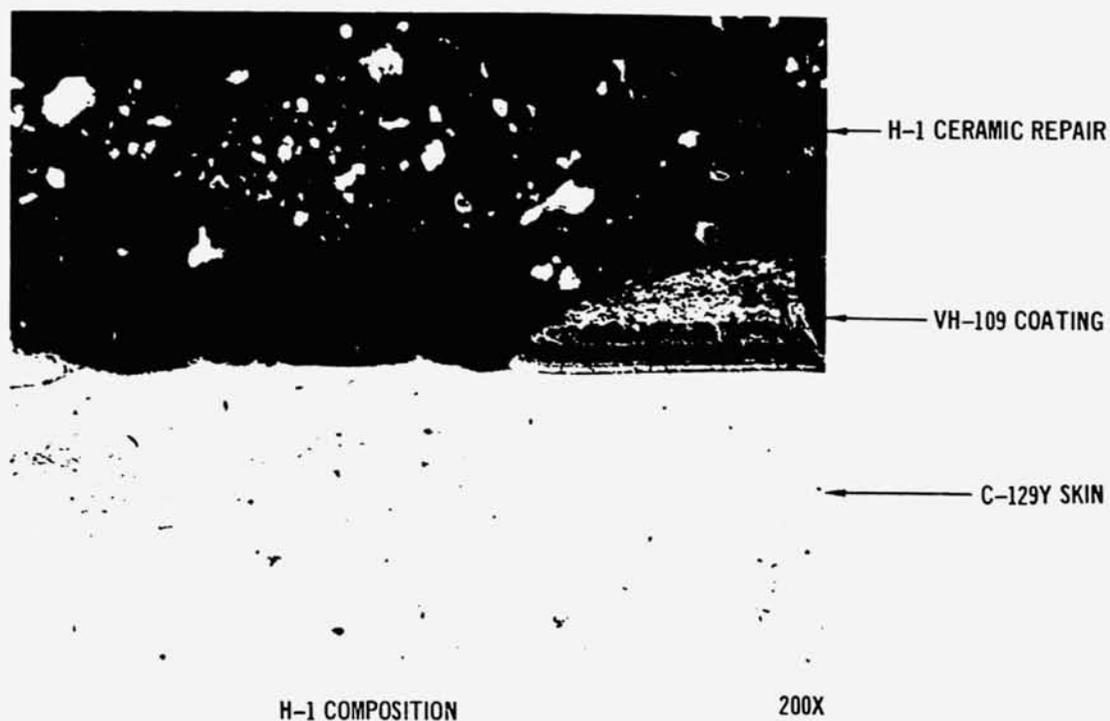
CERAMIC REPAIR ON PANEL VAC-93 AFTER 110 REENTRY PROFILE CYCLES
