NASA TM X-68284

A 9700-HOUR DURABILITY TEST OF A
FIVE CENTIMETER DIAMETER ION THRUSTER

by S. Nakanishi and R. C. Finke
Lewis Research Center
Cleveland, Ohio 44135

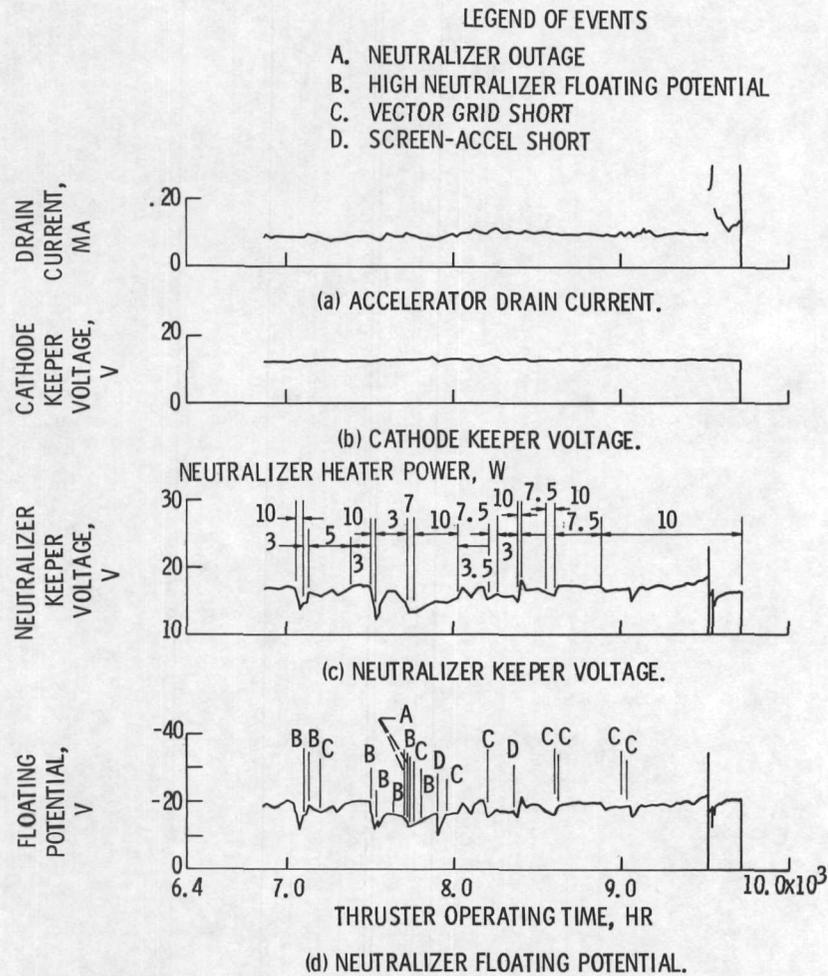
Figure 3. - History of test.

A history of the test from 7000 thruster hours to the end at 9715 hours is shown in figure 3. The electrostatic vector grid was installed at 2027 thruster hours so that the number of hours on the grid is less than the thruster operating time by that amount. The four parameters charted were those most subject to change with time. As described previously,(8) other thruster parameters either remained nearly constant throughout the test or were adjusted to fixed operating values.

The accelerator drain current shown in figure 3(a) was about 0.09 mA from 2027 to 8000 thruster hours. From 8000 to 9500 hours the drain current remained at about 0.10 mA then suddenly increased to more than 0.20 mA. Details of the final 270 hours of the test when numerous grid shorts occurred will be shown later.

The cathode keeper voltage (fig. 3(b)) was constant to the end of the test at a value which prevailed from about 4000 hours.⁽⁸⁾ Actually, the cathode keeper voltage first attained an operating level of 12-13 volts as early as 400 hours into the test. The voltage subsequently rose to about 15 volts and gradually dropped to 12.5 volts by 4000 hours. No heater power was applied to the cathode except during startups.

The neutralizer keeper voltage and floating potential plotted in figures 3(c) and (d) gradually rose with time. The irregular variations in these parameters were induced primarily by the changes in neutralizer heater power made during the test to stabilize neutralizer operation. Continuous strip chart records of neutralizer parameters to be presented later will show the nature of some neutralizer transients.

A consistent trend associated with neutralizer heater power can be seen in figure 3(c). Increasing heater power decreased the keeper voltage and floating potential. The decrease was followed by a gradual rise at approximately the same rate as the overall average rise with time.⁽⁸⁾ This rise rate was about 1 volt per 1000 hours of operation, and it occurred even in the early hours of the test when heater power was 3 watts or less. The conclusion is that the mechanism causing the rise in keeper voltage was not entirely dependent on heater power and neutralizer temperature.

Noted on the test history are four types of recurrent abnormal events. Neutralizer outage precluded beam current operation because of highly negative neutralizer floating potential, but the protective control system shut off only the ion chamber discharge and the accelerating potentials. The cathode was permitted to continue operating in order to facilitate restarts.

High neutralizer floating potential also occurred without a neutralizer outage. This abnormal condition was rare in the first 7000 hours of test. It was especially numerous between 7100 and 7800 hours but nonexistent thereafter. The cause of these occurrences is not known. An excerpt from the continuous strip chart record of neutralizer parameters will be presented later to show details of this abnormal condition.

Shorting between vector grid elements occurred four times between 8000 and 9000 hours. These shorts occurred at a rate of 2 per 1000 hours of operation between 6000 and 7000 hours but were nonexistent prior to that period.

Screen to accelerator shorts were less numerous although one had occurred as early as 5000 hours into the test. In all instances, the shorts were cleared successfully either by application of vectoring voltage or by a capacitor discharge. A capacitor discharge usually quenched the neutralizer (in a manner similar to events early in the test⁽⁷⁾ before installation of inductive ballasts in the high voltage circuits).

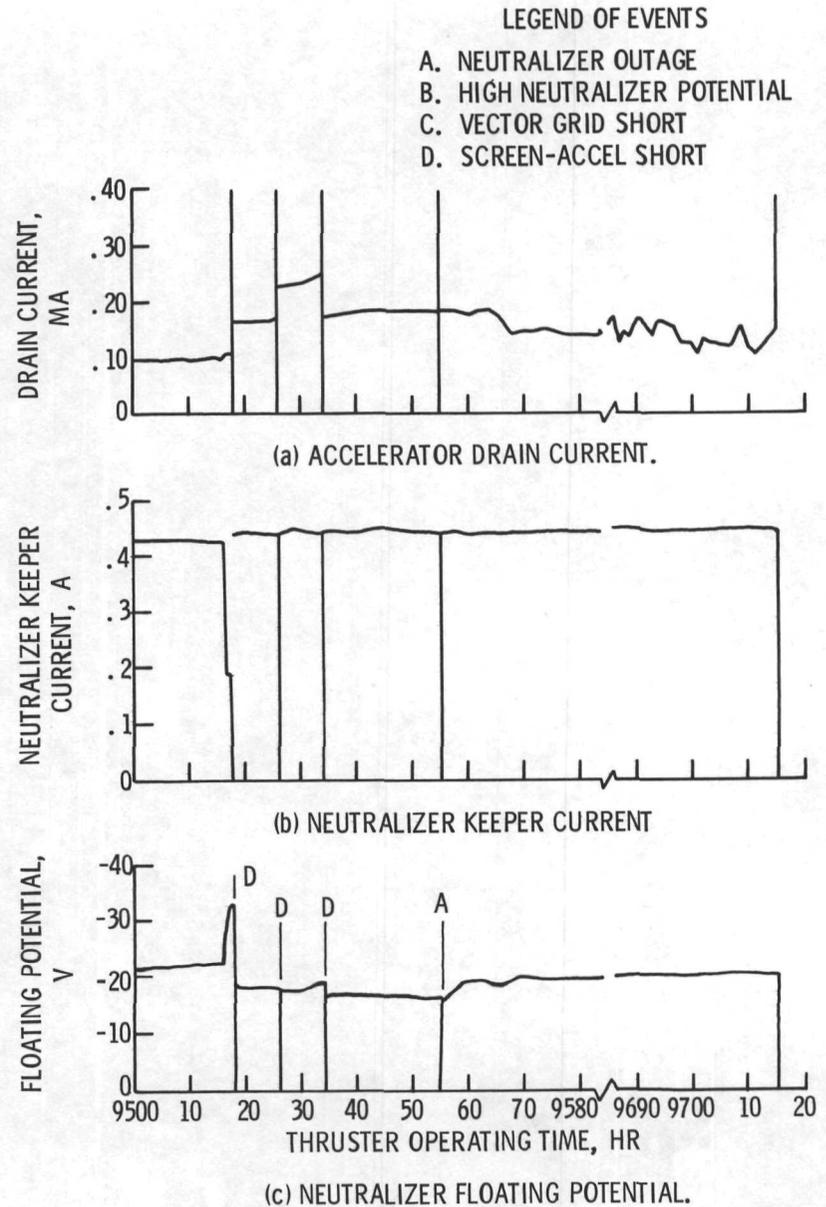
Figure 4. - Terminal history of test.

Terminal history. A history of the final segment of the durability test is shown in figure 4 to an expanded time scale. An uneventful 110-hour segment between 9580 and 9690 hours has been omitted for brevity.

The drain current, neutralizer keeper current, and neutralizer floating potential only are shown because no long-term trends in ion chamber parameters were discernible in this short time span. Thruster shutdowns occurred in close succession at 9518, 9526, and 9534 hours because of screen-accelerator shorts. The accelerator drain current (fig. 4(a)) increased about 0.05 mA after each of the first two events. After the third screen-accelerator short was cleared, the drain-current dropped 0.07 mA. It is believed that flakes of sputtered metal shed from ion chamber surfaces were defocusing the ions passing through partially blocked screen apertures. At worst, the first of grid element failures may have occurred at this point in the test. During the final 181 hours of the test, only one neutralizer-outage event occurred. The accelerator drain current continued to fluctuate with a gradual decline in the mean level. The test ended when a vector grid element cut through by a defocused beamlet dropped against the ground screen mask to cause a permanent short.

The neutralizer keeper current and floating potential are shown in figures 4(b) and (c). The thruster shutdown at 9518 hours was preceded by two hours of unsteady neutralizer operation. The continuous strip chart record showed that at 9516 hours, the neutralizer keeper current dropped to 0.2 A and the vaporizer temperature dropped 17° C. The neutralizer keeper voltage and floating potential increased about 10 volts and contained fluctuations varying in amplitude from 1 to 5 volts. There was no apparent connection between the neutralizer disturbances and the thruster shutdown at 9518 hours. Subsequent shutdowns caused by screen-accelerator shorts occurred during normal neutralizer operation. A neutralizer outage occurred at 9555 hours. From that point to the end of test the neutralizer operated at nearly constant conditions without interruption.

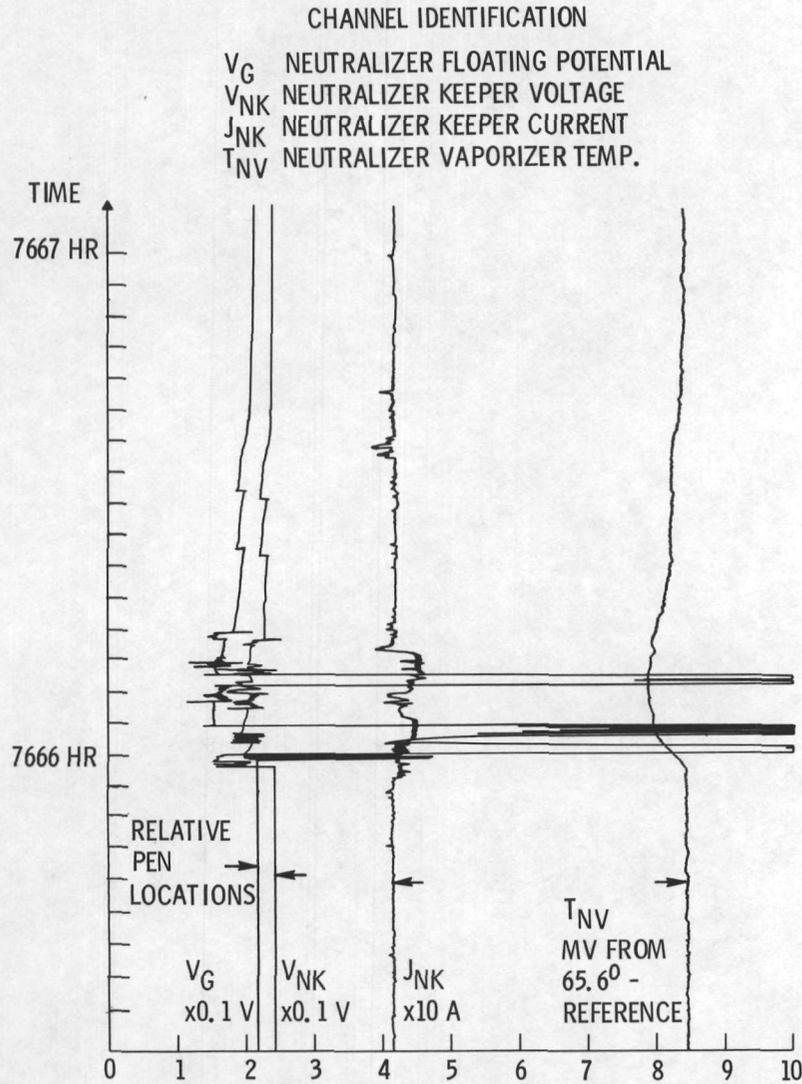
Figure 5. - Strip-chart record of neutralizer parameters.

Neutralizer transients. A selected portion of the continuous strip chart recording of neutralizer parameters is shown in figure 5. Each division along the paper travel corresponds to 3.75 minutes. The four channels from left to right are neutralizer floating potential $\times 0.1$ V, neutralizer keeper voltage $\times 0.1$ V, neutralizer keeper current $\times 10$ A, and neutralizer vaporizer temperature (chromel-alumel thermocouple, MV above 65.6° C). The operating time in hours is noted along the left margin.

The abnormal condition which occurred at about 7666 hours was a series of high floating potential spikes which did not persist long enough to activate the protective control circuit. The relative time positions of the four pens which are staggered to permit cross-over along the chart width are marked on each channel. At the chart speed used, however, the parameter leading the change cannot be resolved.

It is of interest to consider the power and thermal balance during this disturbance. From the initial steady-state conditions, the neutralizer keeper voltage decreased an average of 4 volts and the keeper current increased 0.03 A for a net decrease of 0.83 watt in neutralizer discharge power. The beam current and vaporizer heater power were constant throughout the transient. Neglecting the effects of change in neutralizer floating poten-

tial, the 0.8 watt decrease in neutralizer discharge power appears too small to justify a 13° C drop in vaporizer temperature. Similar transients in which the floating potential varied only 5 volts nevertheless showed the same amount of vaporizer temperature drop. Intentional variations in neutralizer heater power of the order of 3 watts with small variations in keeper voltage at constant keeper current and constant vaporizer power changed the vaporizer temperature only about 1° C. It appears that the relatively large change in vaporizer temperature observed in figure 5 was caused by mechanisms other than the changes in externally supplied power. Also, sudden changes in both keeper voltage and floating potential occurred and then corrected themselves spontaneously.

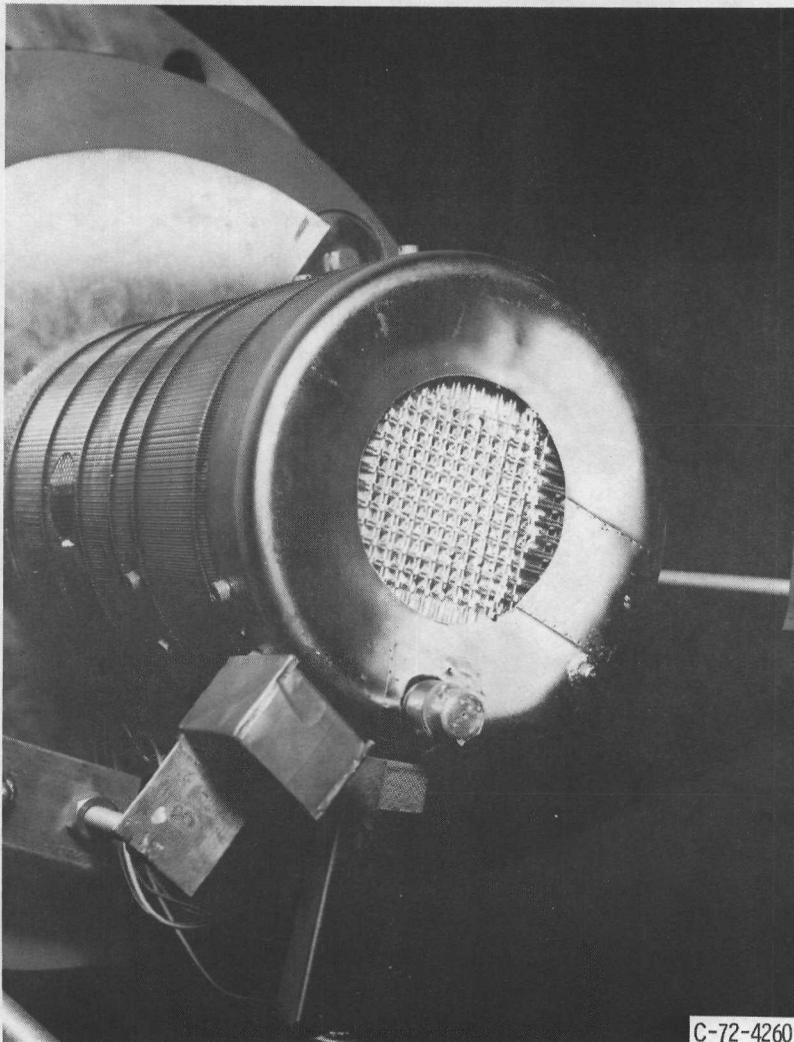
Figure 9. - SIT-5 thruster after test.

Electrostatic vector grid. Figure 9 is a photograph of the thruster in vertical position taken immediately after retraction from the vacuum test facility. The broken vector grid element which caused the decision to terminate the test is in visible contact with the opening in the ground screen mask. The ground screen and adjacent outside structures were remarkably clean and free of any loose metallic deposits.

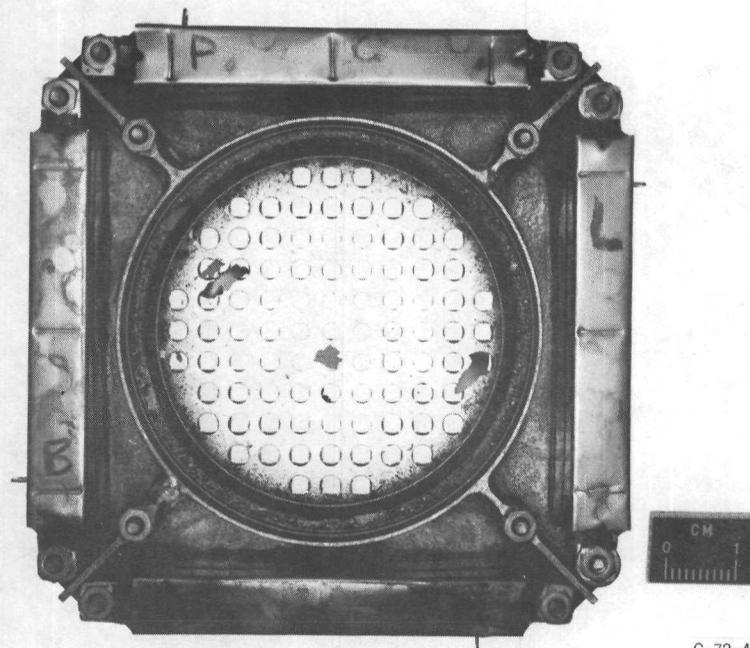
Figure 10. - Electrostatic vector grid after test showing metal flakes on screen electrode.

A photograph of the vector grid taken from the screen or ion chamber side is shown in figure 10. Care was taken to remove the grid assembly in a vertical position to minimize jarring and disturbing the flakes. Flakes can be seen lying in the peripheral regions of the screen grid and the magnetic pole piece.

A comparison of the flake locations and the eroded vector grid elements indicated that anomalous erosion was caused by flake-diverted beam ions. A more gradual type of erosion was caused by highly divergent ions from each beamlet hole and particularly from the 12 outermost holes.

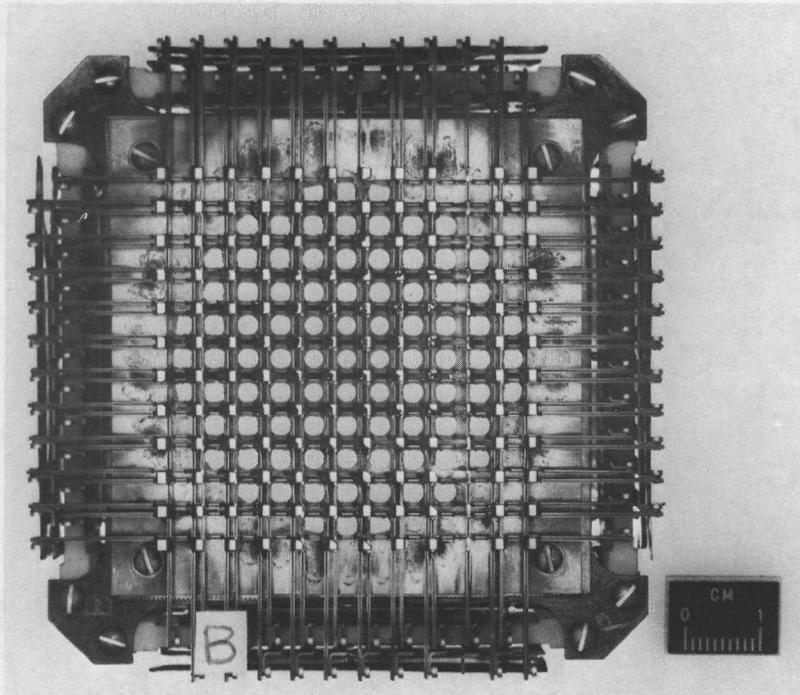
Figure 11. - Electrostatic vector grid after test.

Figure 11 is a photograph taken from the accelerator side of the vector grid. The broken grid element has been removed. Five grid elements were eroded through, but only one element (shown removed) dropped completely out of position. The others were either restrained from falling by the charge-exchange protective shields or held by the orthogonal elements lying cross-wise above them.

Numerous darkened areas outside the hole pattern can be seen on the face of the screen grid. These were arc sites formed where capacitor discharges were used to clear a short between the screen and accelerator. Sputtered metal, probably from the neutralizer, was deposited in those regions not shielded by the ground mask.

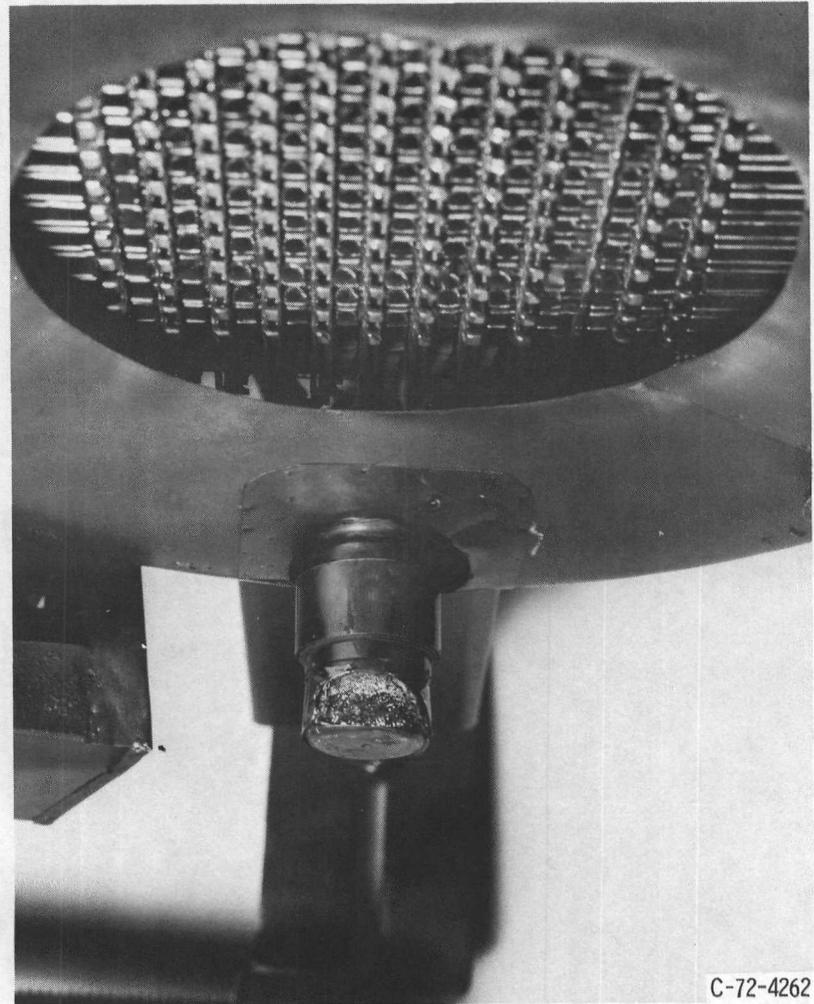
Figure 12. - Neutralizer after test.

Neutralizer. A close-up photograph of the neutralizer taken after the test is shown in figure 12. The double layer of 0.0127 mm thick tantalum foil used as an erosion rate detector marks the approximate boundary of the intercepted ion beam. The boundary lay on a 45 degree line drawn

from the trailing edge of the outermost beam hole grid element. The tantalum foil eroded at a rate of only 13 microns per 500 to 600 hours of undeflected beam operation. The maximum depth of erosion on the neutralizer keeper cap is estimated to be 250 to 300 microns at the corner which projected most deeply into the ion beam.

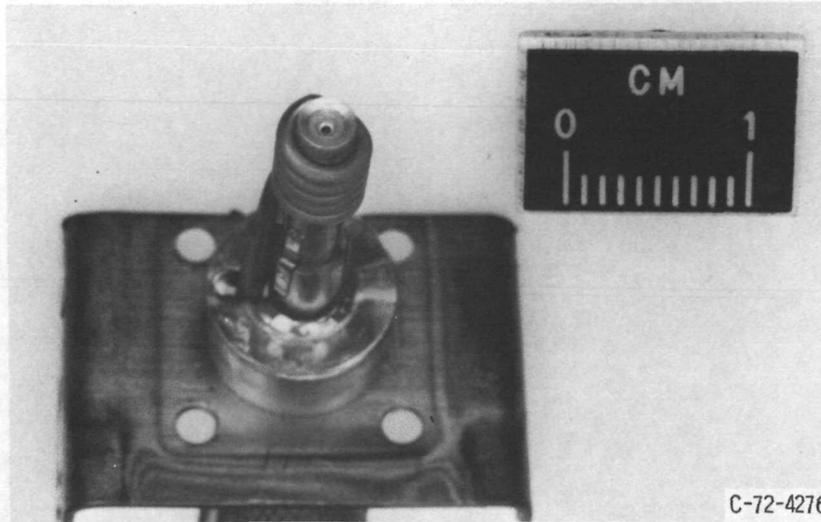
Figure 13. - Neutralizer hollow cathode after 9715 hours.

A photograph of the neutralizer hollow cathode is shown in figure 13. Erosion occurred at the aperture and the chamfered surface of the tip. An enlarged drawing of the tip disk sectioned along a diameter is shown in figure 14. The dotted outline shows the aperture size and the chamfered surface when new. During 9715 hours of operation the aperture eroded from 0.254 to 0.549 mm at the neck.

Preliminary data taken by A. Weigand of LeRC has indicated that neutralizer tip erosion can be a strong function of neutralizer flow rate. Simulation of total depletion of the insert's emissive coating by operating cathodes without any insert or emissive coating has shown that erosion of the tip will take place at the flow rates used during this endurance test. Weigand's data has indicated that for 5 cm neutralizer flow rates at or above 6.9 mA the tip erosion rate is reduced by over 2 orders of magnitude even if the insert has been totally depleted. Thus neutralizer operation at slightly higher flow rates, with a small penalty on propellant utilization efficiency, appears to be an attractive operating mode to prevent excessive tip erosion.

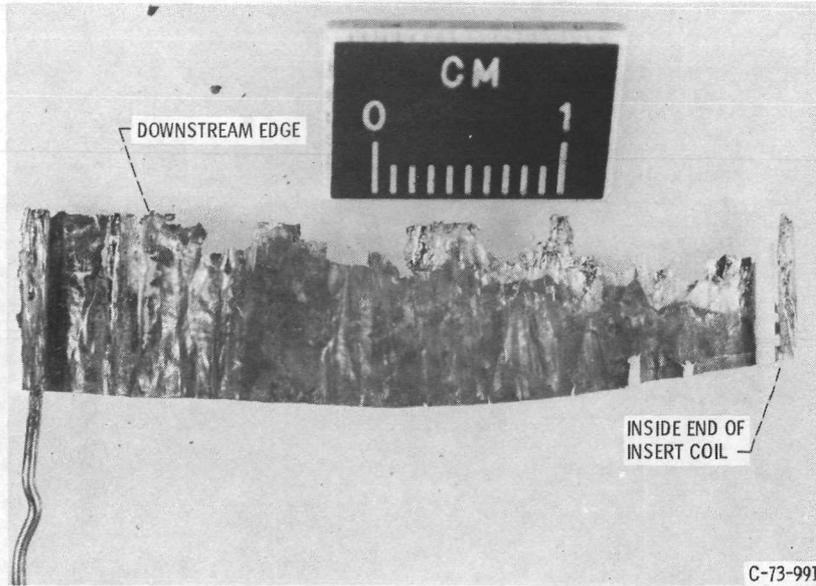
Figure 15. - Unrolled neutralizer insert after 9715 hours.

Neutralizer insert. The neutralizer insert was examined for possible correlation between neutralizer operation and insert condition. Figure 15 is a photograph of the insert after it was unrolled and stretched out. Parts of the downstream edge (nearest the neutralizer tip) of the insert appeared to have reached high enough temperatures to cause embrittlement and erosion. These regions were either sintered layer-to-layer or so brittle that crumbling occurred. The upstream portion of the insert remained intact and springy. A small rod was required to keep the insert from recoiling.

Both the upstream and downstream regions of the insert were examined with an optical microscope and an electron scanning microscope with elemental identification by an energy dispersive analyzer. Barium was detected generally in the upstream region, but the downstream edges were practically devoid of barium except in small isolated or sheltered regions. The conclusion is that an ample amount of the barium emissive mixture was left in the insert, but it was not available or present in localized areas where required for good neutralizer operation.

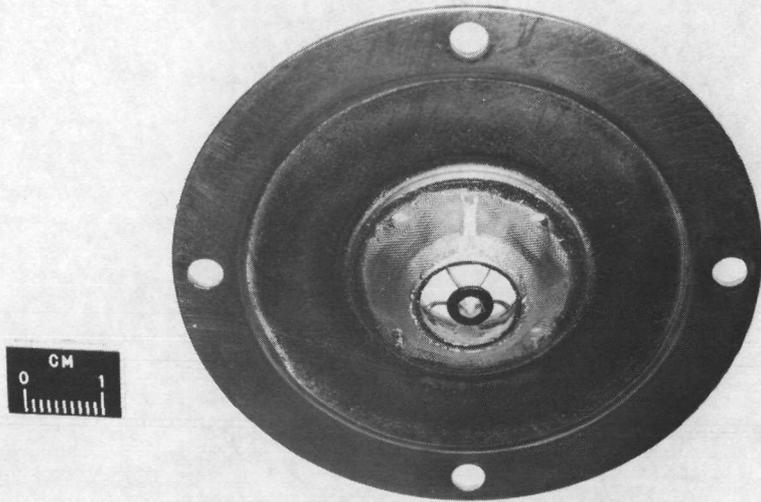
Figure 16. - Cathode pole assembly and thruster back plate after 9715 hours.

Cathode pole assembly and thruster back plate. A photograph of the cathode pole assembly and thruster back plate which were exposed to the ion chamber plasma is shown in figure 16. The extent of erosion can be seen by comparison with figure 17 which is a photograph of the same component after 2027 hours of operation. The magnification was higher so that the initial stages of erosion could be seen around the screw threads and the hexagonal corners of the nut.

After 9715 hours, all but 0.009 gram of the nut (original estimated weight, 0.099 gm) was

eroded. Only two threads of the 0-80 stainless steel screw remained above the baffle. The baffle itself was only slightly eroded at the downstream peripheral edge.

Slight erosion was found on the thruster back plate. Four radial traverses were made with a surface analyzer to determine the depth of surface erosion. Although not axially symmetrical the maximum erosion was about 8 microns at a radius of about 2 cm.

J. Power and E. Wintucky of LeRC have proposed the use of pyrolytic graphite coatings over cathode potential surfaces to reduce the sputtering of these components. The low sputter yield of carbon should greatly reduce the material loss rates from cathode potential surfaces. Tests of pyrolytic graphite baffles and thruster back plates are currently being performed to evaluate these sputter resistant components.

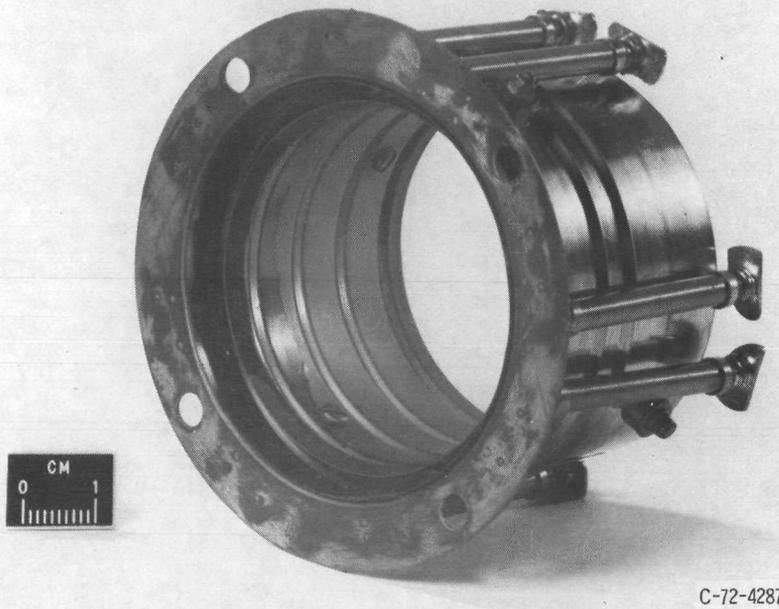
Figure 18. - Anode after 9715 hours.

Anode. A photograph of the ion chamber interior looking from the cathode end is shown in figure 18. The anode showed no sign of erosion. Peeling of sputtered metal which formed the flakes was evident around most of the upstream end of the anode. It is believed that the main source of sputtered metal was the baffle assembly and the thruster back plate. The flakes which peeled off were typically 0.021 mm thick and magnetic.

The exact cause of peeling is not known. Thermal cycling because of thruster shutdowns, the mismatch of expansion coefficients, exposure to atmospheric moisture at 2027 hr, and the mechanical stability limit of sputtered material probably all contributed to the loosening of an already weakly bonded layer.

It has been proposed that an opaque finely woven screen anode would retard the peeling off of sputter deposited material on the anode. Conceptually, the sputter deposited films would have thickness variations around each wire of the woven anode. At points where two wires cross or contact each other the film thickness should be near zero. As a result of the woven anode structure, all sputtered film patches are surrounded by near zero thickness films. Thus, even if a sputter deposited film cracks or peels in the region of thickest deposition, the flakes should remain attached at the places where the film is thin and strongly adherent. If the screen anode is finely woven the distances between maximum and minimum film thicknesses are small, thus reducing the probability of flakes totally detaching from their thinner surrounding regions. Tests of the screen anode are being made to determine its effectiveness in the prevention of loose flakes. The combination of reduction in sputter rate of the cathode potential surfaces and the peel resistant anode could prevent formation of loose flakes.
