NASA TN D-7439

APOLLO EXPERIENCE REPORT - SPACECRAFT STRUCTURAL WINDOWS

by Orvis E. Pigg and Stanley P. Weiss

Lyndon B. Johnson Space Center

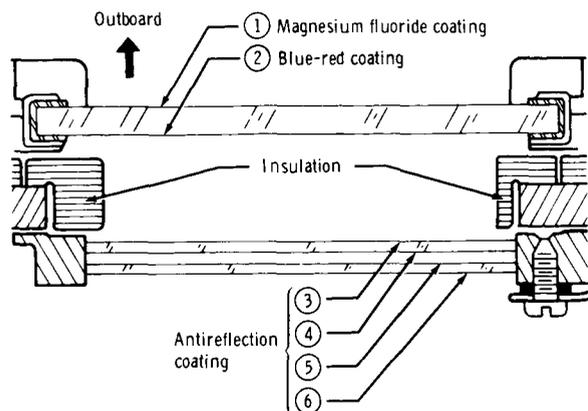
Figure 5. - Command module window-surface notation.

As previously stated, an initial assumption was made that the optical coatings applied to the windows did not degrade their structural capability; therefore, the window qualification tests were conducted using uncoated, abraded windows. This assumption was proved invalid during coating crazing anomaly, and additional qualification testing of the coated windows was required to verify their flightworthiness.

To improve the optical properties of the CM heat-shield hatch window for the lunar multispectral photography experiment (S-158) on Apollo missions 13, 14, and 15, the available hatch windows were surveyed to find those with acceptable optical properties. Two heat-shield side windows with acceptable properties were found, and it was decided to remove the coatings and cut hatch windows from these side windows. At that time, the hatch scientific window could have no coatings because of the S-158 experiment optical requirements. The "no coating" requirement was removed later for the Apollo 14 mission because the S-158 experiment on that flight was rescheduled to the Apollo 15 mission. The first side window was damaged during the polishing procedure to remove the coatings. The second window was cut to size, and both the magnesium fluoride and the blue-red (BR) coatings were left on the window. In the thermal-shock test, the window was heated in air to 1200° F for 45 minutes and immediately immersed in room-temperature tapwater. The BR coating crazed and cracks propagated through the tension layer developed by the thermal gradient of the glass on the underside of the BR coating. Later, an entire side window from spacecraft 014 was tested in a similar manner to verify that the cutting of the window had not caused the crazing; similar results were obtained.

1. The BR coating crazing is temperature dependent.
2. The BR coating crazing is independent of window size or cooling rate.
3. The BR coating crazing occurs during cooling.
4. Window glass fracture sometimes occurs when the BR coating crazes, but does not occur without it.

To determine the minimum temperature at which the heat-shield window coating crazes, a series of tests was conducted on 2- by 7-inch samples cut from a spacecraft 017 heat-shield side window. The results of these tests indicated that the threshold temperature for BR coating crazing is 450° to 500° F. A separate series of tests was conducted on 3- by 3-inch samples cut from a spacecraft 014 heat-shield rendezvous window and also determined that BR coating crazing occurs at approximately 500° F.

The decision was made to continue using the coated windows and to conduct a delta qualification test program to verify the adequacy of these windows at newly predicted flight temperatures. The maximum flight temperature on the inner surface of the heat-shield window was predicted to be 362° F. Because the coating crazing was

determined to be caused by peak temperature and not thermal gradient, it was proposed that the heat-shield windows be tested to a maximum temperature of 462° F to account for variations in oven temperature and the temperature at which the coating was deposited. Three heat-shield side windows were heated in an oven to 462° F to represent worst-case flight temperatures, and the windows were then pressure tested on both sides to verify adequate structural capability for the remaining flight loads. The program was completed successfully and the coated heat-shield windows were considered flight qualified.

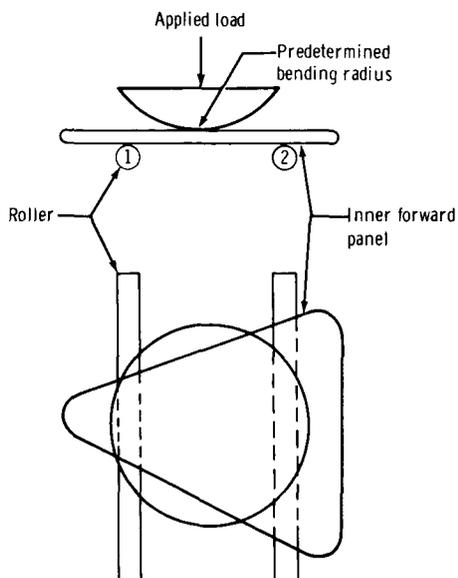
Figure 10. - Lunar module window flexure tests.

Forward window test failure. - In December 1967 during a factory checkout pressure test on the LM-5 ascent stage cabin, a forward window failed at a cabin pressure of 5.1 psid. The pane was completely destroyed, which is consistent with the failure mode of tempered glass. The subsequent investigation revealed no abnormal conditions; it was concluded that the most likely cause of the failure was an undetected flaw in the glass. This pressure test of LM-5 was the first time the window glass had been exposed to the correct stress distribution. Previous structural acceptance tests on the windows consisted of a mechanical flexure test (fig. 10) on the forward windows and a thermal-shock test on the docking window. The mechanical flexure test was accomplished three times on both sides of each panel (each corner on roller 1). The flexure test stressed the pane to a maximum of approximately 30 000 psi, which demonstrated a factor of safety of approximately 5 over normal operating stress. However, this test did not

stress the corners of the pane, which were the areas of maximum stress in the vehicle. Because the docking window was curved, a thermal-shock acceptance test was required instead of a mechanical flexure test. The stress level experienced during thermal shock was approximately 20 000 psi, which demonstrated a factor of safety of approximately 7. To reestablish confidence in the structural integrity of the LM windows, many engineering evaluation tests were conducted. A summary of the tests conducted, including the purpose, condition, and results, is given in table I. These tests showed the structural integrity of the window glass and the window-support structure. The structural integrity was sufficient if glass with critical defects was not used in the spacecraft. Two steps were taken to guarantee that defective glass was not installed. The first step was to modify the acceptance test to include a pressure test on each structural pane in a test fixture simulating the

spacecraft installation. The acceptance test pressure imposed on the panes was 25 psid for the forward windows and 15 psid for the docking window. These pressures correspond to proof factors of 5 and 3 above operating pressure for the two windows, and these proof factors are consistent with requirements based on fracture mechanics techniques. The docking window test pressure was restricted to 15 psid to prevent yielding of the metallic edge member. In addition to the improved acceptance tests, the second step taken was to redesign the window glass protective covers to provide maximum protection from acceptance until launch. Before the acceptance tests were conducted, a polycarbonate protective cover, retainer, and glass pane were installed as a subassembly in the pressure-test fixture. The pressure test was then performed to the proper pressure for 2 to 5 minutes. After the pressure test, the subassembly was removed from the fixture and an additional protective cover was installed on the opposite side to provide a handling and transportation protective cover assembly. The outer covers remained on each pane until the outer pane was installed. The two covers were not removed from the vehicle until just before launch, which provided maximum protection against inadvertent damage from workmen in and around the vehicle.

No vehicle windows have failed since the revised acceptance test procedures and new protective covers were implemented. Eight windows (seven forward and one docking) have failed in acceptance tests. The range of failing pressure on the forward window was 5.0 to 24.8 psid. The only docking window failure occurred at 11.6 psid.

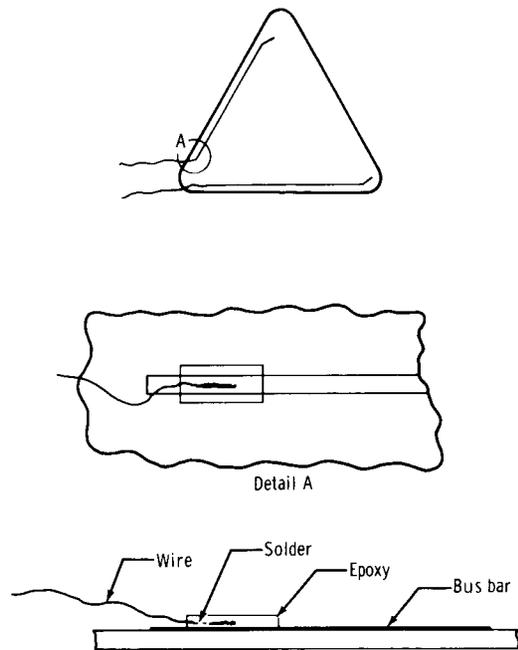
Figure 11. - Lunar module window heater electrical connection.

Window heater electrical connection. - A forward window bus bar arced during the factory checkout test of the electrical heater on LM-8. Failure analysis revealed the glass was spalled under the bus bar, causing the arc when electrical power was applied. A detailed inspection conducted on other LM windows revealed discolorations that indicated spalling.

The configuration of the electrical connection to the bus bar for the window heater is shown in figure 11. The bus bar was a strip of silver paste fused into the glass along the edge of two sides of each window. The electrical wire was subsequently soldered to the bus bar. To provide strain relief to the solder connection, an overlay of epoxy was applied. After the addition of the solder and epoxy to the windows, the window was exposed to various manufacturing processes that elevated the window temperature. Because of the difference in the thermal coefficient of expansion between the glass, solder, and epoxy, residual stresses were induced into the glass. Analysis indicated that the magnitude of thermal stress was sufficient to relieve the compressive stresses in the outer layer of the chemically tempered glass, thereby reducing the strength of the glass. An extensive test program was conducted to verify the cause of the spalling. The MOR test matrix is presented in table II.

program included specimens with solder and epoxy applied that were exposed to the flexure and temperature environment and then the solder and epoxy were removed. These specimens showed that the original strength was reestablished if the solder and epoxy were removed.

The electrical connection to the bus bar was redesigned to eliminate the solder and epoxy. The new electrical connection was achieved by a beryllium copper spring-loaded electrical contact as shown in figures 12 and 13. The window panes in LM-7 and subsequent vehicles were removed from the vehicles and the solder and epoxy were removed from the panes. Following the rework, the panes were proof-pressure tested and reinstalled in the vehicles.
