THE IMPACT RESISTANCE OF CURRENT DESIGN COMPOSITE FAN BLADES TESTED UNDER SHORT-HAUL OPERATING CONDITIONS

INTERIM REPORT

GENERAL ELECTRIC COMPANY
Advanced Engineering and Technology
Programs Department

NASA Lewis Research Center
Contract NAS3-16777

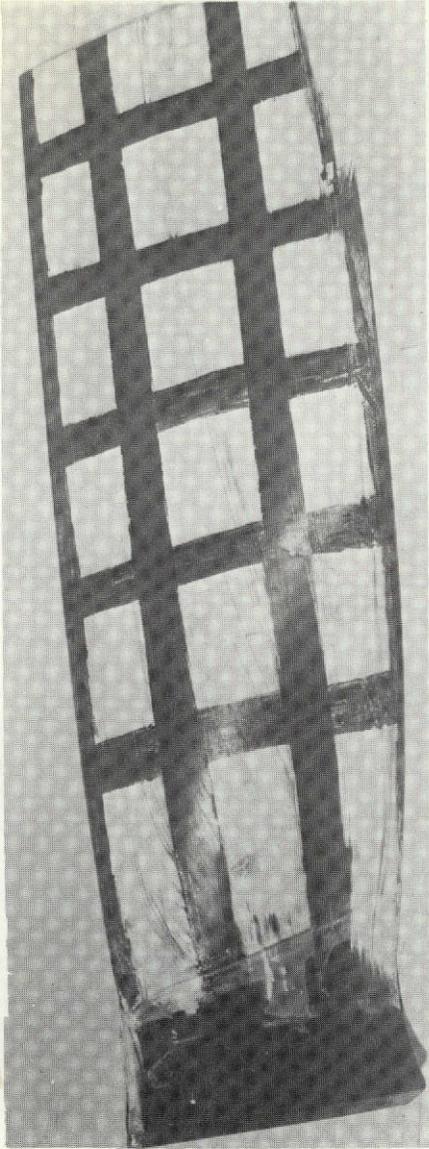
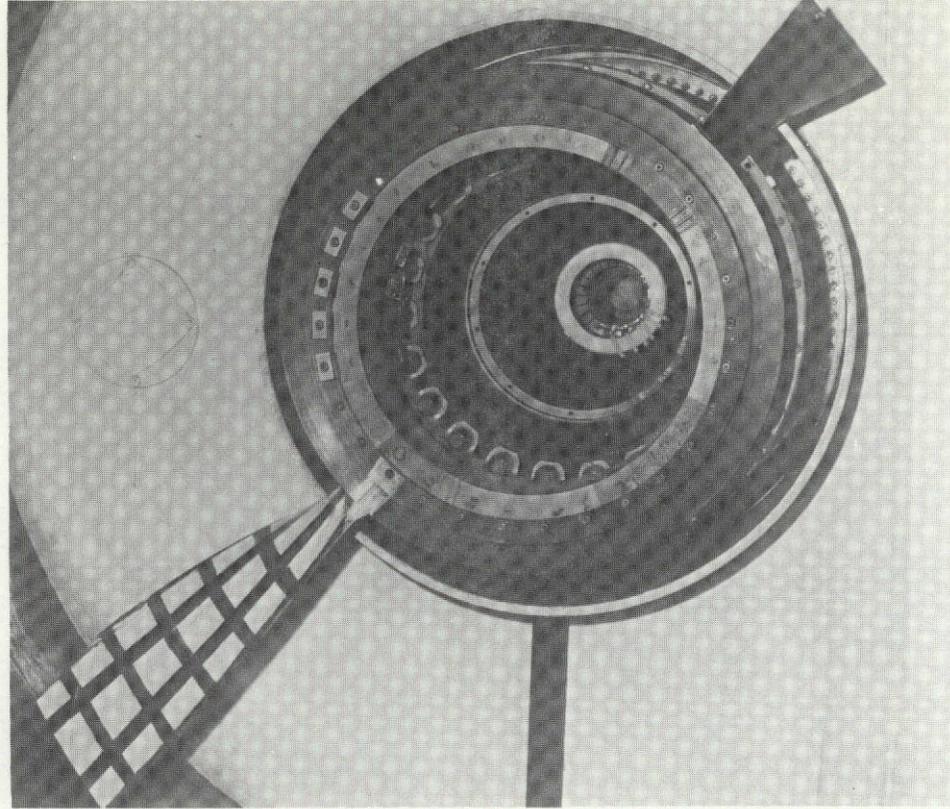
Figure 6. Blade S/N-NG1 after Impact.

Blade S/N	Bird Size	Bite Size	Damage*
NG1	12 Oz Simulated Bird	6 Oz	Loss of sliver and delamination at trailing edge of blade tip. Crack in dovetail.
NB2	12 Oz Simulated Bird	6 Oz	Radial crack in tip. Very small crack in dovetail at leading edge.
NG3	28 Oz Simulated Bird	12 Oz	Blade broke off at root.
NB4	28 Oz Simulated Bird	12 Oz	Blade broke off at root.
NG4	16 Oz Real Pigeon	11 Oz	Crack in root, as indicated by dye penetrant. Delamination in tip area.
NB3	16 Oz Real Pigeon	10 Oz	Delamination at base of leading edge, piece out of tip at leading edge. Delamination across tip.
Ti	16 Oz Real Pigeon	8 Oz	No damage.

NASA-FOD Impact Resistance Test
Blade S/N NG1
Graphite/Epoxy
Tip Speed: 800 ft/sec
12 oz RTV Bird
6 oz Slice
22° Incidence Angle

- Photographs - The after impact photos show the details and extent of damage for each blade. One of the consistent results is the crack which goes along the bottom of the dovetail and up both faces. This crack appears in each of the G/E blades (NG1, NG3, NG4) impacted with birds or simulated birds but only shows up for the one B/E (NB4) blade which broke off at the root. Otherwise for the blades which didn't break off, damage was fairly typical. Damage consisted of radial cracks and splinters at the blade tip with an occasional small crack at the dovetail root.

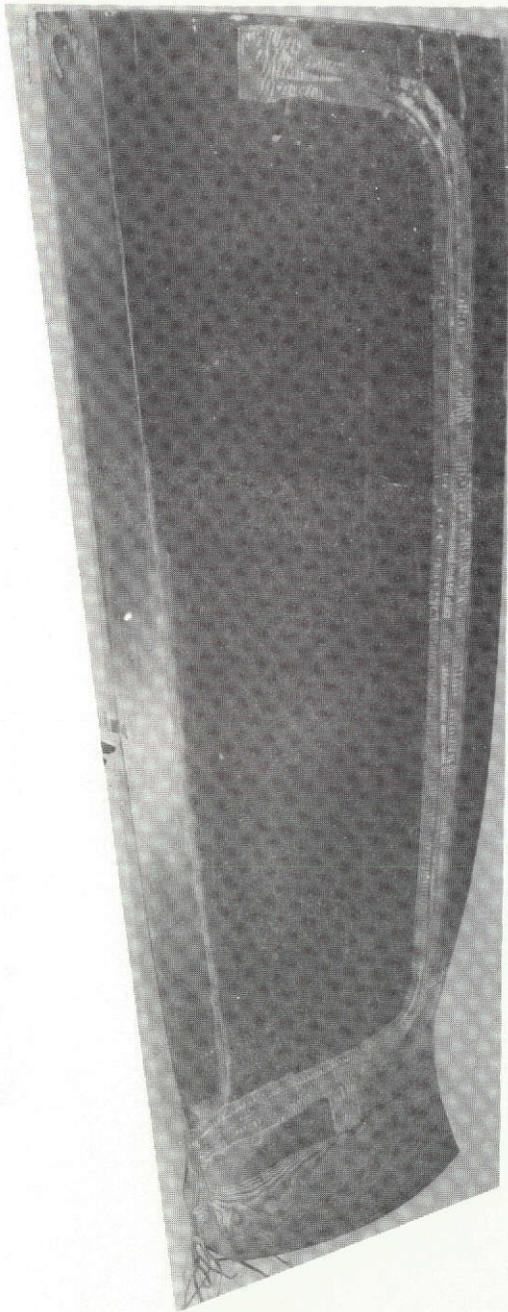
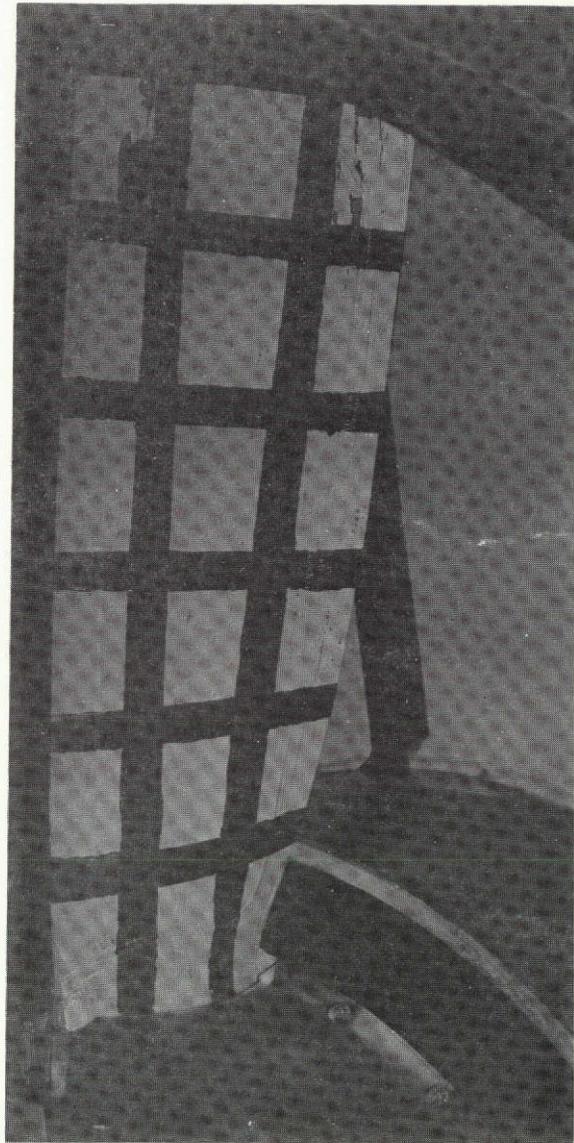
Figure 7. Blade S/N-NB2 after Impact.

NASA-FOD Impact Resistance Test
Blade S/N NB2
Boron/Epoxy
Tip Speed: 800 ft/sec
12 oz RTV Bird
6 oz Slice
22° Incidence Angle

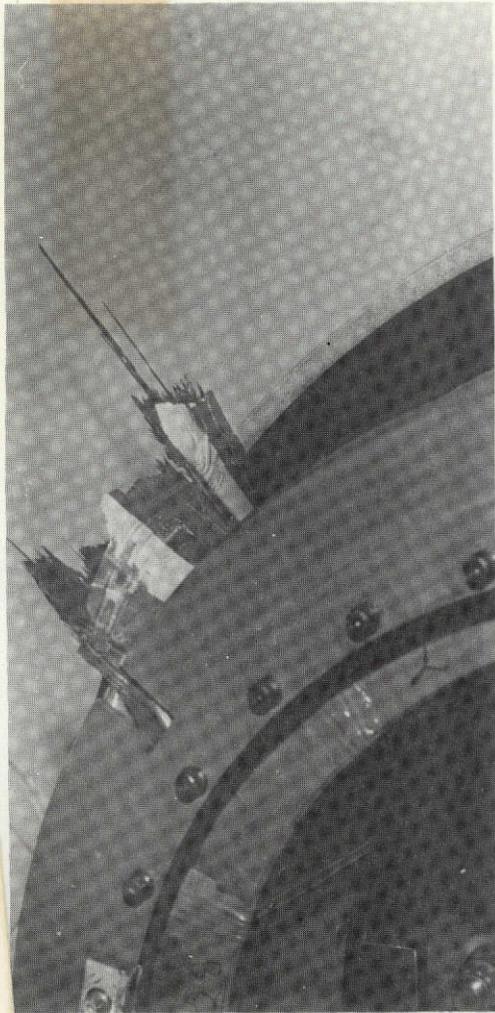
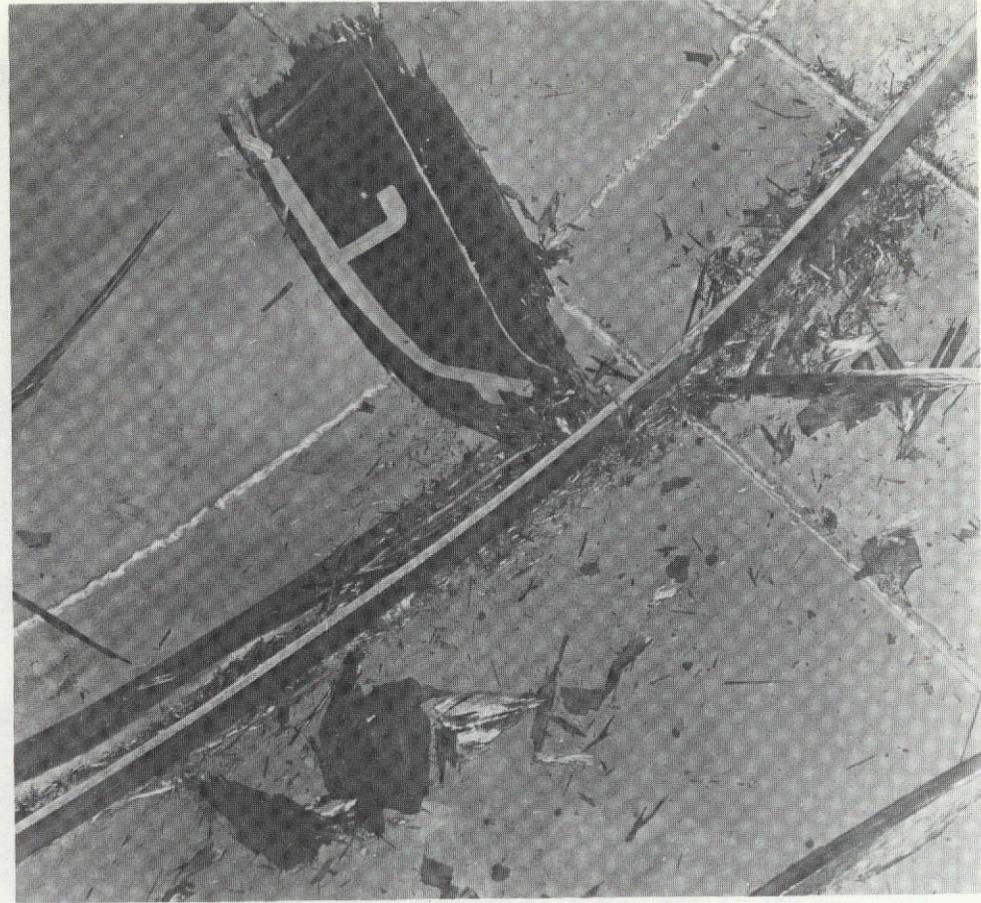
Figure 8. Blade S/N-NG3 after Impact.

A 12 oz bite off a 28 oz simulated bird caused blade failure, apparently resulting from high bending stresses, in both Gr/E and B/E blades at the airfoil root. The blades were contained easily and broke into relatively small pieces.

NASA-FOD Impact Resistance Test
Blade S/N NG3
Graphite/Epoxy
Tip Speed: 800 ft/sec
26 oz RTV Bird
12 oz Slice
22° Incidence Angle

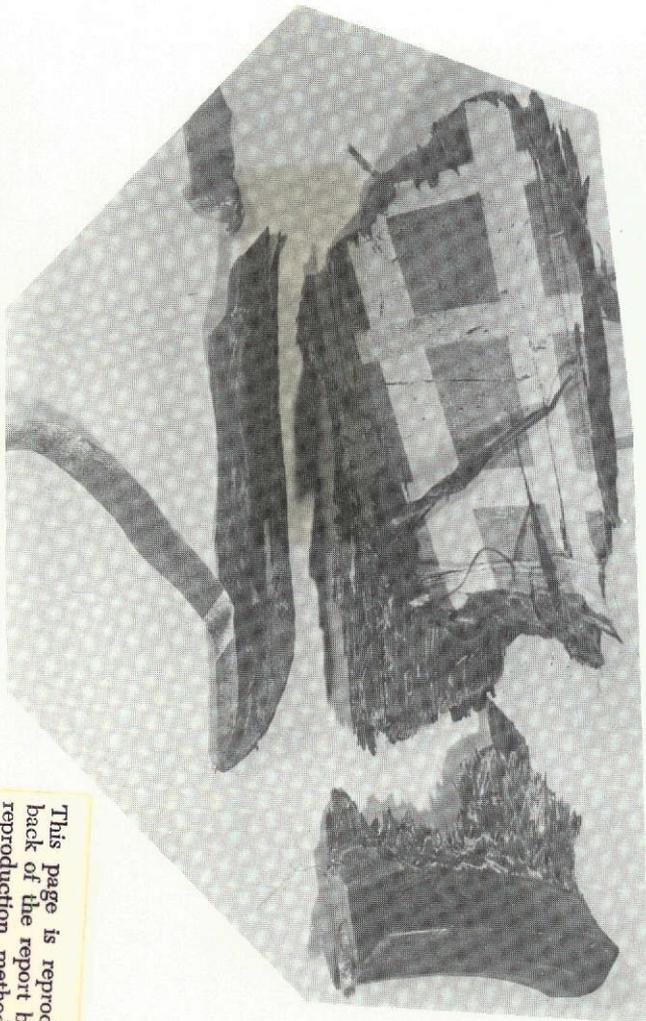
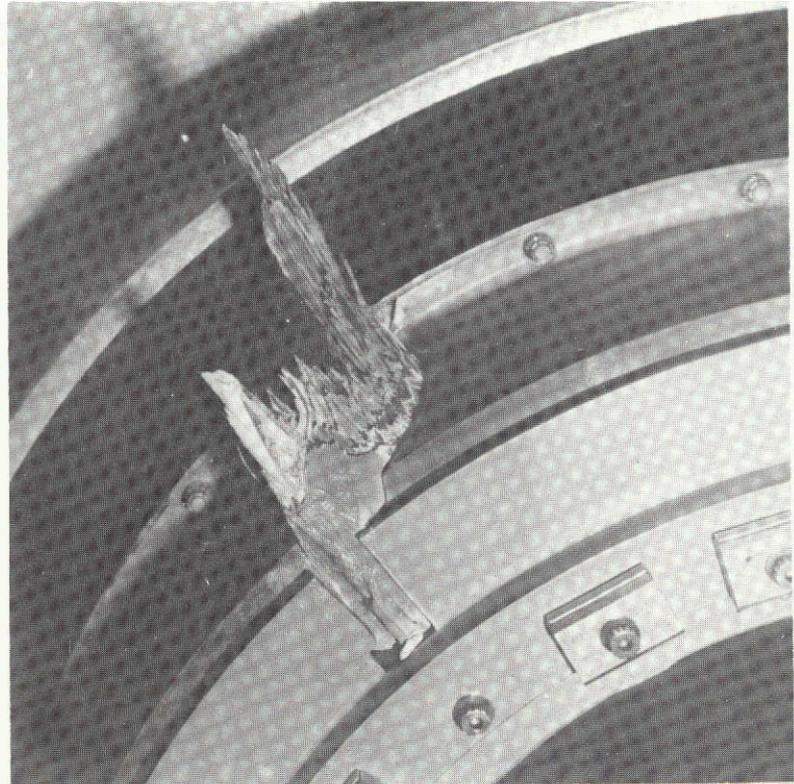
Figure 9. Blade S/N-NB4 after Impact.

NASA-FOD Impact Resistance Test
Blade S/N NB4
Boron/Epoxy
Tip Speed: 800 ft/sec
26 oz RTV Bird
12 oz Slice
22° Incidence Angle

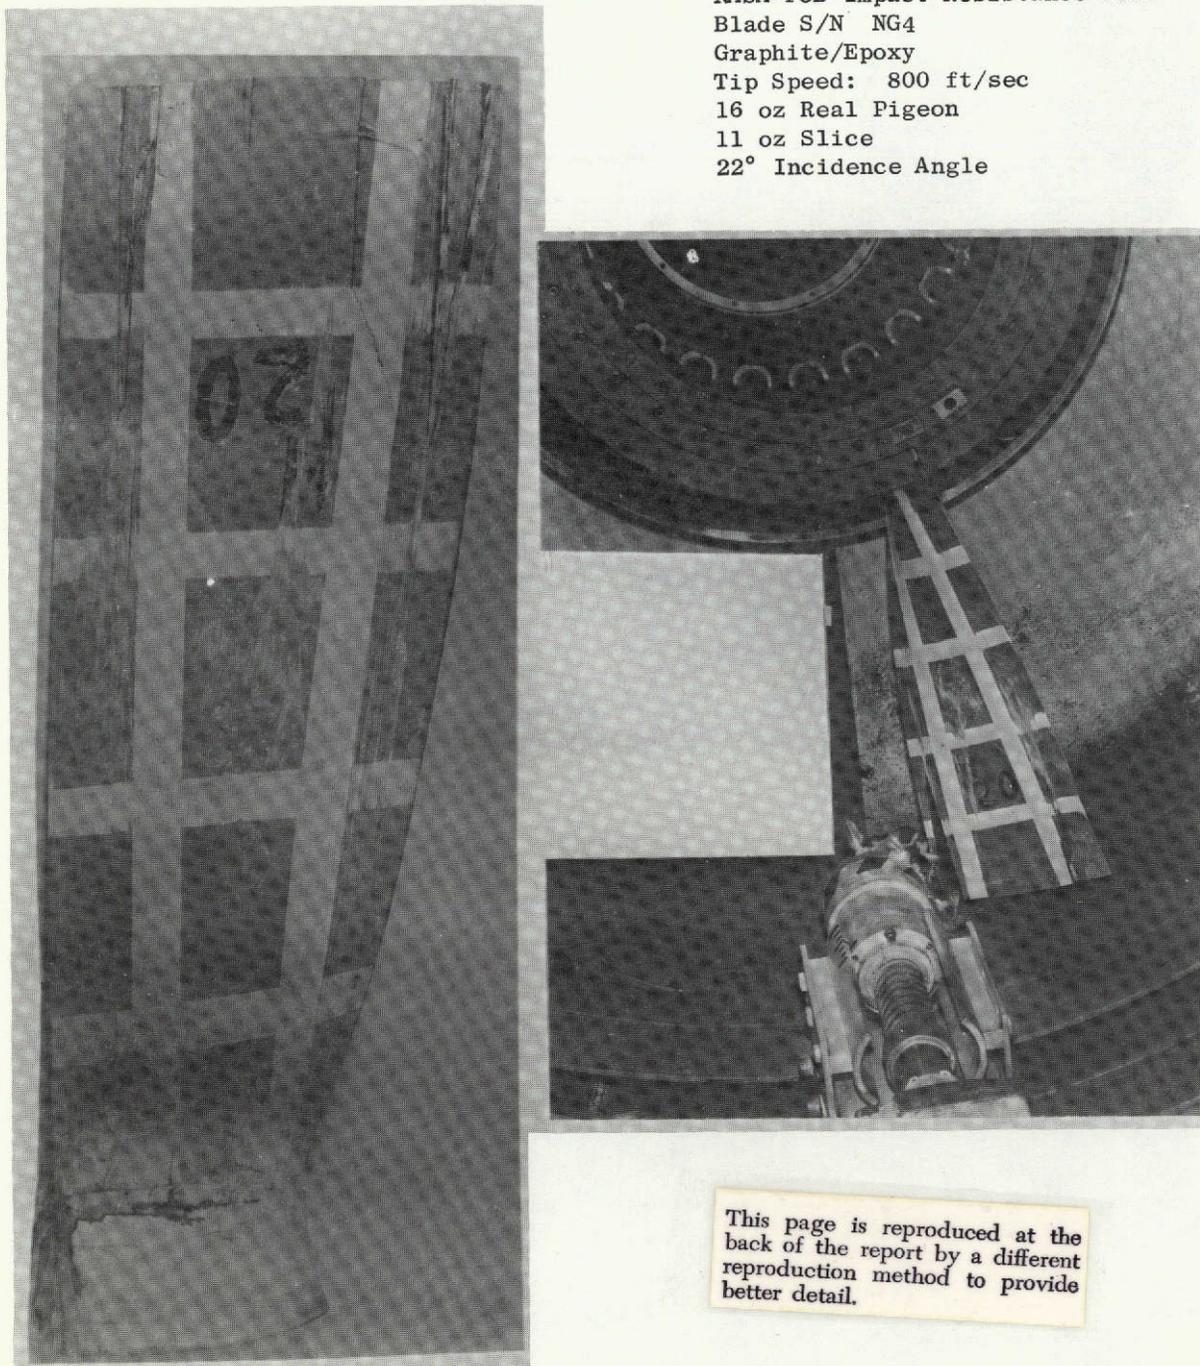
Figure 10. Blade S/N-NG4 after Impact.

For the 11 oz bite off of the 16 oz real pigeon, both blades were damaged as revealed by NDE results. The extent of damage resulting from this impact suggests the upper limit on the bird size which can impinge upon the composite blades under the test conditions described without failure at the root.

- Bench Frequency Check - The bench frequencies for the first three modes of all blades are shown in Table I. In addition, the after test frequencies for the first flex only are presented due to the extent of damage. These data show that for the most part, 1F frequencies remain the same. The biggest change in frequency occurred on graphite blade NG4 which was impacted with an 11 oz slice of a 16 oz pigeon.

NASA-FOD Impact Resistance Test
Blade S/N NG4
Graphite/Epoxy
Tip Speed: 800 ft/sec
16 oz Real Pigeon
11 oz Slice
22° Incidence Angle

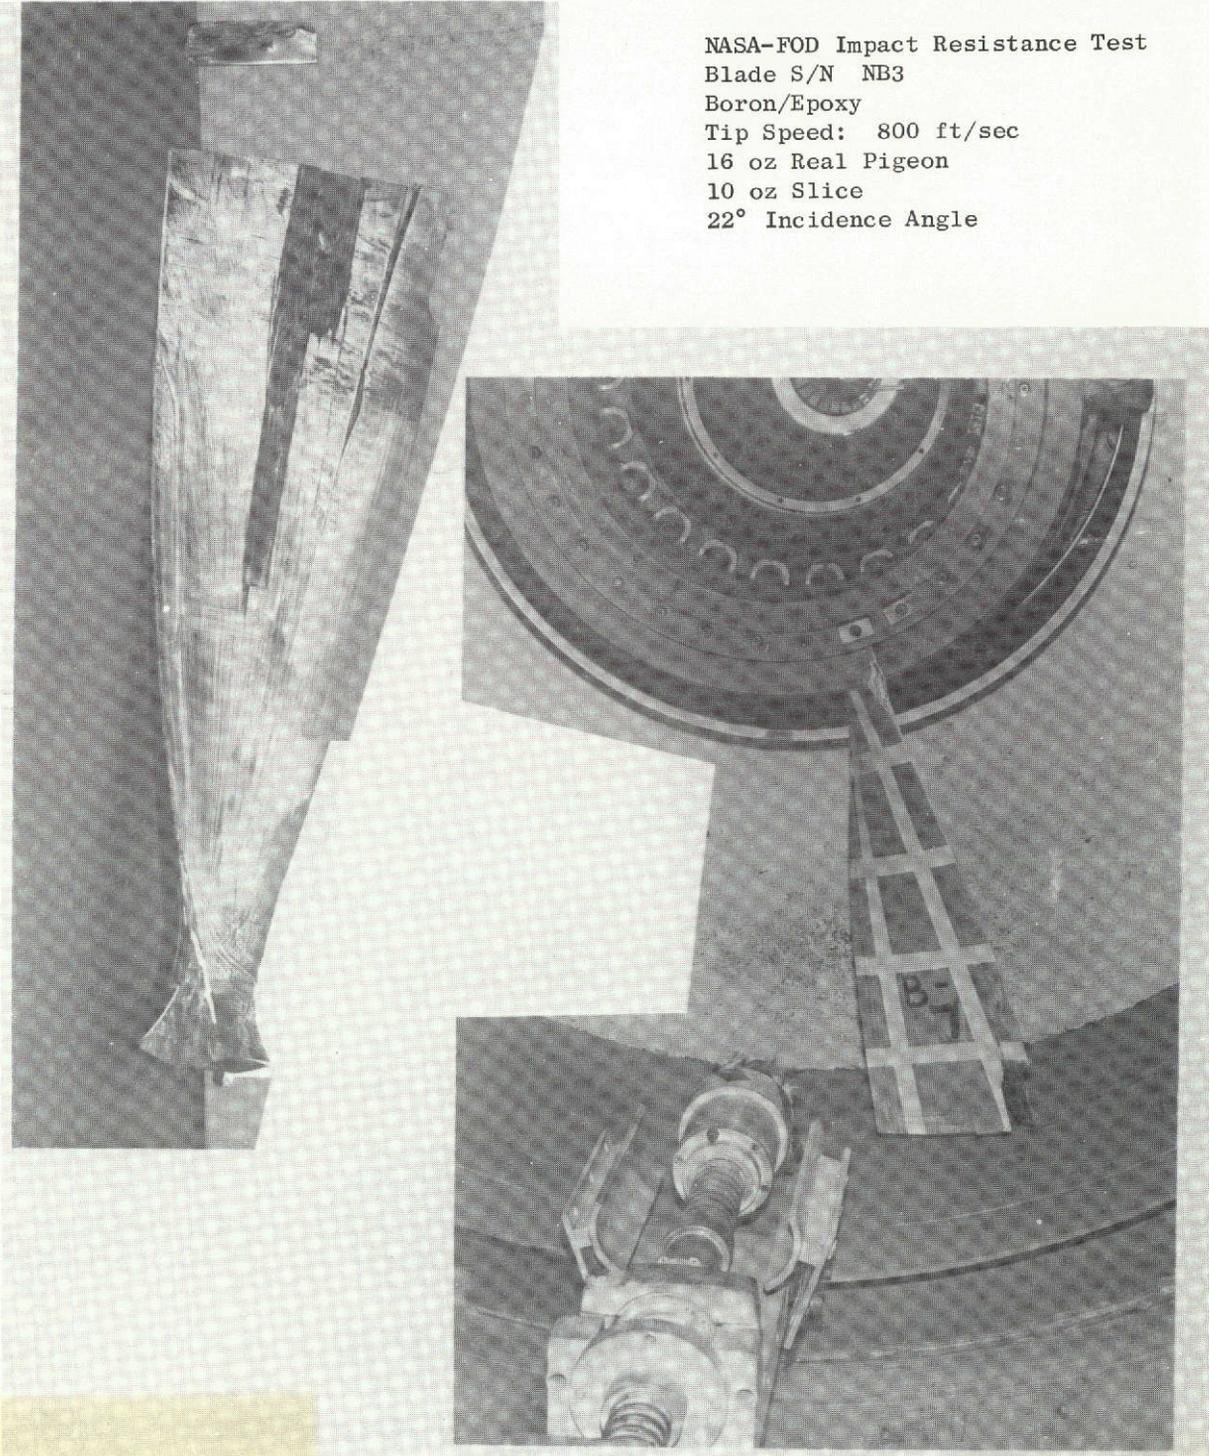
Figure 11. Blade S/N-NB3 after Impact.

NASA-FOD Impact Resistance Test
Blade S/N NB3
Boron/Epoxy
Tip Speed: 800 ft/sec
16 oz Real Pigeon
10 oz Slice
22° Incidence Angle

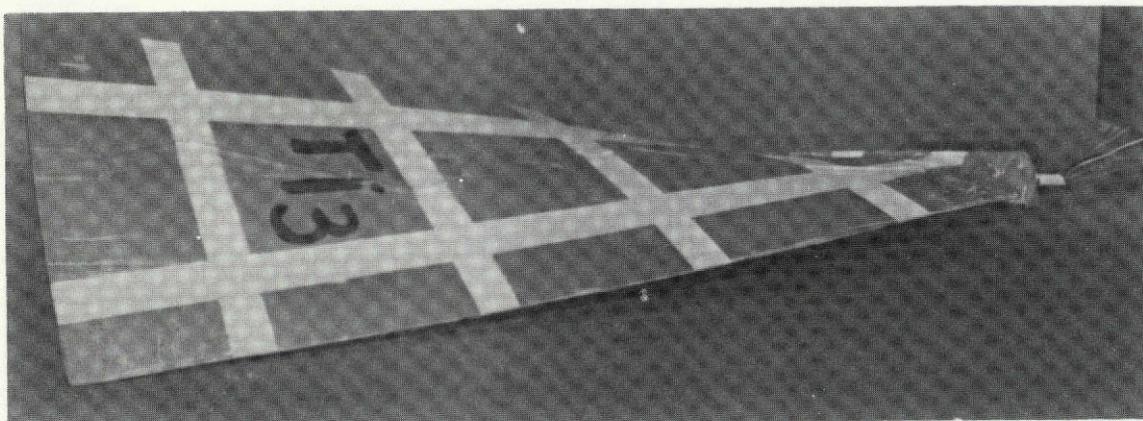
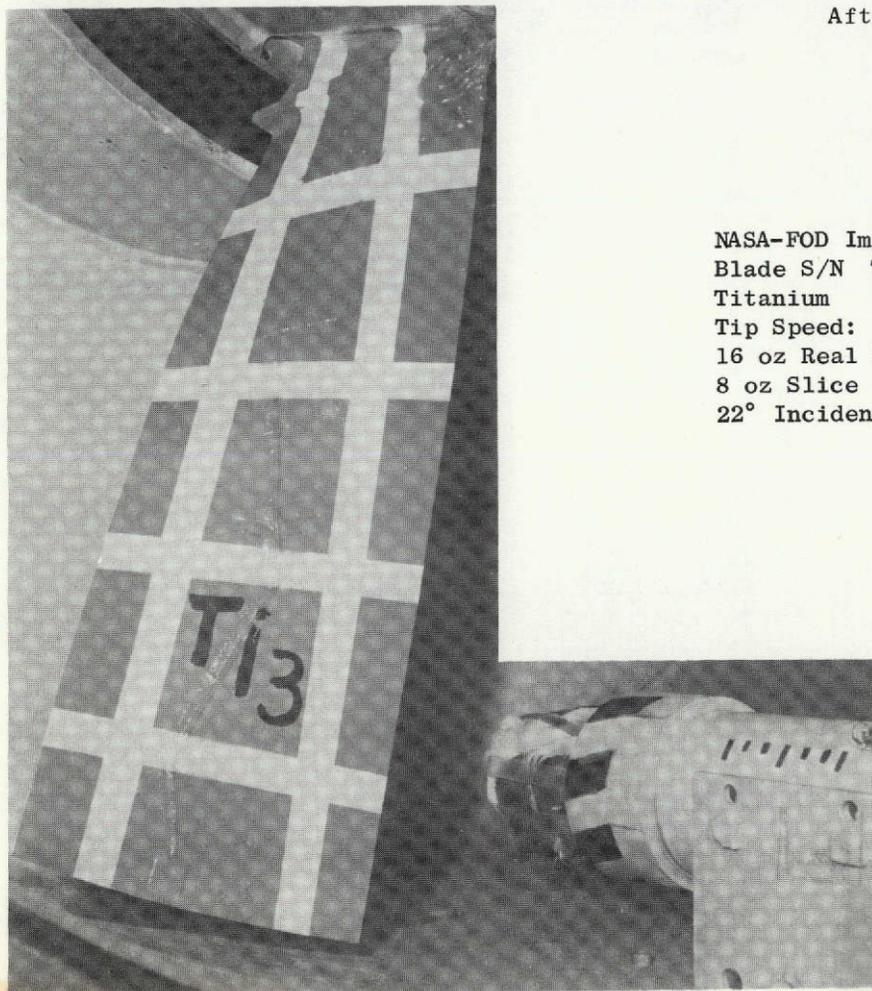
Figure 12. Titanium Blade after Impact.

There was no visible damage to the titanium blade when impacted with an 8 oz bite from a 16 oz pigeon. There was considerable deflection.

NASA-FOD Impact Resistance Test
Blade S/N Ti3
Titanium
Tip Speed: 800 ft/sec
16 oz Real Pigeon
8 oz Slice
22° Incidence Angle

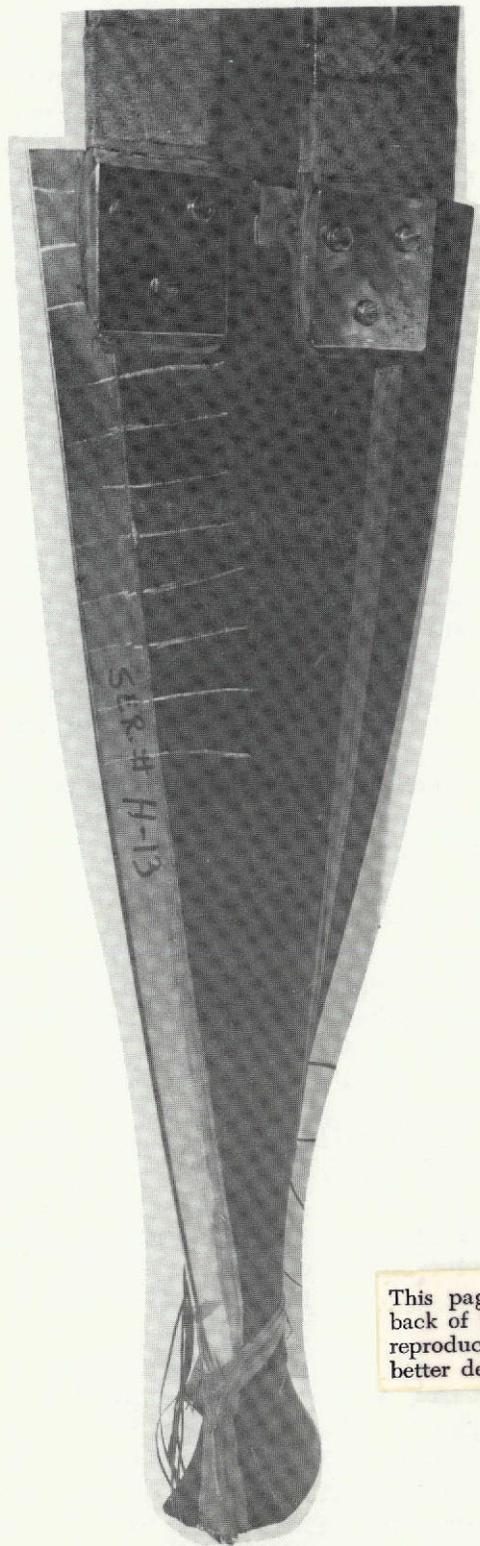
Figure 19. NG5 Graphite/Epoxy Blade after Impact (Convex Surface), Test No. STOL 1.

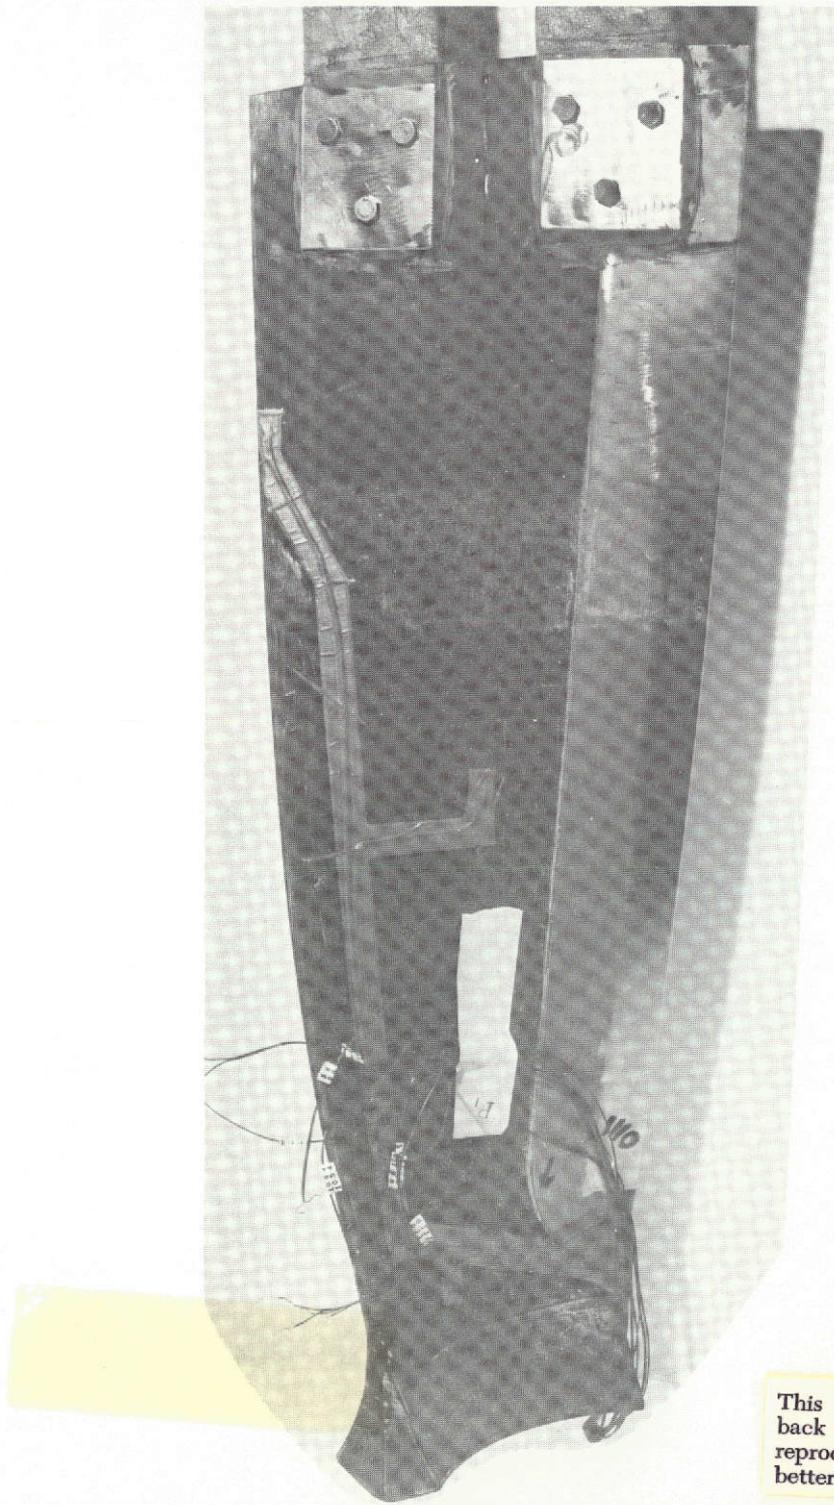
Figure 20. NG5 Graphite/Epoxy Blade after Impact (Concave Surface), Test No. STOL 1.

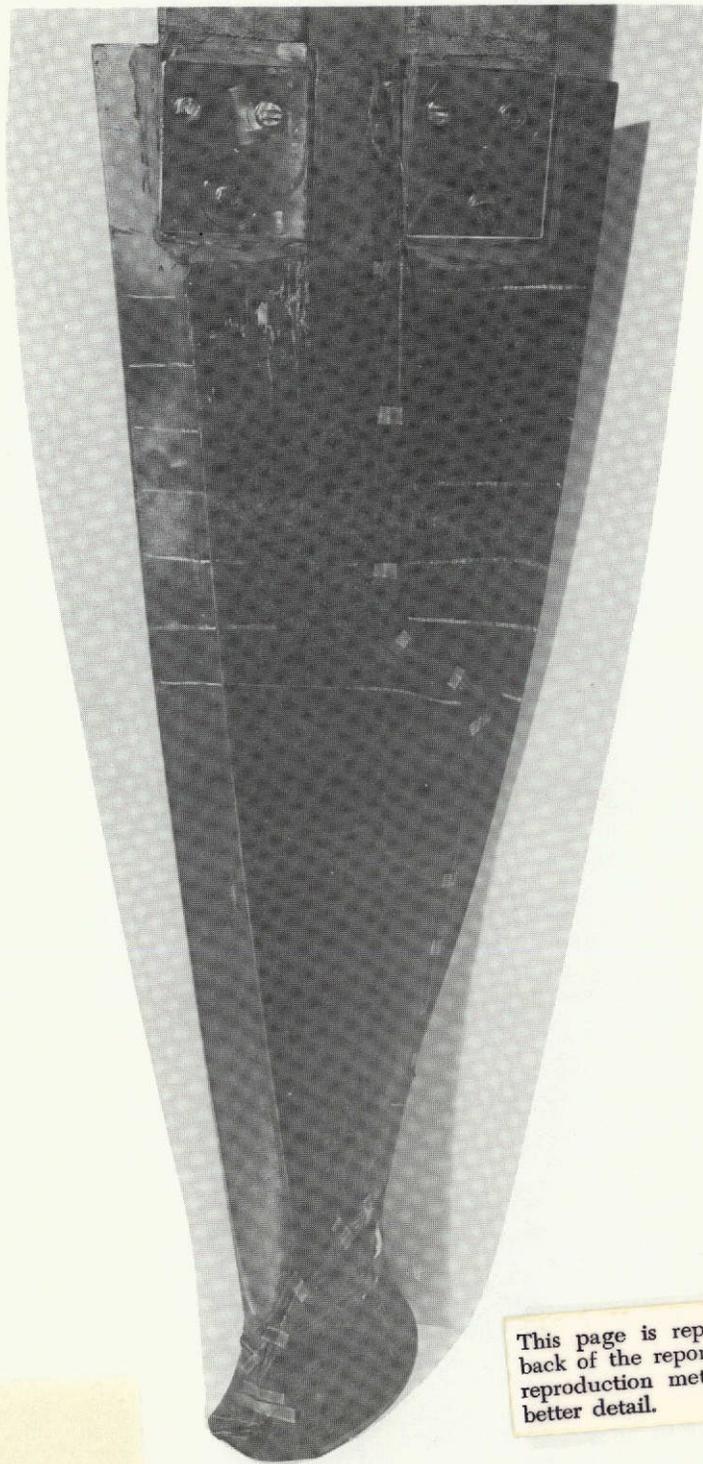
Figure 21. NB5 Boron/Epoxy Blade after Impact (Convex Surface), Test No. STOL 2.

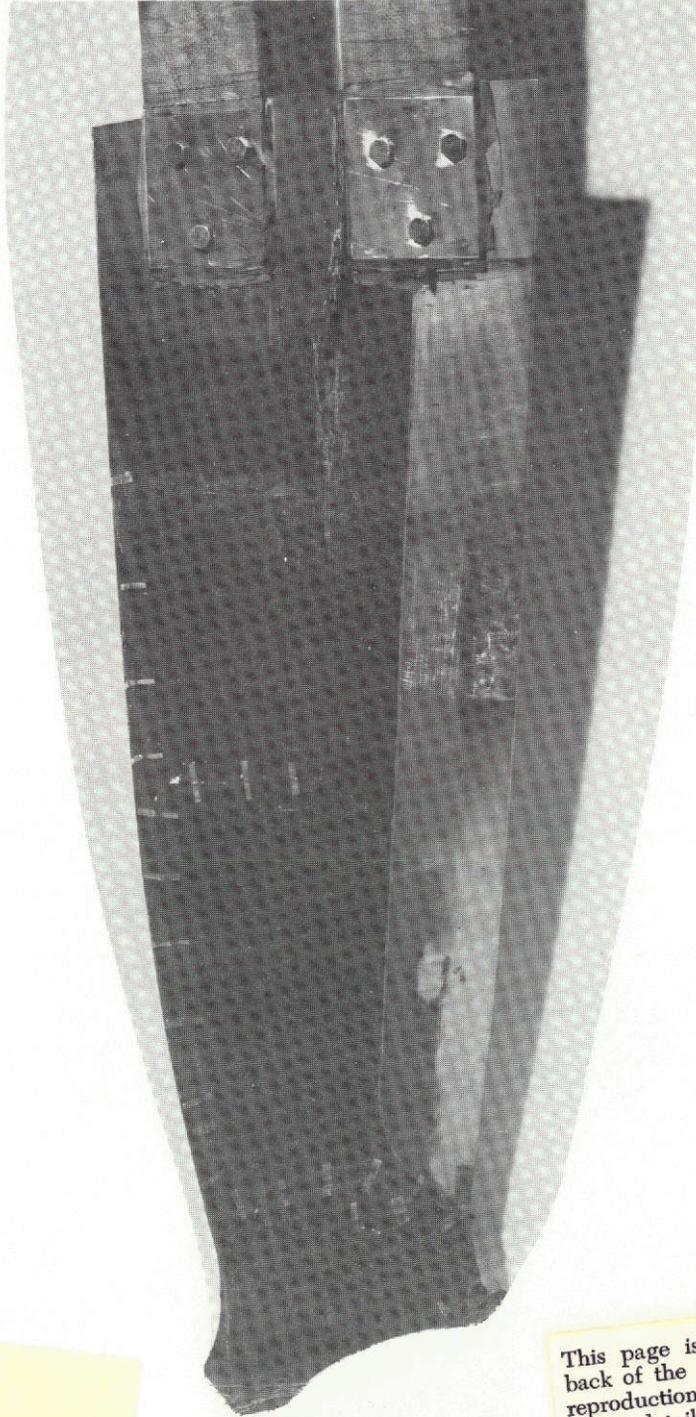
Figure 22. NB5 Boron/Epoxy Blade after Impact (Concave Surface), Test No. STOL 2.

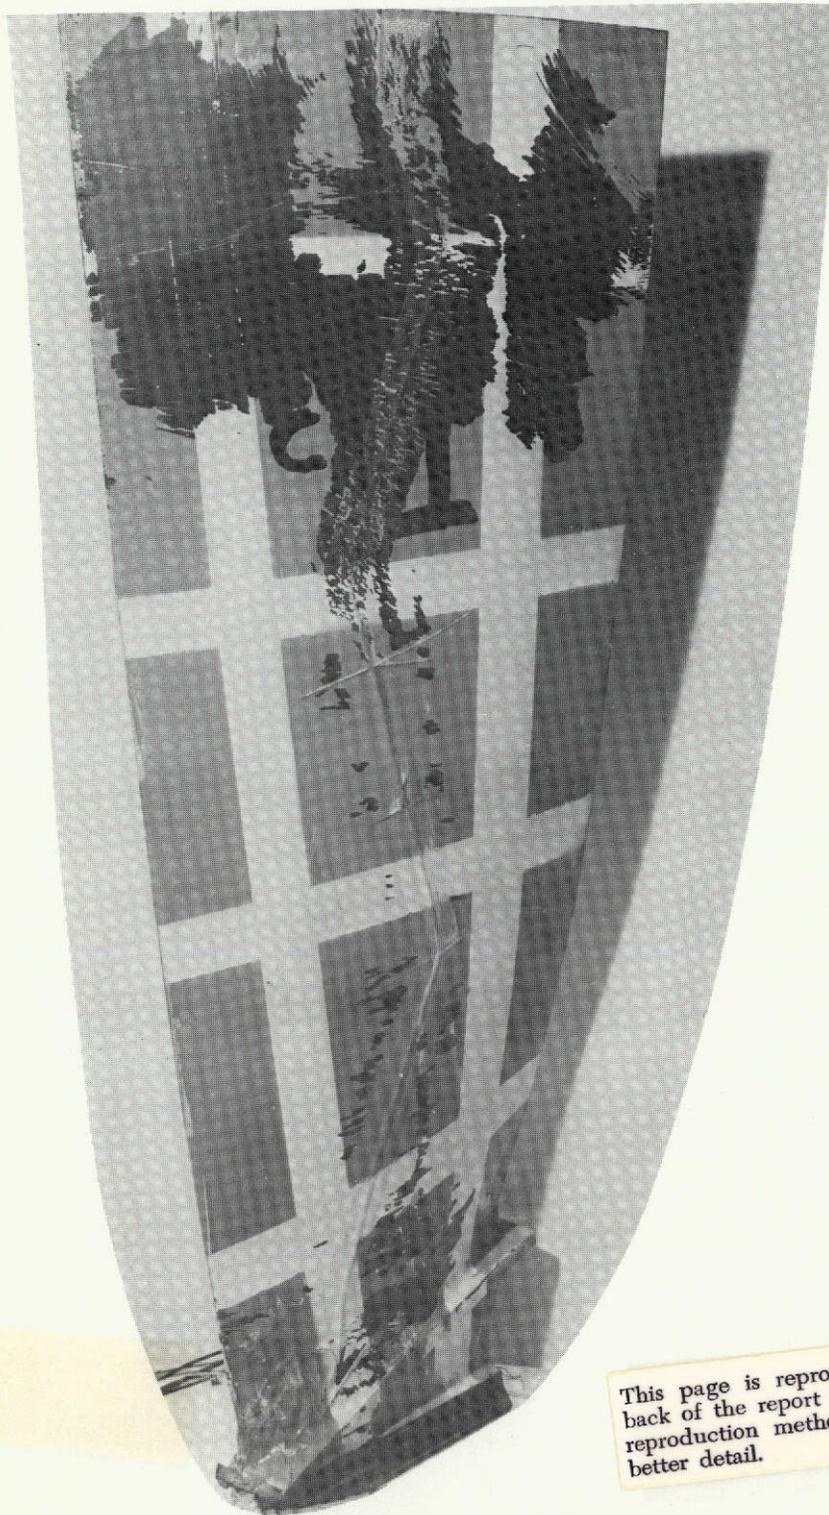
Damage to both the graphite/epoxy and boron/epoxy blades were similar. There was a small amount of damage done to the titanium blade.

Figure 23. Titanium Blade after Impact (Convex Surface), Test No. STOL 3.

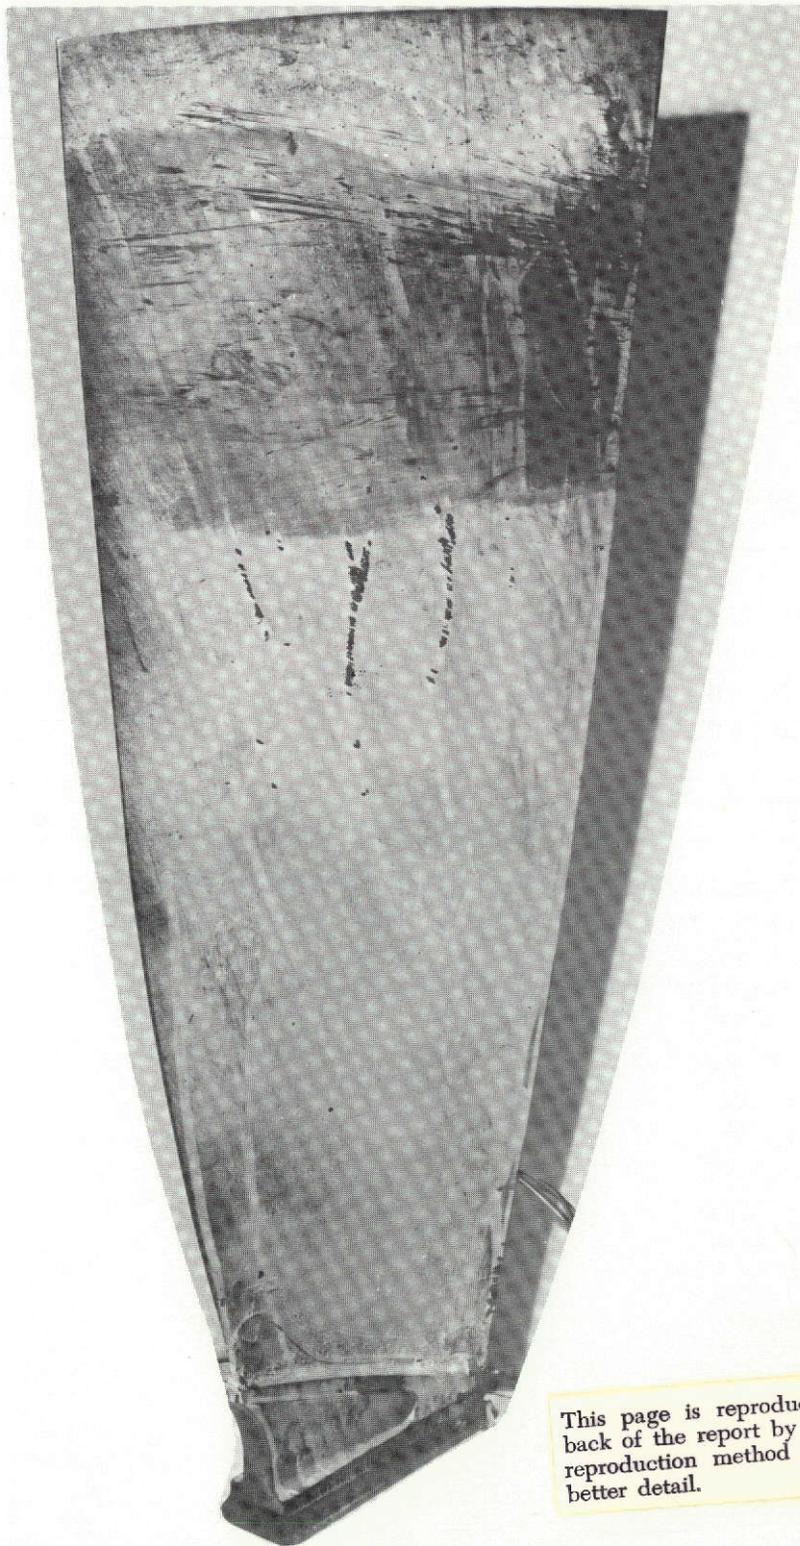
Figure 24. Titanium Blade after Impact (Concave Surface), Test No. STOL 3.
