SKYLAB MISSION REPORT
SECOND VISIT

PREPARED BY
Mission Evaluation Team

NATIONAL AERONAUTICS AND SPACE ADMINISTRATION
LYNDON B. JOHNSON SPACE CENTER
HOUSTON, TEXAS
January 1974

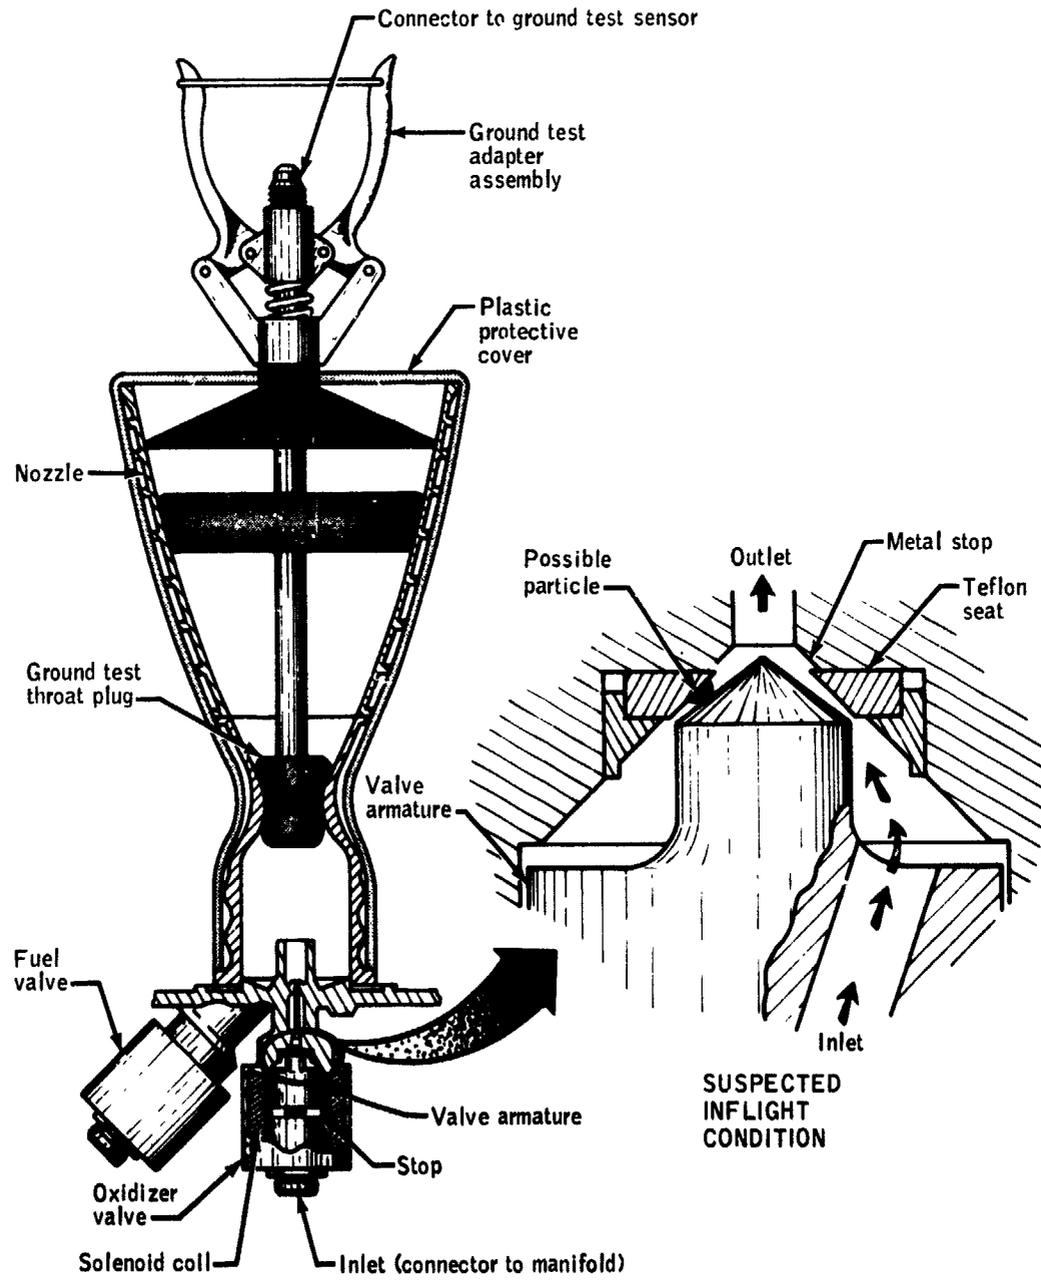
Figure 17-2.- Service module reaction control system quad B positive yaw engine preflight.

Filters are provided in the ground support equipment and spacecraft system lines to the engine, assuring delivery of clean propellant. Records of propellant purity during loading, and the results of subsequent propellant retests indicate no suspect condition. Oxidizer load contamination would be smaller than the 0.005 to 0.015 millimeter rating of the filters in the ground support equipment and in the spacecraft quad B system. Larger particles would be required on the seat to hold the valve open for the leak flow measured. Therefore, particles of sufficient size were either already in the valve prior to loading oxidizer or were introduced through the valve outlet.

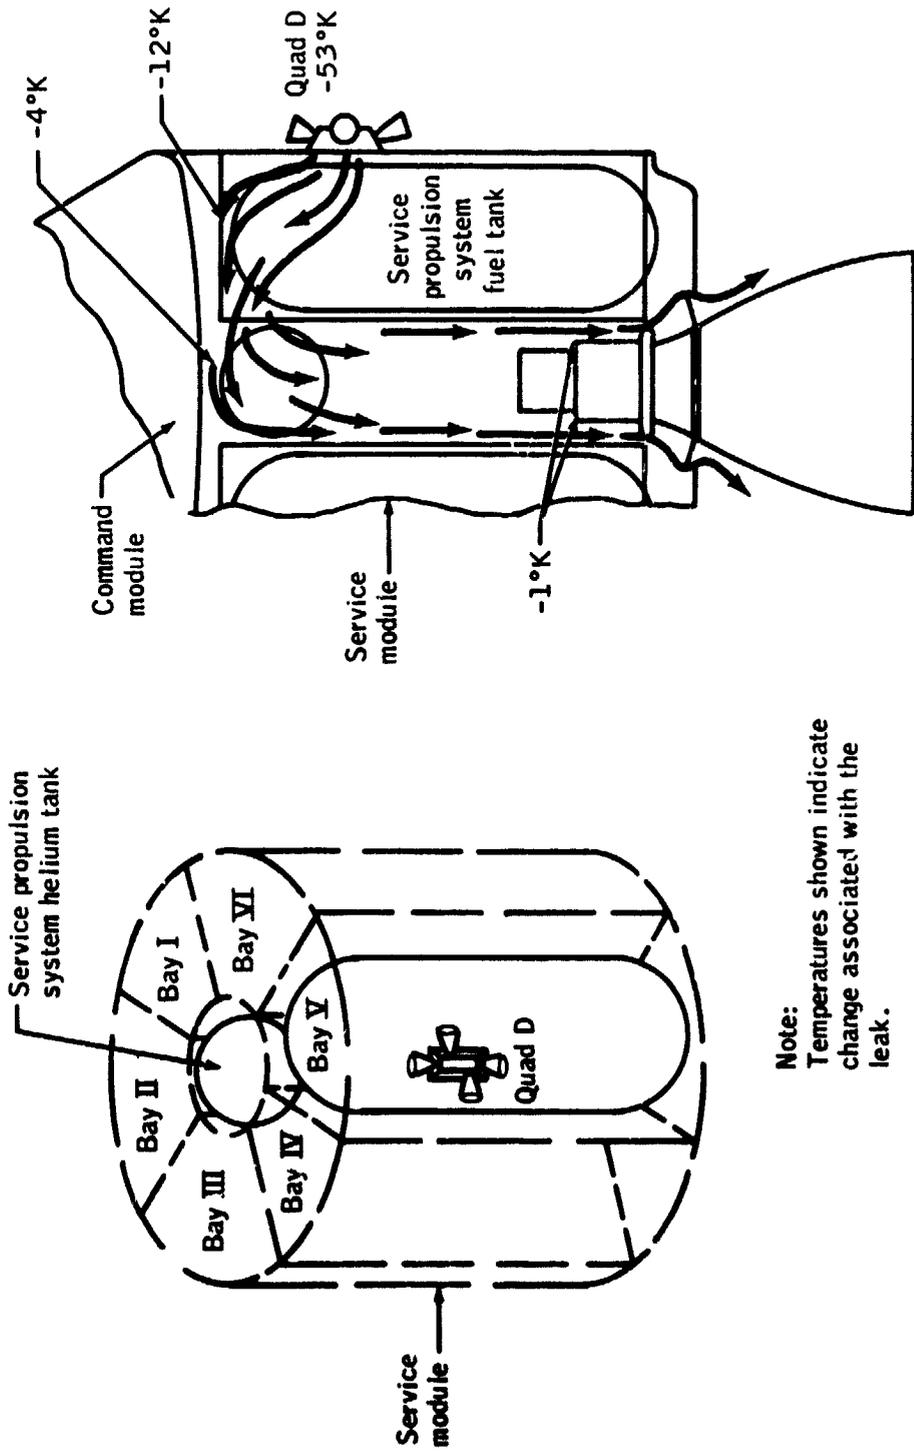
Figure 17-4.- Probable flow path of the majority of the oxidizer.

The problem was first indicated by a quad D package temperature caution and warning signal. Later data showed general cooling in and around quad D caused by the frozen oxidizer. The data showed that the quad D oxidizer leakage probably began about 48 hours after lift-off. In the following three days, only 1.8 kilograms of oxidizer were lost due to seepage. Then, the leak increased sufficiently to vent an additional 11.4 kilograms in 1-3/4 hours. The maximum leak rate experienced was 1.8 grams per second. The quad B package temperature decrease and the oxidizer manifold pressure decrease during the period of the higher rate leak are shown in figure 17-6.

Note:
 Temperatures shown indicate
 change associated with the
 leak.

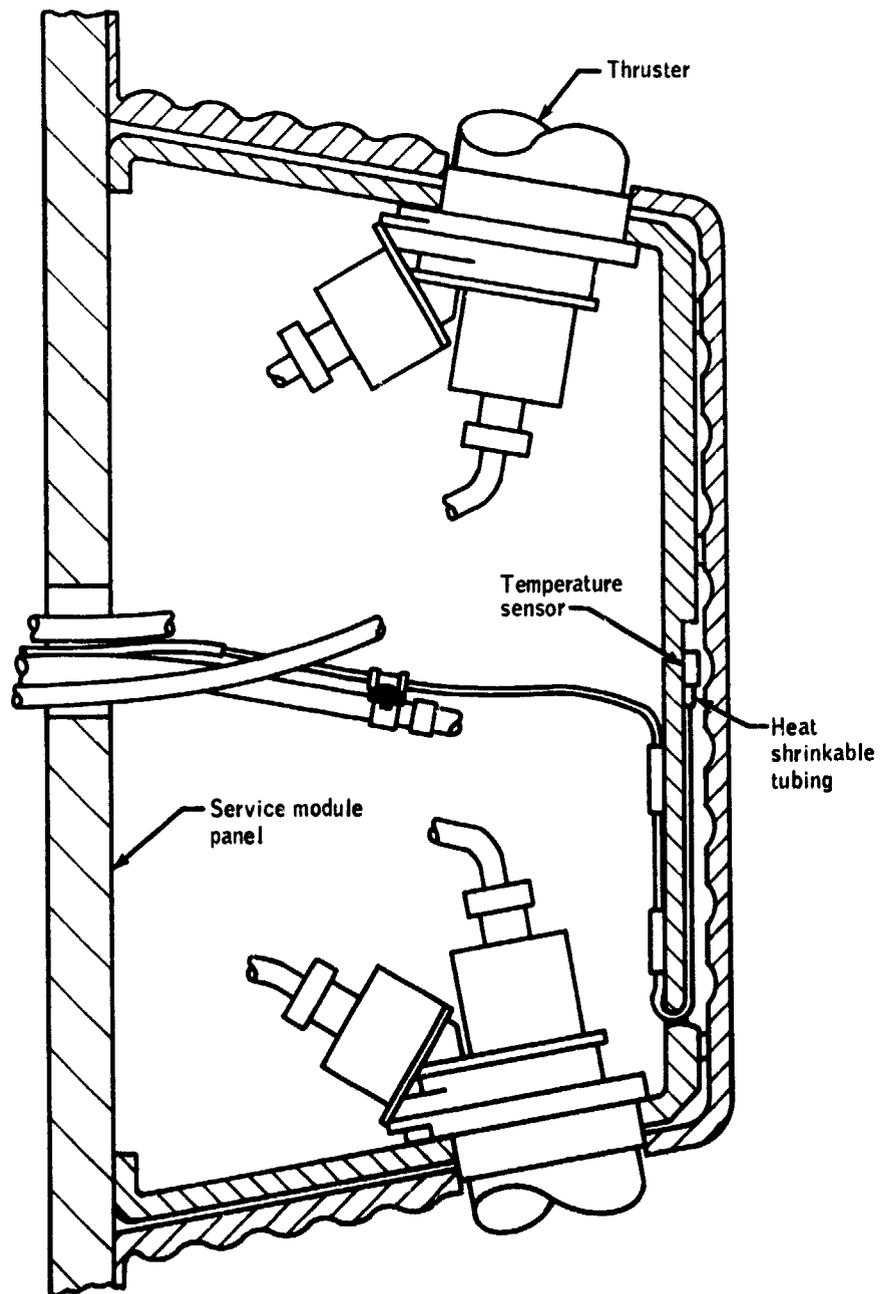
Figure 17-11.- Temperature sensor location in quad housing.

The failed transducer was originally manufactured in December 1966, received a new sensor and cable in June 1969, and passed the solder joint screening test. The loss of solder from the joint due to heating of the shrinkable tubing could have occurred in such a manner that the solder joint passed the screening test and opened during flight.
