SHUTTLE ACTIVE THERMAL CONTROL SYSTEM
DEVELOPMENT TESTING

VOLUME VIII

TUBE ANOMALY INVESTIGATION

Report No. T169-28

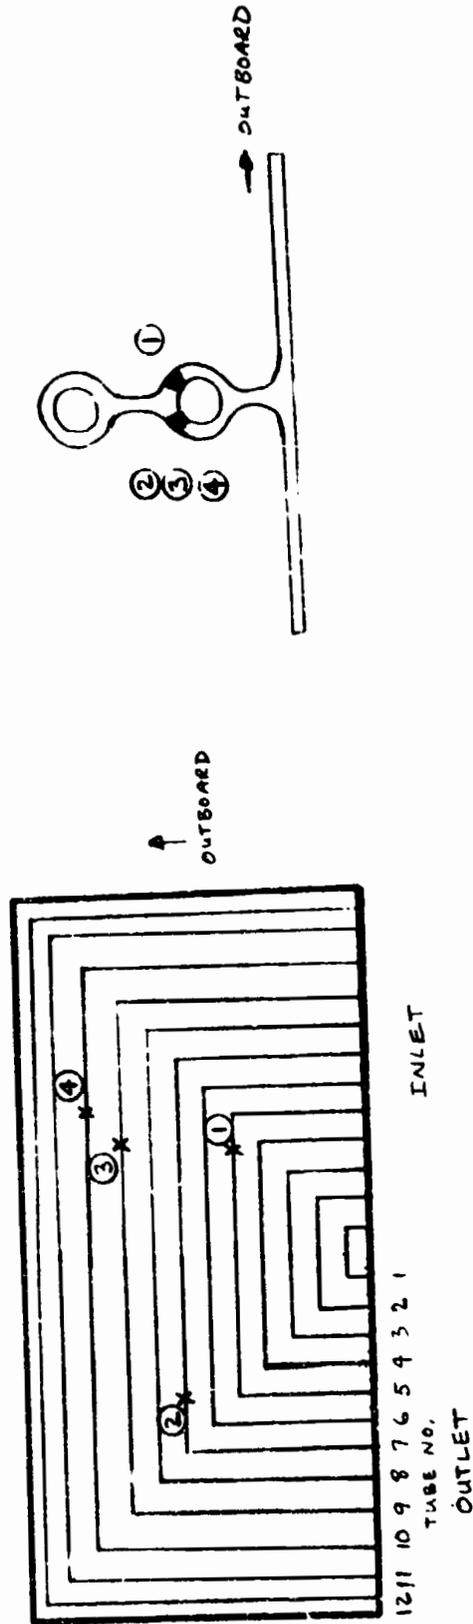
FIGURE 1
ANOMALY DESCRIPTION

During the concluding phase of a six-month thermal-vacuum test ruptures occurred in the coolant tubes* of the modular radiator panels containing Freon 21 (F-21)**. Four tube ruptures on three panels (out of a total of seven panels in test) were noted during a thaw cycle following a two sided radiation condition (prime tube bypassed) to a liquid nitrogen sink temperature. The thermal up-ramp was 60°F/hour maximum. After a cold soak of some twelve hours with temperatures as low as -270°F measured, a recovery transient was started. Approximately 24 minutes into the thaw, tube 5 on panel 6 developed a leak. Tube 7 and possibly tube 9 of panel 5 began to leak some 34 minutes later. The thermal up-ramp was halted, but the thaw continued, causing tube 10 of panel 3 to rupture about 46 minutes after the initial leak was detected. The failure locations are diagrammed on the sketch in Figure 1. Note that all fractures occurred between the tube bends.

0 4 TUBES RUPTURED ON 3 DIFFERENT PANELS DURING RAPID WARM-UP FROM A COLD SOAK CONDITION

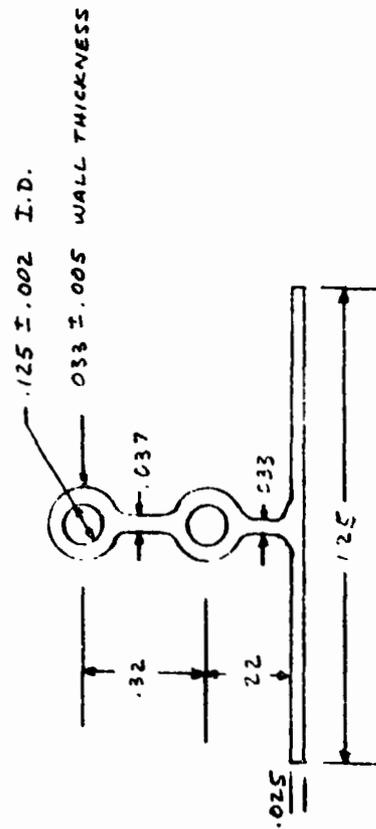
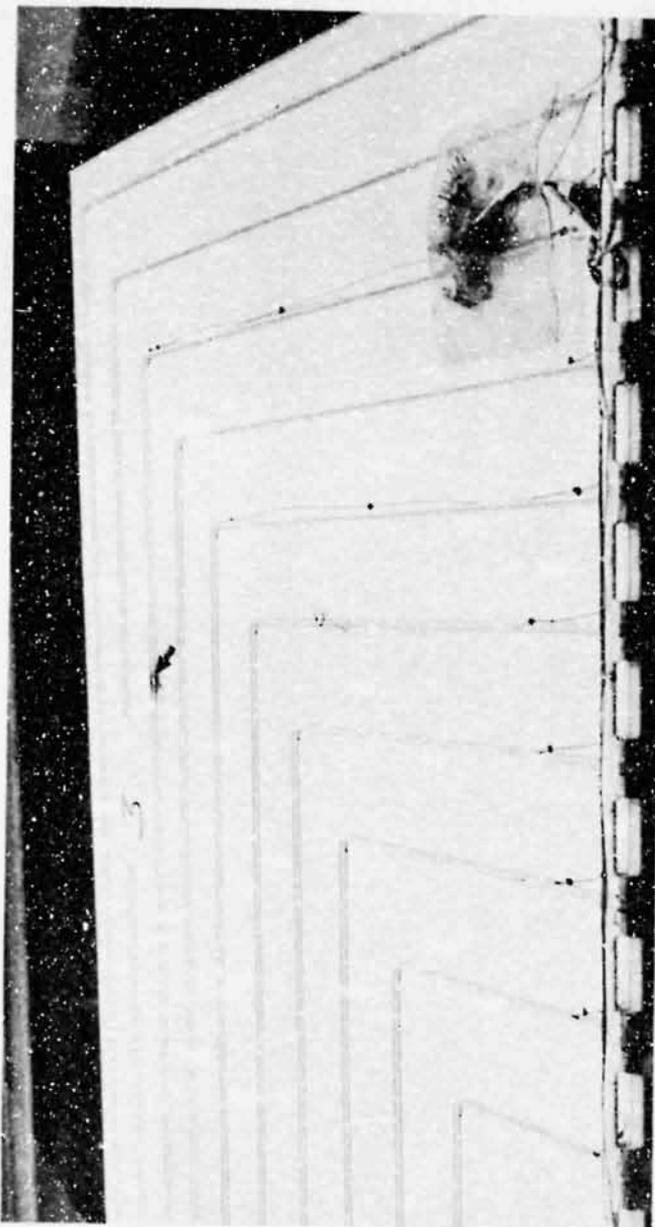
FIGURE 2
COOLANT TUBE CONFIGURATION

Four coolant tubes from three modular radiator panels developed leaks during thermal-vacuum testing. The tubes were fabricated from as-extruded 6063-T42 aluminum alloy to the configuration shown in Figure 2. The four fracture locations and adjacent areas were sectioned from the panels and submitted for analysis.

- o PROTOTYPE TV TEST ARTICLE OF MIN. WEIGHT DESIGN
- o EXTRUSION VENDOR SELECTED FOR MIN. LEAD TIME
- o WELDABLE 6063 AL AS EXTRUDED
- o TUBES NOT ATTACHED AT TUBE BENDS

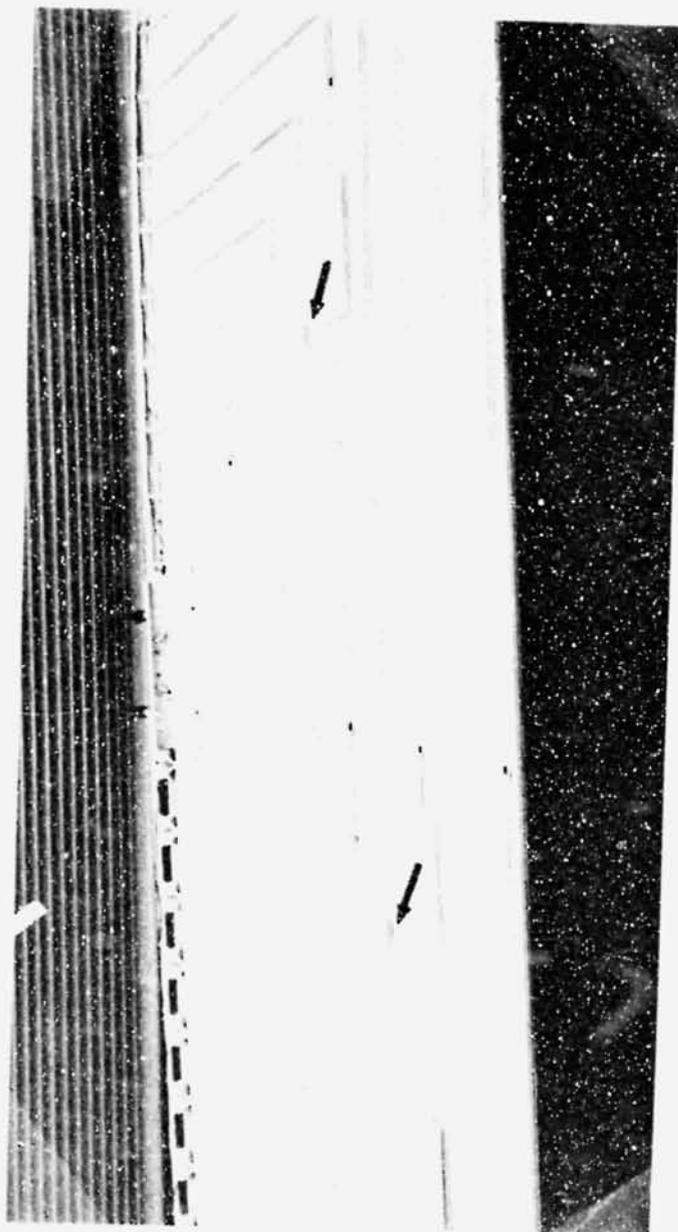
FIGURE 3

Location of the failures on radiator panels 3, 5 and 6 are shown in Figures 3, 4 and 5 respectively. The fracture locations were removed from the panels with surrounding metal intact as seen in Figure 6. A fractured and bulged area of tube 9, panel 5, with associated cracked and flaked paint is typical of each failure site, Figure 7.

LOCATION OF FAILED TUBE 10, PANE 3

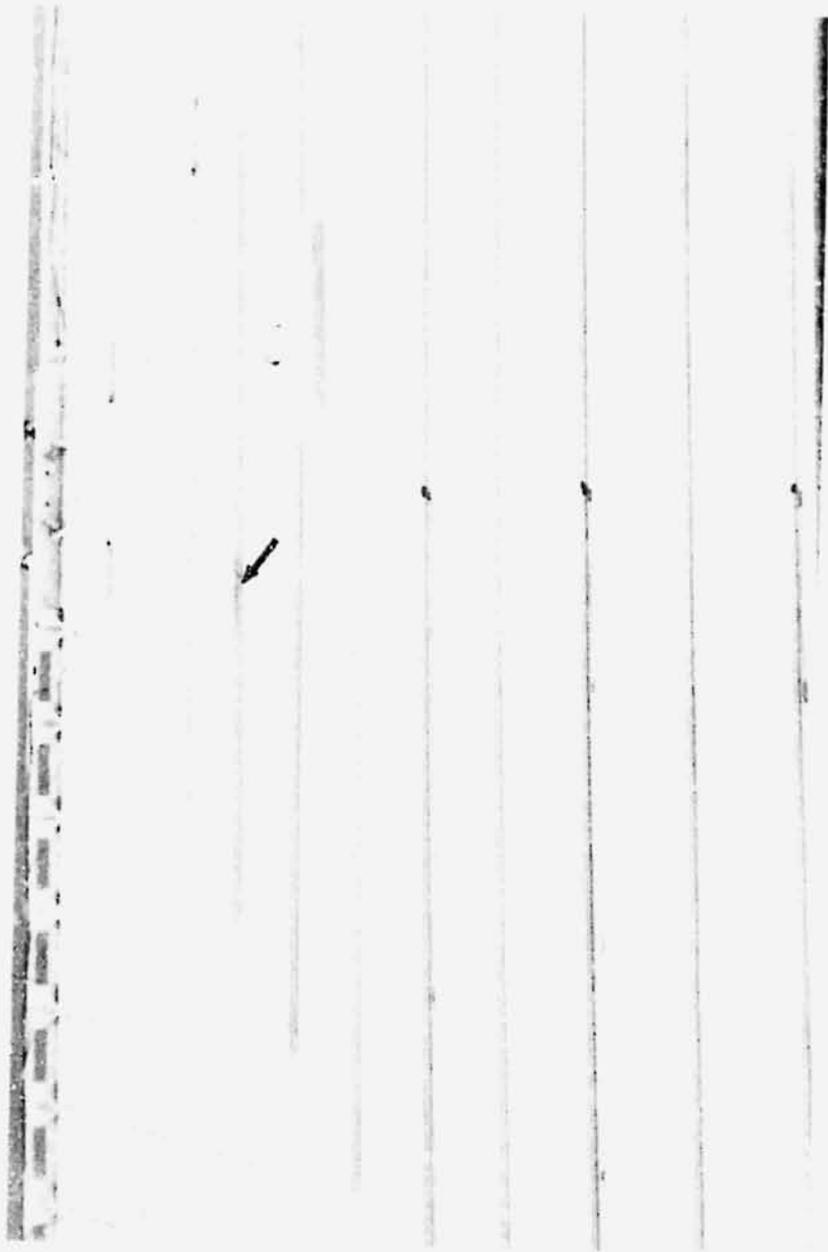
FIGURE 4

LOCATION OF FAILED TUBES 7 AND 9, PANEL 5

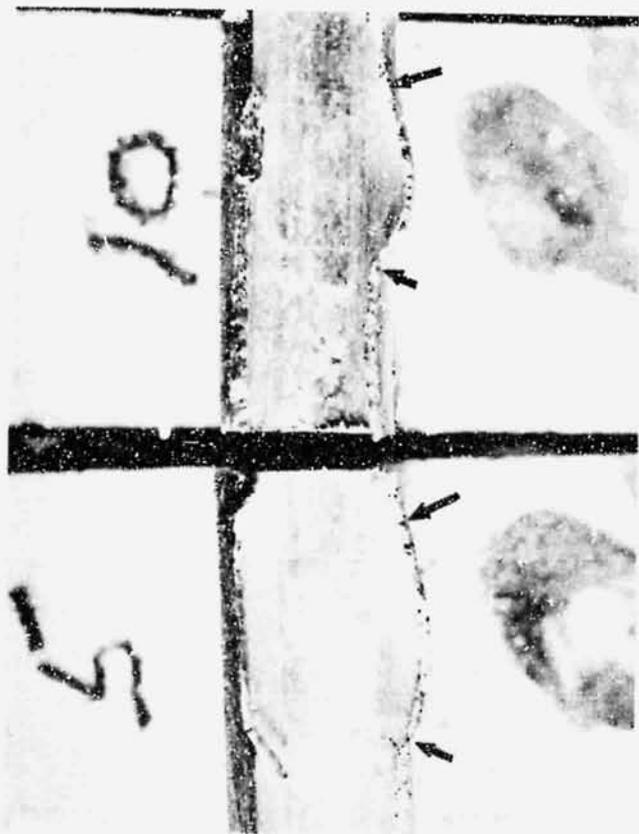
FIGURE 8

A transverse section showing the double bore shotgun extrusion is seen in Figure 8. The lower tube was typically off center as-manufactured. The fracture followed the thin walled area of the tube at each failure location.

PHOTOMICROGRAPH OF EXTRUDED COOLANT TUBE WITH YIELDED THIN WALL ADJACENT TO FAILURE SITE, ARROW, OF TUBE 5

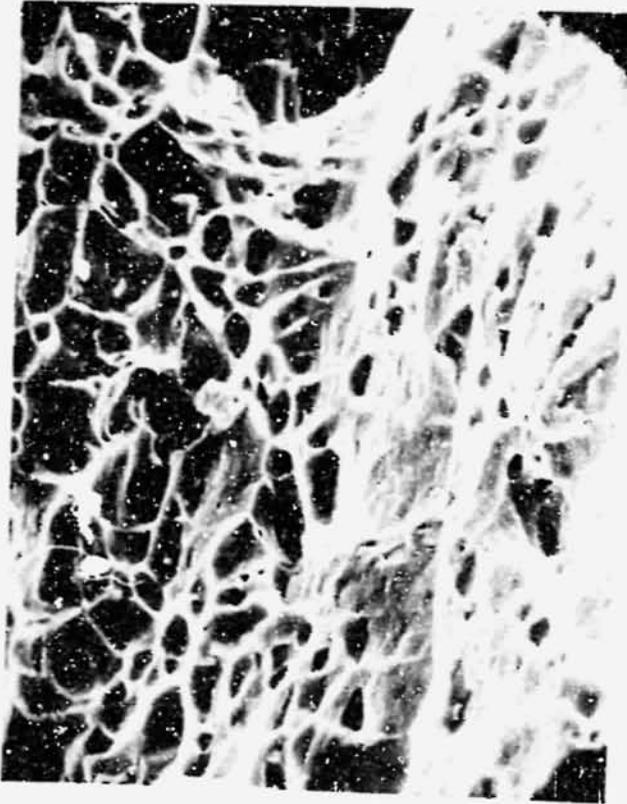
FIGURE 9

Considerable deformation at each of the failure sites was found; Figure 9 depicts the bulging noted in each tube. This indicates that catastrophic failure, i.e., leakage of F-21, was preceded by considerable yielding of the aluminum alloy tubing.

PHOTOMICROGRAPHS OF TUBES 5 AND 10 FRACTURE SURFACES AFTER OPENING
CRACK ORIGINS APPEAR TO BE FROM INSIDE DIAMETER
ARROWS DENOTE CRACK LOCATION

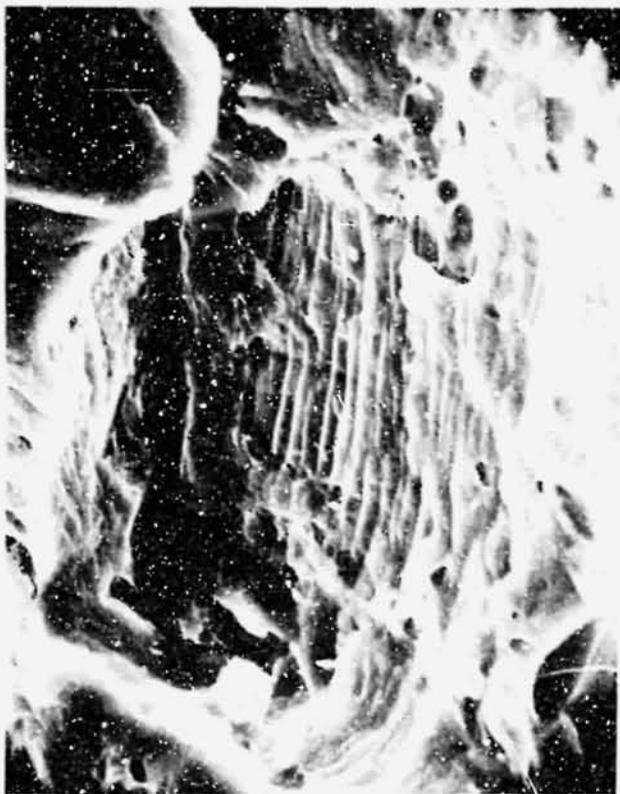
FIGURE 10

Fractographic examination with the scanning electron microscope (SEM) on each of the failure sites revealed a ductile tension mode of failure in every case. The primary topographic feature present was elongated dimples, see Figure 10, which indicates a tensile/shear mode of crack propagation. Indications of possible fatigue cracks originating on the inside diameter of tubes 7 and 9, panel 5 and tube 10, panel 3 were found during the SEM examination. A typical fractograph of an area containing the parallel striations associated with metal fatigue is illustrated in Figure 11. Such areas were patchy and scattered over the fracture surface, indicating that a dual crack propagation mode of fatigue - ductile tension was operative.

SEM FRACTOGRAPH SHOWING DIMPLE TENSION FAILURE
SCAN FROM INSIDE DIAMETER OF BULGED AREA OF TUBE 5

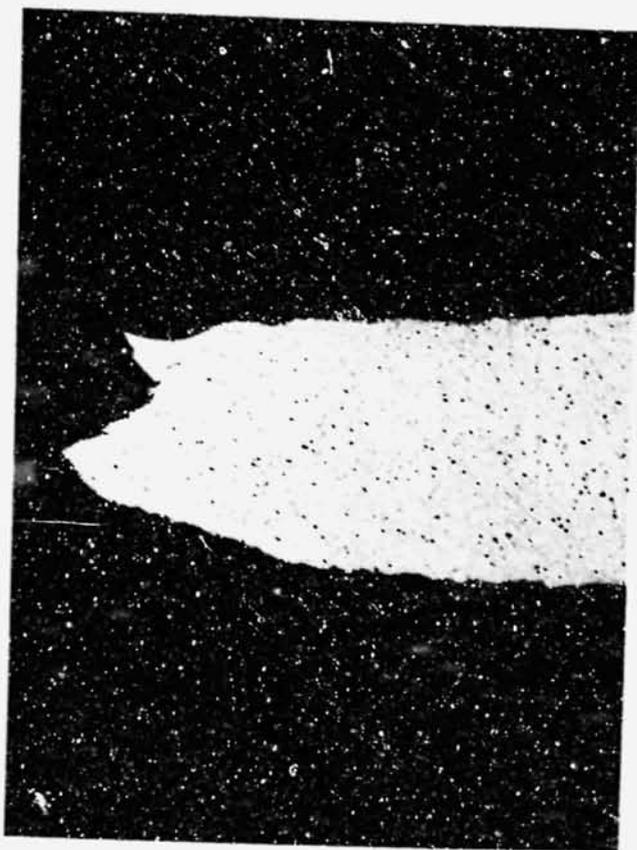
FIGURE 11

SEM FRACTOGRAPH OF FATIGUE STRIATION AREA FROM INSIDE DIAMETER OF TUBE 9

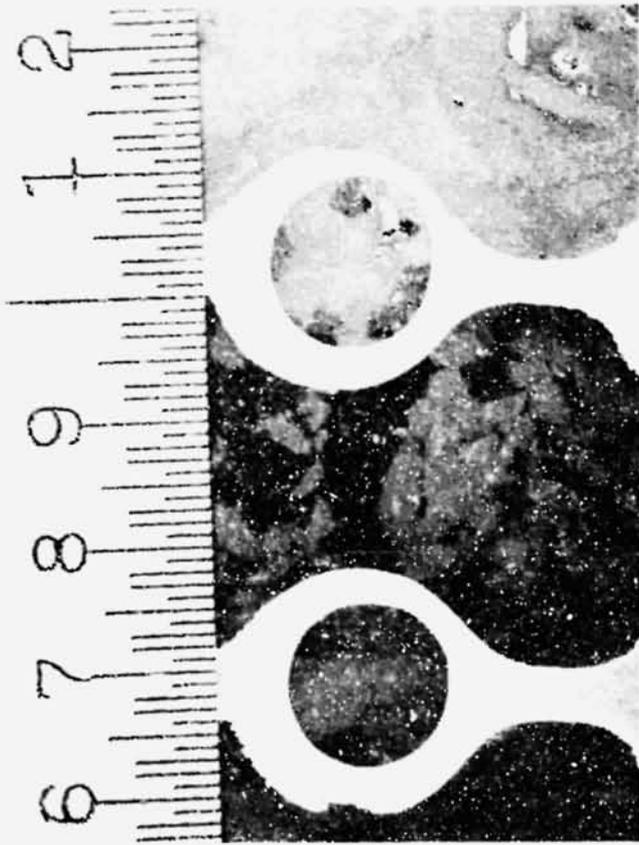
FIGURE 16

Wall thickness in the coolant tubes was below the drawing requirement of 0.033 ± 0.005 ". A typical thickness in tube 5, see Figure 16, was 0.0165" in the thin wall area, decreasing to 0.013" adjacent to the fracture. The thick wall section of the tube measured between 0.023" - 0.024". As-received extrusions varied in wall thickness from 0.021" in the thin area to 0.029" on the opposite thick wall. This implies that yielding of the tube wall occurred remote from the fracture locations.

PHOTOMICROGRAPH OF TUBE 5, PANEL 6 ON INLET MANIFOLD SIDE,
LEFT, AND ADJACENT TO FRACTURE, RIGHT

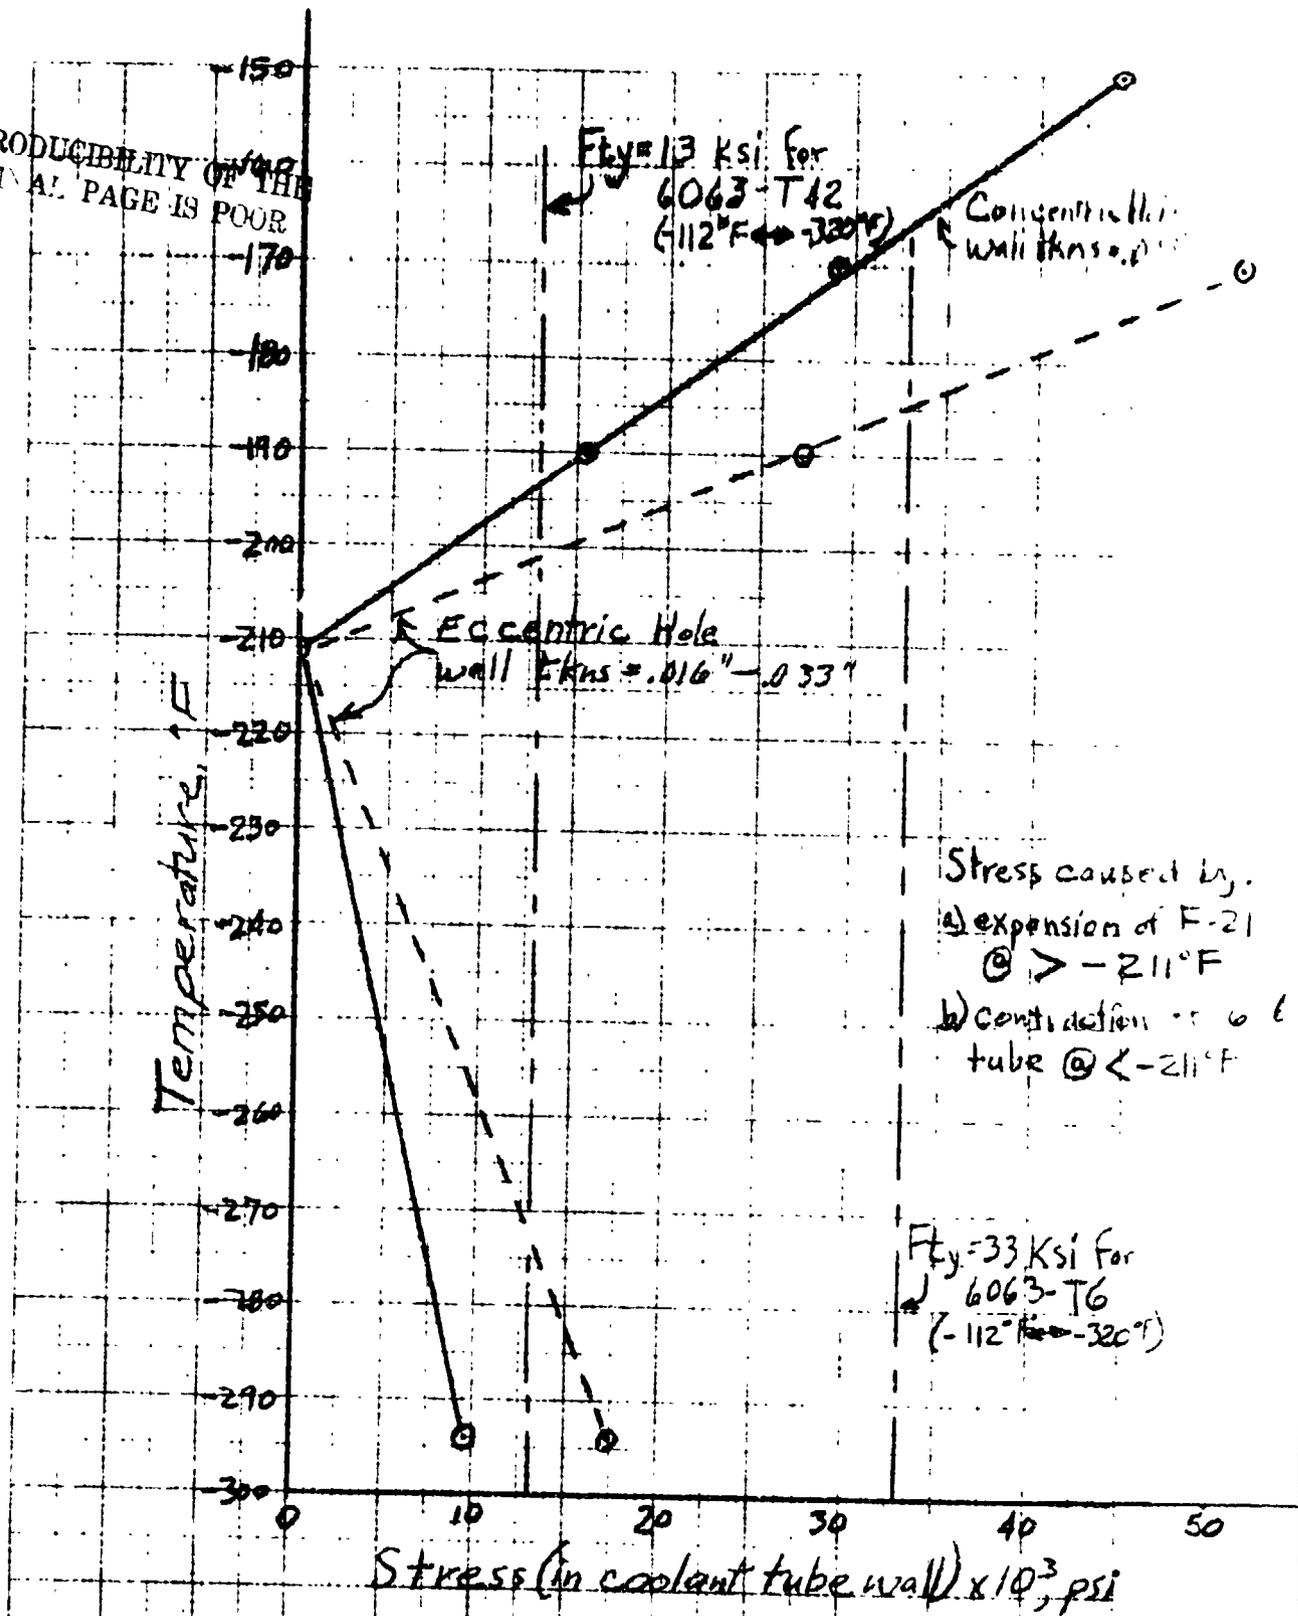
FIGURE 17

The data plotted in Figure 17 show that concentric walls in the coolant tubes cause considerably lower stress levels to be developed at a given temperature of Freon 21. In addition the heat treatment of 6063 to the -T6 condition raises the yield strength to the 33 - 36 ksi range at cryogenic temperatures. Maximum temperature differences of 35°F were measured between frozen corners and thawed tubes at mid-points. Assuming a concentric tube and a delta of 35°F from -211°F to -176°F, a stress of 26 ksi would be induced in the coolant tube by expansion of the F-21. This is below the yield strength of ca. 33 ksi for 6063-T6, allowing a thaw under these conditions to leave the tube undamaged.

STRESS IN COOLANT TUBES VS TEMPERATURE

Analysis indicates that concentric extrusion holes and heat treatment of the tubes to the -T6 condition would have prevented the test anomaly. Thermal analysis indicates that attaching the tube corners to the radiator fin could eliminate the fluid trapping.

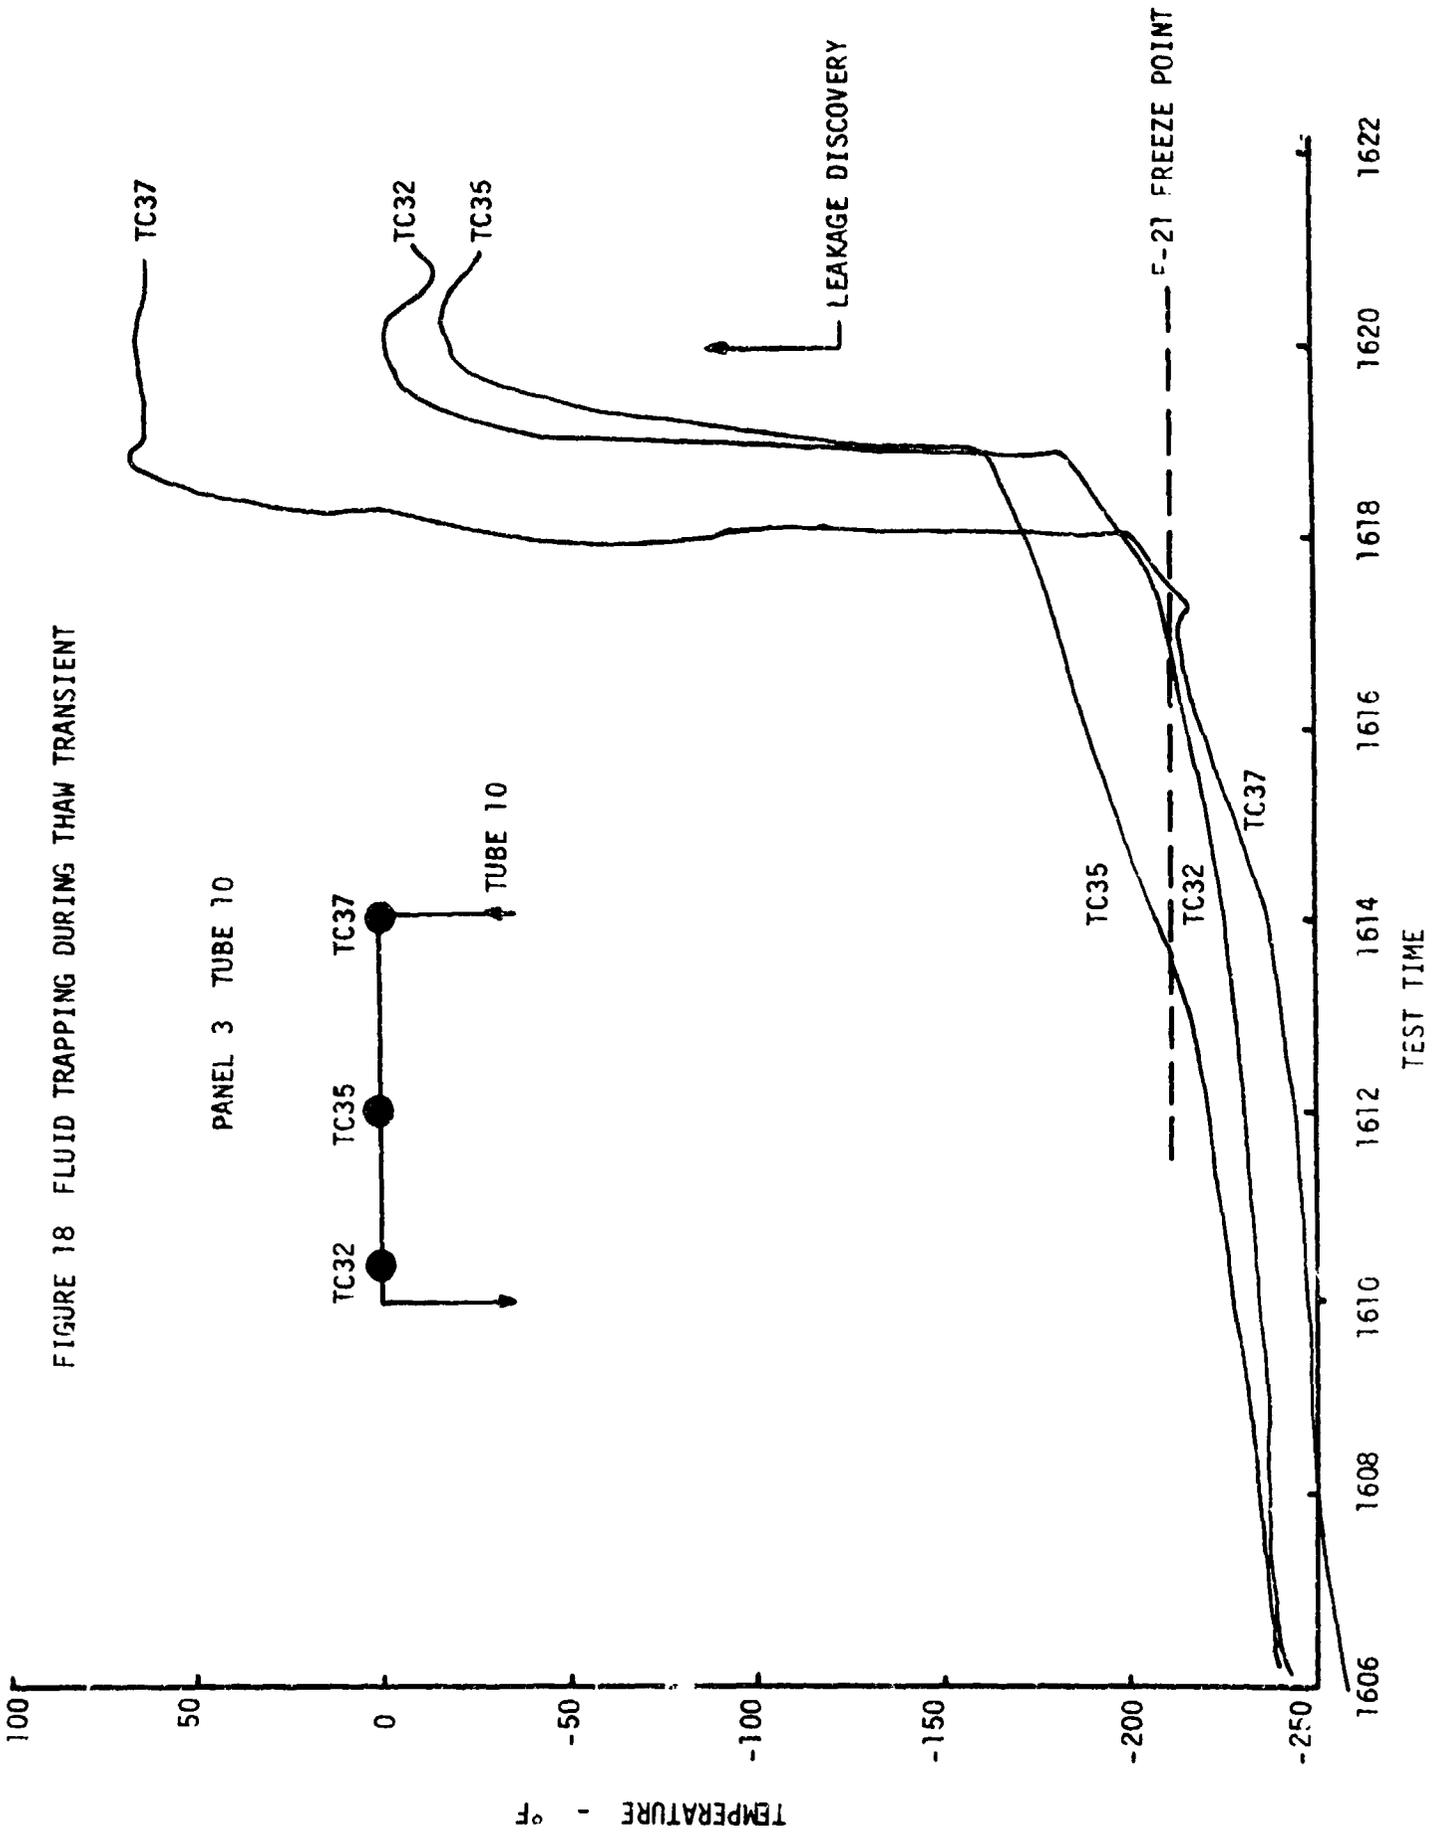
FIGURE 18 FLUID TRAPPING DURING THAW TRANSIENT

Figure 18 presents measured temperature data during the last freeze-thaw cycle in which the tube failed. This data indicates that the section between the tube corners thawed approximately 3 minutes before the corners. The fluid in this section thus underwent thermal expansion while constrained by the frozen corners. The trapped fluid was heated to approximately -180°F before the tube corners thawed and allowed the tube to flow. This demonstrates the postulated failure mechanism and indicates that thermally attaching the tube corners to the radiator fin to provide uniform heating of a frozen tube would prevent or reduce the snapping.
