NASA TM X-64928

## REPAIR OF MAJOR SYSTEM ELEMENTS ON SKYLAB

By Robert E. Pace, Jr.  
Materials and Processes Laboratory

October 1974

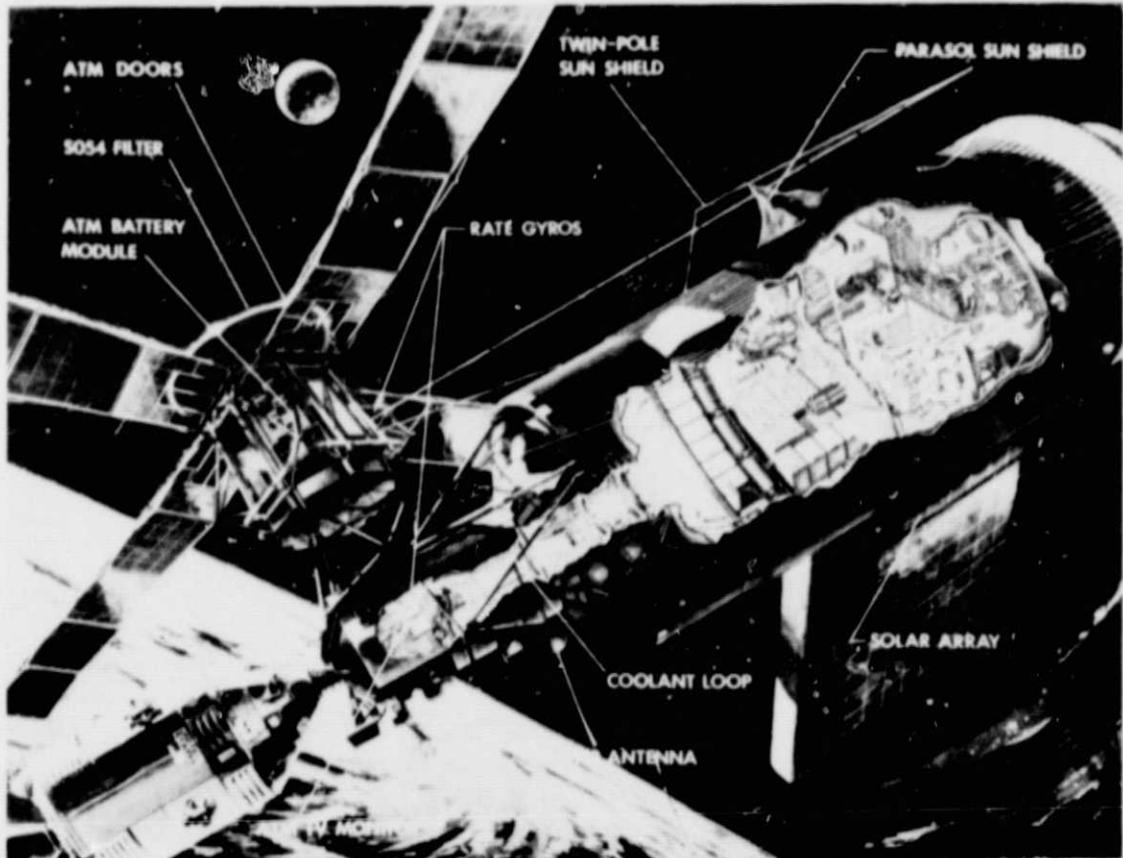
Approximately 30 contingency maintenance tasks were performed by the Skylab crews; Table 3 lists these tasks by mission. Many of these involved major repairs to the cluster systems to permit continuation of the mission or to avoid significant compromises in attaining mission objectives. The locations of major repair activities are shown in Figure 1.

Figure 1. Locations of major maintenance activities.

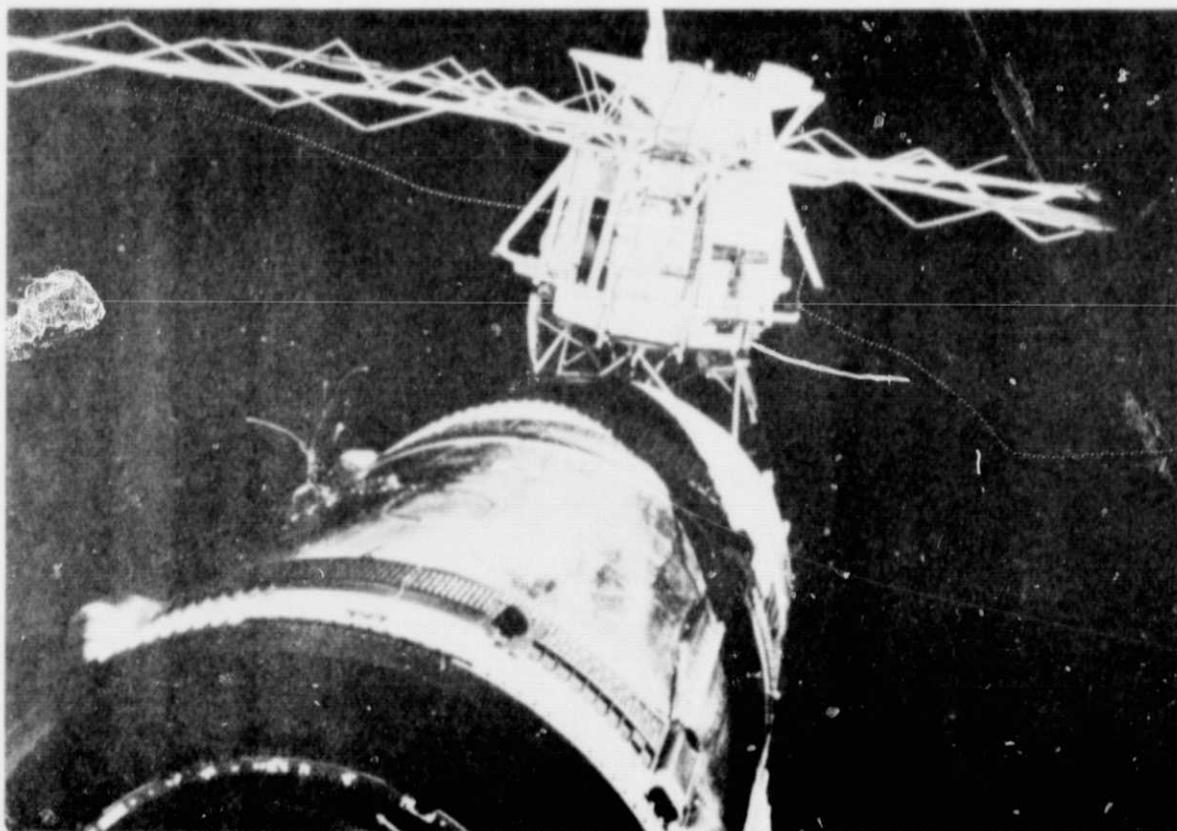
After the SL-2 crew performed their rendezvous with the Skylab, they did a fly-around inspection describing the condition of the damage and making photographs. Live TV coverage was transmitted to the ground for 15 min. The crew confirmed that the meteoroid shield was missing, OWS solar array wing 2 was missing, and that solar array wing 1 was partially deployed. Figure 2 shows a view of the damaged Skylab.

Figure 2. Skylab 2 fly-around inspection. (View of damaged workshop showing unshielded area where parasol was later deployed. The jammed solar wing is at lower right.)

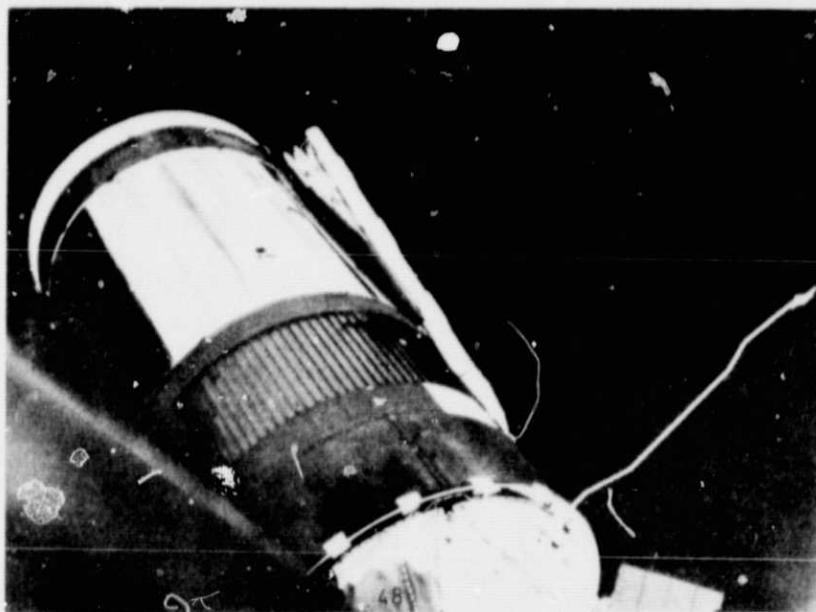
Figure 3 shows solar array wing 1 partially deployed. Closer inspection by the crew revealed that the solar array beam was restrained by a small piece of aluminum alloy strap from the meteoroid shield. The crew attempted to free the wing during a standup EVA from the CSM, using a 3.04 m (10 ft) pole with a hook on the end for prying and pulling. This attempt failed and the wing deployment activities were deferred to a later EVA. Meanwhile work was still in progress on procedures to be used to free the solar array wing. The fly-around television pictures and crew description of the damage provided the basis for the procedures. This contingency repair involved releasing the beam by cutting the aluminum strap and deploying the beam to the normal operation position. The procedures were developed and demonstrated in the neutral buoyancy facility at the Marshall Space Flight Center (MSFC) with astronauts using tools identical to those on board.

Figure 3. Solar array wing 1 partially deployed.

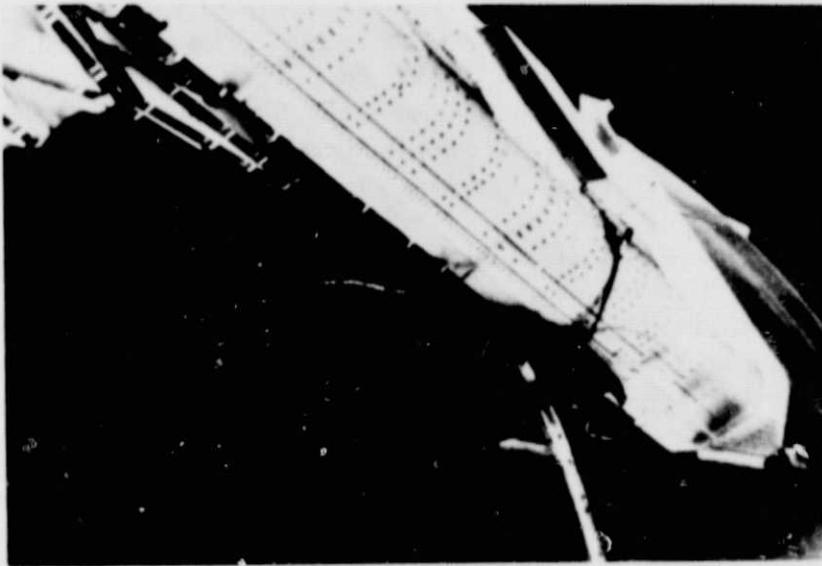
Figure 4. Aluminum strap restraining solar array beam.

On June 7, 1973, the Commander and Science Pilot spent nearly four hours in perhaps the most difficult and daring of all orbital repair jobs. The task was especially complicated by the absence of EVA aids in the area of the solar array beam. Figure 4 shows the aluminum strap holding the beam. The crew translated to the fixed airlock shroud area and assembled a tool made up of a 7.6 m (25 ft) pole with a rope operated cutter on one end. Figure 5 shows

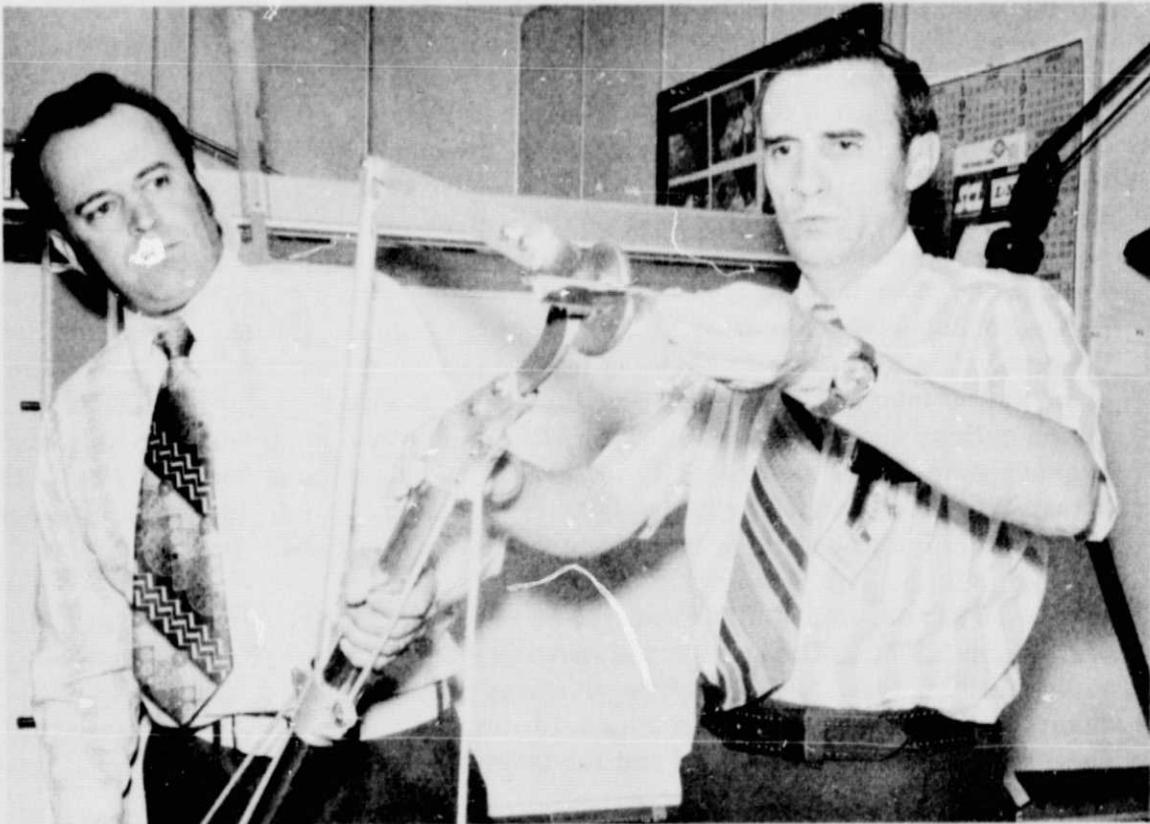
Figure 5. Cutting tool being tested.

this cutter tool being tested by MSFC engineers. The cutter end was attached to the debris and the Commander, using the pole as an aid, translated to the cutter end. Then, with the Commander managing the cutter, the Science Pilot cut the aluminum strap using the rope for control. A typical sample of the aluminum strip that held the solar wing is shown in Figure 6.

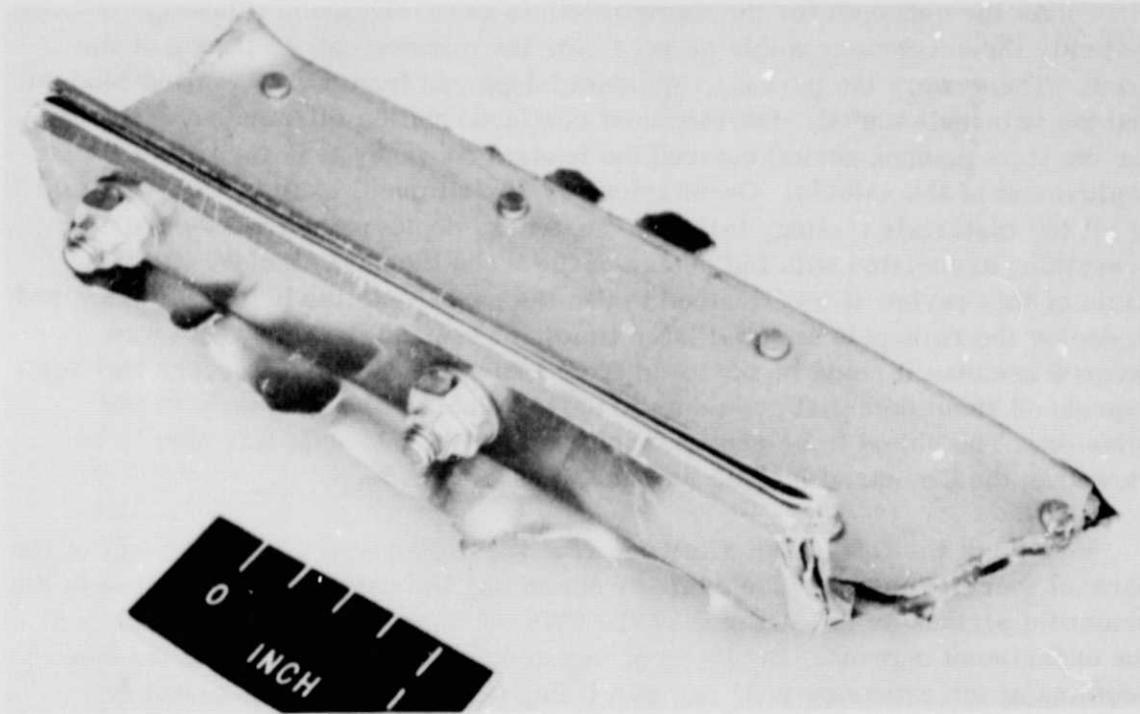
Figure 6. Sample segment of the aluminum (Al 7075-T6) strip that held the solar wing.

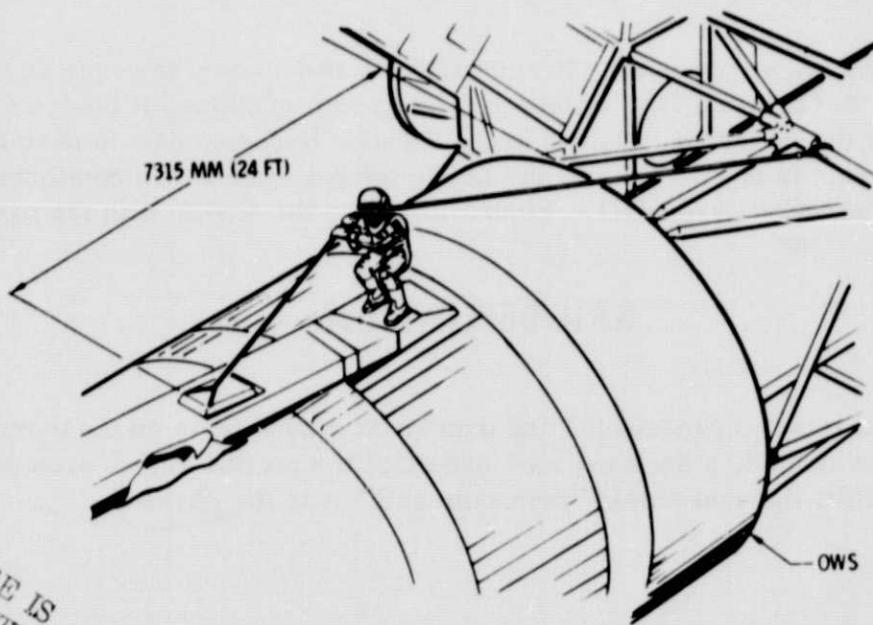
Figure 7. Standup operation used to finally erect the wing.

After release, the beam deployed out to about 20 deg and stopped. This was predictable since the beam damper-actuator was below the freezing temperature of its fluid. In anticipation of this the crew had installed a tether between the vent module and a strut in the fixed airlock shroud area. A crewman then stood up under the tether as shown in Figure 7. The tension thus applied to the solar wing broke loose the frozen damper-actuator that still held the wing, permitting the wing to swing out and lock into place.

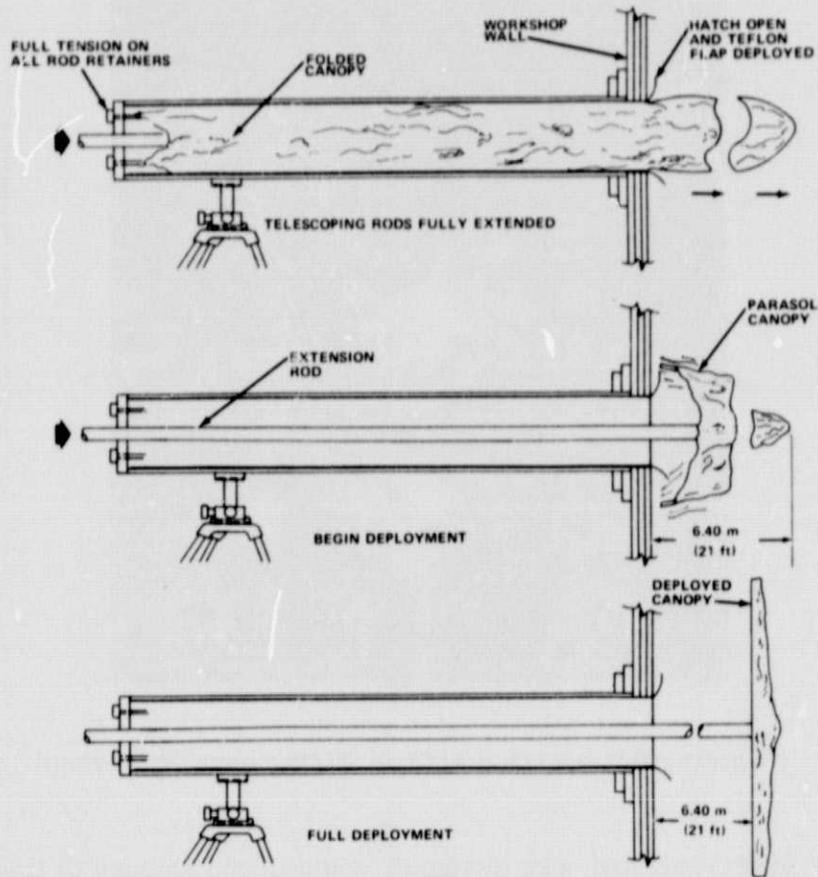
Figure 8. Development sequence of the parasol canopy inside the OWS.

One of the first tasks after entering the Skylab was the deployment of the parasol thermal shield. The canister containing the parasol was mounted to the scientific airlock on the sun side of the OWS supported by the tripod provided for experiment support. Deployment was accomplished by attaching the five sections of the extension rod, one at a time, until the parasol extended far enough out of the scientific airlock to permit release of the four telescoping rods, which in turn deployed the shield. After the shield was deployed, the extension rod was pulled back inside, securing the parasol next to the OWS external surface. The extension rod was removed and stowed. Figure 8 shows the deployment sequence in cutaway views and Figure 9 shows the sequence of deployment as viewed from the outside.

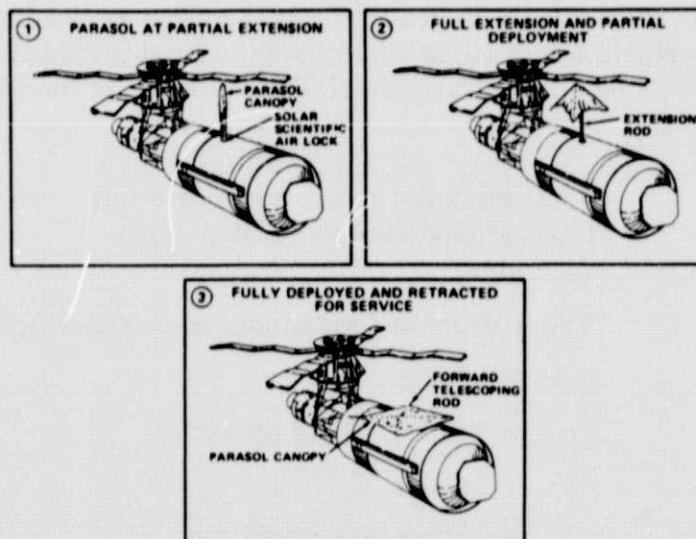
Figure 9. Deployment sequence of the parasol canopy as it appeared outside the OWS.

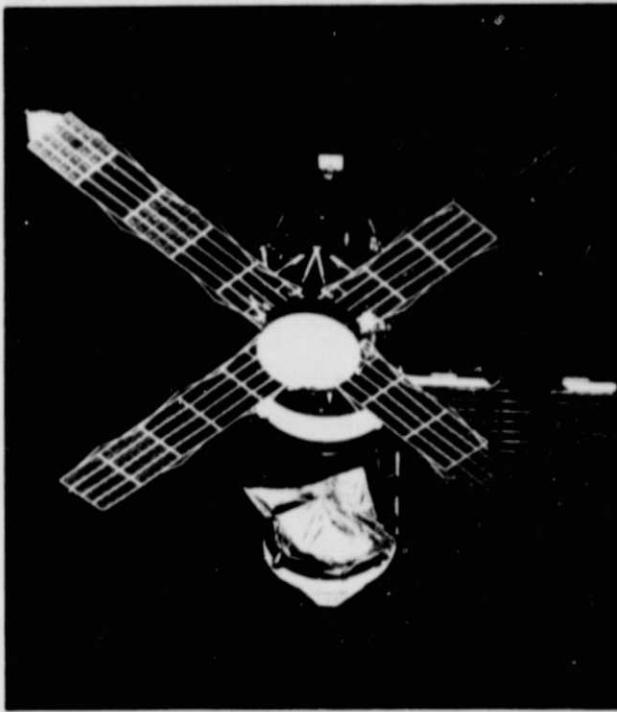
Figure 10. External view of Skylab showing parasol.

The shade, or parasol as it was called, was designed to cover an area 6.70 by 7.31 m (22 by 24 ft). Although it had a few wrinkles, it covered about 90 percent of the proposed area and brought inside temperatures to near normal in about 2 days. In about 11 days, the inside temperature was a comfortable 75 degrees Fahrenheit (23.9°C). Figure 10 shows the Skylab with the parasol in place.

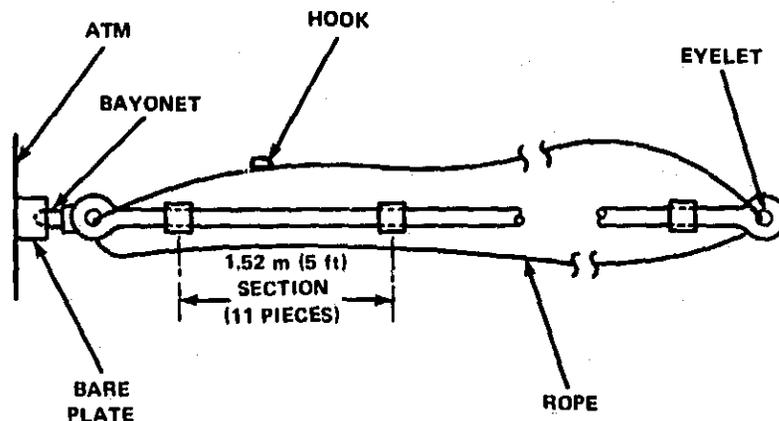
Figure 11. Sail pole as it appears attached to the base plate on the ATM strut.

On August 5, 1973, the SL-3 crew began preparation for an EVA which would involve retrieving and installing film and also attaching the MSFC twin-pole solar sail. Prior to the EVA, the parasol was lowered as close to the Workshop wall as possible. The deployment procedure for the sail began August 6, 1973, with the Pilot translating himself through the airlock hatch to the ATM side, parallel to the damaged side of the Workshop, and mounted temporary foot restraints to the ATM hand rails (near an outrigger). When the foot restraints were in place and the Pilot was properly positioned, the Science Pilot, using the onboard extendible boom (for use on other EVAs), transferred to the Pilot a base plate fitting especially designed to hold the two sail poles in position over the Workshop. While the Pilot was clamping the base plate to an ATM outrigger, the Science Pilot, standing near the open airlock hatch, began assembling a 16.76 m (55 ft) pole from eleven 1.52 m (5 ft) sections, feeding the pole as he built it to the Pilot, who by this time was ready to receive it. The Pilot's position during this entire procedure was only slightly different from the one occupied during a normal EVA for replacing film canisters. After receiving the first pole, he positioned the base end into one of the two receptacles, or sockets, ("V" shaped) on the base plate. The second pole was received and attached in like manner in the other socket. As can be seen in Figure 11, a simple sketch of the pole, the end of the outward section of each pole has an eyelet through which is threaded a continuous loop rope. After the Science Pilot had transferred the sail package to the Pilot, he then hooked two corners of the folded sail onto the pole ropes (attach rings on rope). He then gradually pulled the ropes, alternately, sending the sail out along the poles in a manner similar to raising a flag. After full extension of the sail, the other two remaining ends of the sail were extended and tied off with ropes to the ATM outrigging.

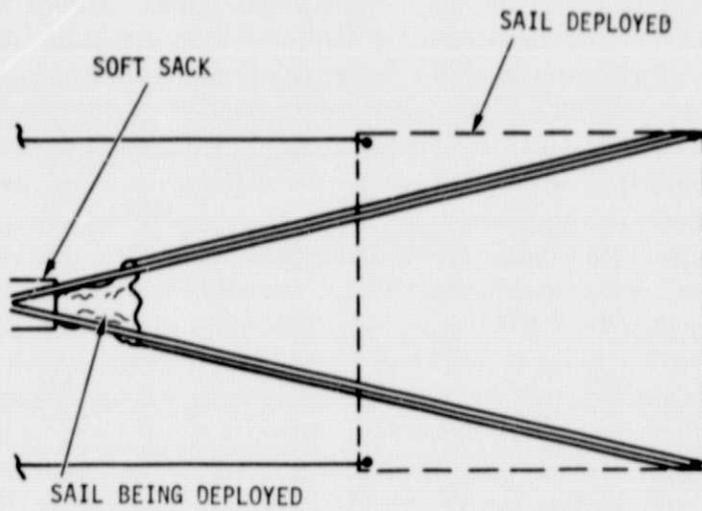
Figure 12. Sketch of sail deployment.

Figure 12 is a sketch of the deployed sail and Figure 13 is an actual view of the attached sail.

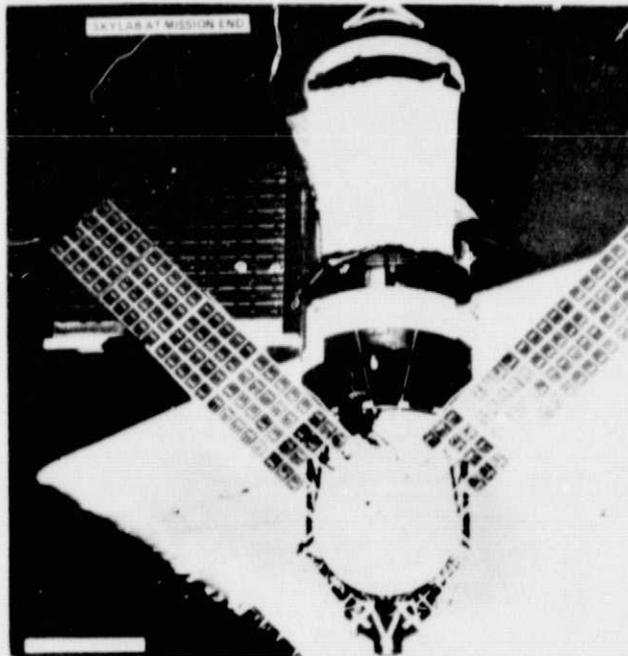
Figure 13. Skylab cluster with attached sail.

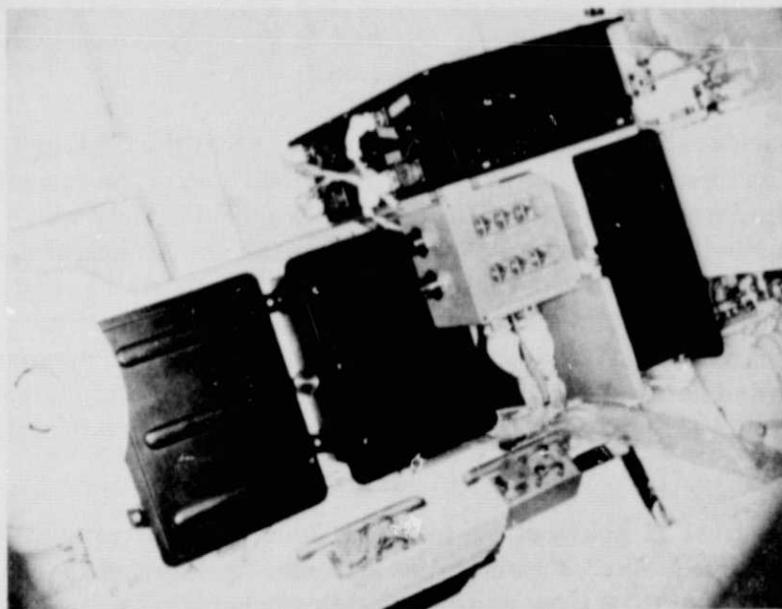
After considerable investigation, it was found that the high drift rates were caused by gas bubbles in the rate gyro flotation fluid. The formation of bubbles in the fluid was apparently caused by a design deficiency which exposed the float chamber bellows to the hard vacuum of space and by entrained gases present in the flotation fluid. Corrective action included tests to verify the theory of bubble formation and a design modification which sealed the float cavity from the hard vacuum of space. The design modification consisted of replacing the vented bellows end up cap with an unvented end cap so that internal float pressure would remain near the original float fill pressure despite external pressure changes.

Within the first 21 hours of the mission, four RGPs were overheating. Subsequently, two more showed identical symptoms. A detailed thermal analysis was performed relating RGP base plate heat sink temperatures of RGP temperatures. It was determined that base plate temperatures of 14° C corresponded to RGP temperatures of about 110° C. Also, a hot RGP was powered down, allowed to cool, and then powered up. The RGP temperature was seen to increase and become off-scale high. It was concluded that the six RGPs in question had

Figure 14. The six gyros mounted in the backup MDA hardware.

During SL-2 an expedited effort was begun to prepare a package of RGPs that could be added to the APCS should additional failures threaten the program. This package containing six RGPs became known as the "six-pack." The gyros in this package contained a design fix for the bubble problem encountered in flight. It was decided to mount the six-pack in the MDA on a mount provided for an experiment. This location was close to the center of gravity, could be aligned within limits, was close to the ATM control and display console for system interconnect, and was near a high power outlet. The installation required IVA and EVA with participation of all three crewmen. The rate gyro six-pack was mounted in the MDA as shown in Figure 14 and was connected to the ATM control and display console.

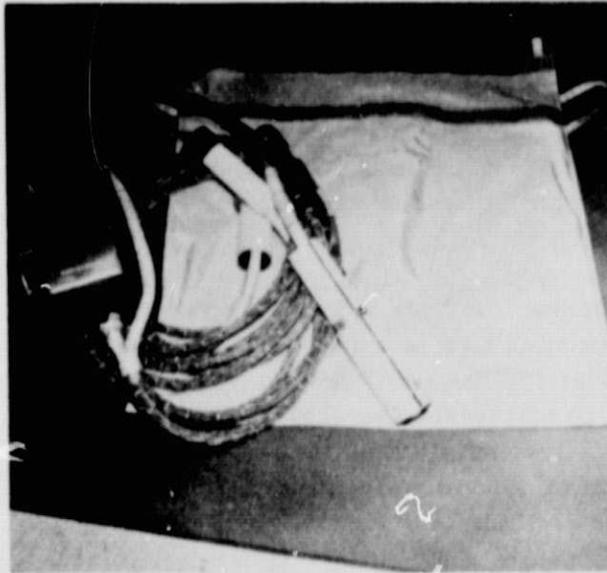
Figure 15. RGP EVA cable assembly and selector box.

The Commander remained inside while the Science Pilot and Pilot went outside to complete the installation which required the disconnecting of three cable connectors and the installation of the new cable and rate gyro selector box which required connecting four connectors. The external cable and selector box are shown in Figure 15. The internal and external cable connections are shown in Figure 16.

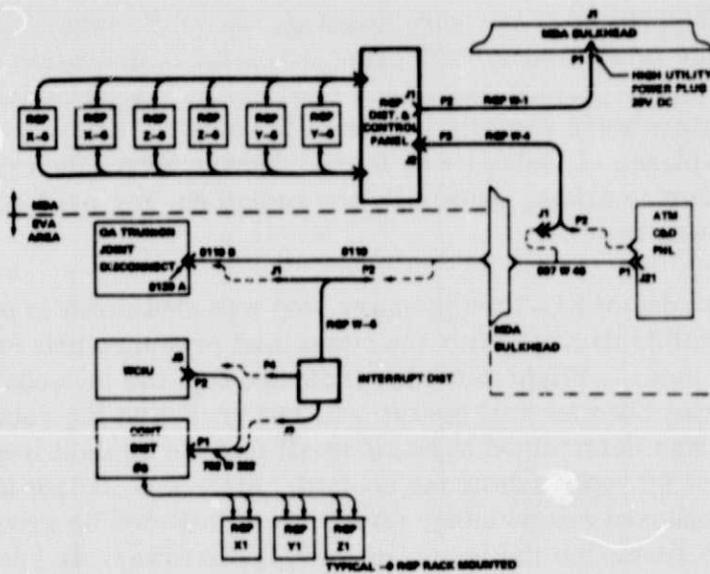
Figure 16. RGP six-pack connection schematic.

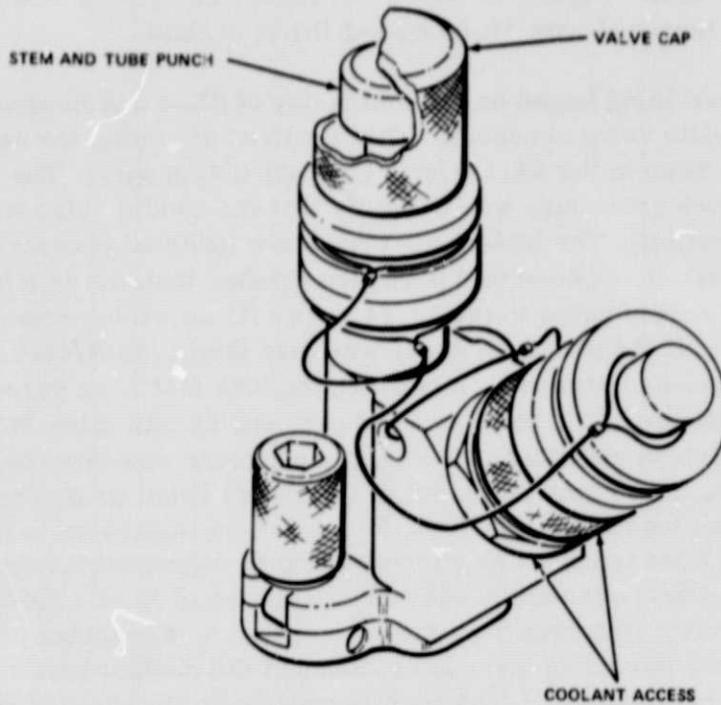
On the ninth day of SL-3, a coolant leak in the primary coolant loop was indicated by a low pump inlet pressure warning. Ground analysis indicated a long term decrease in pressure. The crew attempted to ascertain the location of the coolant leak by removing panels and unwrapping insulation from suspect lines. Wrapped lines were visually inspected for bulging, color changes, and wetness but no evidence of leakage was found. During EVA, the crew inspected the accessible exterior areas, especially the radiators, for evidence of coolant leakage but none was found.

Figure 17. Saddle valves.

The procedure developed included stripping insulation from a coolant line near the cabin heat exchanger in the airlock module, piercing the line with a saddle valve assembly (Fig. 17) which had a quick disconnect for attaching a service hose and forcing coolant from a small storage tank by applying pressure from a  $24.13 \text{ N/cm}^2$  (35 psi) source through a bellows arrangement. Parts for the reservice equipment were primarily qualified by similarity to equipment used in other Airlock Module applications. The tank was adapted from a

Command Module fuel tank. Figure 17 shows the reservice system schematically. The tank was launched with 19.05 kg (42 lb) of coolant.

The in-flight servicing began on the fourth day of SL-4 and progressed smoothly through a saddle valve checkout. This involved attaching the saddle valve and the leak test hose to the 24.1 N/cm<sup>2</sup> (35 psi) GN<sub>2</sub> supply. The purpose of the leak check procedure was to verify that the saddle valve was not leaking prior to penetration. The leak check procedure involved pressurizing the saddle valve and leak check hose to a pressure greater than 20.68 N/cm<sup>2</sup> (30 psig), closing the supply valve in the 18.24 m (60 ft) servicing hose, and monitoring for 30 min. If the pressure decay was less than 1.38 N/cm<sup>2</sup> (2 psi), the servicing was to proceed. However, the leak test hose gage indicated an initial pressure of 22.75 N/cm<sup>2</sup> (33 psi) and 35 min later 21.03 N/cm<sup>2</sup> (30.5 psi). After an additional 20 min, the pressure was down to 17.23 N/cm<sup>2</sup> (25 psi). Thus, a leak was indicated in the saddle valve or the leak check hose. To determine the location of the leak, the crew was instructed to disconnect the leak check hose from the saddle valve and to repressurize the leak check hose. The leak check hose alone showed a pressure drop of 1.38 N/cm<sup>2</sup> (2 psi), indicating a leak. The crew was then instructed to disconnect the leak check hose from the servicing hose and to connect the coolant servicing tank and the coolant servicing hose. The system was carefully checked out and the coolant valves were then opened to supply coolant to the saddle valve under pressure prior to piercing of the coolant line. No coolant leakage was observed; the primary coolant line was then pierced and the servicing proceeded satisfactorily.

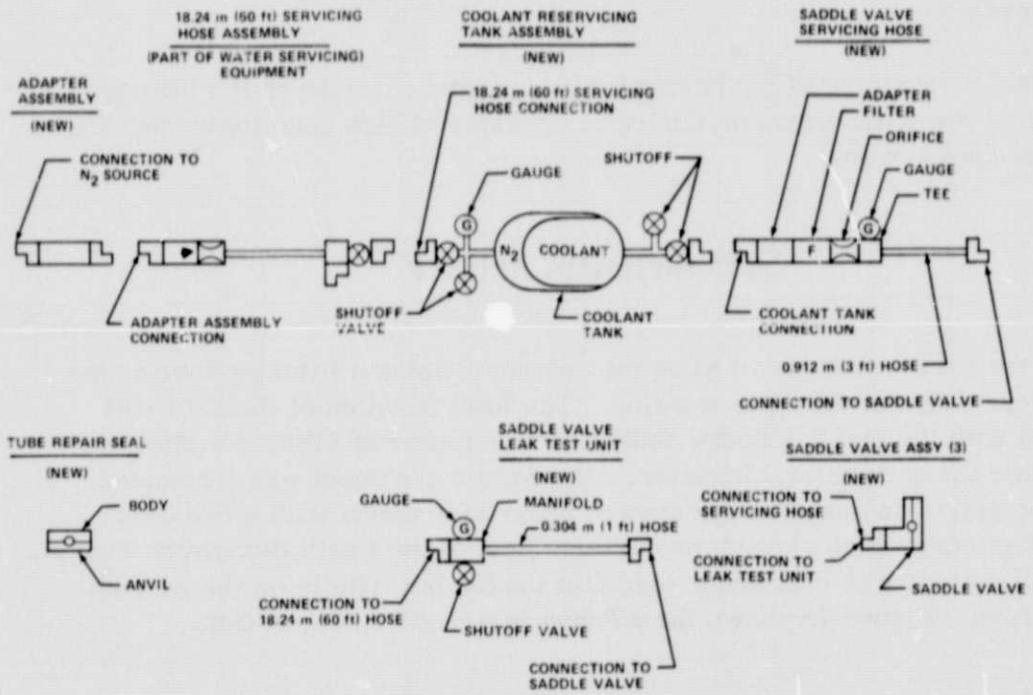
Figure 18. Coolant reservice equipment.

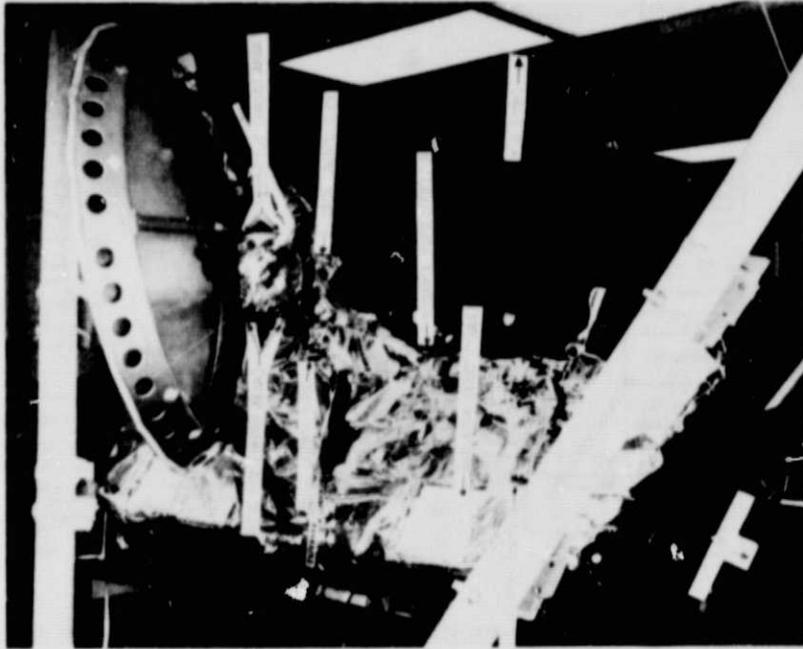
Figure 19. S193 antenna.

A failure occurred earlier during EREP pass 40 on mission day 49 of SL-3 which manifested itself by erratic antenna motion. A subsequent in-orbit SL-3 telemetry test gave ground engineers additional data to analyze the problem and begin working toward a solution. A -10 volt reference in the gimbal servo system was found to be at -1.0 volt. Circuit analysis indicated that the failure was most likely a short in either the pitch or roll gimbal potentiometers, or both. These potentiometers were accessible from outside the experiment (Fig. 19). Following the analysis, NASA decided to perform an EVA to attempt to correct this problem and at least get partial use of the S193 experiment.

On the seventh day of SL-4 the Science Pilot and Pilot performed the first of four EVAs of the SL-4 mission. The total duration of the EVA was 6.5 hours with the last 3.5 hours dedicated to a repair of S193, the Microwave Radiometer Scatterometer Altimeter. The S193 experiment was a complex electronic active and passive microwave radar instrument with a two-axis gimbaled antenna which viewed the earth as part of the Earth Resources Experiment Package. It was mounted external to the Skylab vehicle on the Airlock Module truss. Figure 19 shows the antenna in a flight configuration.
