NASA TM X-71867

OH-58 HELICOPTER TRANSMISSION FAILURE ANALYSIS

by D. P. Townsend, J. J. Coy,* and B. R. Hatvani
Lewis Research Center
Cleveland, Ohio 44135
January, 1976

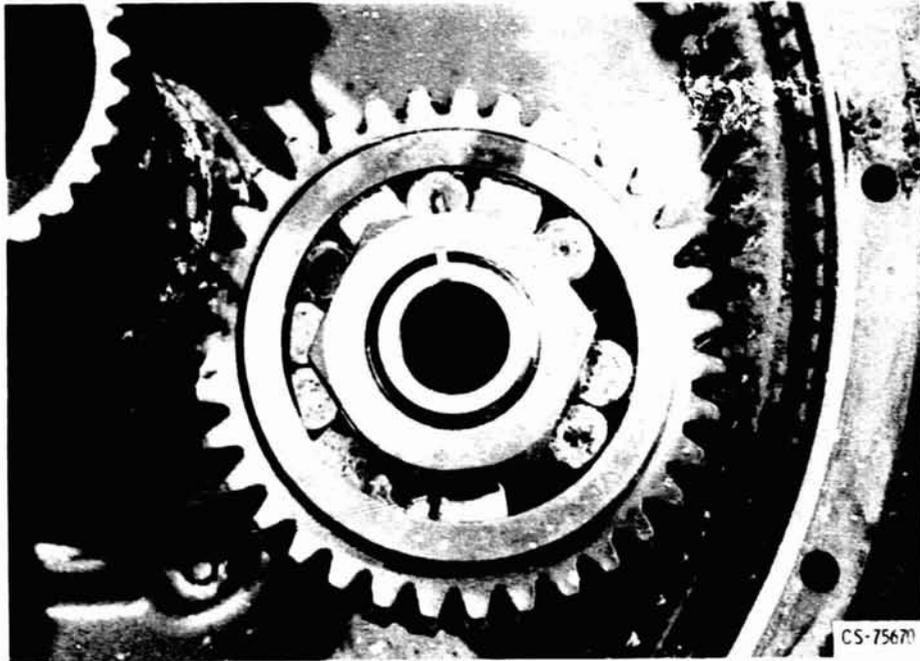
The rate of increase of the pinion temperatures slowed until at approximately 14 minutes the rate began to increase again (figs. 8(a) and (b)). These increases in temperature were caused by additional planet bearing cages melting which allowed the spherical rollers in the planet gear bearings to tumble and slide within the bearings (fig. 11).

Figure 11. - Planet gear support bearing. Badly misaligned and skewed rollers caused high vibration and temperature levels.

3. Change the spherical roller bearings to cylindrical roller bearings with rigid straddle mounting to replace the overhung mounting. This change would reduce the heat generation in the planet bearing up to 30 percent. Further testing would be required.

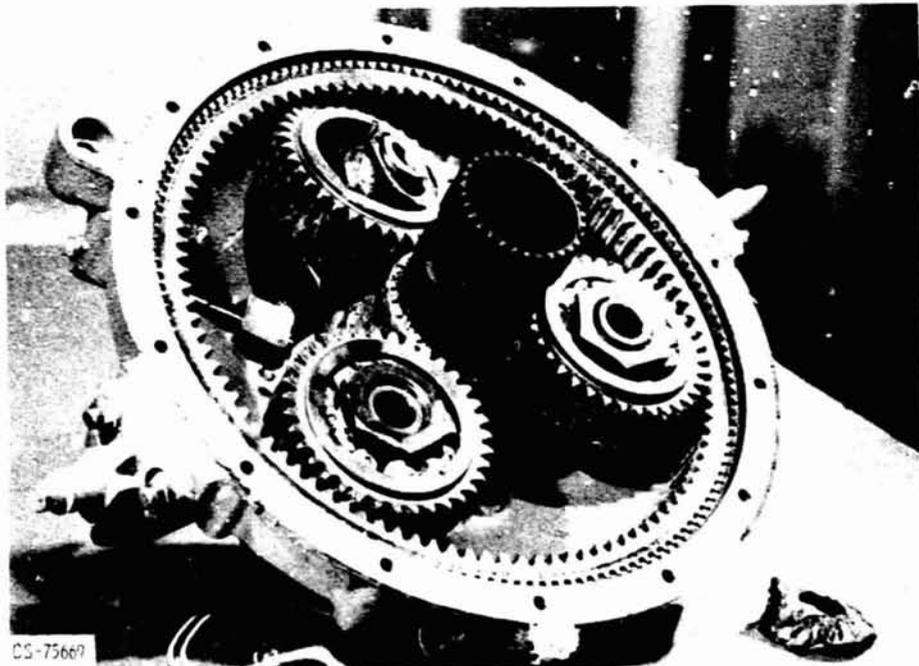
At approximately 27 minutes there is an additional increase in the rate of temperature rise as seen in the planet and (fig. 8(c)), the pinion area (figs. 8(a) and (b)) and to a lesser extent in the bevel gear bearing area (fig. 8(d)). At this point in time the gearbox is approaching complete failure. At these temperatures, the planet gears have very little strength. The lock nut on the planet bearing was being machined by the bevel gear bolt heads (fig. 12). The pinion

Figure 12(a). - Transmission top case with planet gear assembly. Planet lock nut (lower right) was machined to one-fourth original thickness.

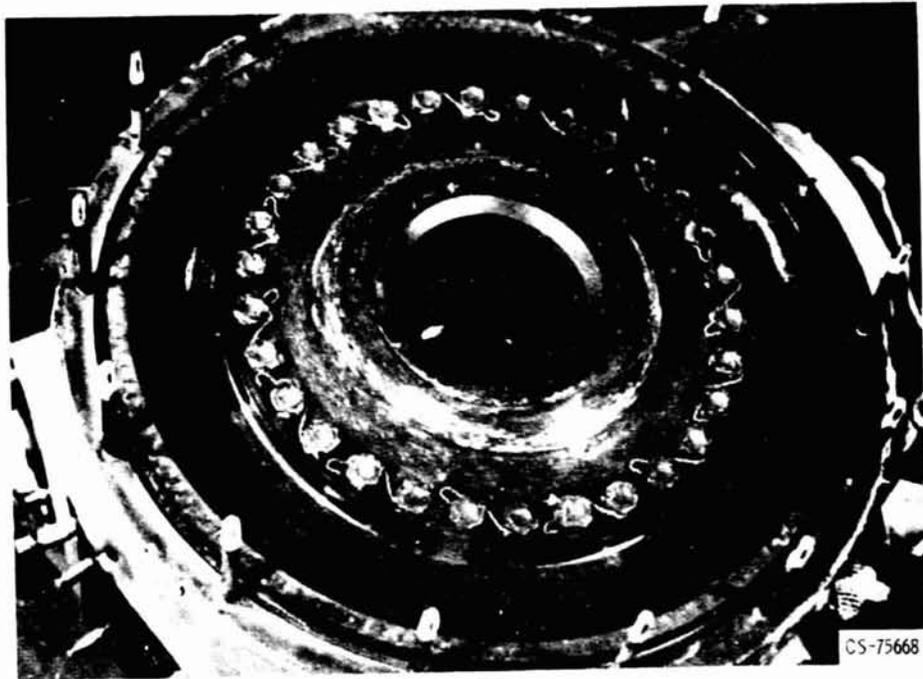
At 27 minutes the vibration levels again increased at the ring gear to the 30 to 40 g level. At that time the shaft nut was being struck by the bevel gear support bolts which were immediately below and on the gear shaft. The relative rotational speed of the planet carrier and the gear shaft was 1300 rpm. The retaining nut was rapidly machined away by the gear shaft bolts. Subsequently, an inner race of one of the spherical roller bearings came off the shaft allowing the spherical rollers to drop out of the bearing. One of the rollers wedged into the ring gear-planetary gear mesh. This caused the planet carrier to lock up. As a result, the teeth on the sun gear were destroyed by the torque overload. At 30 minutes after the oil drain was opened, complete transmission failure occurred.

Figure 12(b). - Transmission lower case with bevel gear shaft and bevel gear mounting bolts showing. Scored area caused by scraping lock-nut is visible.

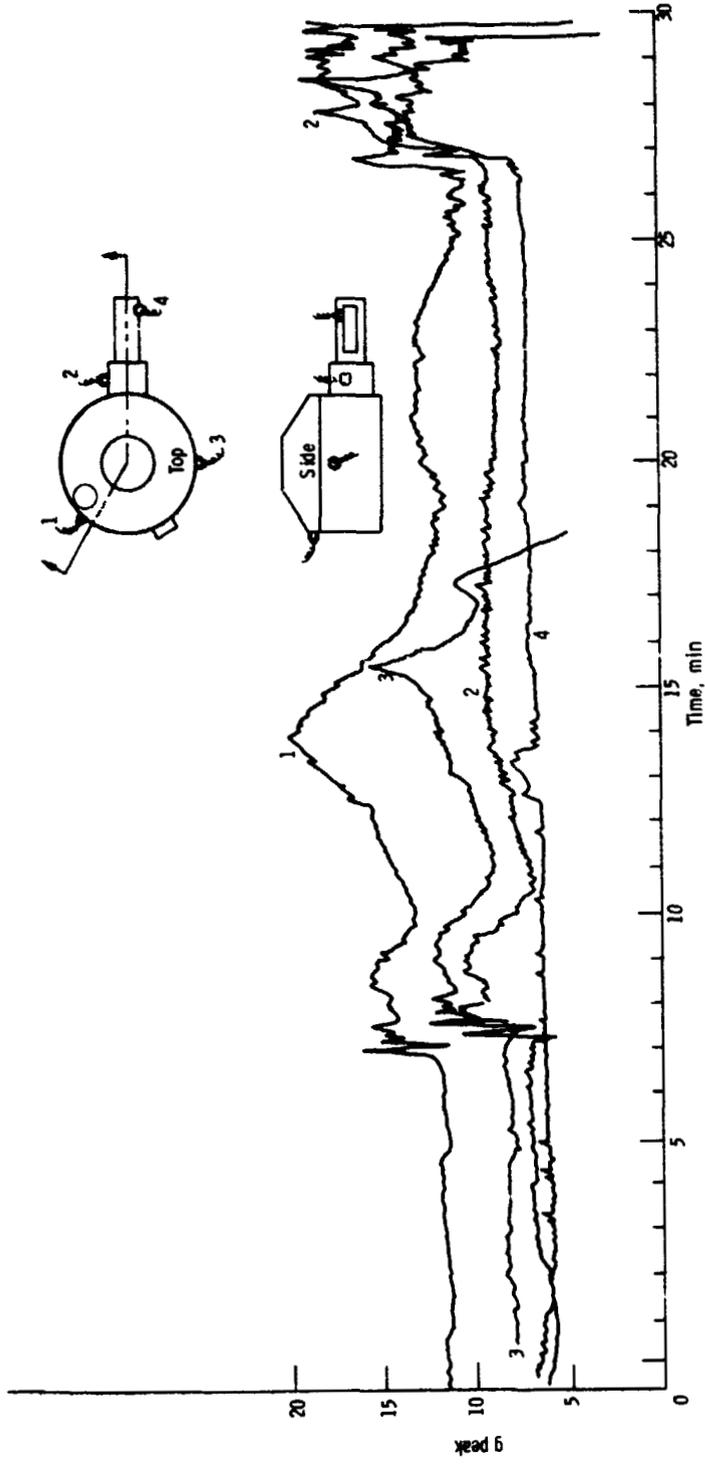
Figure 13. - Time history of acceleration measured on transmission during survivability test. Input speed, 6200 rpm; output torque, 36 000 in.-lb.

Figure 13 shows the record of the four acceleration peak amplitude levels as a function of elapsed time from the moment the lubricant drain was opened. The respective numbers in the figure indicate the location of the accelerometers, shown in figure 13. The accelerations are plotted on a logarithmic scale. Accelerations were measured (1) in the horizontal direction on the top case in the region of the ring gear, (2) in the horizontal direction on the lower case near the input spiral bevel pinion gear shaft, (3) in the horizontal direction on the bottom case in the plane of the spiral bevel gear, and (4) in the vertical direction on the outboard end of the slipping unit. The acceleration peak levels were lowest on the slipping unit and highest on the top case near the planetary ring gear. It was expected that the highest vibrations would be in the region of the ring gear on the top case. This is because the planet spur gears are the heaviest loaded gears. Also, the spur gears should have higher dynamic loads than the spiral bevel gears.

The first indication of failure occurrence in the gearbox was at zero plus 7 minutes. The vibration level increased very abruptly, by approximately 80 percent, at all three locations on the transmission. This rapid buildup and subsequent sustained level of vibration was an indication of a cage failure in the planet gear bearings. The thermocouples located at the spiral bevel mesh exit airstream showed a rapid increase to 360° F in the 2 minute time period following this event. The thermocouple located on the pinion tooth showed a much larger increase in temperature to 490° F in the same time period. The rapid increase in these temperatures indicated the sudden increase in the torque passing through the input gear mesh caused by the cage loss in the planet bearing. After 9 minutes, the vibration levels decreased briefly. Also, the input pinion

At 10 minutes, vibration amplitude began increasing again, with the peak level occurring at 14 minutes. At this time, a level of 40 g's was observed on the ring gear. This was about 230 percent of the level at time zero. This vibration activity was caused by the breakup of the second and third aluminum planet gear bearing cages. Once again, the vibration level decreased while the temperatures continued to rise at a steady rate. The accelerometer mounted on the lower case at location 3 dropped off at 18.5 minutes. The high temperature had weakened the mounting cement. During the time from 17 to 27 minutes the acceleration levels at the number 1 location were erratic and stayed between 10 and 16 g's. During this time, the rollers were skidding and their axes were badly skewed. The drag torque offered by the damaged bearings was sufficient to cause the inner races to turn on the planet bearing posts. The cotter key was sheared on two of the bearings and the shaft nut was being turned by the bearing inner race.

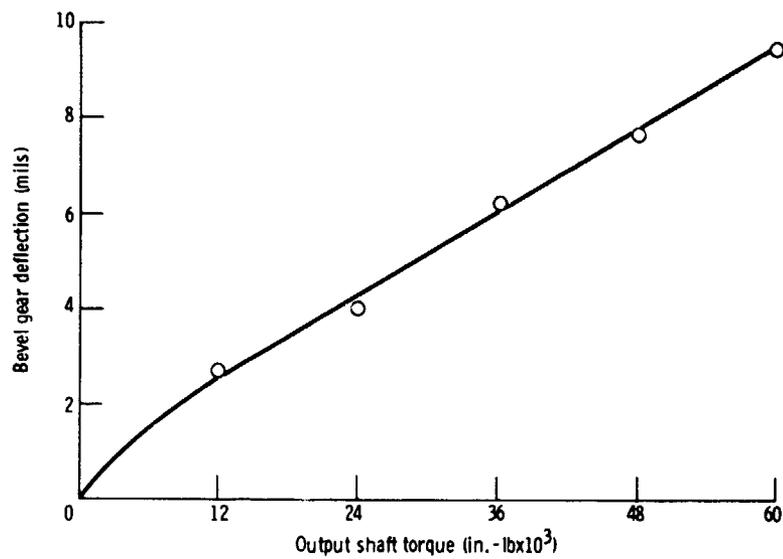
Figure 17. - Bevel gear deflection as a function of output shaft torque. Input speed, 6200 rpm.

Figure 17 shows the bevel gear deflection as a function of output shaft torque. The deflection is very nearly a linear function of the torque with the spring rate being approximately 6.8×10^6 in.-pound/in. This deflection can cause reduced load capacity and life (ref. 2).

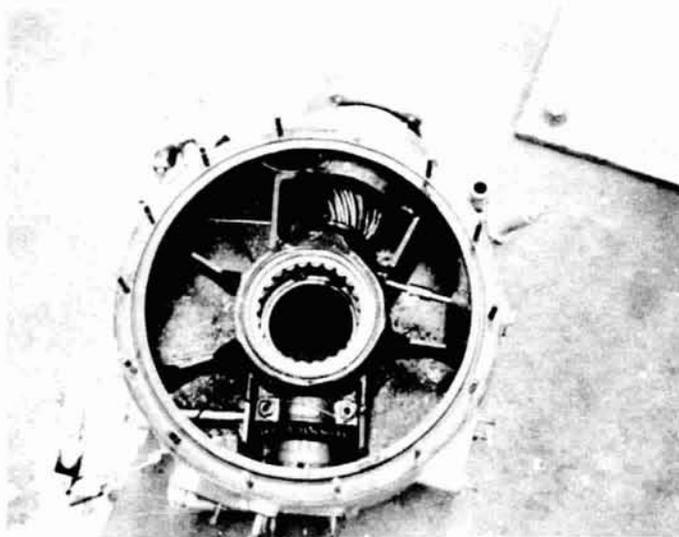
The lower gearbox assembly which comprises the input spiral bevel gear set was not damaged during the survivability test (fig. 19). The maximum temperatures within the lower gearbox assembly were in the range from 325° to 525° F. It would appear from the condition of gearing and bearing components after the survivability test that the materials were adequate for the time duration of the test which was 30 minutes. However, for longer time periods both the bearing and gear materials may be marginal. Consideration should be given to replacing all the bearing materials within the transmission which are AISI 52100, CVM 52 CM, and CVM AISI M-50 with vacuum-induction melted vacuum-arc remelted (VIM-VAR) AISI M-50 steel. This steel has high temperature bearing operating capability to 600° F (refs. 5 and 6) and rolling-element fatigue lives of approximately 20 times current design requirements (ref. 4). Manufacturing specifications incorporating the technology of reference 4 is contained in reference 7.

Figure 19. - Lower gear assembly after survivability test.

Insufficient gear data exists to recommend a high-temperature gear material in place of the AISI 9310 steel currently being used for the bevel gear set. Endurance testing of currently used and prospective gear materials are being performed at the NASA-Lewis Research Center. Out of those potential high-temperature materials studied, Super Nitralloy exhibited lives exceeding AISI 9310 (refs. 8 and 9). Nitralloy N (AMS 6475) is a material which also has high temperature characteristics but has not been endurance tested in rolling-element fatigue. However, this material has found acceptance as a gear material and is used for the sun and ring gear material in the OH-58 transmission. Consideration should be given to changing all the gear materials except as noted below to Nitralloy N (AMS 6475).
