NASA TN D-8301

**APOLLO EXPERIENCE REPORT -
COMMAND AND SERVICE MODULE
CONTROLS AND DISPLAYS SUBSYSTEM**

Aaron B. Olsen and Robert J. Swint

Lyndon B. Johnson Space Center

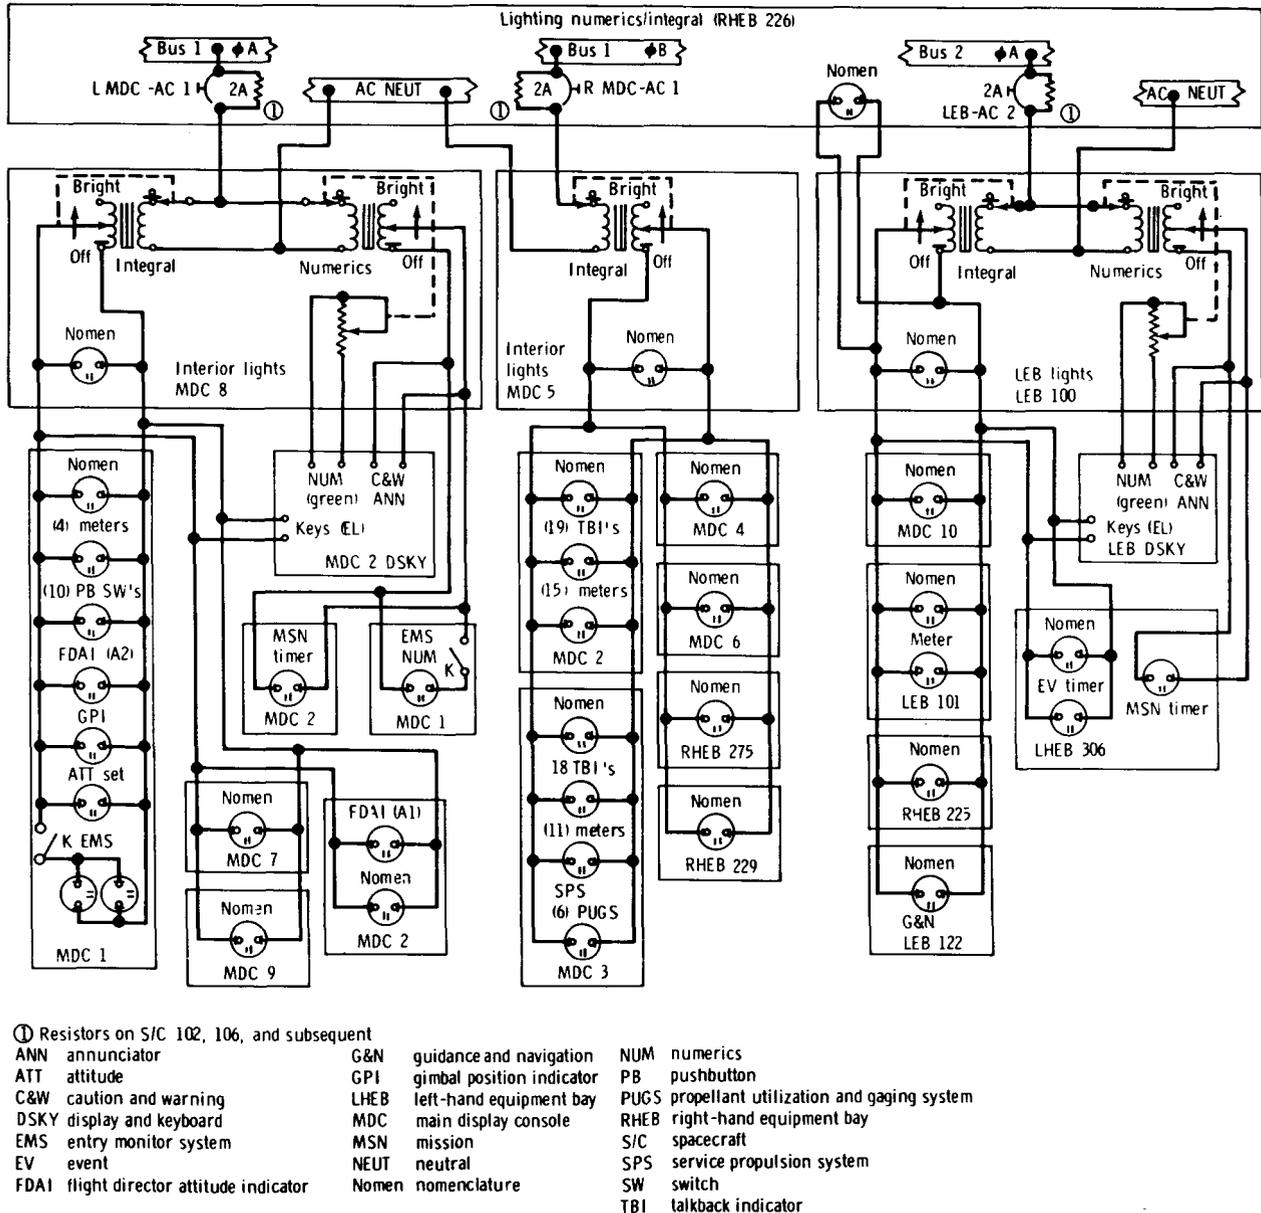
Transient susceptibility. - In July and August 1966, floodlight failures were attributed to transient susceptibility of the lamp circuitry, which created conditions that allowed the lamp assembly to draw excessive current that, in turn, opened the fuse. The circuitry was redesigned to limit the current flow by the addition of an input filter, a time-delay network, and a zener diode.

Figure 2. - Panel lighting schematic (integral and numerics).

Transient protection. - To protect against the effects of switch contact bounce, the input filter chokes were replaced with 0.25-ohm resistors, and the 6.8-microfarad input filter capacitance was increased to 68 microfarads. Also, a 102-millisecond time-constant delay network and a zener diode were added to limit the maximum voltage that could be applied to the trigger circuit.

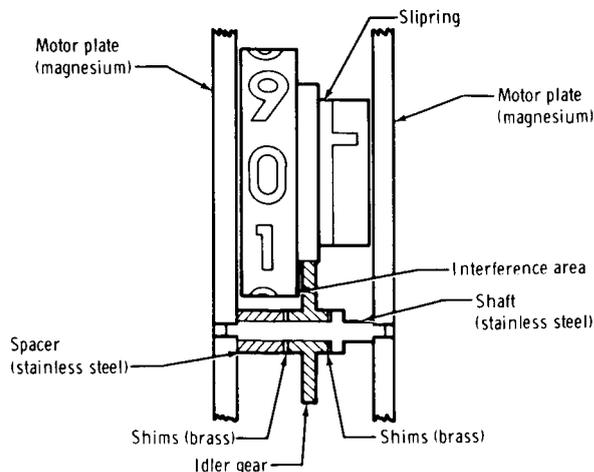
The mechanical problems consisted of interference between the gear and the counter wheels and contamination of the brushes and the sliprings. These problems were first attributed to the looseness of the dimensional tolerances, which allowed the idler gear (figs. 8 and 9) to rub against the number wheel and dislodge paint particles from it. Being nonconductive, the paint particles would adhere to the slipring and prevent the brush from making contact, which, in turn, would prevent the counting pulse from being transmitted to the next counter wheel. When brass shims, inserted between the idler gear and the spacers on the shaft to provide more clearance, did not correct the problem, a more thorough investigation was made. During this investigation, it was found that the stainless-steel shaft on which the idler gear turned was not fastened securely to the magnesium motor plates. This slack allowed the shaft to turn, and the small moment applied to the end of the shaft by the idler gear eroded the shaft hole to an oval shape. The end-plate erosion was sufficient to allow the shaft to move and to cause the idler gear to rub the paint off the number wheel. Because the timer was not mission critical and because only one flight remained in which the timer would be used very often, the decision was made to visually inspect the timers before flight rather than to attempt a redesign and refurbishment program.

Figure 8.- Apollo 15 DET anomaly.

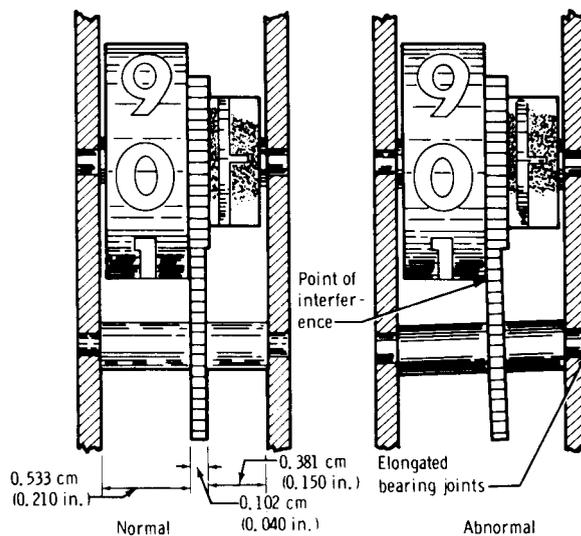
Figure 9.- Idler gear.

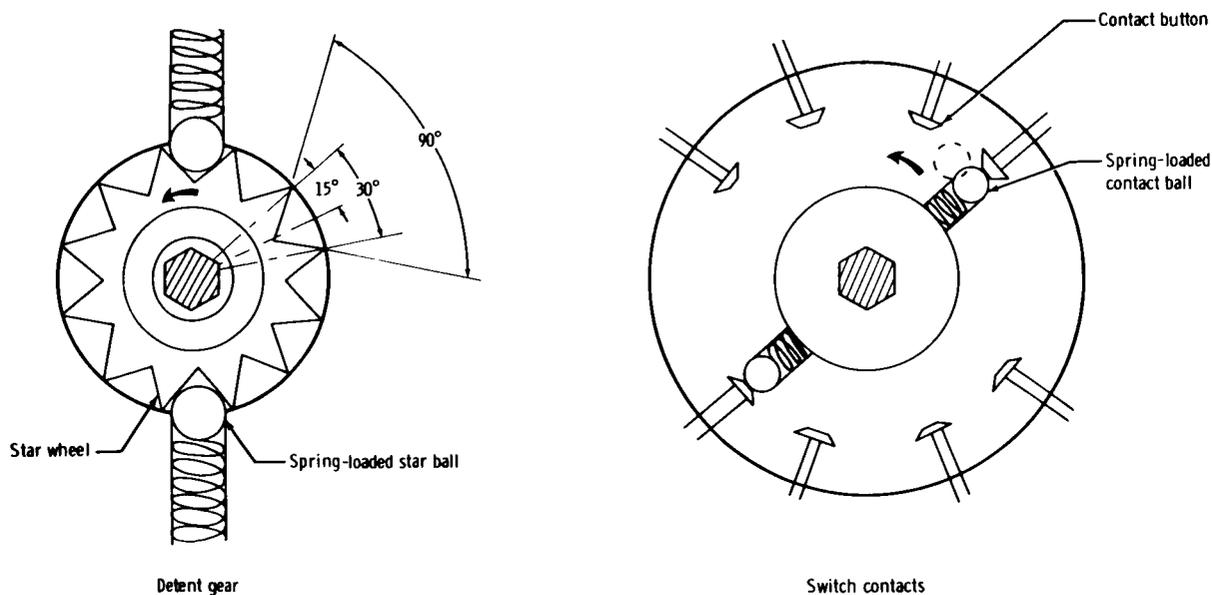
The "extra" detent indication was a development problem first noticed on spacecraft 008 and 012 (both block I vehicles). The irregularity had been previously noticed but no corrective action was taken until a short circuit occurred between contacts. When the short circuit occurred, the switch was in the extra or "false" detent position because assurance had been given that no current flow would occur when the switch was in that position. As a result, a redesign and reevaluation effort was made, and the switches delivered for spacecraft 012 changeout were of the redesigned configuration. The extra detent difficulty is explained in the following discussion.

The span between positions was 30° (fig. 10). During the first 15° of rotation, the spring-loaded star ball was climbing the ramp of the star wheel, and the spring-loaded contact ball was going down the ramp of the contact button. During the last 15° of rotation, the spring-loaded star ball was going down the ramp of the star wheel, generating enough force to permit the spring-loaded contact ball to climb the ramp of the contact button. Extra detent was felt at the 15° point because the spring-loaded contact ball was starting to climb the contact button ramp and the spring-loaded star ball was not yet going down the ramp of the star wheel. Because the star ball was at the point of the star, no force was being generated for climbing the ramp of the contact button. This effect was more noticeable on multiple-pole, multiple-deck switches where there were many contact button ramps to climb. Because of the tolerance build-up at this midway position, the number of contacts made could not be readily determined.

Figure 10.- Rotary switch.

To remedy the extra detent problem, the vendor lowered the ramp angle on the contact buttons and improved tolerances by changing the tooling jigs. The spacecraft 012 deliveries were the first to have these modifications.

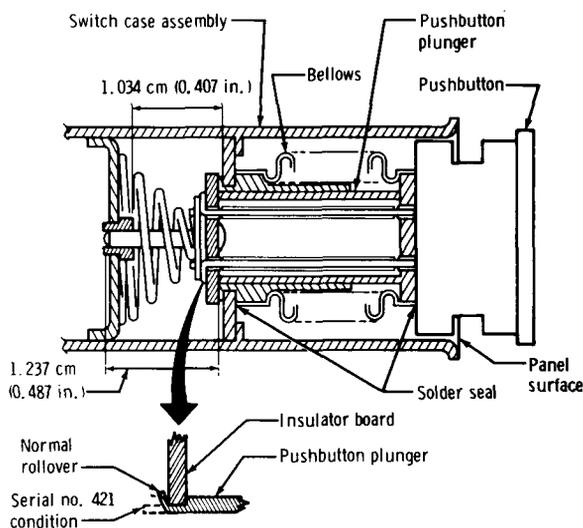
Pushbutton switches were used as backup controls for the initiation of events that would normally occur as automatic functions and as the C&WS MA reset. No flight failures were recorded, but several failures occurred during vehicle testing. One of these failures, which forced the removal of approximately 57 switches from vehicles produced after CSM 107, resulted from the vendor's use of a paraffin-type material in a grinding operation to avoid the entry of ground-off particles around the actuation buttons on the contact portions of the switch. The material hardened and prevented switch actuation. Another vehicle failure resulted from a switch missing one of the manufacturing process steps, which was to have crimped the pushbutton plunger base over the insulation board of the EL lamp lead. The problem occurred in the environmentally sealed portion of the switch. When the external ambient pressure was reduced in the altitude chamber, the plunger, which had been held in by the strength of the EL lead wires as long as the pressures remained equal, pushed the face of the switch out so that it was protruding from the surface of panel 1 (fig. 11).

Figure 11. - Pushbutton switch plunger cutaway.

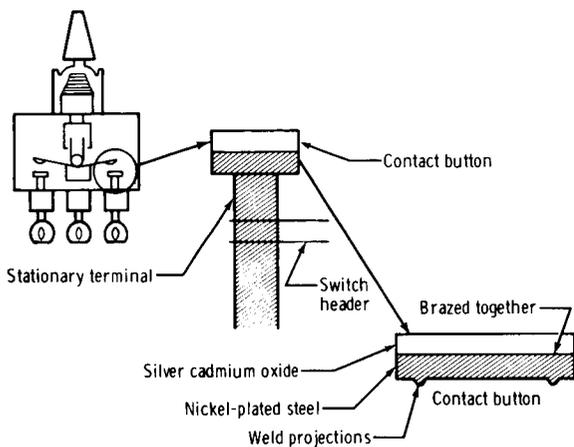
Toggle switches, used as manual control elements on the CM, were configured in one to four poles and in two or three positions and were of a maintained, momentary, or lock type, depending on the use. The block I toggle switch was an environmentally sealed unit with a low failure rate. After the block II requirements were established for a hermetically sealed switch, it was determined that the block I vendor did not manufacture one and did not choose to manufacture one. Consequently, the initial block II toggle switch was a hermetically sealed plunger-type unit with an unsealed toggle mechanism for switch actuation. Early in the block II program, switch problems became apparent. Failures caused by high contact resistance, by mechanical lockup, and by nonfunction at high or low pressure resulted in a change to the present completely hermetically sealed switch. This switch had many serious problems (figs. 12 to 14), such as internal solder balls, extra parts and pieces inside switches, contact buttons welded to a terminal post in an inverted position, defective contact-button welds, auxiliary contact-plate welds, momentary shorting of contact arm with spring, cracked toggle block assembly and bellows, annealing and displacement

Figure 12.- Toggle-switch problem.

of the momentary return spring, spring shorting to contact arm during sinusoidal vibration, and high contact resistance.

Most of these problems were corrected by the addition of inspection stations during manufacturing, by better workmanship, by altering some of the weld processes, and by adding several additional steps to the acceptance test procedure (ATP). One of the most valuable additions was the requirement for multiaxis X-ray exposures. Despite the poor performance during ATP and vehicle test, only one flight failure was
