1. Report No. NASA TM X-73569		2. Government Accession No.		3. Recipient's Catalog No.	
4. Title and Subtitle INSPECTION OF TWO BRAYTON ROTATING UNITS AFTER EXTENSIVE ENDURANCE TESTING				5. Report Date

INSPECTION OF TWO BRAYTON ROTATING UNITS AFTER
EXTENSIVE ENDURANCE TESTING

by James H. Dunn

Lewis Research Center

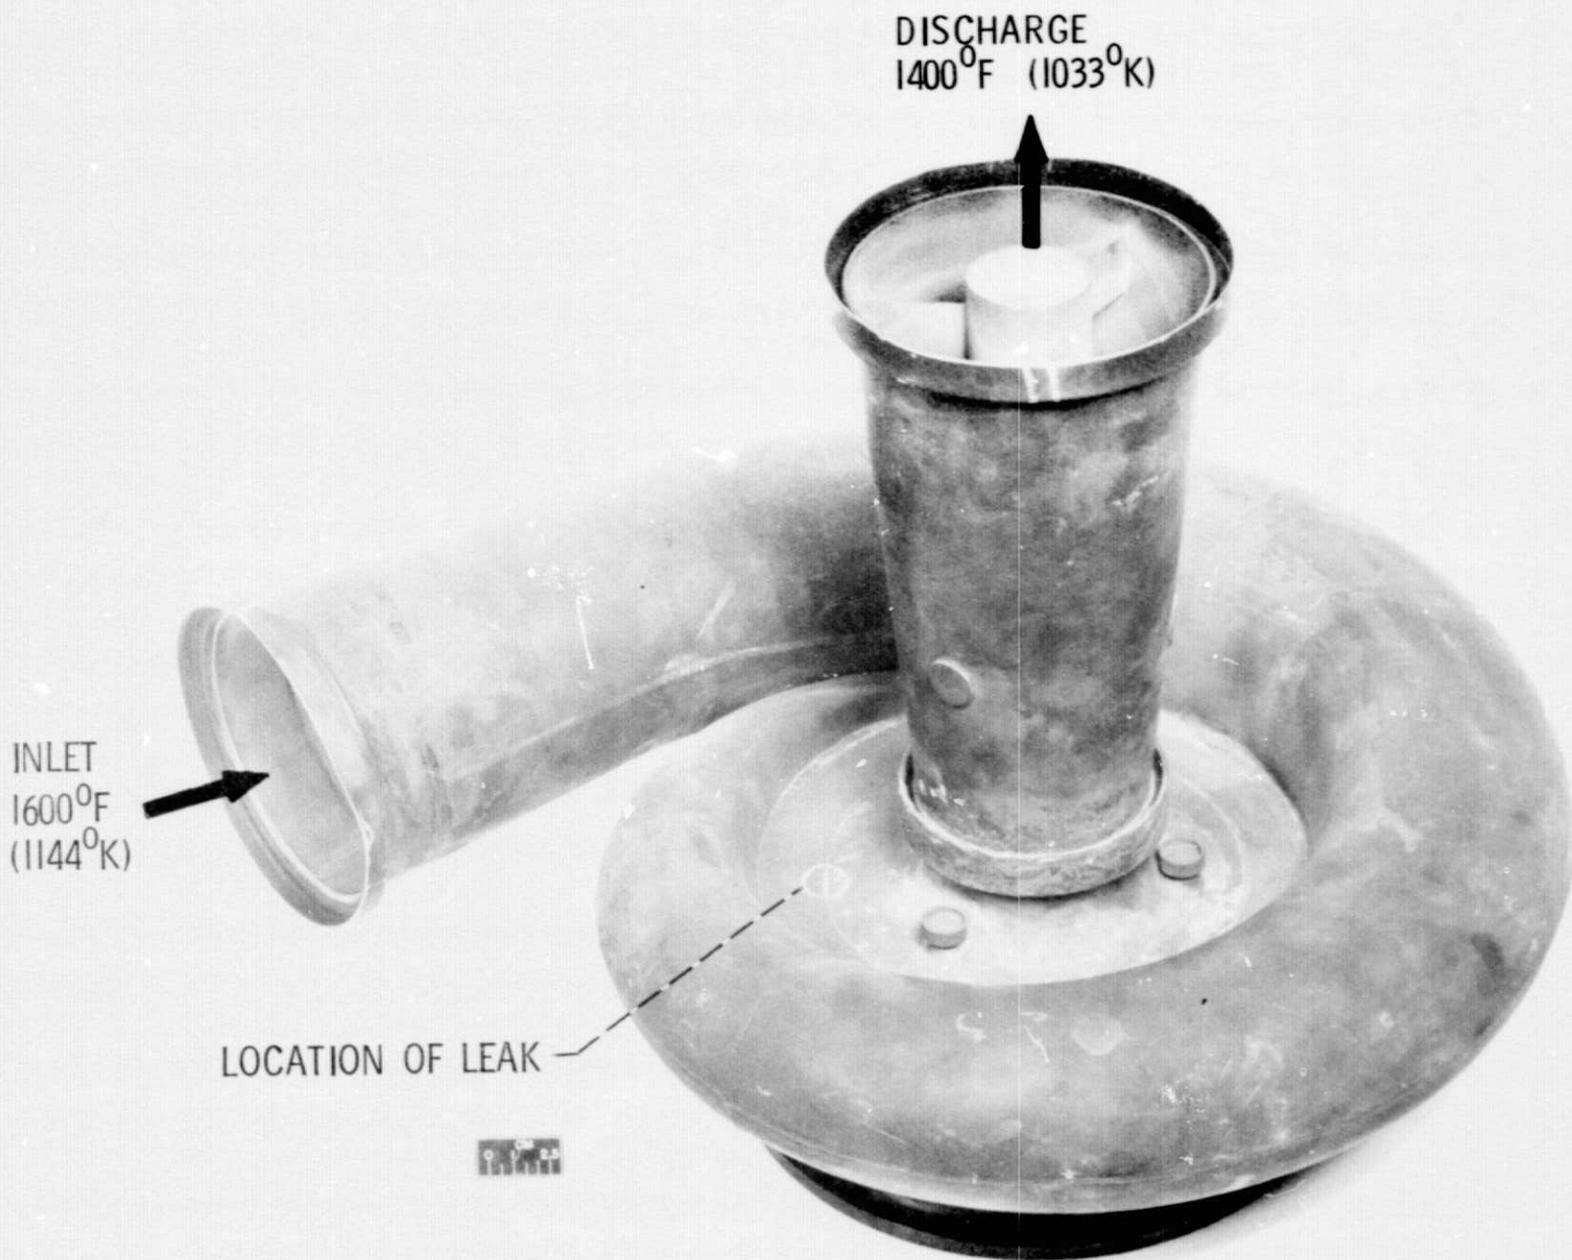
Figure 7. - Turbine scroll brayton rotating unit no. 2.

After removal from the Brayton engine (21 000 hrs operation) and prior to disassembly, BRU-2 was helium leak checked. This check revealed a crack that had developed in the turbine scroll along one of the welds (see fig. 7). No other leaks were detected.

The turbine scroll is the only potential life-limiting component identified in the BRU's after 21 000 hours of operation. This weakness (weld failure) can be eliminated by changing the configuration from the conventional torus, as used in the BRU, to a simple plenum. The plenum configuration is much simpler to fabricate and eliminates most of the present welds. Wall thickness can be increased in the plenum, thus reducing the operating stresses and increasing cycle fatigue life.

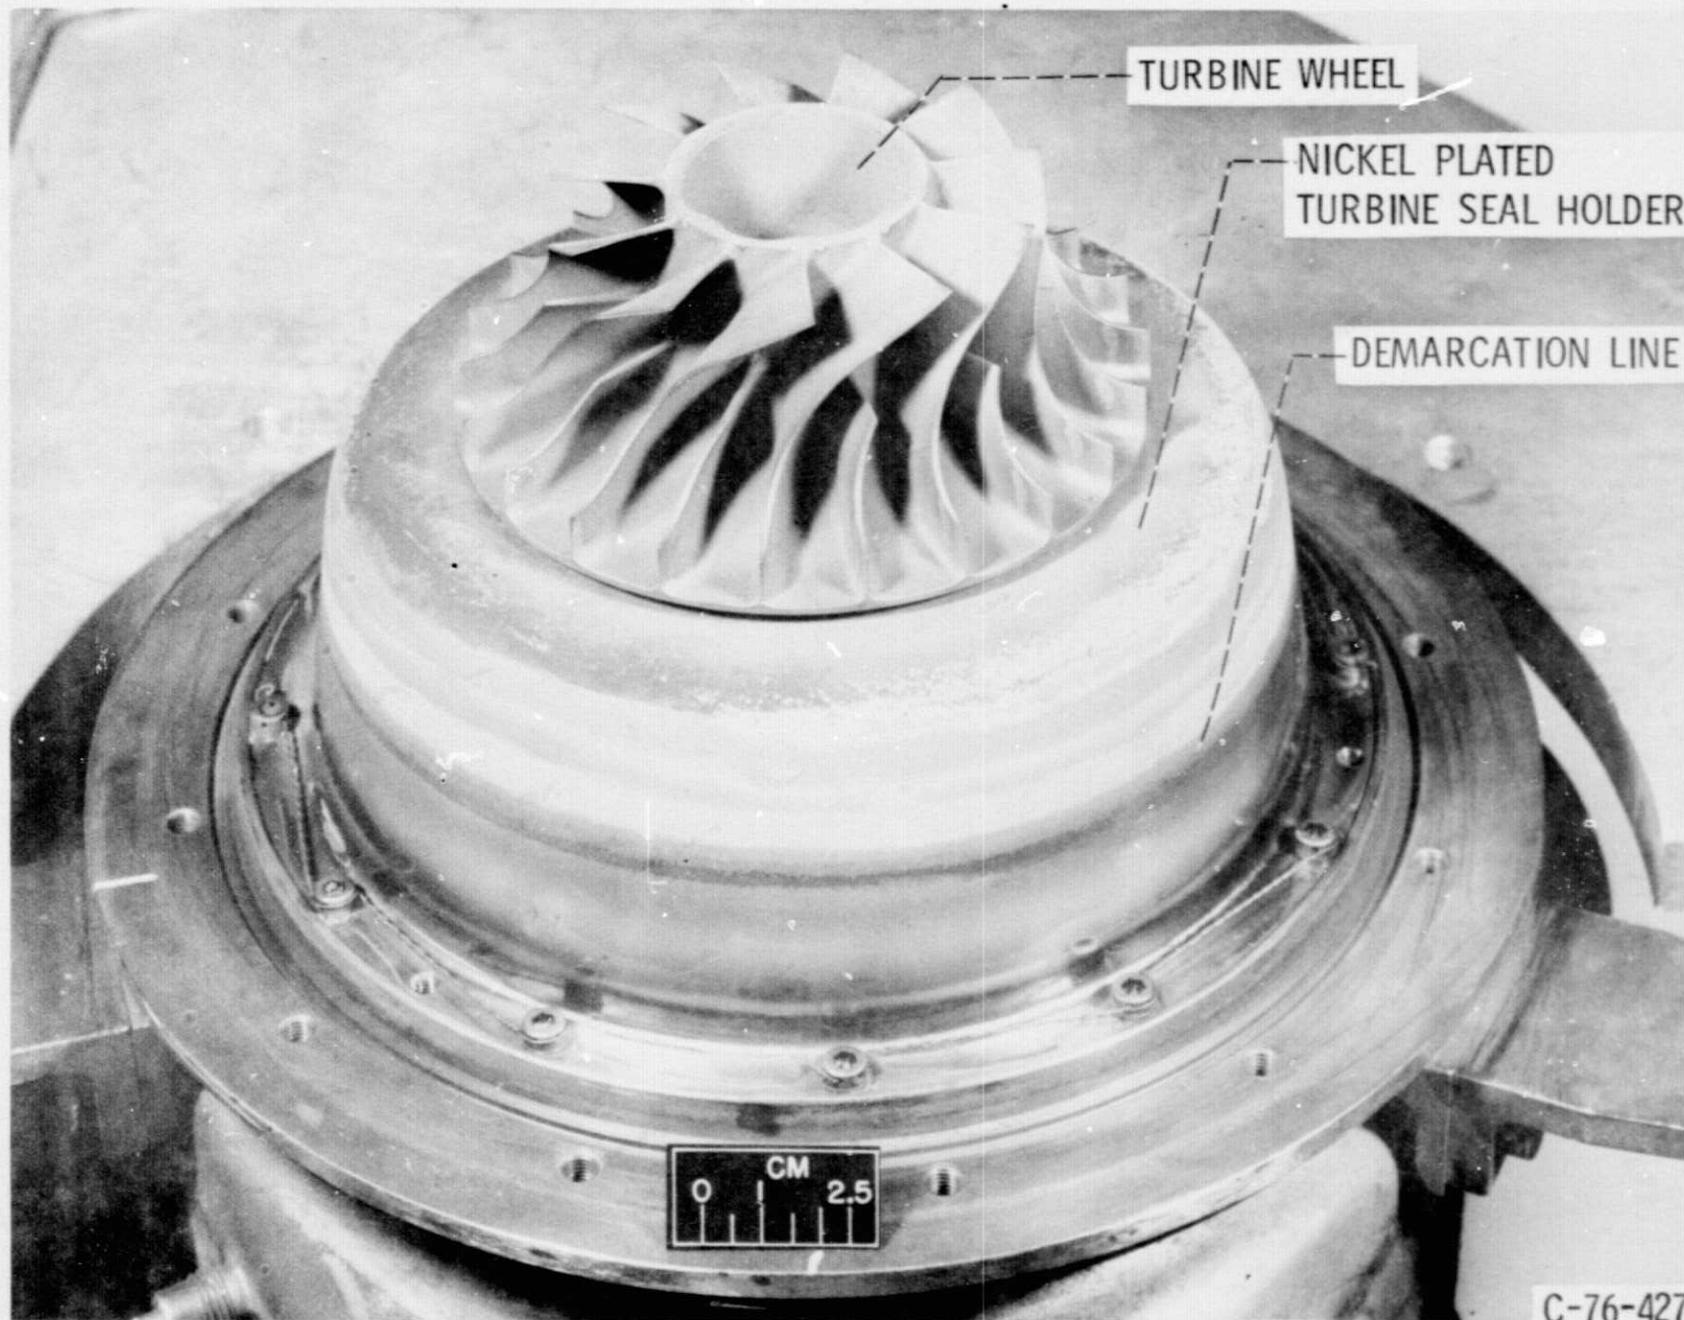
Figure 8. - Turbine wheel and seal holder bru no. 2.

(1) The backswept portion of the turbine blades and the hub were coated with a fine black powder that had the appearance and characteristics of lamp black.

(2) The turbine seal holder was originally plated with nickel and polished to produce a highly reflective surface. The outside surface down to the demarcation line shown in figure 8 and the entire inside surface (fig. 9) had a thin coating that had the rust-colored appearance of iron oxide. The lower outside portion of the holder material was discolored a dark blue. No evidence of the original nickel plating was found.

The black powder on the turbine wheel contained mostly manganese, with nickel and chromium. The rust-colored coating on the seal shroud contained mostly iron, copper, and manganese. The predominate element in the white powder on the copper heat shunt and in the turbine end of the alternator was silicon.

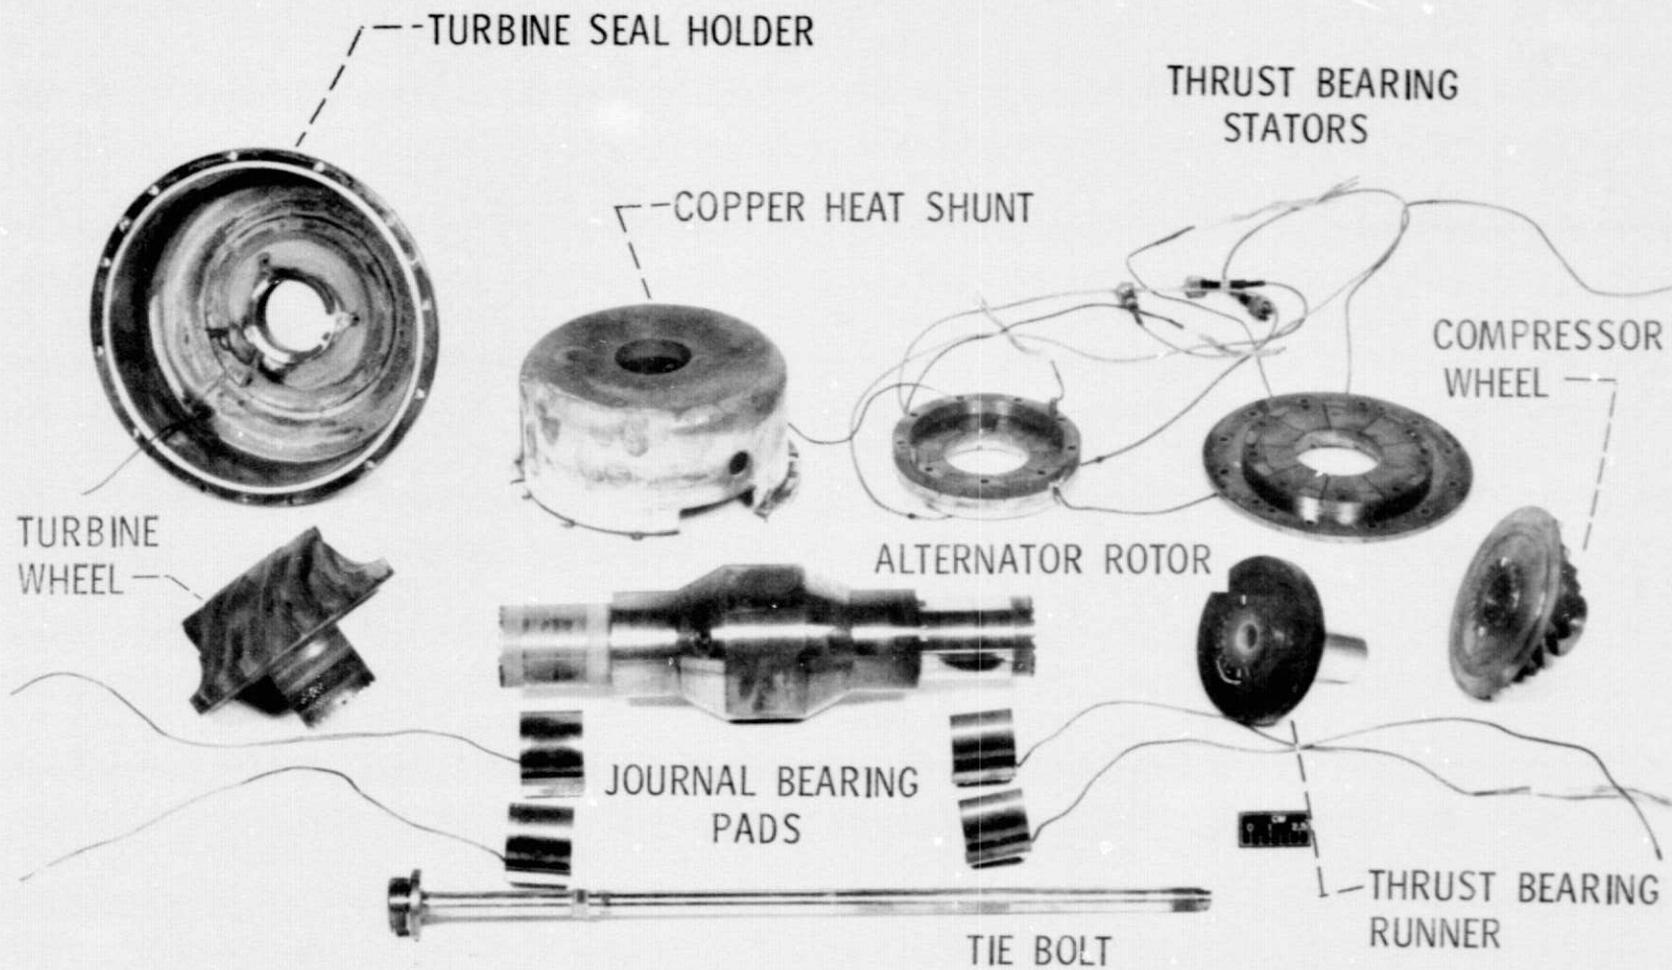
Figure 9. - Brayton rotating unit components - bru no. 2

(3) The copper heat shunt (fig. 9) was plated with gold to provide a reflective surface. None of the gold plating remained and the cylindrical surface was lightly coated with a fine white powder.

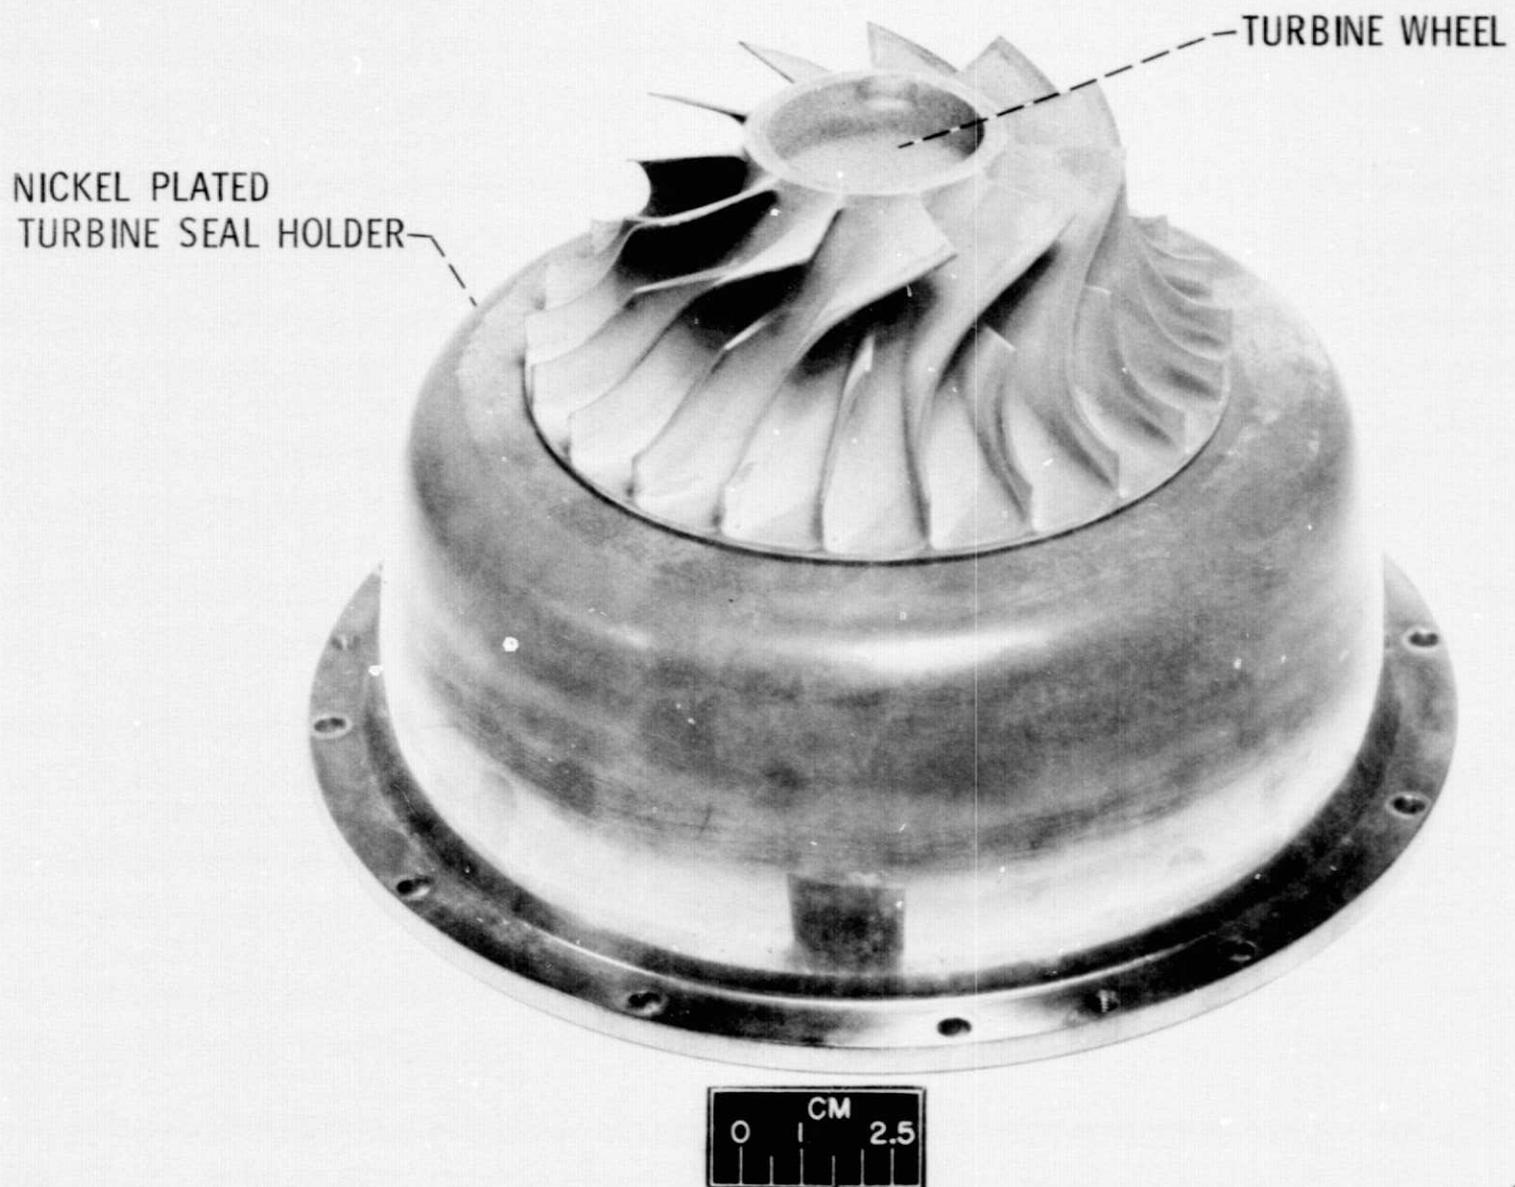
Figure 10. - Turbine wheel and seal holder - bru no. 4

(1) The turbine wheel (figs. 10 and 11) was coated with what appeared to be the same black powder found on the turbine wheel in BRU-2.

(2) The dark area of the seal shroud (figs. 10 and 11) was a dark blue color. The nickel plating in this area was gone. This condition also existed on the inside surface.

The deposits found on both turbine wheels consisted primarily of manganese with some chromium and nickel. The most likely origin of these elements was the facility heat source. The resistance heating elements in the heater were Inconel 600 tubes. The tubes were supported by ceramic headers. These headers were no doubt the source of the white powder found on the copper heat shunt and in the alternator cavity of BRU-2.
