**NASA TM X- 74039**

HYPERVELOCITY IMPACT TESTS ON SPACE SHUTTLE ORBITER  
THERMAL PROTECTION MATERIAL

Donald H. Humes  
Langley Research Center

June 1977

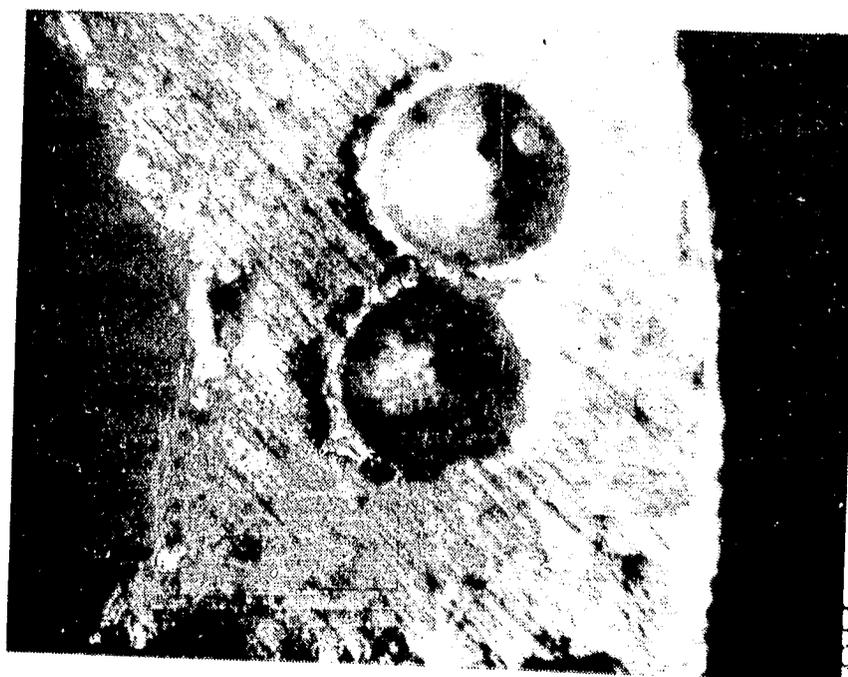
Figure 4.- Photographs of damage caused by 0.27 mm glass projectiles  
at 5.4 km/s.

velocity. One projectile struck specimen 3-74 while the other two struck the cold rolled steel baffle. The photographs in figure 4, which are at the same magnification, show the damage produced in the specimen and the steel. The area damaged on the LESS material specimen is 6 times the area damaged on the steel. The depth of penetration was about 480  $\mu\text{m}$  in the LESS material and about 240  $\mu\text{m}$  in the steel. That shows good resistance to penetration especially since the LESS material is only about 1/5 as dense as steel.

(a) LESS material specimen 3-74  
0.3 J

(b) cold rolled steel  
0.3 J

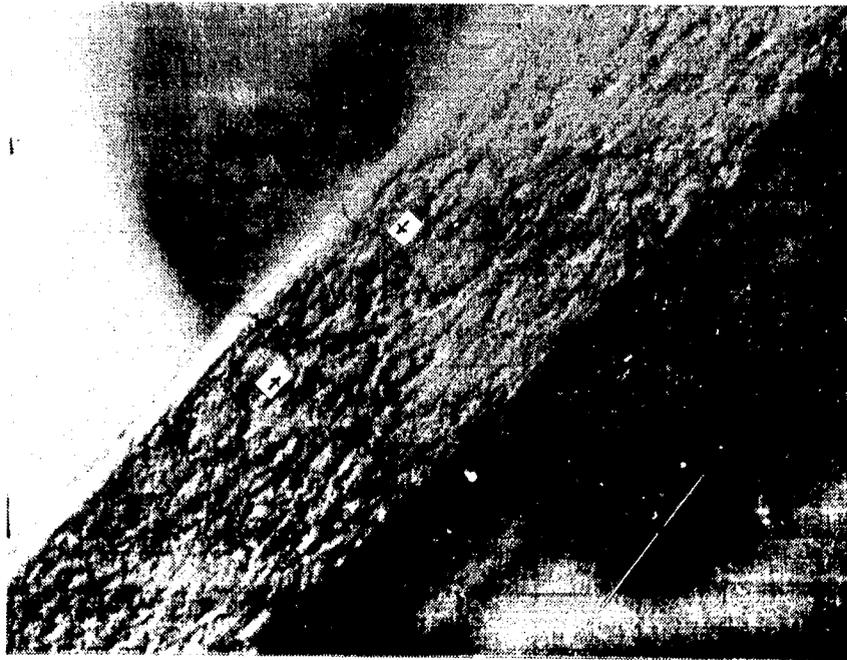
Figure 7.- Photographs of specimen 3-73 showing cracks on the back surface and edge.

One of the specimens developed cracks during the hypervelocity impact test. The cracks, which are on the back surface and edge of specimen 3-73, did not cause the specimen to fragment or to lose material. The photographs in figure 7 show two cracks running from the impact site to the edge of the specimen and other cracks perpendicular to these. No attempt was made to determine the depth of the cracks or the degree to which they effect the strength of the material. The impact site on specimen 3-73 was just 15 mm from the edge of the target. The cracking occurred near the shortest path from the impact site to the edge. None of the other specimens showed any evidence of cracking, even though, in two cases, the impact energy was greater than that for specimen 3-73. In these cases, however, the impact sites were 29 mm or more from the edge of the specimen, see table I.

(a) back surface

(b) edge
