Paper No. 10

**LIGHTNING TESTS OF THE ORBITER PYROTECHNIC ESCAPE SYSTEM**

R. Cohen, *Johnson Space Center, Houston, Texas*  
E. H. Schulte, *McDonnell Aircraft Company, St. Louis, Missouri*

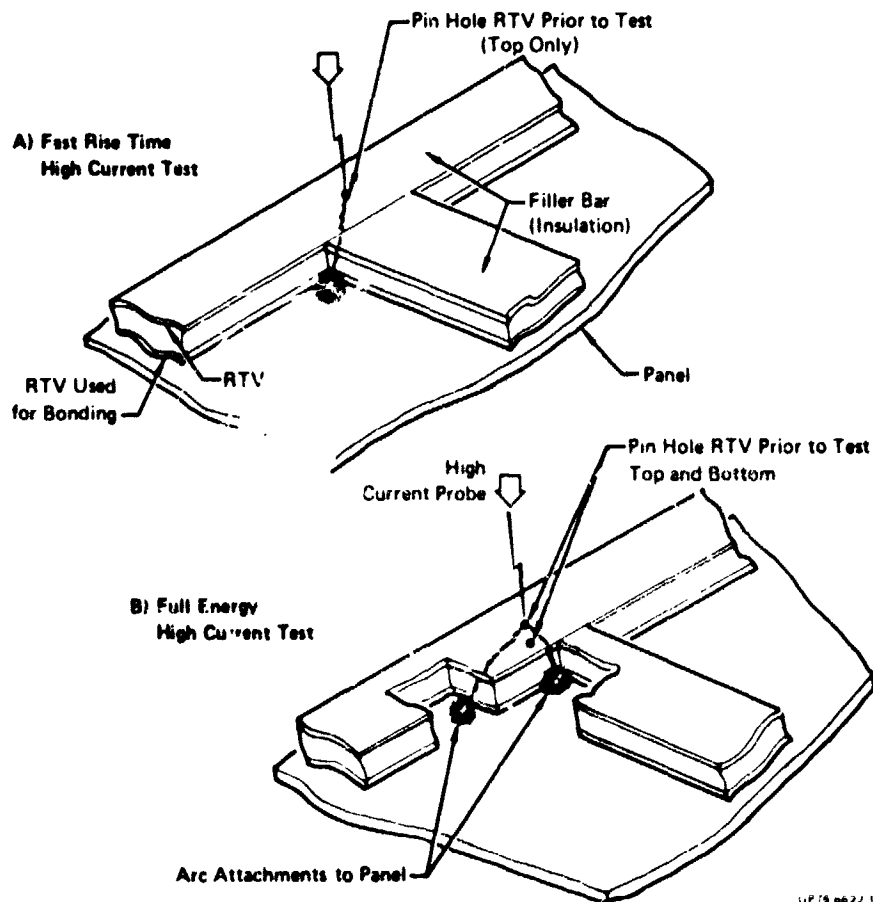
The results of the 2  $\mu$ sec rise, 180 kA current pulse are shown in Figure 11. Damage to the tiles extends over an area 9.5 cm (1-3/4 inches) in diameter area. The lightning arc did not puncture the RTV used to attach the filler bar to the metal panel as expected; it attached to the metal at the junction of the filler bars and the SIP as shown in Figure 12A. The damage to the metal panel consisted of only slight erosion of the plate over a 0.32 cm (1/8-inch) diameter area. The lightning current waveform is shown in Figure 13. A review of the high-speed movie sequence shows that tile particles are leaving the strike area at an initial velocity approaching the speed of sound. For example, selected frames are shown in Figure 14 and reveal that on the third frame some particles are already 25.4 cm away from the panel. The arc is first seen during frame 1, the exact instant of time of the initiation of the arc during frame 1 is not determinable, therefore the approximate average velocity of the particles during the 2-frame sequence (frame 1 to frame 3) would be 10 inches  $\times$  1750 fps  $\div$  2 frames = 22.2  $\times$  10<sup>3</sup> cm/second (8.75  $\times$  10<sup>3</sup> inches/second).

OP 76 6622 12  
**FIGURE 12 – RECONSTRUCTED PROBABLE ARC PATHS TO PANEL DURING HIGH CURRENT SURGE TESTS**
