NASA Technical Memorandum 79227

THE EROSION/CORROSION OF SMALL  
SUPERALLOY TURBINE ROTORS  
OPERATING IN THE EFFLUENT  
OF A PFB COAL COMBUSTOR

G. R. Zellars, S. M. Benford, A. P. Rowe,  
and C. E. Lowell

July 30, 1979

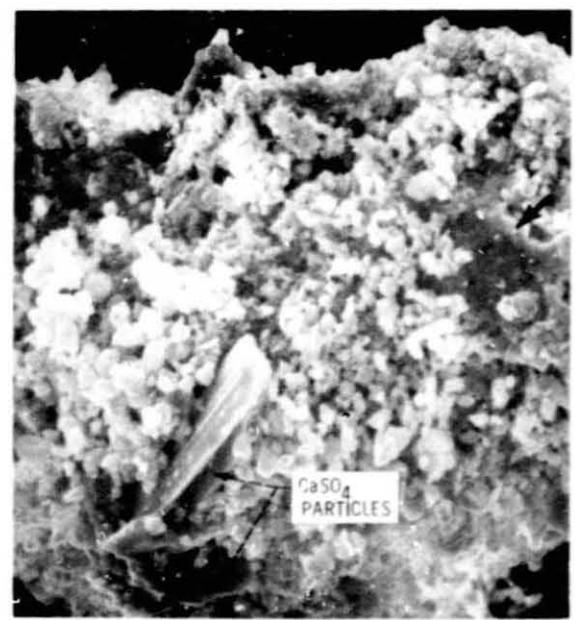
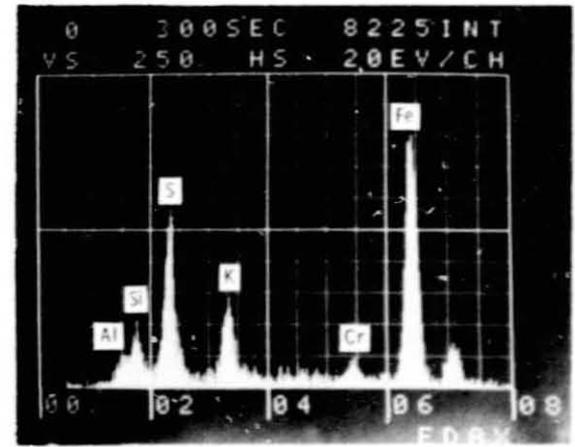
Figure 8 shows solids particles adhering to chromium oxide scraped from the pressure side of an R4 blade. The oxide may be from the surface or may have been deposited, perhaps after erosive removal from another blade or surfaces upstream. The solids particles are generally fluffy with varying Al-Si, K, Ca, and Fe content. The presence of sulfur is often accompanied by K and Fe, suggesting the presence of alkali metal-iron trisulfates. The smooth, dark appearance of these regions may indicate previous melting. Large CaSO<sub>4</sub> crystals imbedded on the oxide are representative of highly erosive species.

Figure 8. - Solids particles adhering to chromium oxide.

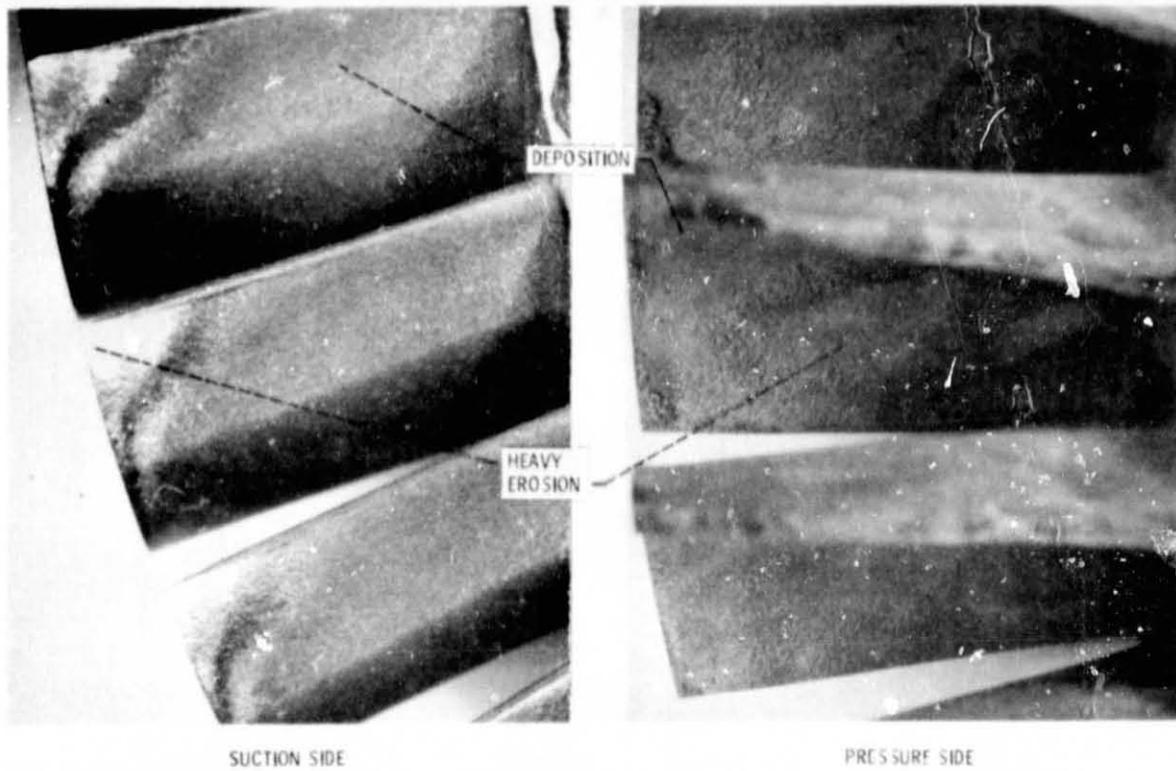
ROTOR 3, Pa COAL/LIME STONE

Average surface materials loss on the Alloy 713 LC rotor (R3) was 0.1 mm (4 mils) and the loss rate was about 0.6 u/hr (0.024 mil/hr). Leading edge to trailing edge losses were comparable. Figure 9 shows the erosion and deposition pattern on an R3 blade. After rebounding from the leading edge, some heavy particles appear to impact on the pressure side of the blade above as they are thrown radially outward, finally impacting a third time on the trailing edge tip. The rippled appearance of erosion on the pressure side (Figure 10) is evidence of impact at the maximum erosion angle ( $\approx 30$  degrees) (5). Average erosion loss rates projected from small-scale turbine tests are likely to be conservative because of the higher probability of multiple impact with smaller blade separations. A larger centrifugal force in small radius rotors also enhances erosion near the tip. Deposition occurred on areas surrounding the heavy particle path primarily on the suction side.

Figure 9. - Erosion of alloy 713 LC exposed at 260 m/sec, 690° C, 164 hours. Solids loading = 600 ppm (0.3 gr/SCF).

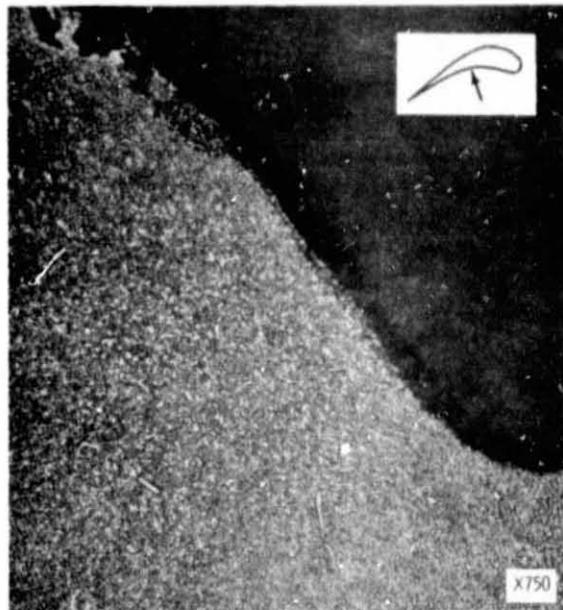
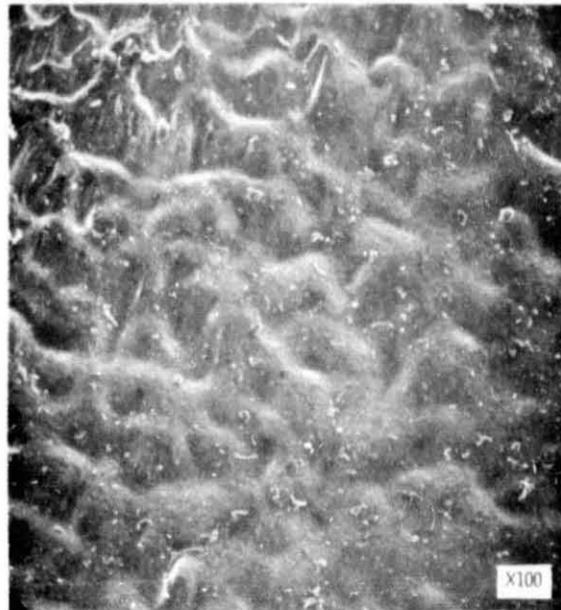
Figure 10. - Rippled appearance of pressure side erosion on alloy 713 LC (R3).

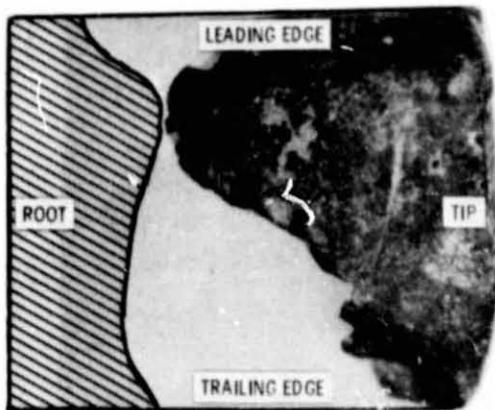
ROTOR 4, OHIO COAL/DOLLOMITE

R4 was terminated by complete loss of the blades after 13 hours. Erosion damage had severely weakened the structure of the blades, and examination of the blade fragments revealed that many were joined to the root at a single point near the leading edge (Figure 11) prior to failure. Average surface loss, estimated from blade fragments, was 0.25 mm (10 mils) and the loss rate was 18 u/hr (0.7 mil/hr). The location of sites of heavy metal loss is consistent with the leading edge notch and teardrop shaped pressure side erosion observed on R3 blades. After 12 hours at nearly the same high solids loading, R5 blades had lost only the trailing edge tip section. Average surface loss (0.1 u, 4 mils) and erosion rates (6.5 u/hr, 0.3 mil/hr) were less than half as great as R4 losses.

Figure 11. - Erosion of IN 792 + Hf blades at 330 m/sec, 780° C, 12-13 hours. Solids loading, ≈ 2700 ppm (1.5 gr/SCF).

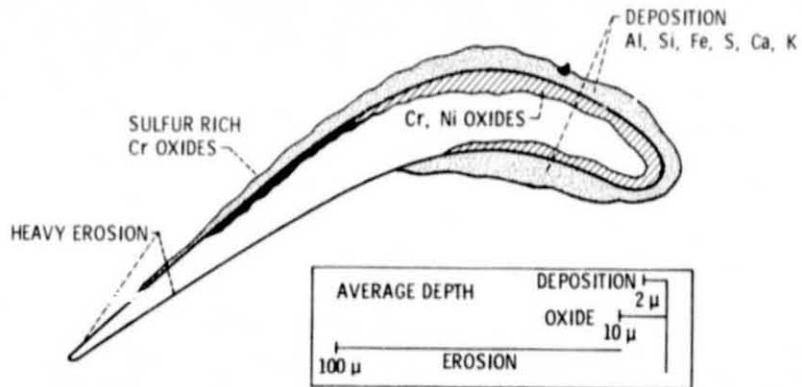
The oxidation pattern of an Alloy 713 LC blade, exposed for 164 hours at 690 C, is shown in Figure 14. Oxide affected layers of about 10  $\mu$  are seen on most of the suction side beneath 1-2  $\mu$  deposition layers. The average erosion depth is an order of magnitude greater than the average oxidation affected depth. Oxides on the suction side are typically rich in chromium (Figure 15) and may be protective unless erosively damaged by brittle cracking (Figure 16).

Figure 14. - Erosion/corrosion schematic of an alloy 713 LC blade; tip section (R3).

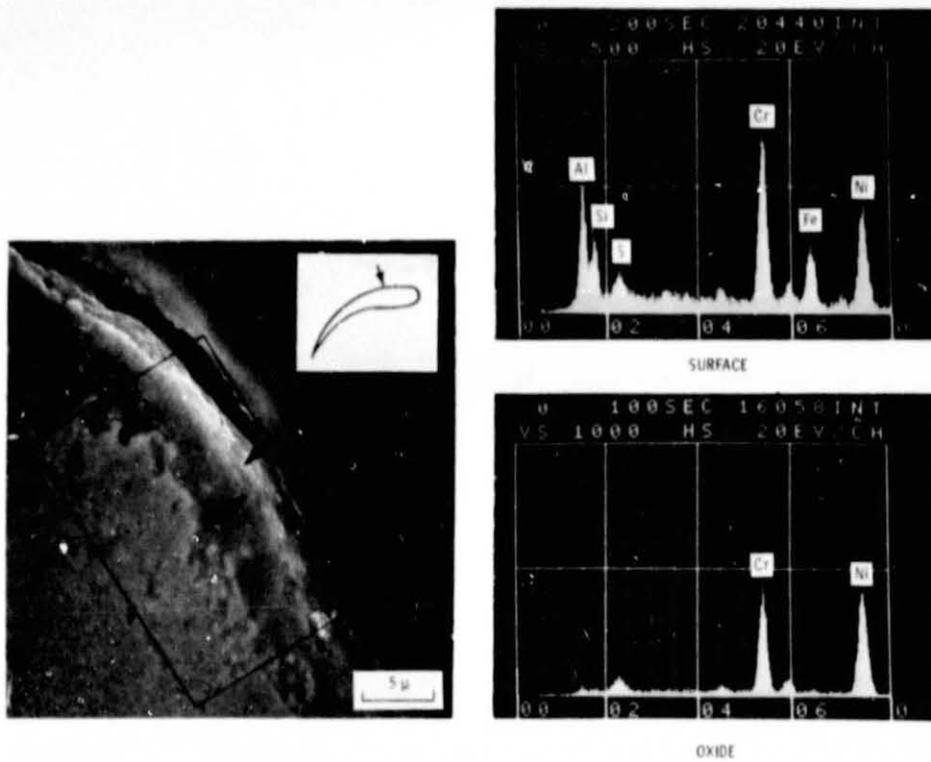
Figure 15. - Chromium-rich oxide on alloy 713 LC blade, exposed at 690<sup>o</sup> C for 164 hours (R3). Erosion rate, 0.6 μ/hr (0.024 mil/hr).

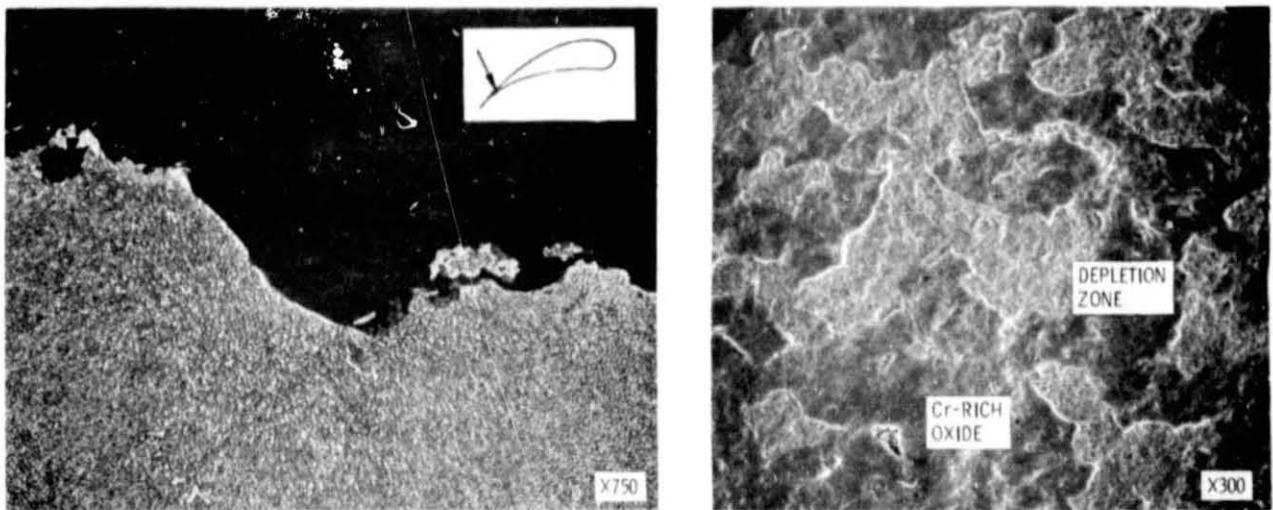
Figure 16. - Erosion of protective oxide layers in transition zones on alloy 713 LC (R3).

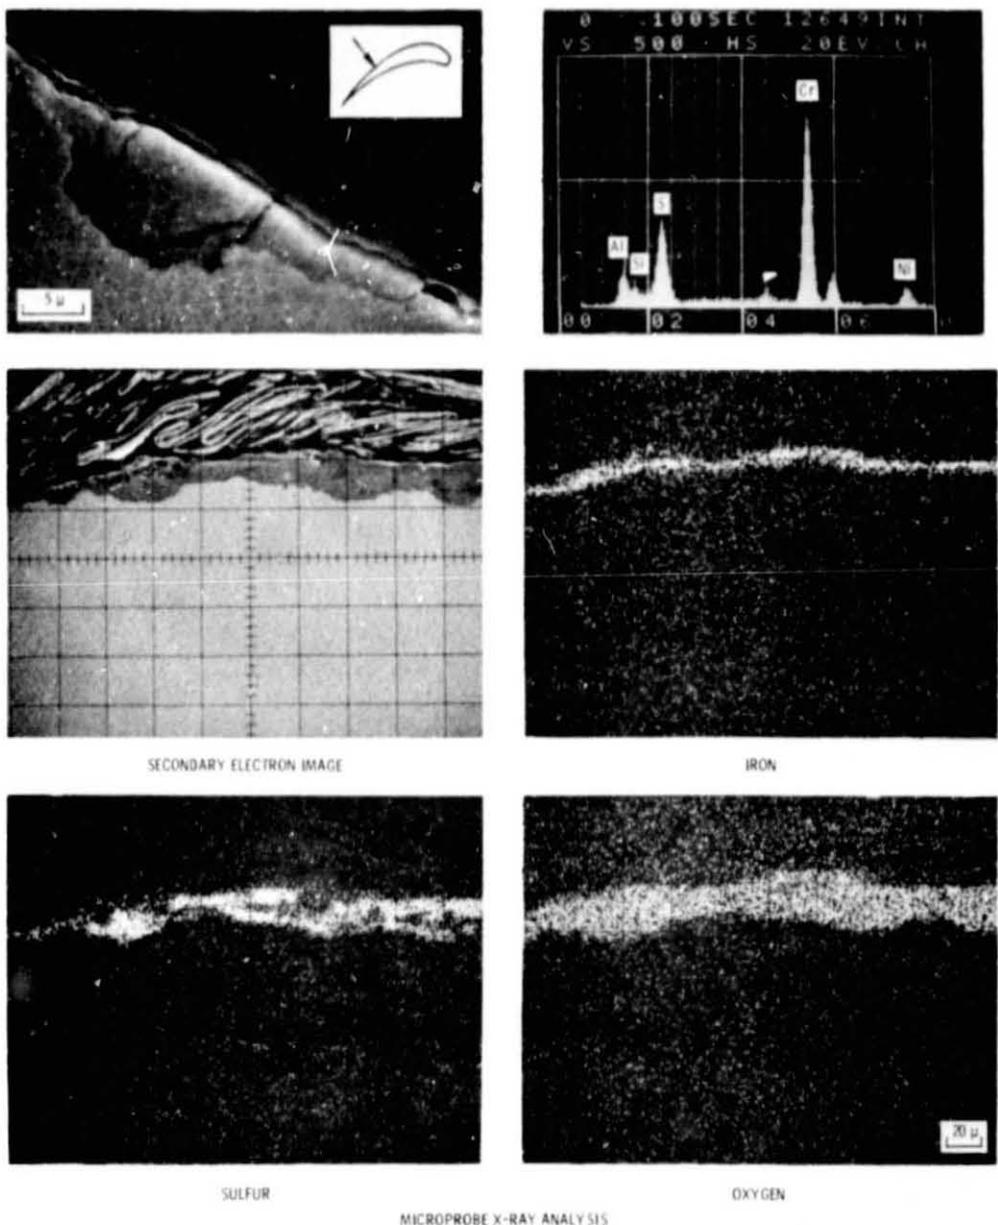
limitation at the scale/gas interface, if such is the case, is uncertain. Deposition materials containing potassium iron trisulfate ( $K_3Fe(SO_4)_3$ ) or other sulfates are a possible source of sulfur (9).  $SO_2$  pressures beneath coherent deposit layers may be sufficiently high to permit some form of sulfur penetration. Microprobe analysis reveals a coherent iron bearing deposition layer on the surface above the sulfur-rich Cr oxide, and visible deposition near the trailing edge has the dark, glassy appearance of fused trisulfates.

Figure 17. - Sulfur-rich chrome oxide on suction side of an alloy 713 LC blade, exposed at 690° C for 164 hours (R3).

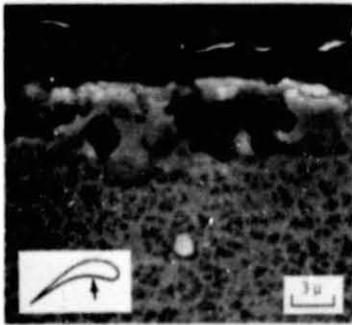
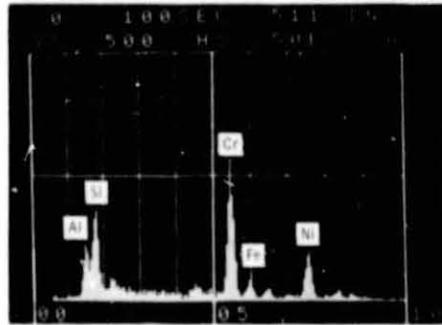
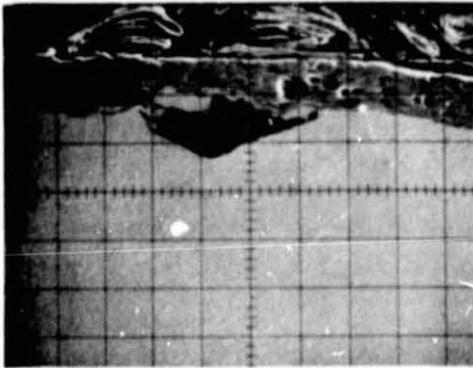
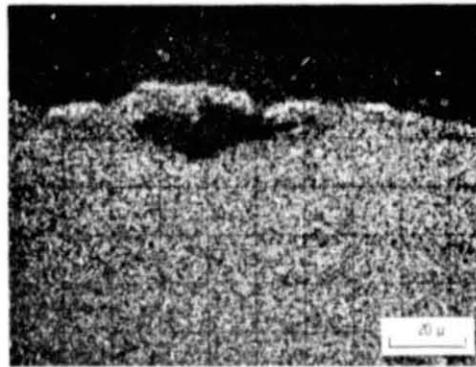
On the pressure side, oxide growth is irregular and deposition is heavy ( $\approx 10\mu$ ). In some areas, Cr oxides are mixed with deposition materials in the absence of visible depletion zones (Figure 18). This buildup may be primarily composed of rebound particles from the leading edge of another blade. The formation of heavy deposits may also be protective against erosion, but heavy deposits do not necessarily enhance oxide or sulfide growth.

Figure 18. - Heavy pressure side deposition on alloy 713 LC blade (R3).

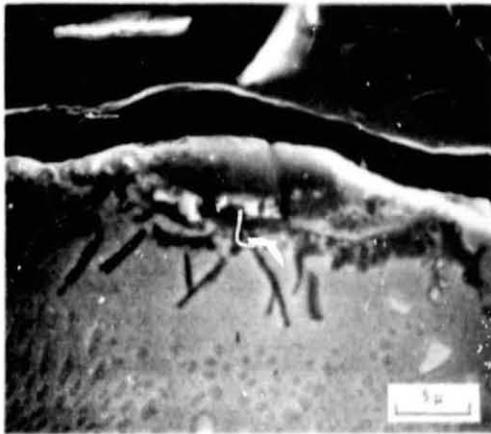
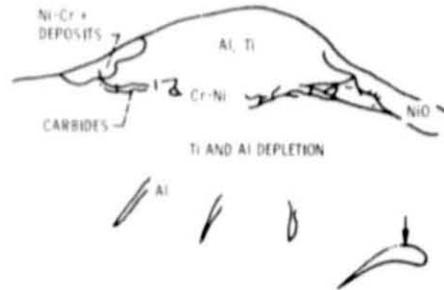
Oxides on heavily eroded R4 (IN792+Hf) blades, exposed for 13 hours at 780 C, were limited to projecting aluminum and titanium oxide nuclei with substrate oxide streamers in broad ( $\approx 10\mu$ ) depletion zones (Figure 19). Remnants of Cr and Ni rich oxides surrounding the nuclei or knobs suggest an oxide evolution picture in which harder subsurface aluminum oxide deposits either remain after surface oxides are eroded away or form in exposed depletion zones. Aluminum rich knobs seen on the pressure side of an R4 blade (Figure 20) may correspond to similar knobs observed on previous Lewis wedge bar tests with IN792. Deposition materials form a wake behind the knobs. Since the erosion rate of these blades was extremely high, the presence of highly localized aluminum oxide deposits does not appear to diminish the erosion rate. The relatively rapid formation of subsurface oxides after erosive removal of protective oxide elements may, in itself, be a materials problem at lower loadings.

Figure 19. - Aluminum and titanium rich oxide on IN 792 + HT blade, exposed at 780° C for 13 hours (R4). Erosion rate, 18 μ/hr (0.7 mil/hrs).

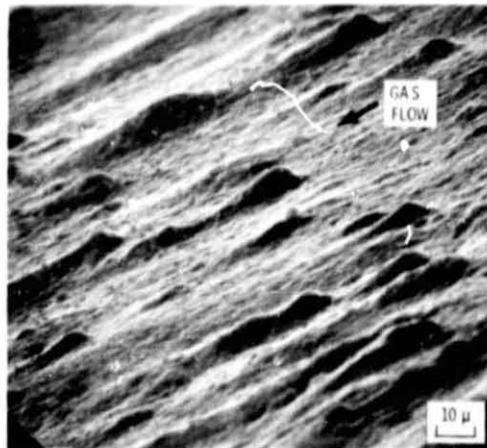
Figure 20. - Aluminum-rich knobs on pressure side of an IN 792 + HT blade (R4).

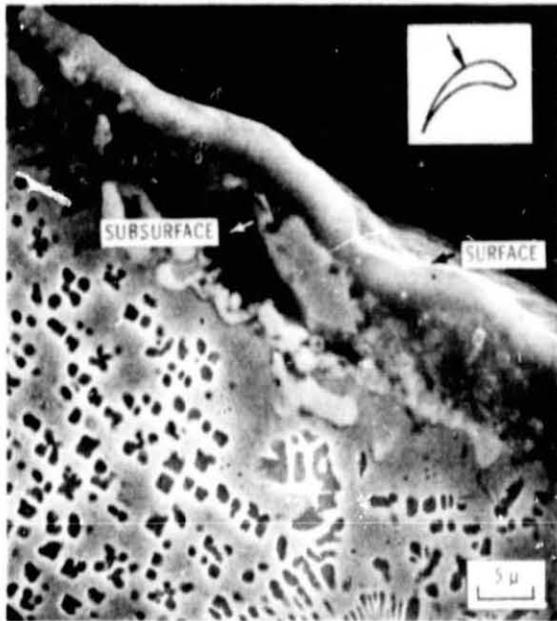
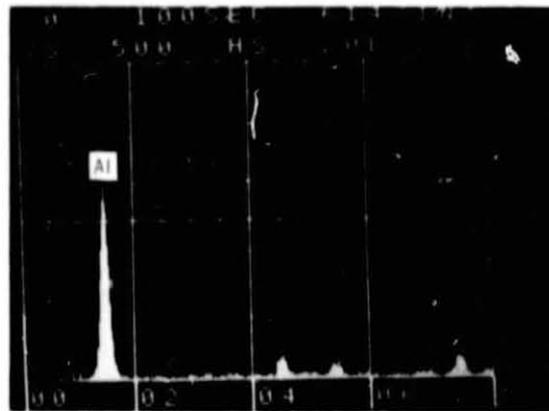
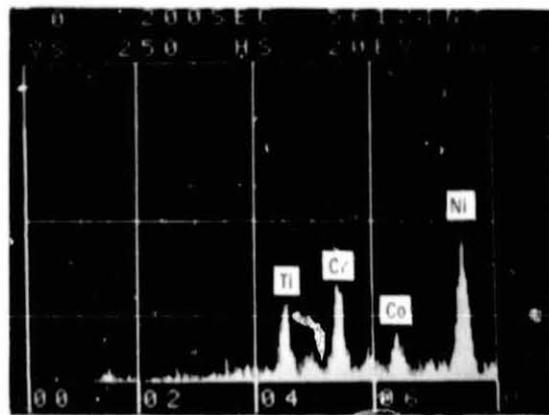
R5 blades (IN792+Hf), also exposed at 780 C for 12 hours, contained a somewhat more protective oxide layer on the suction side. Aluminum rich deposits formed beneath chrome and titanium rich overlayers (Figure 21). The apparent presence of Hf and Ti carbides imbedded in mixed oxides on both R4 (Figure 22) and R5 blades suggest that carburization may also occur in the primarily oxidizing PFB effluent under deposition layers (10). The carbides are often seen rimming an oxide region.

Figure 21. - Aluminum, chromium, and titanium rich oxides on IN-792 + Hf blade, exposed at 790°C for 12 hours (R5). Erosion rate, 8.5 μ/hr (0.32 mil/hr).

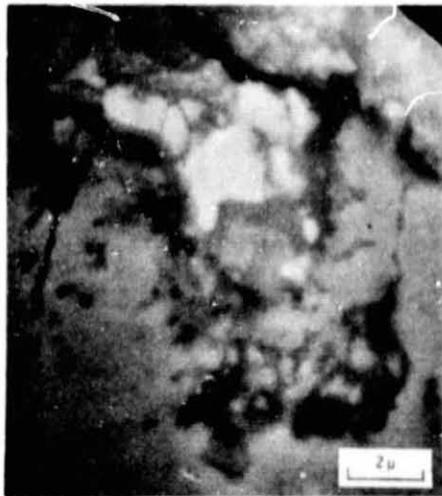
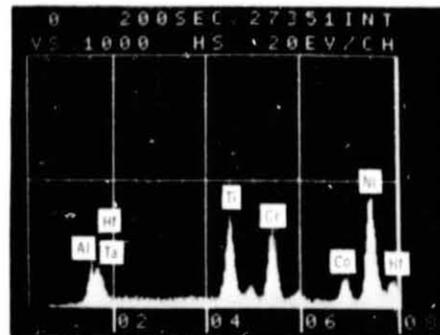
Figure 22. - Carbides imbedded in mixed oxides on IN-792 + Hf blade (R4).
