**737 GRAPHITE COMPOSITE FLIGHT SPOILER
FLIGHT SERVICE EVALUATION**

**BOEING COMMERCIAL AIRPLANE COMPANY
SEATTLE, WA**

AUG 78

1. Report No. NASA-CR-158933	2. Government Accession No. N79-77914	3. Recipient's Catalog No.	
4. Title and Subtitle 737 GRAPHITE COMPOSITE FLIGHT SPOILER FLIGHT SERVICE EVALUATION		5. Report Date August 1978

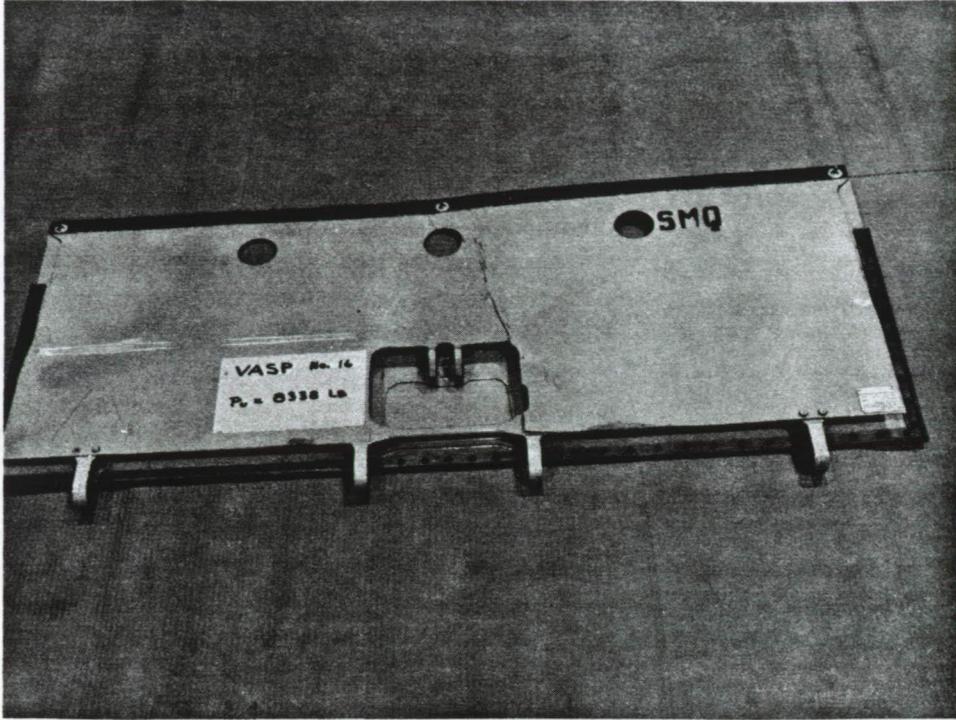
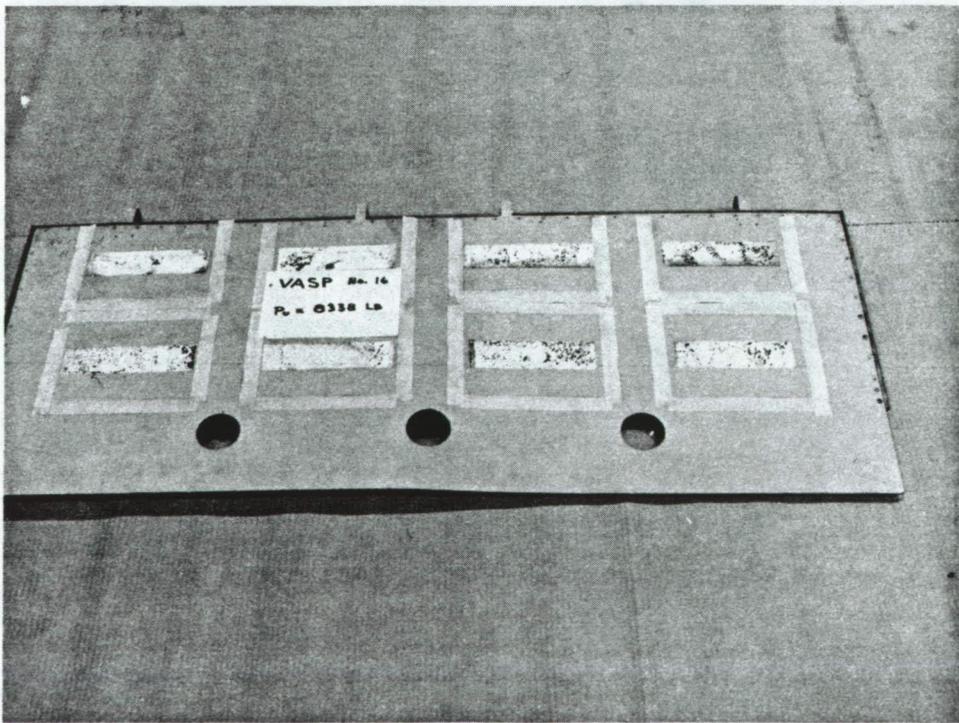
Figure 2.—Spoiler S/N 0016 Static Test

Spoiler serial number	Airline	NDI results	Failure load % DLL	Static test results		Time in service	Flight hours
				% change strength	% change stiffness		
0011 (-1)	LH	Clear	—	Not tested		47 mos 25 days	9033
0016 (-1)	VASP	Clear	220%	-11%	+6%	49 mos 2 days	8495
0066 (-2)	NZ	Clear	—	Not tested		45 mos 20 days	8400
0071 (-2)	PI	Clear	274%	- 5%	0%	48 mos 2 days	10,424
0107 (-3)	Aloha	Clear	212%	-12%	-5%	46 mos 22 days	7283
0111 (-3)	VASP	Not yet processed	—	Not scheduled for test		—	—

Additional core corrosion investigations conducted during this reporting period followed the previous technique of visual examination of the static test specimens subsequent to testing. Two of the specimens (S/N 0016 and 0107), were sectioned similar to spoiler S/N 0054 in ref. 1. Both panels were completely free of any evidence of corrosion in the honeycomb core.

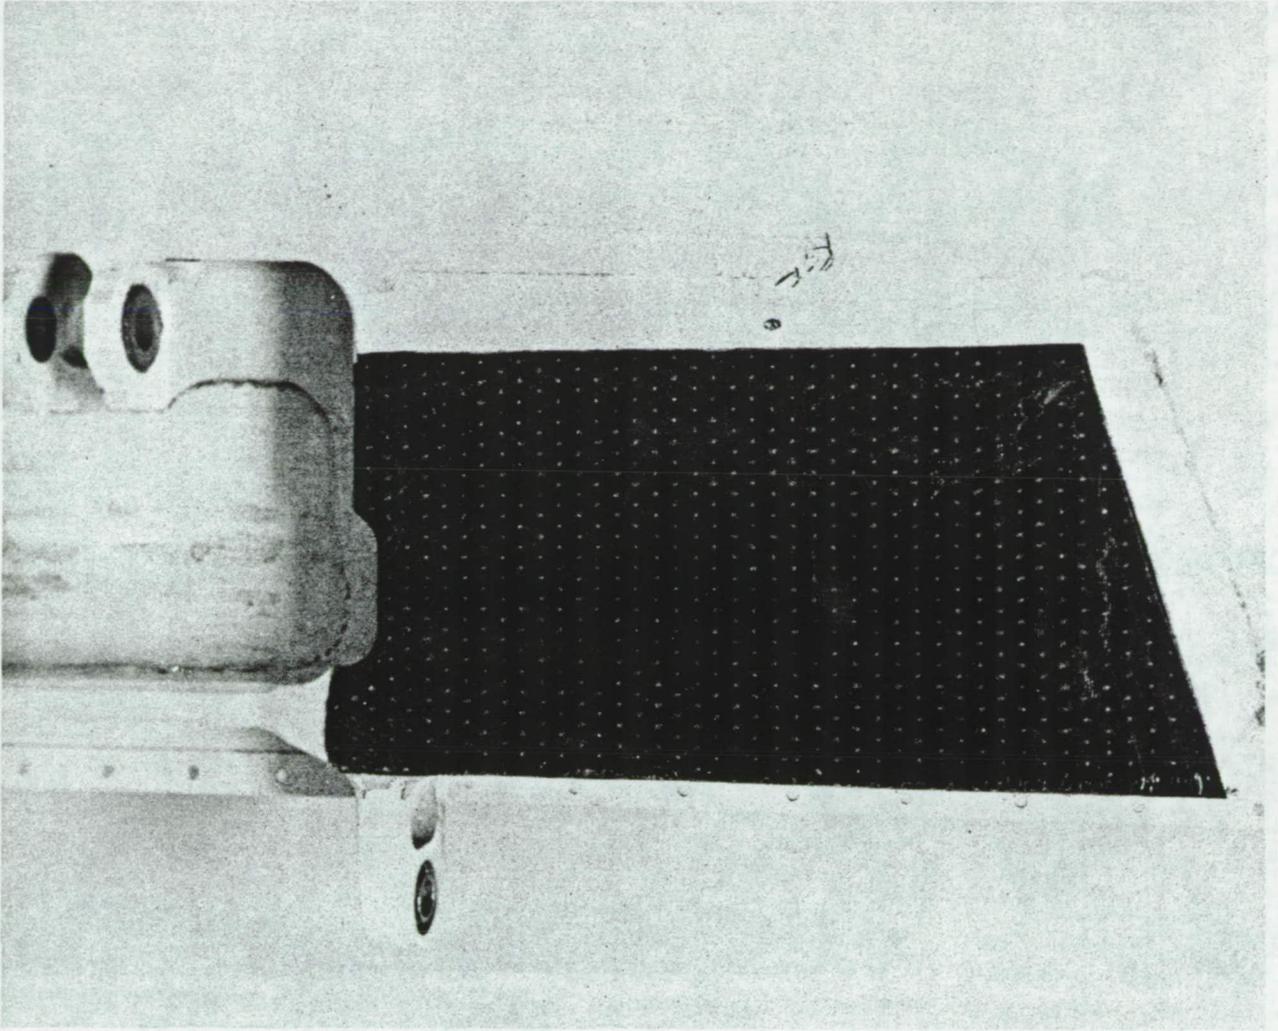
Figure 12.—Completed Repair on Aloha's S/N 0049

In reference 1, spoiler panel S/N 0049 was reported as being in the repair process. The repair, which included dressing out the corrosion and re-processing the spar surface, was successfully accomplished on this panel, as well as on panel S/N 0009 (previously reported in ref. 2). This successful repair process is being followed by similar processing of those panels withdrawn from service during the present reporting period. Figure 12 shows the completed repair on S/N 0049 prior to surface refinishing. Not only was S/N 0009 refurbished with a spar repair in the manner of S/N 0049, but this panel also required repair of the three core samples removed as a portion of the core-sampling technique development in 1976. (Figure 13 shows both the cored trailing edge and a partially completed spar repair). Having successfully repaired the spar, the core-sample repair was then undertaken to return S/N 0009 to flight-worthy status.

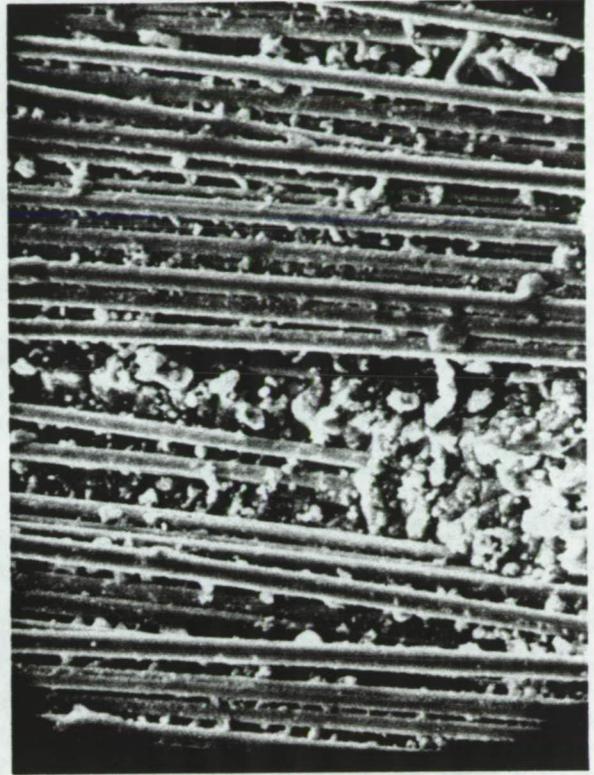
Figure 17.—Graphite/Epoxy Surface Degradation (3-Year Outdoor Exposure)
