BLADE DESIGN AND OPERATING EXPERIENCE  
ON THE MOD-OA 200 KW WIND TURBINE  
AT CLAYTON, NEW MEXICO

Bradford S. Linscott and Richard K. Shaltens  
NASA Lewis Research Center  
Cleveland, Ohio

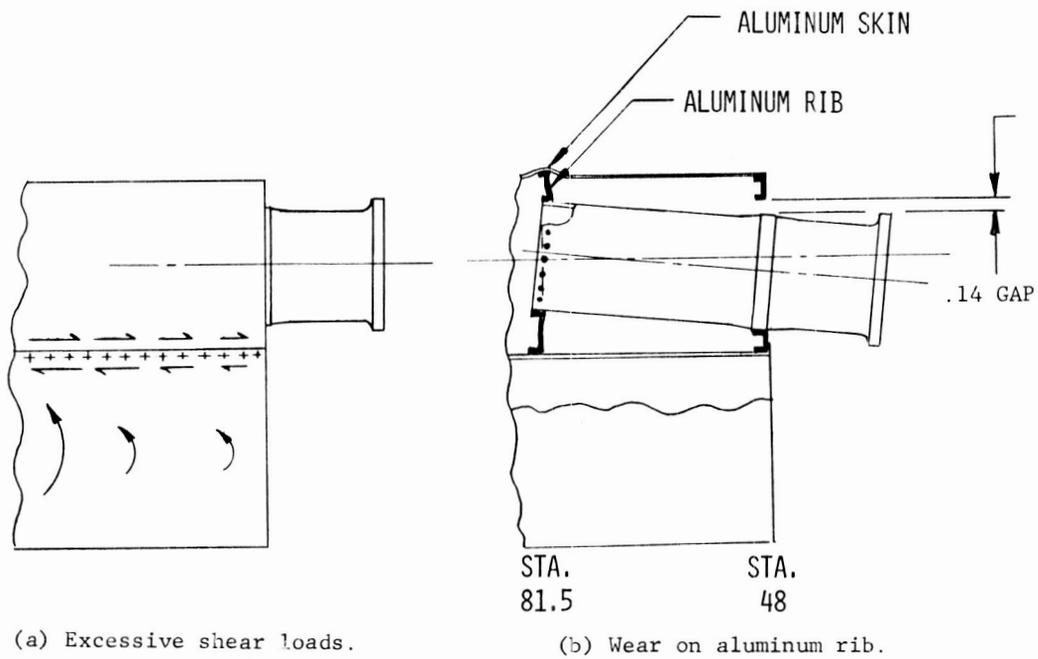
One design deficiency was located along the line of fasteners joining the trailing edge skin to the D-spar, shown in figure 5a. It was determined that the joint, shown in figure 5a, could not carry the applied shear loads. The shear loads occur primarily due to the weight of the blade. As a result broken and loose fasteners were found, and cracks were found in several angle stringers located in the root end end of the D-spar. This design deficiency was corrected by adding doublers, on the exterior of the blade, between station 48 and 100, as shown in figure 6.

The second design deficiency was the bearing interface, located between the aluminum rib, at station 48, and the steel root end fitting, shown in figure 5b. It was observed, during the blade inspection at the Lewis Research Center, that the steel root end fitting had rubbed on the aluminum rib during operation. This rubbing action caused excessive wear of the aluminum rib. The wear resulted in a radial clearance of 0.14 inches between the root end fitting and the rib as shown in figure 5b. Because of the large radial clearance at sta 48, a bending moment, larger than the design allowable, was applied to the rib at station 81.5. The high bending moments applied to the station 81.5 rib caused the rib to crack and also caused the 0.25 thick D-spar skin to crack.

Figure 5. - MOD-0A detail design deficiencies.

As a result, doublers were added to the blade exterior at station 81.5, as shown in figure 6. A special bearing was designed, as shown in figure 7, to reduce the wear of the aluminum rib at station 48.

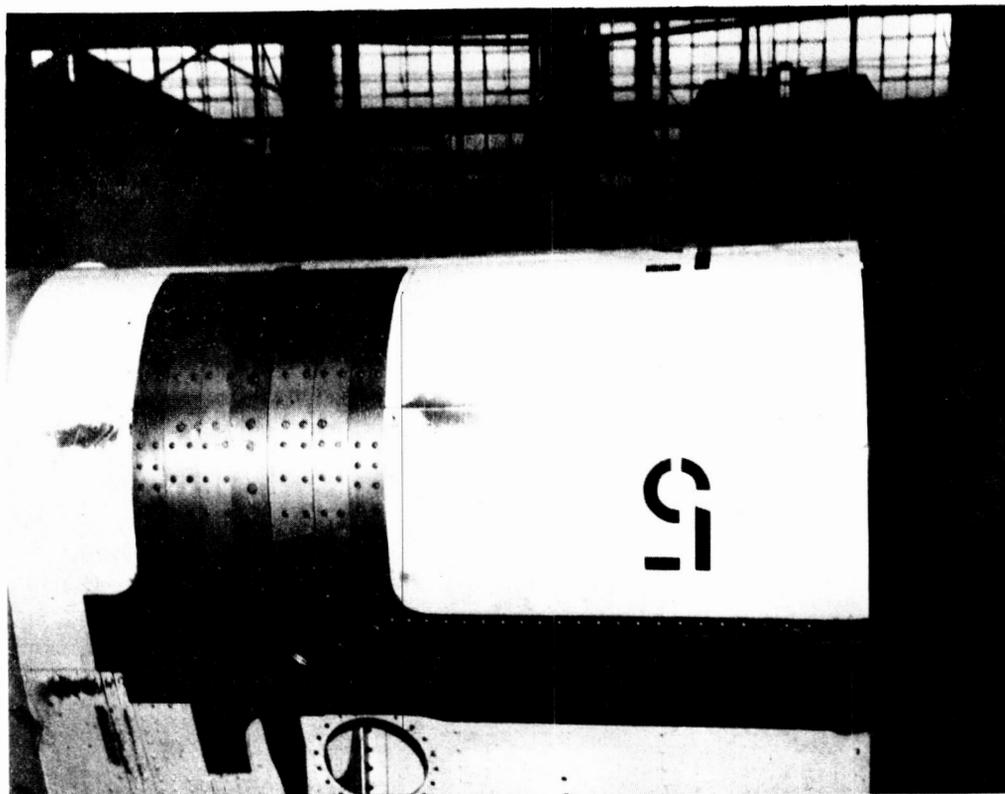
Figure 6. - Final installation of doublers on the low pressure side of blade SN-1005.

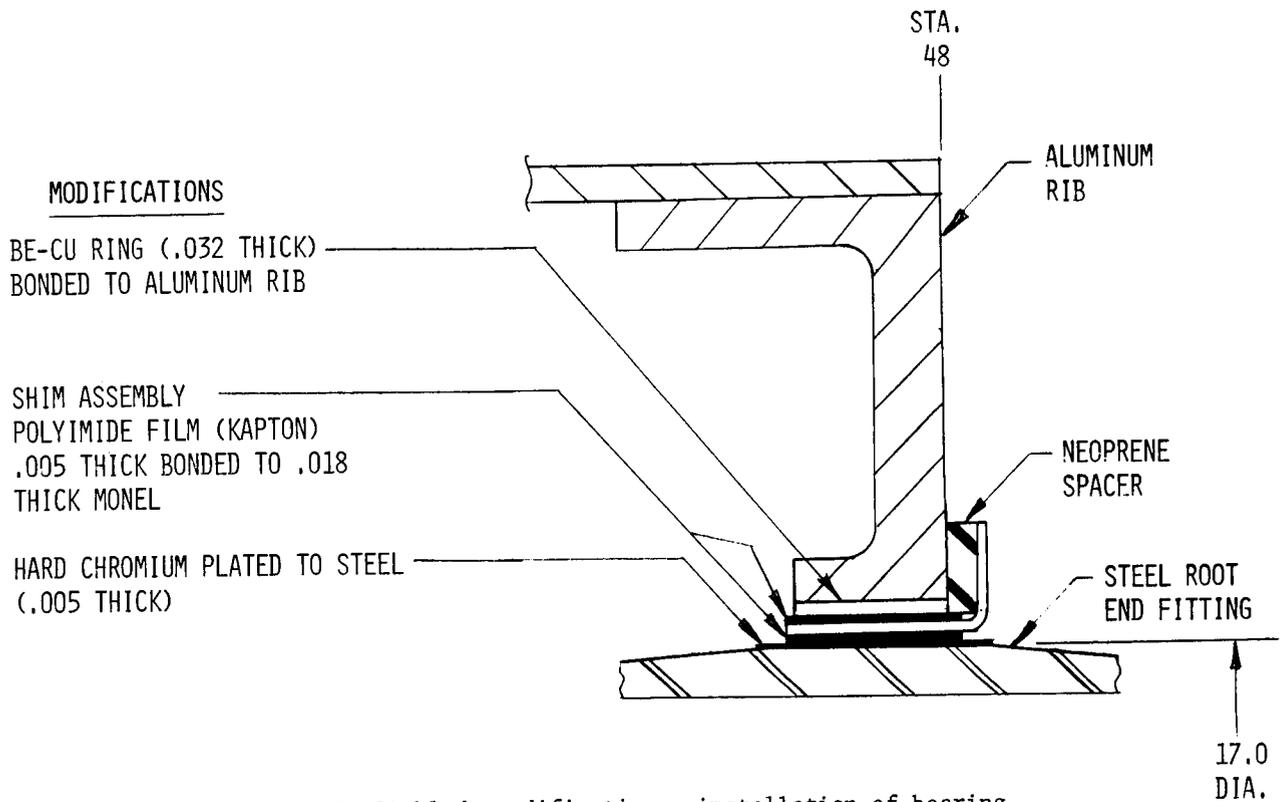
Figure 7. - MOD-0A blade modification - installation of bearing.

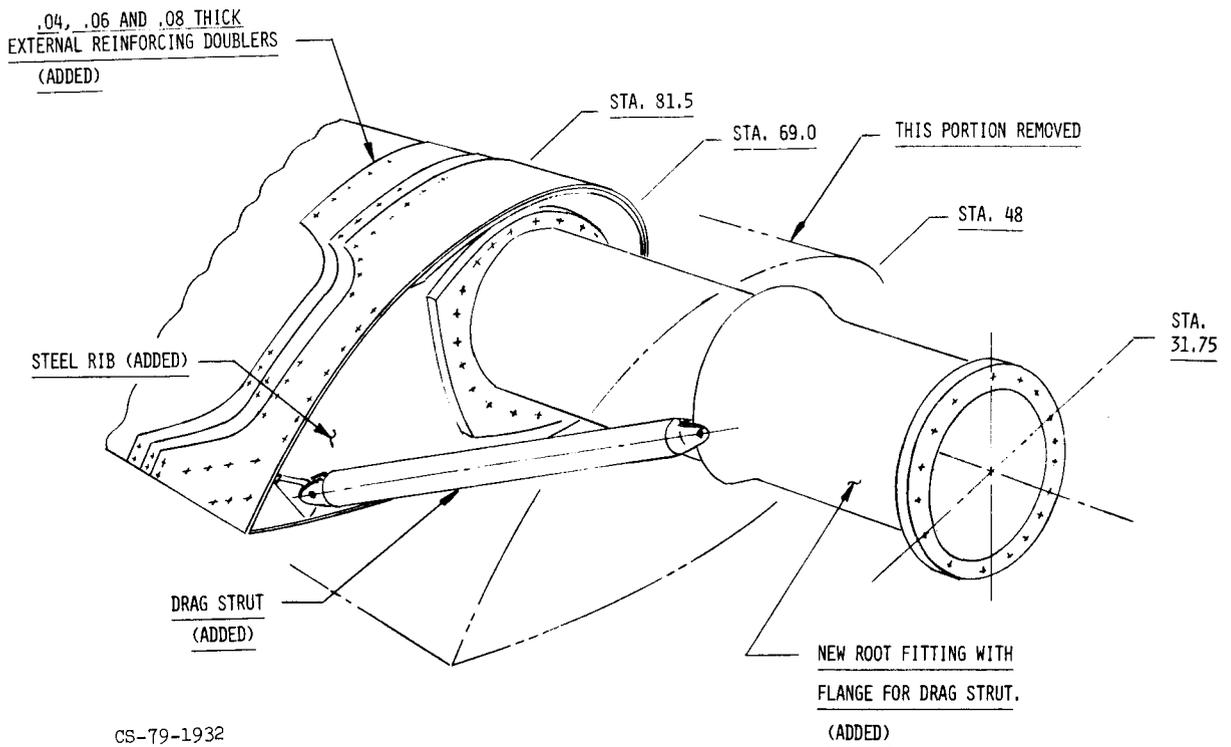
Figure 8. - MOD-0A blade. Alternate modification.

Figure 8 shows an alternate method for securing the steel root end fitting to the blade. This modification is currently being made to the MOD-0 aluminum wind turbine blades. This design eliminates the need for a bearing at station 48. A new steel rib, installed at station 69, carries load from the new root end fitting directly into the D-spar. The new rib at station 69 eliminates the need for the rib at station 81.5. As a result, no structural modification to the heavily damaged rib at station 81.5 was needed. When the blades are complete, they will be installed and operated on a MOD-OA wind turbine. Operational experience with the newly modified blades will allow NASA to assess the structural integrity of the new design.
