FIELD TEST EXPERIENCE

R.W. Weaver
Jet Propulsion Laboratory
California Institute of Technology
Pasadena, California 91109

INTRODUCTION

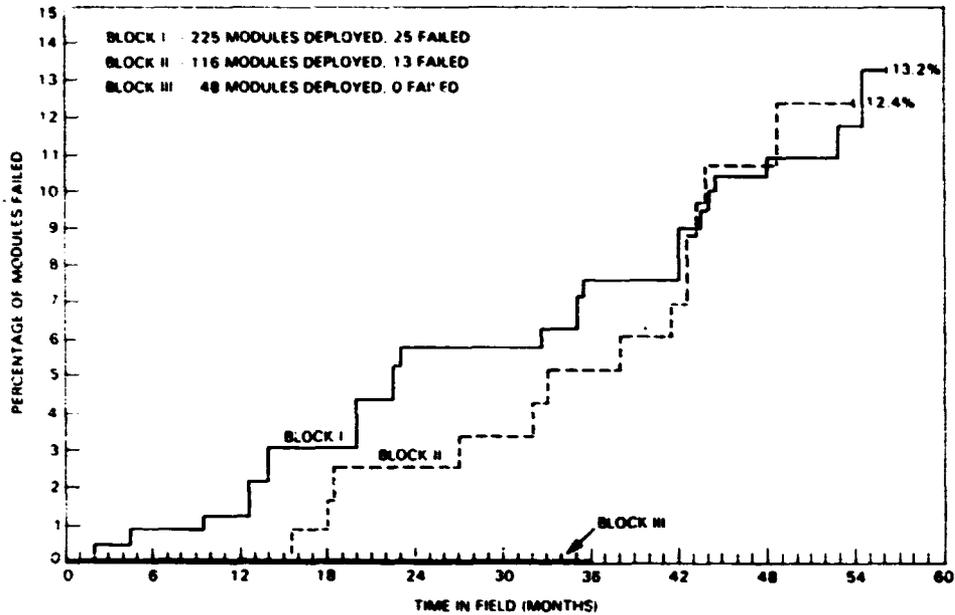
Figure 5. Blocks I, II and III Results

In the nearly five years of field testing Blocks I, II and III modules, almost 10% failed the performance test. Many more experienced physical degradation that did, or would eventually, result in an unserviceable module. The plot in Figure 5 depicts performance failures as a function of time in the field. The curves show that for the Blocks I and II modules failure rate increased over the last 18 to 24 months. This means that more modules (per module deployed) were failing after the first three years than before that time. This leads to the conclusion that there is definitely a time-versus-design correlation for field failures.

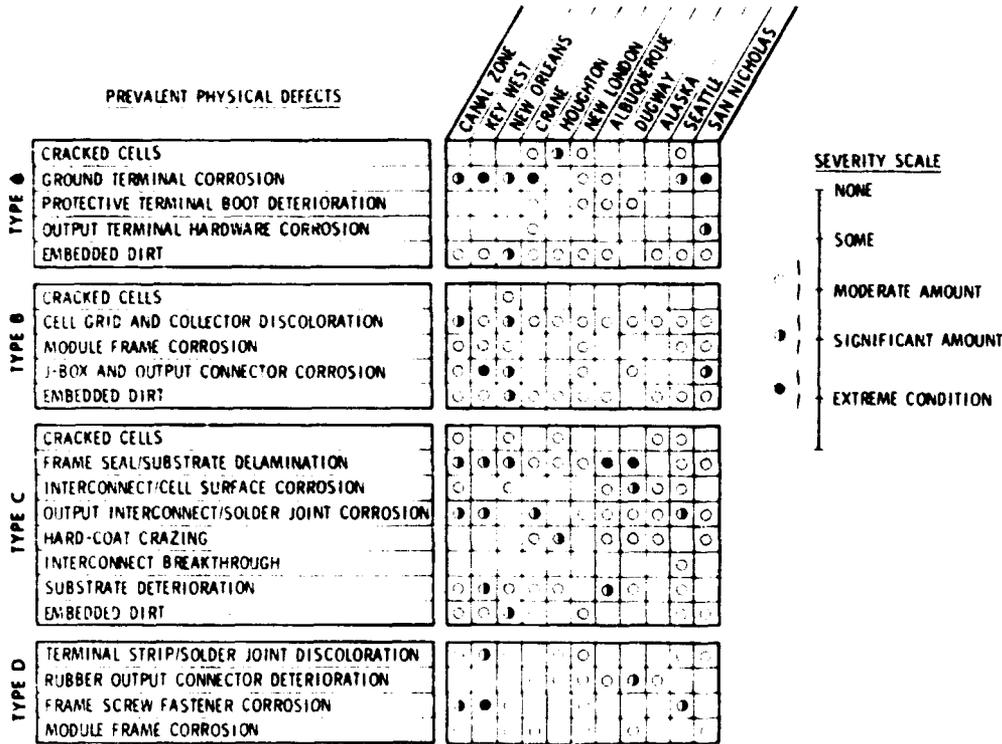
Figure 6. Physical Inspection Summary of Remote-Site Modules

The results of the physical inspections are shown in the chart in Figure 6 for the Blocks I and II modules (type refers to manufacturer). The defects are ranked by severity for each site and type. No site stands out as being more severe than any other in the chart. However, when the performance data are also considered, the sites with hot-humid climates clearly have more severe environments.
