RUBIDIUM AND CESIUM FREQUENCY STANDARDS
STATUS AND PERFORMANCE ON THE GPS PROGRAM
HARRY BETHKE, DALE RINGER AND M. VAN MELLE

Rockwell International
Satellite System Division
Seal Beach, California

This paper describes the on-orbit operational performance of the frequency standards on the GPS 1-10 Navstar satellites. The history of the Rb frequency standards showing the improvements incorporated at various stages of the program and the corresponding results are presented. Also presented is the operational history of the Navstar Cesium Frequency Standards. The frequency standards configuration data presented will cover the chronology of events from the concept validation satellites, Navstars 1-10, starting in 1978 to the present, including the configurations of clocks to be used on the GPS Production Program.

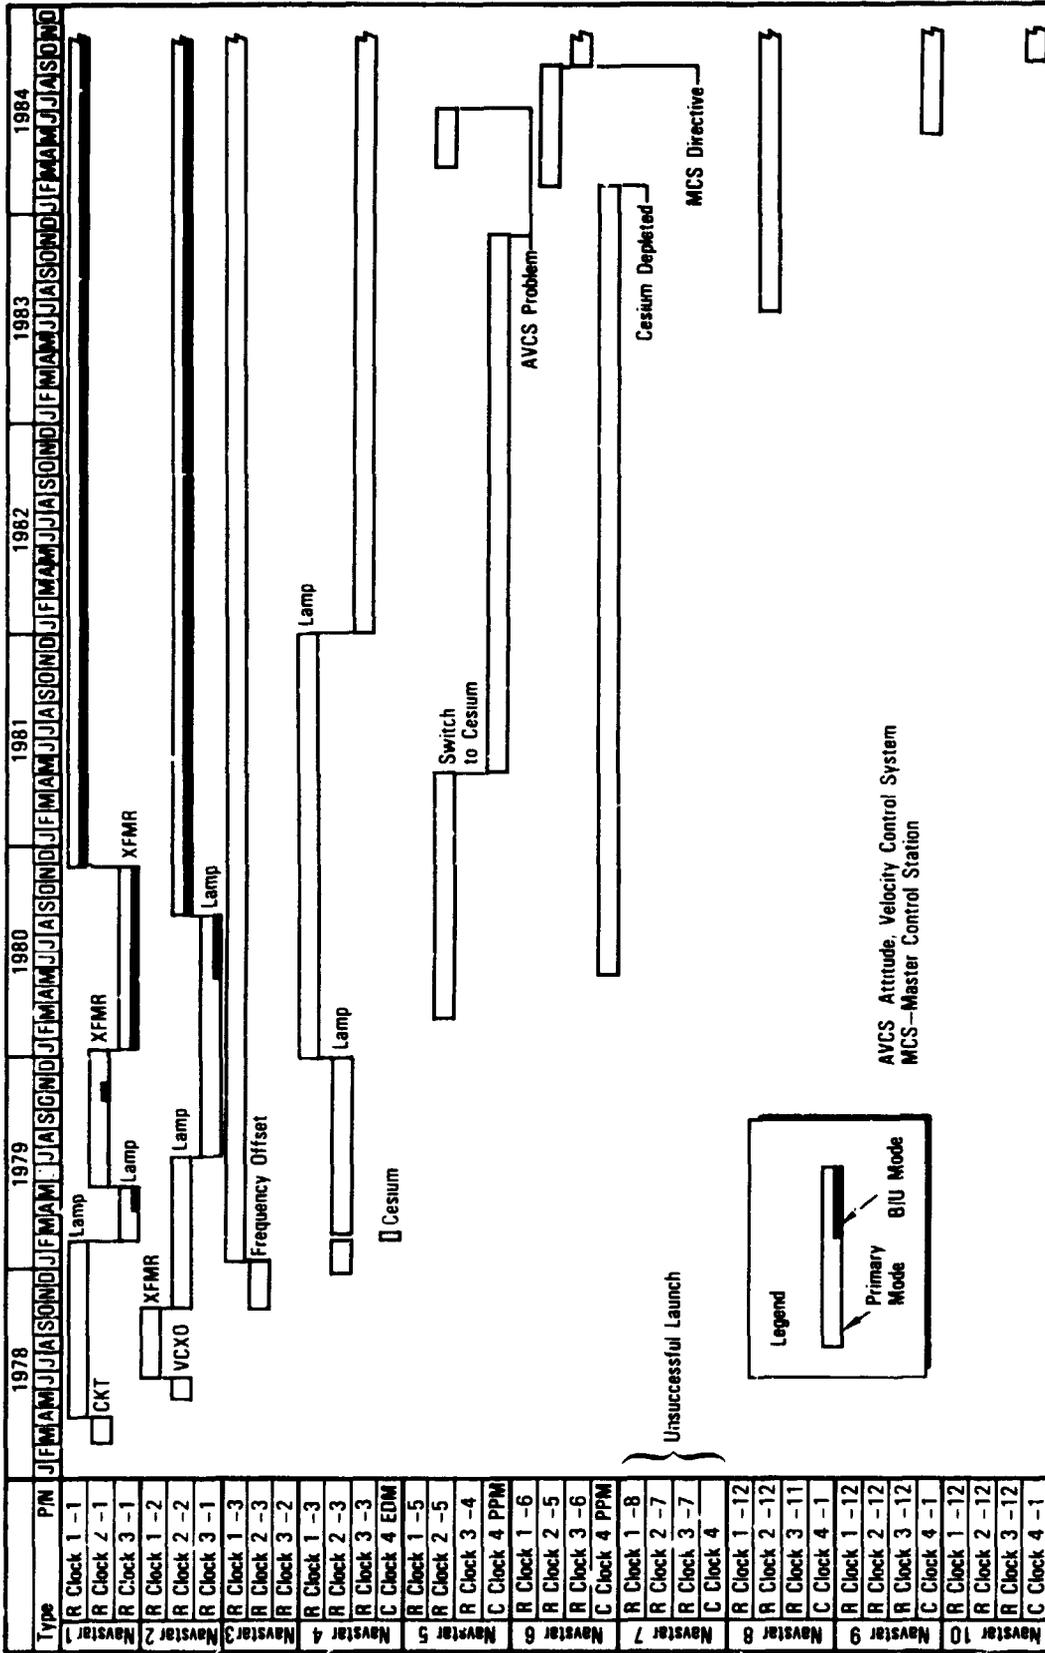
Figure 1. Navstar Clock Operating History

On-orbit operation data of GPS Rb frequency standards started with Navstar 1 in March, 1978, followed by Navstar 2 in May, 1978. The original Dash 001 part number clocks were used in Positions 1, 2, and 3 on Navstar 1 and in Positions 3 on Navstar 2. Dash 002 clocks were used in Positions 1 and 2 and Navstar 2. The only difference in the Dash 002 from the Dash 001 clocks was a time constant change in the servo control loop. As shown in Figure 1, three types of problems were experienced:

1. Power supply transformer failures
2. Lamp failures
3. Low frequency oscillation of the VXCO heater control

The new transformer was installed in all Dash 003 and subsequent clocks. Results of this change are very apparent from the data shown on Table 1. A total of 186 months (15.6 years) of on-orbit operation have accumulated with no transformer failures. Referring to Figure 1, note that Frequency Standard 1 on Navstar 3 has been operating continuously for 70 months (approximately six years); this provides a very high degree of confidence that the transformer problem has been corrected.

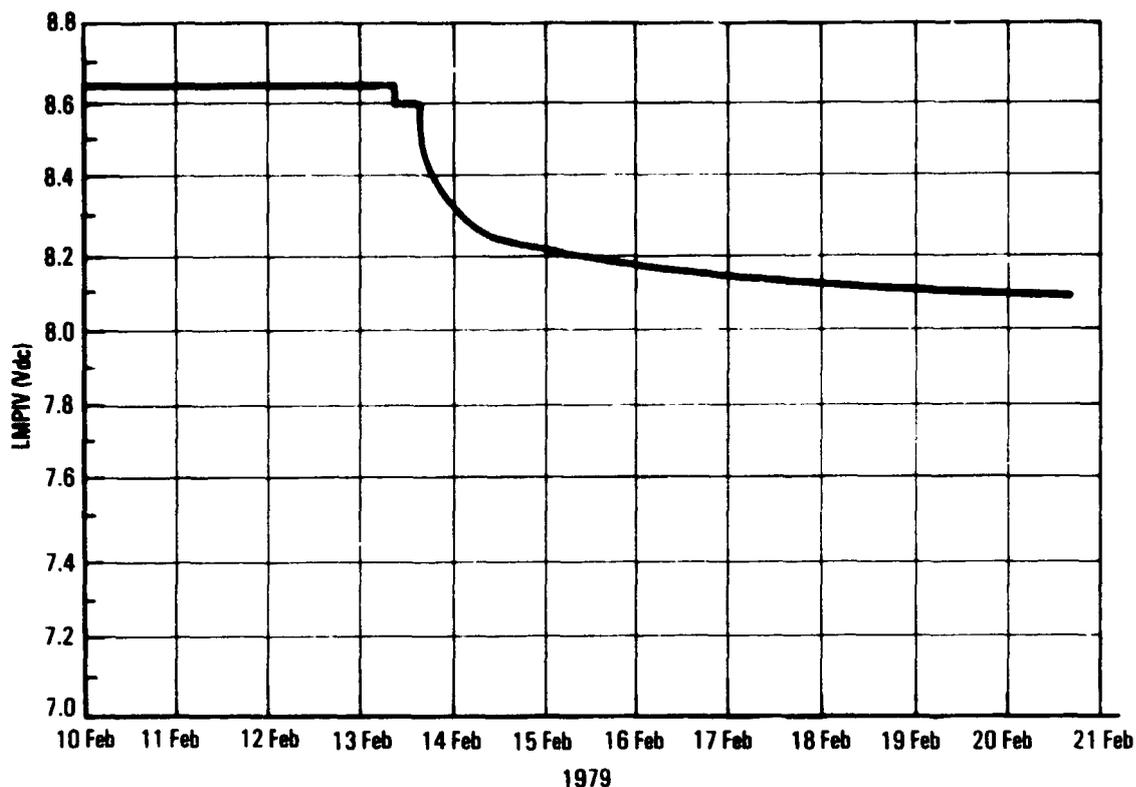
Figure 2. Navstar 1 Frequency Standard No. 1 LMPIV Anomaly

The Rb lamp failures were perhaps the most critical on-orbit problem encountered on the early space vehicles. To investigate the problem, a team was assembled that consisted of representatives from Rockwell, the National Bureau of Standards, Duke University, the USAF, Aerospace Corporation, and Efratom. Once the clock failure was established to be the lamp, a plan was initiated to duplicate the on-orbit failures in the laboratory. Lamps were prepared with an intentionally low Rb fill, installed into the physics packages, and subsequently installed into several frequency standards. Laboratory testing on these standards duplicated the on-orbit lamp failures. All units exhibited the same lamp voltage decay characteristics symbolic of the suspected lamp failures as illustrated in Figure 2.

To determine the amount of Rb in the lamps, a three-fold corrective plan of action was instituted:

1. For Rb lamps already built, the fill would be determined by neutron activation.
2. The fill of newly fabricated lamps would be determined by sampled destructive analysis.

3. A calorimetric measurement utilizing a differential scanning calorimeter is now used.

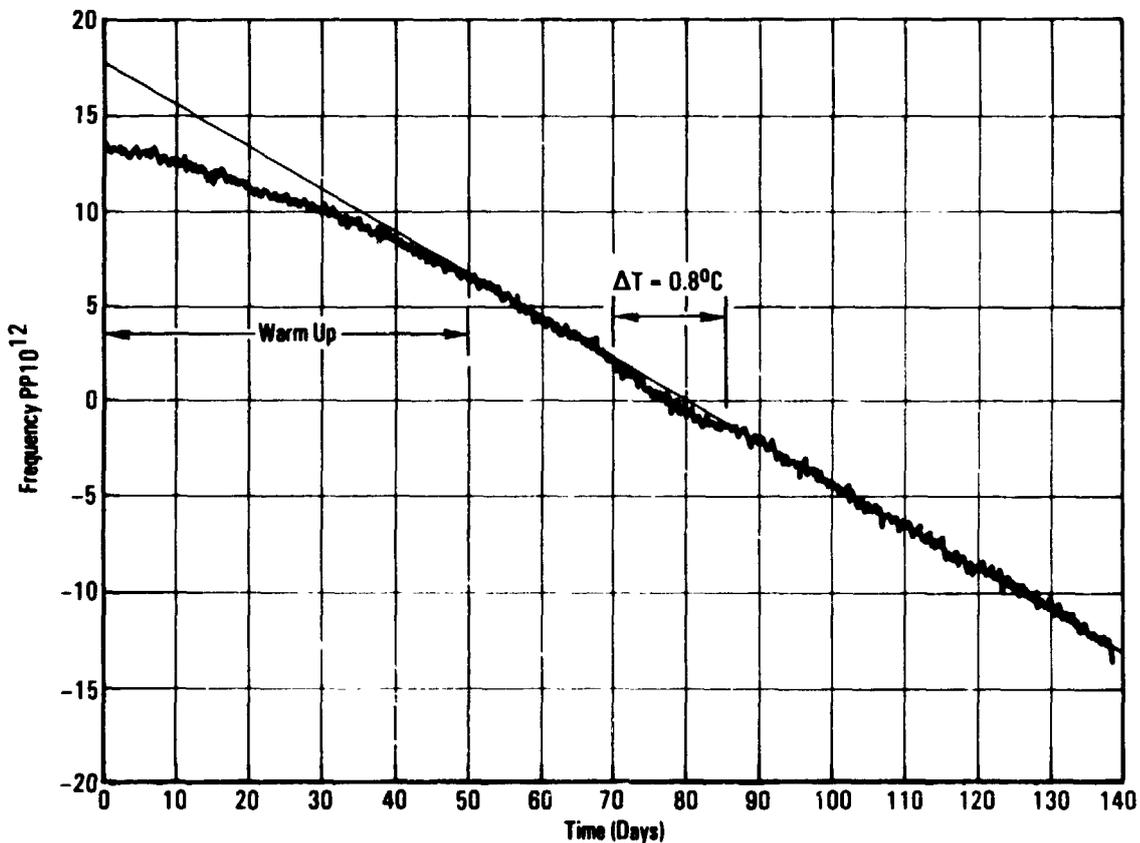
Figure 3. GPS 140-day Rb Stability Test

The beat frequency, $\Delta f/f$, is shown in Figure 3. The frequency was calculated from 1,000-second period average data, which was then averaged over 10 data points to conform to computer storage requirements. Examination of the entire 140-day period shows an initial "warmup" period of about 50 days, during which the drift changes from about minus $6 \times 10^{-14} \Delta f/f/\text{day}$ to minus $2 \times 10^{-13} \Delta f/f/\text{day}$. The frequency drift is relatively constant from Day 50 to Day 140, except for a dip from Day 70 to Day 86. This dip correlates to a drop in the clock baseplate temperature of about 0.8°C . This points out the critical role that temperature stability plays with frequency and time prediction error.

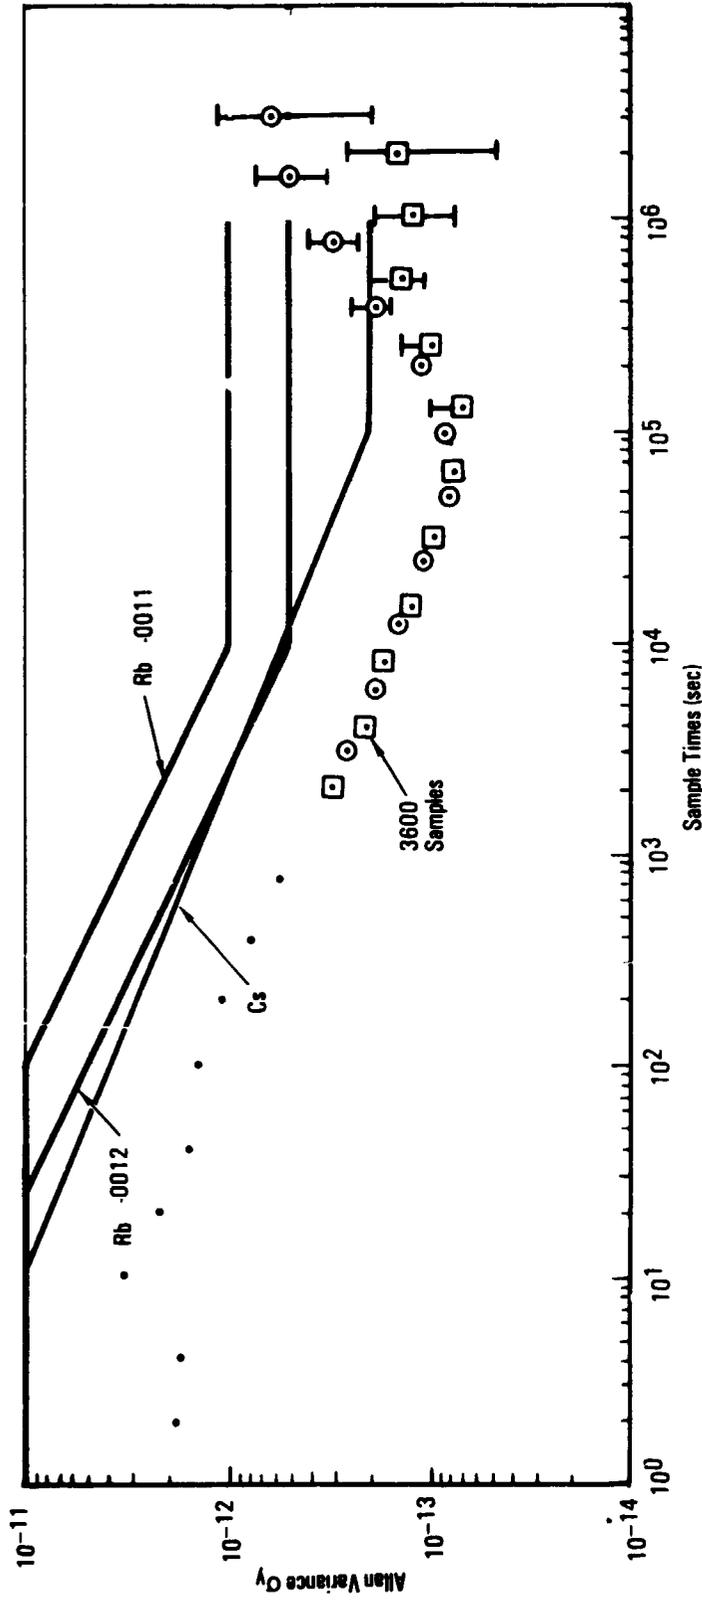
Figure 4. IR&D Time Error 140-day Stability Test Rb Frequency Standard No. LQX0001

The Allan variance, σ_y , can be calculated both with and without the warmup period data. It can be seen in Figure 4 that the main effect of the behavior is on the long-term values or the "random walk." The total data σ_y represents the usual RFS Allan variance signature; whereas, the day 50-150 σ_y values are better in terms of random walk. If μ is the slope of the random walk portion of the Allan variance plot where $\sigma_y \sim t\mu$ for large t , then $\mu = 0.7$ for Day 0 to Day 140 data, and $\mu \approx 0.1$ for Day 50 to Day 140 data.

Excluding the data which was affected by the warmup or temperature change, the time prediction error is found to be very small. This points out the importance to the time error of small temperature changes to the RFS. Since the on-orbit Rb standards now have a baseplate temperature controller that controls the clock temperature to within $\pm 0.1^\circ\text{C}$, excellent time error values on orbit are expected as evidenced in Navstar 8.

It was seen from the baseplate temperature that a 0.8°C temperature plateau resulted in a small frequency shift. For a 15-day period, this gave a 600 to 700-nanosecond offset. This period influenced longer data length prediction intervals before, during, and after the occurrence of the plateau. All subsequent RFS's now are being controlled to $\pm 0.1^\circ\text{C}$ by a temperature controller.
