LMSC-HREC TM D784769

SRB ATTACH RING PHENOLIC
TPS FISHTAIL SEAL EVALUATION
TESTS

February 1982

Contract NAS8-32982

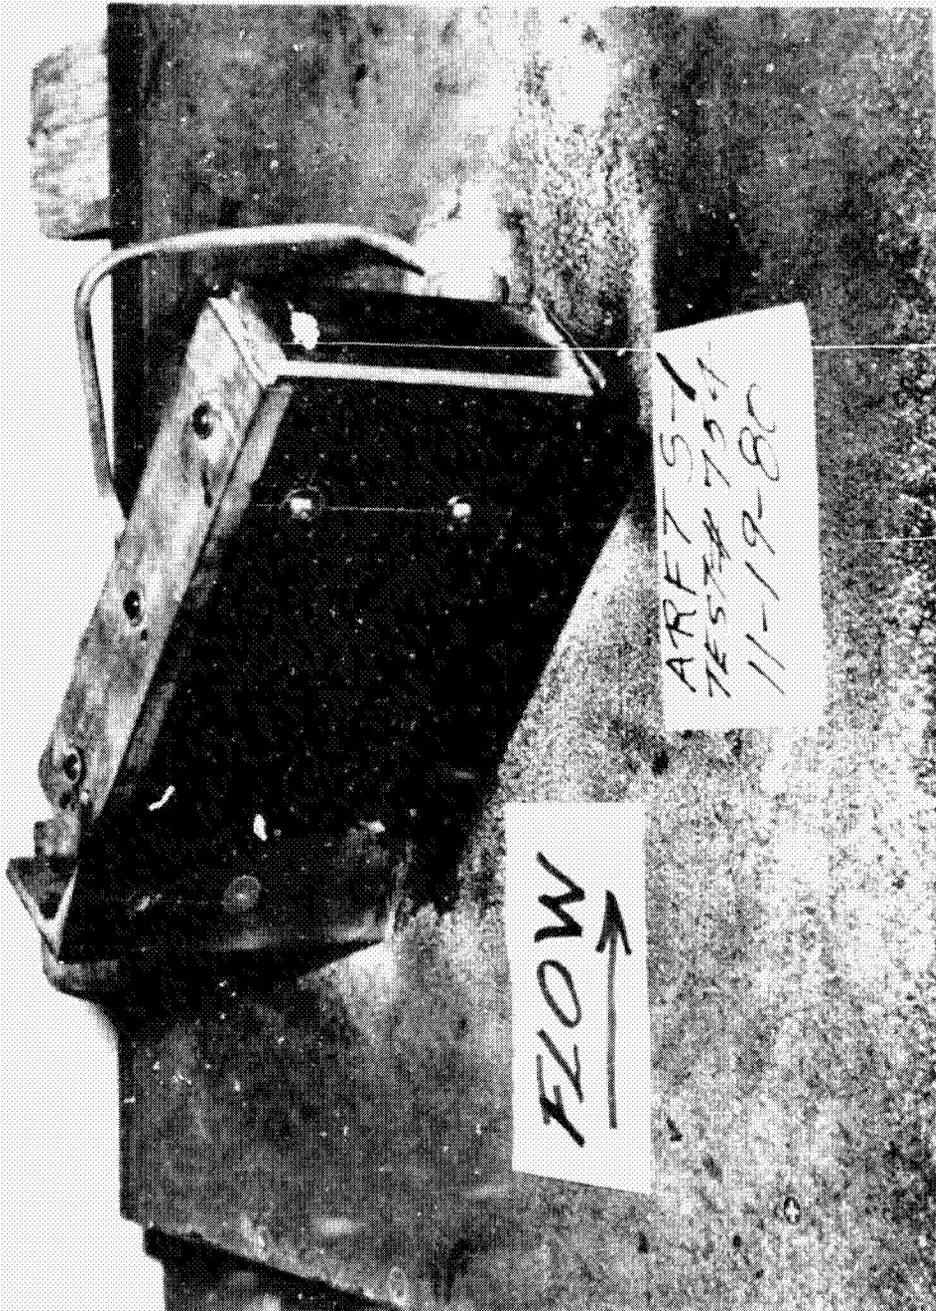
Fig. 1 - Attach Ring Phenolic TPS Fishtail Seal Test on Fixture Mounted at 41 deg
to Flow (Material of Seal is E60C Viton Fluorinated)

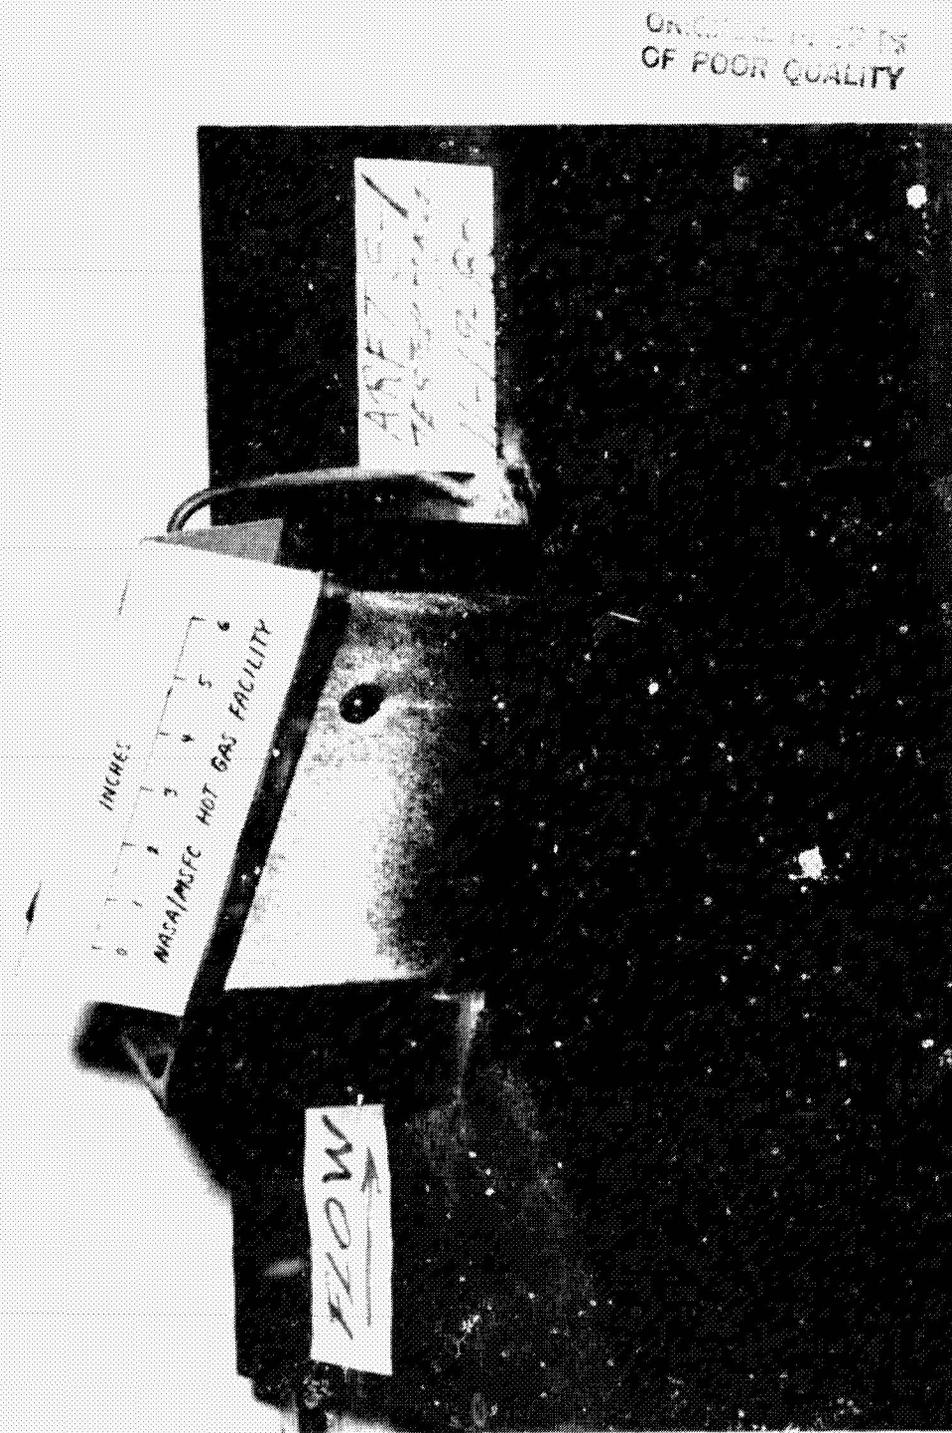
Fig. 2 - E60C Viton Rubber Seal Performed Well But the Material is Seen to Have Melted and the Residue Spread Onto the Bottom Panel

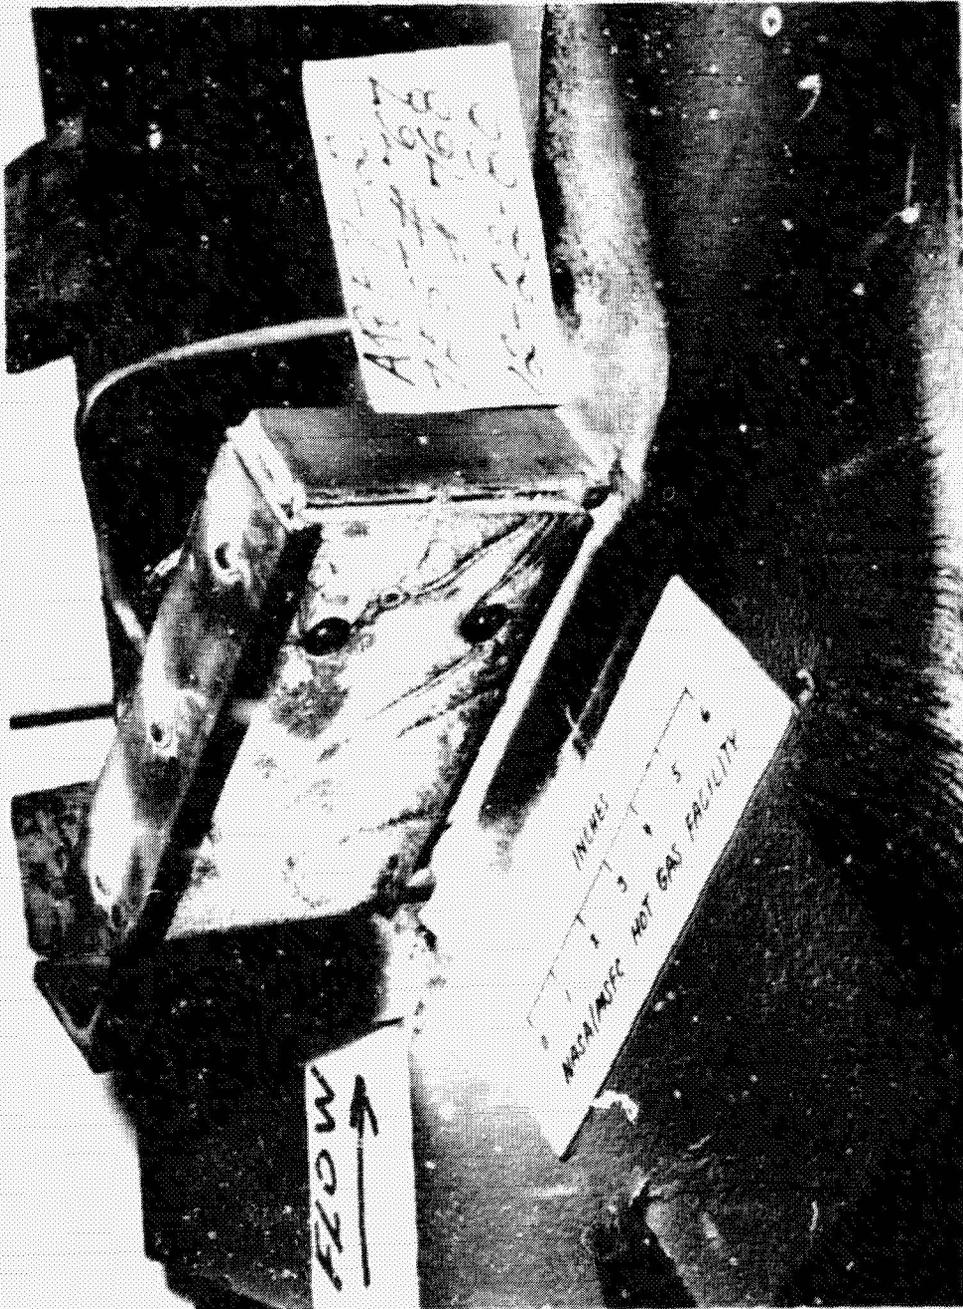
Fig. 4 - Seal Is Lost Due to High Shear Environment in This Test Configuration

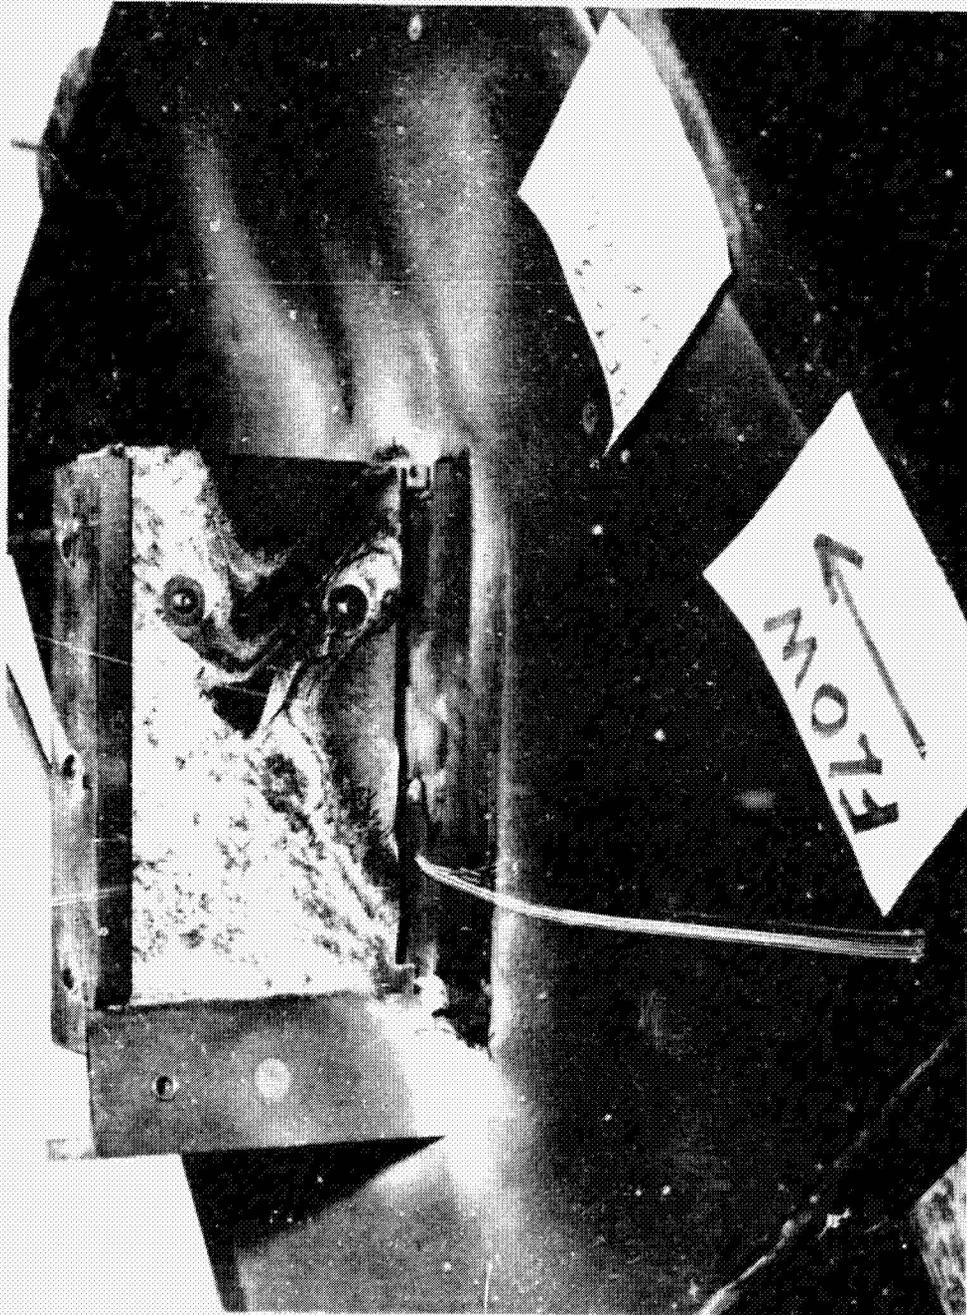
Fig. 6 - Results of This Test Are Similar to Those of Test in Fig. 4

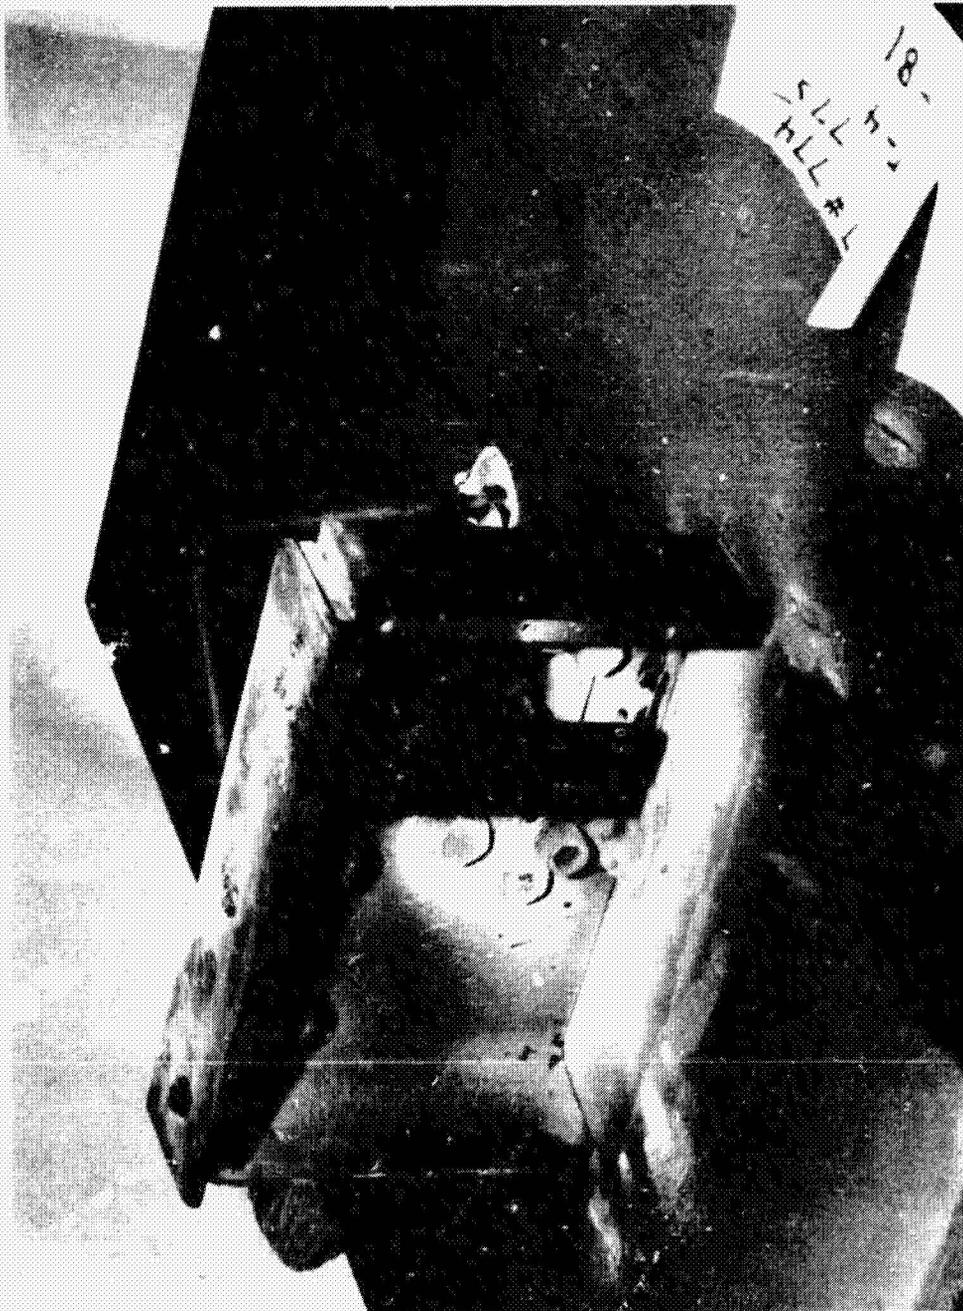
Fig. 8 - This Orientation of the Test Fixture Stagnated the Flow, Produced Severe Heating Along the Top Edge and Failed the Phenolic TPS

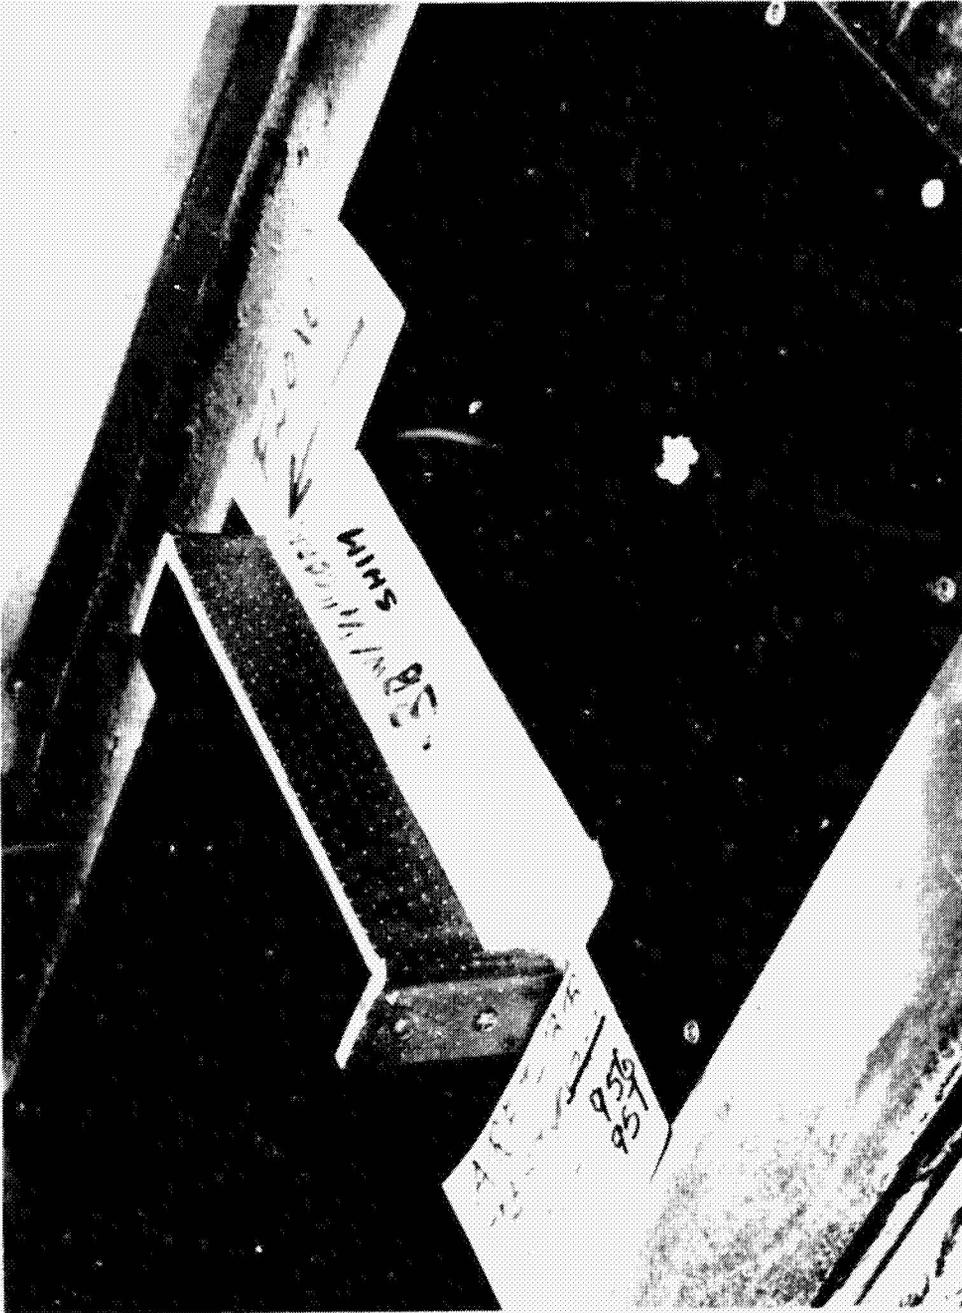
The series of tests to evaluate the performance of the seals was started with the small fishtail seal bonded to the phenolic in the standard usual way, i.e., at the back and bottom of the seal groove. The gap left under the phenolic was 0.60 in. and a 0.25 in. thick shim of cork was placed under the seal to provide the designed compression (see Fig. 12). This configuration proved adequate as seen by the performance of the seal which has eroded fairly uniformly in Fig. 13. Figs. 14 and 15 are for the repeat test of this configuration and here the seal is seen to be affected a little more. A cavity pressure pickup was installed beginning this test and the pressure held in the first 55 sec test indicating that the seal performed well at least for half of the required heat load.

Fig. 12 - Small Fishtail Seal Bonded to Phenolic TPS With 0.60 in. Gap Under it. A 0.25 in. Thick Cork Shim is Seen Placed Under the Seal to Provide Necessary Compression for Sealing

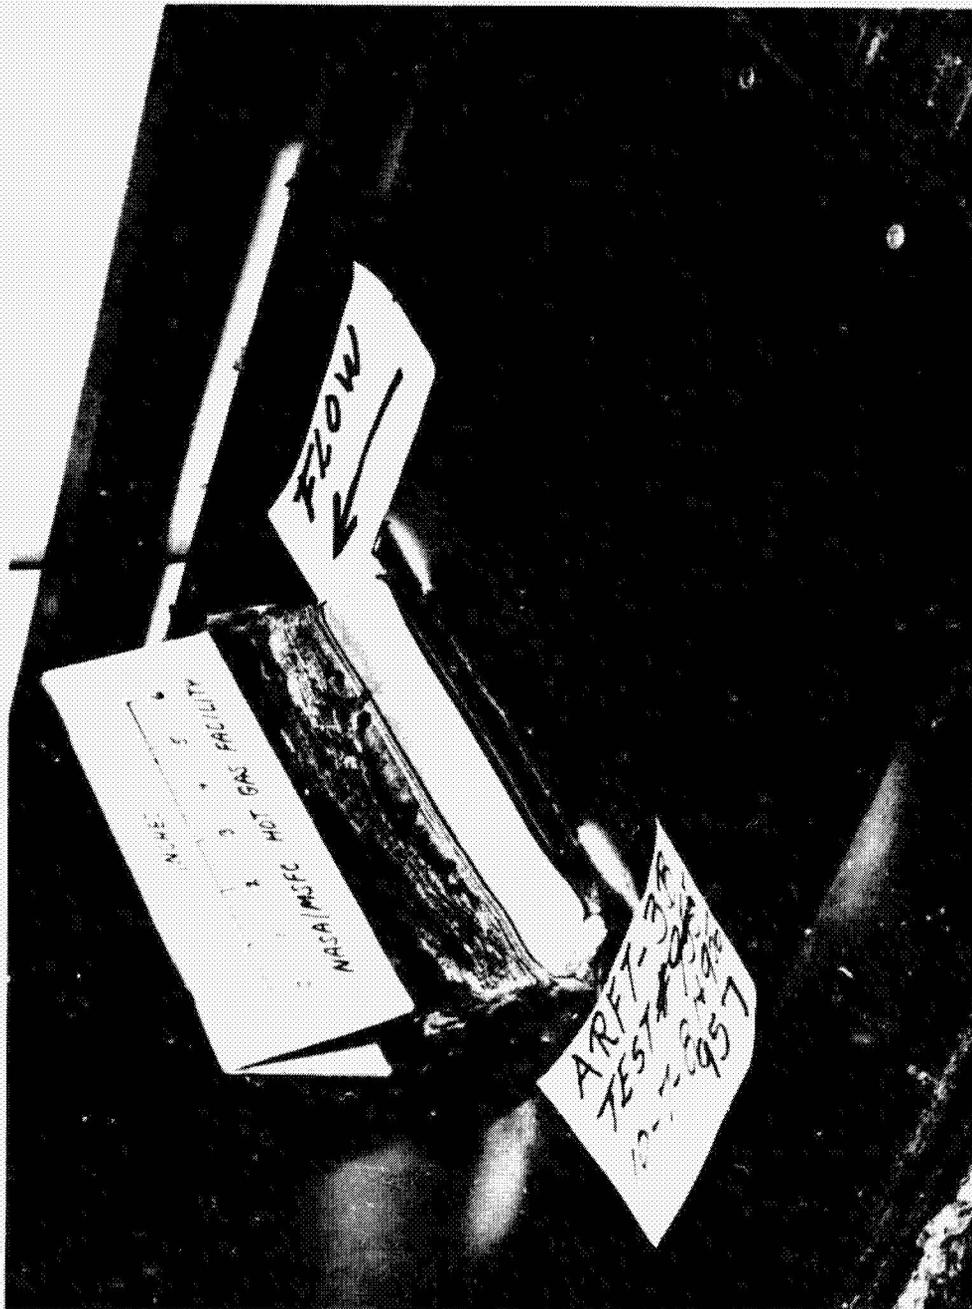
Fig. 13 - Phenolic TPS Burned Through But Seal Looks Good

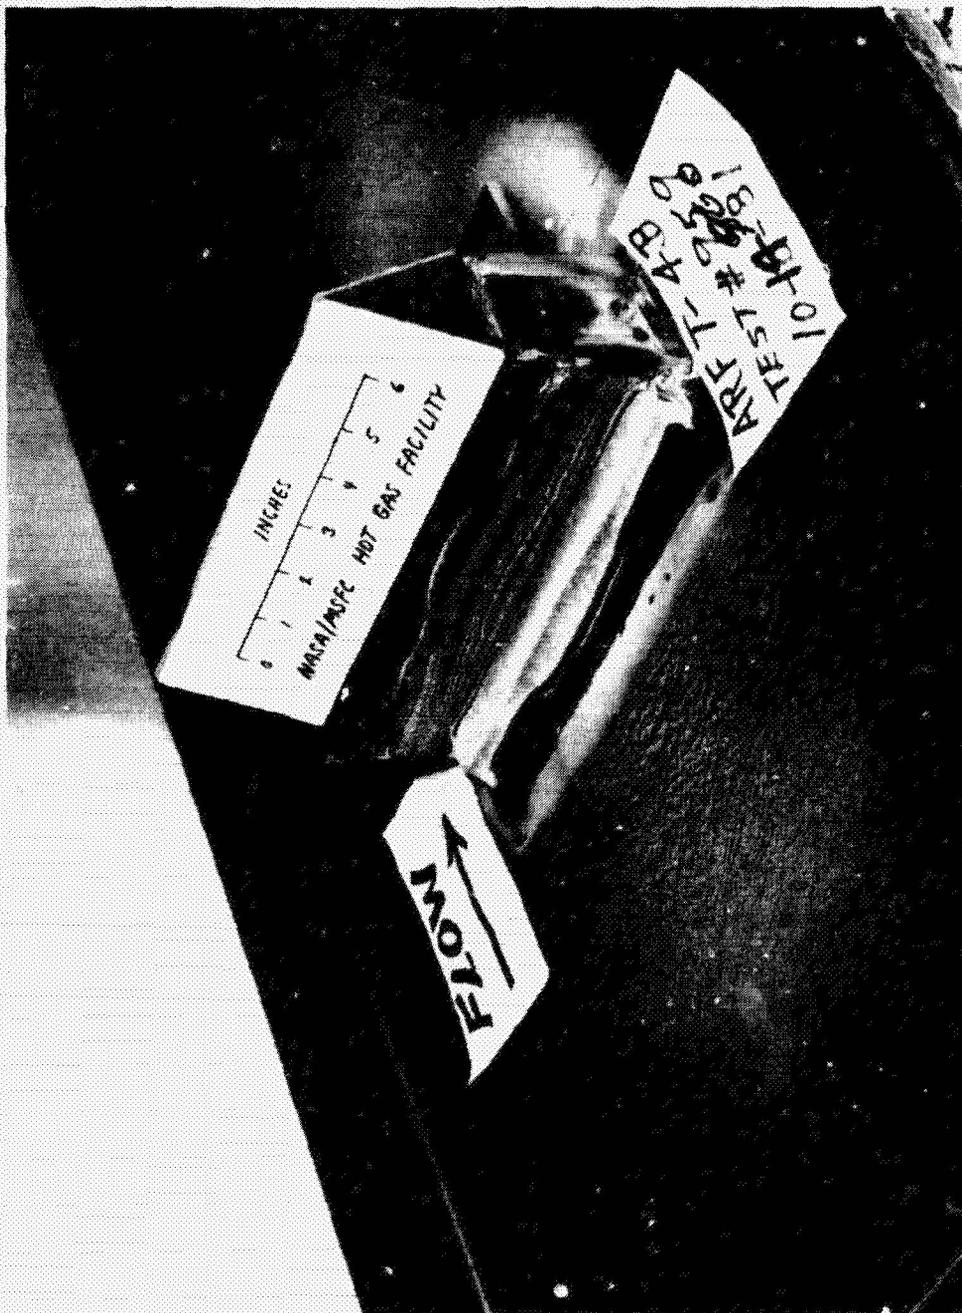
Fig. 15 - Phenolic and Seal Performance in This Test Was Similar to That of Fig. 13

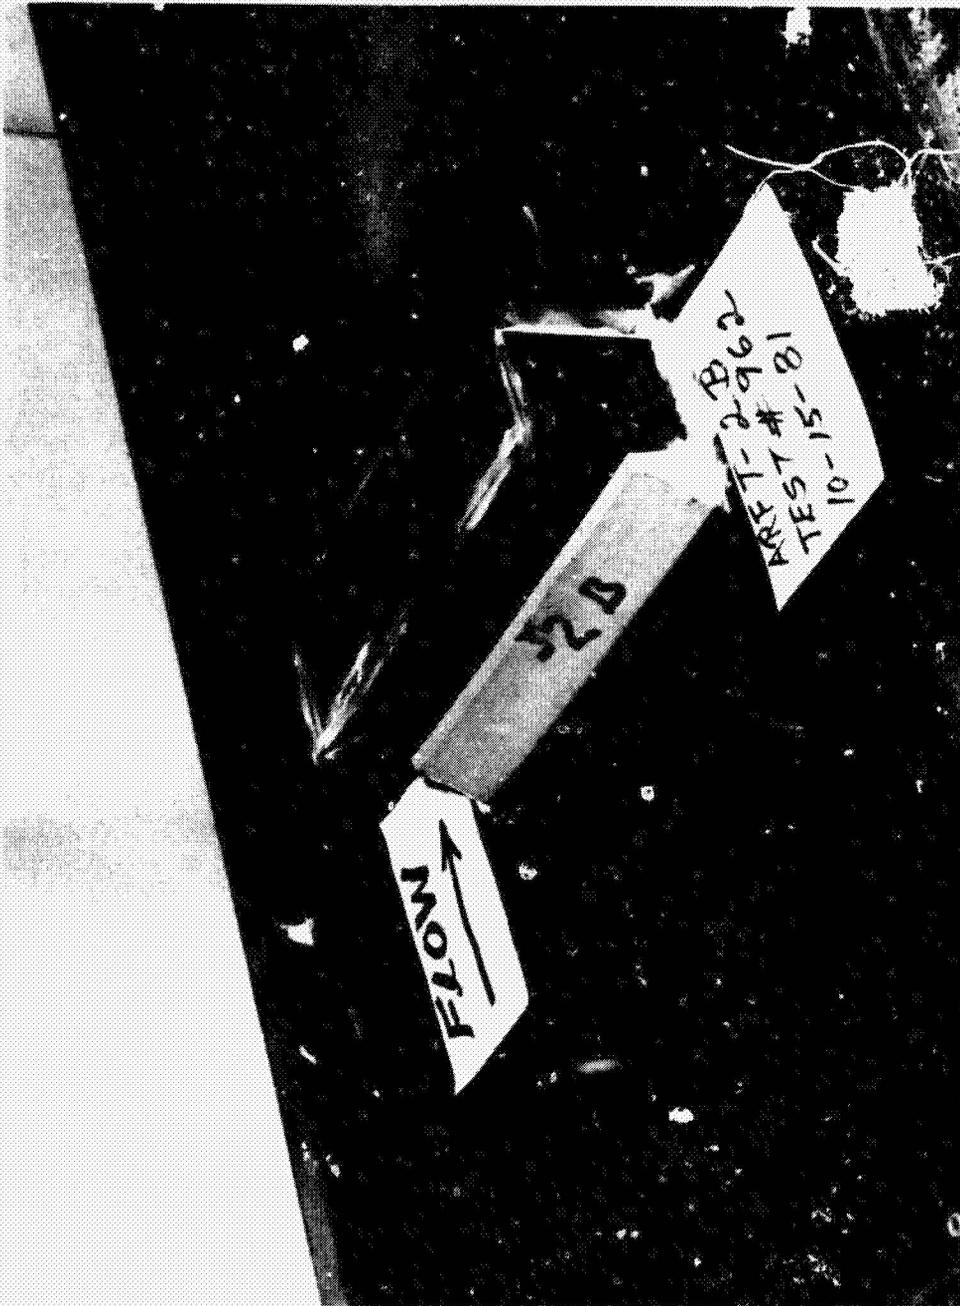
Figures 16 and 17 represent an identical test setup except for the cork shim which is left out to see if the seal would perform or not. Movies indicated that the seal was very weak and could not stay firmly on the bottom surface, allowing flow to get under it till it finally broke in the middle of the second 55 sec test. This configuration without the cork shim is not adequate as indicated by the broken seal of the repeat test also, shown in Figs. 18 and 19.

Fig. 16 - Small Fish-tail Seal With 0.60 in. Gap Under Phenolic But Without the Cork Shim to Provide Required Compression of Seal

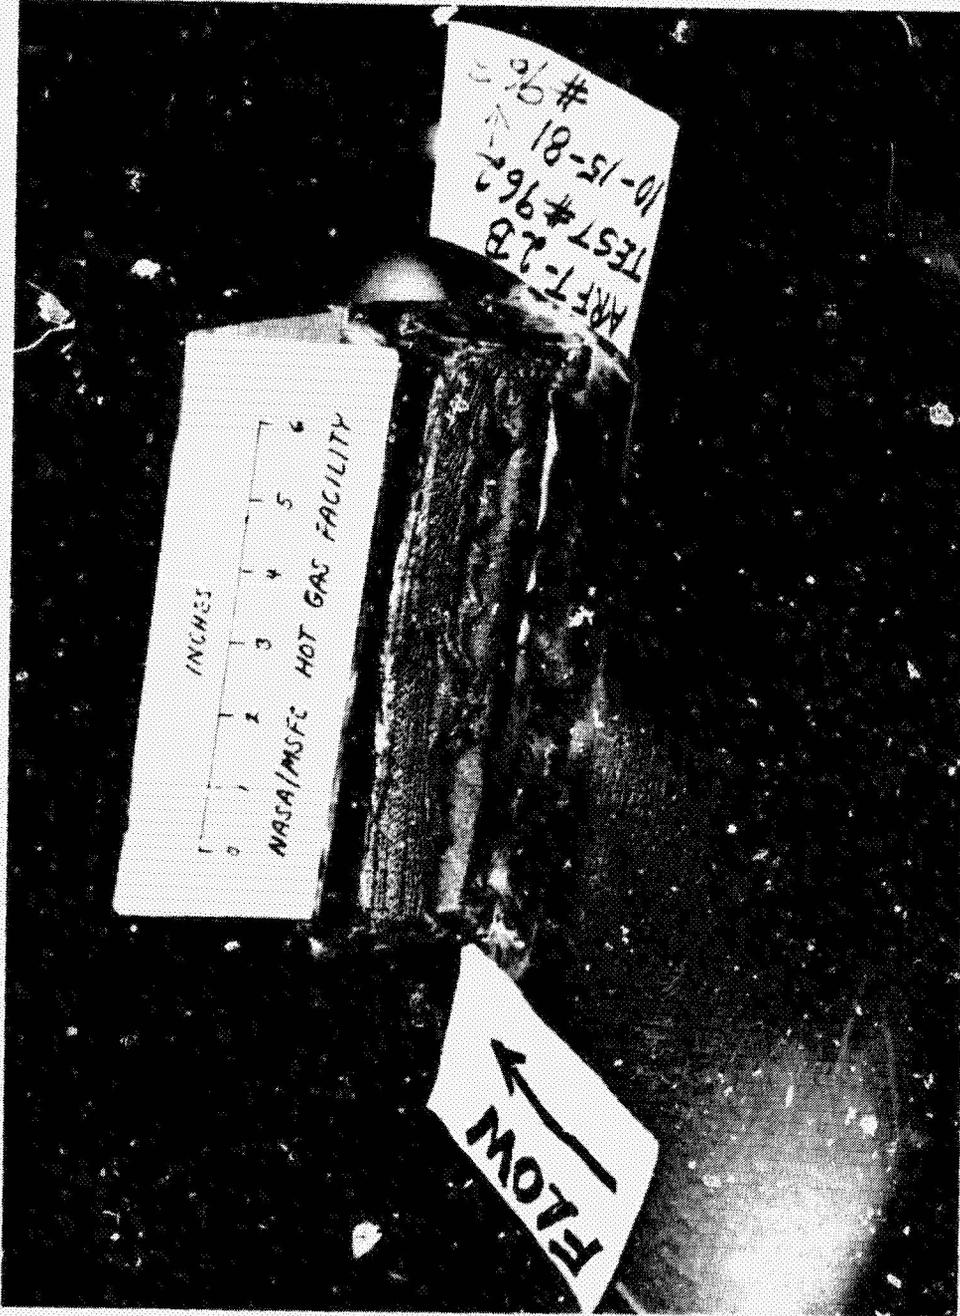
Fig. 17 - Seal Did Not Survive Test Since It Did Not Have Sufficient
Compression to Be Held Down Firmly Against Bottom Plate

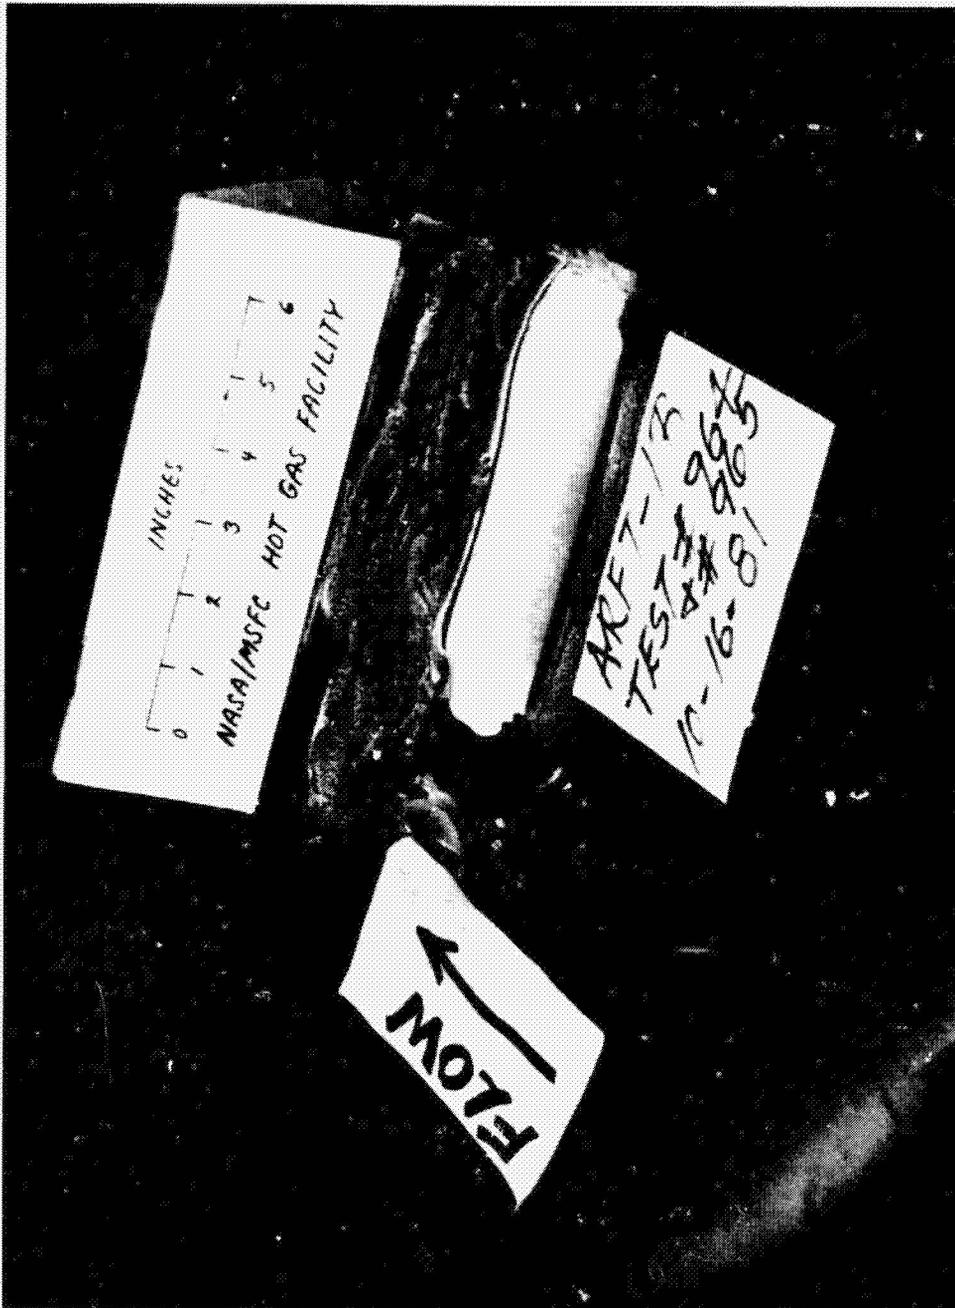
Fig. 19 - Though The Seal Has Not Been Completely Lost, It Has Nevertheless Failed Due to Lack of Sufficient Compression to Give It Strength

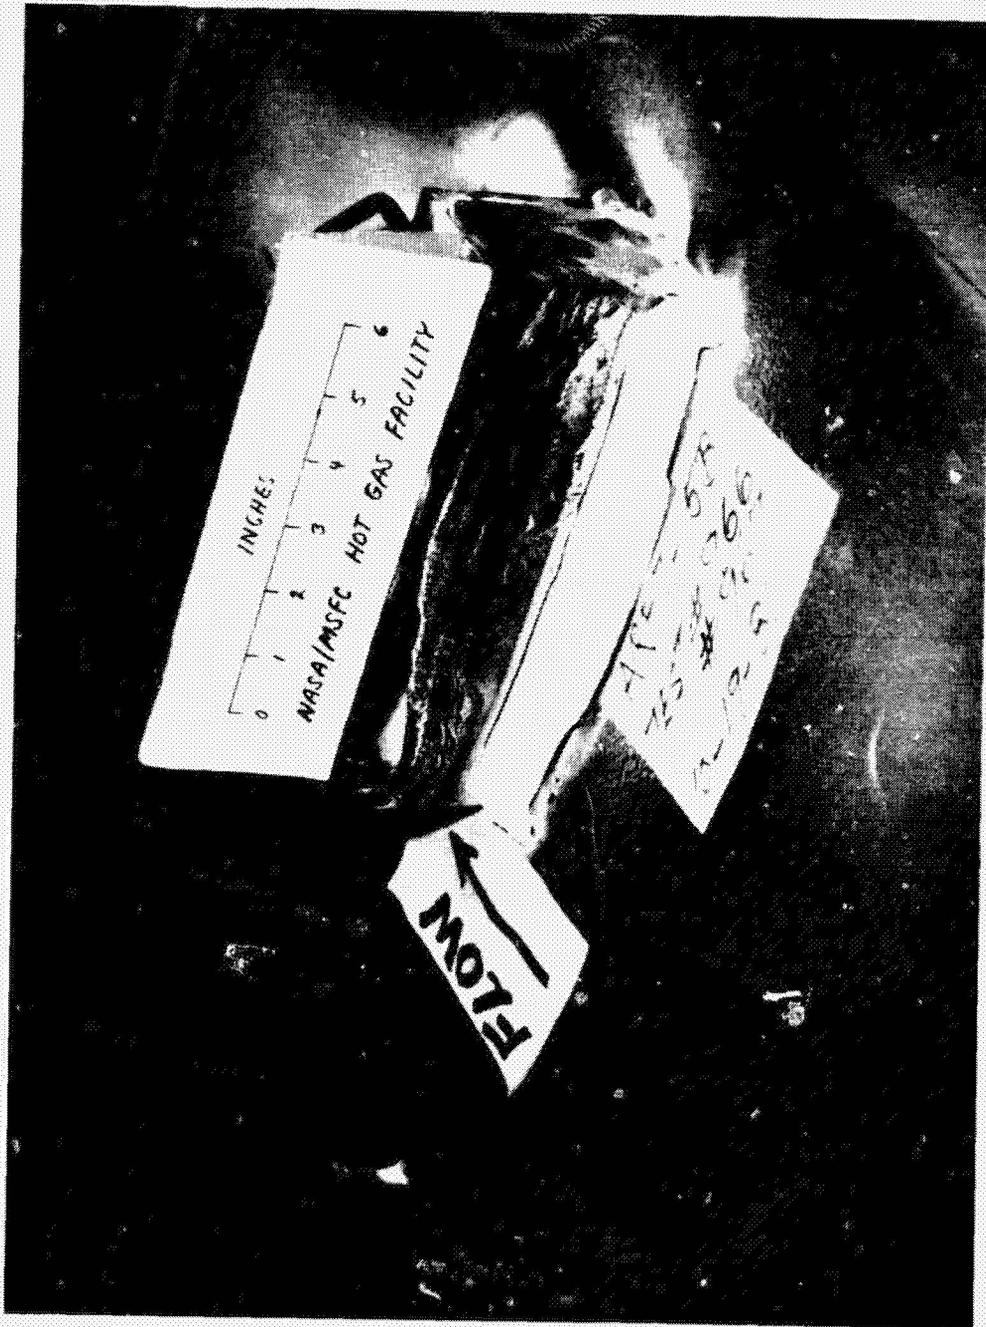
Figures 20 and 21 are for the seal test of the original design configuration with 0.375 in. gap under phenolic. As per design requirements, the seal performed well. The cavity pressure held until about 45 sec into the first test. This type configuration was not repeated.

FIG. 21 - Though the Phenolic Has Burned Through at the Top, the Seal Has Performed Adequately

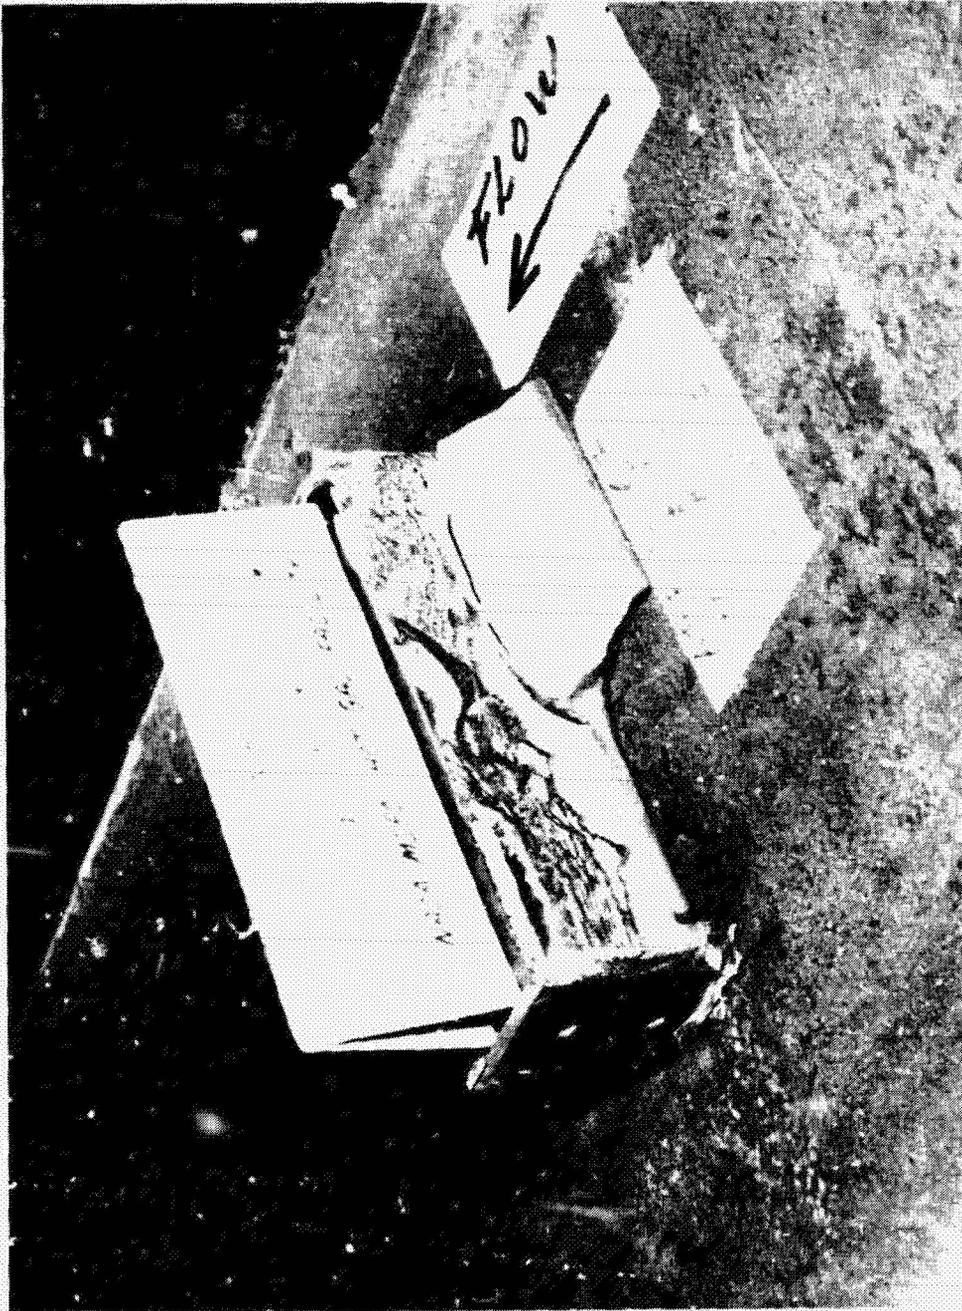
50% of the front half of the seal was lost during the second exposure to the flow (Fig. 23). The first exposure had lasted only 29.62 sec due to facility problems. It is not known why the large chunk of seal was lost on this model. The repeat run of Figs. 24 and 25 was to throw more light on this problem. During the repeat test, the seal performed very well with the cavity pressure holding throughout the first run of 55 sec.

Although the large seal of Figure 23 failed during its second exposure, it was decided that this seal was acceptable because it performed well during the repeat test.

Fig. 23 - Front Half of the Seal Was Lost Near the End of Test

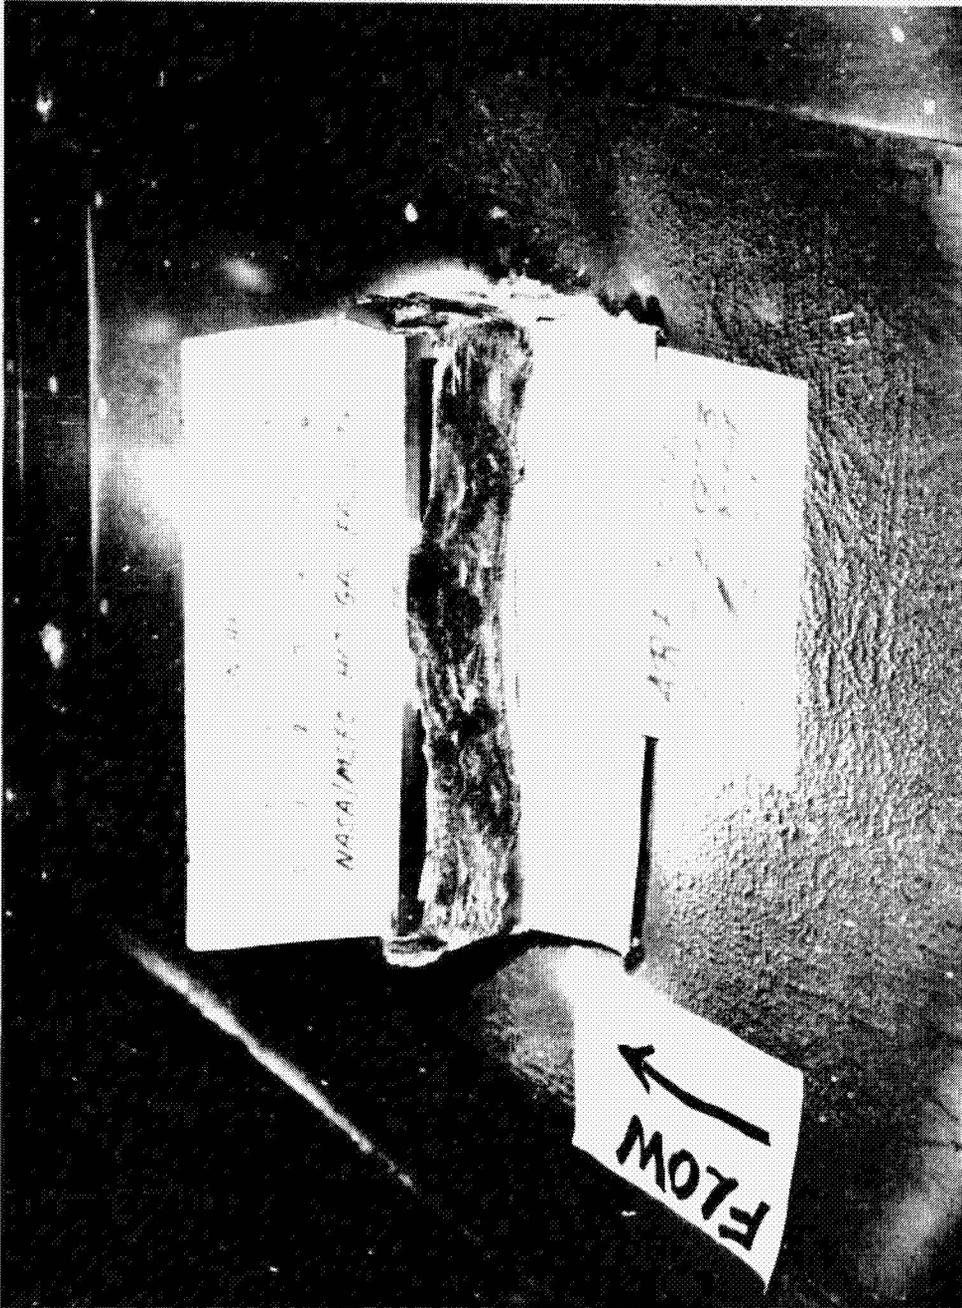
Fig. 25 - Seal Performed Well Unlike the Previous Identical Type Shown in Fig. 23

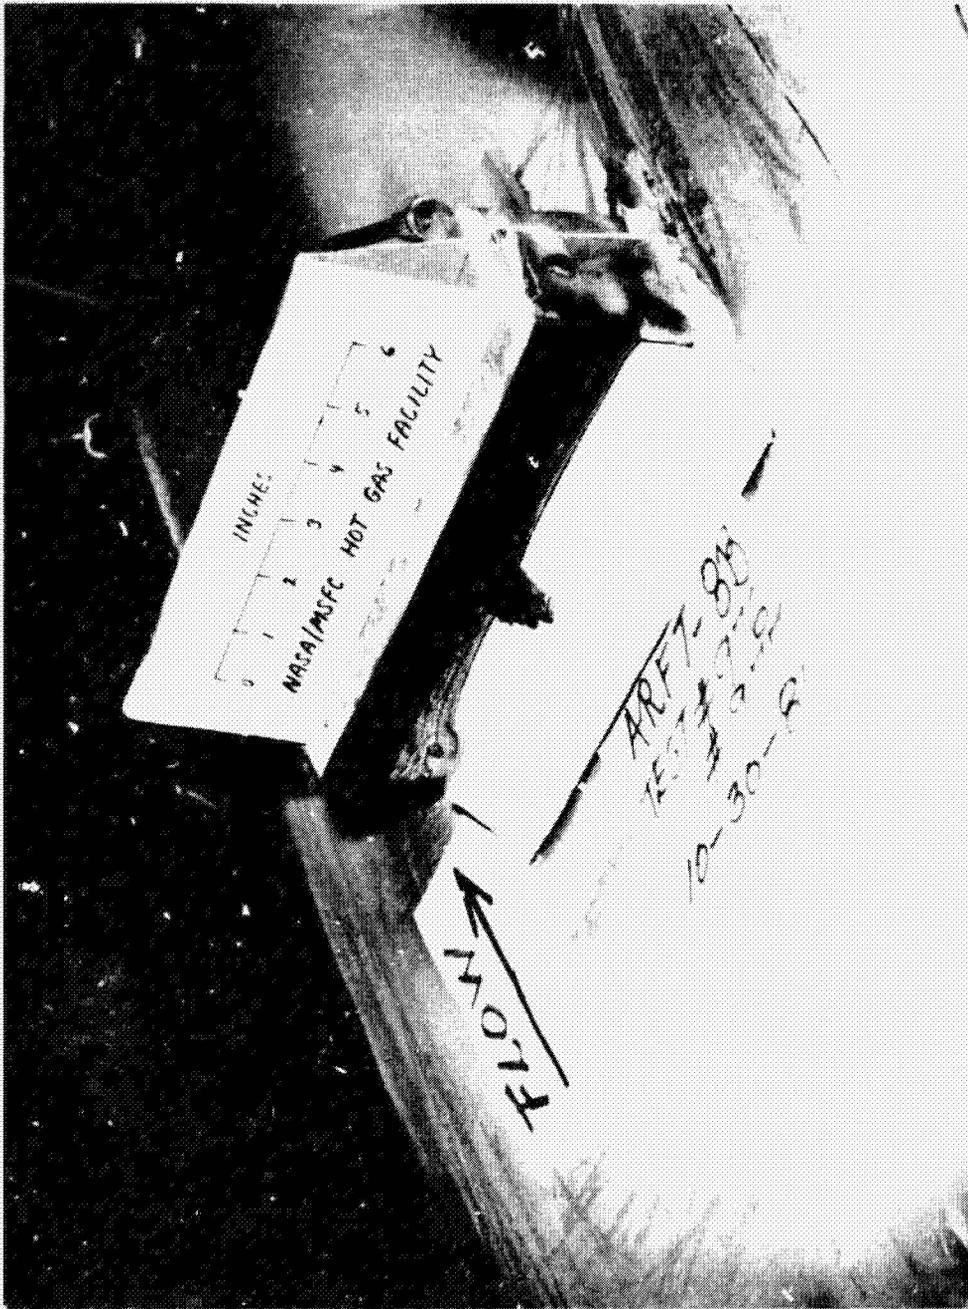
The other hardness type (Class 2B/grade 40), which is less hard, of silicone rubber large seal was tested. To prevent the phenolic TPS from burning through at the top of the model, a protective steel strip was installed over the phenolic upper edge as seen in Fig. 26. This protection helped the phenolic TPS stay together (Fig. 27) and hence the cavity pressure held up throughout both the runs indicating a perfect function of the seal. The repeat run of Figs. 28 and 29 performed identically.

Fig. 27 - Seal Performed Well and Due to the Protective Strip on the Phenolic, Model Cavity Pressure Held Up

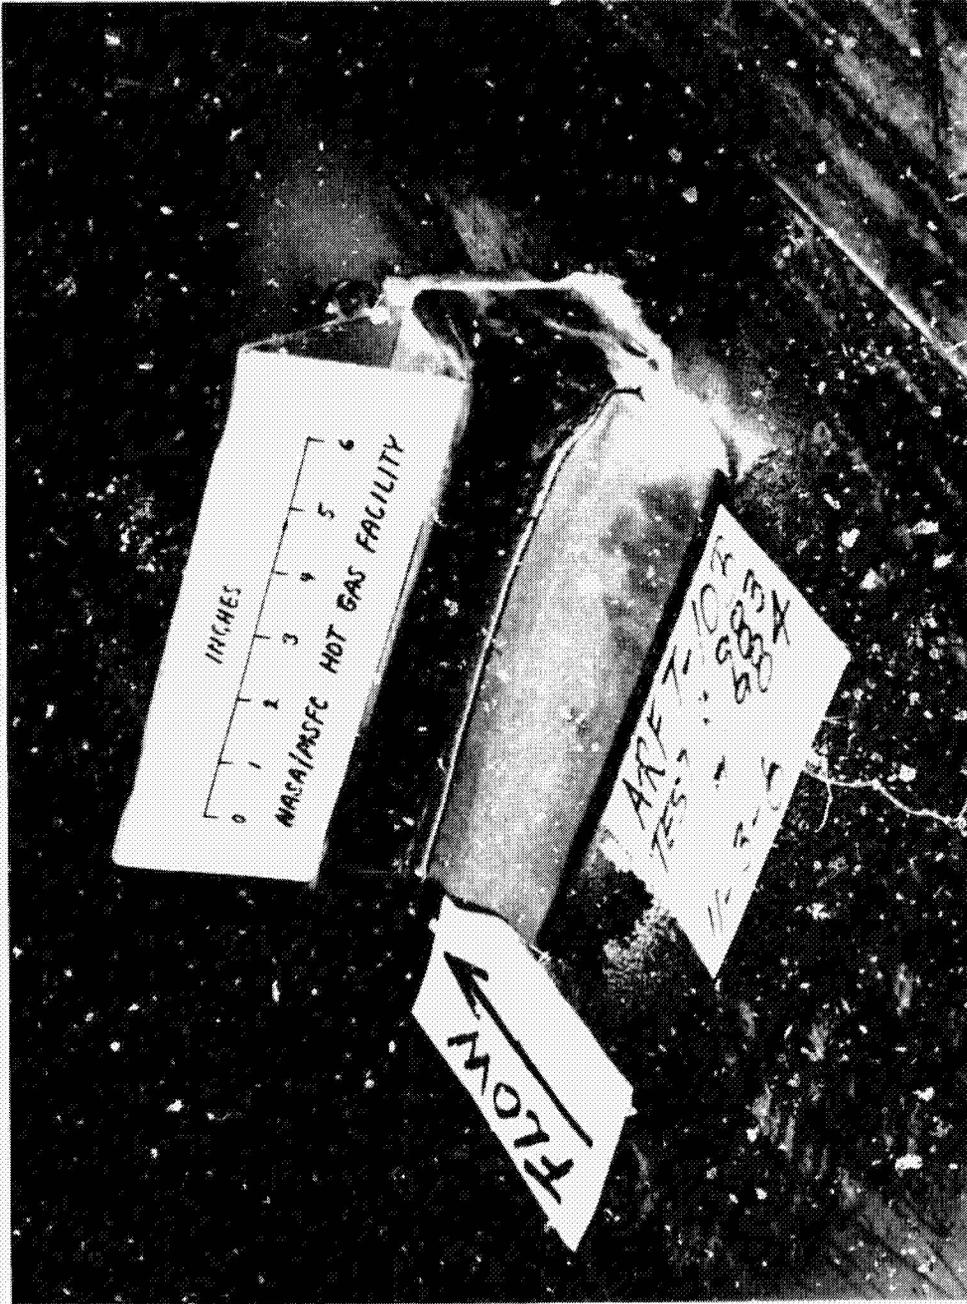
Fig. 31 - Seal Performance Identical to Its Performance When Seal Not Bonded to the Phenolic at the Front of Seal Groove

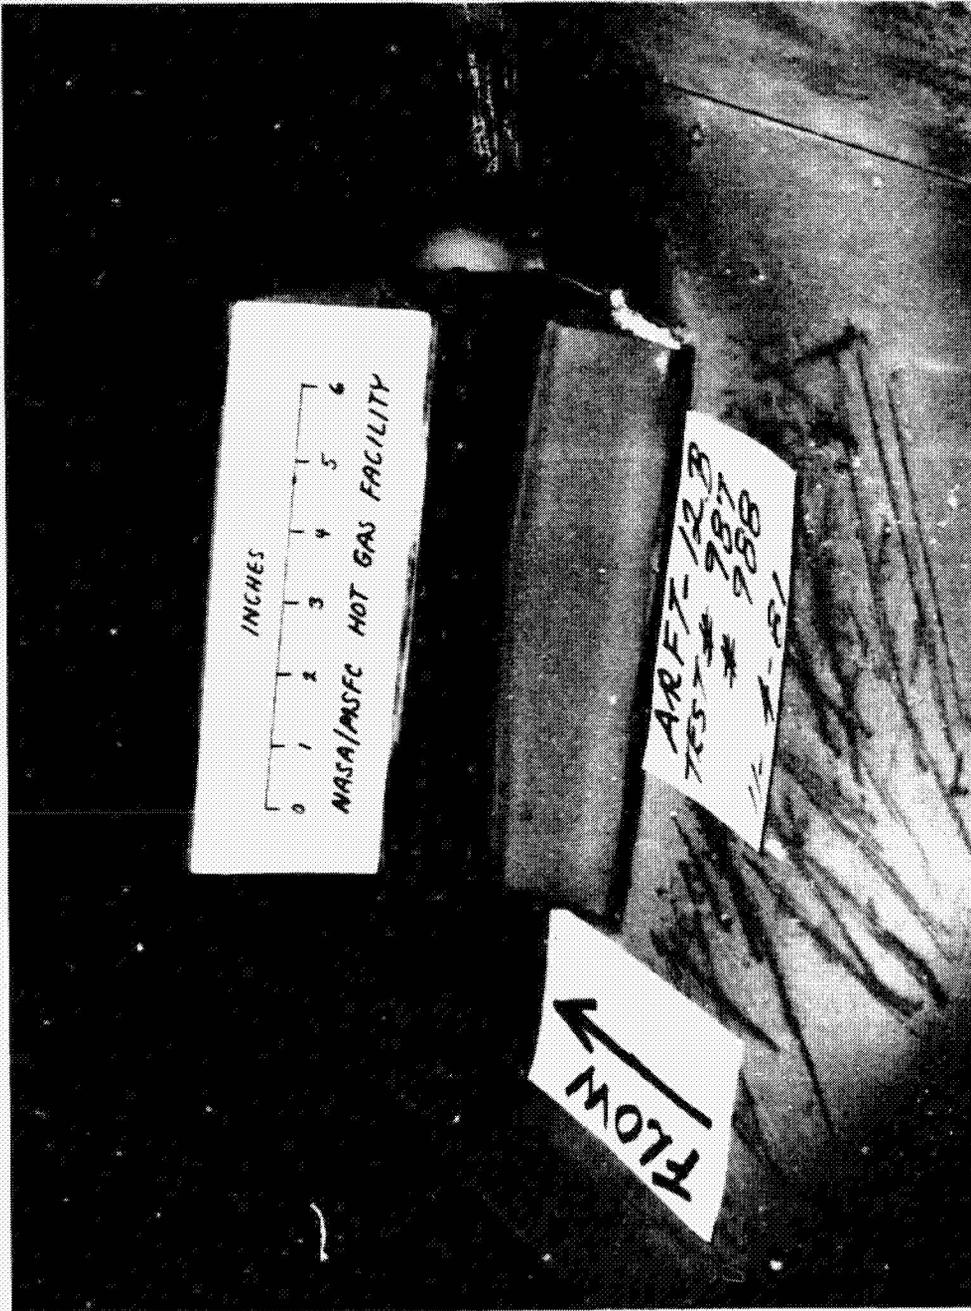
Fig. 35 - Seal Performance Identical to Its Performance When Seal Not Bonded to Phenolic at Front of Seal Groove
