LMSC-HREC TM D784769

SRB ATTACH RING PHENOLIC
TPS FISHTAIL SEAL EVALUATION
TESTS

February 1982

Contract NAS8-32982

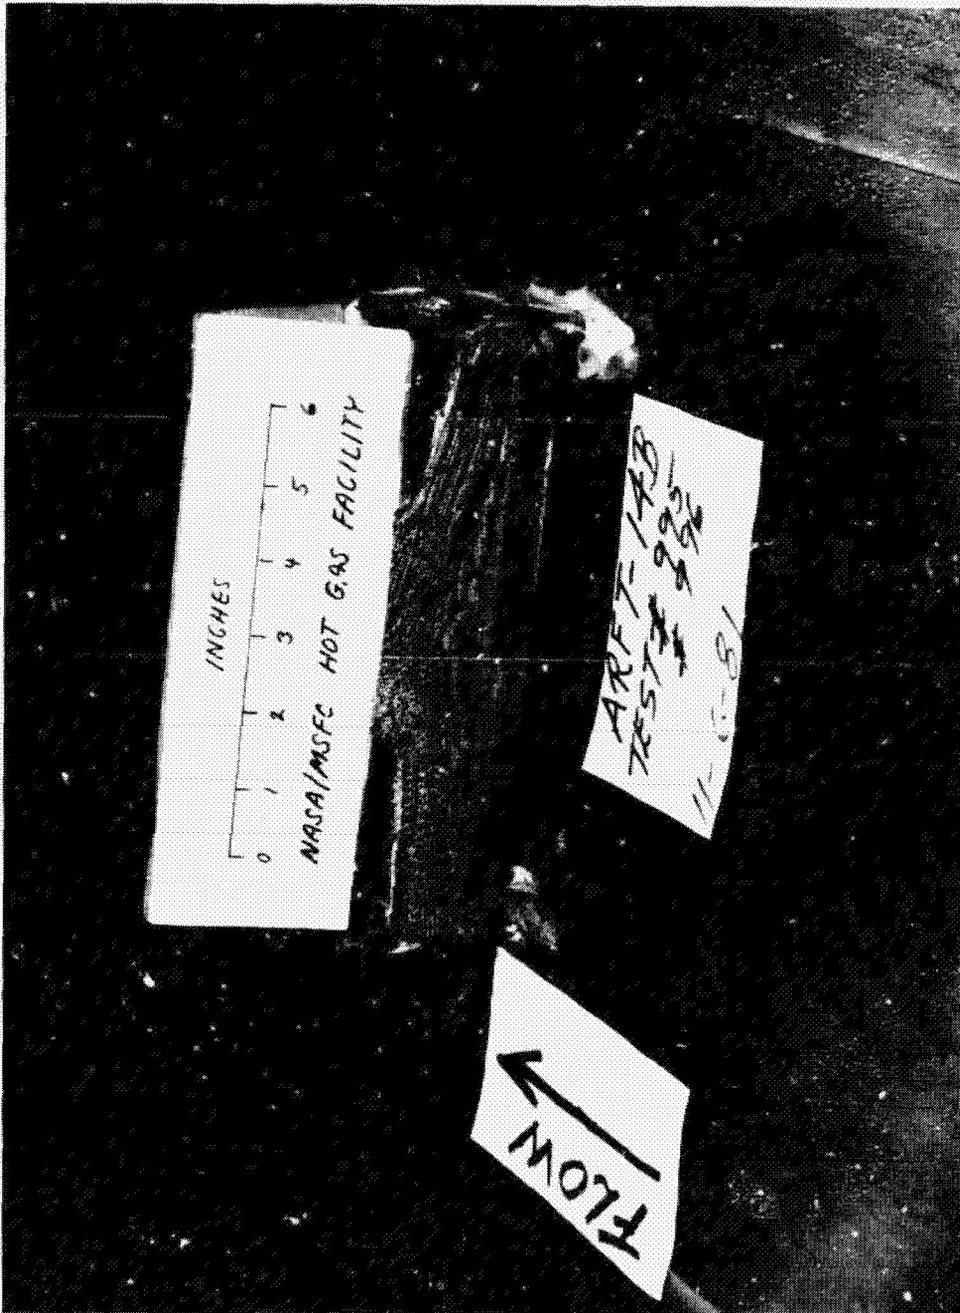
Lastly, a run was made with the small fishtail seal which had not been tested earlier with the seal bonded to phenolic at the front of the seal groove. The gap under the phenolic was 0.60 in. and there was no cork shim under the seal. Because of the lack of the cork shim, the seal did not survive (see Fig. 38) as in the similar tests of Figs. 16 through 19.

Fig. 38 - Post-Test Photograph of Small Fishtail Seal with 0.60 in. Gap Under Phenolic and Seal Bonded to the Phenolic at Front of Seal Groove Also. As in Tests of Figs. 16 and 17, the Seal Did Not Have Sufficient Compression to Provide Strength Necessary to Withstand Aerodynamic Forces.
