NASA Contractor Report 172383

Advanced Manufacturing Development of a Composite Empennage Component for L-1011 Aircraft

Phase III — Final Report
Production Readiness Verification Testing

LOCKHEED-CALIFORNIA COMPANY
BURBANK, CALIFORNIA 91520

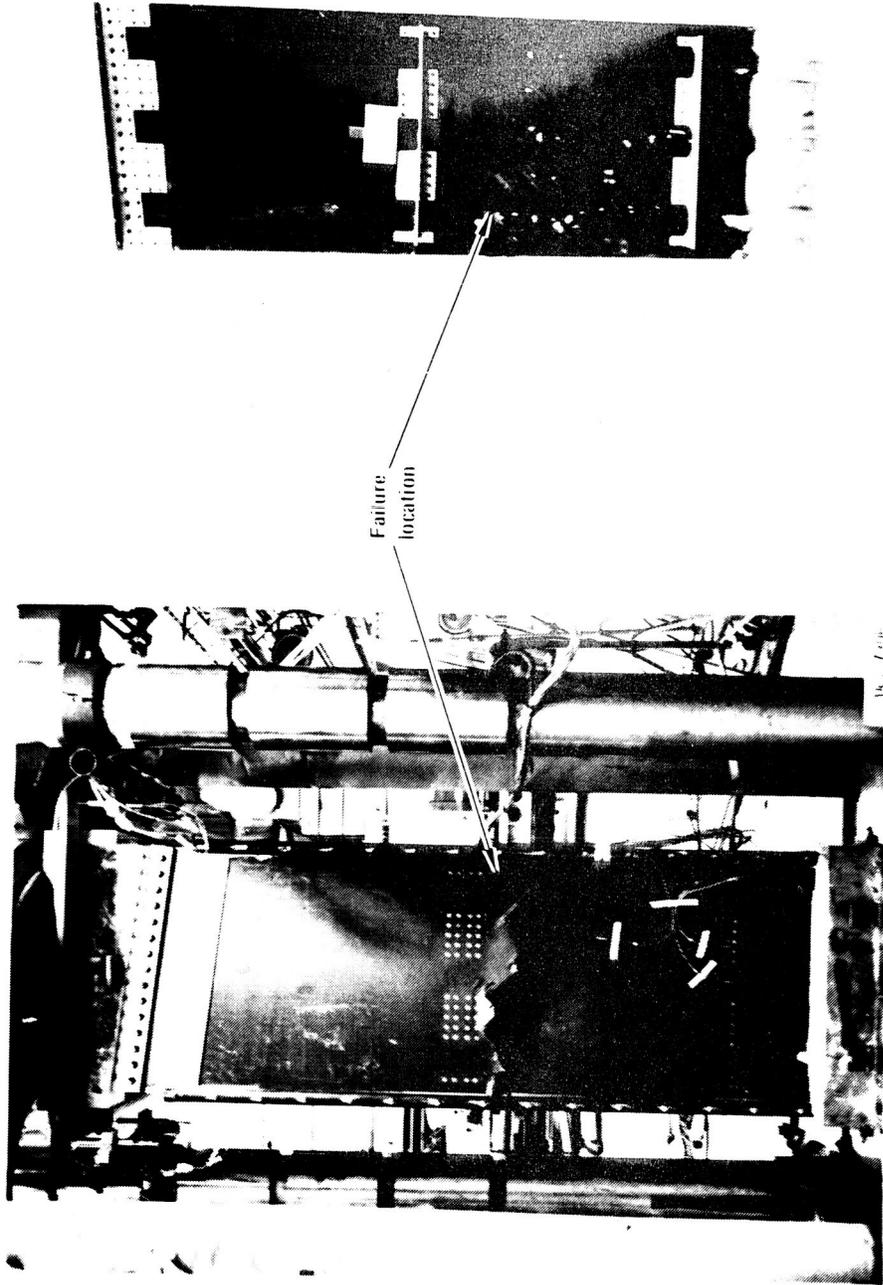
Figure 11. - Typical failure from skin side.

3.1.5 Test results. - The covers all behaved in a similar manner up to failure. All but one cover failed in the same manner. Figure 11 shows a typical failure from the skin side and figure 12 shows another typical failure from the stiffener side. The failures were initiated by the skin buckling between the hats and the buildup of interlaminar tension stresses that caused the skin and hats to separate. These failures occurred in the 16-ply skin between the two rib supports.

Figure 12. - Typical failure from inner side.

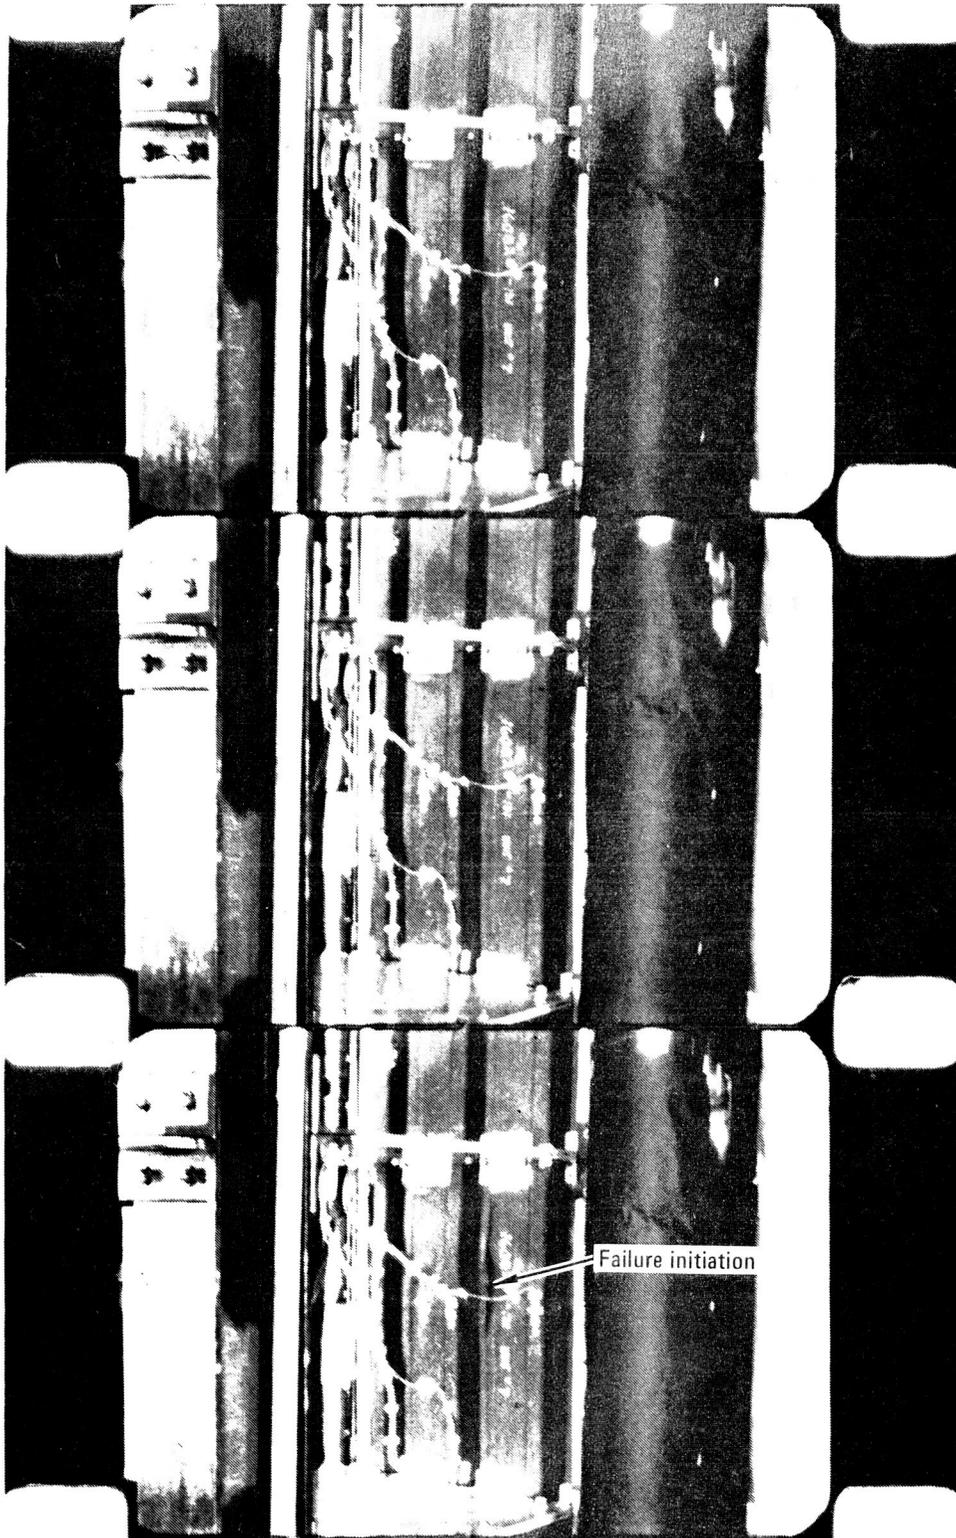
Figure 13. - Failure initiation, cover no. 7, test number 4.

High speed movies (400 frames/second) were taken during each failure run. In most cases the failures occurred within 1/400th of a second and were consequently not picked up by the two high speed cameras. In test 4, cover No. 7, the camera did show the failure initiation at the center hat as shown in figure 13. The camera also caught the failure of cover No. 16 in test 10 as shown in figure 14. In this latter figure, the failure is too far advanced to be certain of the actual origin.

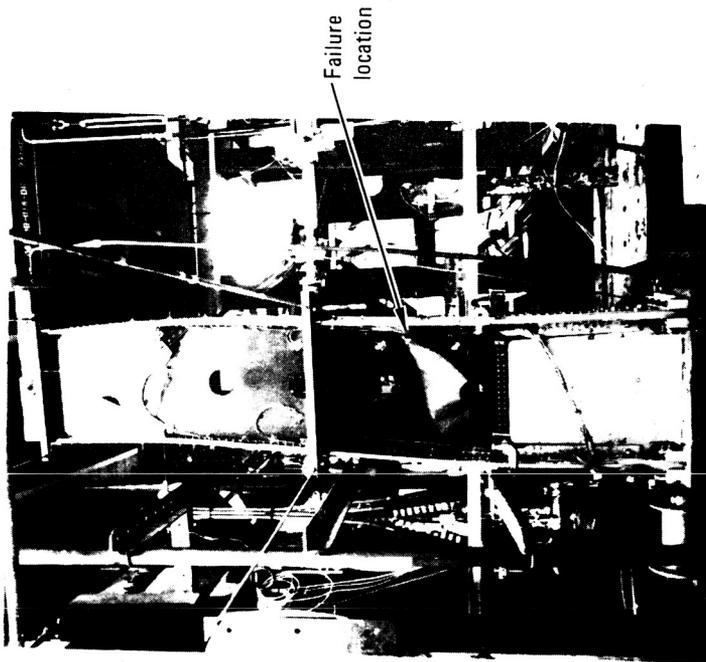
Figure 24. - Failure of spar no. 1 through lower access hole.

Spar no. 1 experienced the nontypical failure. Figure 23 shows a large buckle which occurred at the lower access hole at specimen station 19.89 just prior to failure. Failure occurred at the lower access hole as shown in figure 24.

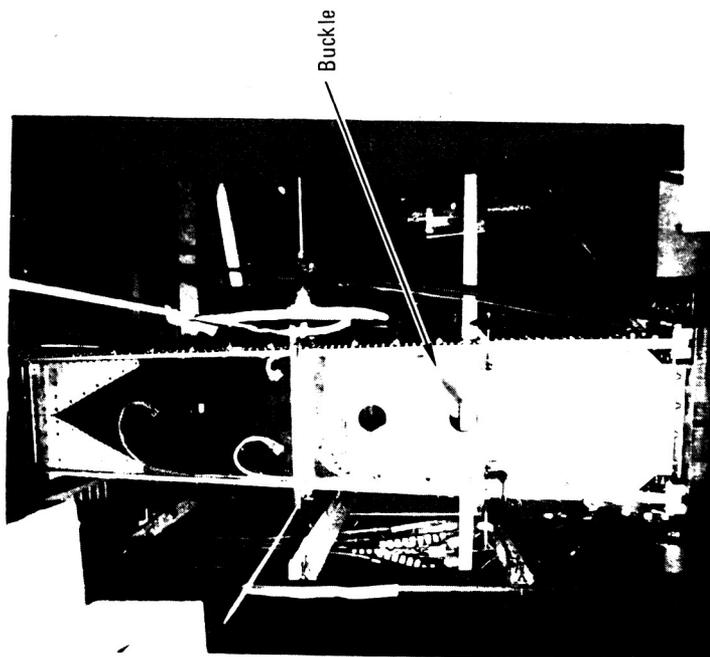
Figure 23. - Photograph of spar no. 1 taken just prior to failure showing buckle at lower access hole at specimen station 19.89.

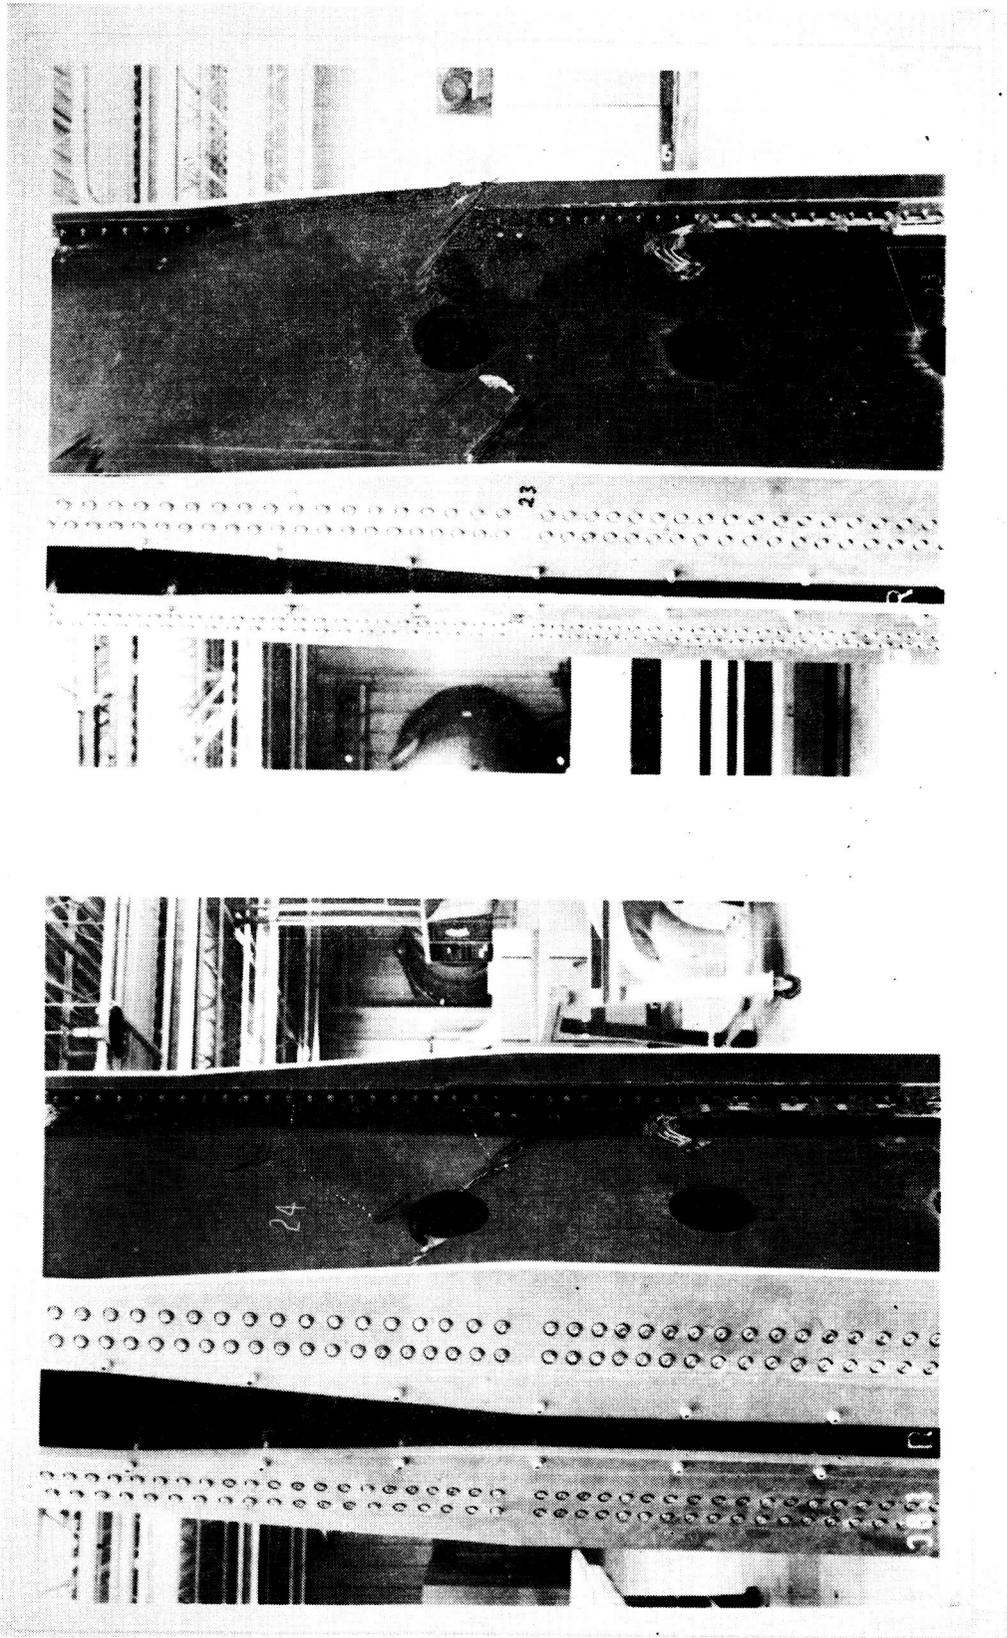
5.2.2 Hi-strain spar failures.- Failure occurred on May 21st 1982 during application of the 150 percent Design Limit Load (DLL) cycle. The full load

Figure 69. - Spar 23 failure.

Figure 68. - Spar 24 failure (initial failure).
