NASA Technical Memorandum 100232

A Life Test of a 22-Newton (5-lbf) Hydrazine Rocket

P.R. Meng, S.J. Schneider, C.J. Morgan,
and R.E. Jones
Lewis Research Center
Cleveland, Ohio

A LIFE TEST OF A 22-NEWTON (5-LBF) HYDRAZINE ROCKET

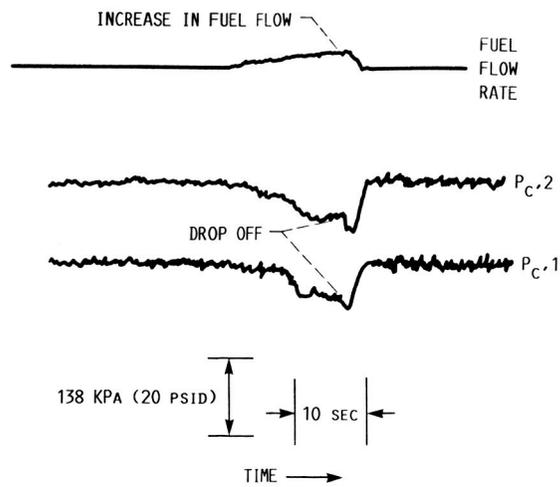
In actual operation the chamber pressure fluctuations were on the order of 6 to 7 percent and never reached the 15 to 20 percent level which was the criterion for end-of-life. After approximately 3.5×10^6 N-sec (7.5×10^5 lbf-sec) of total impulse was obtained, a drop-off in chamber pressure began to occur with increasing frequency. Figure 5 shows a typical trace of chamber pressure where this drop-off was observed. On occasion, this drop-off in chamber pressure would be great enough to trigger an automatic shut-down. However, as this figure illustrates, sometimes the pressure would recover and the test proceed as before. This phenomena is well documented in the hydrazine thruster literature and is known as "washout" (Refs. 1 and 2). This washout was thought to be caused by the gradual accumulation of aniline in the catalyst bed. The hydrazine used in this program was "propellant grade" and contained about 0.337 percent aniline as shown in the chemical analysis in Table II.

During the extended test firings, aniline could gradually build up and contaminate a portion of the catalyst bed. Eventually, hydrazine would pass through a portion of the catalyst bed without contacting any active catalyst. This results in a drop in chamber pressure as all the hydrazine is not being decomposed. A reduction in chamber pressure (and a corresponding increase in fuel flow) results in a change in the gas flow pattern through the bed, which could now bring hydrazine into contact with active catalyst resulting in a restoration of the chamber pressure to previous levels. Such an occurrence is illustrated in Fig. 5. This problem would not occur if the thruster was used in a space flight application because the aniline would rapidly outgas after each firing. However for these tests, the test capsule pressure was high enough that the outgassing of the aniline was not completed between test firings.

FIGURE 5. - VARIATION OF CHAMBER PRESSURE AND FUEL FLOW RATE
TYPICAL OF HYDRAZINE "WASHOUT" PHENOMENON.

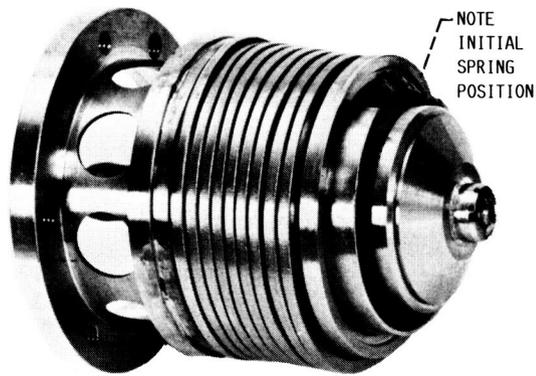
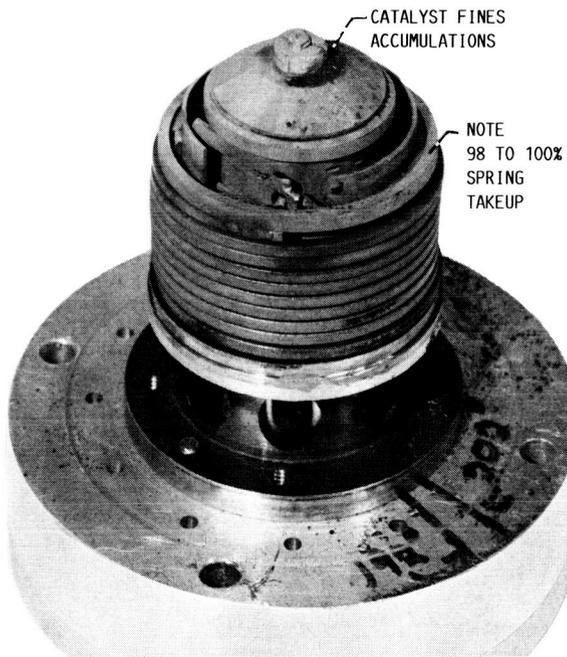
The aft thruster chamber (and attached heat shield) was cut open and separated from the rest of the thruster. Visible accumulations of catalyst fines were present on all internal surfaces, Fig. 6. The torsional catalyst bed compression spring was taken up to 98 to 100 percent of its maximum deflection with the spring travel almost at the stop as indicated in Fig. 7. All internal moving parts moved smoothly through their full range of motion, and all internal metal parts showed no mechanical or thermal degradation under close examination.

FIGURE 6. - SPRING-LOADED ASSEMBLY FROM 22-N (5-LBF) THRUSTER BEFORE AND AFTER TEST.

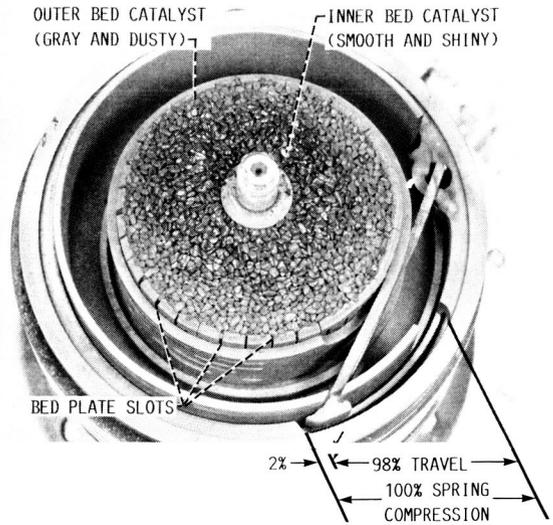
The bed retainer nut, lubricated before testing began with magnesium oxide and tack-welded into place, was easily removed after the weld was machined off. The aft bed closure and bed support were removed, exposing the catalyst bed. The catalyst, Fig. 7, completely filled the catalyst bed chamber with no apparent voids or visible particle degradation. Some catalyst particle penetrations through the bedplate slots were apparent. The outer 53 percent (by distance from the injector) of the catalyst particles visible, appeared gray and "dusty," while the inner 47 percent appeared smooth and shiny. The catalyst was "cored" concentrically with the injector using a modified 5 cc laboratory syringe. The inner bed sample weighed 5.3 g (31 percent of total weight) and was collected from the injector surface out to a 0.59-cm (0.233-in.) radius. The outer bed sample weighed 11.63 g (69 percent of total weight) and was collected from the catalyst bedplate to a 0.60-cm (0.235-in.) radius from the injector centerline.

Before testing began, 20.92 g of 25 to 30 mesh catalyst were loaded into the thruster. 3.99 g of catalyst (19.07 percent of total weight) were lost as fines during testing. The thruster was designed to allow up to a 20 percent catalyst loss without developing voids in the catalyst bed. A particle size analysis, Table III, showed no significant change in particle size distribution between the outer bed and inner bed samples taken.

FIGURE 7. - 22-N (5-LBF) SPRING-LOADED THRUSTER POST-TEST CATALYST BED DETAIL.

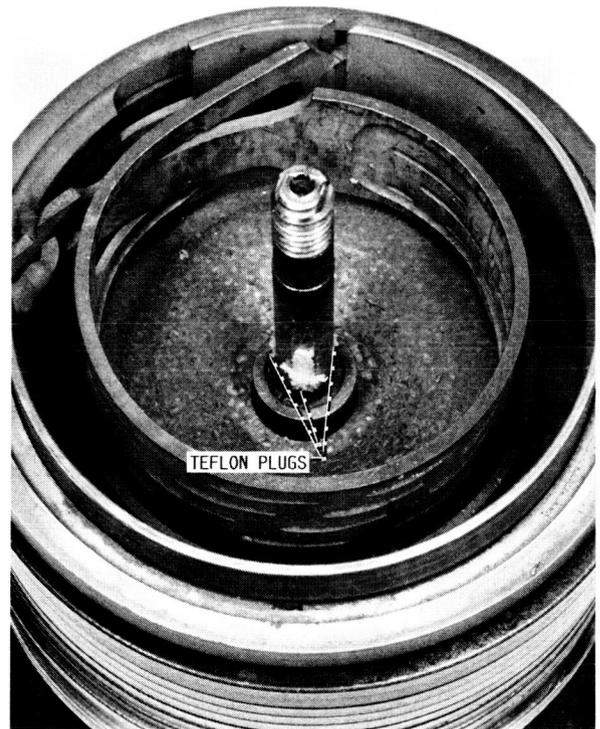
The thruster was removed from the test chamber after the attempt to bake off the catalyst bed contaminants with a heat lamp resulted in the autodecomposition of the hydrazine fuel entrapped in the valve. When the valve exploded violently, part of the Teflon valve seat was forcibly ejected into the thruster's fuel injector, causing it to become plugged. Attempts at removing the plug failed, so the thruster was returned to Rocket Research Company for disassembly and analysis.

Further inspection of the thruster injector by a water flow calibration showed that the flow through the injector was almost completely cut off by the Teflon from the valve seat. A pre-test flow calibration at 276 KPa (40 psia) flowed 856.4 g/min, while a post-test calibration flowed only 7 g/min of water. Post-test photographs of the exposed injector, Fig. 8, clearly show why the post-test injector flow rate was so low. Teflon from the ejected valve seat was extruded through the small injector orifices and was forced into the fuel delivery slots behind the injector dispersion element.

FIGURE 8. - 22-N (5-LBF) SPRING-LOADED THRUSTER REMAINS OF A TEFLON VALVE SEAT EXTRUDED THROUGH INJECTOR ORIFICES.
