**MATERIALS FOR ADVANCED TURBINE ENGINES  
PROJECT COMPLETION REPORT  
PROJECT 4**

**OXIDE-DISPERSION-STRENGTHENED  
TURBINE BLADES**

**VOLUME II**

(NASA-CR-179561-Vol-2)

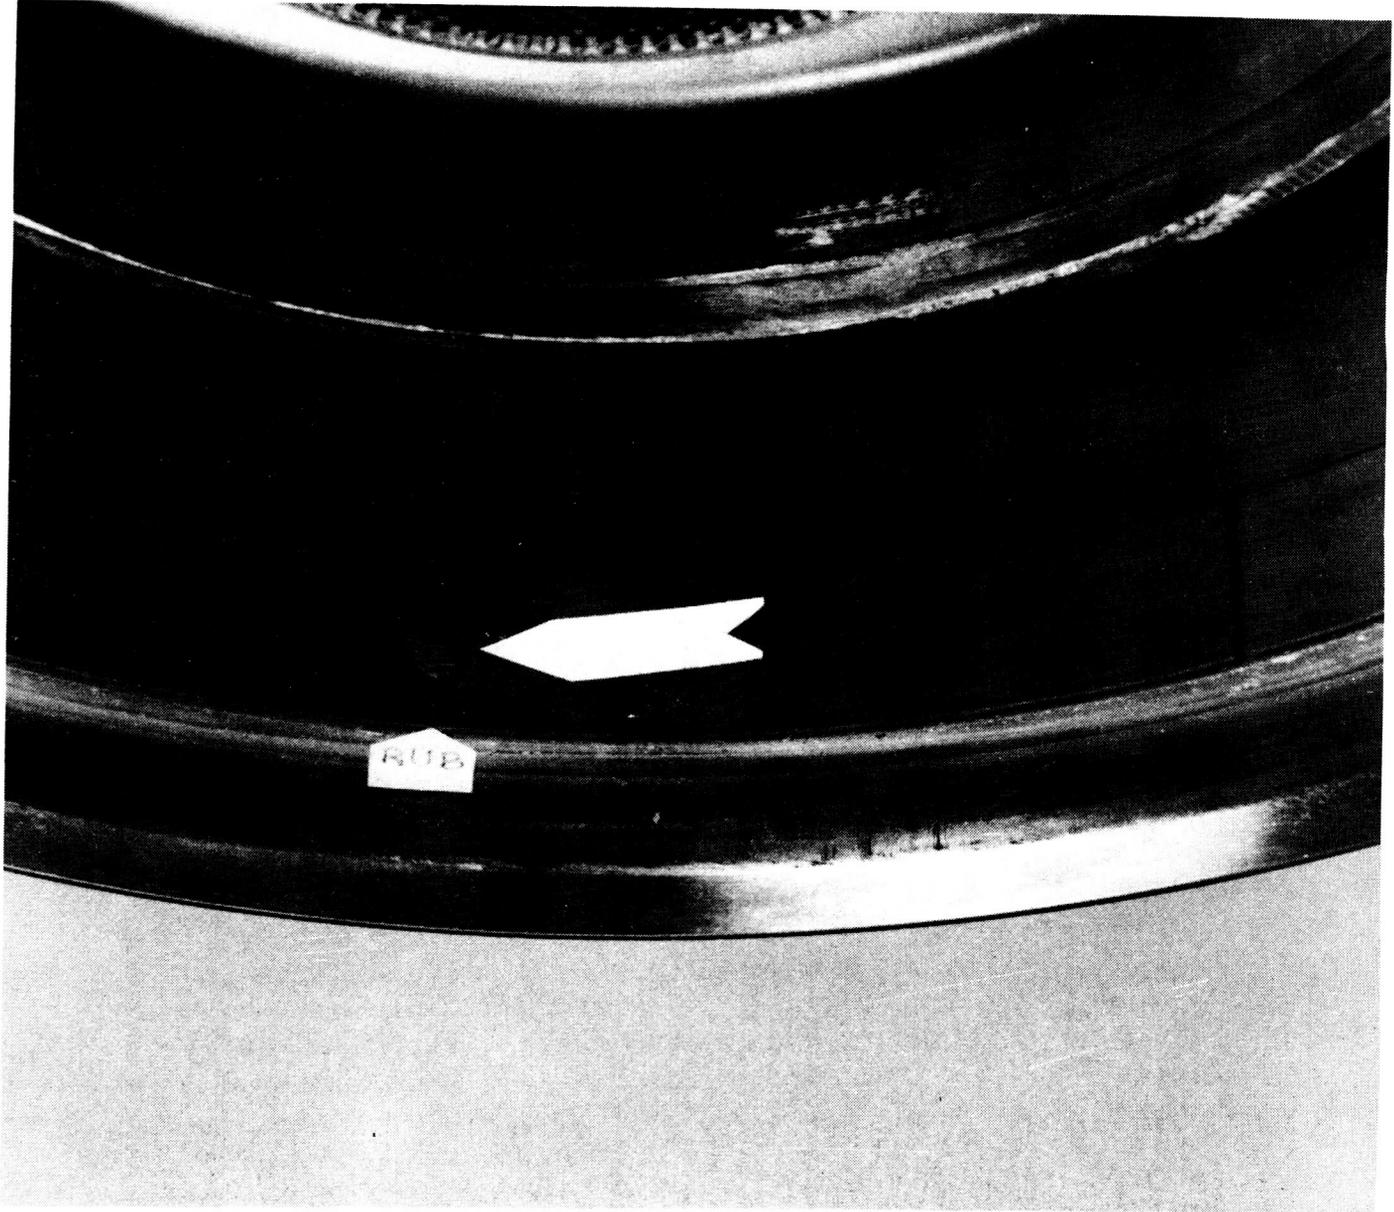
The second 50-hour test called for a stress rupture evaluation (Figure 2). No problems arose during testing. However, upon disassembling the engines, a small shroud rub was found, as shown in Figure 7. There was no significant damage to the turbine blade tips; therefore, dressing of the tips was deemed unnecessary. Upon inspection of the shroud, it was found that the rub occurred due to a high spot, which was subsequently machined off per TFE731-3B specifications. Subsequent FPI and visual inspection performed when the engine was disassembled at the midpoint and end of test segments indicated no difficulties or signs of distress.

Figure 7. Small Shroud Rub.

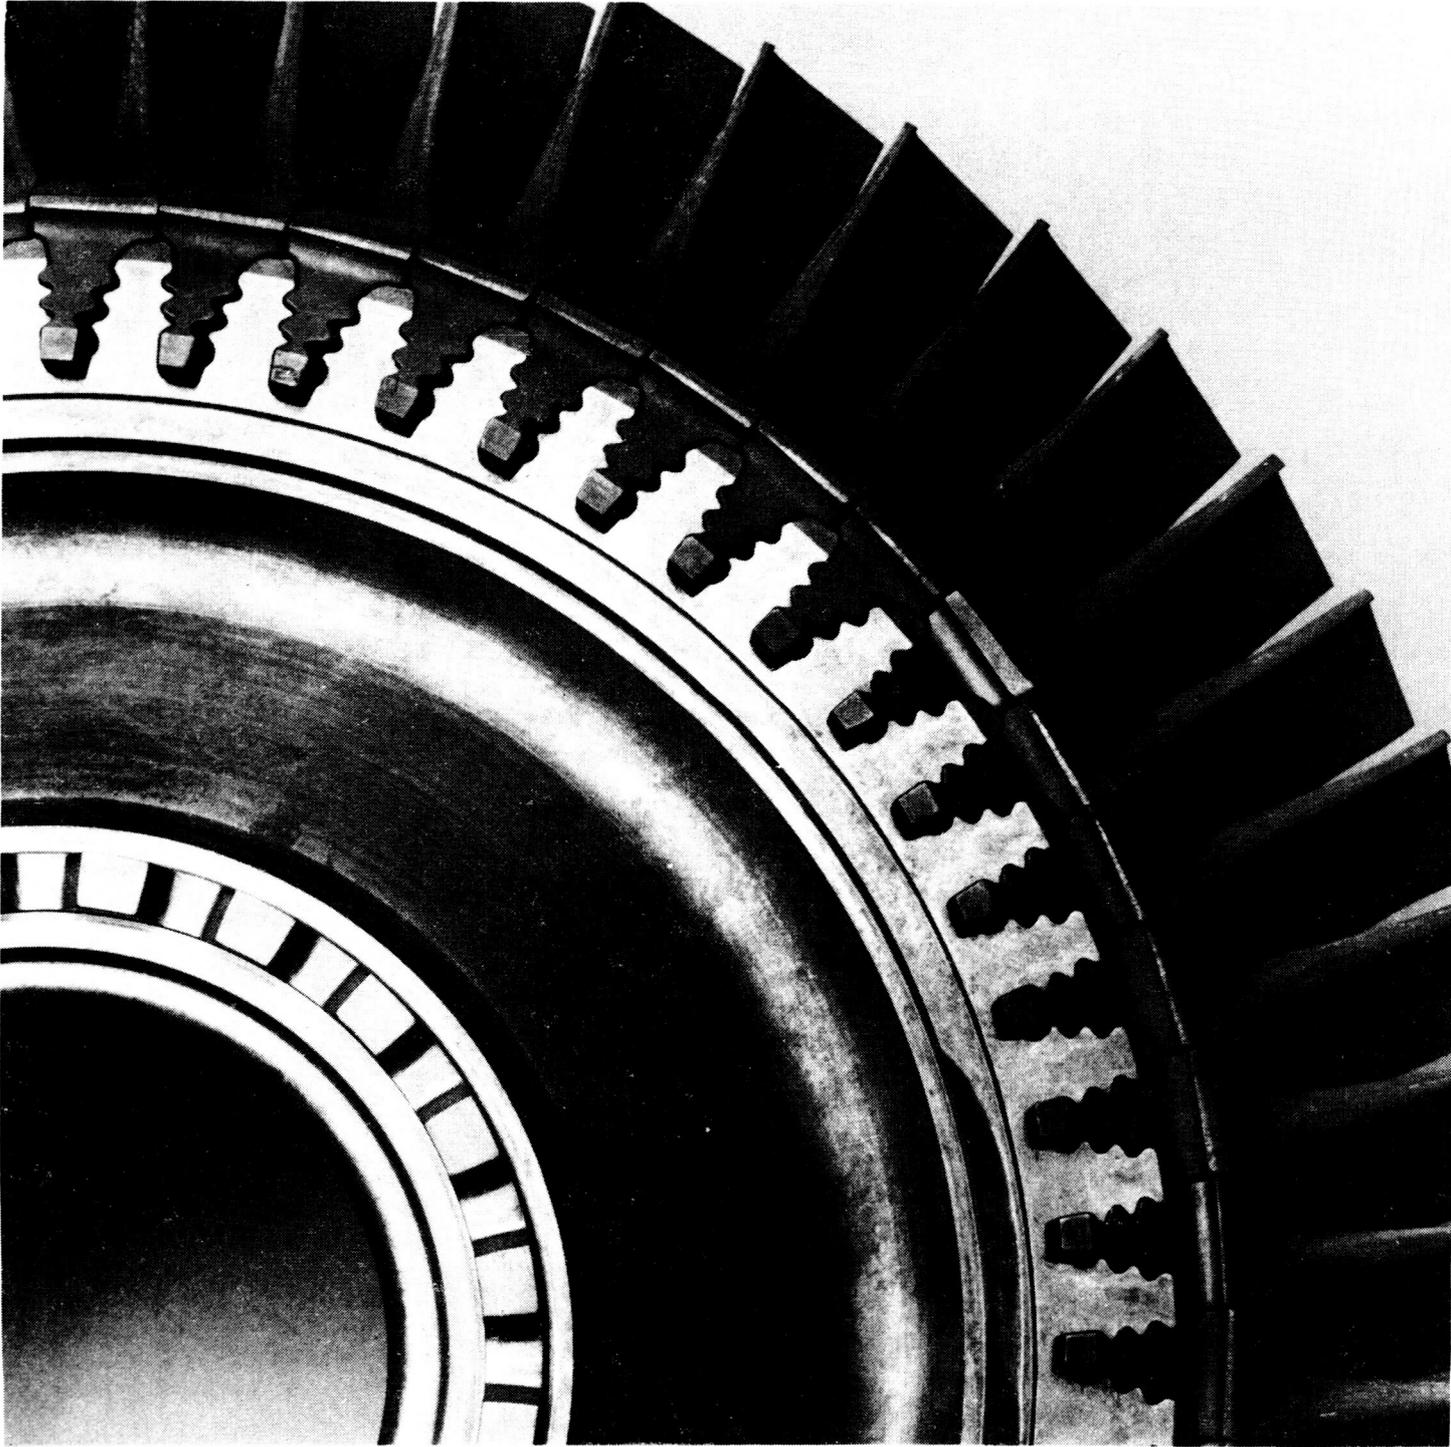
The final test was a high temperature demonstration cycle, and was designed to expose the MA6000 blades to a  $T_4$  approximately 133F greater than that normally experienced in a TFE731-3B. This increase in temperature was accomplished by installing a reduced area nozzle that back pressured the low pressure spool, thus allowing a greater fuel flow without overspeeding the engine. The high temperature was maintained for five minutes. The disk and blades after the high temperature demonstration cycle are shown in Figure 8. The engine was then disassembled and visual inspections of the HP blades and disk revealed no degradation. The blades and disk were then cleaned and penetrant inspected. Again, no flaws or signs of distress were found.

Figure 8. Disk and Blades After High-Temperature Demonstration Cycle.

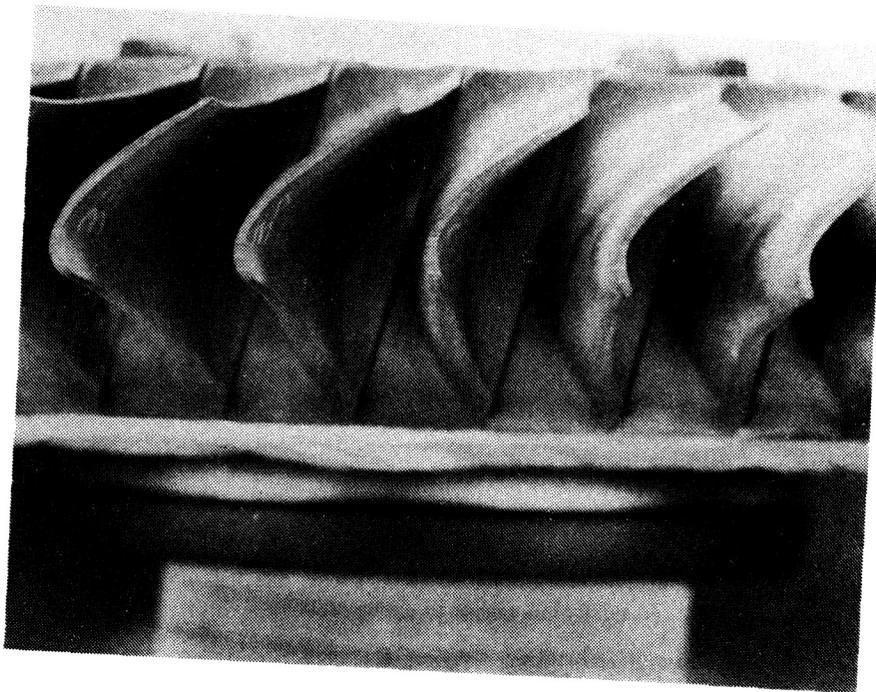
A minor blade tip rub occurred during the stress rupture cycle test (between 50 and 100 hours), due to a high spot on the shroud. The blade tips are shown in Figure 9. The rub was primarily localized inboard of the leading edge and less than 0.100 inches wide. It was not considered severe enough to require dressing the blade tips. The shroud was cleaned, however, prior to continuation of the test to avoid another rub. No further rubs were experienced for the duration of the engine testing. No blades were found to have rejectable FPI indications after this second test.

Figure 9. Tip Rub on MA6000 Turbine Blades During Stress Rupture Cycle Test.

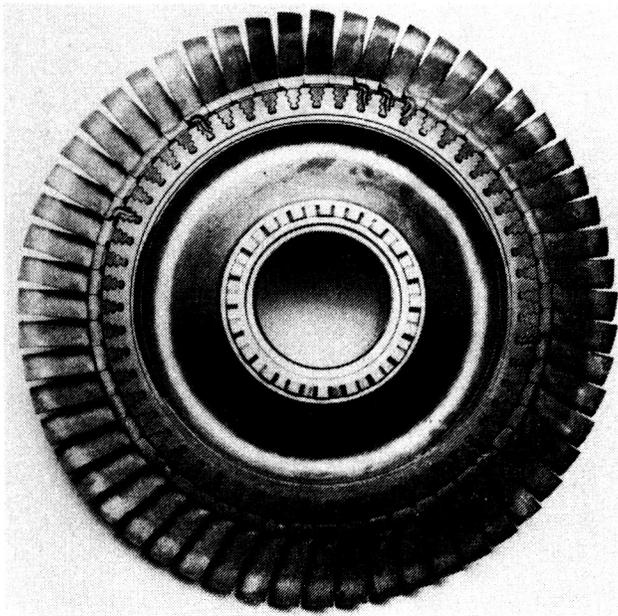
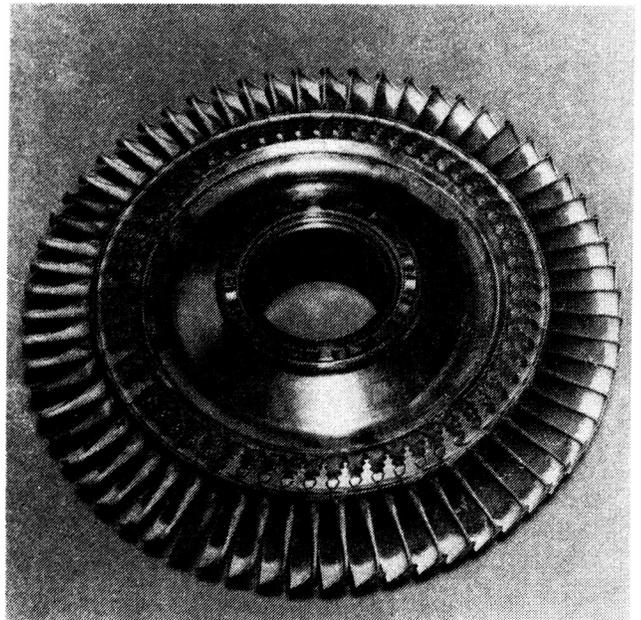
Following the successful completion of the scheduled engine testing, a general assessment of the rotor's condition was made. Overall, the blades and disk survived the 200-hour engine test in excellent condition. The minor airfoil surface oxidation and discoloration was compared to the cast single crystal (SC) NASAIR 100 bladed rotor (Project 3) after a 200-hour engine test run (Figure 10), and the two sets of blades were found to be similar in appearance.

Figure 10. MA6000 Turbine Rotor Compared to Single-Crystal NASAIR 100 After 200-Hour Endurance Engine Test.

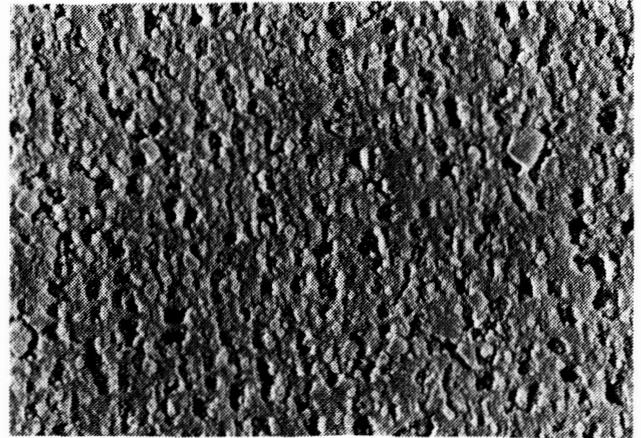
Scanning Electron Microscopy (SEM) of the unexposed blade revealed a cuboidal gamma prime phase structure in a background of very fine gamma matrix. Coarsening of the gamma prime precipitates was observed in the thermally exposed blade (Figures 14

Figure 14. Scanning Electron Micrographs of MA6000 Turbine Blade Before and After 200-Hour Test Comparing Gamma Prime Size.

and 15). As discussed in Volume I, Section 4.2.1 of this report, this coarsening accounts for the decrease in tensile and rupture strength of the alloy between the temperatures of 1300 and 1800F. Beyond these temperature regimes, the high temperature properties of the alloy becomes primarily controlled by the oxide dispersion.

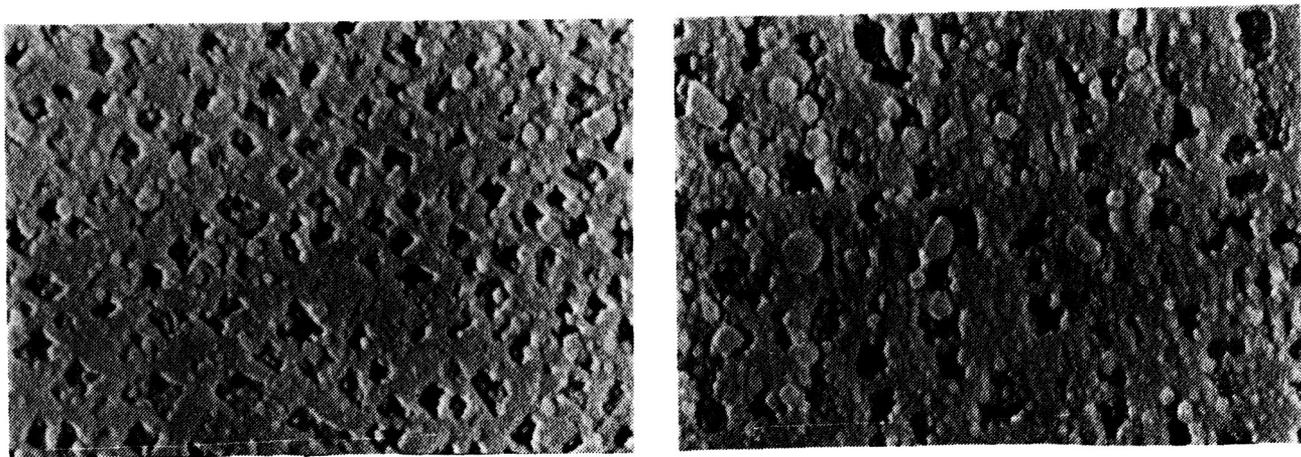
Figure 15. SEM Micrographs of MA6000 Turbine Blade Before and After 200-Hour Test Comparing Gamma Prime Morphology.

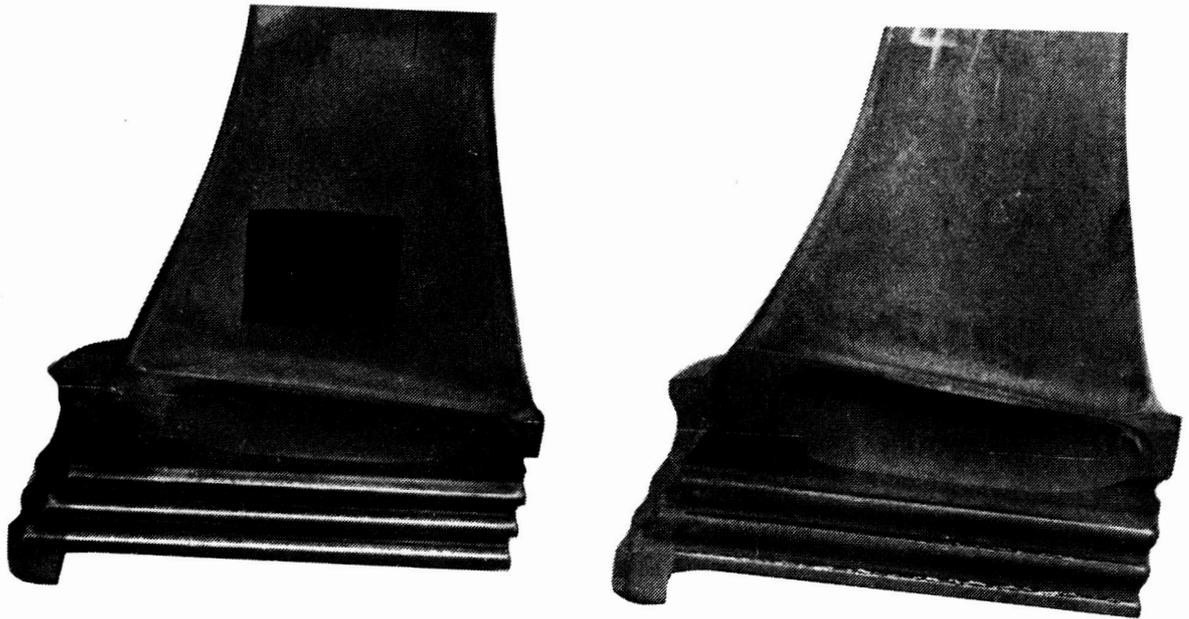
as compared to the previous cycles. Firtree fretting was observed on the blade after only 50 hours verifying the assumption that the fretting initiated prior to the 150-hour test when it was first noticed. The 200-hour blades showed only a slight worsening of the fretting condition, particularly at the contact surface of the lowest firtree lobe. None of the blades or the disk were rejected after visual examination and FPI.

**4.2.2 Firtree Fretting.** The fretting condition at the firtree region of a 50- and 200-hour blade are compared in Figure 16. Since the condition of the 150-hour blade was similar to the 200-hour blade, the latter blade was used in this evaluation to represent the maximum exposure condition observed. Initiation of fretting at the contact surfaces of the firtree lobes after 50 hours was observed on one blade. The 200-hour blades showed that the fretting worsened at the bottom lobe but not at the upper two lobes. Under microexamination of the firtree cross-section shown in Figure 17, the fretted surface appeared as a very shallow, cold, worked metal, no more than 0.0005 inches deep. Under microexamination, there was very little difference seen in the depth and severity of fretting between the 50-hour blade (Figure 18) and the 200-hour blade (Figure 19).

Figure 16. Firtree Fretting After 50 Hours (Left)  
and 200 Hours (Right).

- o Consider MA6000 blades for future applications where uncooled, high temperature operation is the primary consideration.
- o MA6000 alloy operating in a long-term engine operating environment should be coated with an oxidation resistant coating such as NiCrAlY. This can be overlaid with CoCrAlY if hot corrosion conditions are anticipated.
- o Evaluate method(s) to alleviate firtree fretting on the MA6000 blades.

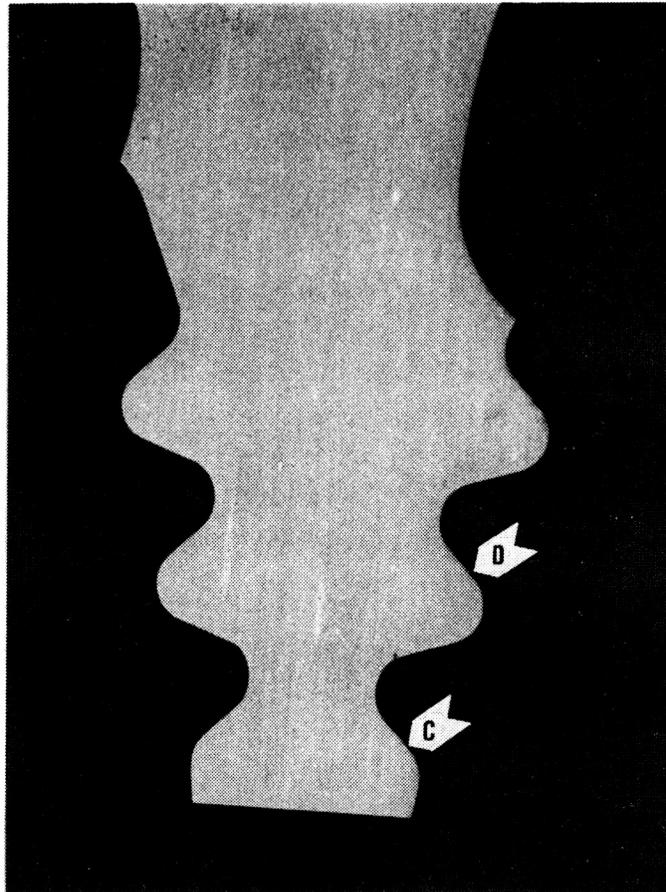
Figure 17. Firtree Cross-Section to Evaluate Fretting Condition.

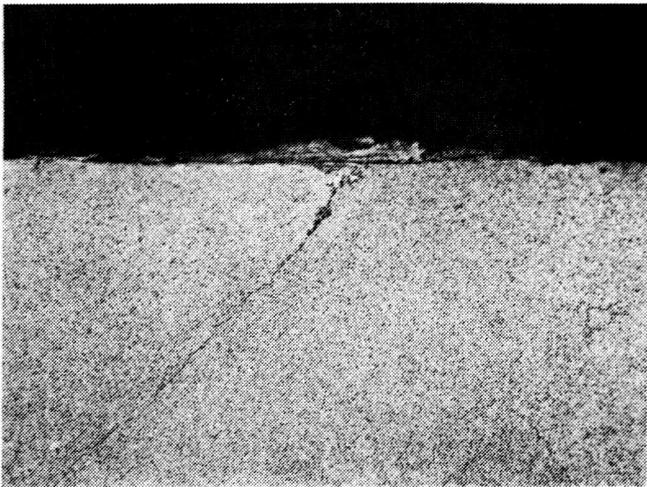
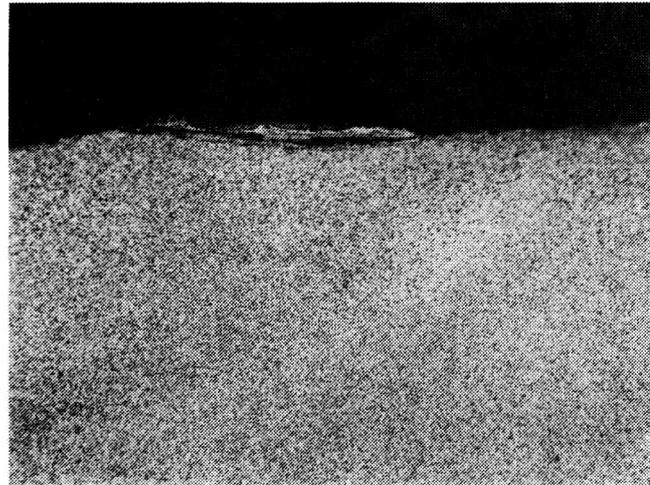
Figure 18. Firtree Fretting of MA6000 Blade  
After 50-Hour Engine Test.

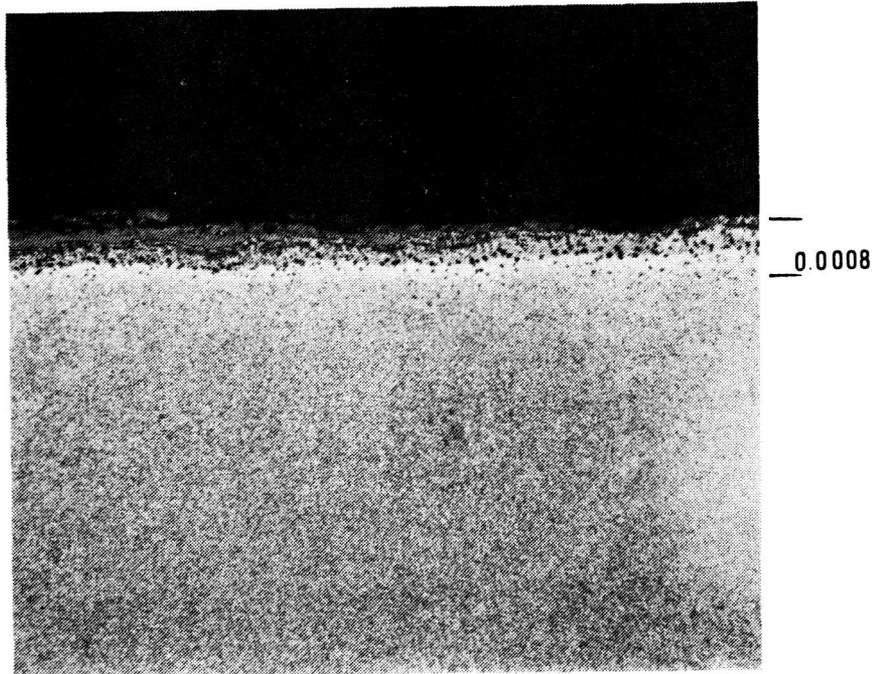
**4.2.3 Blade Oxidation.** The surface oxidation was generally uniform and approximately 0.0008 inches thick (Figure 20). However, a more severe grain boundary type of oxidation was observed in the blade microsections. This intergranular oxidation (IGO) condition appears to be more severe where the grain boundary intercepts the free surface at a relatively steep angle. Thus, at the airfoil tip and platform outboard surfaces (Figure 21), and likewise at the firtree lobe areas (Figure 22), IGO extends as deep as 0.0015 inches after 50 hours and propagates to depths of 0.0025 after 200 hours. The airfoil IGO, in comparison, was measured to be an average of 0.0010 inches after 200 hours of engine running.

Figure 20. Surface Oxidation in MA6000 Turbine Blade  
After 200-Hour Endurance Engine Test.

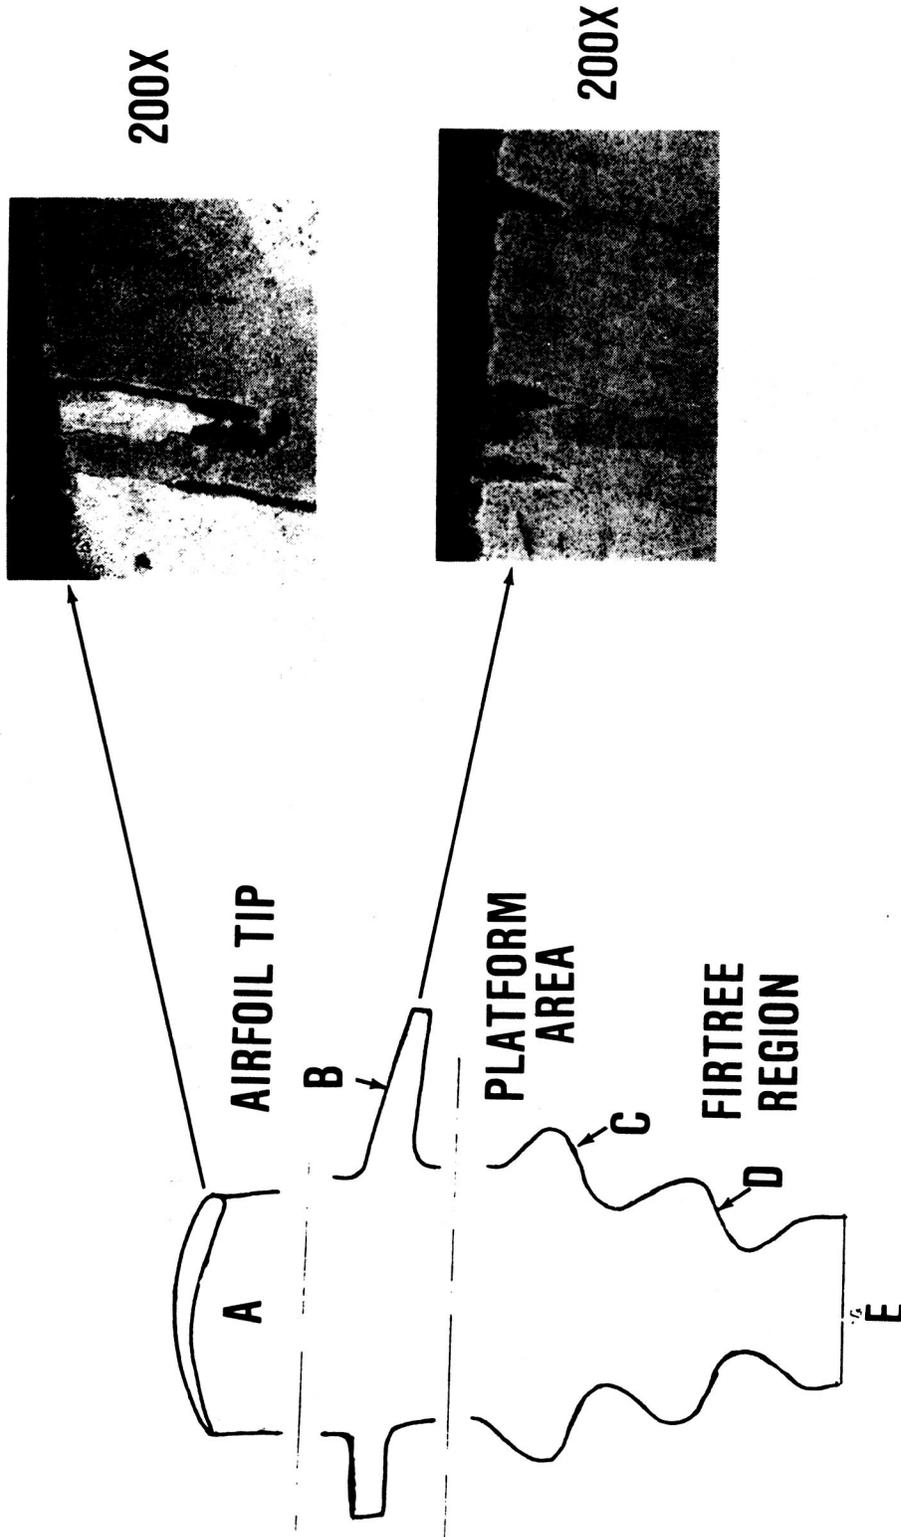
Figure 21. Grain Boundary Oxidation in MA6000 Turbine Blade After 200-Hour Endurance Engine Test.

The intergranular oxidation observed in these turbine blades tends to confirm that MA6000 is not as oxidation resistant as MAR-M 247 alloy. As noted earlier in this program, MA6000 alloy will require oxidation protection such as NiCrAlY coatings if it is to survive a long term engine operating environment.

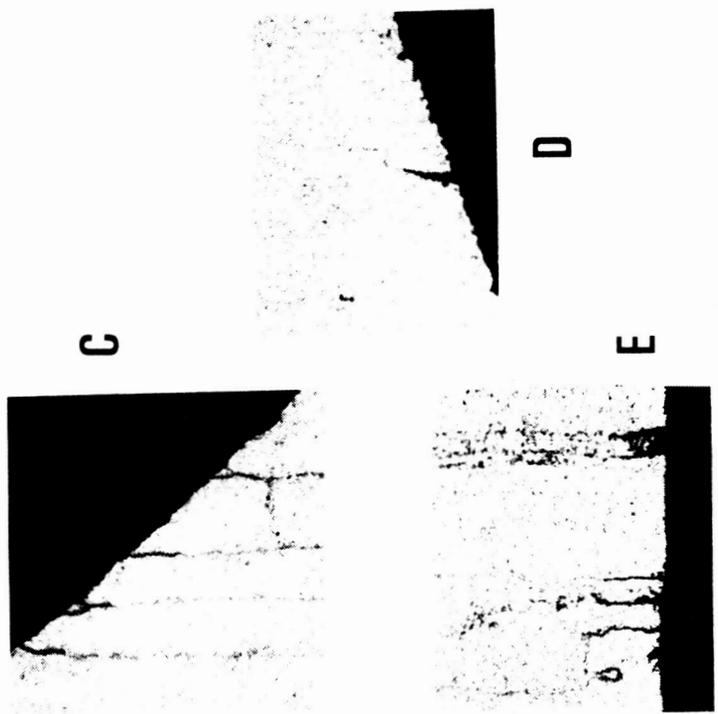
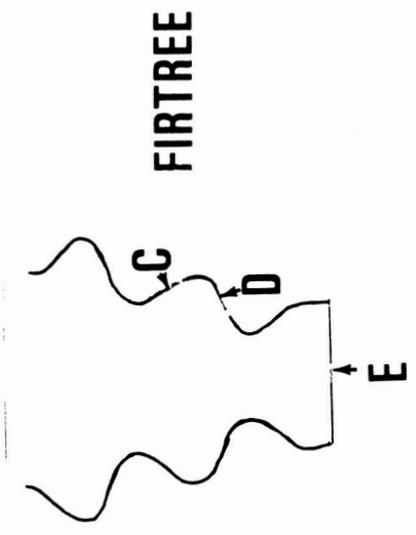
Figure 22. Grain Boundary Oxidation at the Firtree Region of MA6000 Turbine Blade After 200-Hour Endurance Engine Test.

The oxidation attack on the firtree region may be alleviated by the application of sputtered MAR-M 247 alloy coating. MAR-M 247 has demonstrated superior oxidation resistance over MA6000.

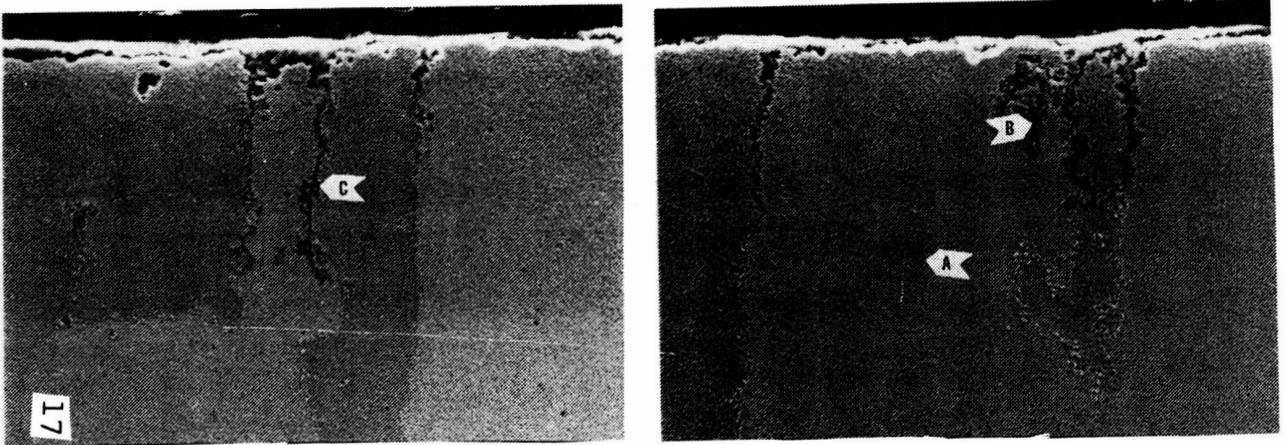
SEM photomicrographs of typical IGO are shown in Figure 23. Energy Dispersive X-ray analysis (EDAX) comparing the matrix (Figure 24) and the oxidation region (Figure 25) shows a higher level of chromium in the latter. This suggests chromium oxide as the predominant oxidation product in the alloy system. An EDAX scan of the area adjacent to the oxidized region did not reveal any significant elemental depletion. It has been reported by M.J. Fleetwood (J. Inst. Metals 1966, Vol. 94, p.218) that Cr diffusion is enhanced in thoriated alloys such as those prepared by attrition milling of fine powders. His study indicated that this rapid diffusion was attributed to a very high density of dislocations and subgrain boundaries in dispersion strengthened alloys which might then result in the absence of a well-defined depleted zone, at least one that is not readily observed from the relatively qualitative peaks of an EDAX analysis.

Figure 23. SEM Micrograph of Grain Boundary Oxidation in MA6000 Blade After 200-Hour Engine Test.

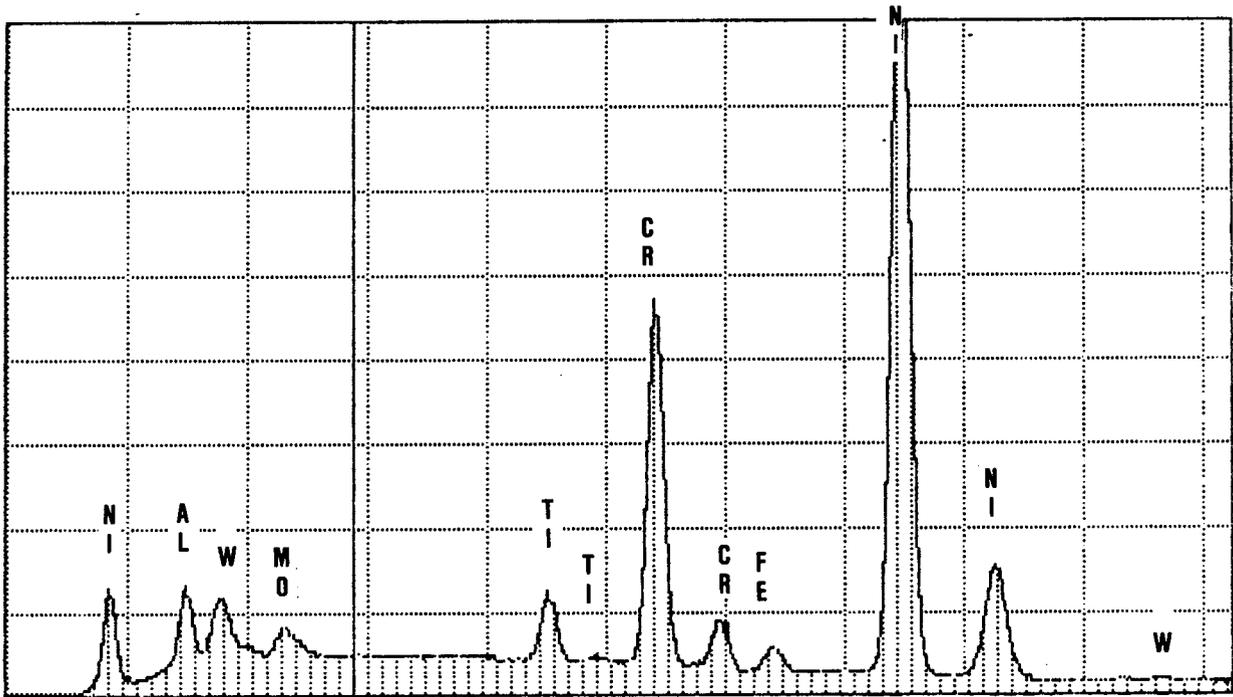
Figure 24. EDAX Spectrum of MA6000 Matrix at Location A in Figure 23.

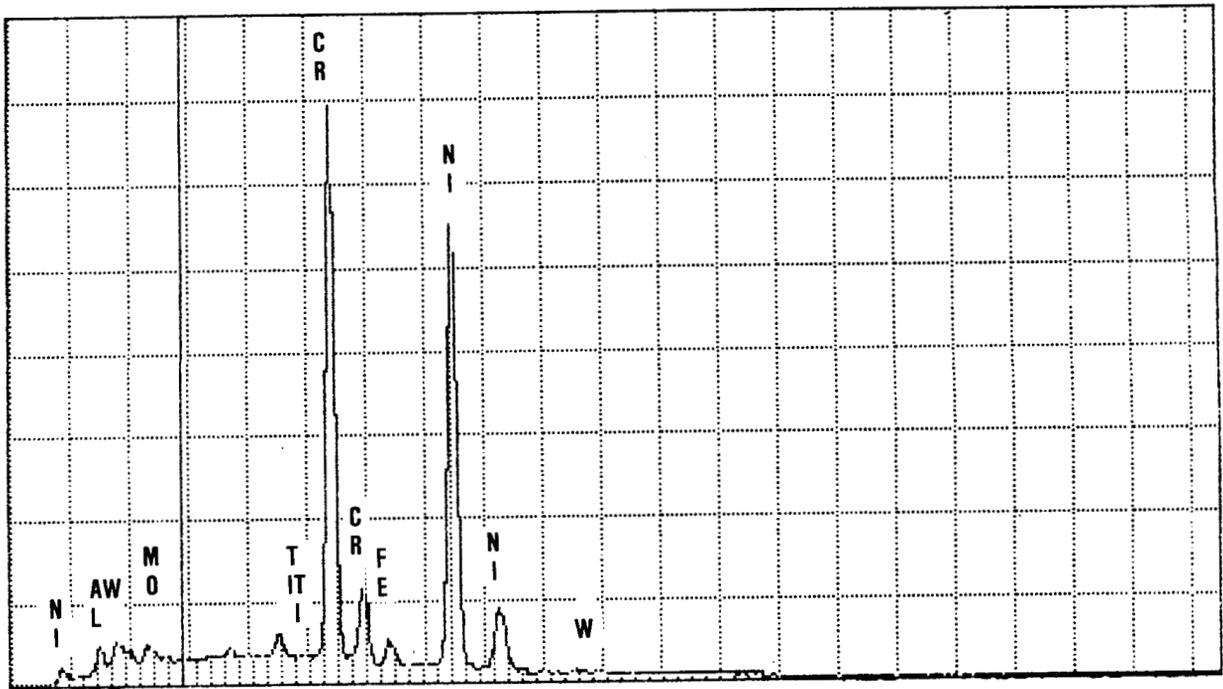
Figure 25. Typical EDAX Spectrum of MA6000 at Oxidized Region at Locations B and C in Figure 23 Showing High Cr Level.
