**VOLUME II
MATERIALS FOR ADVANCED TURBINE ENGINES
(MATE) - PROJECT 4
EROSION RESISTANT COMPRESSOR AIRFOIL COATINGS
FINAL REPORT**

**UNITED TECHNOLOGIES CORPORATION
Pratt & Whitney
Engineering Division**

**Prepared for
National Aeronautics and Space Administration
Lewis Research Center
Contract NAS3-20072 - Project 4**

1. REPORT NO. CR- 179645		2. GOVERNMENT AGENCY		3. RECIPIENT'S CATALOG NO.	
4. TITLE AND SUBTITLE MATE PROGRAM Erosion Resistant Compressor Airfoil Coating - Volume II			5. REPORT DATE November 1986

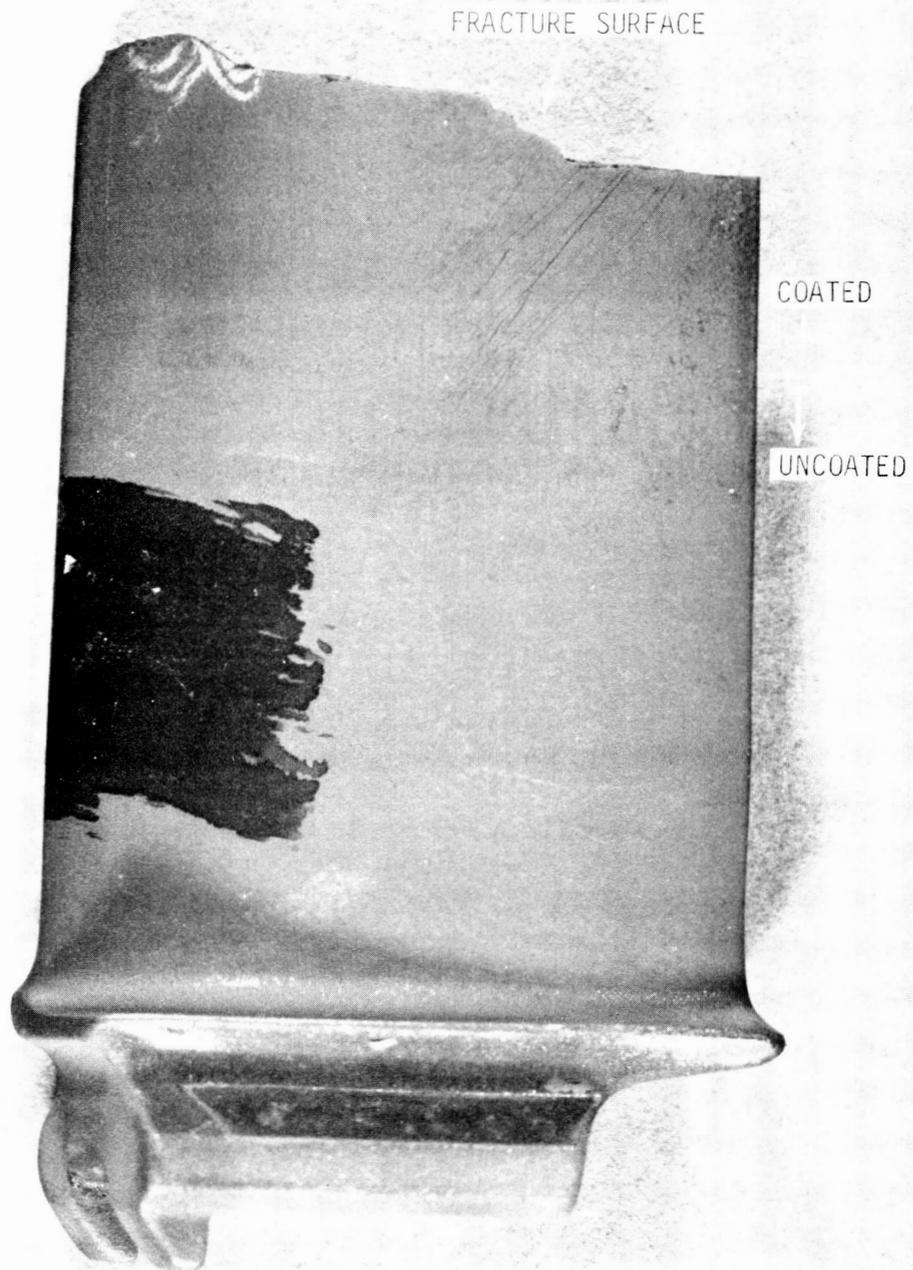
One Gator-Gard plasma spray coated 88WC-12Co eighth stage AMS 4928 compressor blade fractured transversely through the airfoil approximately 1 1/2" above the root platform (Figure 8). Binocular and scanning electron microscope examinations revealed fatigue which progressed from a Gator-Gard coated airfoil surface approximately 0.01 - 0.03" from the trailing edge (Figure 9). Metallographic examination of a longitudinal section through the airfoil at the fatigue origin revealed a transgranular fracture path.

Figure 8 JT8D Engine Operated 8th Stage AMS 4928 Compressor Blade Showing Fracture in Gator-Gard Plasma Sprayed 88WC-12Co Coated Airfoil Region

The JT8D engine test was terminated after 744 cycles of a planned 1000 cycle test. In addition to coated compressor airfoils, an experimental weld repaired eighth stage stator anti-rotation lug was also incorporated for evaluation in this engine. This repaired anti-rotation lug experienced a fatigue fracture and was not found at engine disassembly. The part was presumed to have entered the gas path prior to the seventh stage and was the primary cause of heavy impact damage observed on the seventh stage blades. Examination of the impact damaged areas suggested that the event occurred some time prior to the termination of the test. Examination of the fractured JT8D compressor blade indicated there was no evidence of impact damage in the vicinity of the fatigue origin. Although the Gator-Gard plasma spray coating resulted in a significant debit to the eighth stage airfoil, the debit, by itself, was not sufficient to have caused the blade to fracture. However, failure of the anti-rotation lug would have resulted in increased eighth stage rotor vibratory stress which could initiate fatigue damage in the airfoils. Inspection of the remainder of airfoils in the rotor revealed various degrees of foreign object damage which precluded coating crack assessment on the other airfoils.

- o Airfoil fracture of the JT8D airfoil is believed to have occurred as a result of the fracture of another engine component which resulted in increased eighth stage vibratory stress. Fracture of the JT9D seventh stage airfoil was the result of fatigue originating in the Gator-Gard plasma spray 88WC-12Co coated section of the AMS 4928 airfoil at the leading and trailing edges.

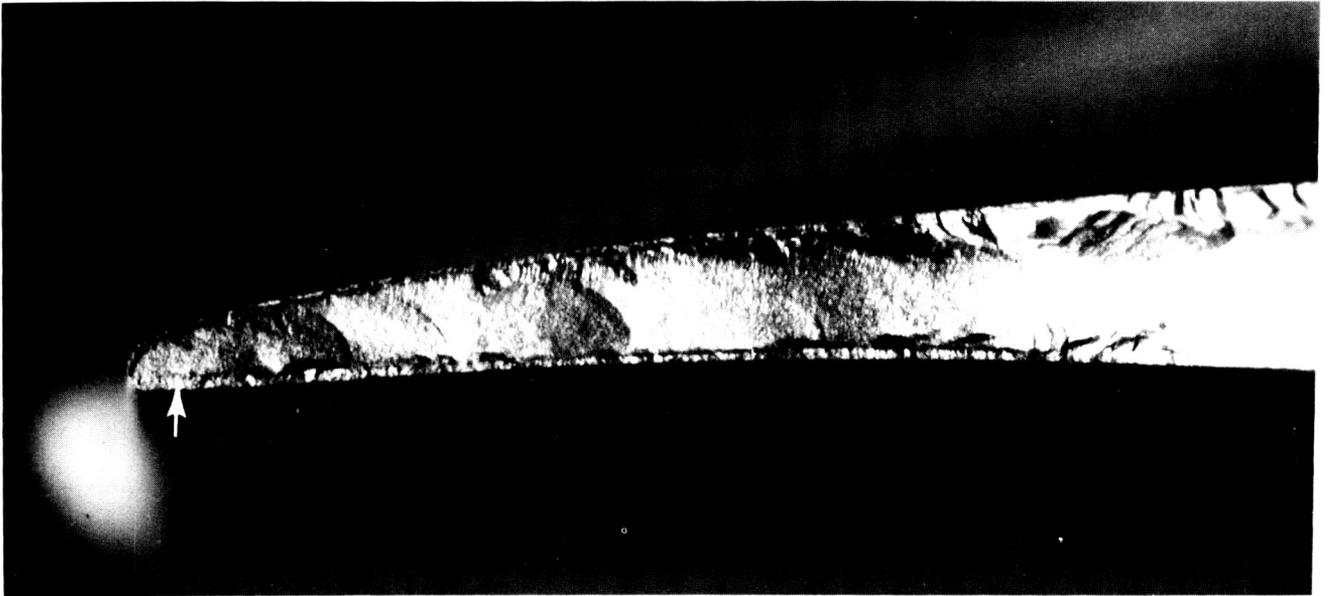
Figure 9 JT8D 8th Stage Engine Operated AMS 4928 Compressor Blade Gator-Gard Plasma Sprayed with 88WC-12Co Showing Transverse Fatigue Fracture Through Coated Area From Origin Near Trailing Edge (Arrow)

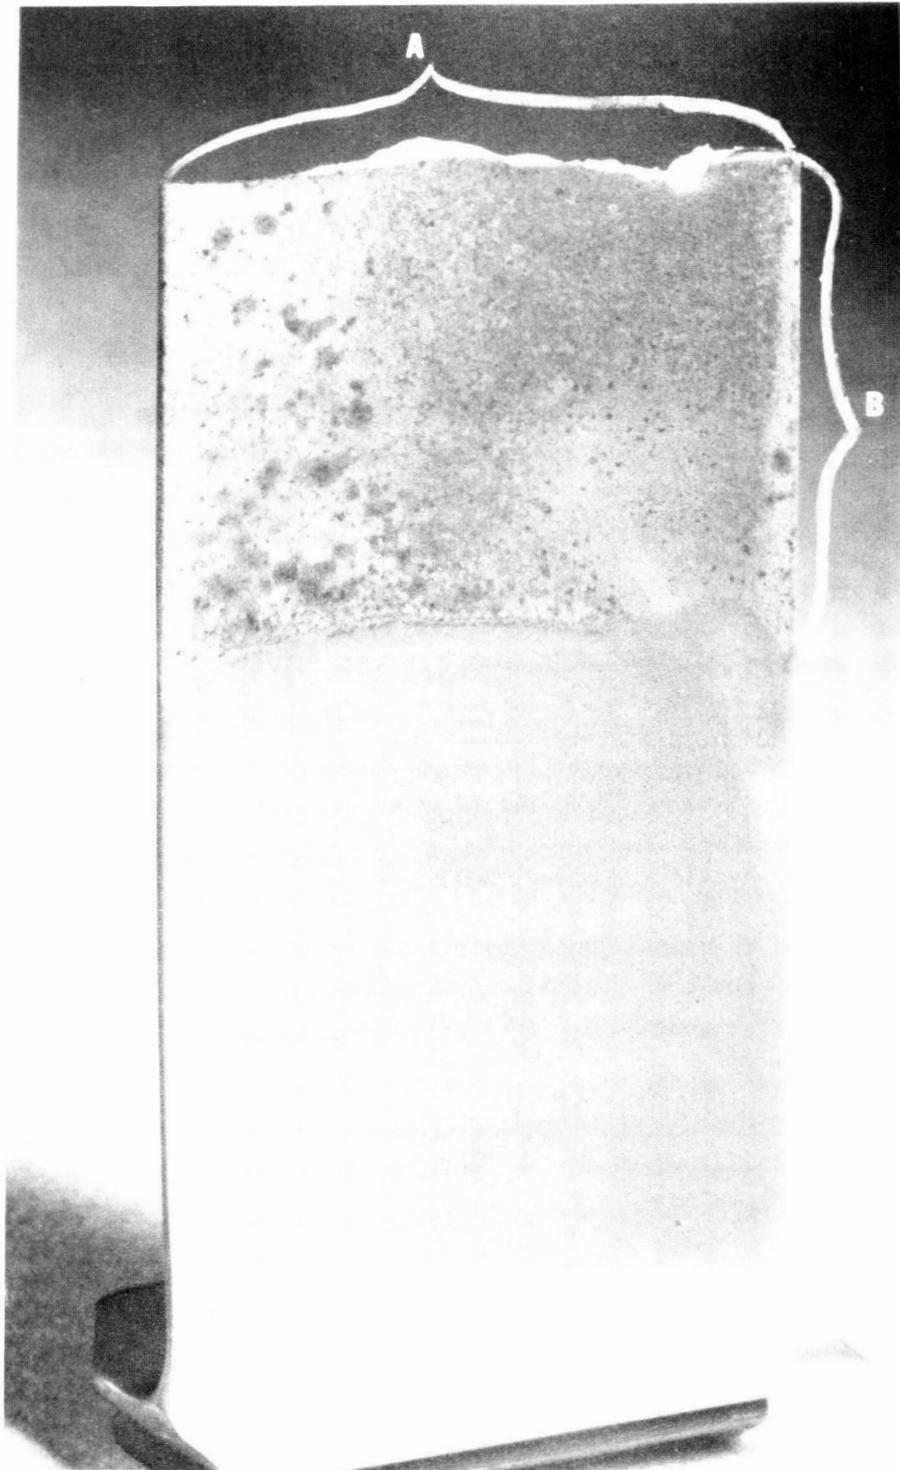
One Gator-Gard plasma spray coated 88WC-12Co seventh stage AMS 4928 compressor blade fractured through the airfoil approximately 2 5/8" above the root platform (Figure 10).

Figure 10 JT9D 7th Stage Engine Operated AMS 4928 Compressor Blade Showing Fracture (Bracket A) in Gator-Gard Plasma Sprayed 88WC-12Co Coated Airfoil Region (Bracket B)

The JT9D engine test was terminated after 189 cycles due to a high cycle fatigue fracture of one Gator-Gard plasma spray coated seventh stage compressor blade. Fluorescent penetrant inspection of all remaining seventh stage coated airfoils revealed no crack indications, i.e. there was no incipient cracking on any other seventh stage airfoils. While the examination failed to detect the precise cause of the airfoil fracture, the possibility remains that the coating application process may have created a critical defect which resulted in the subject airfoil fracture.

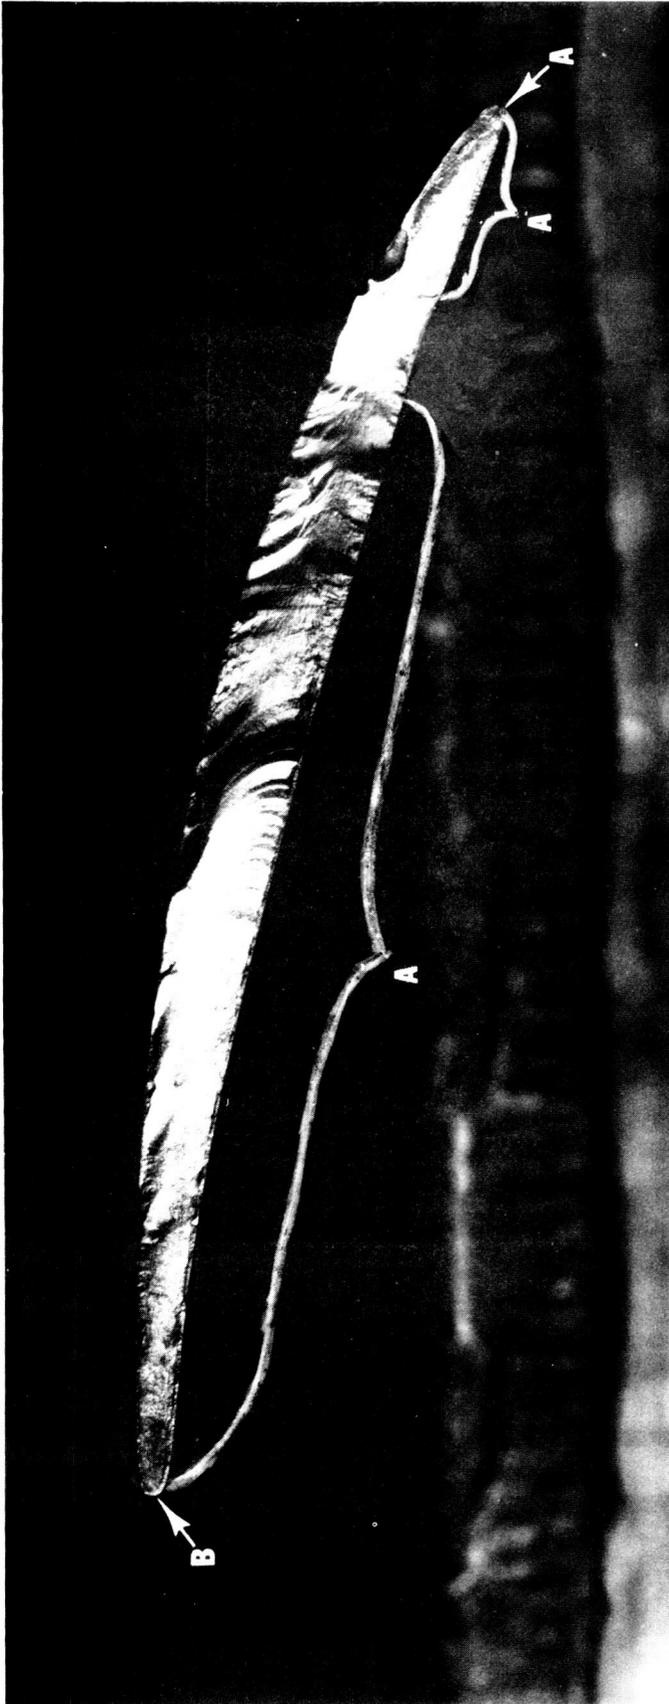
Binocular and scanning electron fractographic examination of the JT9D seventh stage airfoil fracture surface revealed high cycle fatigue (HCF) which had progressed for approximately 7/8" from an origin at the trailing edge surface, and for approximately 5/32" from an origin in vicinity of the leading edge (Figures 11 and 12); rubbed leading edge fracture surface precluded identification of the exact origin location. Fracture terminated in tensile overload between the extremities of the two HCF progressions.

Figure 11 Fracture Surface of JT9D 7th Stage AMS 4928 Engine Operated
Compressor Blade Gator-Gard Plasma Spray Coated With 88WC-12Co
Showing High Cycle Fatigue (Brackets A) Originating at Leading Edge
(Arrow A) and Trailing Edge (Arrow B)

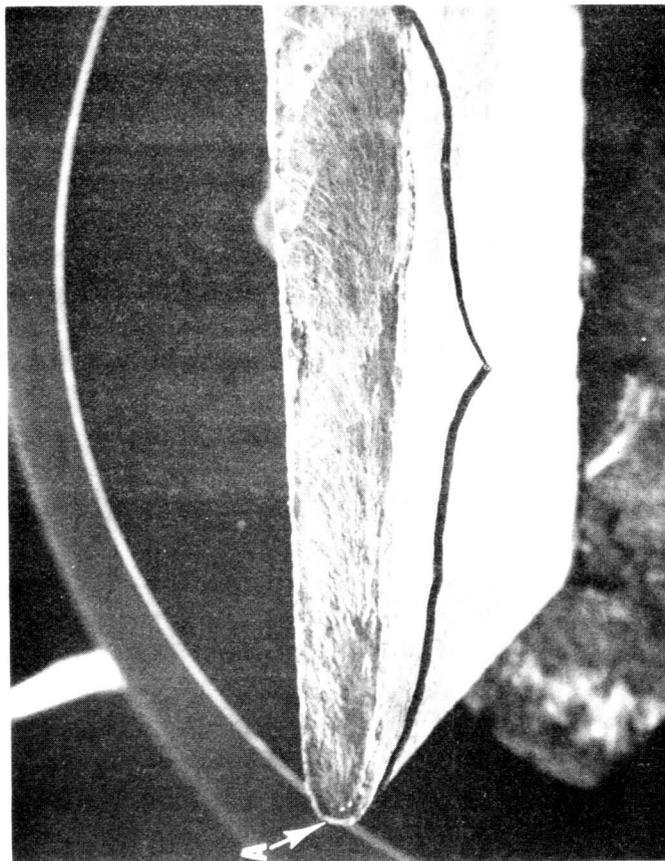
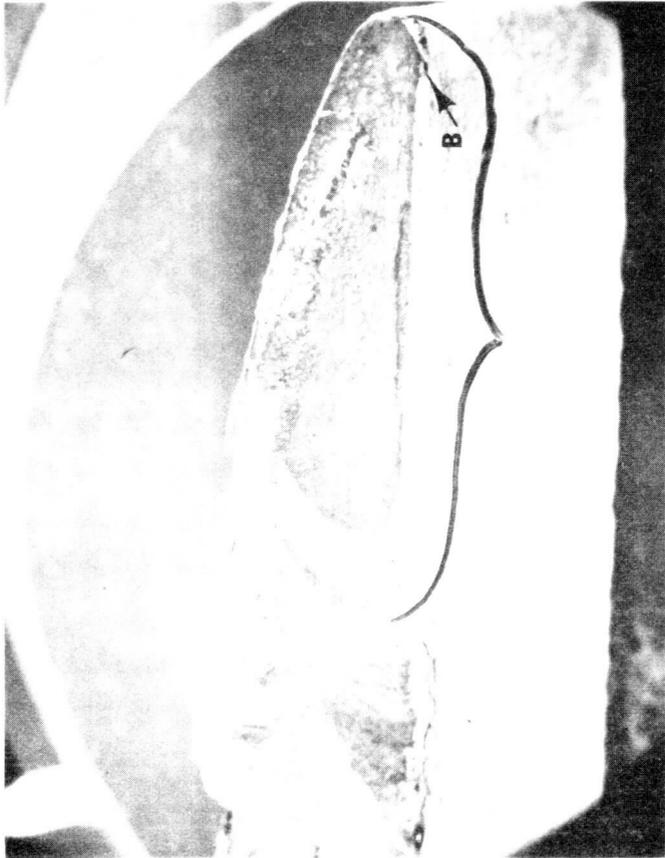
Figure 12 Scanning Electron Fractographs of JT9D AMS 4928 Engine Operated Airfoil Trailing Edge (left) and Leading Edge (right) Fracture Surfaces, Showing High Cycle Fatigue (Brackets) From Origins at Trailing Edge (Arrow A) and in Vicinity of Leading Edge (Arrow B).

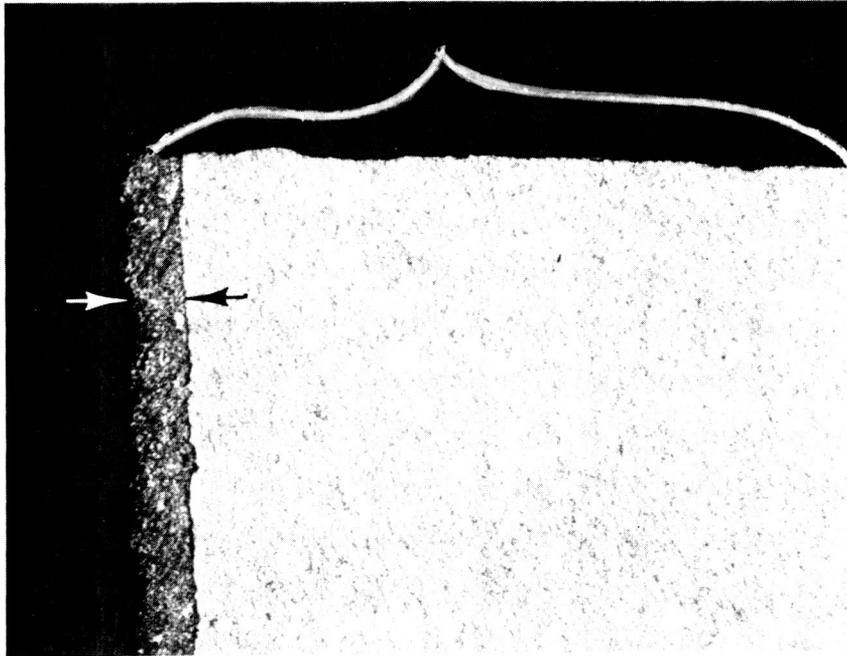
Metallographic examination of plasma coated sections through the leading and trailing edges revealed transgranular HCF fracture paths; there were no apparent material or processing defects at the fatigue origins (Figure 13). Examination of a transverse section through the airfoil, inboard of the fracture, revealed that the coating conformed to the thickness requirement of 25 to 63 microns (1 to 2.5 mils). Coating microstructure was similar to the coating tested in Task VI.

Figure 13 Planar Section Through Trailing Edge of JT9D Engine Operated Fractured Blade Showing a Transgranular, High Cycle Fatigue Fracture Path (Bracket) and Gator-Gard Plasma Sprayed 88WC-12Co Coating (Between Arrows). A Similar Fracture Path Was Evident at Leading Edge.
