KSC Ice/Frost/Debris Assessment For Space Shuttle Mission STS-30R

May 1989

KSC
ICE/FROST/DEBRIS ASSESSMENT
FOR
SPACE SHUTTLE MISSION
STS-30R
MAY 4, 1989

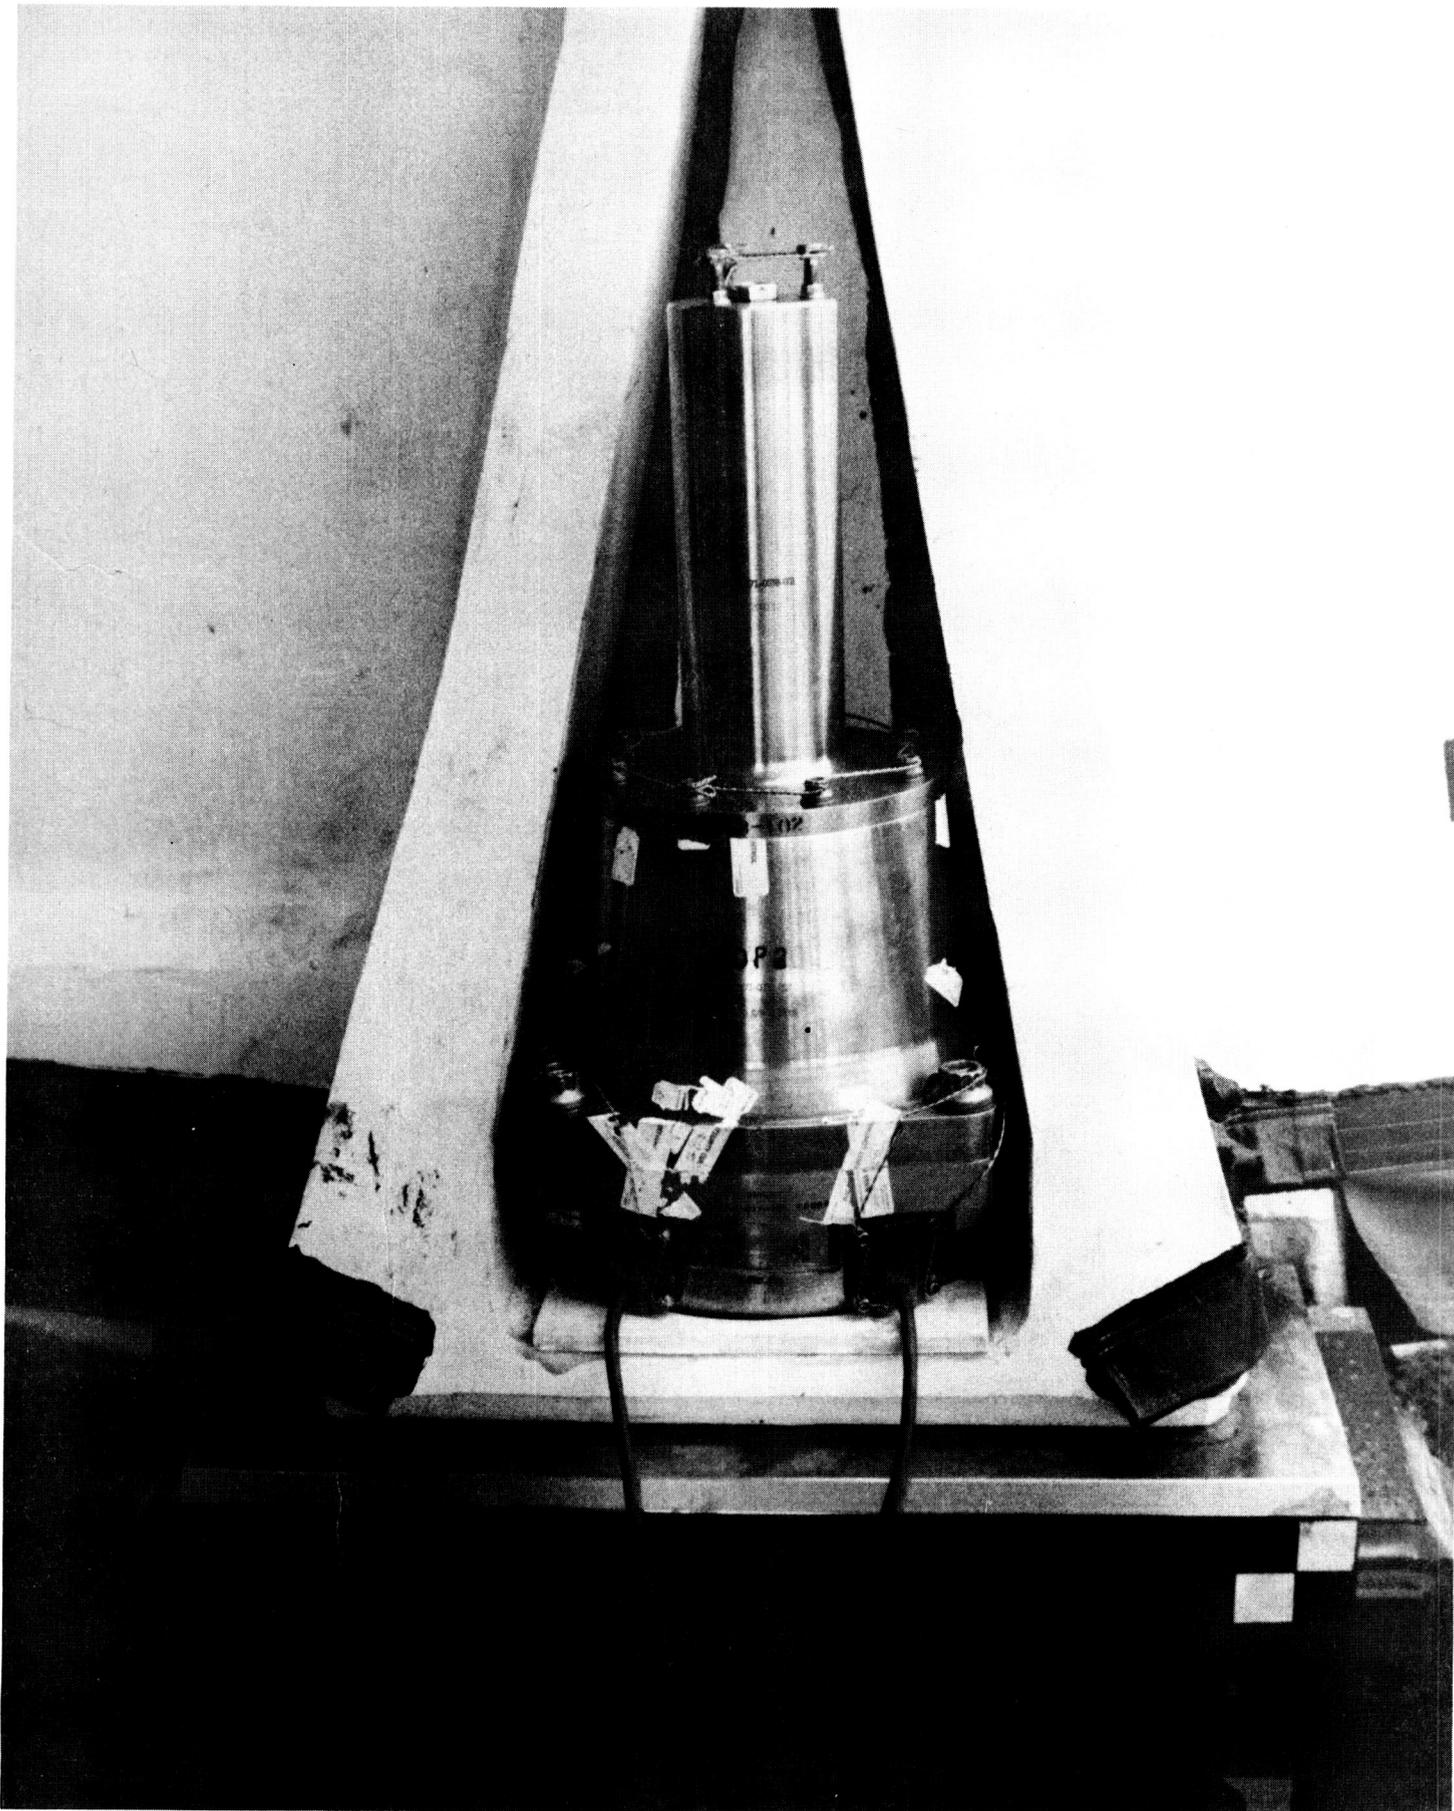
COVERS ON THE HDP SEPARATION BOLT FIRING LINES WILL
BE REMOVED LATER IN THE COUNT IN FUTURE FLOWS

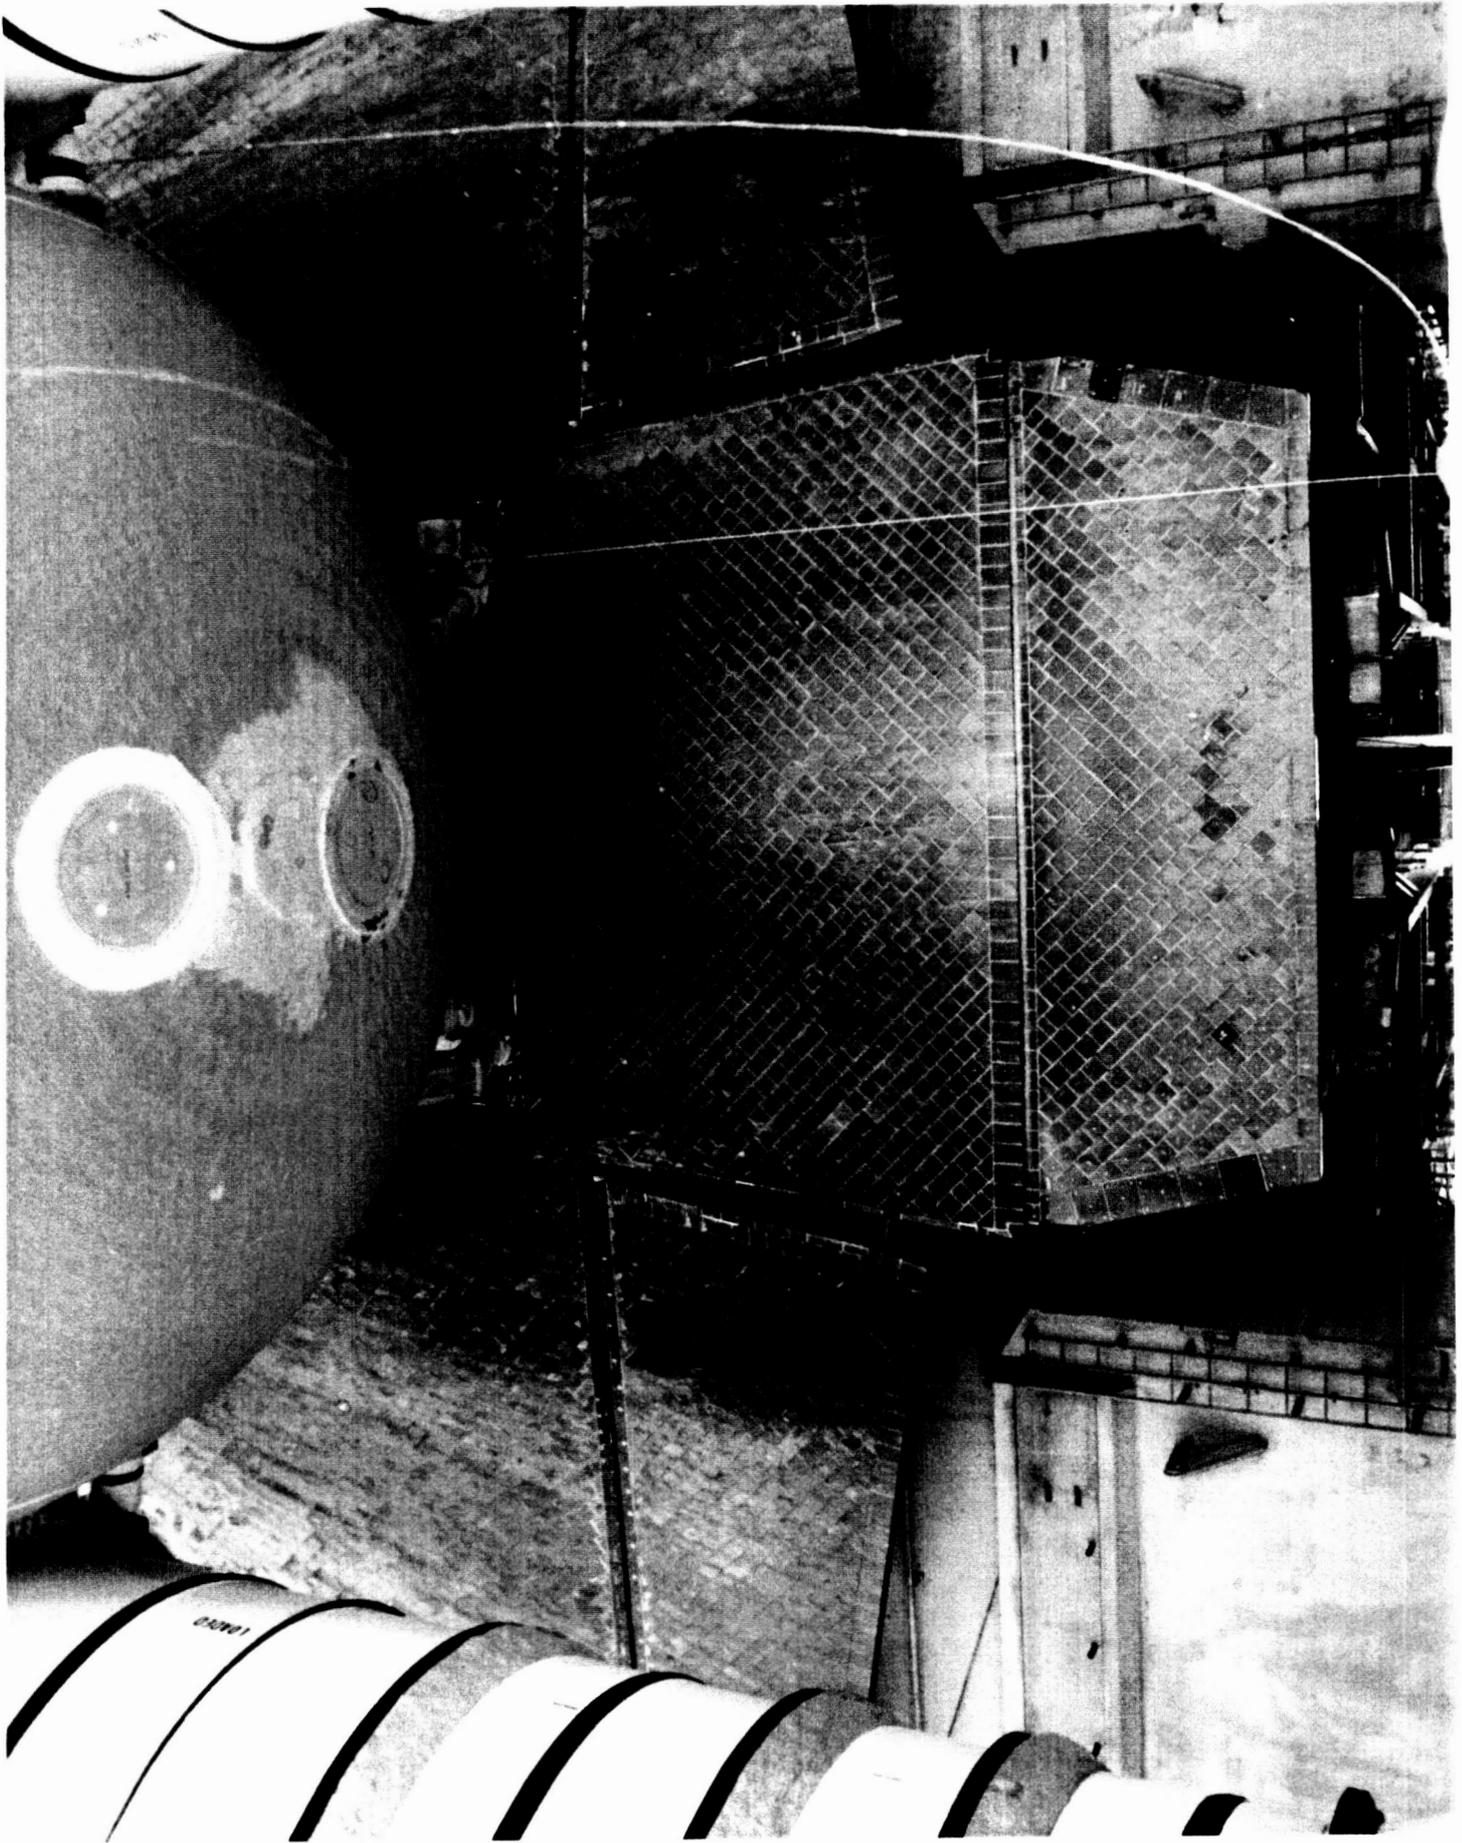
TYGON TUBING AND RELEASE CORD INDICATE TEMPORARY INSTALLATION
OF ET/ORB HYDROGEN UMBILICAL LEAK DETECTOR

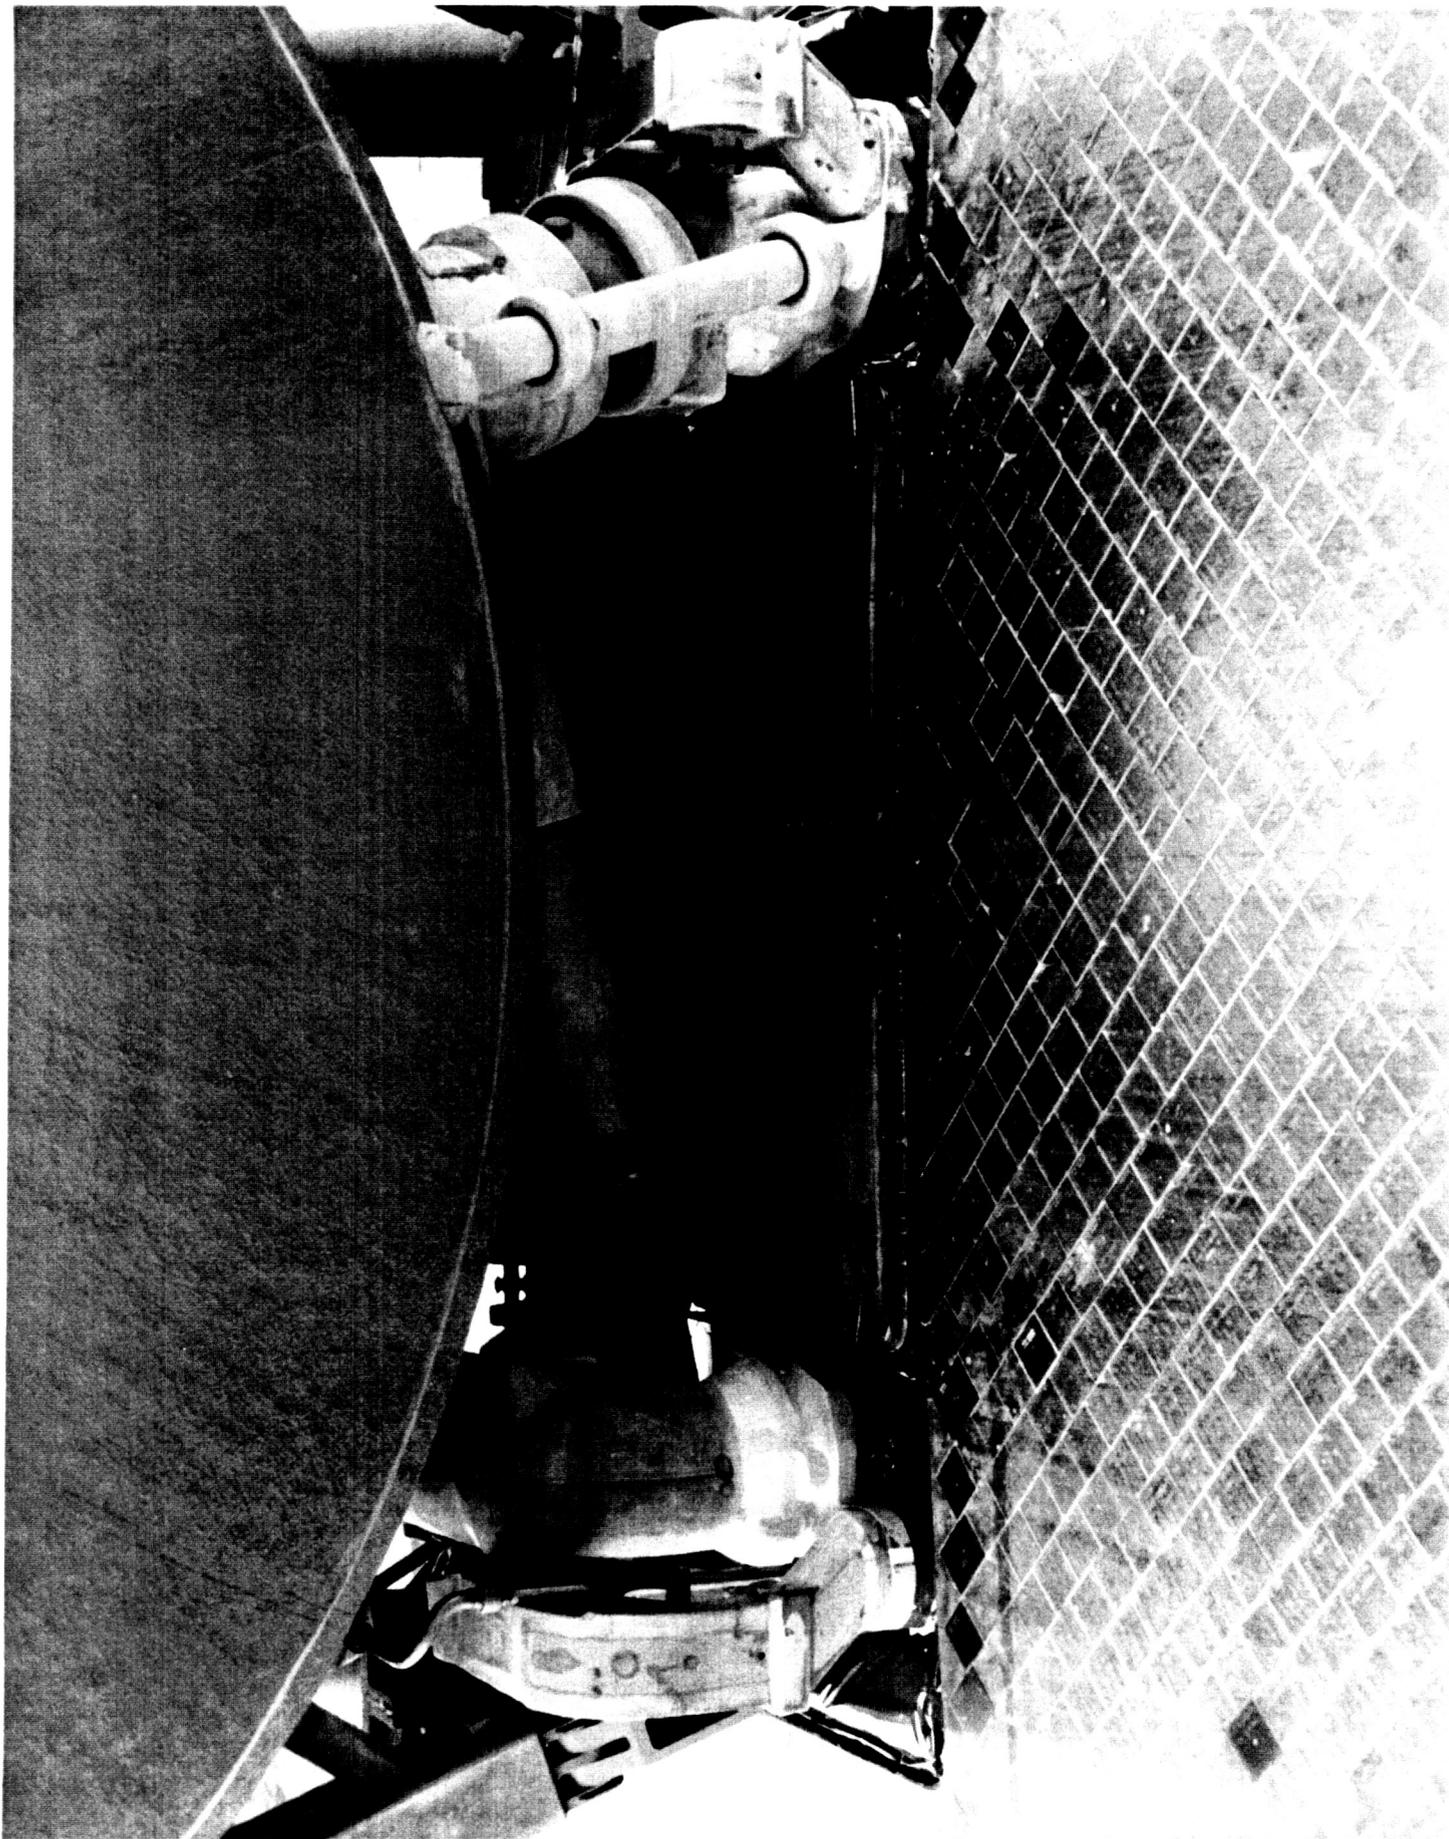
BAGGIE CLOSEOUT ON ET/ORB UMBILICALS. HYDROGEN LEAK DETECTOR
TYGON TUBE IS VISIBLE AT LH2 UMBILICAL CABLE TRAY.

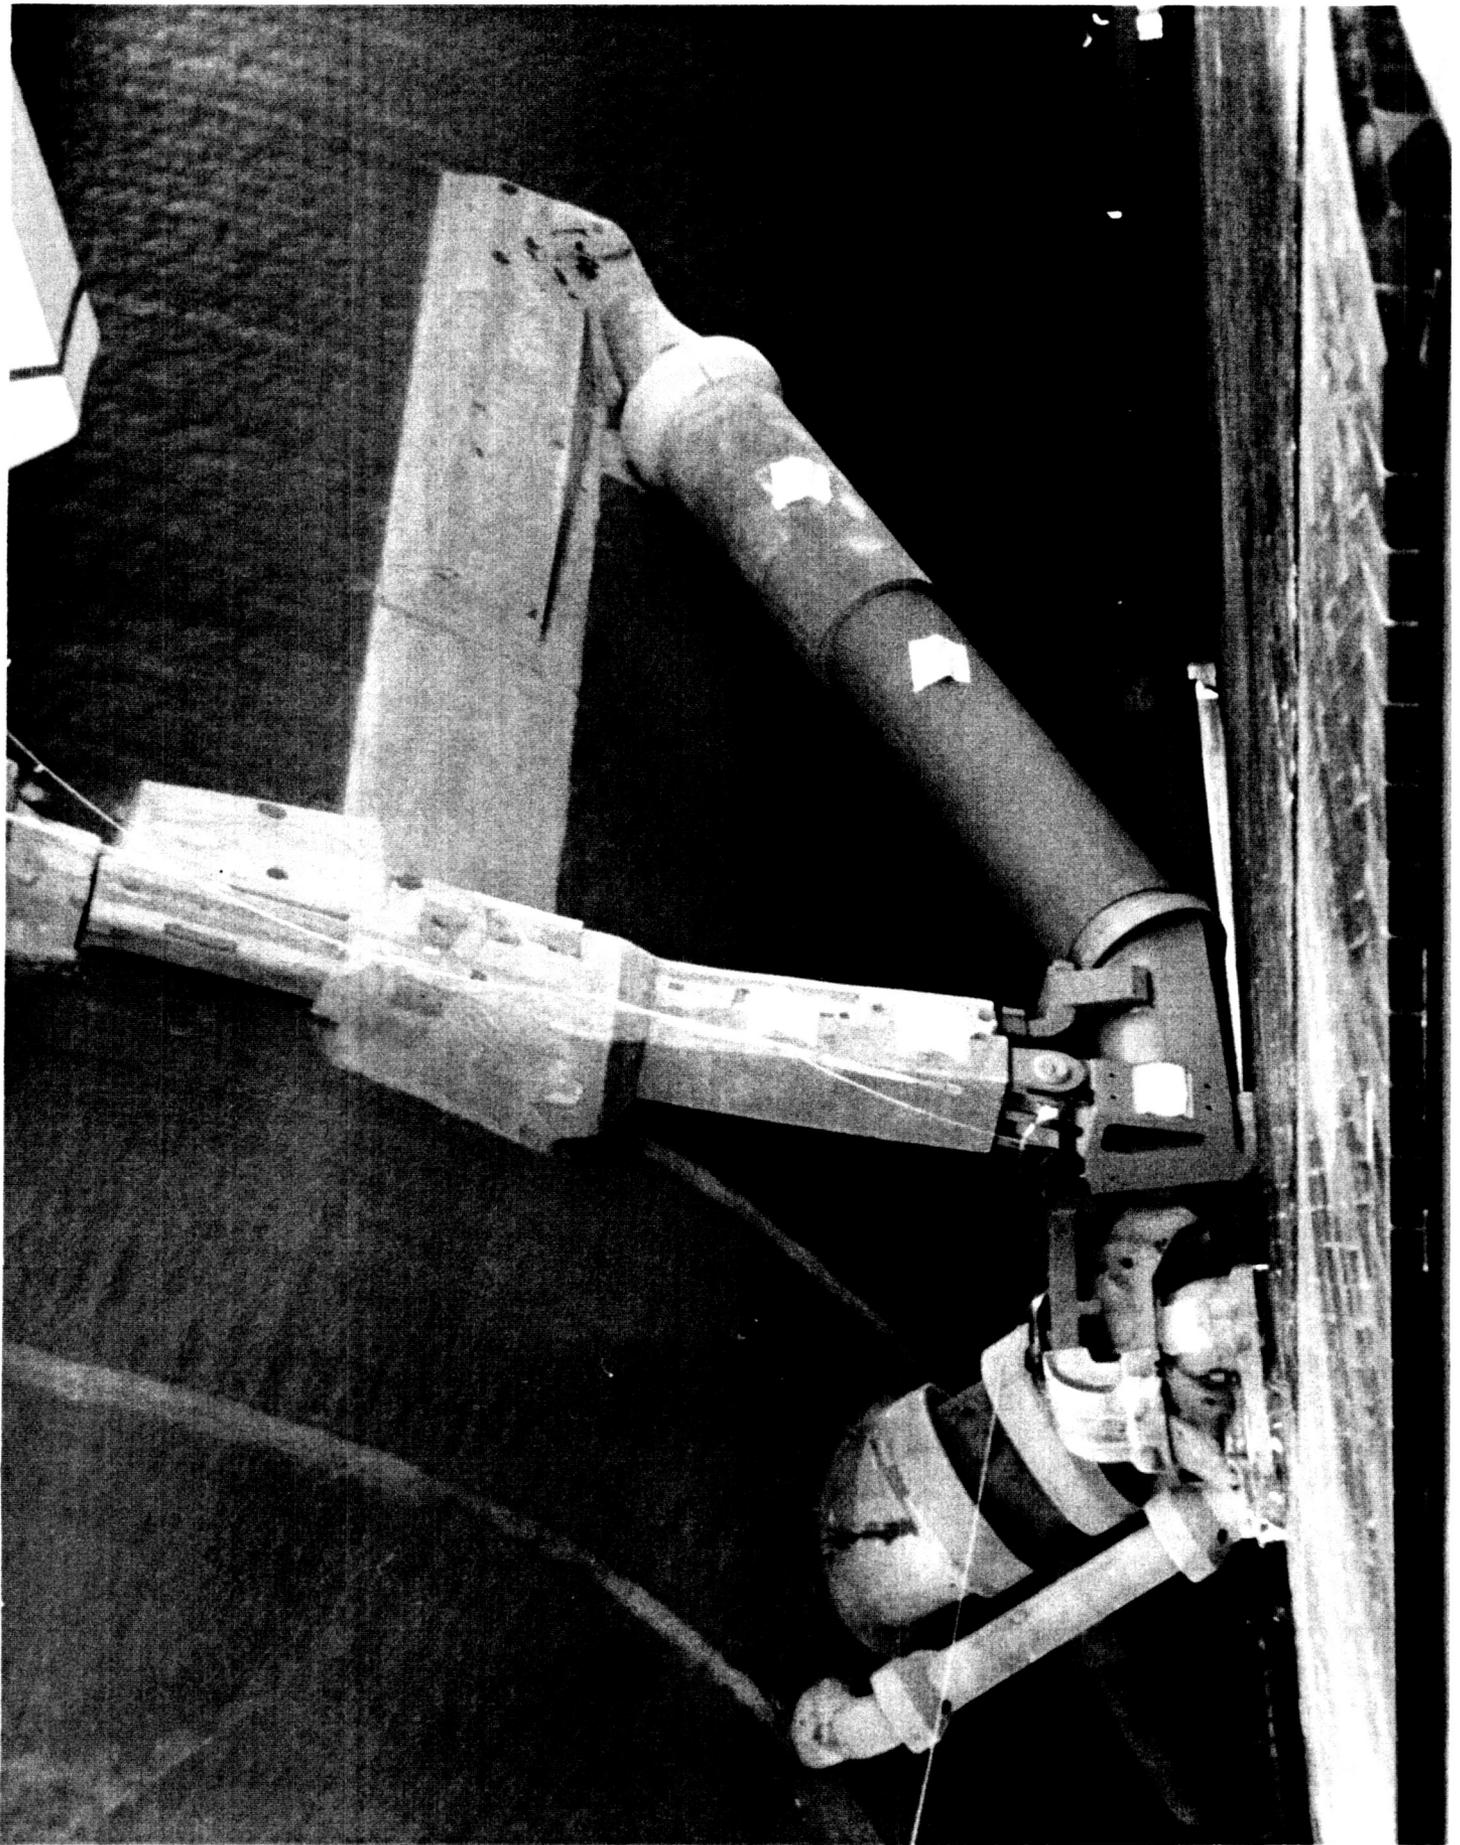
HYDROGEN DETECTOR IS TEMPORARILY ATTACHED TO ET/SRB STRUT
FAIRING, ET THRUST FITTING, AND LH2 TANK PRESS LINE

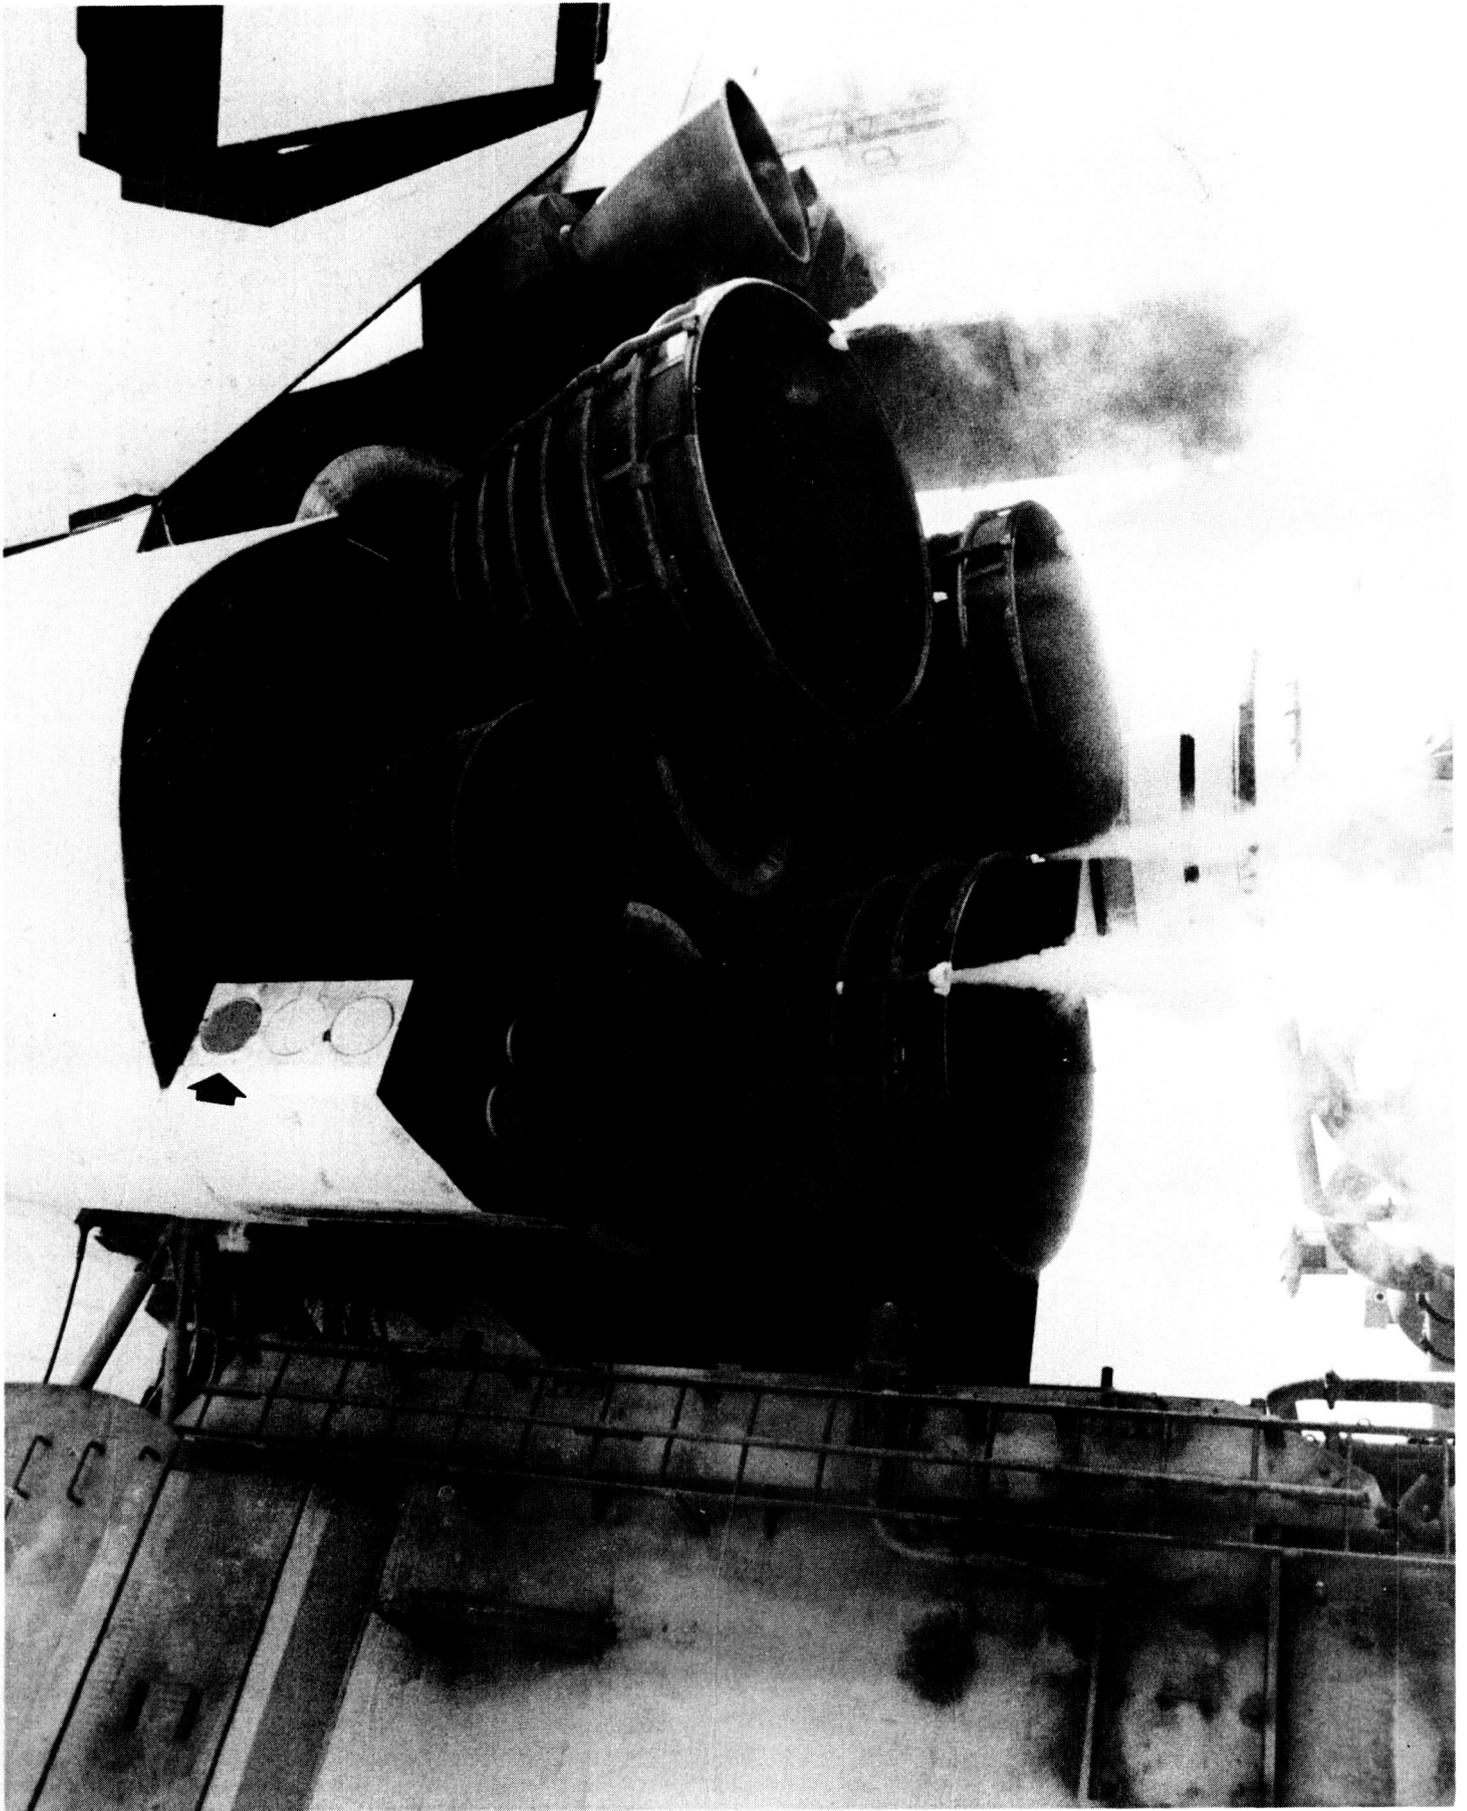
OVERALL VIEW OF SSME'S. NOTE DISCOLORED
PAPER COVER ON LH RCS STINGER.

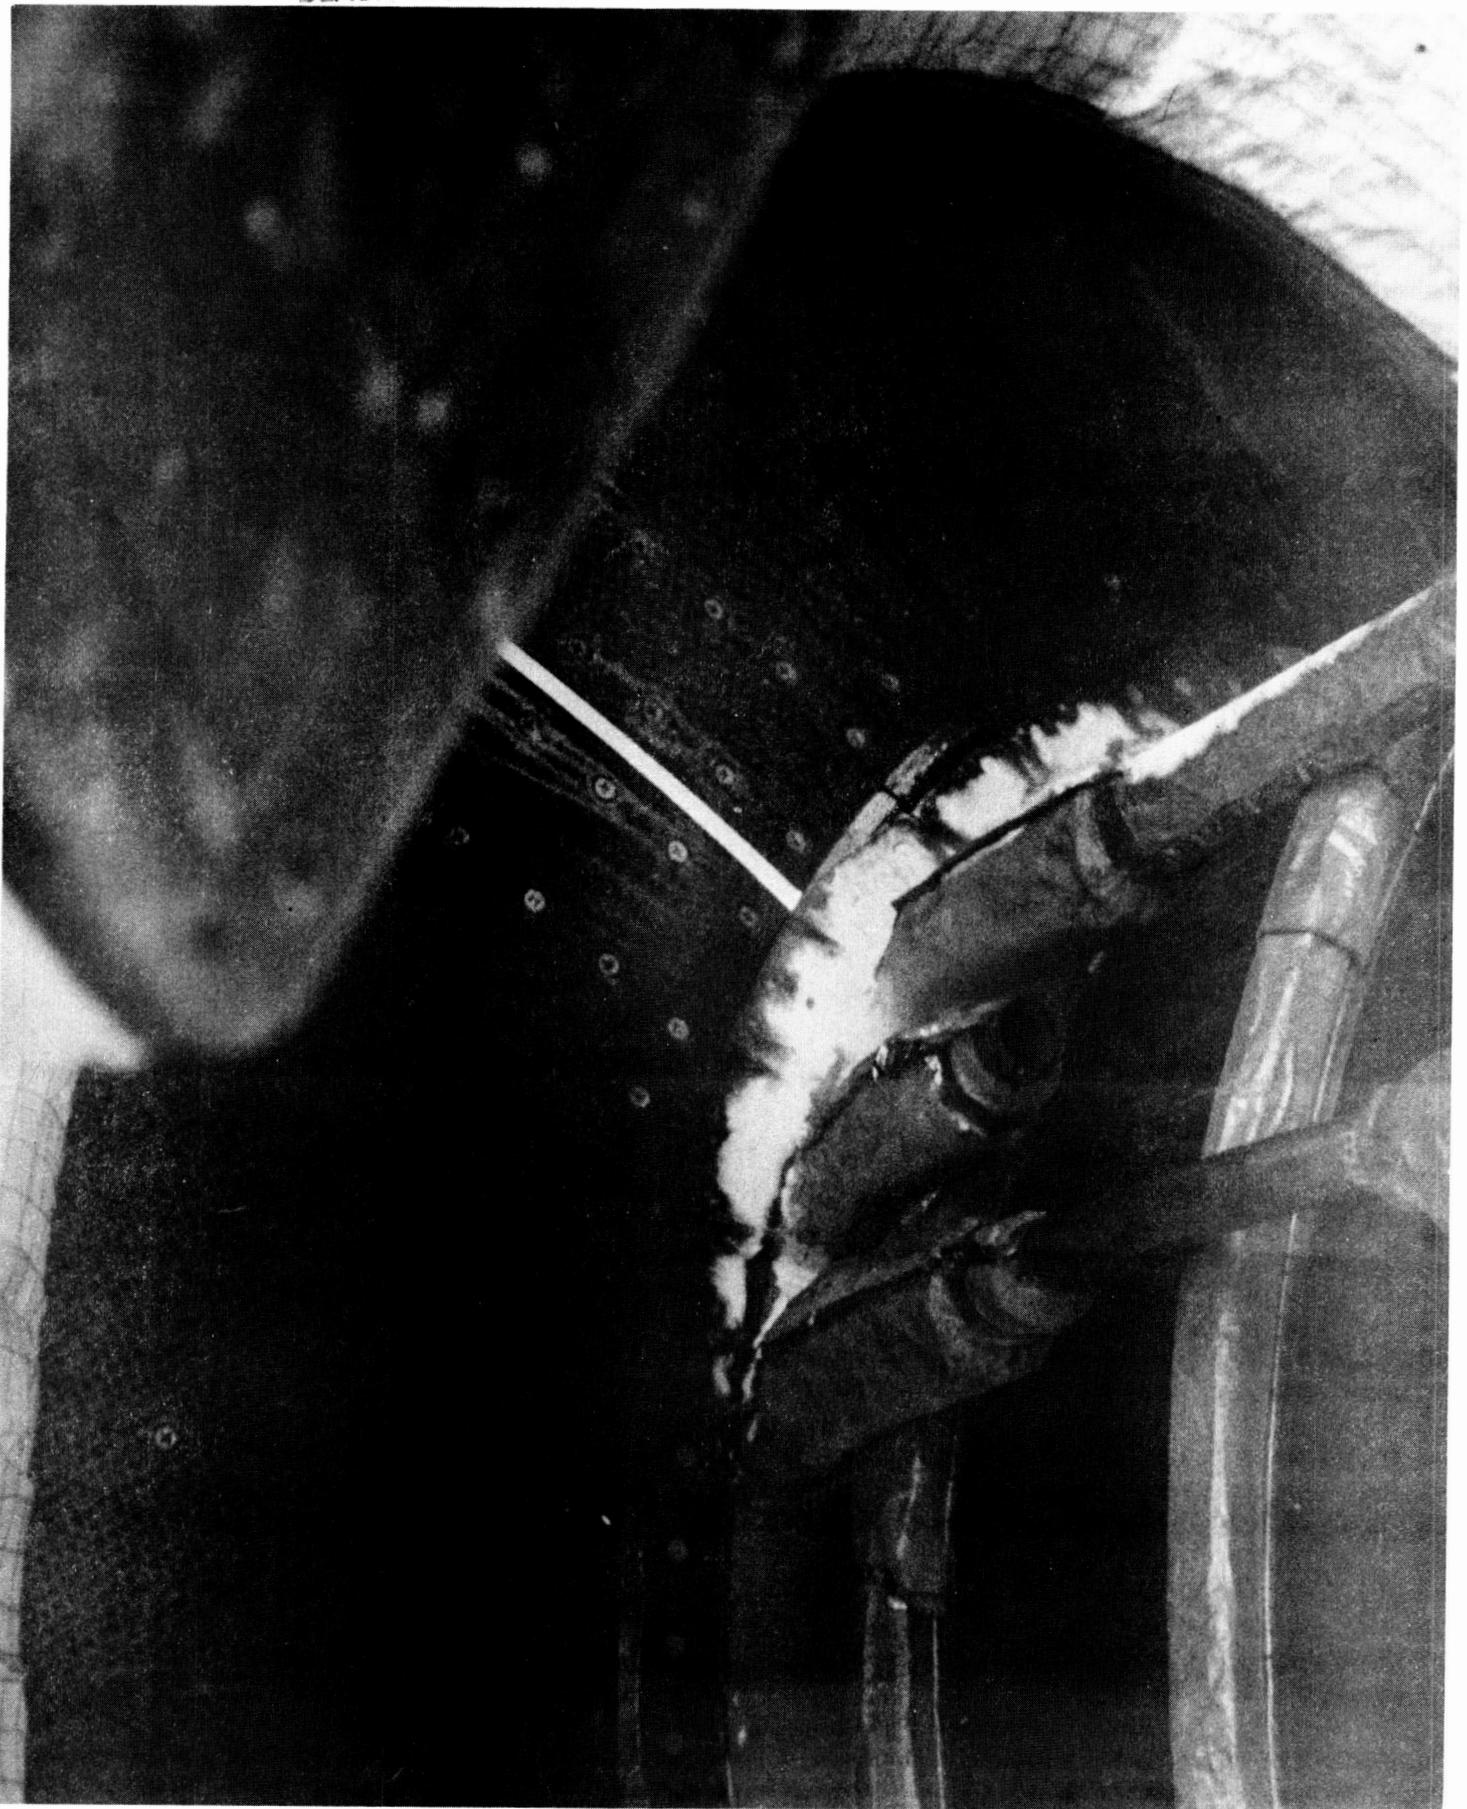
ICE/FROST ACCUMULATION AT ENGINE MOUNTED HEAT SHIELD
TO NOZZLE INTERFACE. CONDENSATE IS ALSO VISIBLE.

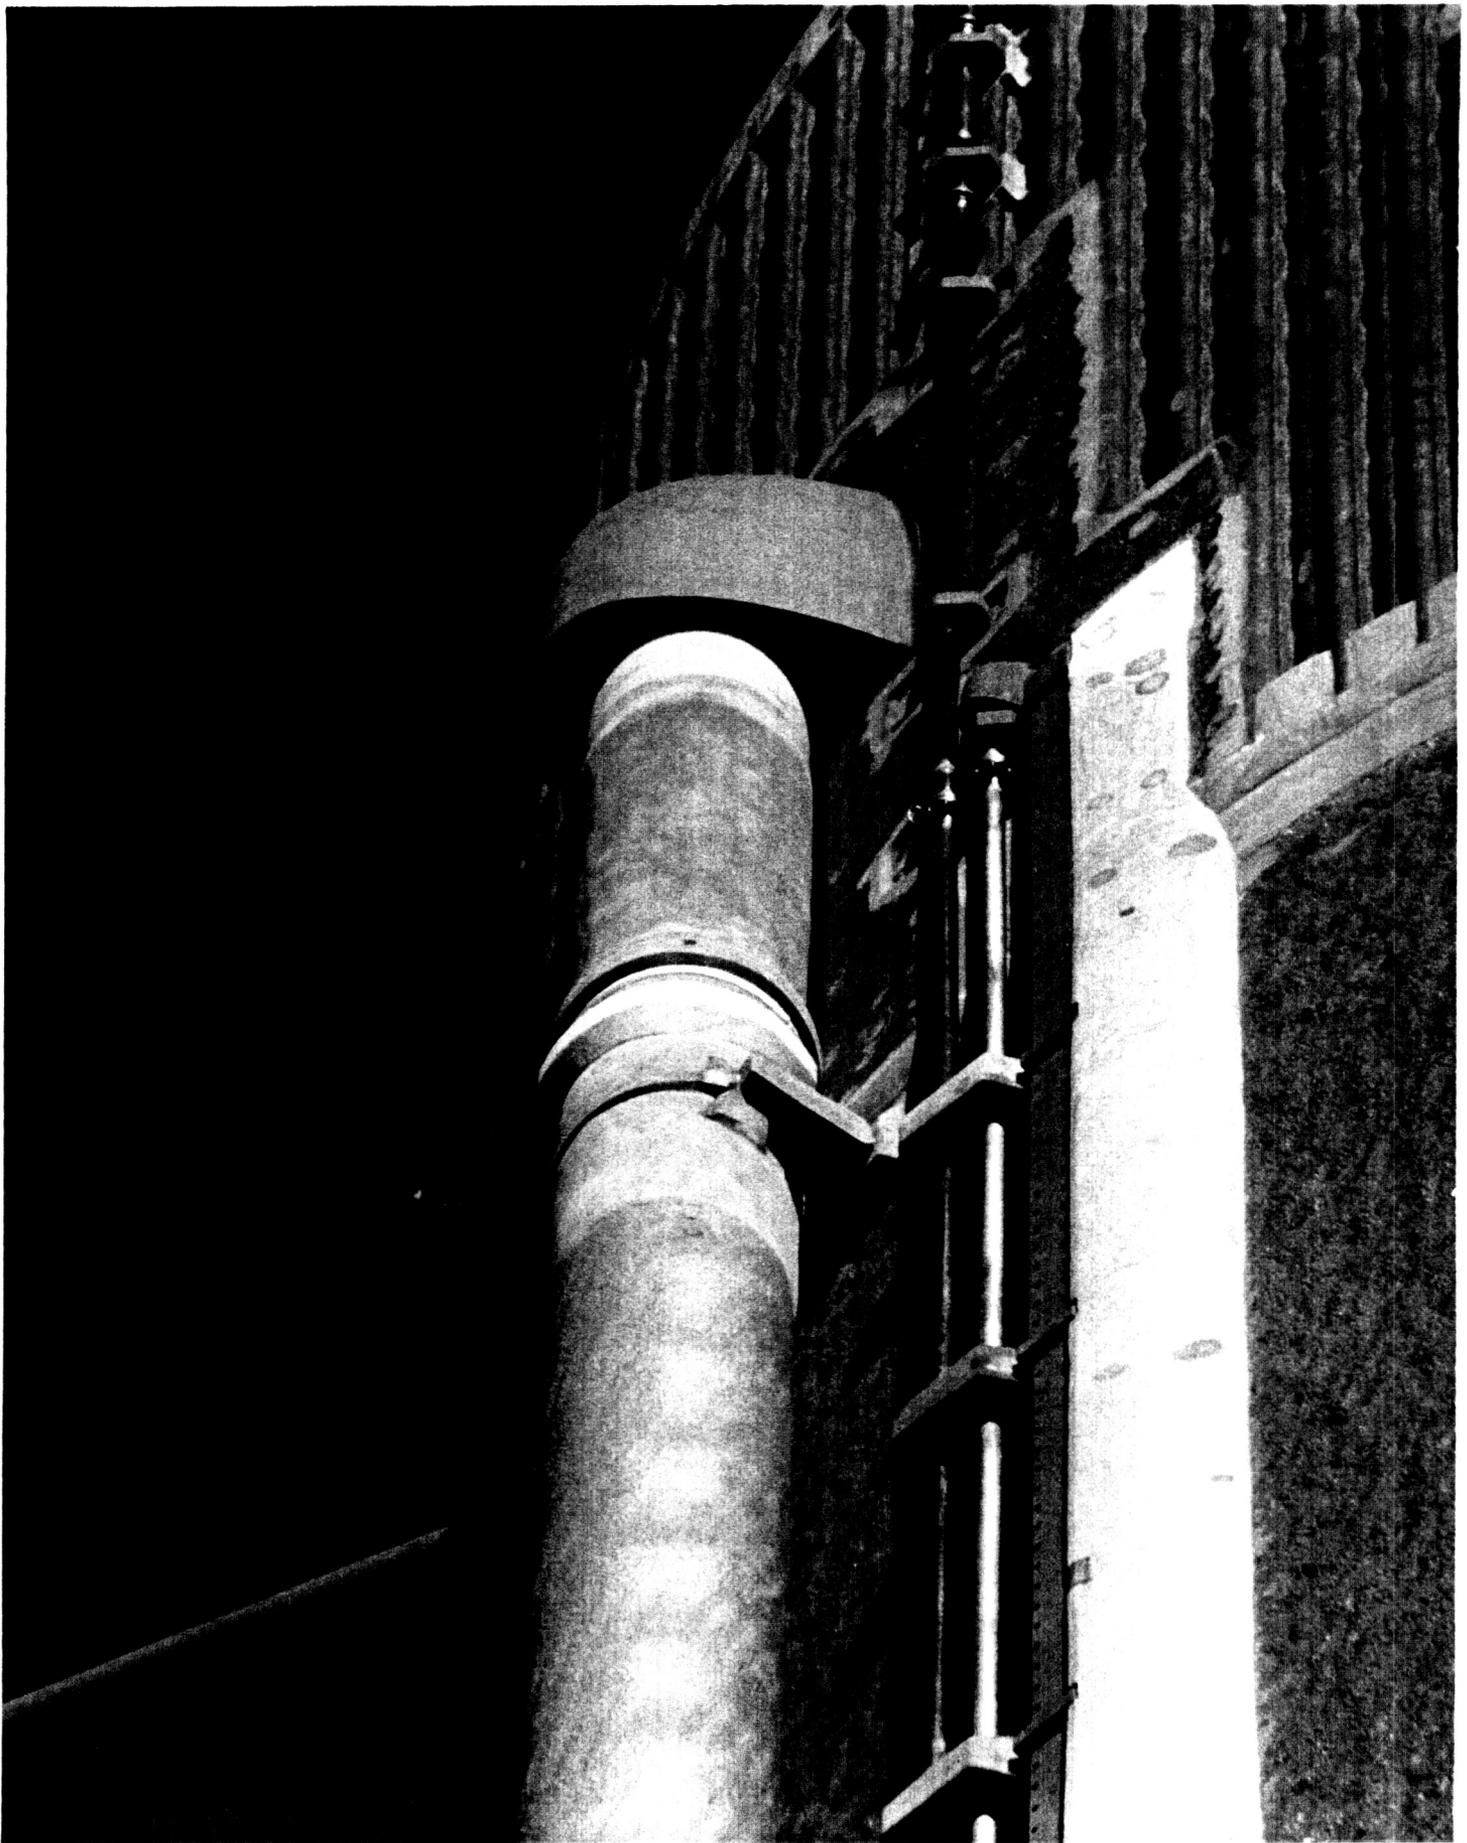
TYPICAL ICE/FROST ACCUMULATION IN
LO2 FEEDLINE BELLOWS AT XT 1106

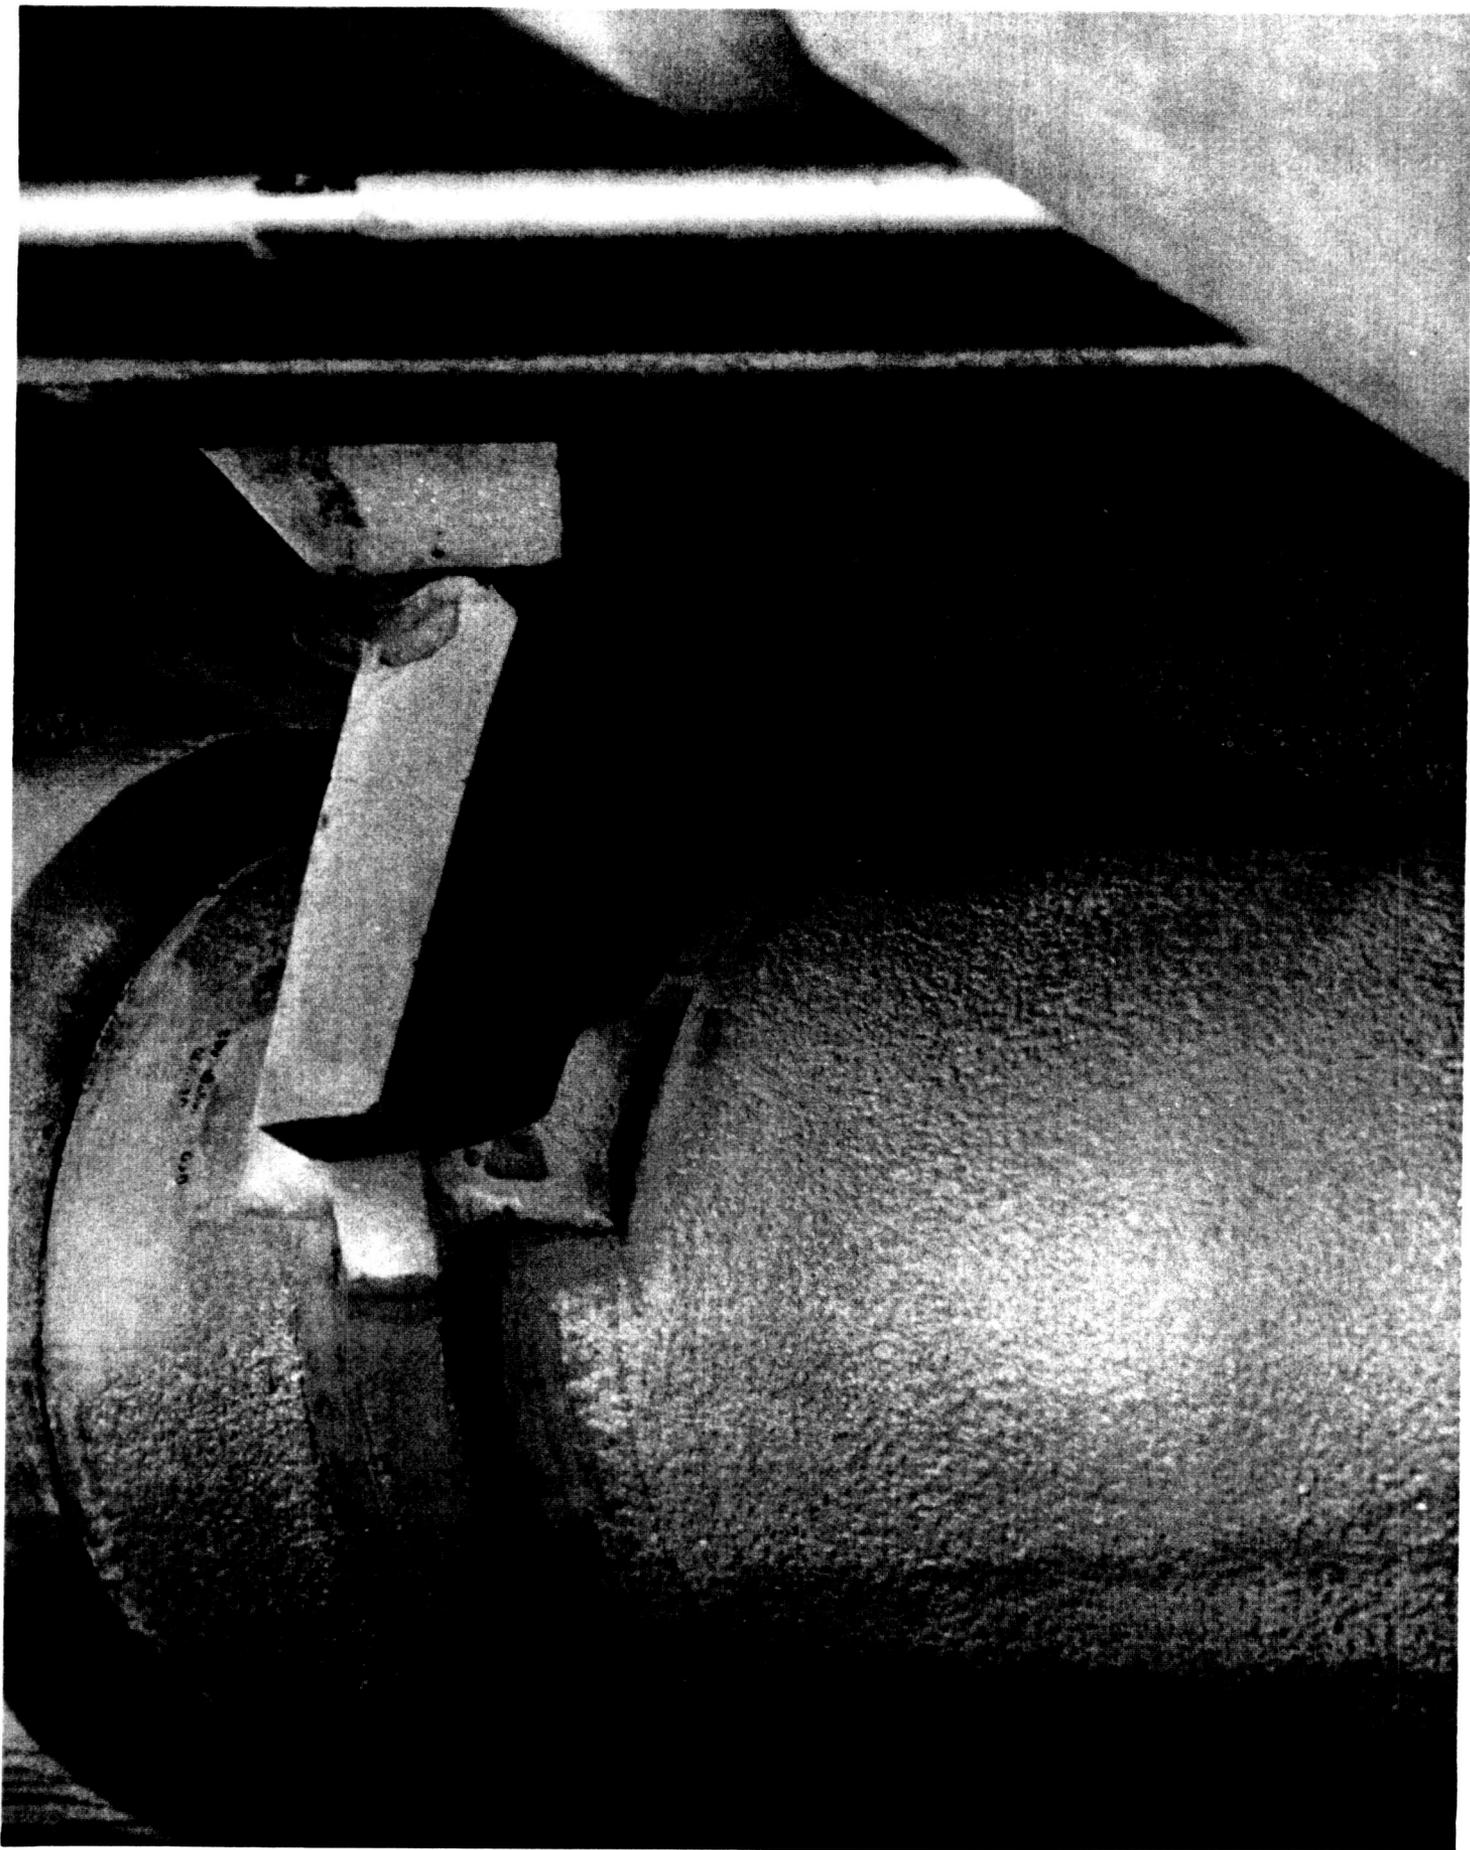
TYPICAL ICE/FROST ACCUMULATION IN LO2
FEEDLINE SUPPORT BRACKET AT XT 1871
