KSC Ice/Frost/Debris Assessment For Space Shuttle Mission STS-30R

May 1989

KSC
ICE/FROST/DEBRIS ASSESSMENT
FOR
SPACE SHUTTLE MISSION
STS-30R
MAY 4, 1989

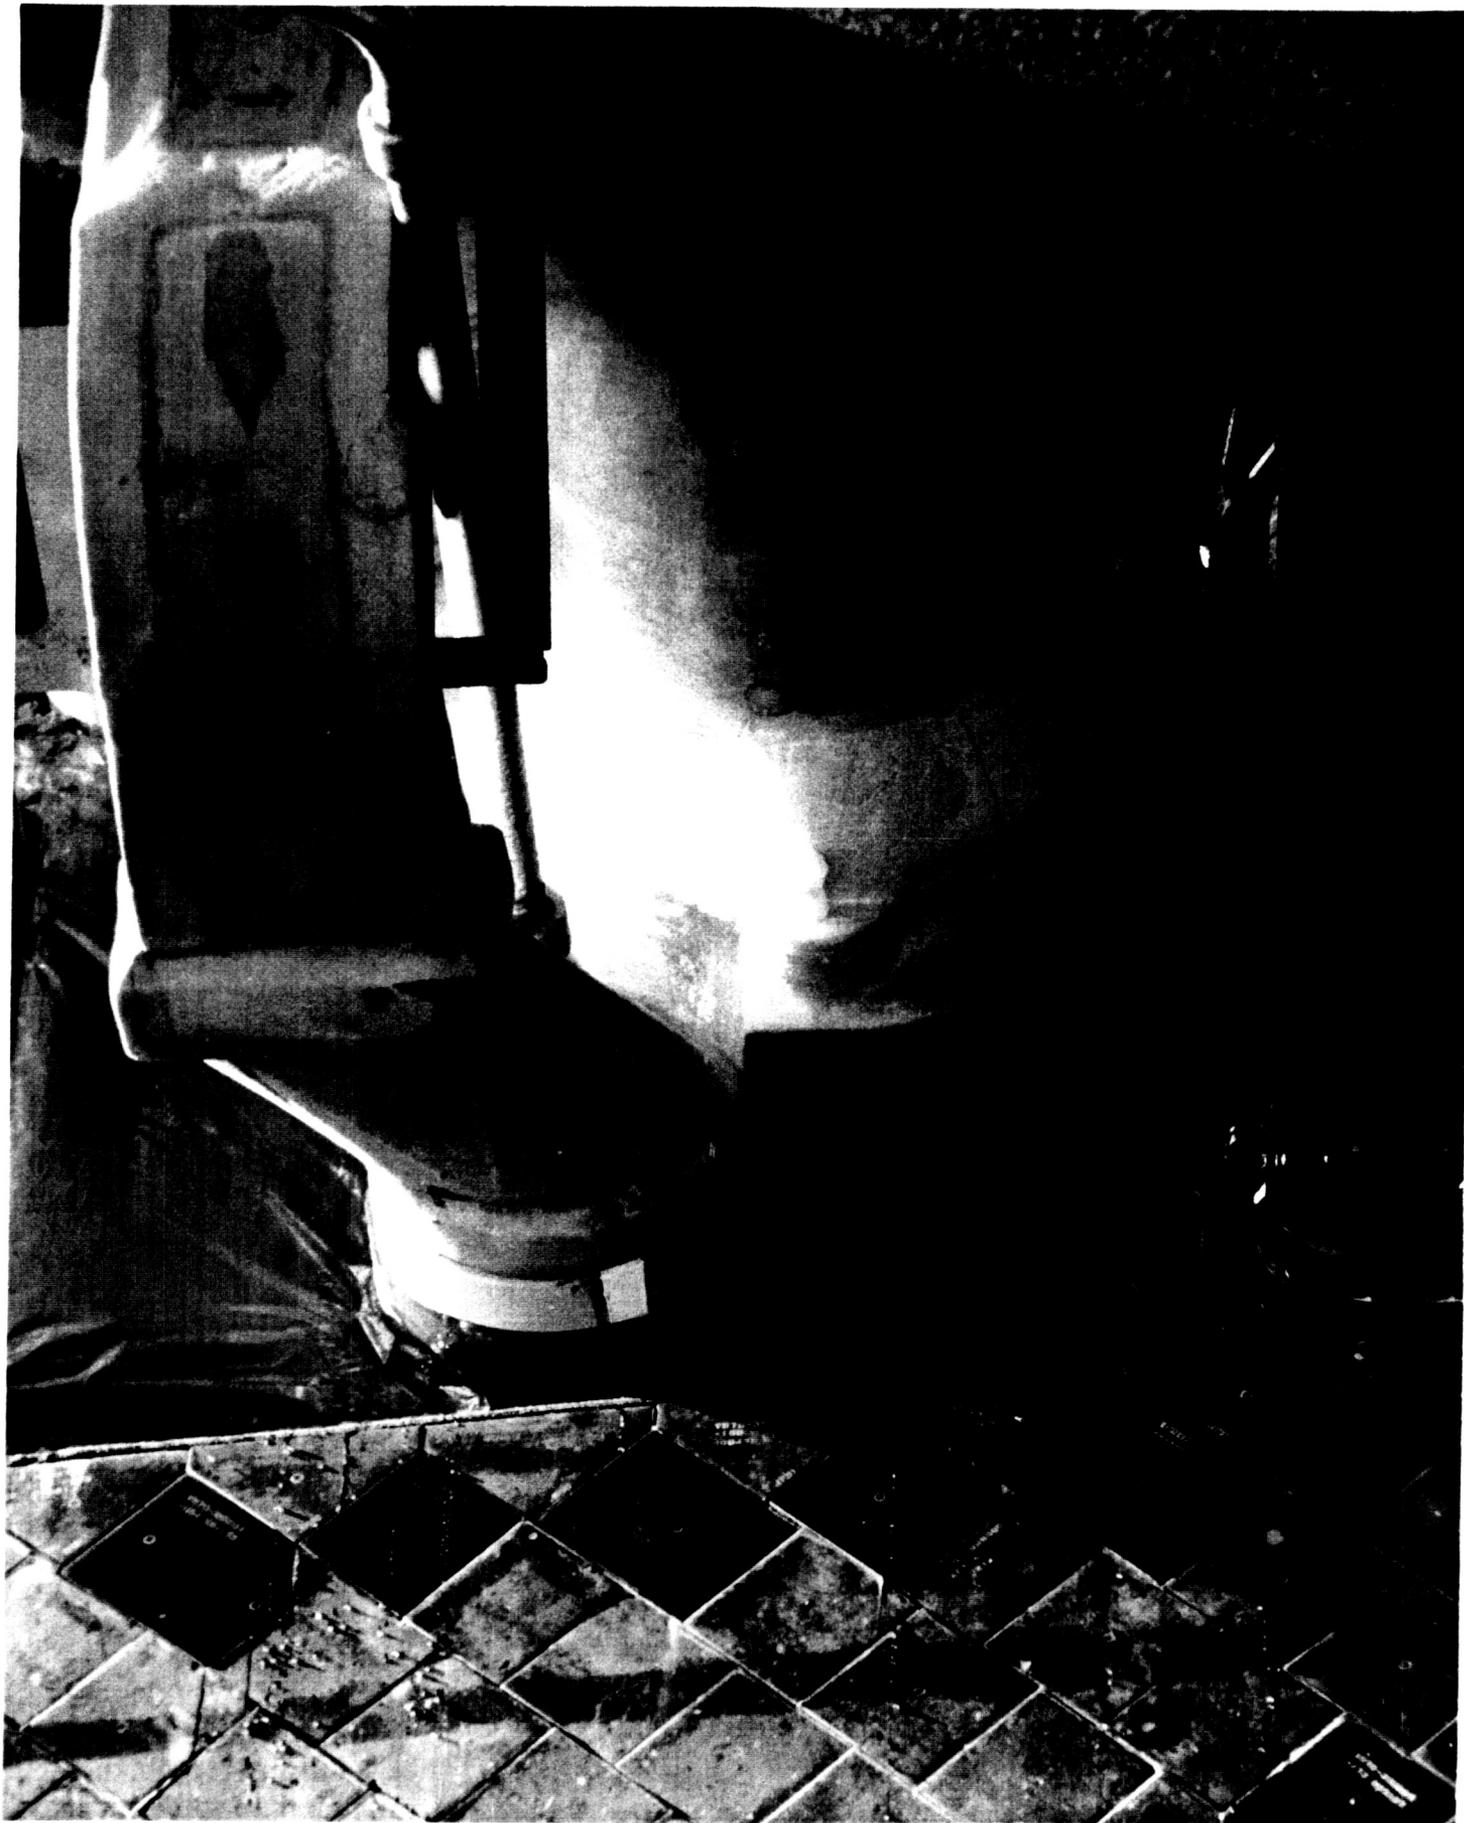
ET/ORB LO2 UMBILICAL EXHIBITING FROST FINGERS ON PURGE
VENTS AND ICE ACCUMULATION ON INBOARD SIDE OF BAGGIE

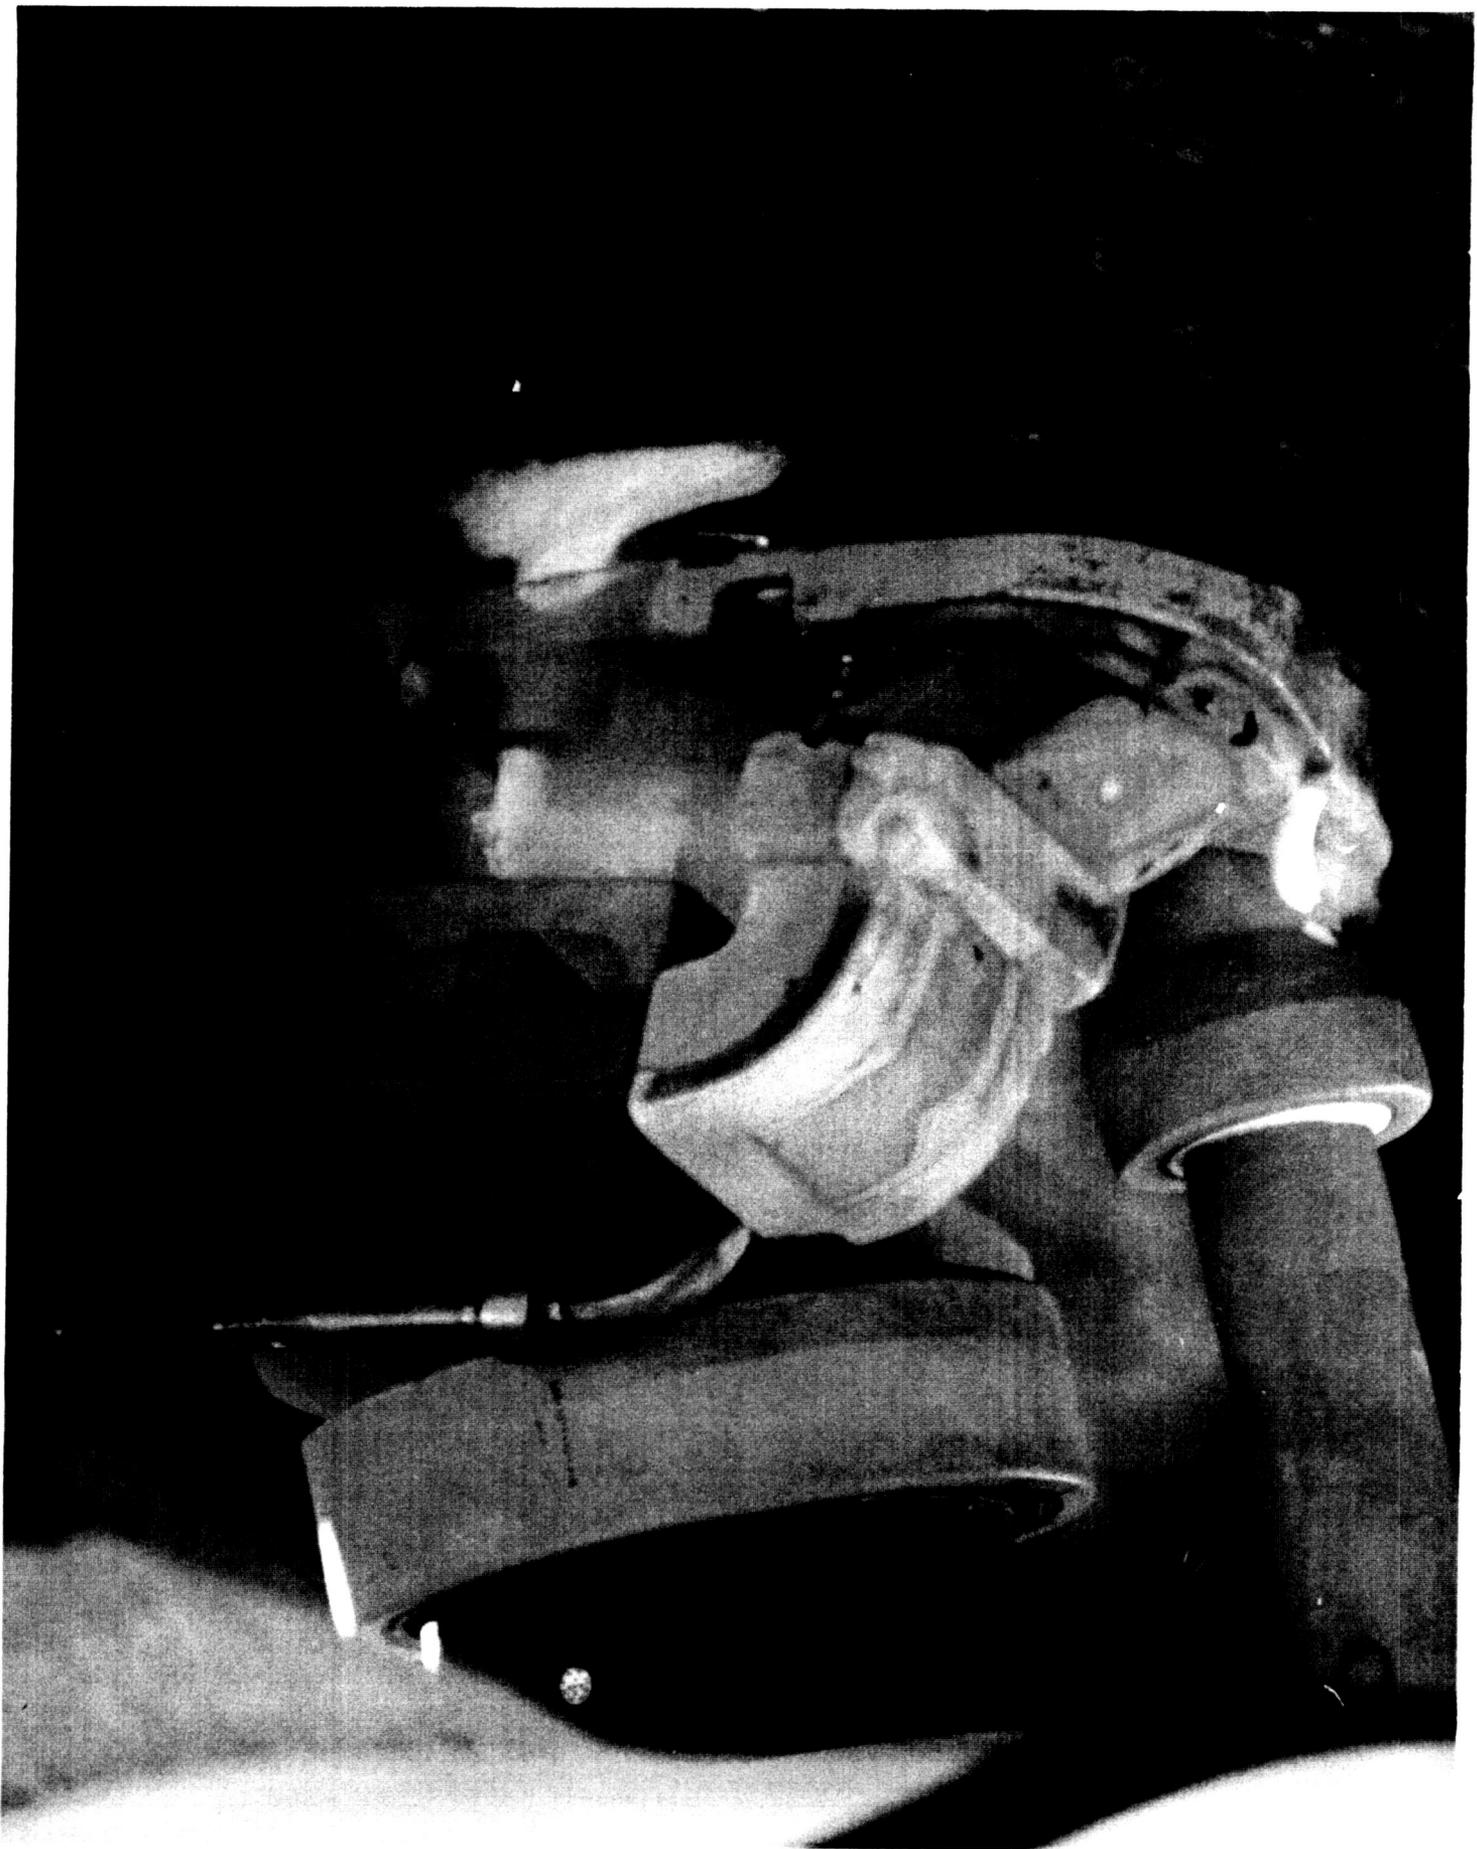
TYPICAL FROST FINGERS ON PURGE VENTS AND LESS THAN USUAL
ICE ACCUMULATION ON ET/ORB LH2 UMBILICAL BAGGIE

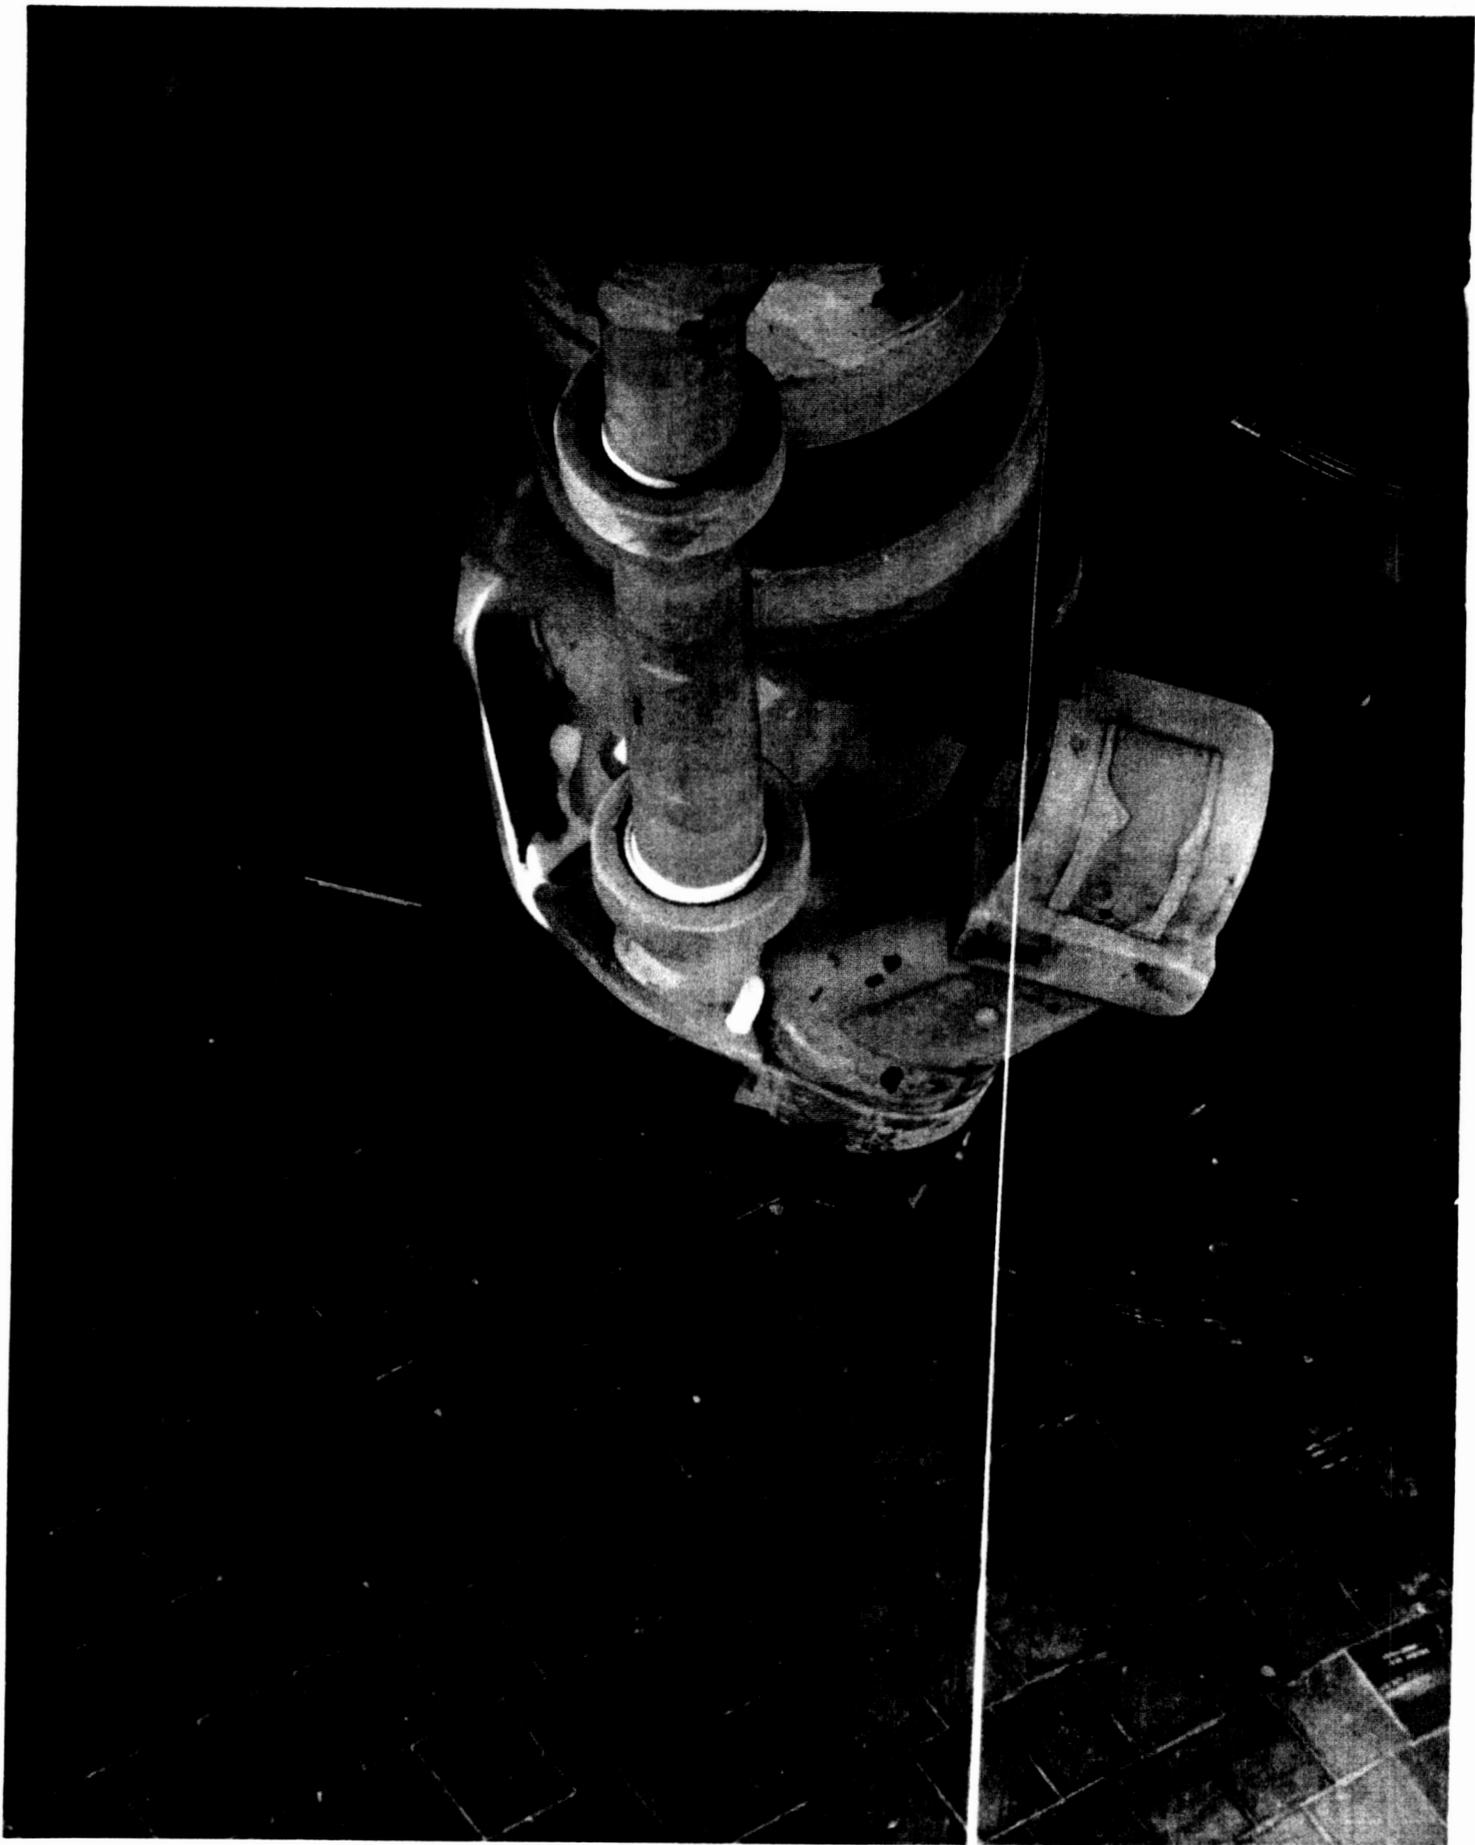
FROST HIGHLIGHTS THERMAL SHORT ALONG EDGE OF UMBILICAL
SEPARATION BOLT DEBRIS CANISTER

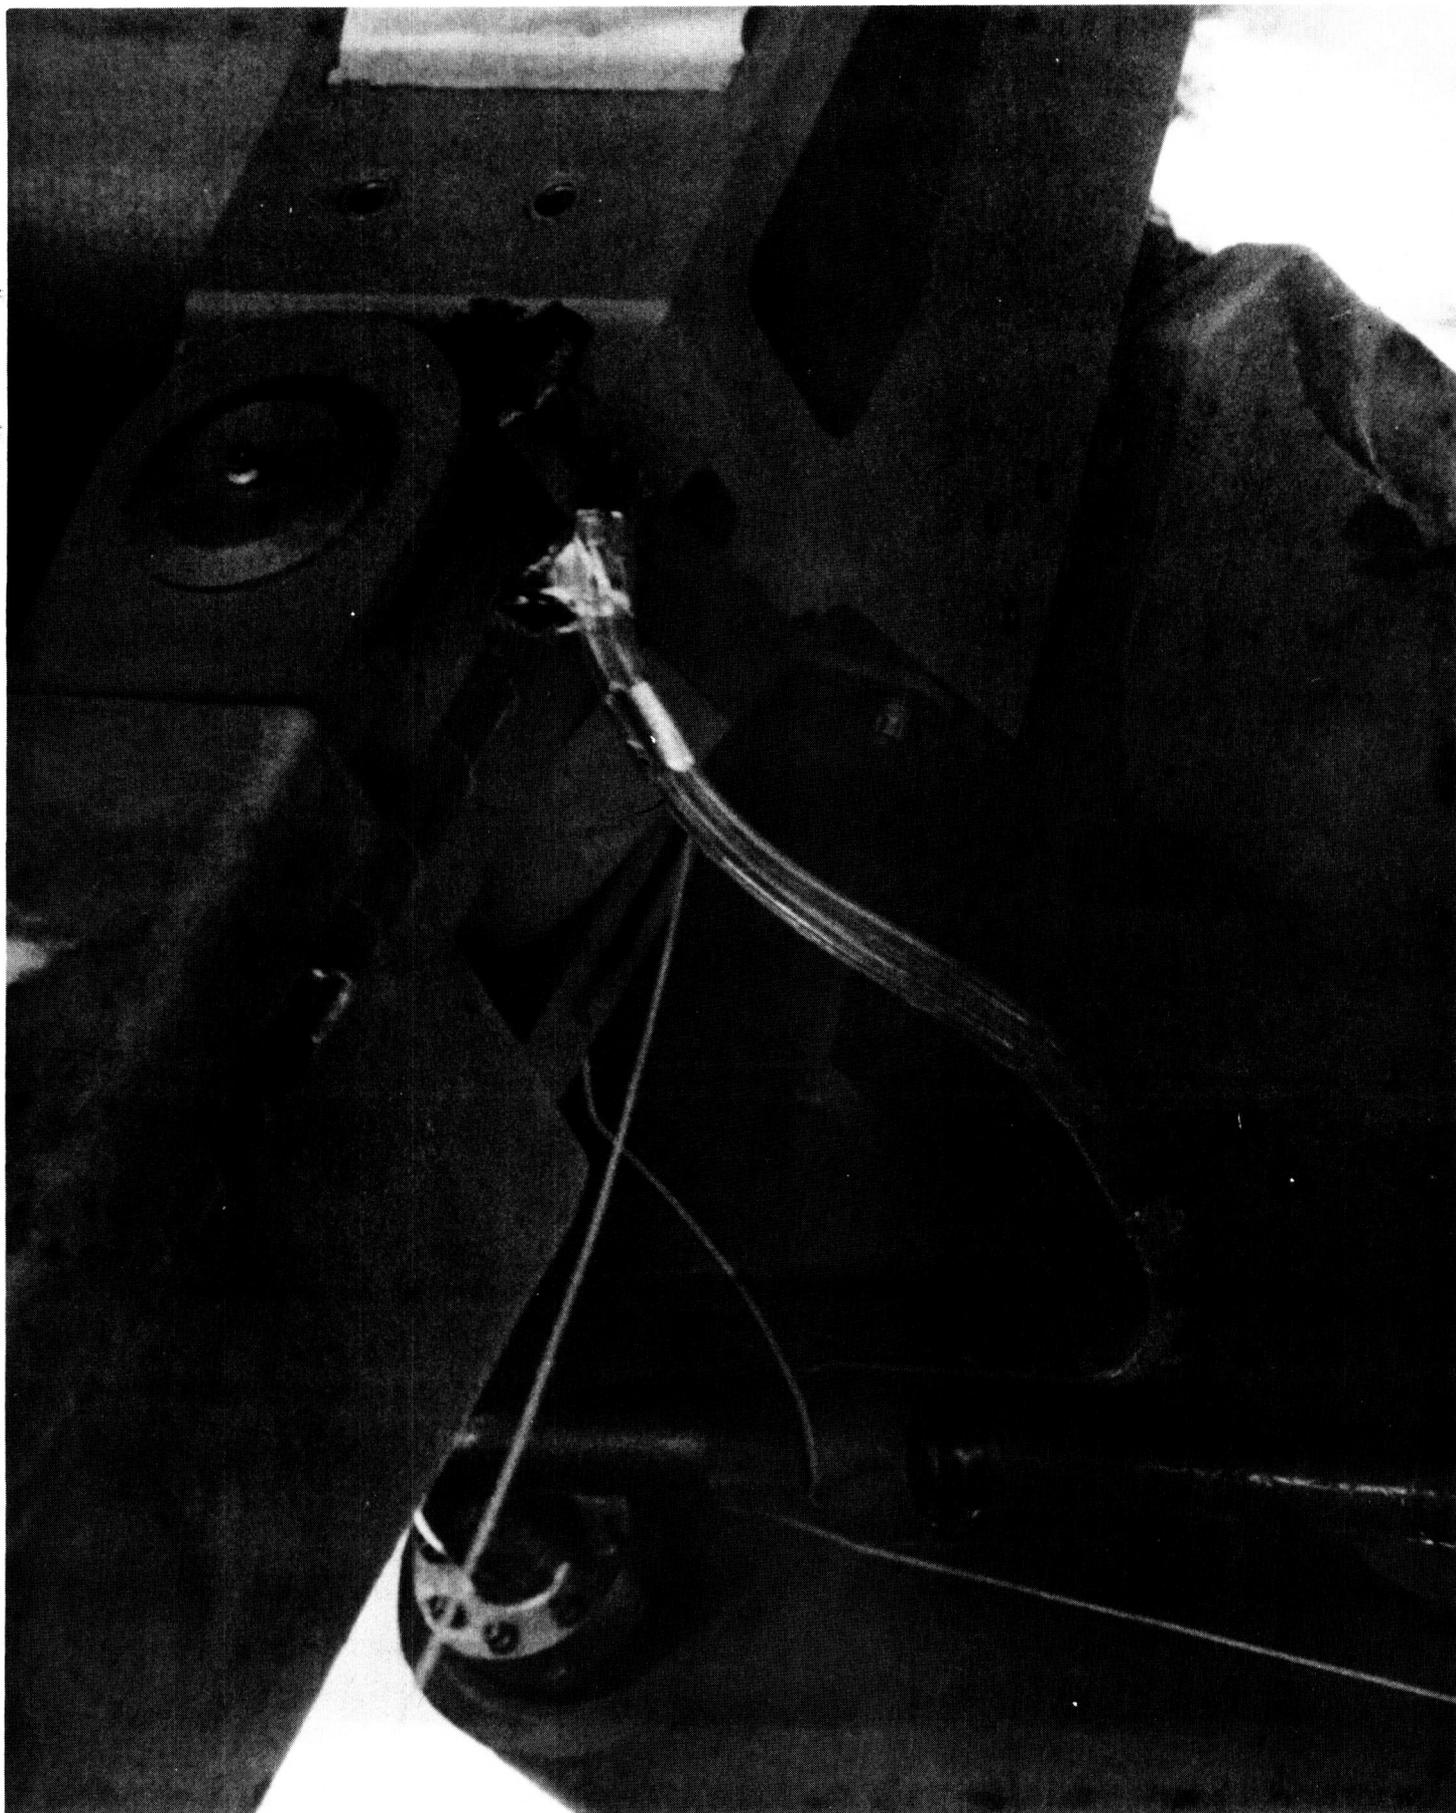
HYDROGEN LEAK DETECTOR TYGON TUBES ARE TEMPORARILY INSTALLED
WITH VELCRO STRAPS ON ET THRUST STRUT AND LH2 TANK PRESSLINE

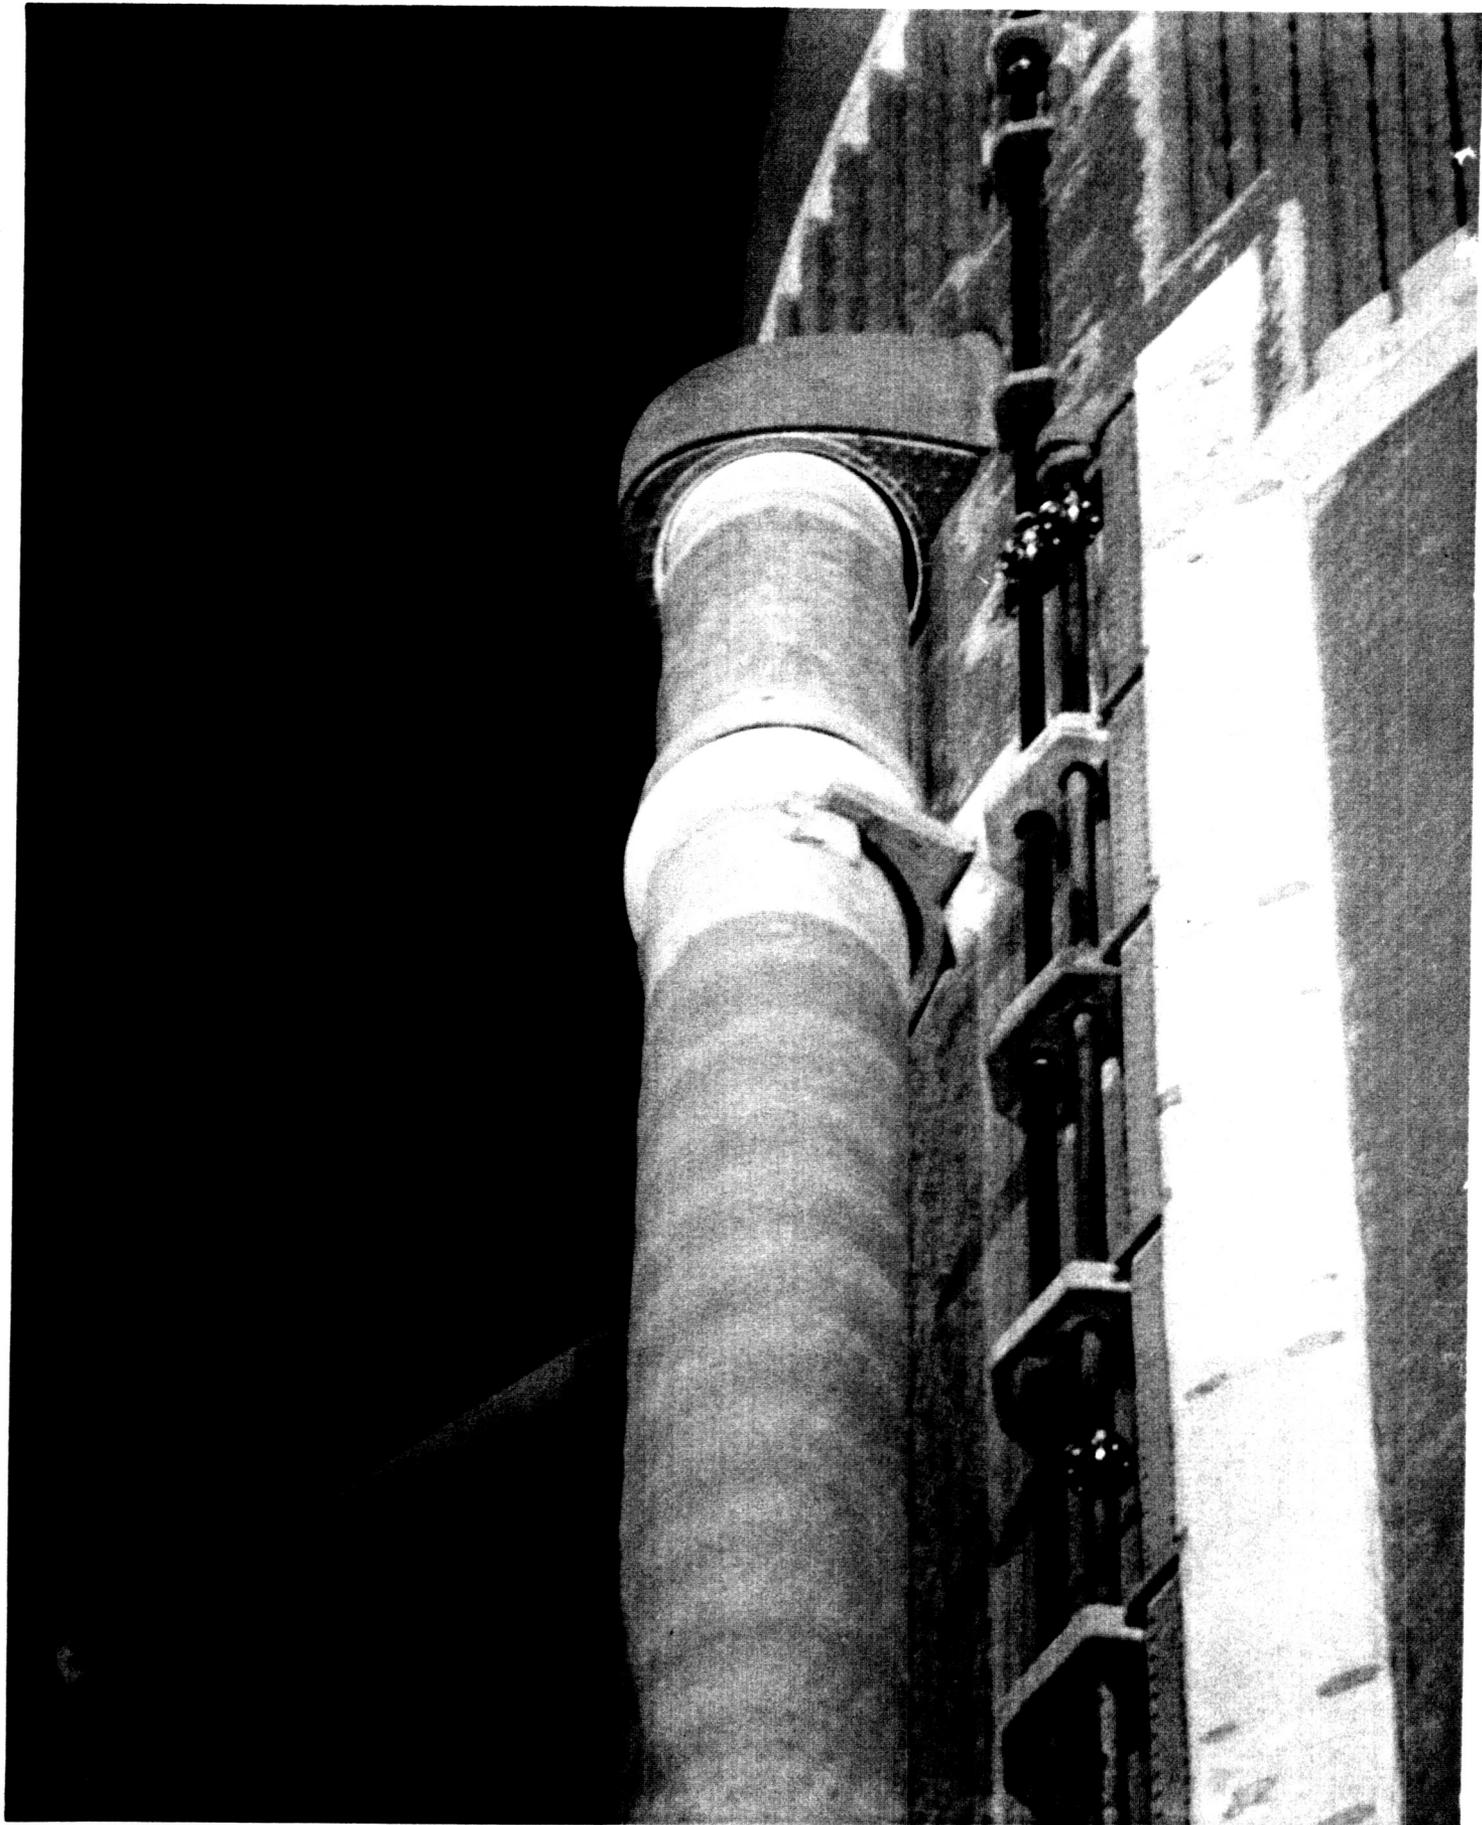
ICE REMAINS IN LO2 FEEDLINE BELLOWS XT 1106 AFTER DRAIN

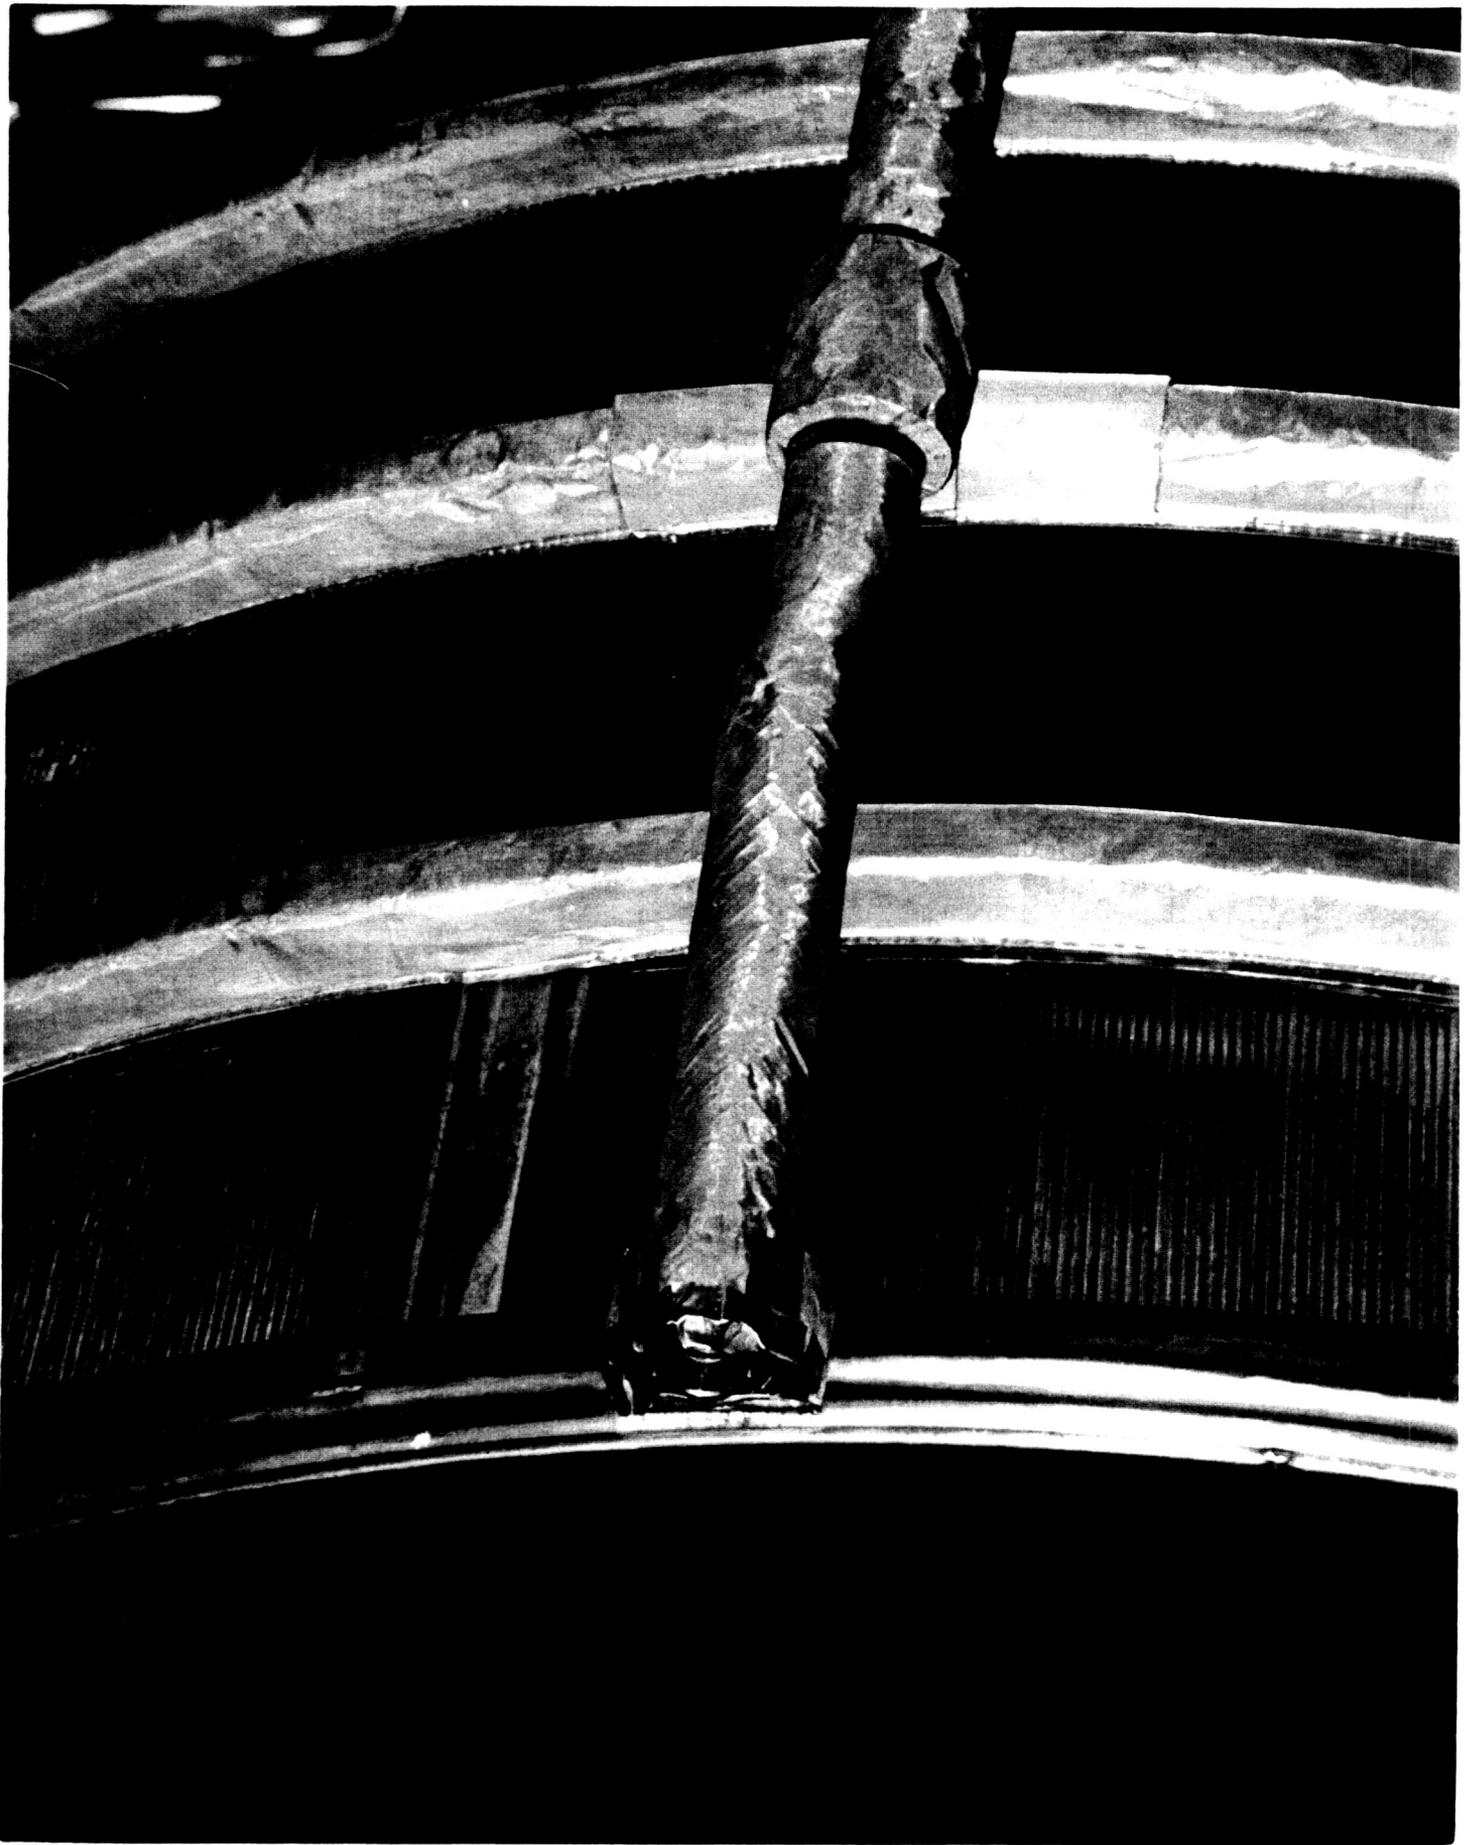
TWO PIECES OF RED QUALITY TAG ATTACHED
TO THE SSME #1 OXYGEN OVERBOARD VENT

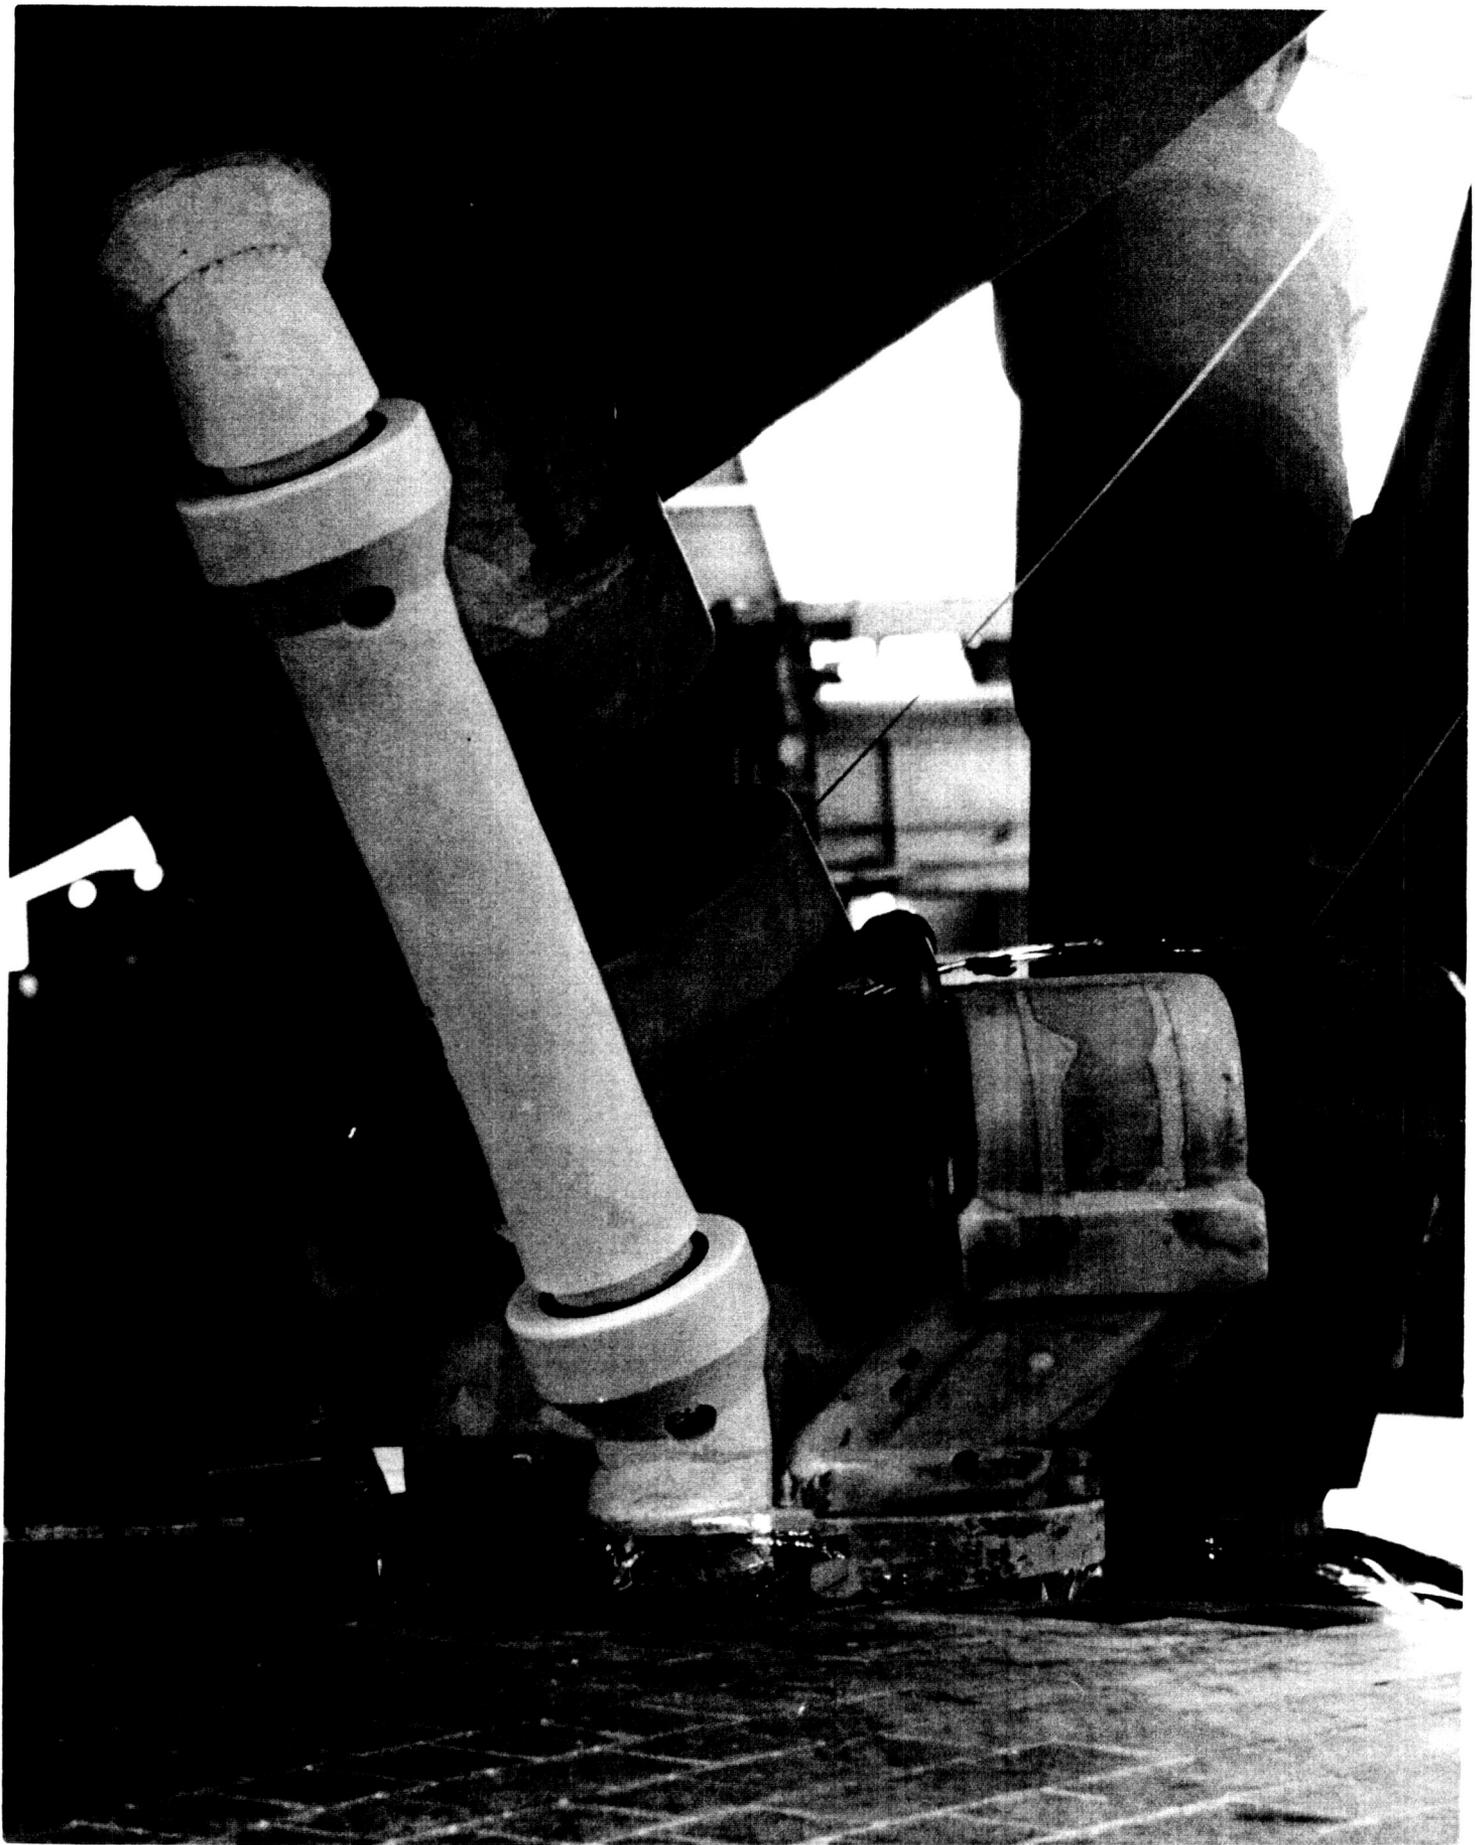
NEW LH2 RECIRCULATION LINE REPLACED AFTER SCRUB TURNAROUND

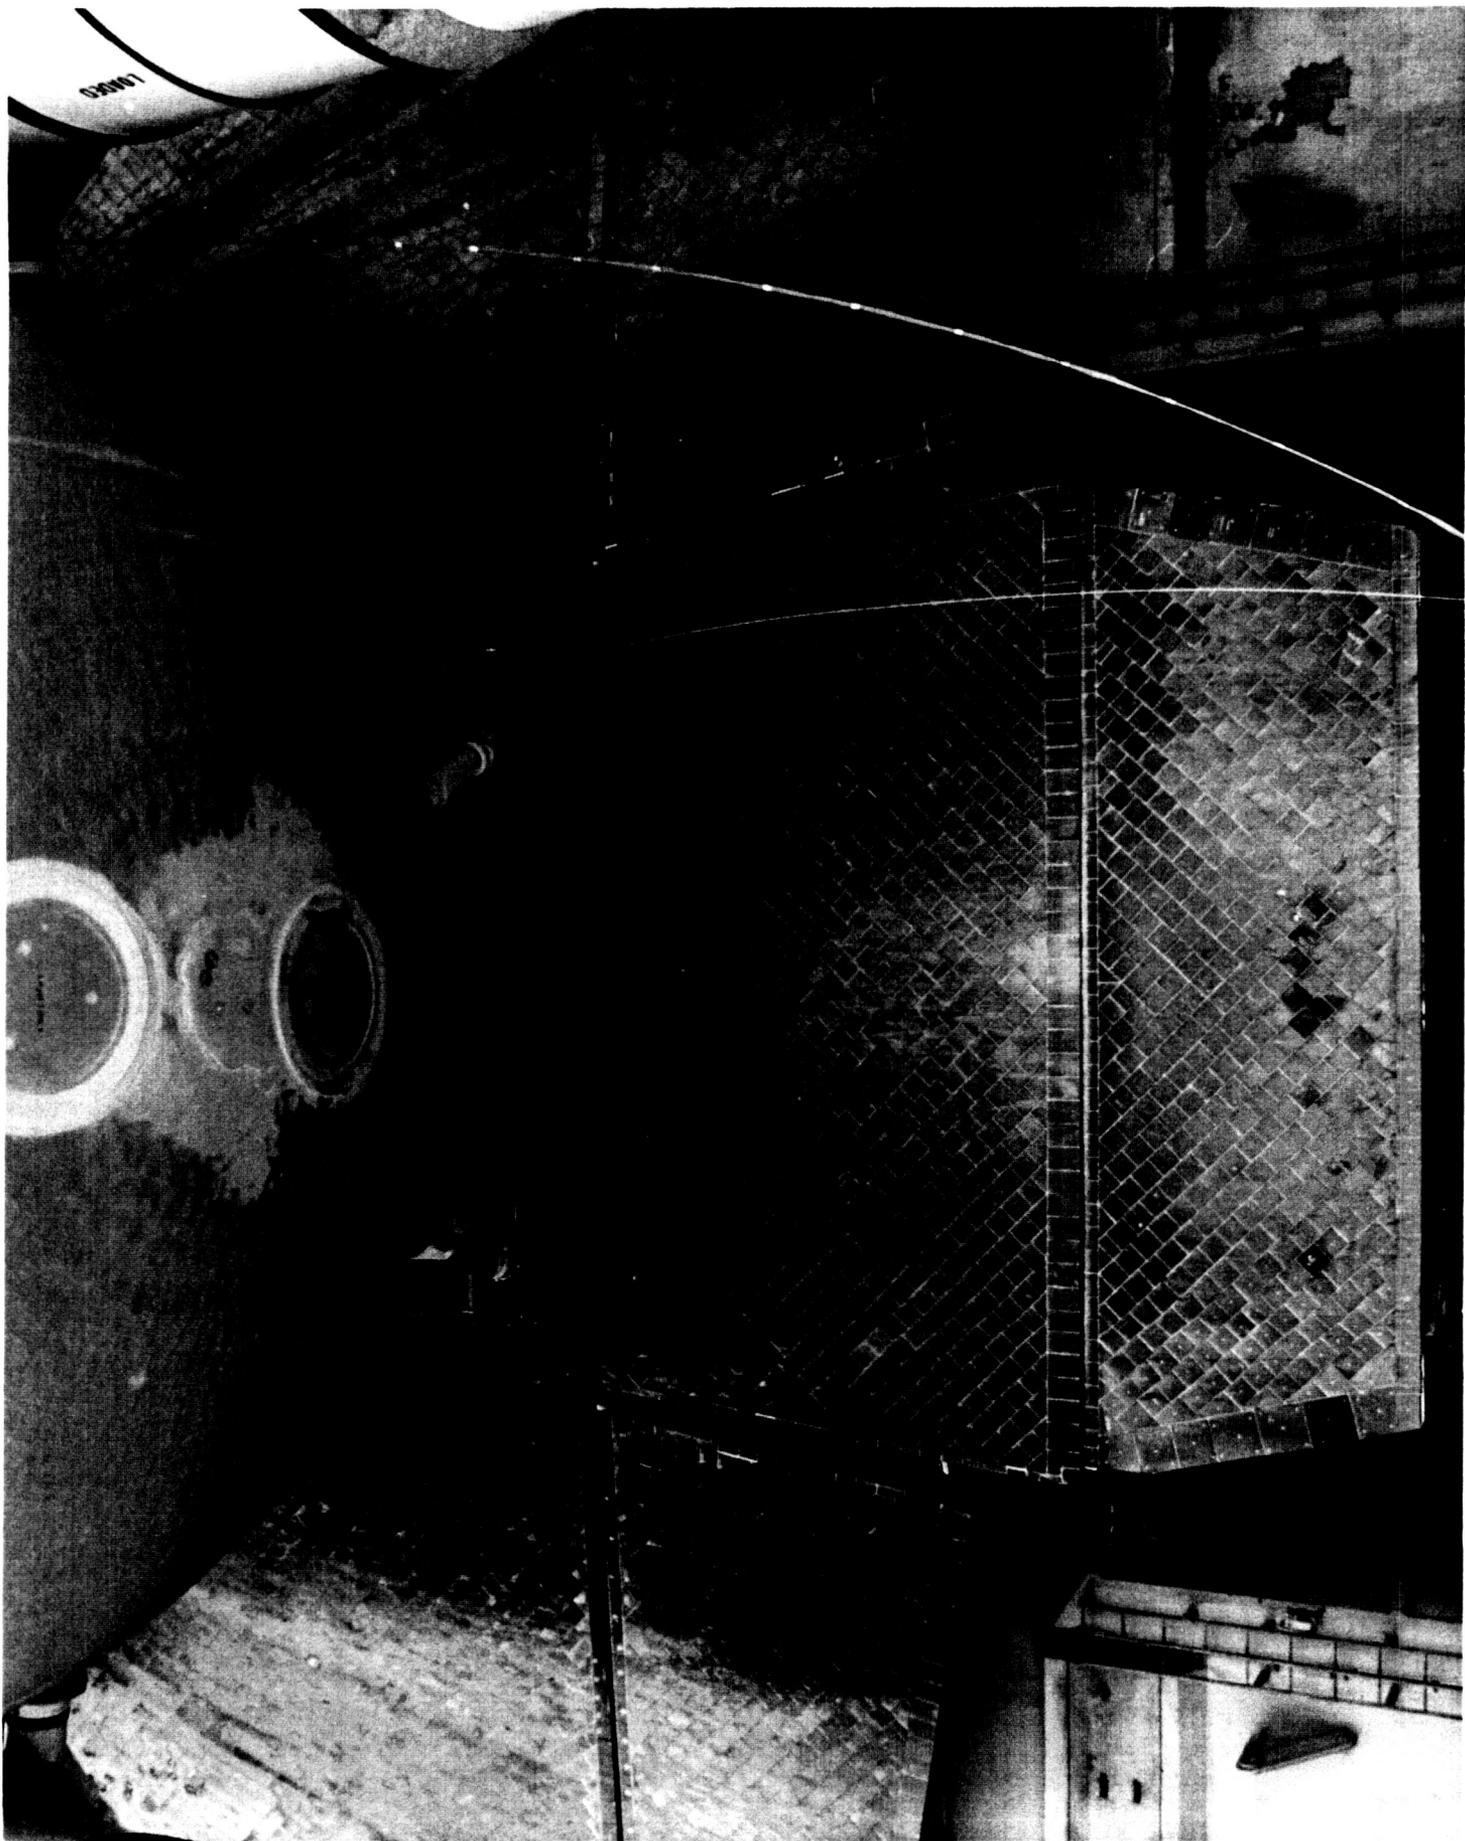
HYDROGEN LEAK DETECTOR REINSTALLED FOR SECOND LAUNCH ATTEMPT
