KSC Ice/Frost/Debris Assessment For Space Shuttle Mission STS-30R

May 1989

KSC
ICE/FROST/DEBRIS ASSESSMENT
FOR
SPACE SHUTTLE MISSION
STS-30R
MAY 4, 1989

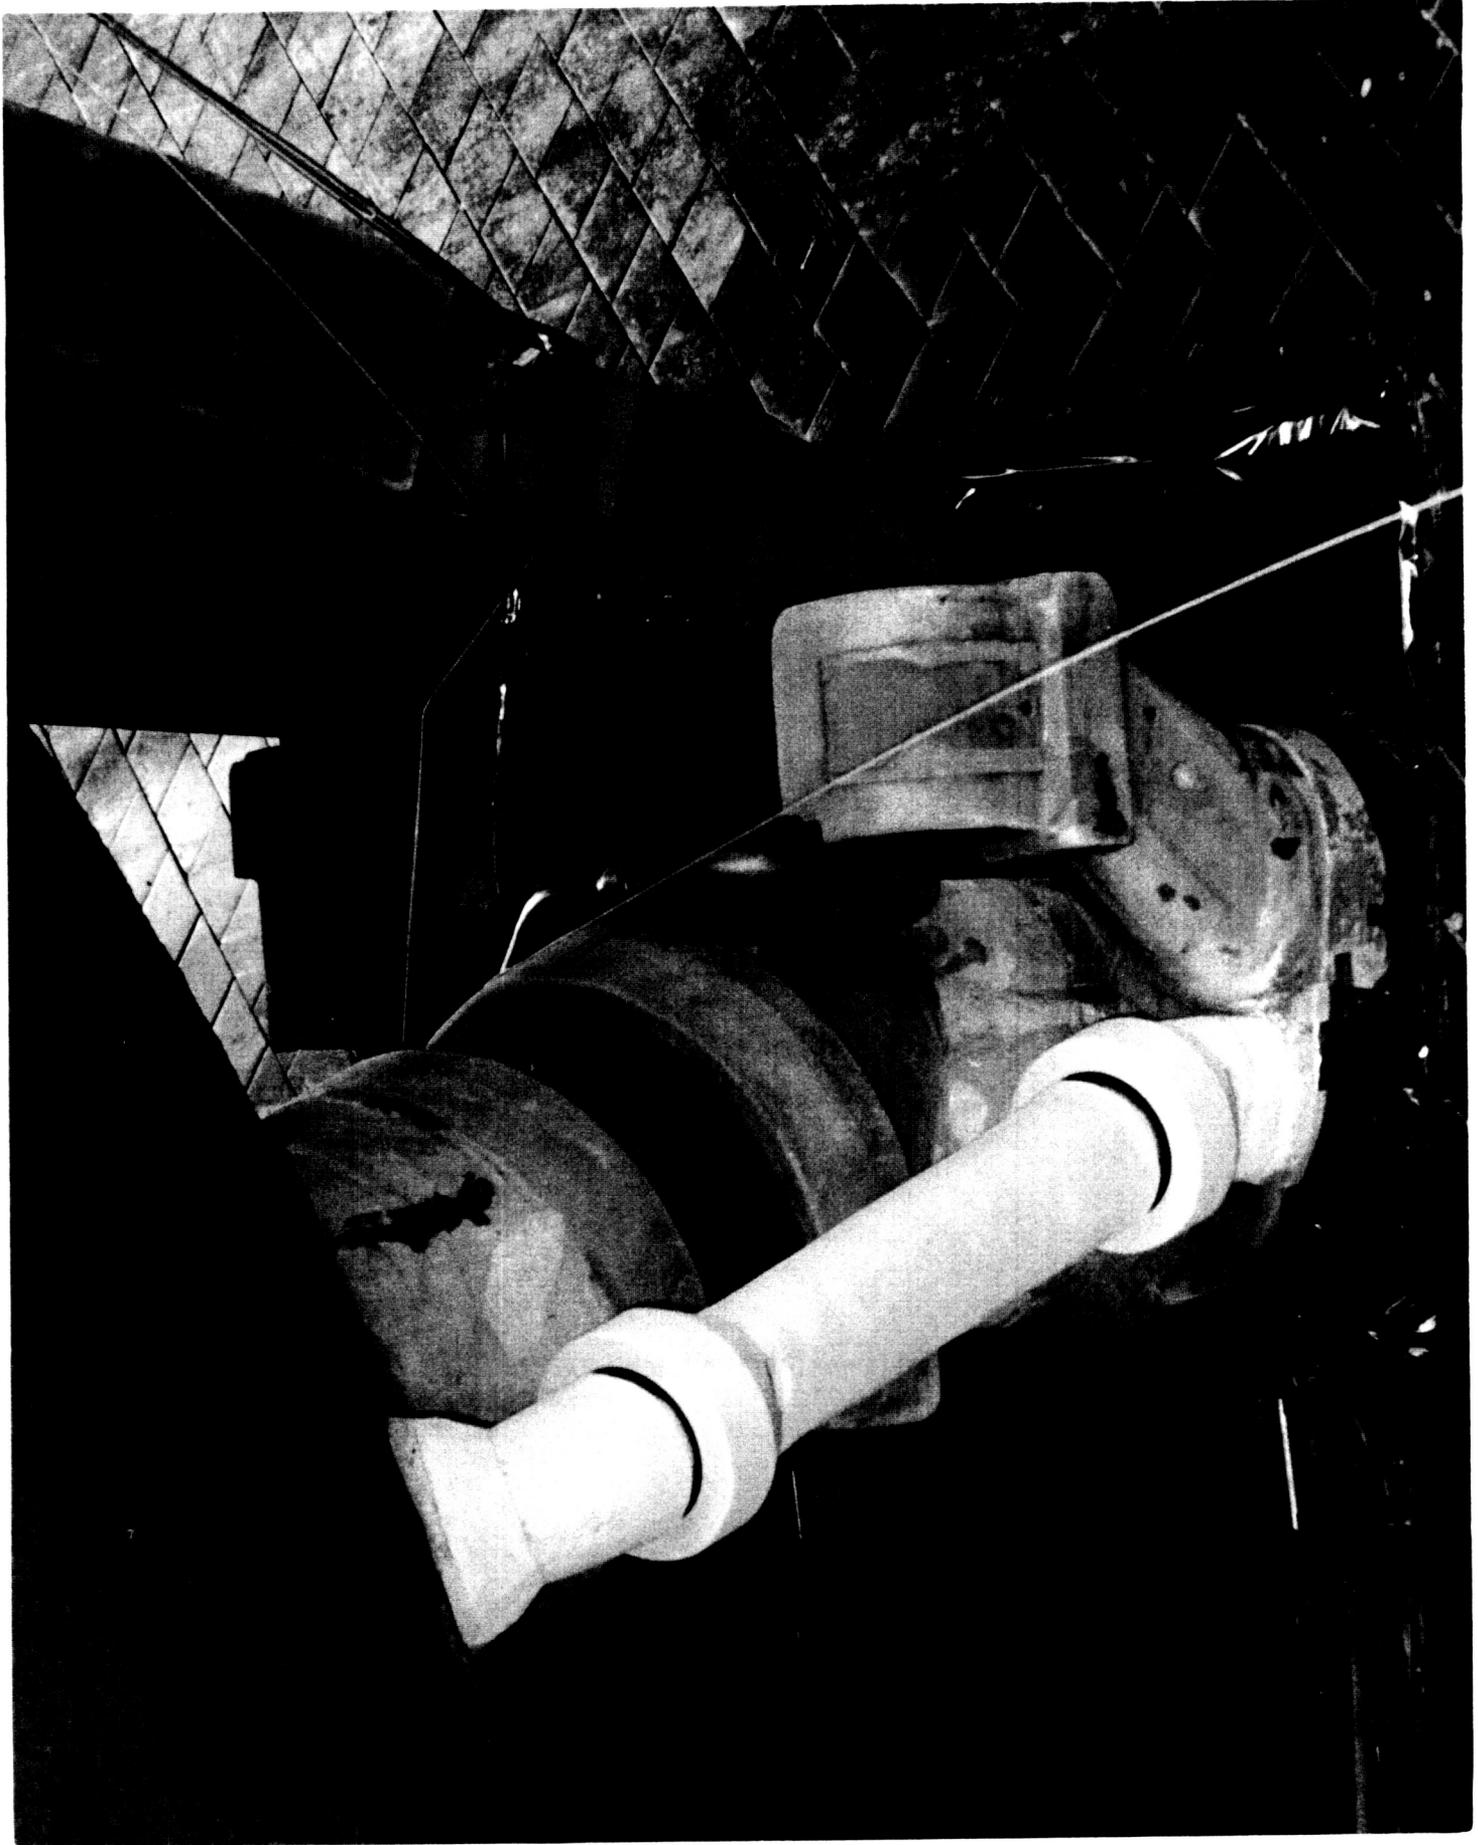
HYDROGEN LEAK DETECTOR POSITIONED ABOVE LH2 FEEDLINE AREA

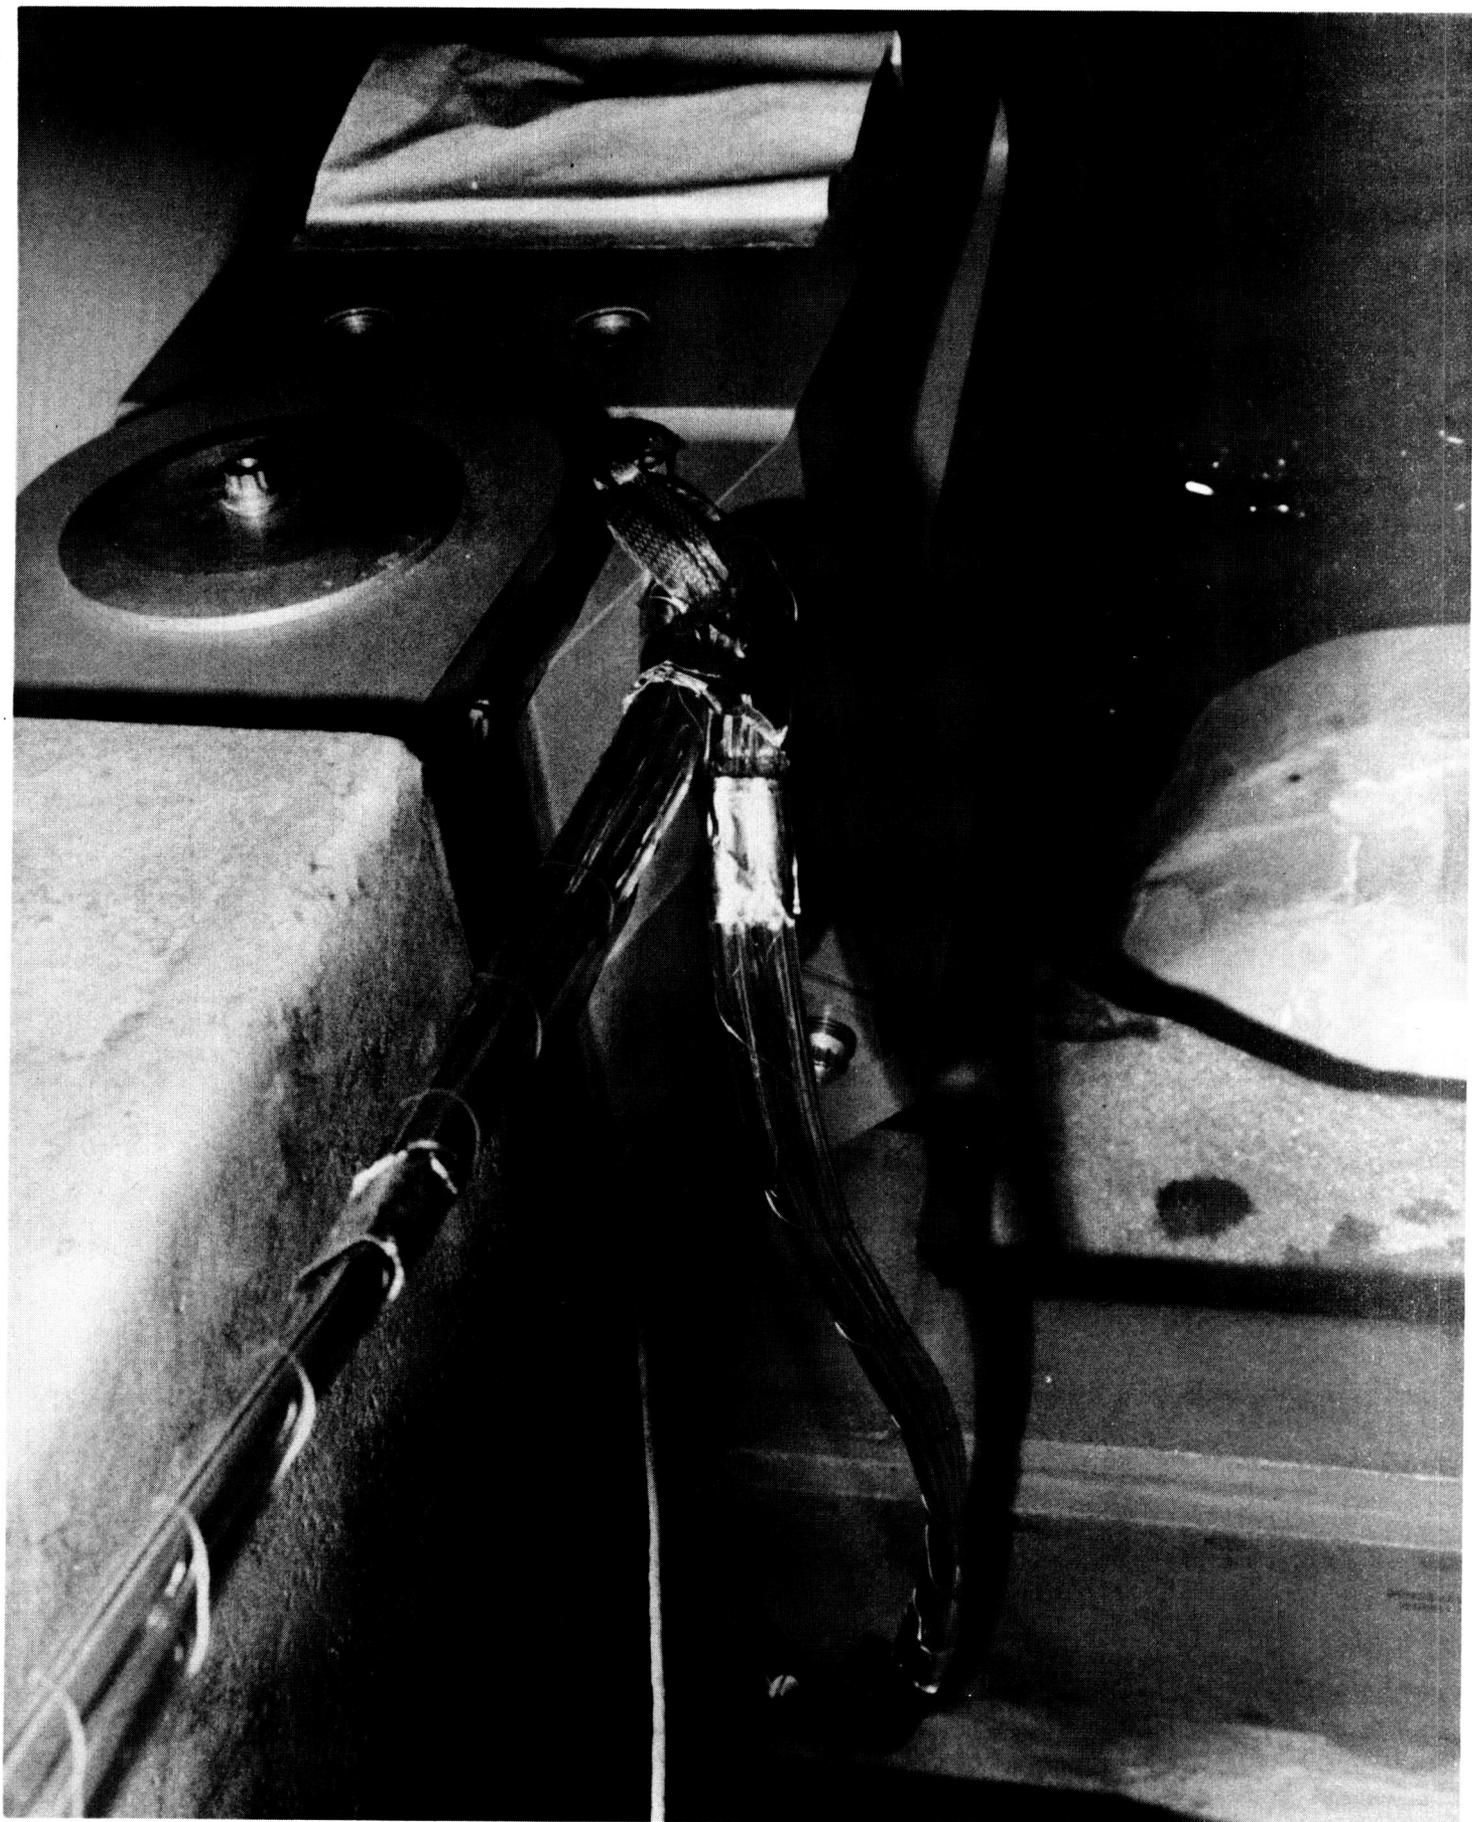
TYGON TUBE IS ATTACHED TO ET THRUST STRUT WITH VELCRO STRAP

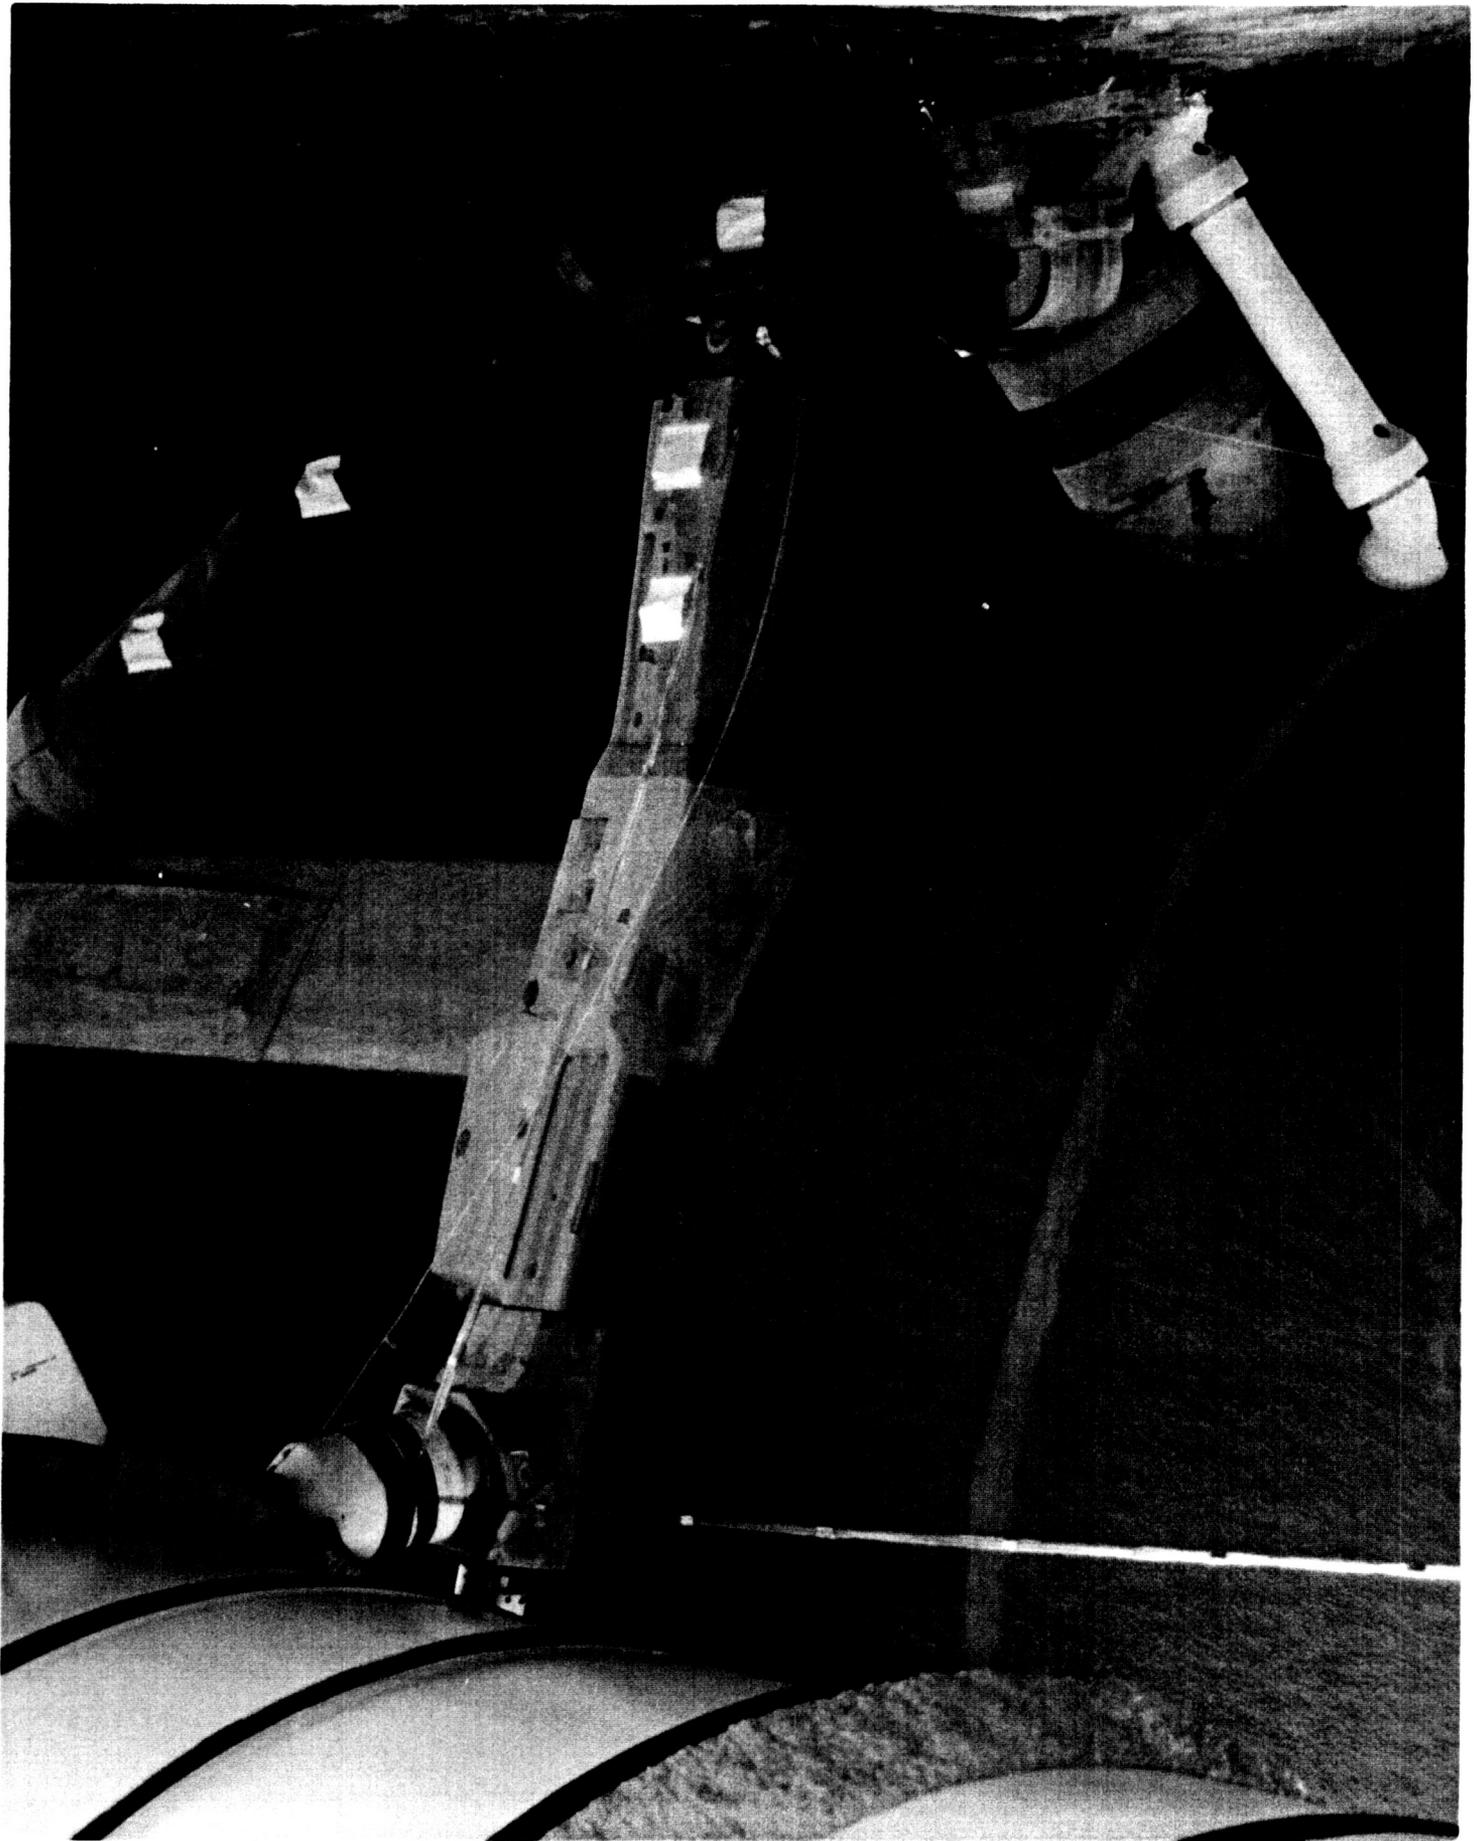
HYDROGEN LEAK DETECTOR TYGON TUBE IS ROUTED FROM UMBILICAL
ALONG ET/SRB CABLE TRAY TO STRUT AND DOWN TO MLP DECK

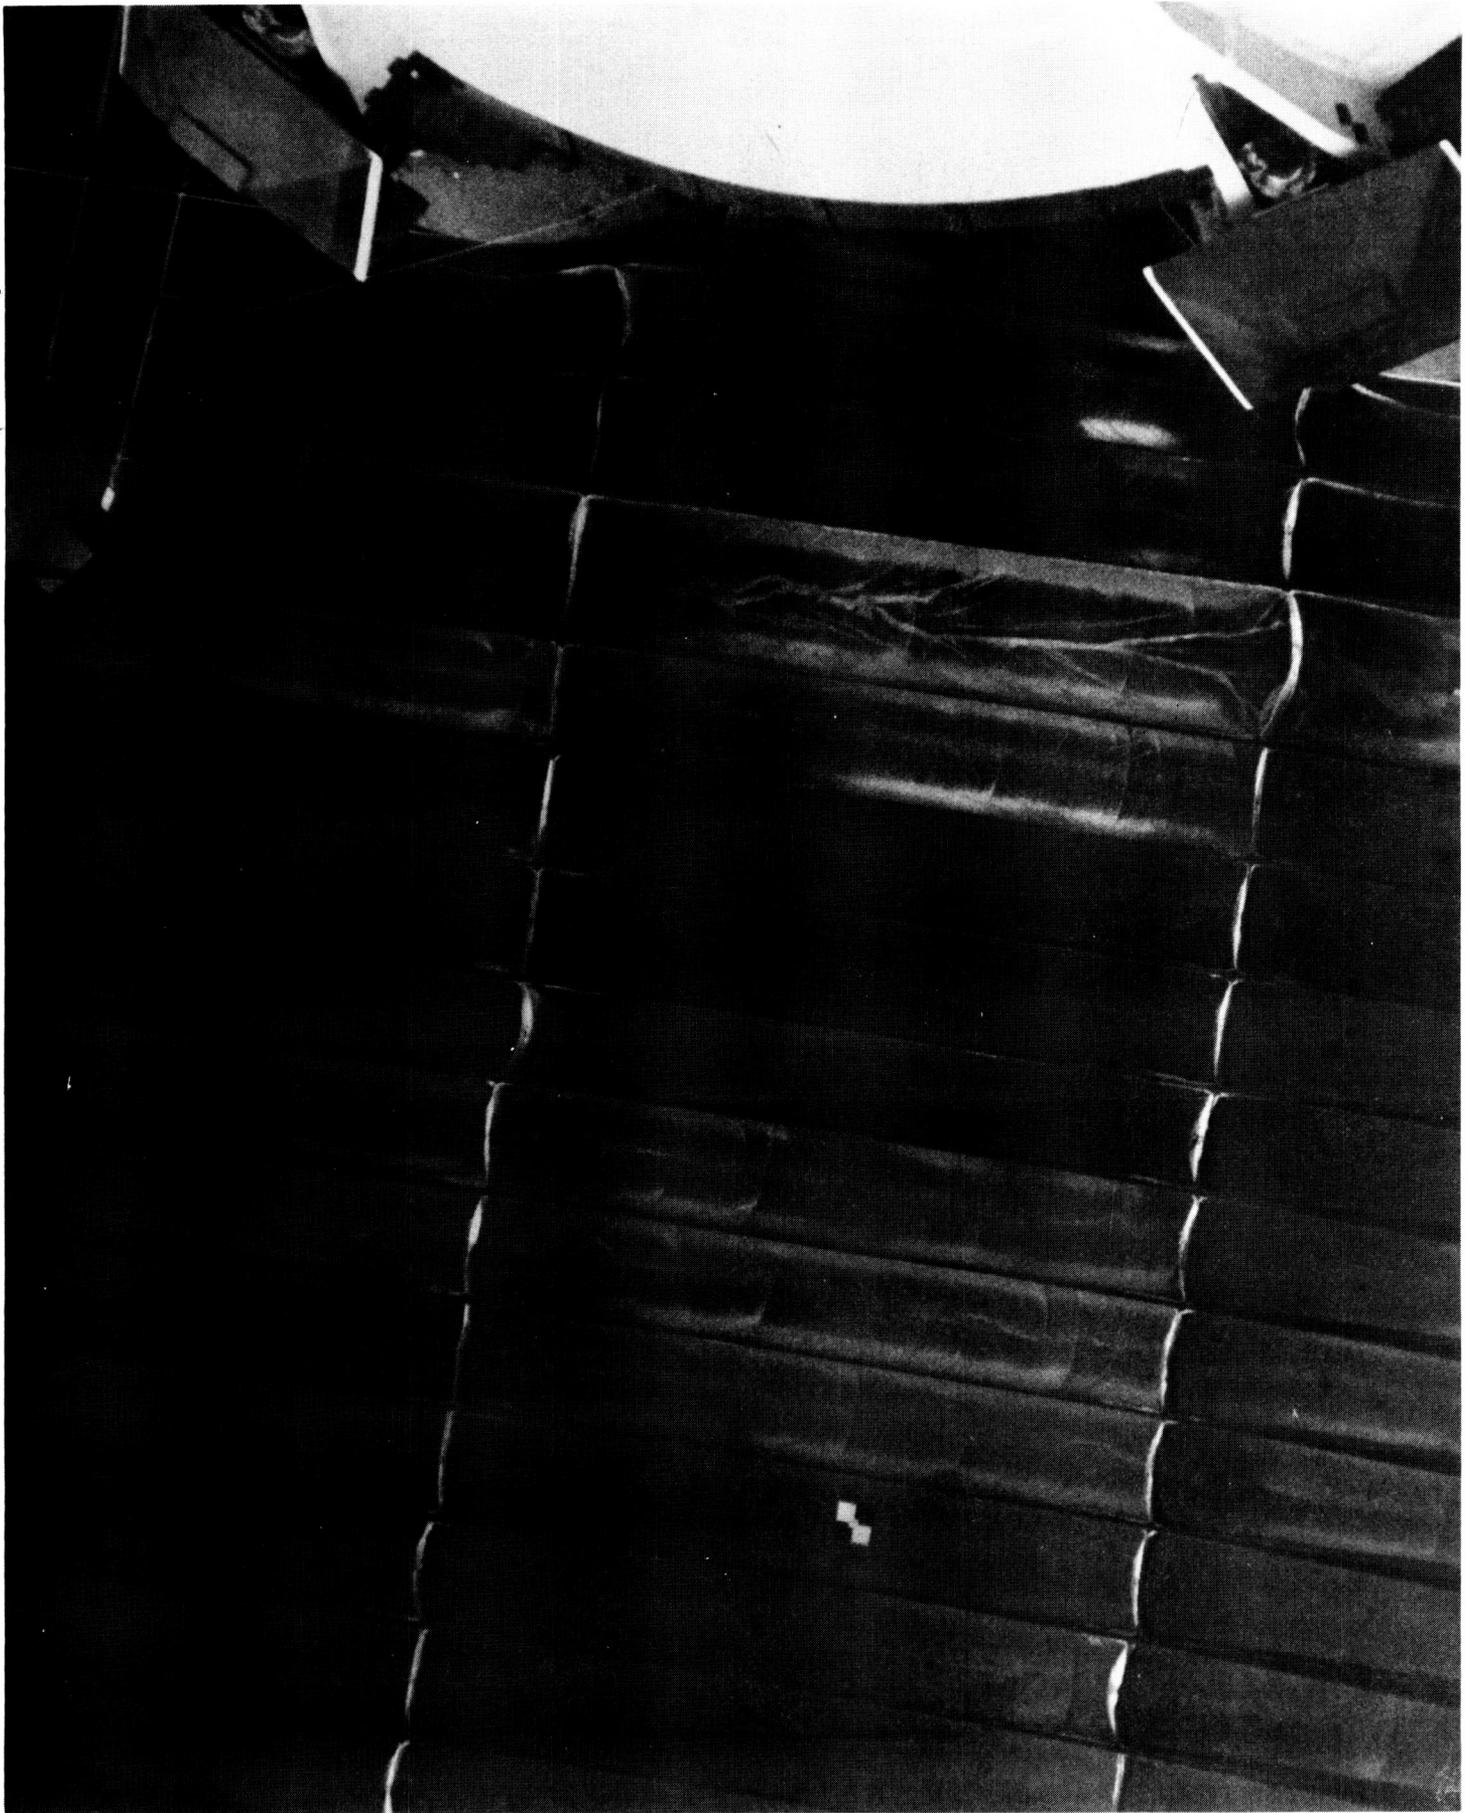
LOOSE OPTICAL TARGET SUBMERGED IN SOUND
SUPPRESSION WATER TROUGH

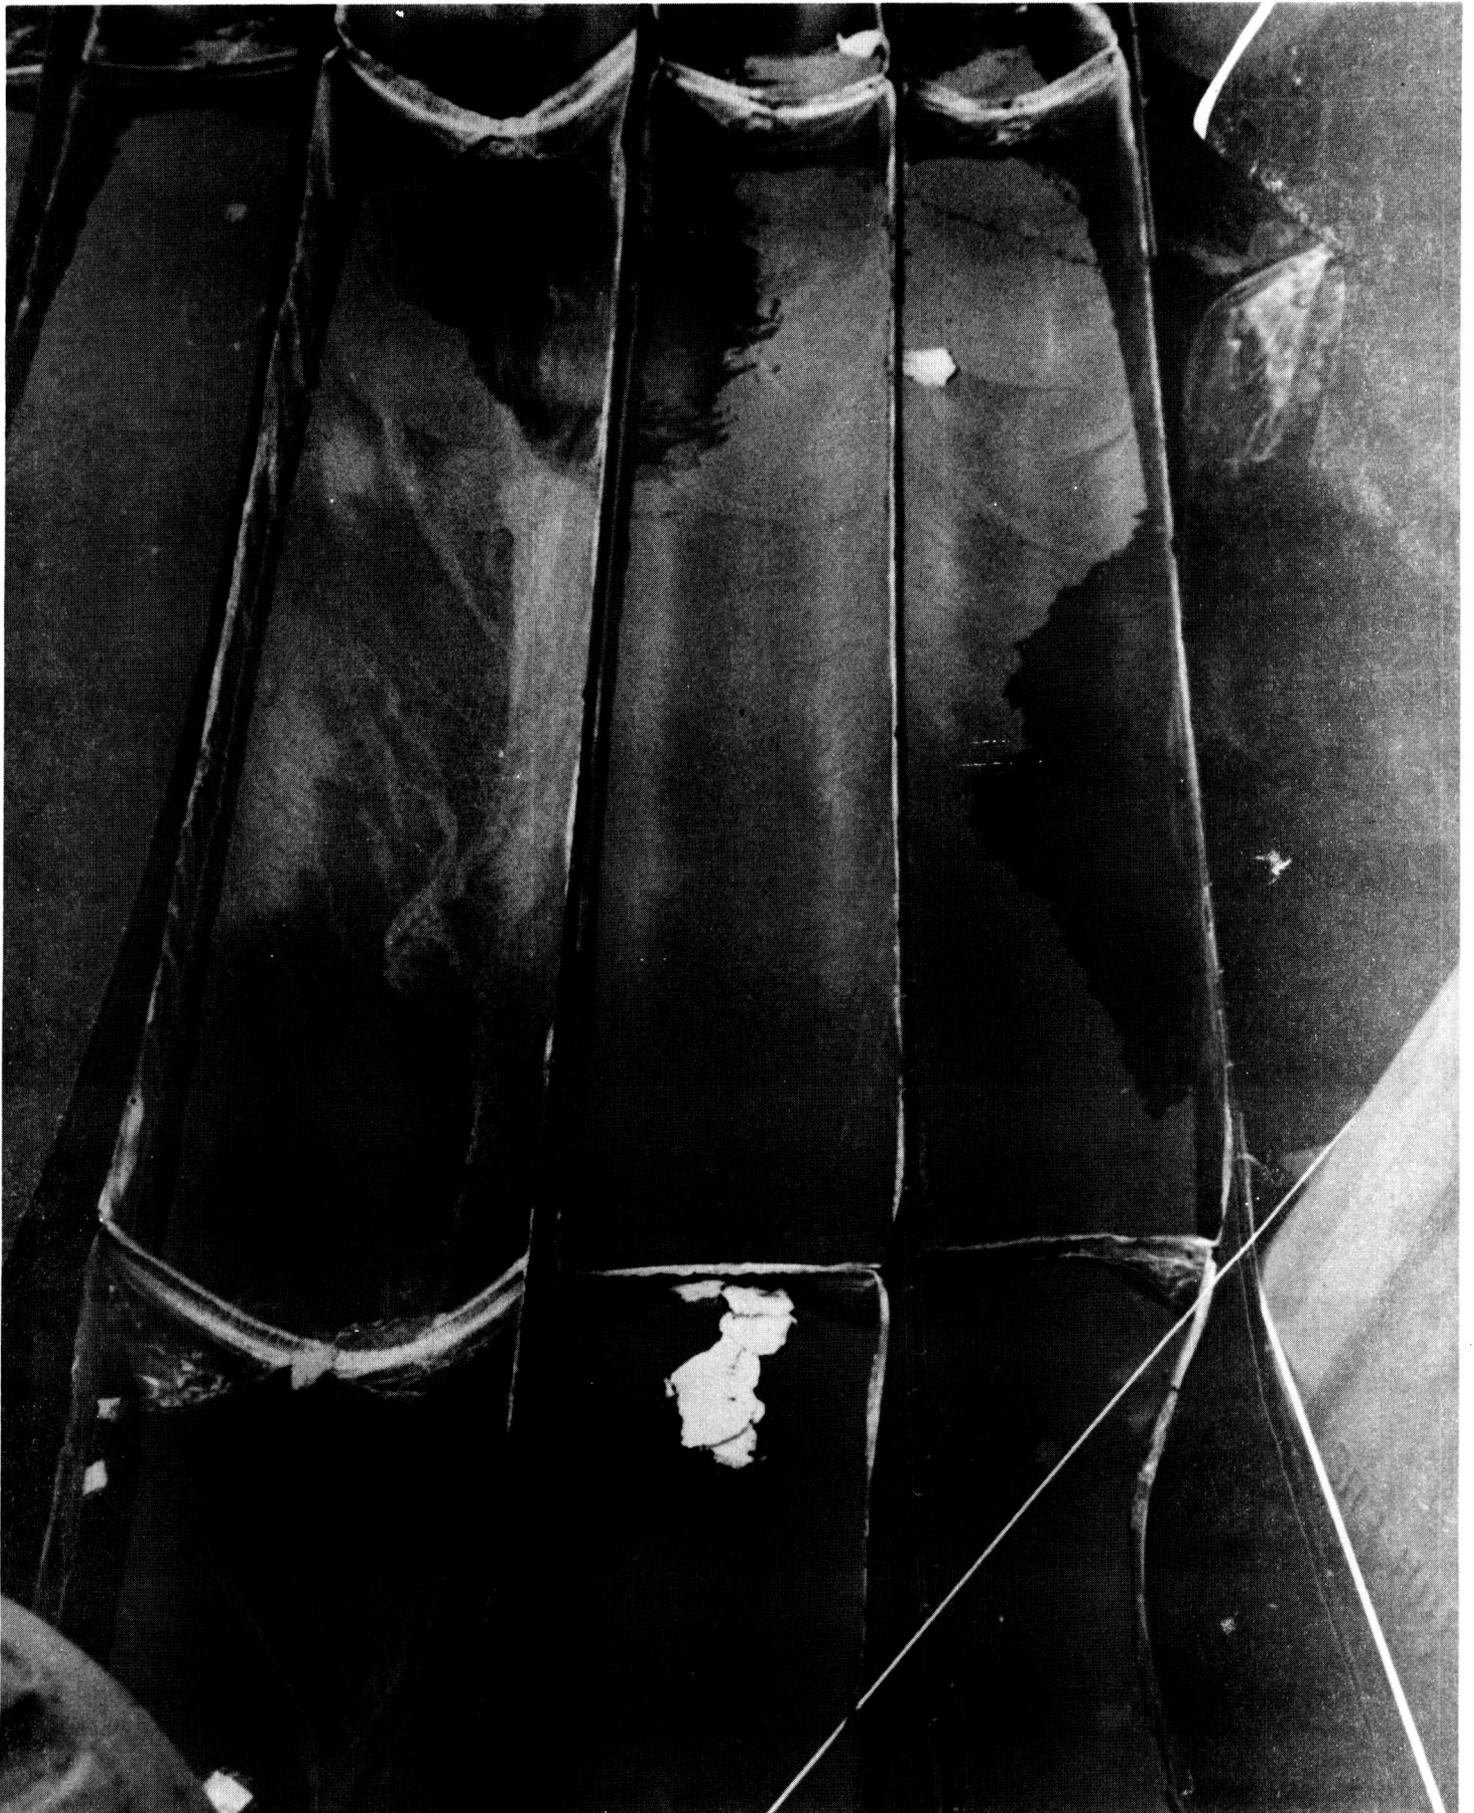
BX-250 FOAM TRIMMINGS FLOAT IN THE SECONDARY SOUND
SUPPRESSION WATER TROUGHS OF BOTH SRB EXHAUST HOLES

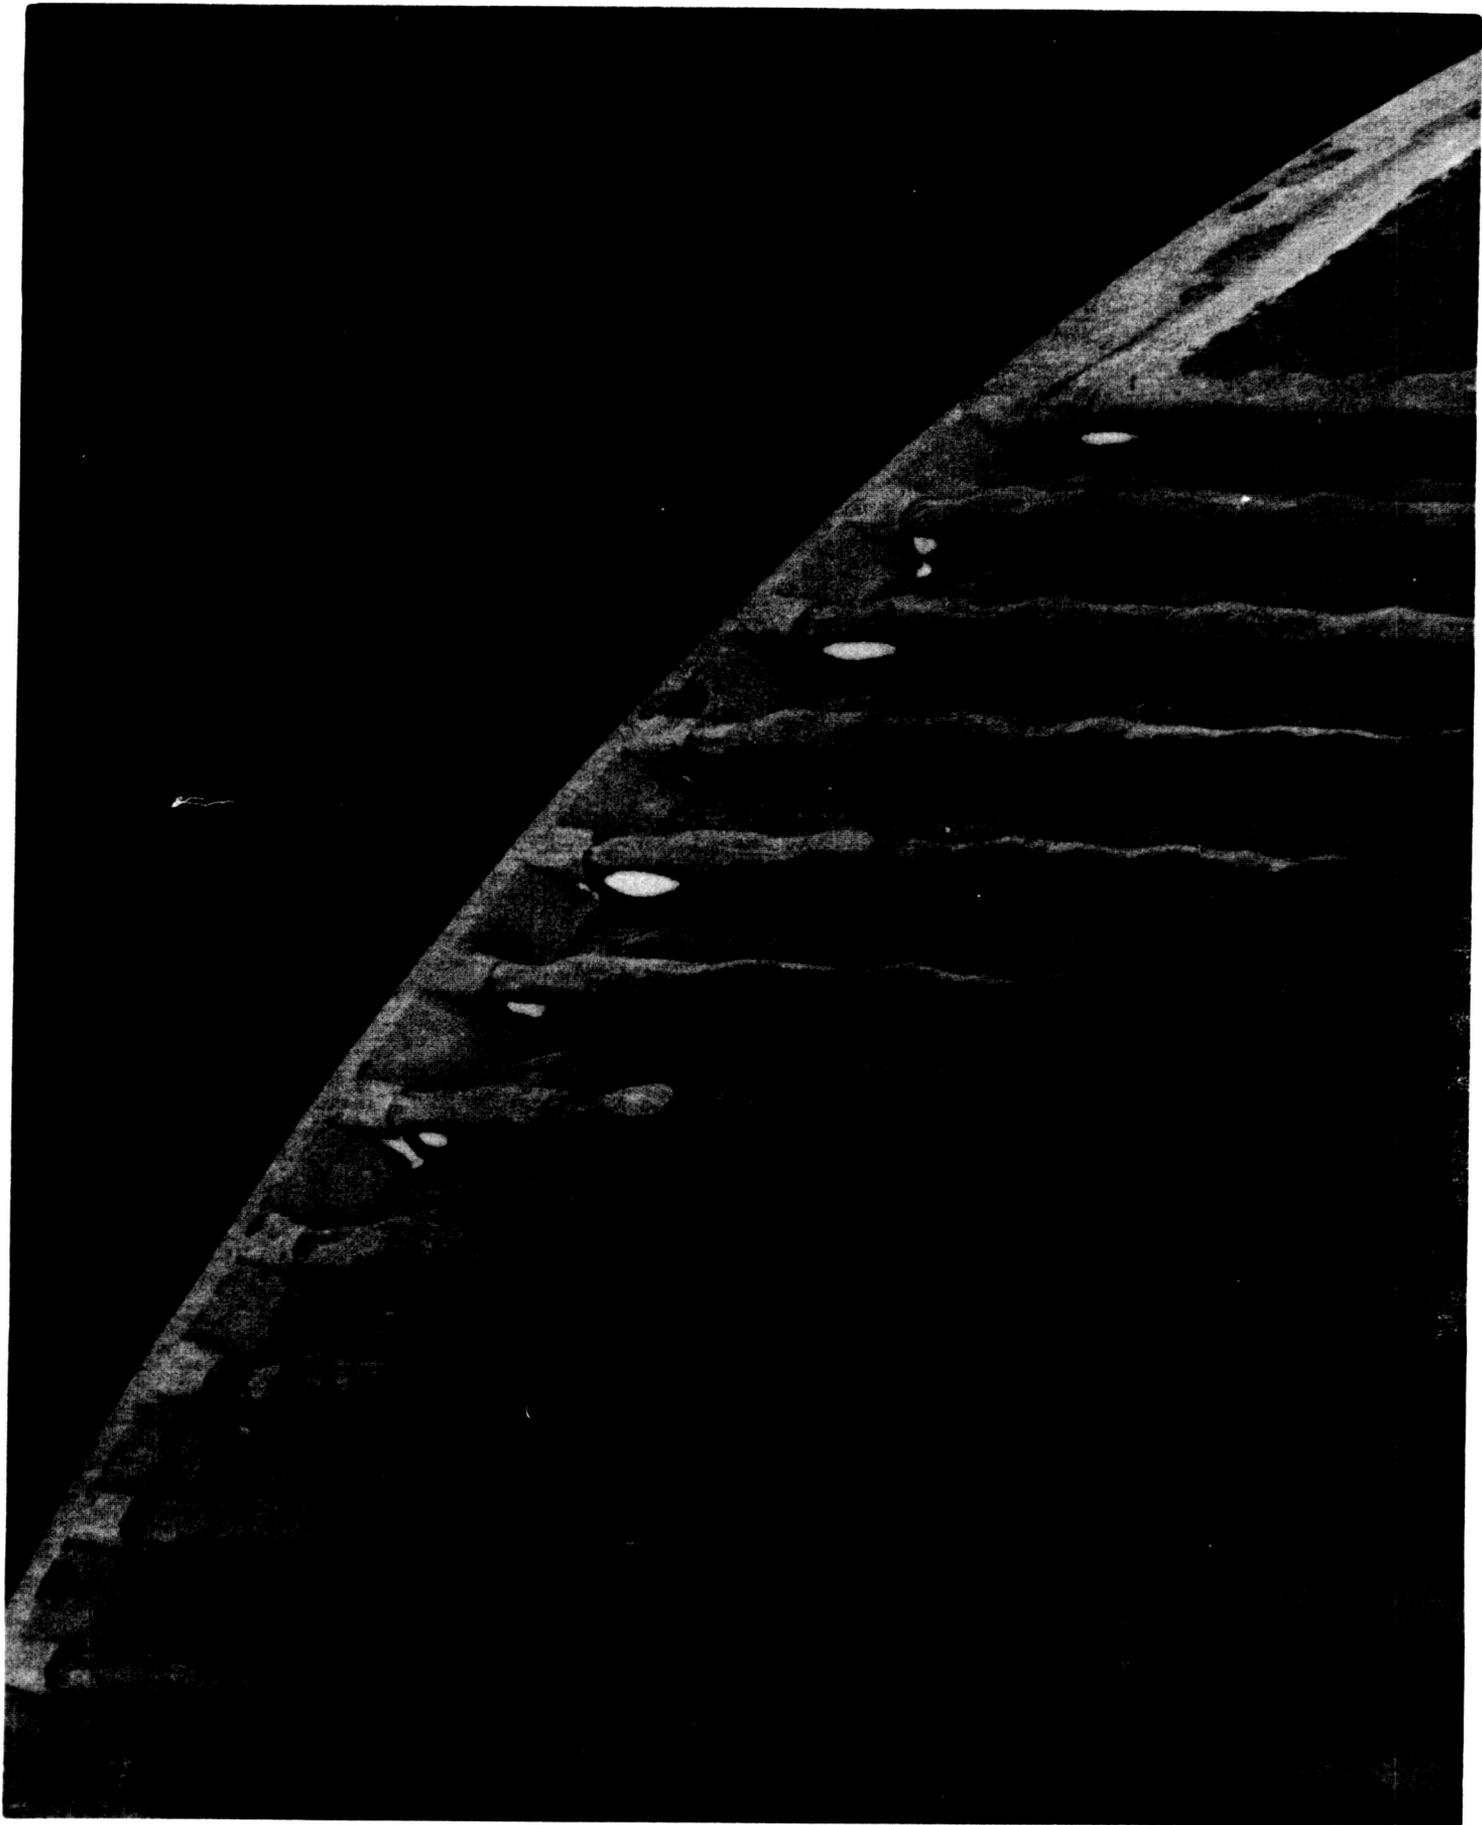
FROST ACCUMULATION AT INTERTANK TO LO2 TANK
INTERFACE FLANGE IN THE -Y-Z QUADRANT

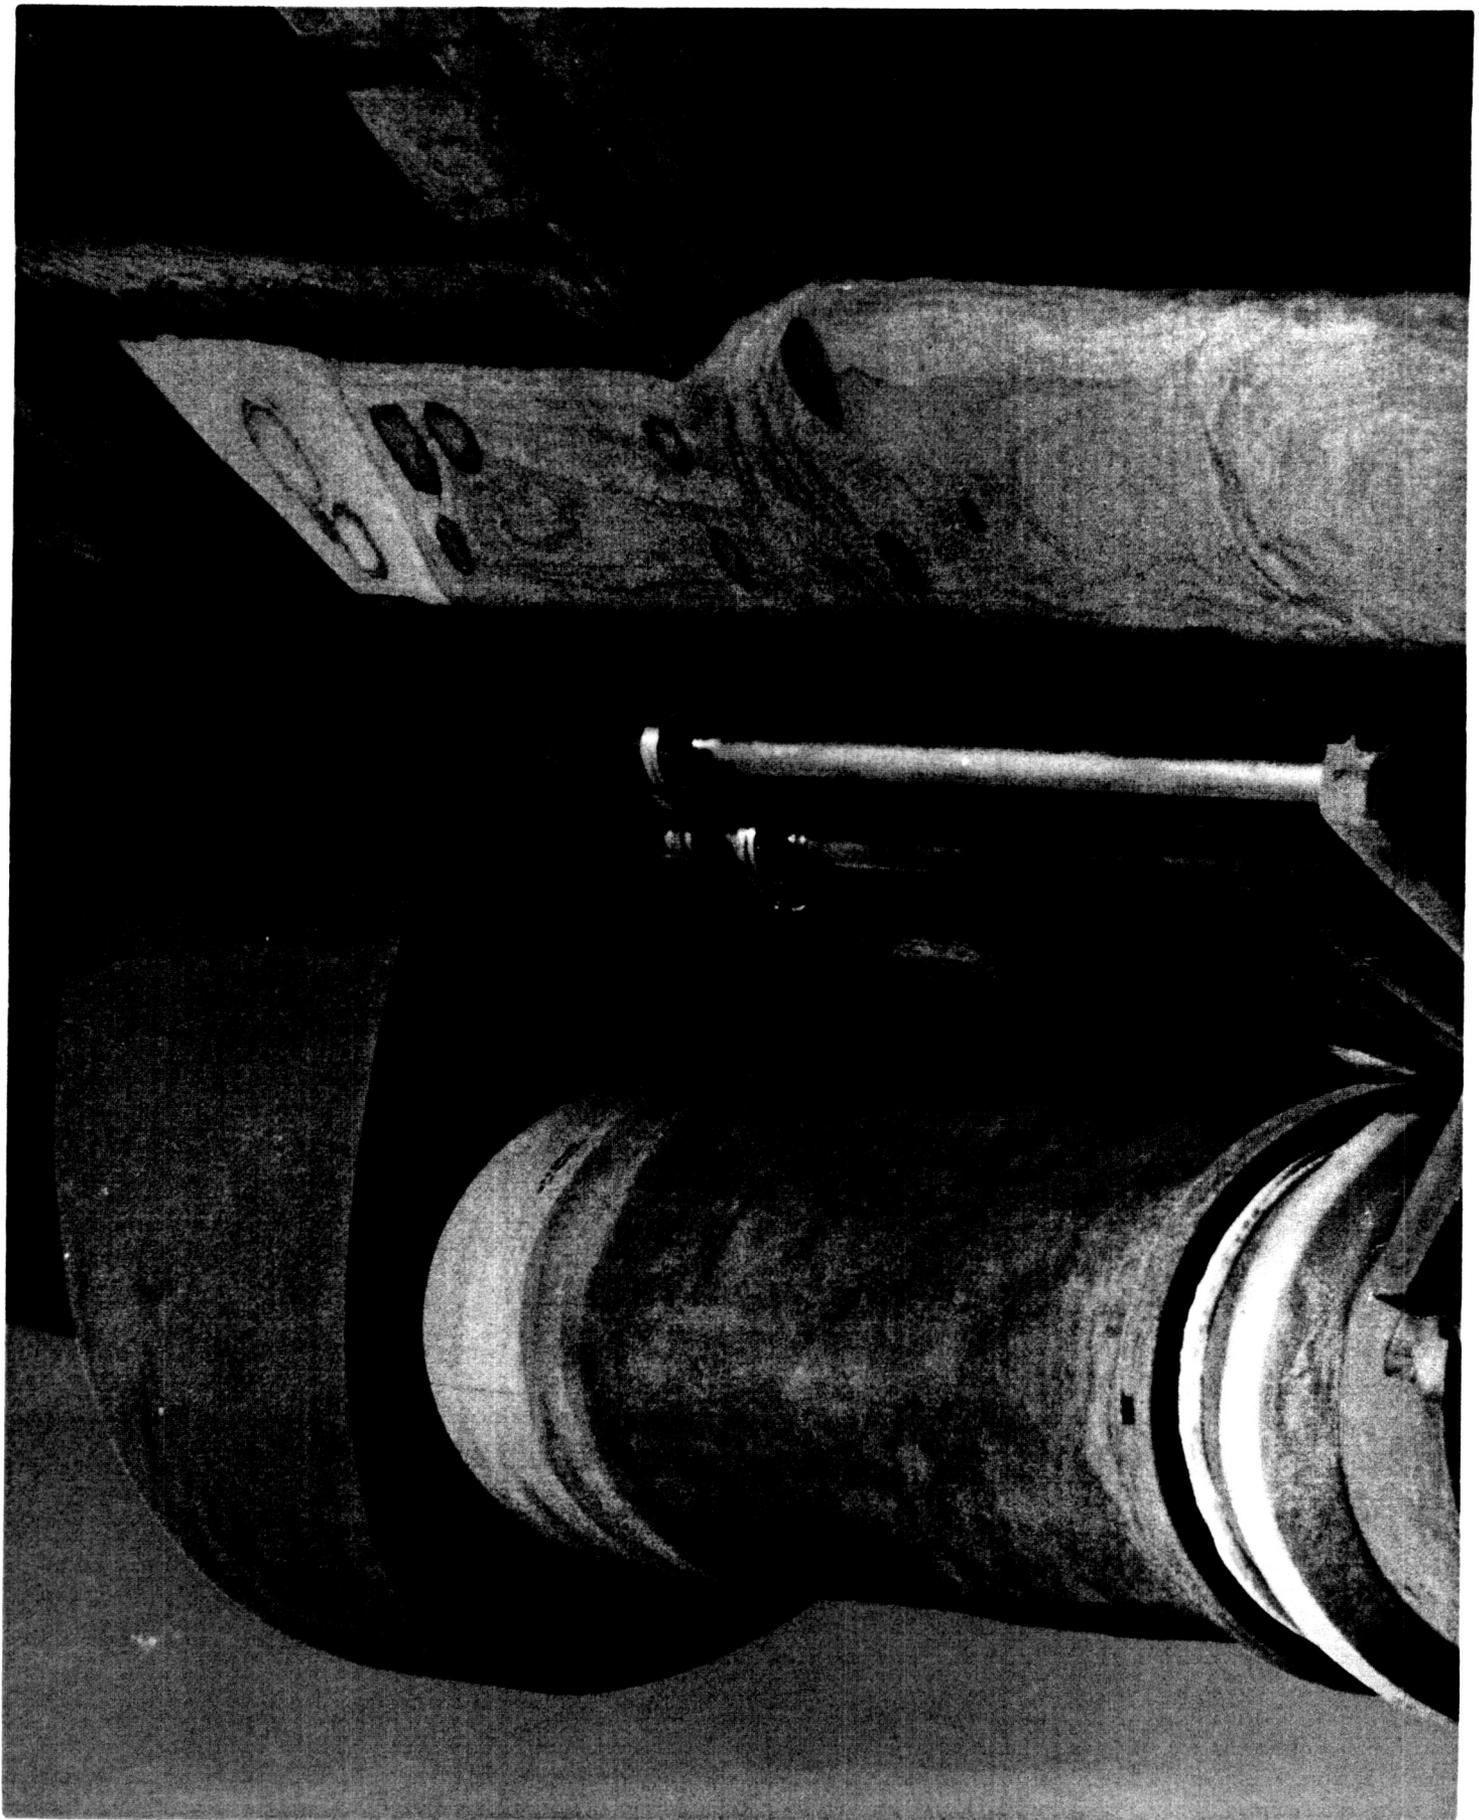
TYPICAL ICE/FROST ACCUMULATION IN
THE LO2 FEEDLINE BELLOWS XT 1106

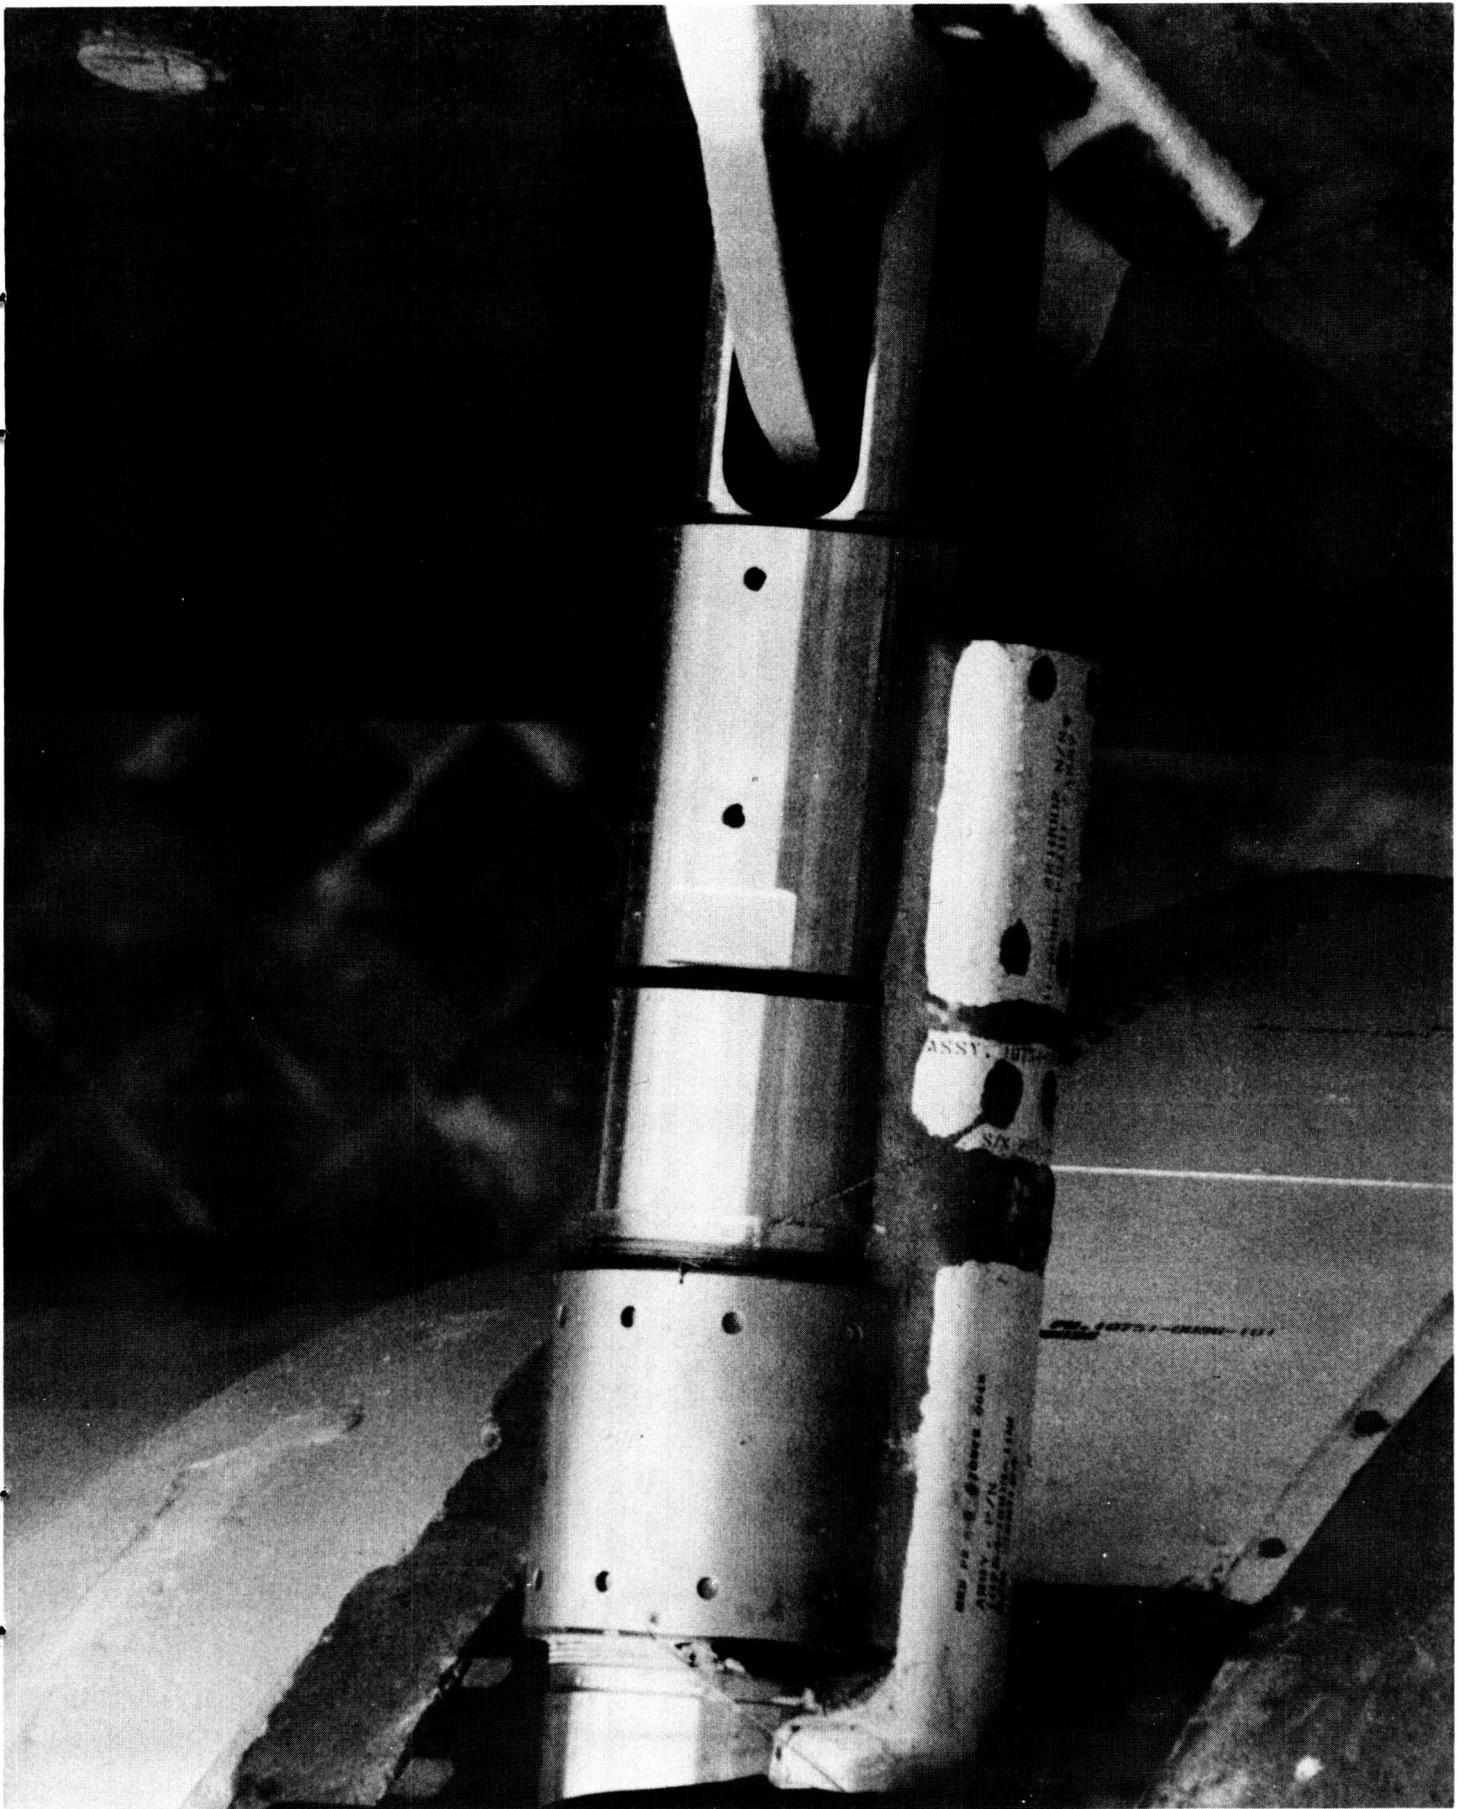
ICE FORMATION ON EB FITTING OUTBOARD TO STRUT PIN HOLE.
ONLY CONDENSATE IS PRESENT ON THE REST OF THE FITTING.
